INVESTIGATION OF A MODIFIED 9CR-1MO (P91) PIPE FAILURE

R. L. Klueh and J. P. Shingledecker

Materials Science and Technology Division

A modified 9Cr-1Mo steel (P91) pipe failure in a feedwater line in a chemical plant was investigated. The failure occurred in the vicinity of an elbow produced with socket welds of the pipe to the elbow. Based on metallography and hardness measurements, it was concluded that failure occurred because of an improper post-weld heat treatment of the socket weldment.

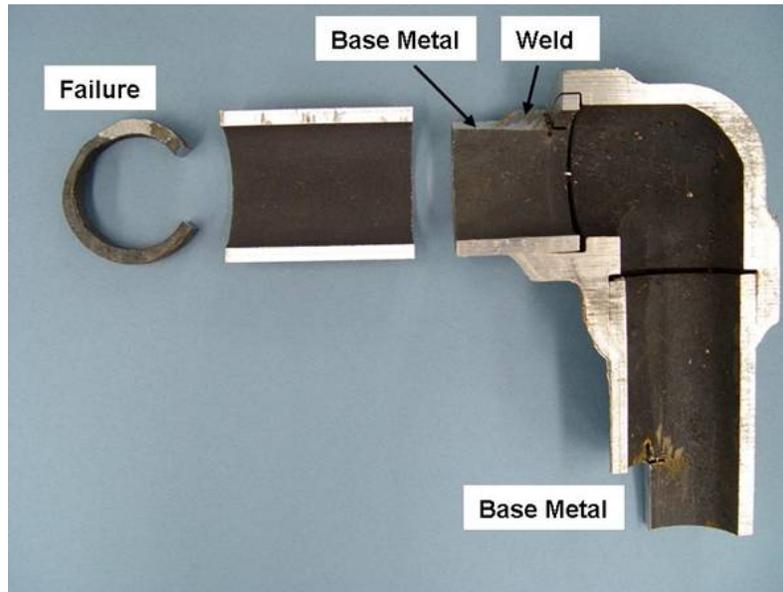
Failure of the 1.5-inch pipe occurred near one of two socket welds that connected the pipe to the elbow in the steam system, which operated at 1762 psig and 325°F (163°C). Since failure occurred in the vicinity of one of the welds, it was assumed that failure was associated with the welding and subsequent post-weld heat treatment (PWHT). Therefore, metallographic examination was carried out (1) on base metal in the 1.5-inch pipe in the unfailed leg of the elbow, (2) on weld metal and base metal of the weld on the leg containing the failure, and (3) on the failure and surrounding base metal. Figure 1 shows the elbow, pipe, and failure after samples for metallography were cut out (no sample was taken from the extra piece of pipe).

Fig. 1. Picture of elbow labeled to show where metallography specimens were obtained.

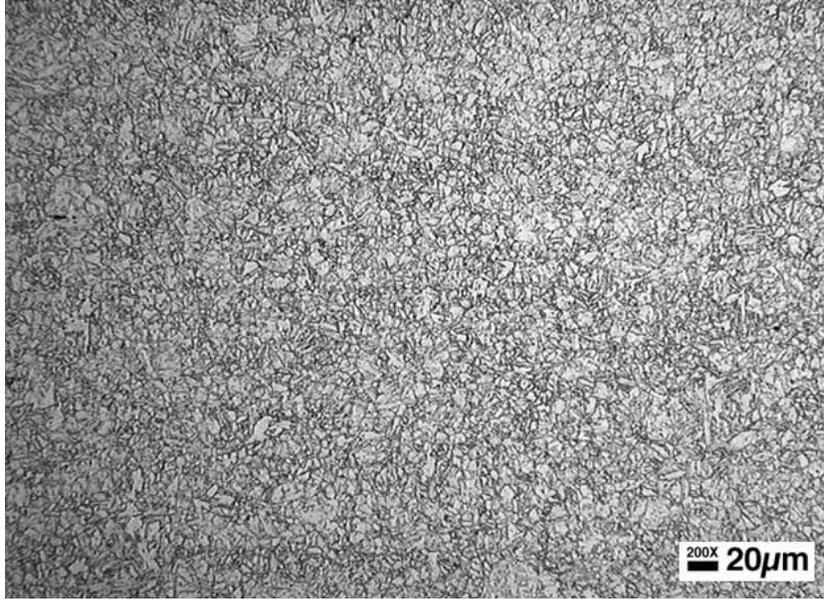
The microstructure of the tube wall in the unfailed leg of the elbow was indicative of tempered martensite with a relatively fine prior-austenite grain size estimated at ASTM No. 9.5–10, which means the average grain diameter was 10–15 μm (Fig. 2). Microhardness was 229 HV. Such grain size and hardness values are typical of normalized-and-tempered modified 9Cr-1Mo steel austenitized at $\approx 1040^\circ\text{C}$ and tempered at $760\text{--}780^\circ\text{C}$, which are typical heat-treatment conditions for modified 9Cr-1Mo steel.^{1,2}

Fig. 2. Base metal microstructure in unfailed leg of the elbow.

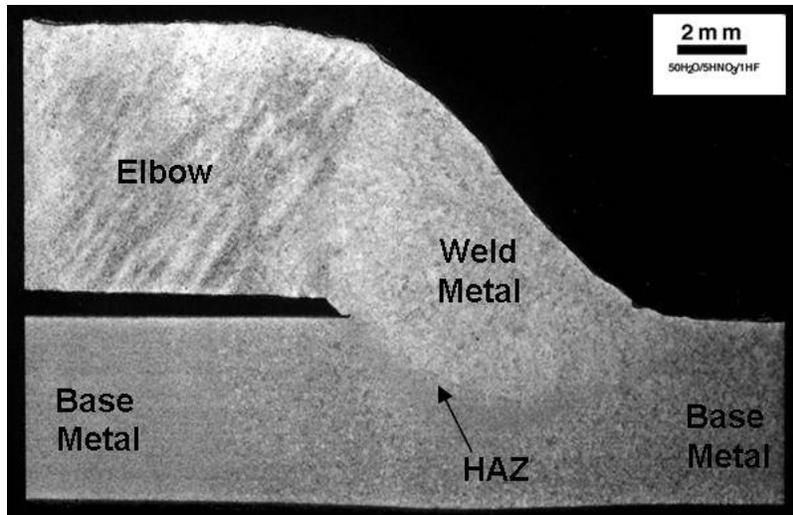
Figure 3 is a low-magnification photomicrograph of the socket weld and surrounding base metal. The heat-affected zone (HAZ) between the weld metal and pipe base metal can be seen in the figure. The microstructures of the weld metal and elbow base metal were martensite, both of which had variable prior-austenite grain sizes (Fig. 4), with an average grain size much larger than that of the base metal in the unfailed leg (Fig. 2).

A significant difference in prior-austenite grain size was observed between the martensitic base metal of the pipe inside the elbow at the greatest distance from the weld (lower left side of Fig. 3) and the base metal just outside the elbow near the weld (lower right side of Fig. 3). The prior-austenite grain size for the pipe outside the elbow was significantly larger (Fig. 5). The small prior-austenite grain size (ASTM No. 9–9.5) at the end of the pipe inside the elbow [Fig. 5(a)] approached that of the tube in the unfailed leg (Fig. 2).

Fig. 3. Low-magnification photomicrograph of the weldment of the P91 tube to the elbow.

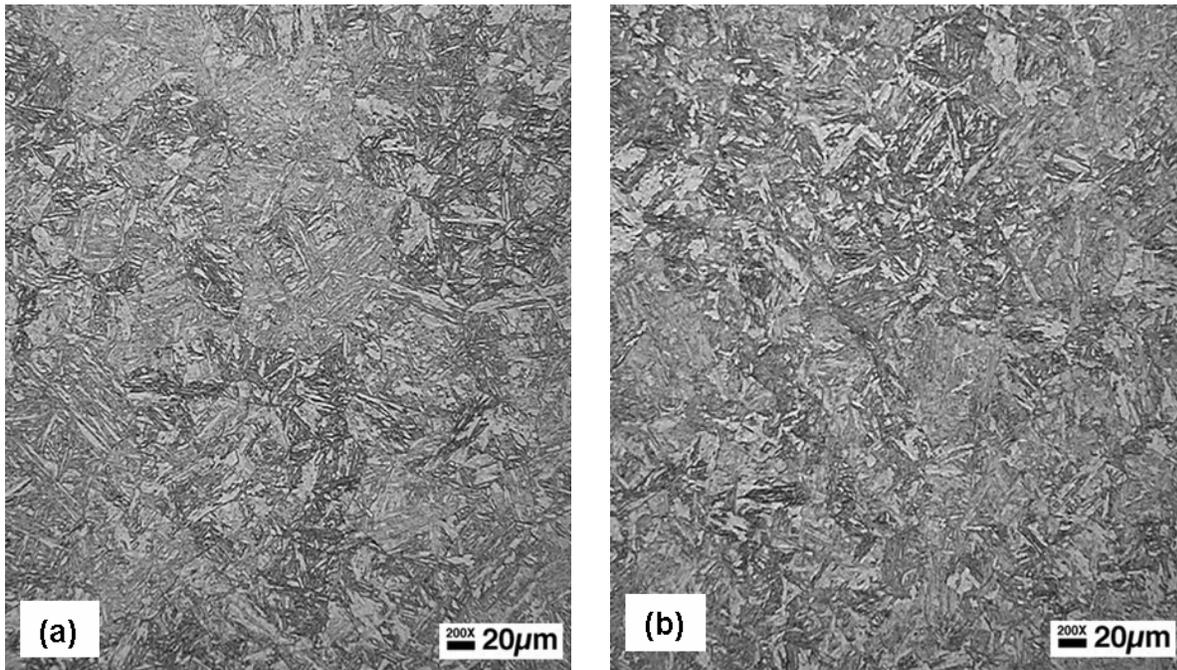
Fig. 4. Martensite microstructure of the (a) elbow (upper left of Fig. 3) and (b) the weld metal that formed the weld from the elbow to the pipe (center of Fig. 3).

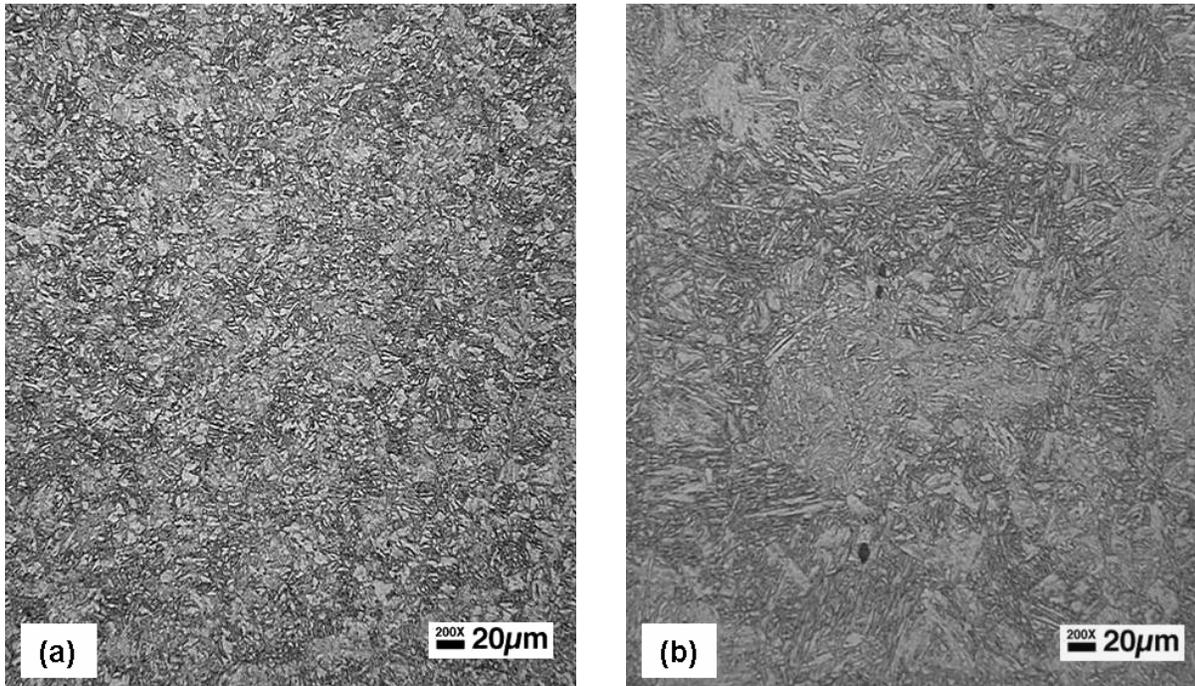
Fig. 5. Base metal of pipe (a) inside the elbow away from the weld (lower left of Fig. 3) and (b) outside the elbow away from the weld (lower right of Fig. 3).

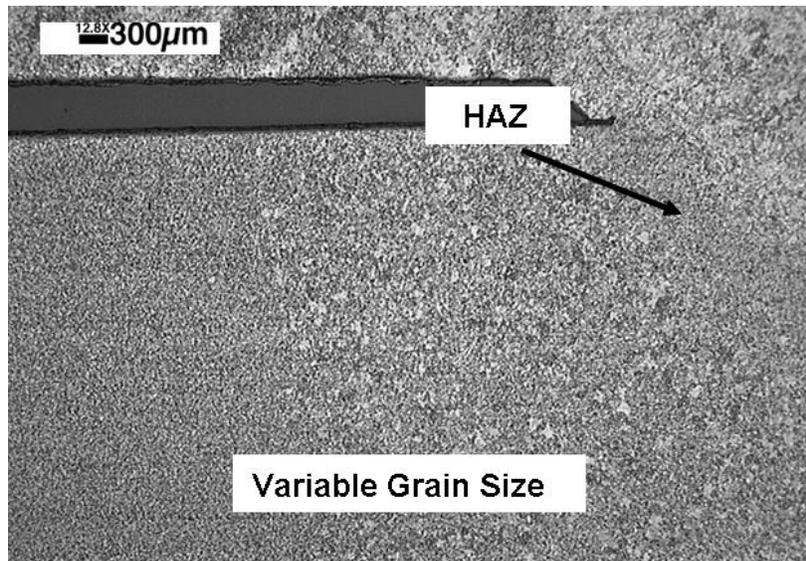
An interesting observation is that there was a variation in prior-austenite grain size of the pipe base metal inside the elbow near the weld. This grain-size change is visible in Fig. 3, but it is more easily delineated at higher magnification in Fig. 6. The grain size of the prior austenite decreased continuously with distance from the HAZ. At some distance from the HAZ as the end of the pipe is approached (lower left of Fig. 3), the grain size decreased to a size approaching that of the pipe in the unfailed leg. From this observation, it was concluded that this base metal was heated above A_3 , the equilibrium temperature at which all of the ferrite transforms to austenite on heating.* This heating most likely occurred during the PWHT, since the extent of the HAZ—the extent of any change in the optical microstructure of the base metal caused by welding alone—can be easily delineated, and this region made up a much smaller area.

Fig. 6. Photomicrograph of pipe base metal inside elbow in vicinity of the weld HAZ showing the decrease in prior-austenite grain size with increasing distance from the HAZ.

The variation of the prior-austenite grain size in the pipe inside the elbow (Fig. 6) can be explained by the fact that the PWHT would have been done by applying heat at the OD. Therefore, not all of the pipe inside the elbow would experience the same temperature as the pipe OD and the pipe outside of the elbow, since the objective was to PWHT the weld metal and the base metal adjacent to the weld. Although the hardnesses indicate that the temperature of the entire pipe inside the elbow exceeded A_3 , the part farthest from the heat source with the finer grain size was not heated to a sufficiently high temperature to grow

excessively large grains as was possible in the region immediately adjacent to the weld, which was heated to a much higher temperature. An A_3 temperature of 885–910°C is expected, depending on the composition.^{1,2}

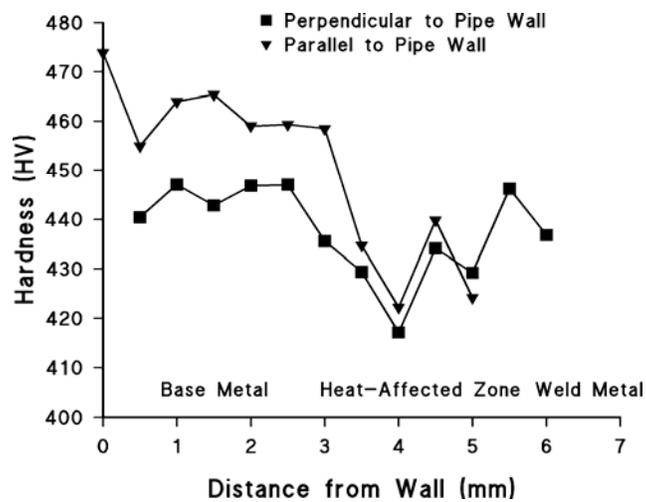
Vickers microhardness profiles were determined by making measurements across part of the weld and through the HAZ toward the pipe wall (vertical direction in Fig. 3), as well as across part of the weld and through the HAZ along the pipe wall (horizontal in Fig. 3). These profiles were typical of a ferritic/martensitic steel weldment, displaying a soft zone in the HAZ (Fig. 7). The difference in base metal hardness in the two profiles indicates a possible hardness gradient across the pipe wall, since the hardness traverse along the pipe wall was closer to the pipe OD than the pipe base-metal hardness measured in the vertical traverse. There was quite good agreement of the hardness in the softer zone of the HAZ for the two profiles (Fig. 7). Note the high hardness of the base metal in the two profiles (over 440 HV). The average base metal hardness at the end of the pipe inside the elbow (lower left side of Fig. 3) was 459 HV. The average weld metal hardness was 440 HV, and the average hardness of the elbow material was 443 HV. All these hardness values are indicative of untempered martensite.¹ For comparison, the hardness of the base metal of the pipe in the unfailed leg was 229 HV, a value typical of a normalized-and-tempered modified 9Cr-1Mo steel.^{1,2}

Fig. 7. Microhardness profiles across base metal, HAZ, and weld metal of the weldment taken perpendicular to and along the pipe wall.

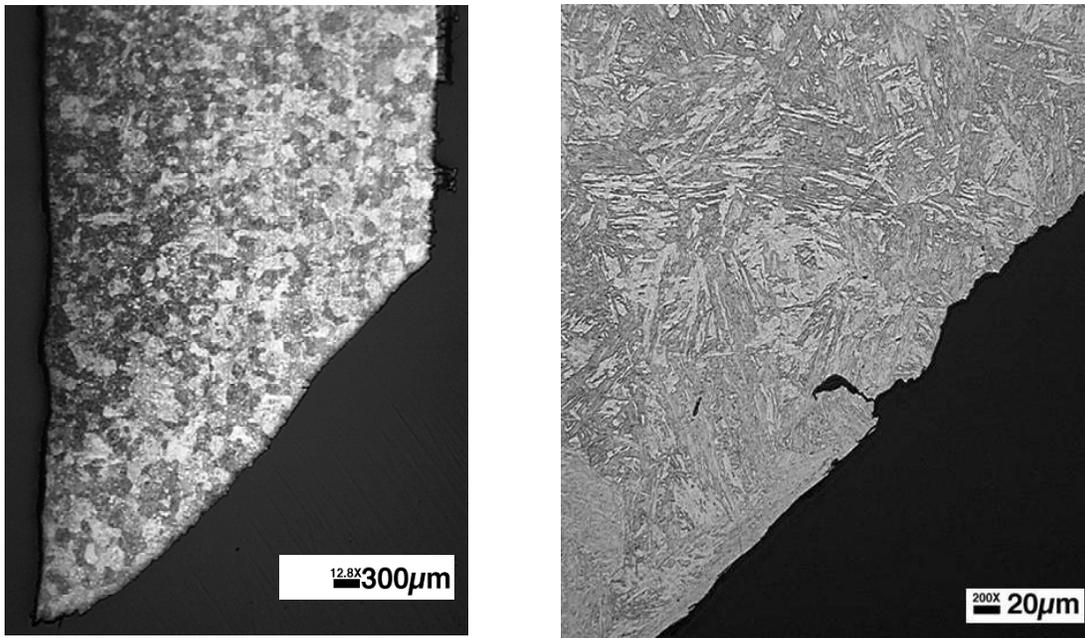
Examination of the cross section of the failure indicated that the fracture occurred with little ductility and may have propagated along prior-austenite grain boundaries—at least in some areas (Fig. 8). On the ID near the fracture, there were indications that small cracks had formed beneath the oxide surface and penetrated a short distance into the pipe (Fig. 9). Some of these cracks contained oxide. The oxide on the ID [Fig. 10(a)] near the fracture was about four-times thicker than on the OD [Fig. 10(b)], about 0.04-inch and 0.01-inch thick, respectively.

Average hardness of the base metal near the fracture surface was about 460 HV. This was again much harder than the base metal in the pipe of the unfailed leg (229 HV), and it is indicative of untempered martensite.¹

Fig. 8. Photomicrographs of the cross section of the pipe failure at two different magnifications.

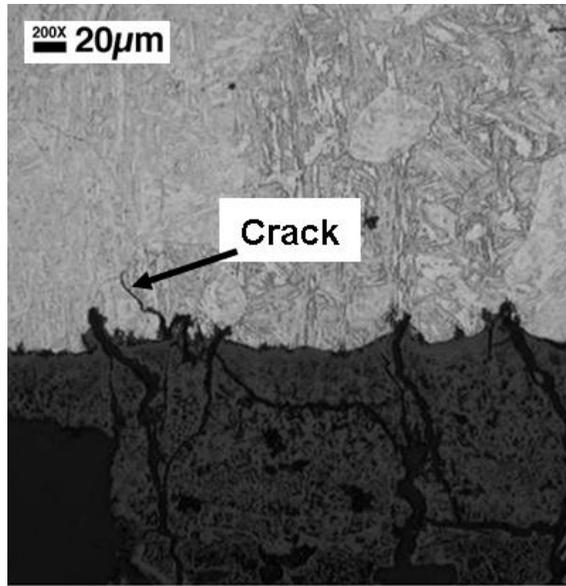
Fig. 9. Photomicrograph that shows cracks on prior-austenite grain boundaries below a thick oxide scale on the inside diameter of the P91 pipe.

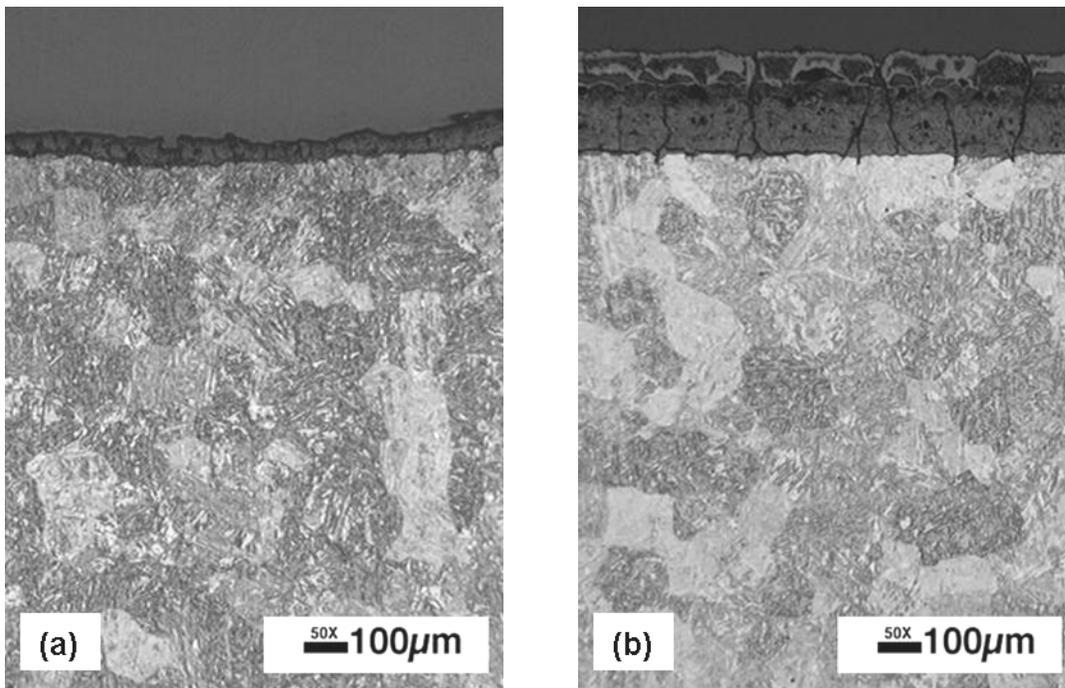
Fig. 10. Photomicrographs that show the difference in oxide thickness on the (a) outside diameter and (b) on the inside diameter of the pipe near the failure.

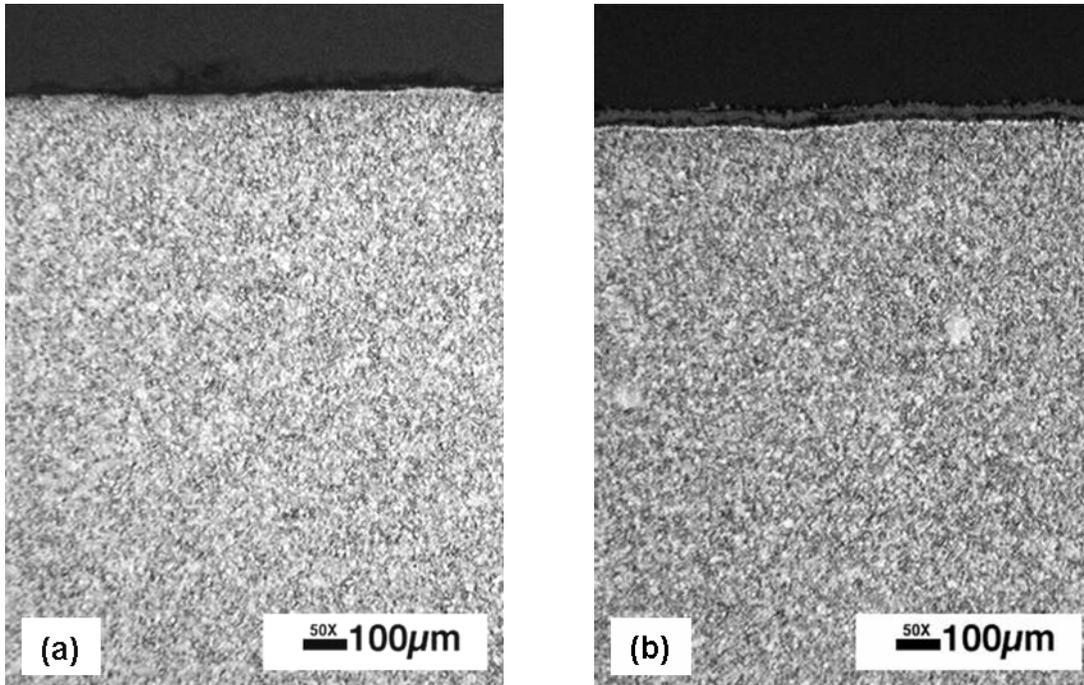
The oxide thickness near the fracture was considerably larger than that on the base metal of the unfailed pipe (Fig. 11), suggesting that the failed area had experienced a significantly higher temperature. In addition to the difference in oxide thicknesses on the base metal of the two legs that is evident by comparison of Figs. 10 and 11, the large difference in prior-austenite grain size is also obvious from this comparison. An ASTM grain size number of 3.5–4.5 was estimated for the base metal near the fracture, which would mean an average grain diameter of around 100 μm . This compares to an average grain diameter of 10–15 μm for the base metal in the unfailed leg.

Fig. 11. Photomicrographs that show the difference in oxide thickness on the (a) outside diameter and (b) the inside diameter of the unfailed pipe.

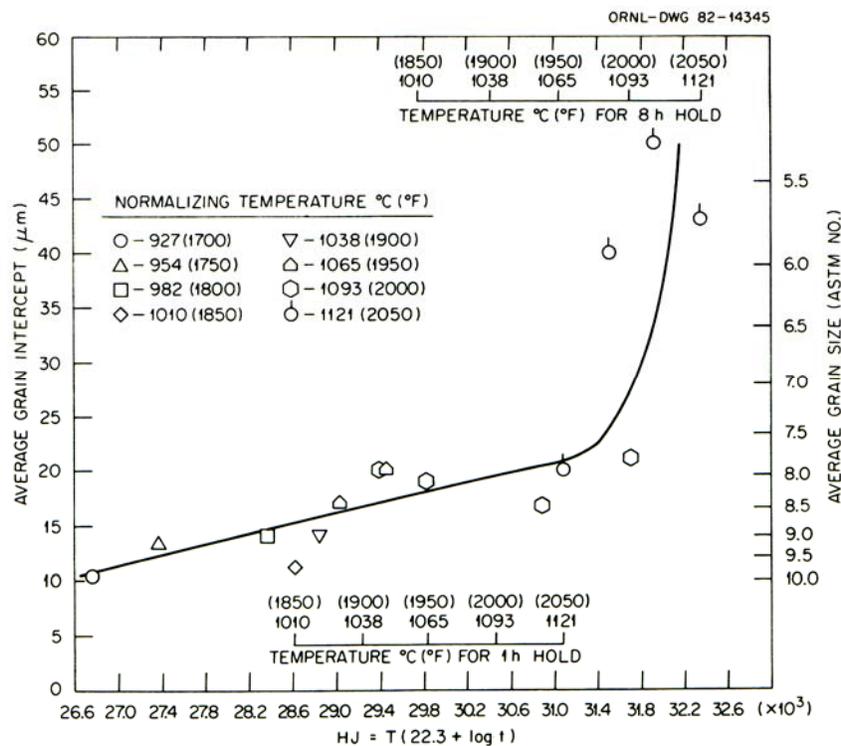
Figure 12 shows a plot of prior-austenite grain size vs. the Holloman-Jaffe (H-J) parameter for different austenitizing times and temperatures. If the estimated grain size of the base metal near the fracture is correct ($\approx 100 \mu\text{m}$), then the temperature during the PWHT exceeded 1100°C and may have approached 1200°C. The estimated grain size for the base metal in the pipe of the unfailed leg agrees with that for the typical austenitization temperature of about 1 h at 1040°C.

Fig. 12. The effect of austenitization temperature and time on austenite grain size.¹
