INVESTIGATION OF A MODIFIED 9CR-1MO (P91) PIPE FAILURE

April 2006

R. L. Klueh and J. P. Shingledecker

Materials Science and Technology Division

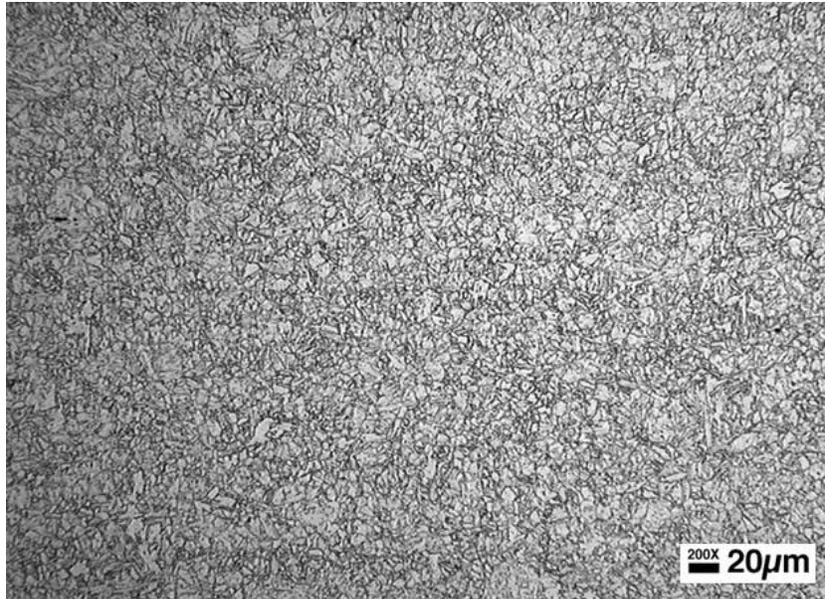
The microstructure of the tube wall in the unfailed leg of the elbow was indicative of tempered martensite with a relatively fine prior-austenite grain size estimated at ASTM No. 9.5–10, which means the average grain diameter was 10–15 μm (Fig. 2). Microhardness was 229 HV. Such grain size and hardness values are typical of normalized-and-tempered modified 9Cr-1Mo steel austenitized at $\approx 1040^\circ\text{C}$ and tempered at $760\text{--}780^\circ\text{C}$, which are typical heat-treatment conditions for modified 9Cr-1Mo steel.^{1,2}

Fig. 2. Base metal microstructure in unfailed leg of the elbow.

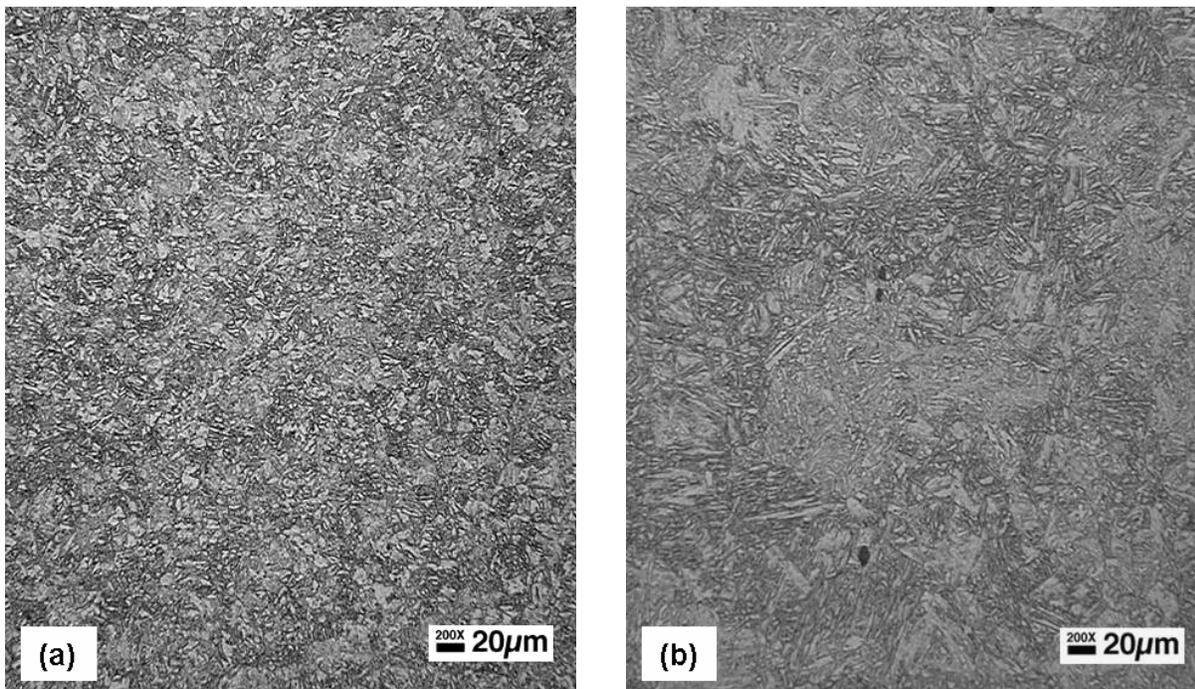
A significant difference in prior-austenite grain size was observed between the martensitic base metal of the pipe inside the elbow at the greatest distance from the weld (lower left side of Fig. 3) and the base metal just outside the elbow near the weld (lower right side of Fig. 3). The prior-austenite grain size for the pipe outside the elbow was significantly larger (Fig. 5). The small prior-austenite grain size (ASTM No. 9–9.5) at the end of the pipe inside the elbow [Fig. 5(a)] approached that of the tube in the unfailed leg (Fig. 2).

Fig. 5. Base metal of pipe (a) inside the elbow away from the weld (lower left of Fig. 3) and (b) outside the elbow away from the weld (lower right of Fig. 3).

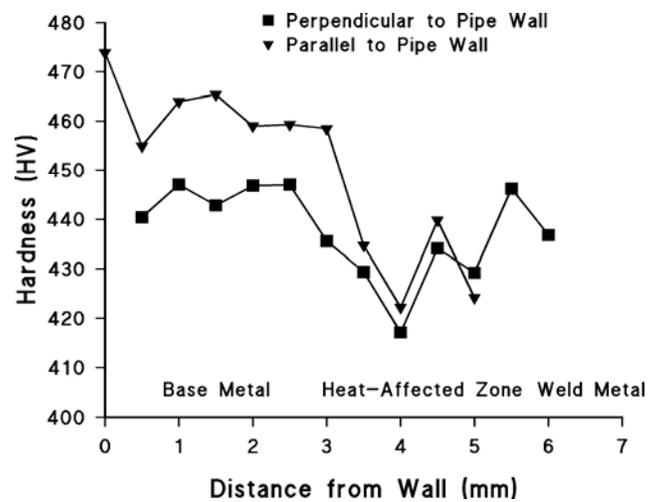
Vickers microhardness profiles were determined by making measurements across part of the weld and through the HAZ toward the pipe wall (vertical direction in Fig. 3), as well as across part of the weld and through the HAZ along the pipe wall (horizontal in Fig. 3). These profiles were typical of a ferritic/martensitic steel weldment, displaying a soft zone in the HAZ (Fig. 7). The difference in base metal hardness in the two profiles indicates a possible hardness gradient across the pipe wall, since the hardness traverse along the pipe wall was closer to the pipe OD than the pipe base-metal hardness measured in the vertical traverse. There was quite good agreement of the hardness in the softer zone of the HAZ for the two profiles (Fig. 7). Note the high hardness of the base metal in the two profiles (over 440 HV). The average base metal hardness at the end of the pipe inside the elbow (lower left side of Fig. 3) was 459 HV. The average weld metal hardness was 440 HV, and the average hardness of the elbow material was 443 HV. All these hardness values are indicative of untempered martensite.¹ For comparison, the hardness of the base metal of the pipe in the unfailed leg was 229 HV, a value typical of a normalized-and-tempered modified 9Cr-1Mo steel.^{1,2}

Fig. 7. Microhardness profiles across base metal, HAZ, and weld metal of the weldment taken perpendicular to and along the pipe wall.

The hardness values measured for the pipe near the fracture and in the vicinity of the weld, the weld metal, the elbow adjacent to the weld, and the pipe adjacent to the weld inside the elbow were all > 400 HV, which is the expected hardness of untempered martensite in modified 9Cr-1Mo steel.¹ This conclusion is corroborated by comparing it to the hardness of 229 HV for the pipe in the other leg of the elbow, which is the magnitude of hardness typically found in normalized-and-tempered modified 9Cr-1Mo steel using recommended heat treatment practices.^{1,2}

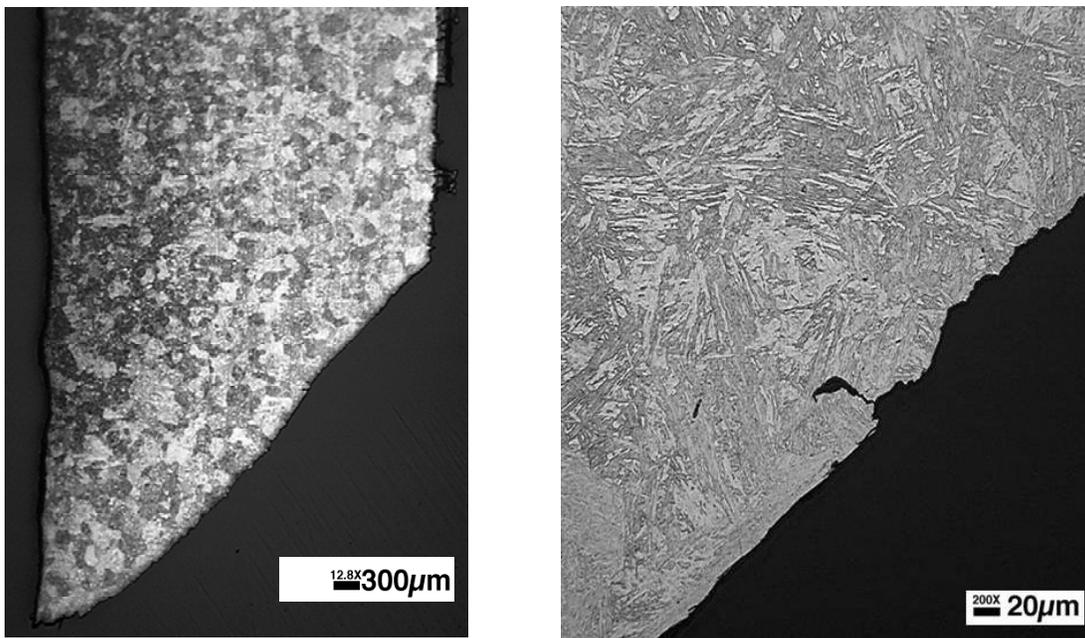
Examination of the cross section of the failure indicated that the fracture occurred with little ductility and may have propagated along prior-austenite grain boundaries—at least in some areas (Fig. 8). On the ID near the fracture, there were indications that small cracks had formed beneath the oxide surface and penetrated a short distance into the pipe (Fig. 9). Some of these cracks contained oxide. The oxide on the ID [Fig. 10(a)] near the fracture was about four-times thicker than on the OD [Fig. 10(b)], about 0.04-inch and 0.01-inch thick, respectively.

Fig. 8. Photomicrographs of the cross section of the pipe failure at two different magnifications.

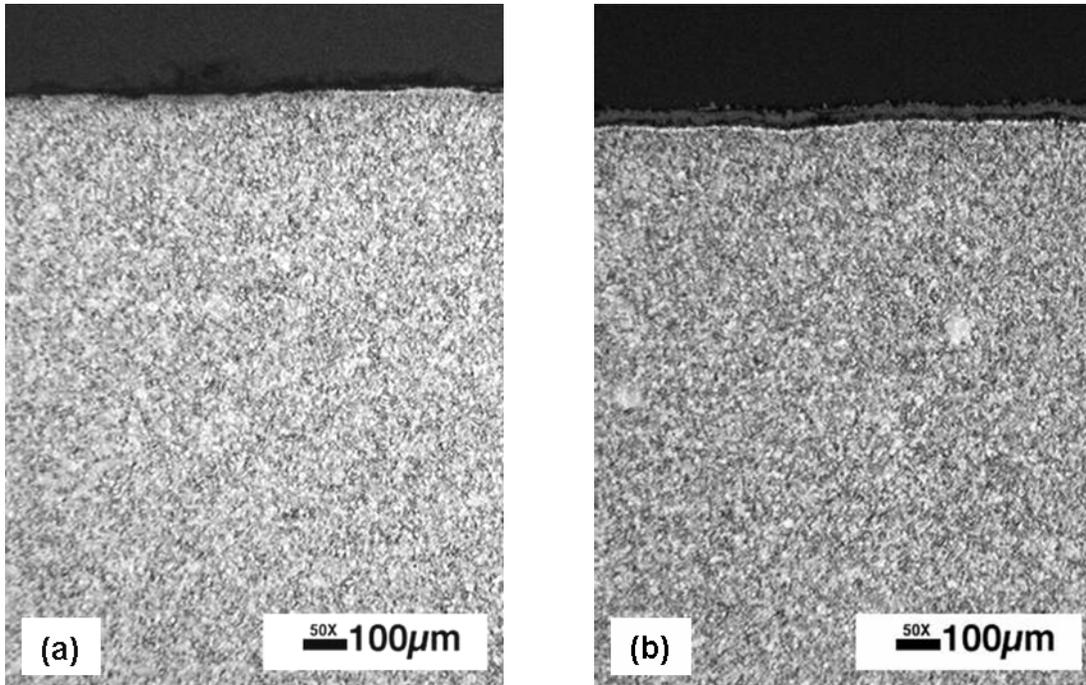
The oxide thickness near the fracture was considerably larger than that on the base metal of the unfailed pipe (Fig. 11), suggesting that the failed area had experienced a significantly higher temperature. In addition to the difference in oxide thicknesses on the base metal of the two legs that is evident by comparison of Figs. 10 and 11, the large difference in prior-austenite grain size is also obvious from this comparison. An ASTM grain size number of 3.5–4.5 was estimated for the base metal near the fracture, which would mean an average grain diameter of around 100 μm . This compares to an average grain diameter of 10–15 μm for the base metal in the unfailed leg.

Fig. 11. Photomicrographs that show the difference in oxide thickness on the (a) outside diameter and (b) the inside diameter of the unfailed pipe.
