Wear Analysis of Wind Turbine Gearbox Bearings

March 31, 2010

**P. J. Blau, L.R. Walker, H. Xu, R. Parten, J. Qu, and T. Geer
Materials Science and Technology Division
Oak Ridge National Laboratory**

Final report

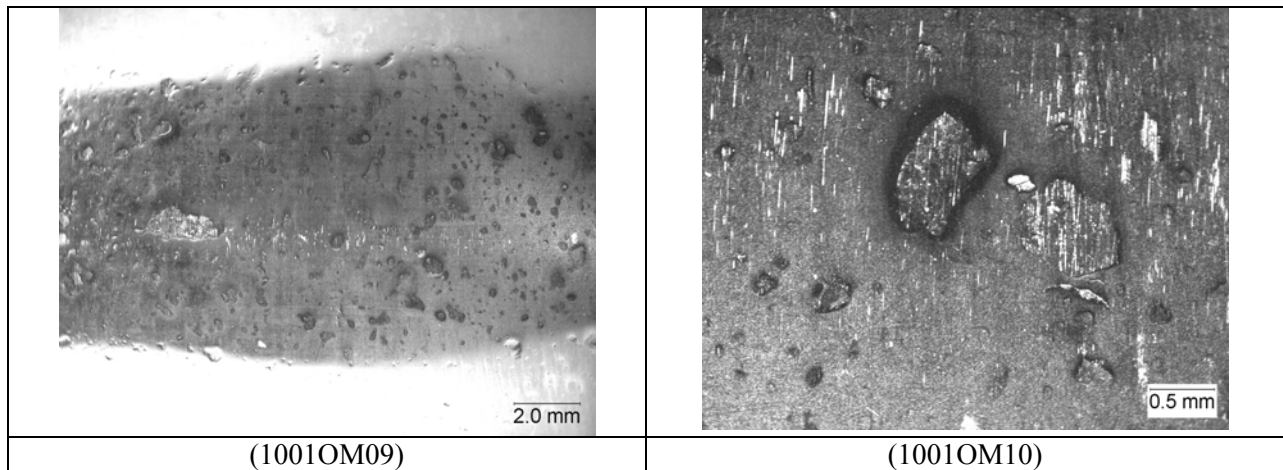
(1001OM09) MacI of embedded debris particles and indentations on the surface of a rolling element removed from the 16 roller complement that was less damaged. The axis of the roller is approximately horizontal.

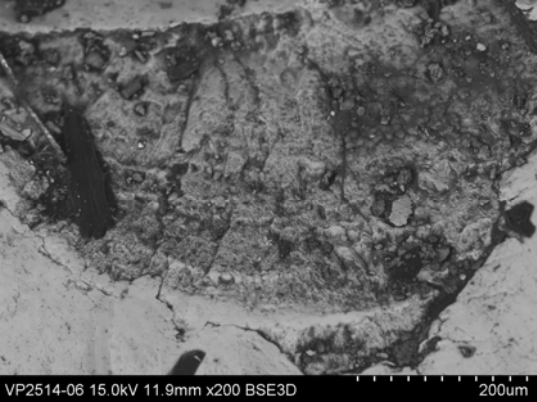
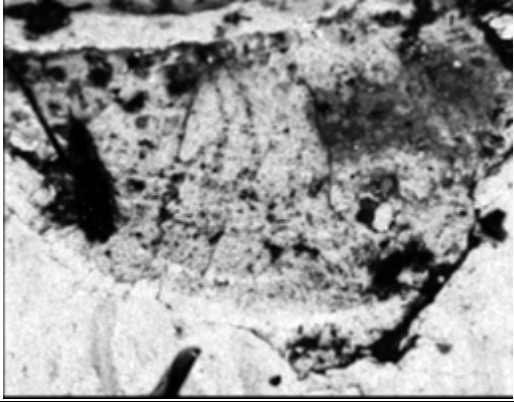
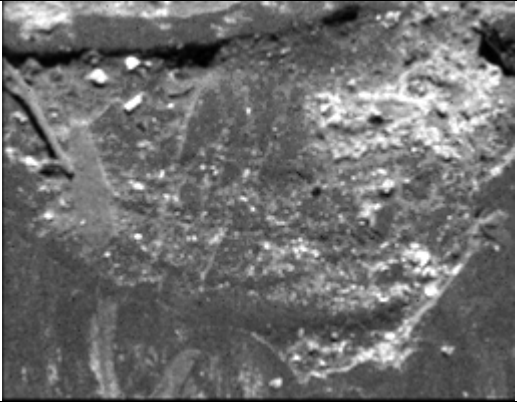
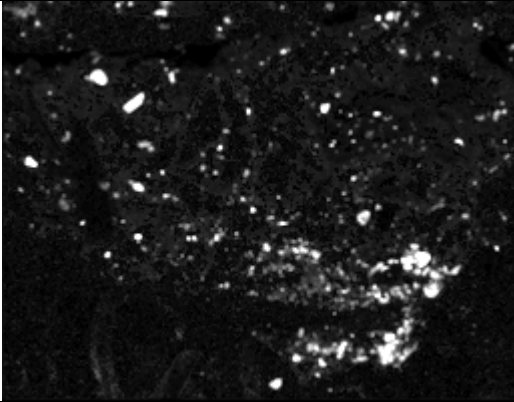
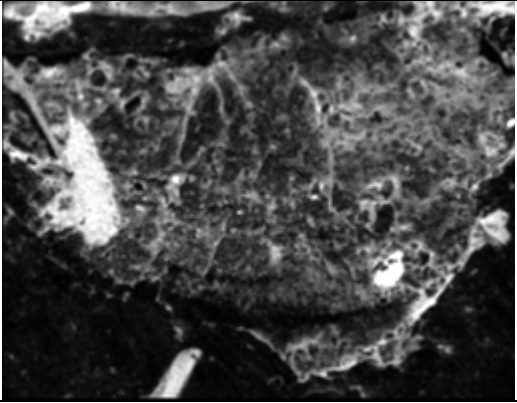
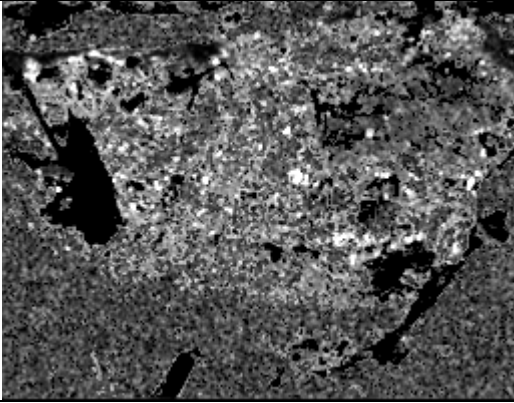
The first image presented below is a BSE image of a relatively large spalled area (1001EM01). Atomic number contrast causes heavier elements, like iron and copper, to appear brighter in the image. Conversely, oxides and organic residues containing carbon, appear darker. The figures that follow the BSE image are EDX maps of the same area and at the same magnification. They were obtained by accumulating signals of specific characteristic x-ray energies for more than 30 minutes on the same area. Maps are shown for iron (Fe), oxygen (O), silicon (Si), carbon (C), and copper (Cu). Maps were also obtained for Al, Mn, Zn, Ca, K, Na, Mg, Ba, and Cl, but are not shown here. In these long-counting-time maps, the brighter the area on the image, the higher the concentration of the given element. Darkest areas are depleted in the element being recorded. Relative to the areas surrounding the spall, the Fe in the bottom of the spall is depleted. That low area could be filled with lubricant residues or wear debris from elsewhere in the bearing. O is concentrated in the granular deposit in the upper right-hand corner of the depression and is probably associated with oxides. Si seems localized into a few bright particles which also indicate oxygen. Therefore, they may be silica. C is located at the upper left of the spall, suggesting an organic constituent. It is too large to be a carbide from the microstructure of the alloy because the carbides are typically round and micrometer-sized. The copper may have come from the bronze bearing cage, but patterns on an EDX map for zinc did not correspond one-to-one with the bright spots for copper, suggesting a different source than the cage.

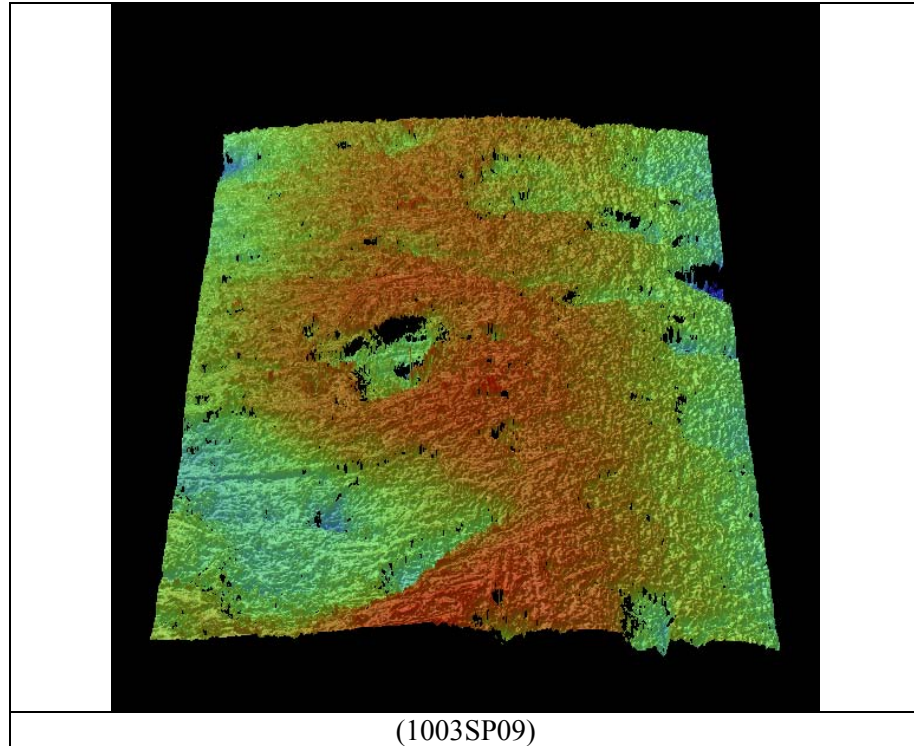
(1003SP09) 3D reconstruction of the surface of a cylindrical roller such as that profiled in 1003SP06 and 1003SP08.

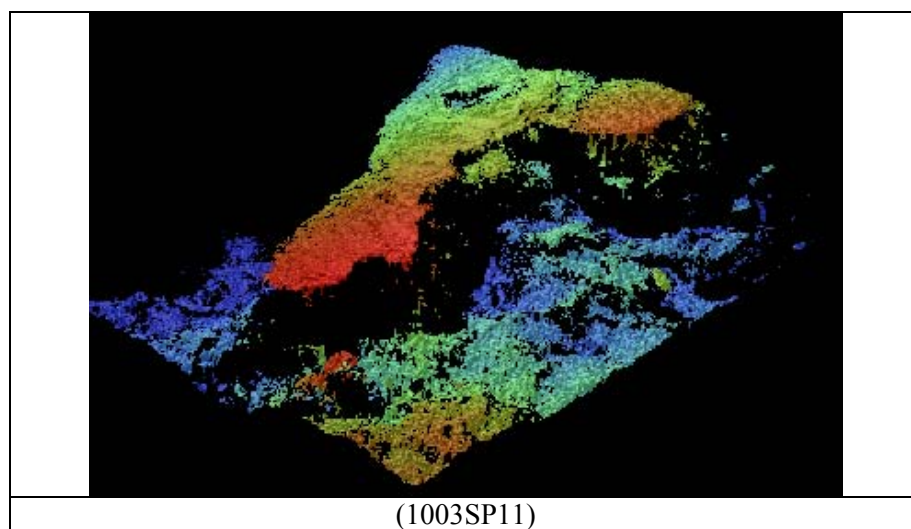
(1003SP11) 3D reconstruction of an embedded metallic particle on the surface of a separator. In terms of altitude, red color is highest, yellow is lower, then green and blue.
