Sister Rod Nondestructive Examination Final Report

Spent Fuel and Waste Disposition

***December 21, 2018
SFWD-SFWST-2017-000003 Rev. 1
(M2SF-17OR010201021)
ORNL/SPR-2017/484 Rev. 1
(ORNL/SPR-2018/801)***

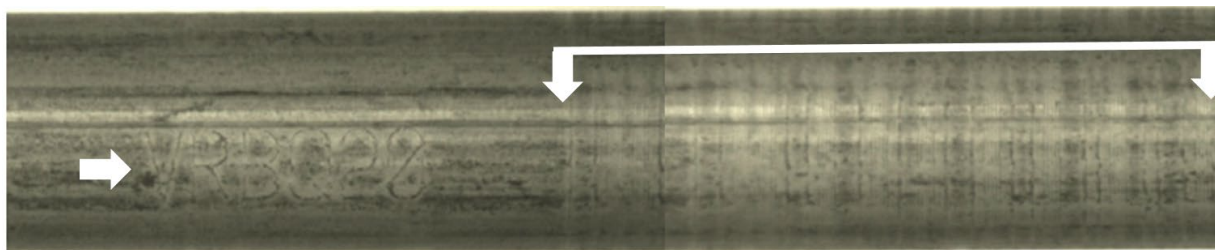
Figure 1. Example of Visible Rod Labeling and Bar Coding (Partial Shown).

Two images — 3F9N05-2017050901-A000_D3811_S768.jpg and 3F9N05-2017050901-A000_D3771_S753.jpg — are stitched together. Although these images are from the same rod and are adjacent photos, there is an obvious difference in image contrast (right vs left) due to instantaneous lighting conditions.

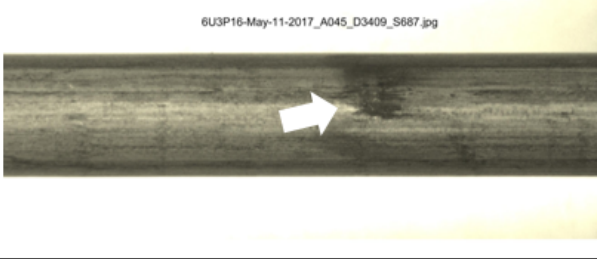
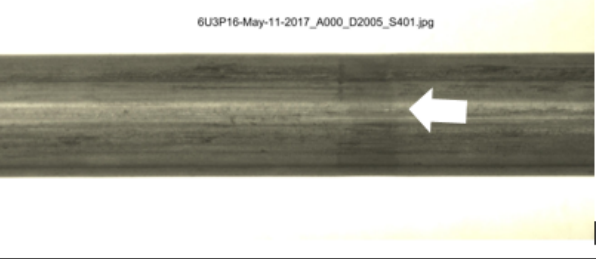
(g) Flow marking (darker region) associated with turbulent flow around a spacer grid with a shallow GTRF mark.	(h) Banded region is pellet-pellet gap (~5 mm) noted by gamma scan and measured by profilometry.

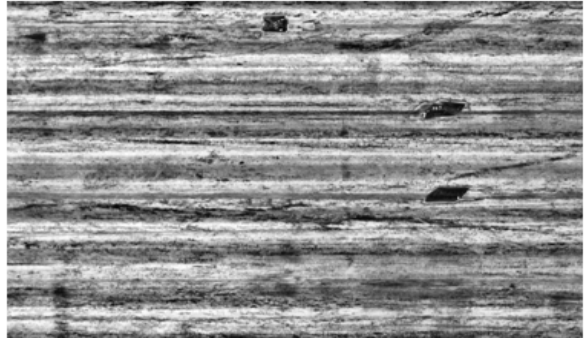
(i) Unwrapped image (all azimuthal locations at 2246 mm elevation) of 3F9D07, moderate to deep fretting wear.

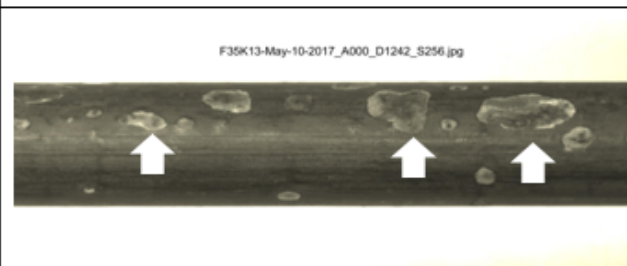
(a) Significant oxide spalling; some pellet-pellet interface bands are visible.

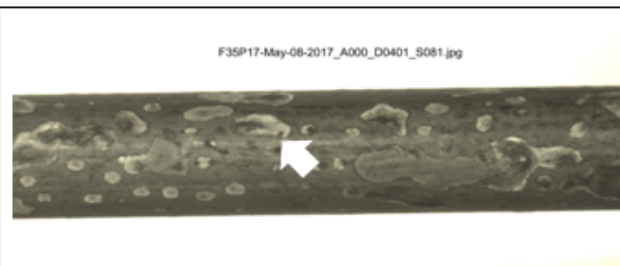
(b) Significant oxide spalling.

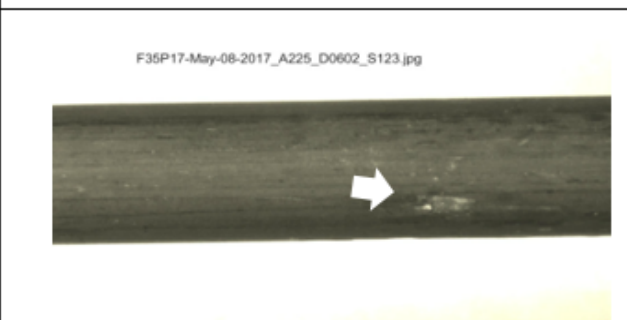
(c) Shallow GTRF.

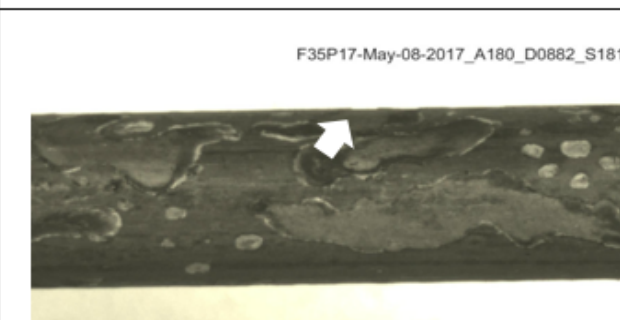
(d) Significant oxide spalling with CRUD; an indication of the oxide thickness is visible at the upper edge of the rod image.

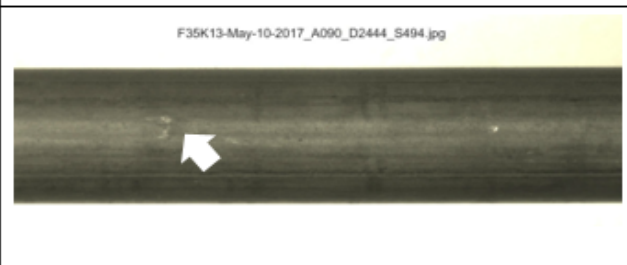
(e) Shallow GTRF.

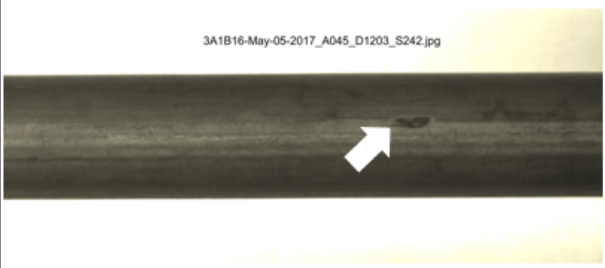
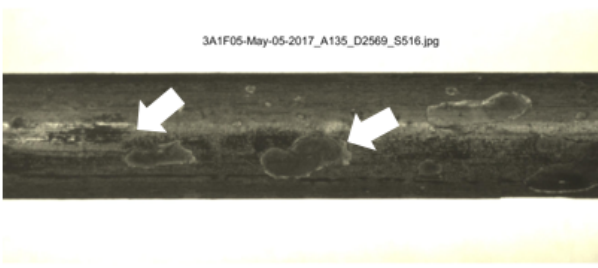
(a) Moderate GTRF mark.	(b) Significant oxide spalling with some peeling CRUD.

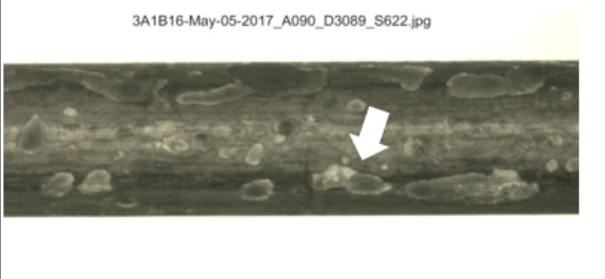
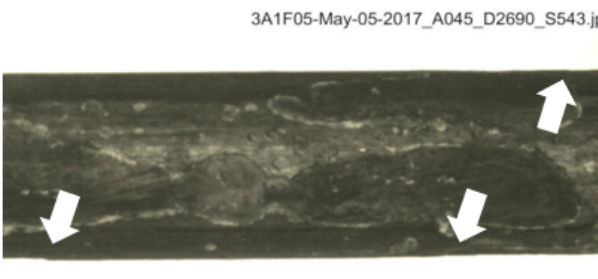
(c) Significant spalling oxide.	(d) Significant oxide spalling with CRUD; an indication of the oxide thickness is visible at the lower and upper edges of the rod image.

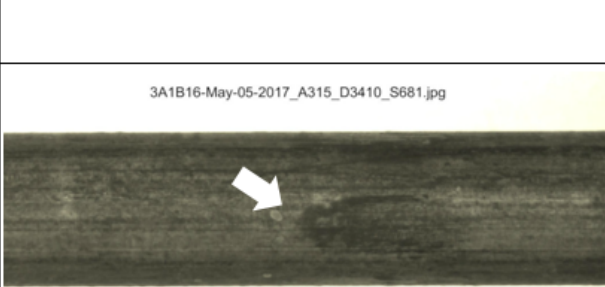
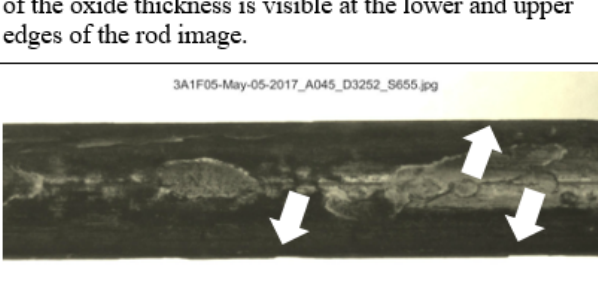
(e) Flow marking.	(f) Significant oxide spalling with CRUD; an indication of the oxide thickness is visible at the upper and lower edges of the rod image.

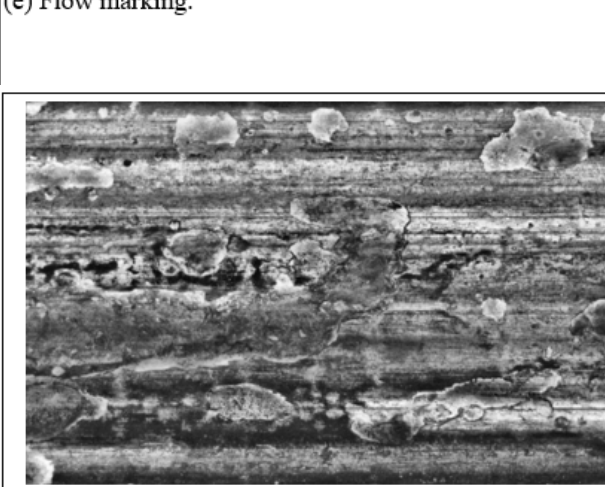
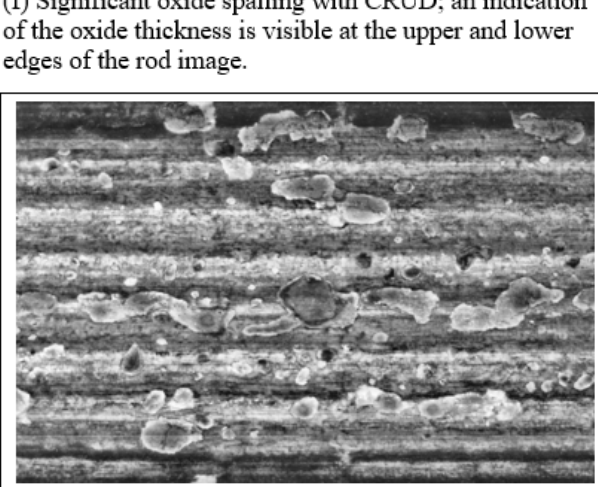
(g) Unwrapped image (full rod circumference shown at 3252 mm elevation) of 3A1F05, heavy oxide layer with spalling.	(h) Unwrapped image (all azimuthal locations at 3089 mm elevation) of 3A1B16, heavy oxide layer with spalling.

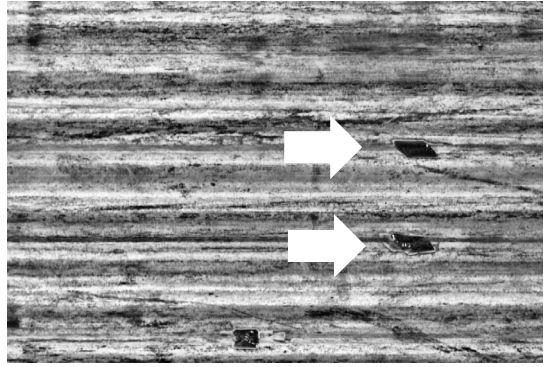
Sister rod	Elevation of defect (mm) ^{Note 1}	Defect type	Image from location of interest
3F9D07	2,264	GTRF: 2% depth through the remaining wall. Estimated depth based on 2% is 16 μm . Marks were later measured with the pancake coil as 18 and 28 μm deep (see Section 3.4.2.5).

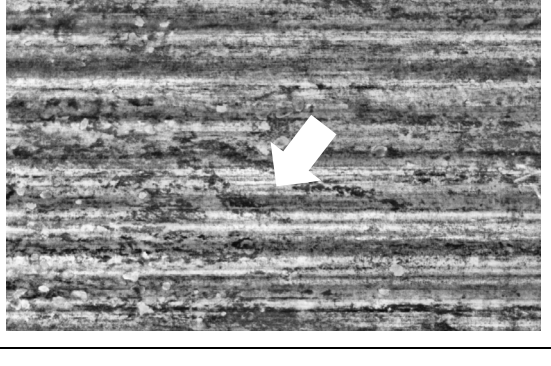
3A1B16	3,309	Likely oxidized GTRF: 1% local reduction in total cladding cross-sectional volume

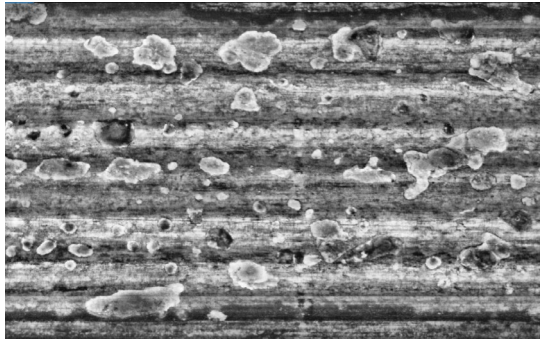
Sister rod	Elevation of defect (mm) ^{Note 1}	Defect type	Image from location of interest
3A1B16	3,129	Low phase angle indication consistent with GTRF. No visual confirmation and the location is not consistent with expected grid elevations. Likely this indication is a spalled location.

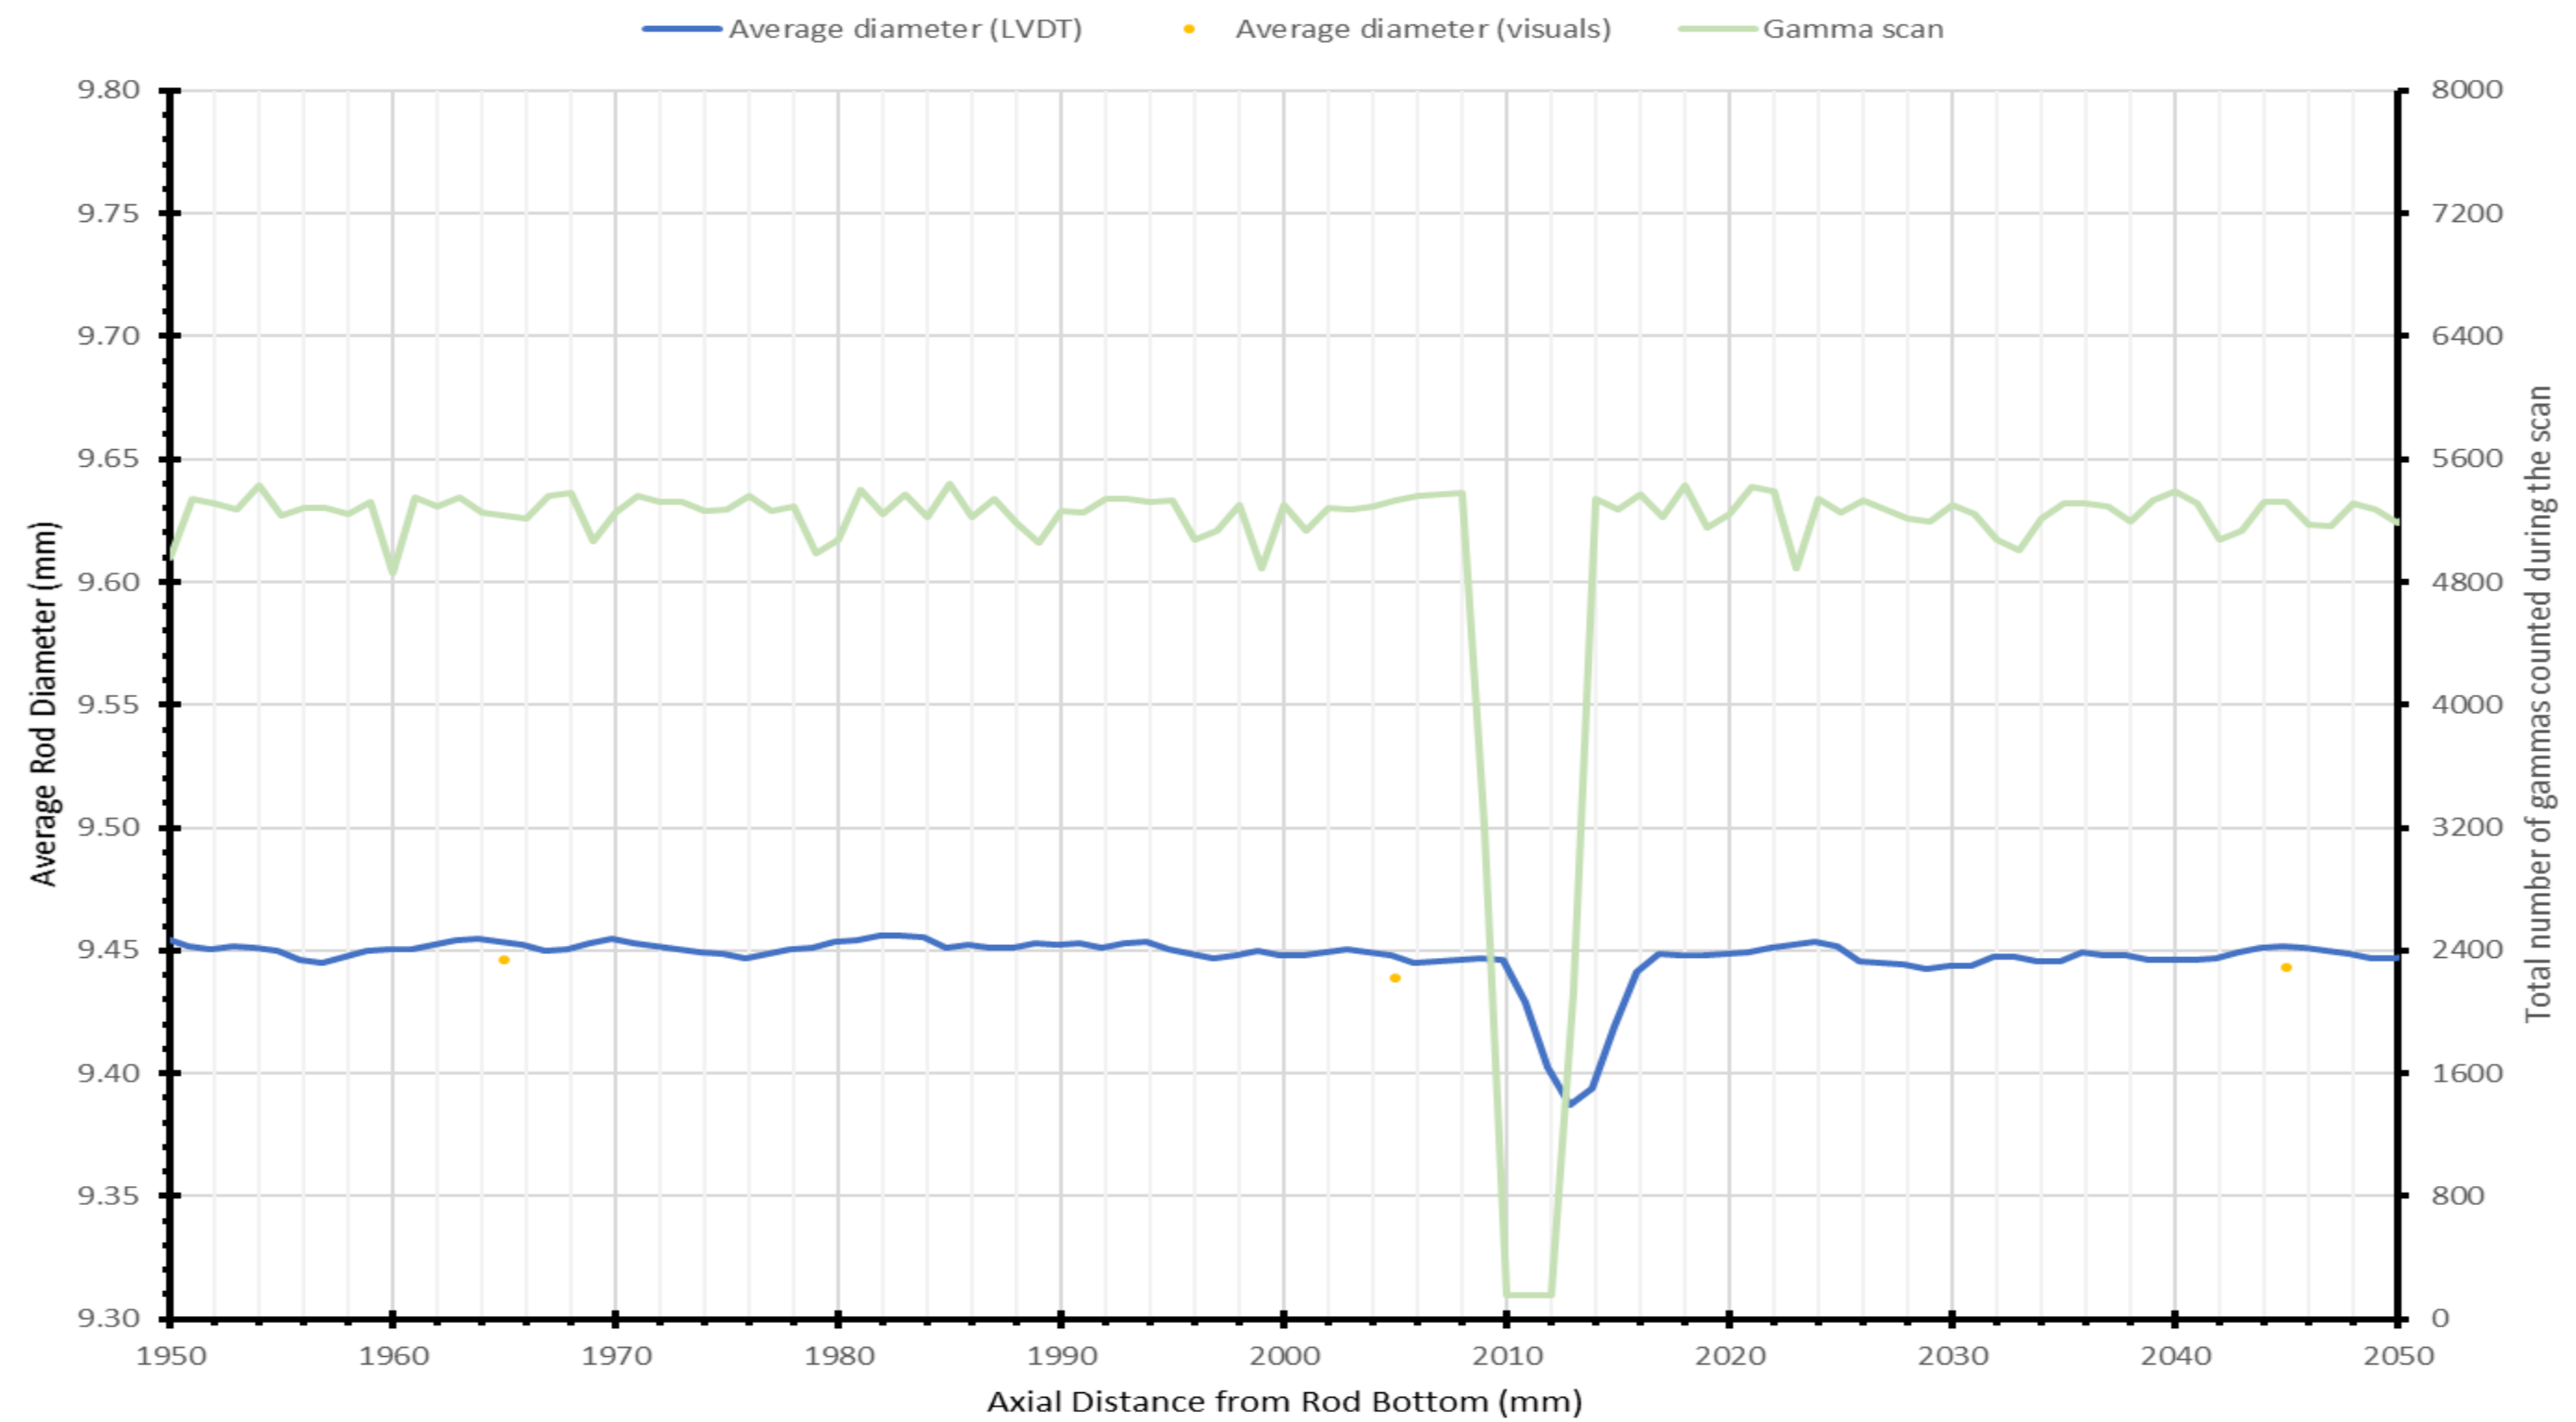
Figure 76. Average Diameter Reduction in Rod 6U3P16; This Reduction Nearly Aligns with the Pellet Stack Gap Noted in the Gamma Scan.

No serious structural defects were noted in any of the rods because of the gamma scanning; some small fuel stack gaps were observed, and the largest was estimated as 5 mm on sister rod 6U3P16.
