# Laser Line Scan Characterization of Cavitation-Induced Erosion to SNS Mercury Target Vessels

Neutron Technologies Division  
Spallation Neutron Source  
Oak Ridge National Laboratory

**LASER LINE SCAN CHARACTERIZATION OF CAVITATION-INDUCED EROSION TO SNS  
MERCURY TARGET VESSELS**

Date Published: January 2019

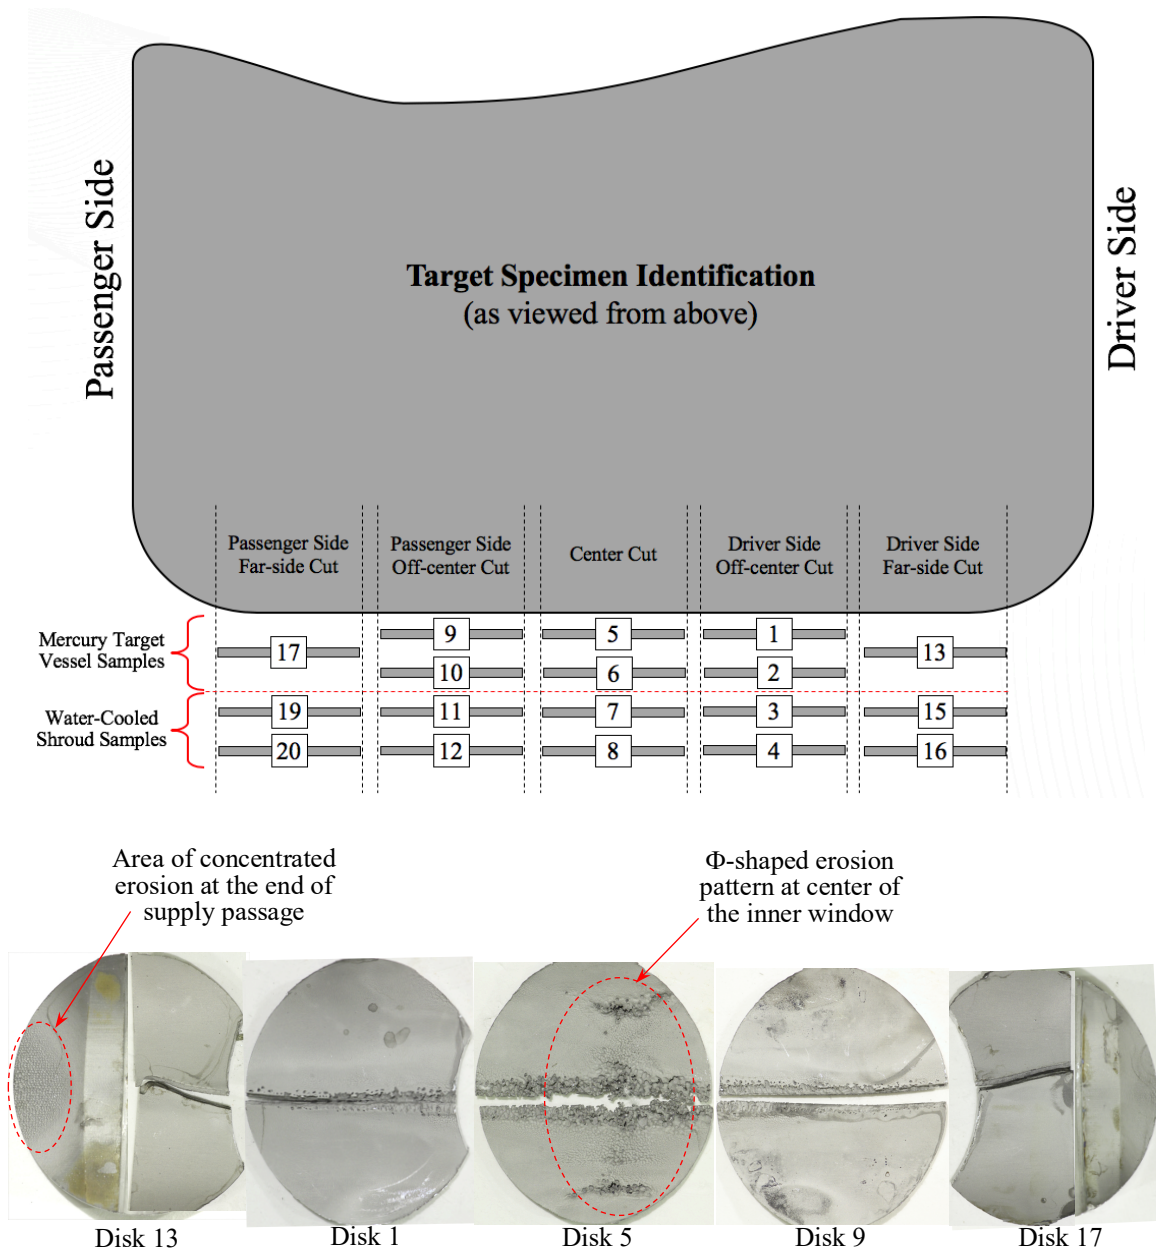
PIE observations from early targets showed erosion damage was most severe along the inner wall of the mercury vessel at the beam entrance region of the mercury target vessel. A diagram with the target sample identification scheme and photographs of samples from the inner wall of Target 8 are shown in Figure 5. Target 8 was operated at an average power of approximately 850 kW to 3750 MW-hr and had erosion damage patterns representative of an original design SNS target after service. Erosion damage to the inner wall was concentrated along the vertical centerline where the wall was fractured, and an erosion pattern resembling the Greek letter “phi”,  $\Phi$ , was observed at the center of the beam entrance region. Erosion damage was observed along the window-flow facing surfaces as well, but the pits were generally shallow and did not threaten to penetrate the vessel wall. Regions of appreciable erosion were also observed

at the extents of the inner wall where the supply passages turn the flow towards the center of the target, but were not considered threatening to the vessel until a leak was discovered in Target 12 at this location.

**Figure 5.** Diagram of target sample identification scheme and photographs of disk-shaped samples from the Target 8 mercury vessel inner wall.

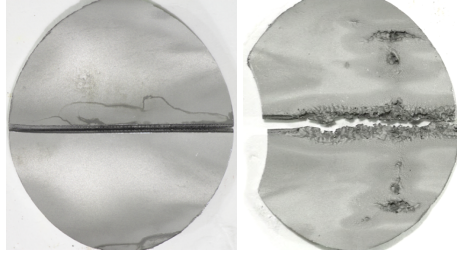
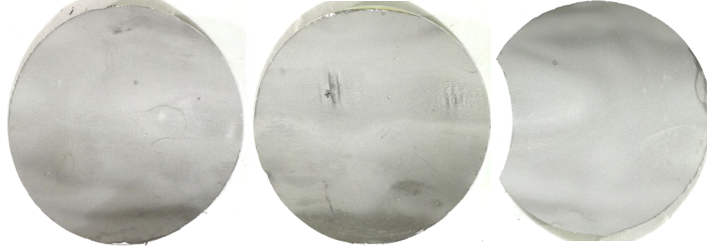
Target 10 was the first jet-flow target operated at the SNS, but unfortunately a mercury leak occurred relatively early during operation due to failure of a weld joining the front and transition sections of the mercury vessel near the middle region of the target. However, the early failure provided valuable insight into the progression of damage to the inner wall at the beam entrance region of the original and jet-flow target designs. Coincidentally, an earlier original design target, Target 6, also leaked at a weld after operating at almost the identical average power and to the same total absorbed energy as Target 10. The PIE characterization of these two targets provided a direct comparison of the damage observed in original and jet-flow targets operated under almost identical conditions. Images of samples from the inner walls from Targets 6 and 10 are shown in Figure 7. Erosion damage to the Target 10 inner wall was less severe at the center compared to Target 6, with no  $\Phi$ -shaped damage pattern observed on the Target 10 inner wall. Small patches of erosion were observed near the center of the Target 10 inner wall, but the wall was not perforated or fractured like the Target 6 inner wall. These initial observations of a jet-flow target inner wall were encouraging and additional jet-flow targets were fabricated and operated to further investigate the mitigating effect of flow at the beam entrance inner wall.

**Figure 7.** Photographs of specimens from the inner wall of Target 6 (original design) and Target 10 (jet-flow design).

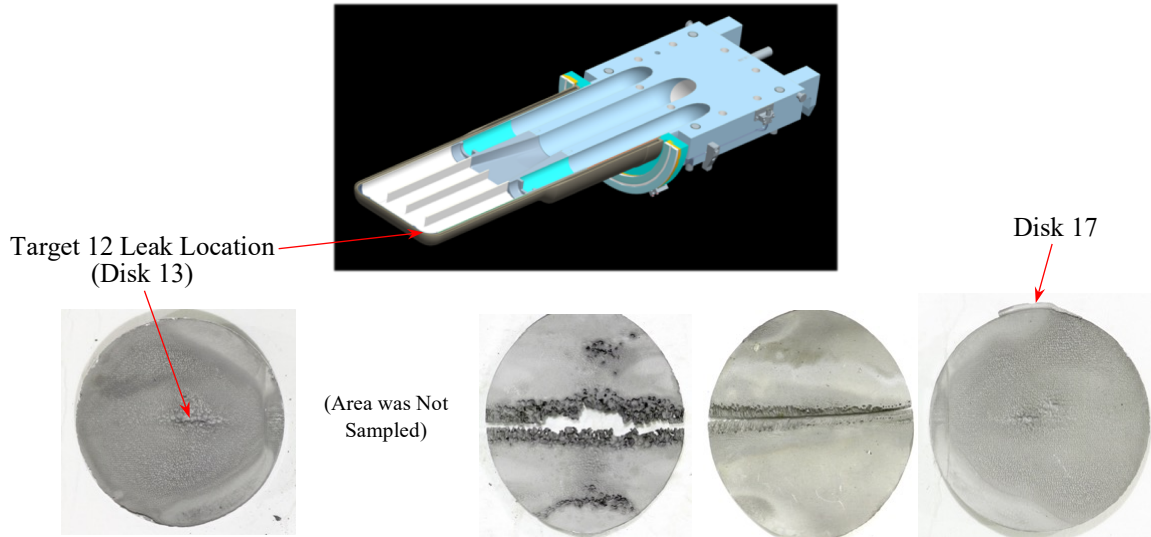
Following the Target 11 leak, Target 12 was operated for an extraordinarily long time, setting the current record for total absorbed energy in an SNS target at 4,460 MW-hr. Unfortunately, Target 12 leaked during operation and required an unplanned target change that interrupted the neutron-science user program. PIE techniques were used to locate the leak, and the area of the vessel containing the leak was sampled using the target sampler. The Target 12 leak was located on the single wall section on the *driver* side of the inner wall (refer to Figure 2), as shown in Figure 8. The erosion damage pattern on the sample from the passenger side of the inner wall, designated Disk 17, was almost an identical mirror image of the damage on the driver side, but no leak occurred on the passenger side.

**Figure 8.** Photograph mosaic of samples from the inner wall of Target 12 and a diagram identifying the leak location.

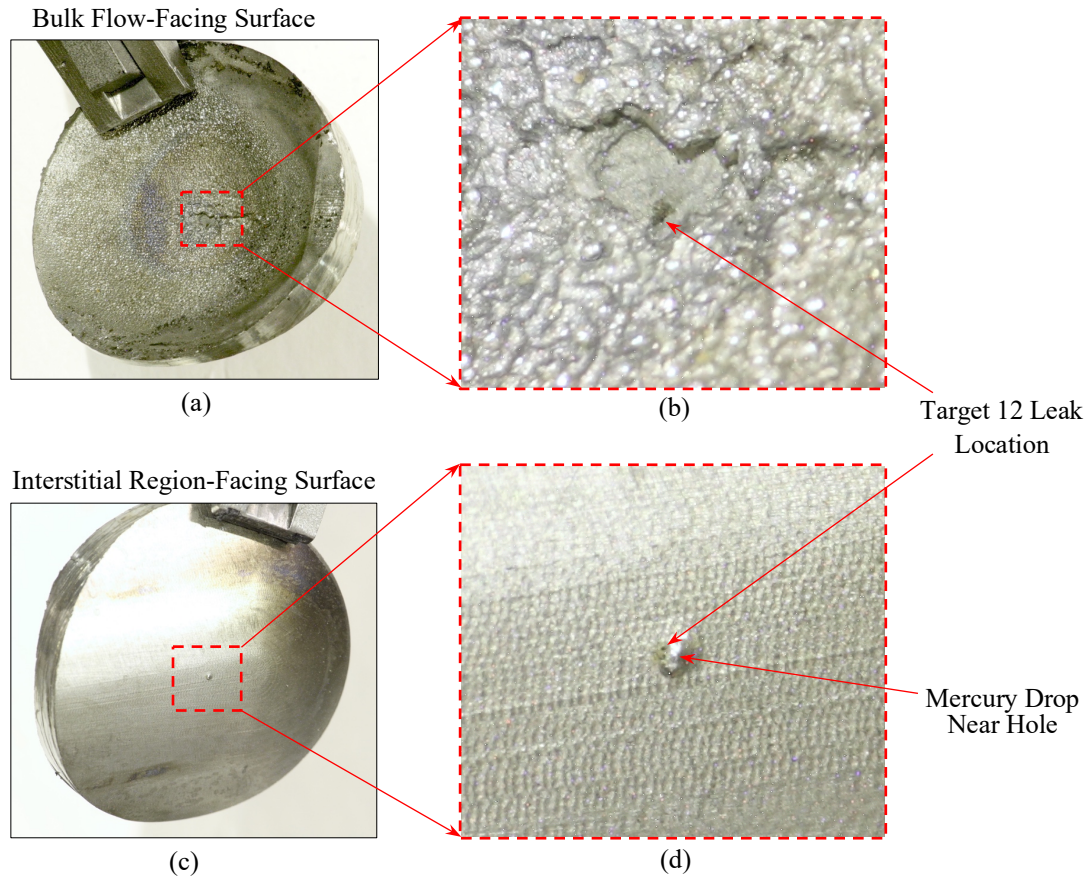
Subsequent photography showed the hole through the Target 12 inner wall was very small and located at the base of the eroded cavity, as shown in Figure 9. The formation of this cavity appeared to be caused by mass-wastage type of erosion, which is described in greater detail in reference [5]. This type of erosion occurs when an erosion pit penetrates the hardened Kolsterising<sup>®</sup> treated layer on the vessel surface and begins to erode the soft underlying base material. As erosion continues, sections containing the hardened surface layer are undercut by erosion of the soft underlying material and the sections begin to lose support. After the underlying material is sufficiently eroded the sections of the hardened surface layer break loose from the surface and become entrained in the mercury flow. Flow is known to mitigate cavitation-induced erosion damage [10], but as the cavity grows, the mitigating effect of flow is reduced. The reduction in flow mitigation is expected to exacerbate the cavity growth process and accelerate localized erosion damage.

**Figure 9.** Photographs of the sample containing the Target 12 leak location: (a) bulk-flow facing surface, (b) magnified image of the leak location, (c) interstitial region-facing surface, and (d) a magnified image of the leak location viewed from the interstitial region-facing side. NOTE: a drop of mercury is shown adhering to the surface near the leak location hole in (d).

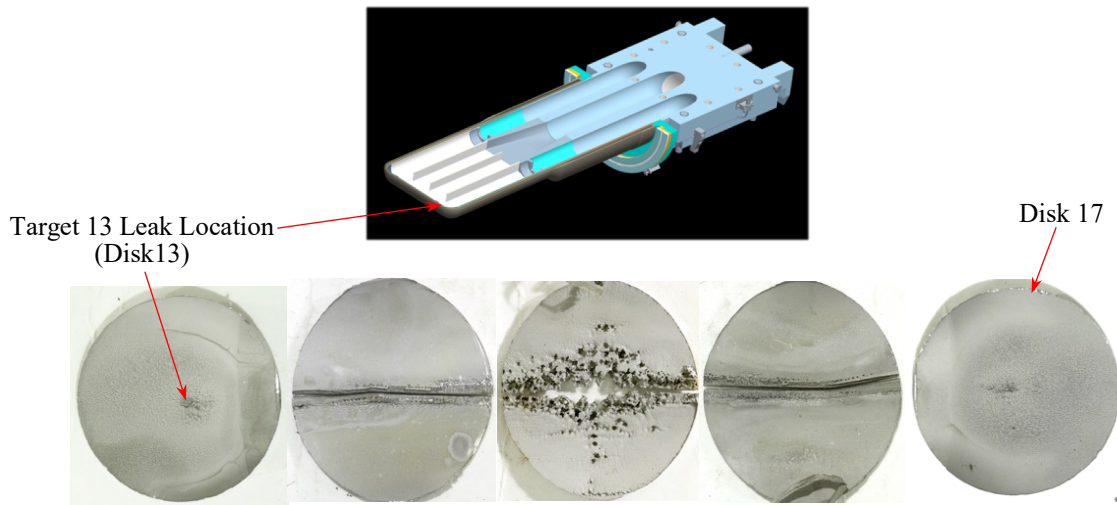
After Target 12 was removed from service, Target 13 was operated to 2,589 MW-hr and subsequently developed a leak. PIE inspection with an articulating videoprobe revealed that the Target 13 leak had occurred at the same location as the Target 12 leak: in the single-wall section of the inner window at the end of the bulk-flow supply passage on the driver side, as shown in Figure 10. Also, similar to Target 12, the erosion pattern on the passenger side of Target 13 was a mirror image of the erosion pattern on the side that leaked. But unlike Target 12, the shape of the erosion pattern at the center of the inner window of Target 13 did not have a pronounced “I” component of the  $\Phi$ -shape pattern previously observed, rather the pattern on the Target 13 inner window contained more large pits located at the center compared to the Target 12 window.

**Figure 10.** Photograph mosaic of samples from the inner wall of Target 13 and a diagram identifying the leak location.

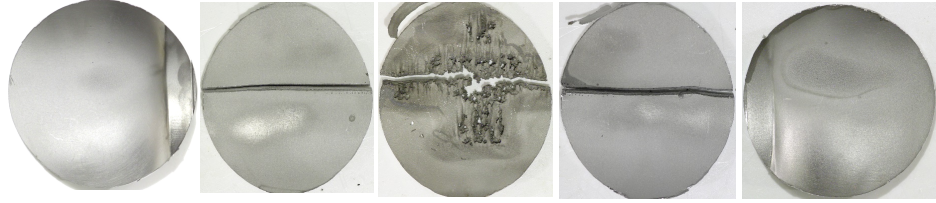
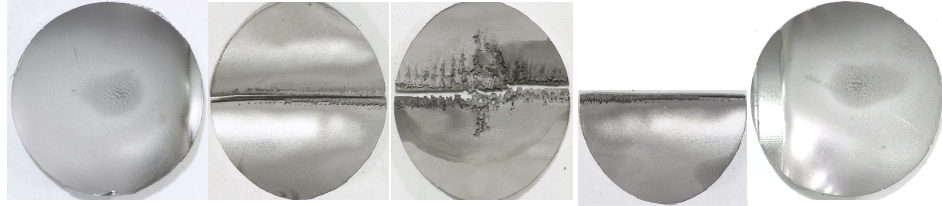
Targets 16 and 17 were both jet-flow targets and provided information on damage to jet-flow targets operated at average power and total absorbed energy levels of 968 and 1,127 MW, and 1,780 and 1,936 MW-hr, respectively. While the Target 10 results showed the jet-flow design had reduced the damage to the inner wall compared to Target 6, PIE of Targets 16 and 17 revealed that appreciable damage occurred to the inner wall during operation. Photographs of specimens from the inner walls of Targets 16 and 17 are shown in Figure 11. Unlike Target 10, the inner walls of Targets 16 and 17 were fractured along the horizontal centerline and an appreciable amount of erosion damage was present at the center of the beam entrance region. These observations showed that erosion damage mitigation with flow was not effective at protecting the inner wall from erosion or fracture, and alternative mitigation techniques would be necessary to protect the mercury vessel inner wall.

**Figure 11.** Photographs of specimens from the inner wall of Targets 16 and 17 (jet-flow designs) after operation.

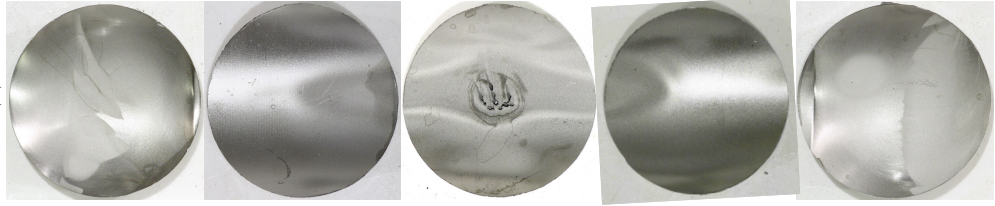
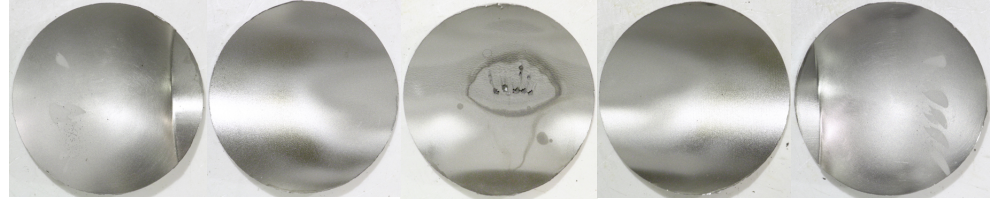
Targets 18 and 19 were both jet-flow target designs that were operated with small-bubble gas injection. The gas flow rate for the Target 18 bubbler varied throughout operation from 0.25 to 0.45 standard liters per minute (SLPM), whereas the gas flow rate during Target 19 operation was fairly constant at approximately 0.45 SLPM. Photography of samples from Targets 18 and 19 show an appreciable decrease in erosion damage compared to previous targets, as shown in Figure 12, and the inner walls were not fractured. The most pronounced erosion occurred at the center of the window, where the erosion pattern had an elongated morphology oriented parallel to the direction of the high-velocity jet flow. Erosion damage to the Disk 13 position in Targets 18 and 19, where Targets 12 and 13 leaked, was not appreciable compared to previous targets.

**Figure 12.** Photographs of specimens from the inner wall of the Targets 18 and 19 (jet-flow designs) after operation with small-bubble gas injection.

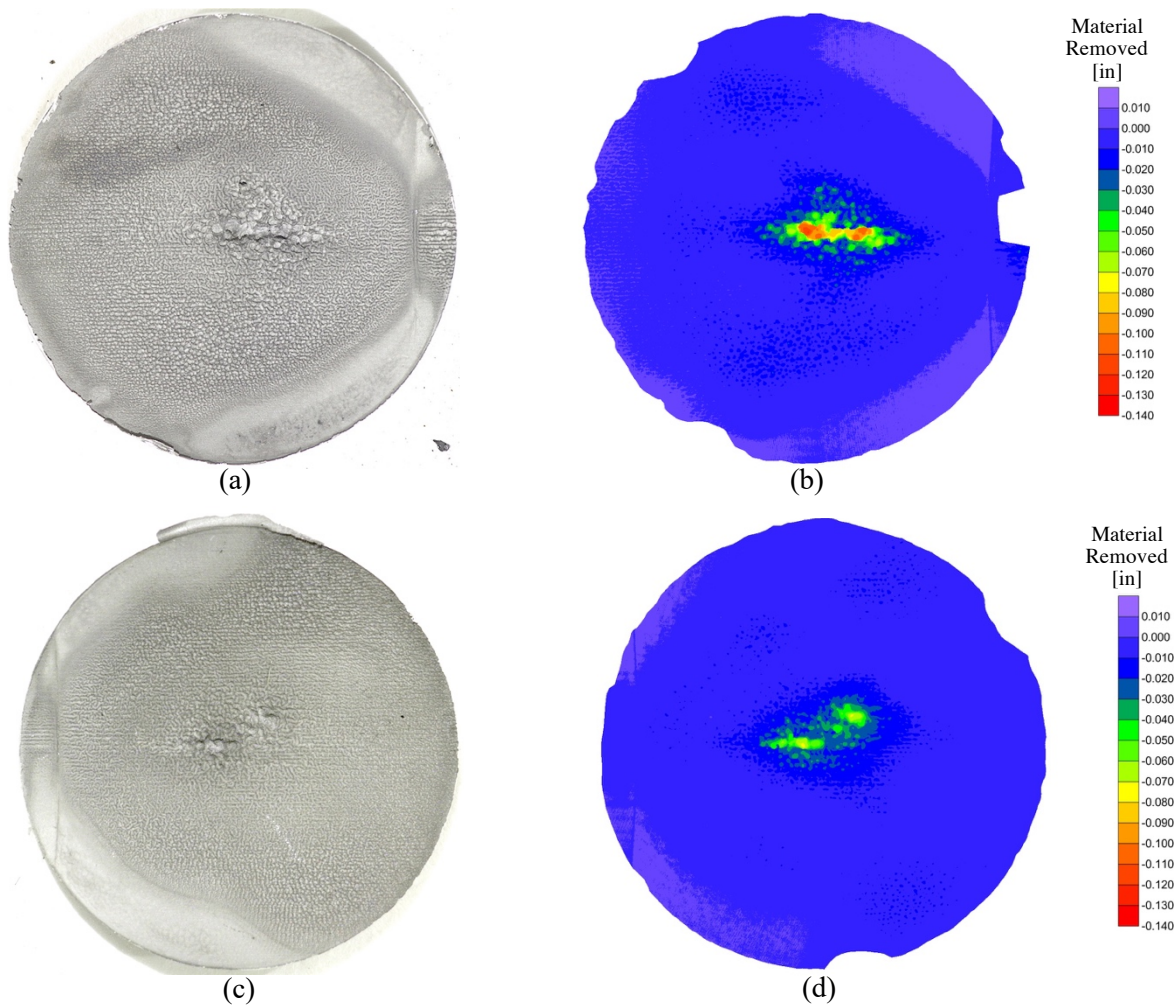
The distribution of the material eroded from Disk 13 from Target 12 (Disk 13/Target 12) and Disk 17 from Target 12 (Disk 17/Target 12), are shown in Figure 20. The damage to these disks had two general types of erosion damage present: (1) relatively shallow (< 0.010 in) dimple-like pitting and (2) deep cavity-like erosion (>0.050 in). The shallow pitting-type erosion is shown in the plots of the material eroded are in the blue to purple range, which corresponds to an erosion depth of approximately 0 to -0.020 in and is found on the majority of the sample surface. The areas with deep cavity-type erosion are shown in the erosion plots as the green to red range, and are located near the center of the sample. The leak was located

in Disk 13 and the maximum depth of erosion was 0.121 in, which completely perforated the sample at the leak location. Maximum erosion to Disk 17/Target 12 was 0.073 in, and 0.045 in of thickness remained at this location.

**Figure 20.** (a) Image and (b) distribution of the material eroded from Disk 13/Target 12, which contained the Target 12 leak, and (c) image and (d) distribution of material eroded from Disk 17/Target 12.

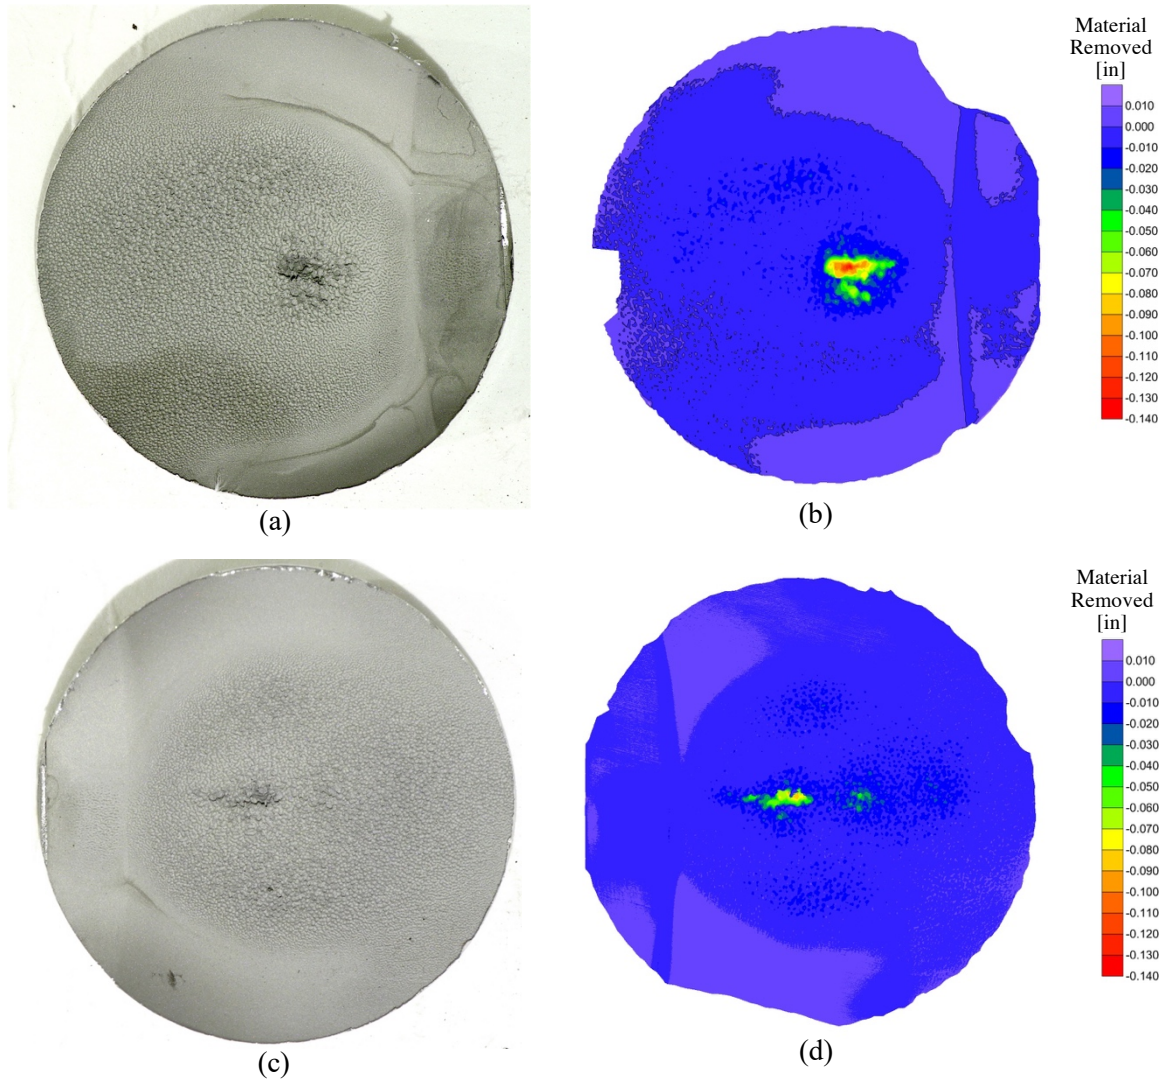
Images and distribution of material removed for the Disk 13 and 17 locations in Target 13 are shown in Figure 21. The erosion damage morphology on the Target 13 Disks 13/17 were very similar to that observed on the samples from Target 12. That is, small cavities of deep erosion near the center of the disks surrounded by shallow dimple-like pitting. Target 13 also leaked at the Disk 13 location, and both targets had more pronounced cavity-type erosion on the driver side of the target. The deepest erosion measured on Disk 17/Target 13 was 0.096 in with 0.035 in of material remaining in the thickness, which was slightly deeper than the deepest cavity measured on Disk 17/Target 12.

**Figure 21.** (a) Image and (b) distribution of the material eroded from Disk 13/Target 13, which contained the Target 13 leak, and (c) image and (d) distribution of material eroded from Disk 17/Target 13.

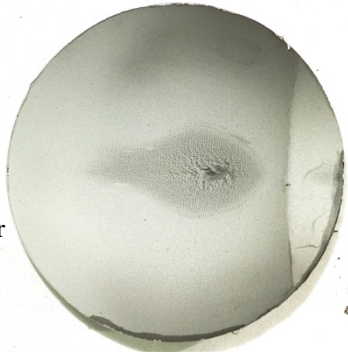
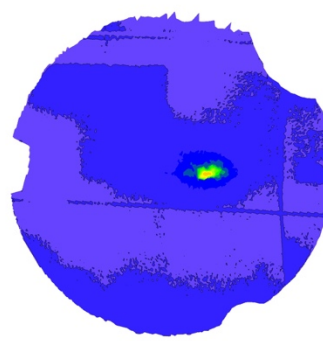
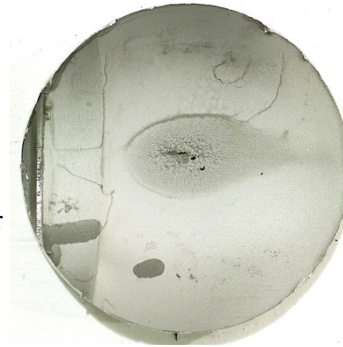
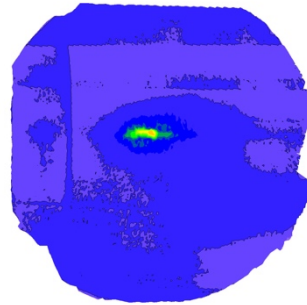
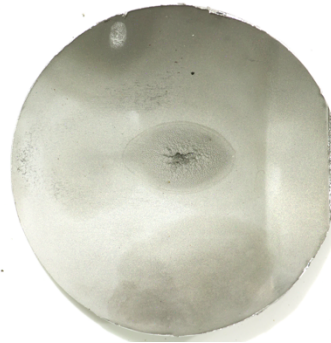
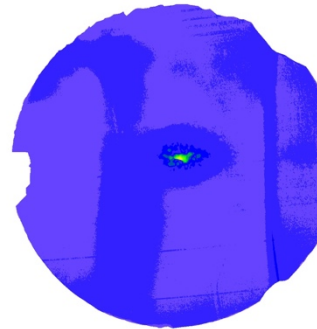
**Figure 22.** Images and erosion plots for Disks 13 and 17 from Targets 14 and 15 (original design).

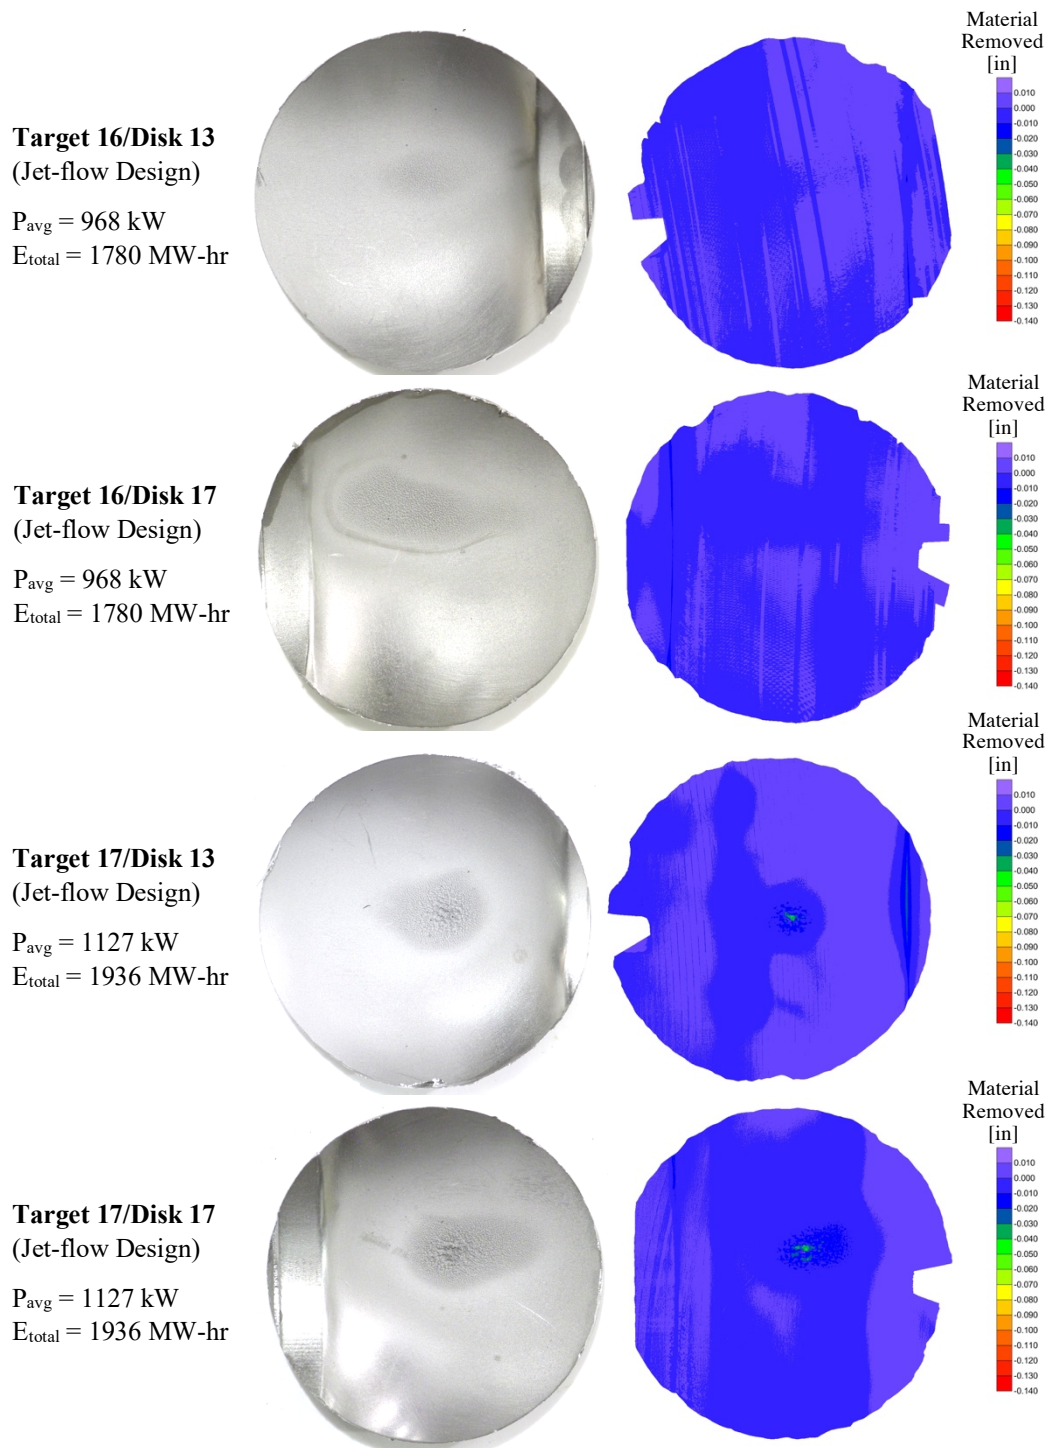
Scans of Disks 13 and 17 from Targets 16 and 17 were the first erosion measurements of samples from the end of supply passages of a jet-flow design target. The images and plots of the material removed from the Target 16 and 17 samples are shown in Figure 23.

**Figure 23.** Images and erosion plots for Disks 13 and 17 from Targets 16 and 17 (jet-flow design).

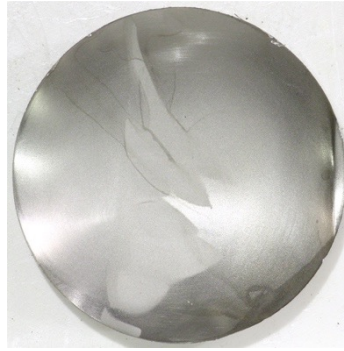
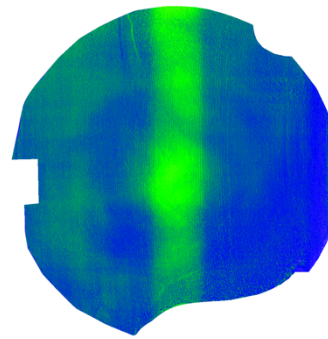
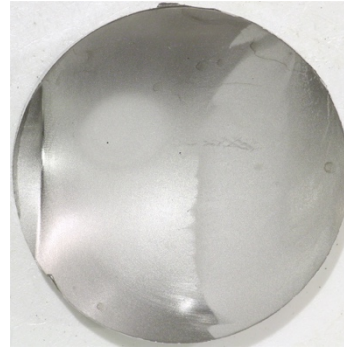
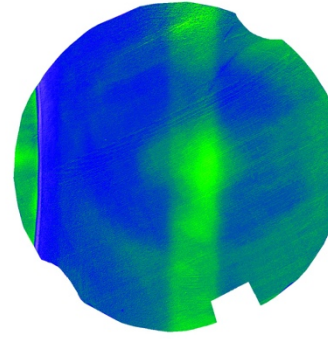
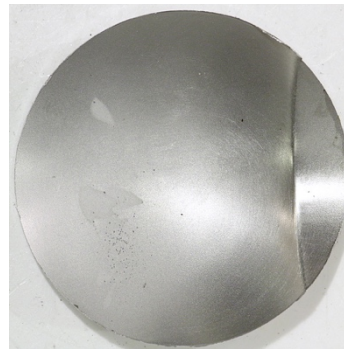
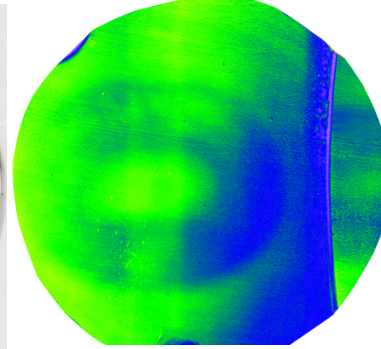
**Figure 24.** Images and erosion plots for Disks 13 and 17 from Targets 18 and 19 (jet-flow design with gas injection).

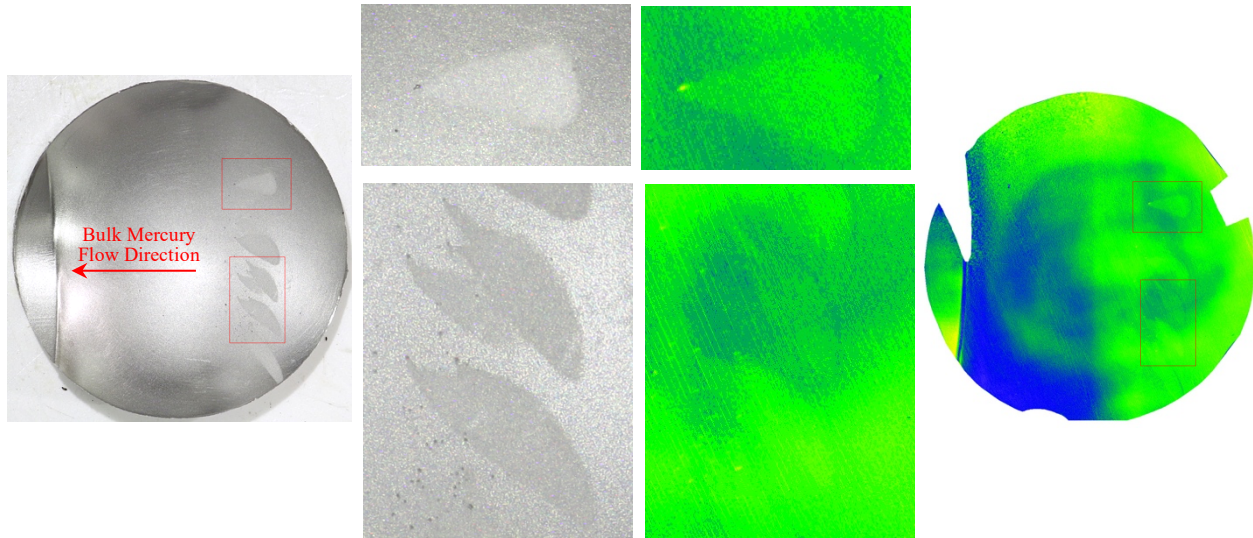
**Figure 25.** Images and erosion plots for Disks 17 Target 19 showing magnified views of regions containing “pit/comet” discolored features.

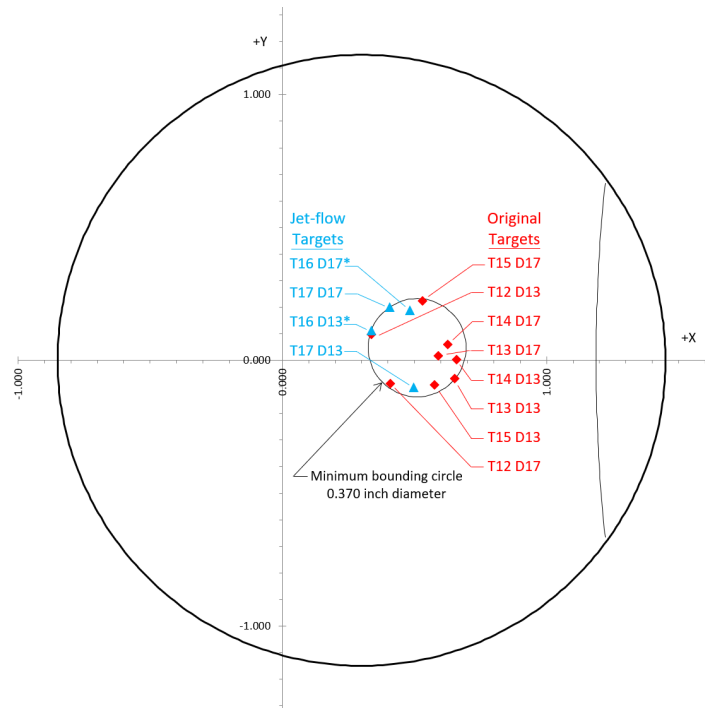
The location where the maximum depth of erosion occurred was calculated from the scan data for each Disk 13/17. The location of maximum depth of erosion for the Disk 13/17 samples scanned for all targets is overlaid together on one figure in Figure 26; locations from the Disk 17 samples are mirrored onto the locations for the Disk 13 samples. The location of the maximum erosion was similar for each Disk 13/17 sample; all the points of maximum erosion were contained within a minimum bounding circle with a 0.370 in diameter.

**Figure 26.** Locations of the maximum depth of erosion for the Disk 13 and 17 samples overlaid onto one figure; locations for Disk 17 samples are mirrored onto the Disk 13 locations. (\*Both disks from Target 16 showed shallow erosion with no single, well-defined, deep point. The point of maximum erosion was defined to be the center of a wider-than-normal area of deep points found.)

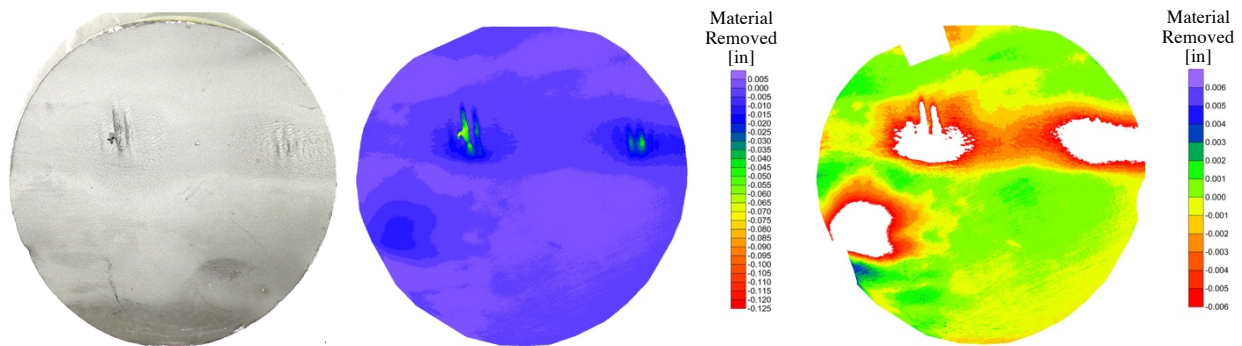
Target 10 was the first jet-flow target design operated at the SNS, but was operated to only 601 MW-hr due to a leak that developed at a weld joining the target front body and transition sections. The short life of Target 10 provided an opportunity to obtain information on the progress of erosion damage during the early stages of operation. Also, the short life of Target 6 provided an almost direct comparison of the evolution of damage between original and jet-flow target designs, which was shown in Figure 7. The erosion patches on the Target 10 Disk 5 sample were not centered and had a morphology that was oriented parallel to the direction of the jet flow against the inner wall. A photograph and erosion plots of the Disk 5 sample from Target 10 are shown in Figure 27. The erosion plots are on two different length scales to fully illustrate details of the erosion patterns. Three large areas of erosion were present: one large patch at approximately the eight o'clock position on the disk, and two areas just above the horizontal center line. The maximum depth of erosion was 0.068 in and occurred in the patch above the centerline on the left. This pattern has not been observed on other SNS target inner windows and it is not clear if flow-induced erosion might have contributed to the erosion damage observed on the Target 10 inner window.

**Figure 27.** Image and erosion plots for Disk 5 from Target 10 (jet-flow design).

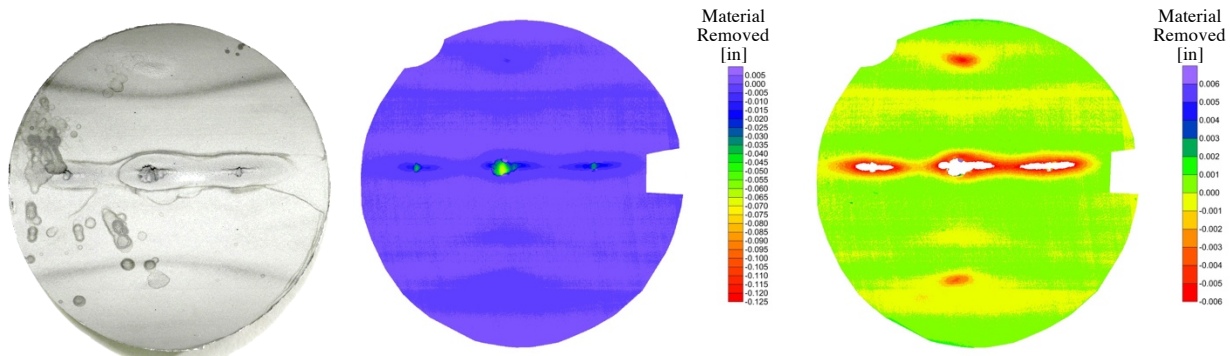
observed in original design targets operated to higher total exposure levels, as shown in Figures 5 and 7. The damage pattern at the center of the sample might be a contributing factor to the fracture of the inner wall by providing a stress concentration along the horizontal centerline of the wall, which might increase the local stresses and initiate fracture during fatigue loading of the inner wall.

**Figure 28.** Image and erosion plots for Disk 5 from Target 11 (original design).

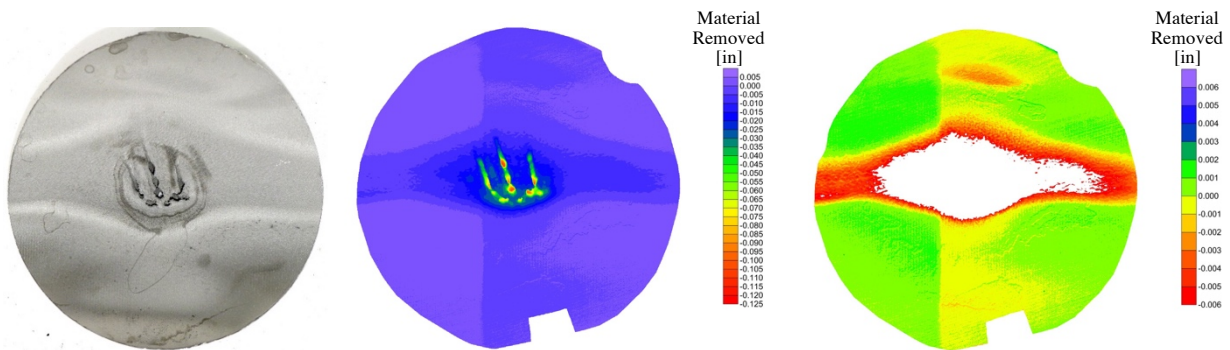
**Figure 29.** Image and erosion plots for Disk 5 from Target 18 (jet-flow design with gas injection).

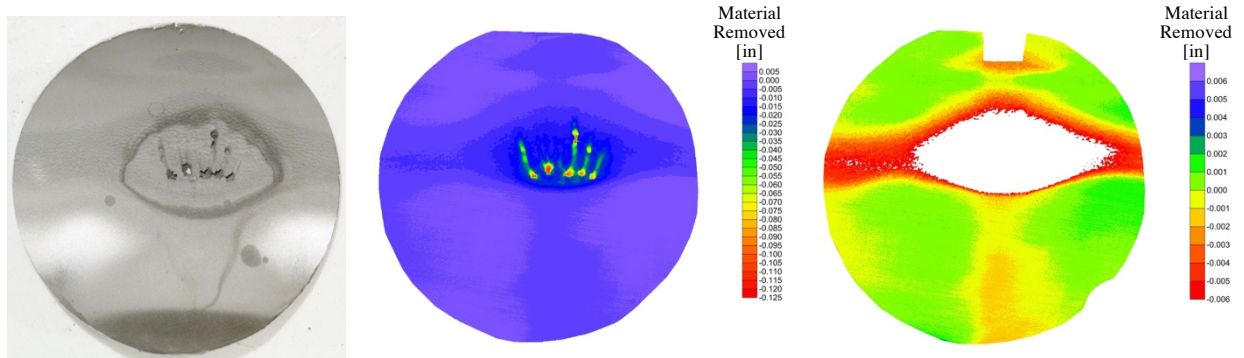
**Figure 30.** Image and erosion plots for Disk 5 from Target 19 (jet-flow design with gas injection).

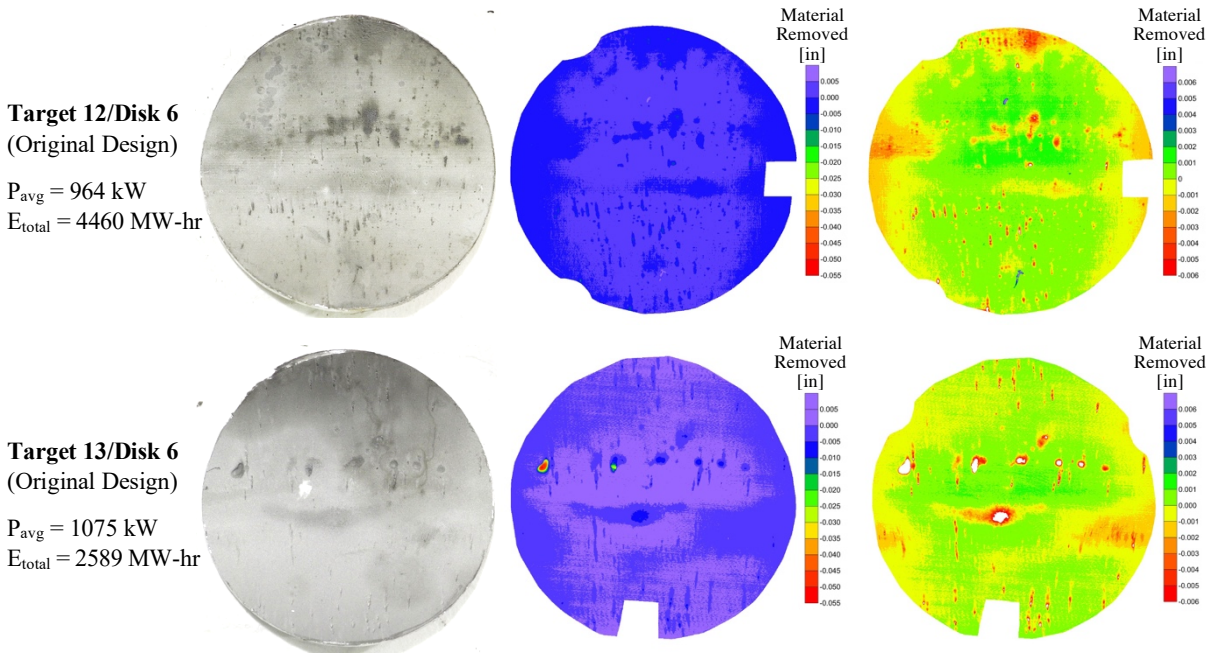
**Figure 31.** Images and erosion plots for Disk 6 samples from Targets 12 and 13 (original design without gas injection).

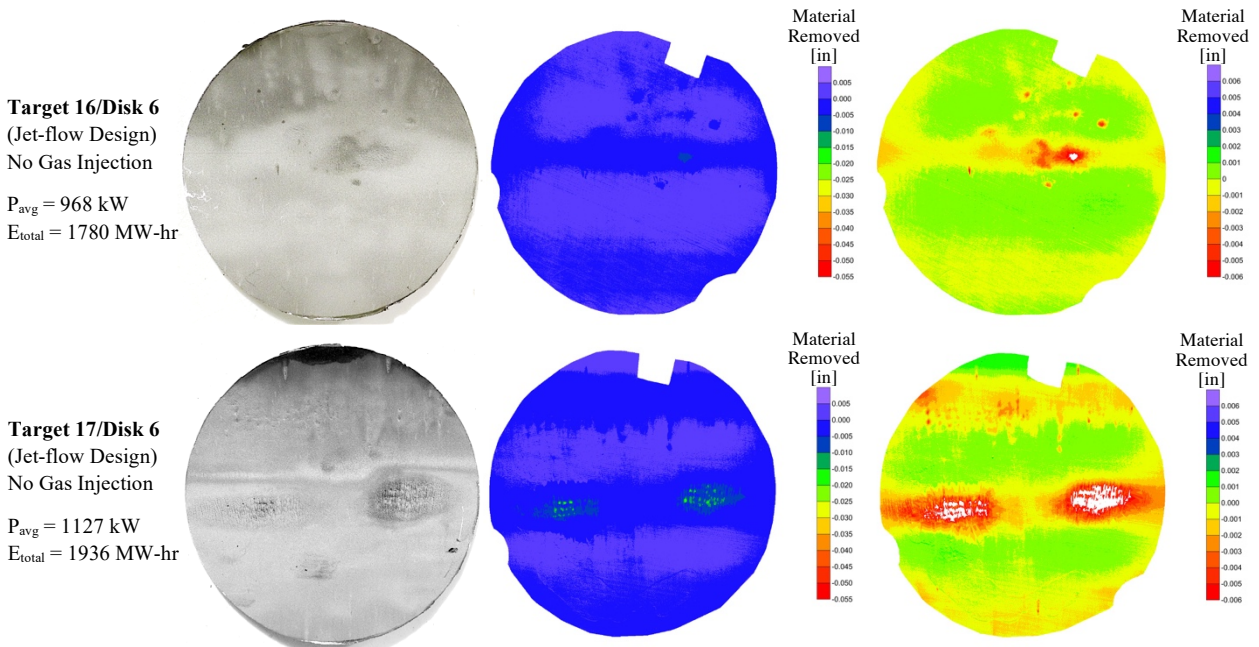
**Figure 32.** Images and erosion plots for Disk 6 samples from Targets 16 and 17 (jet-flow design without gas injection).

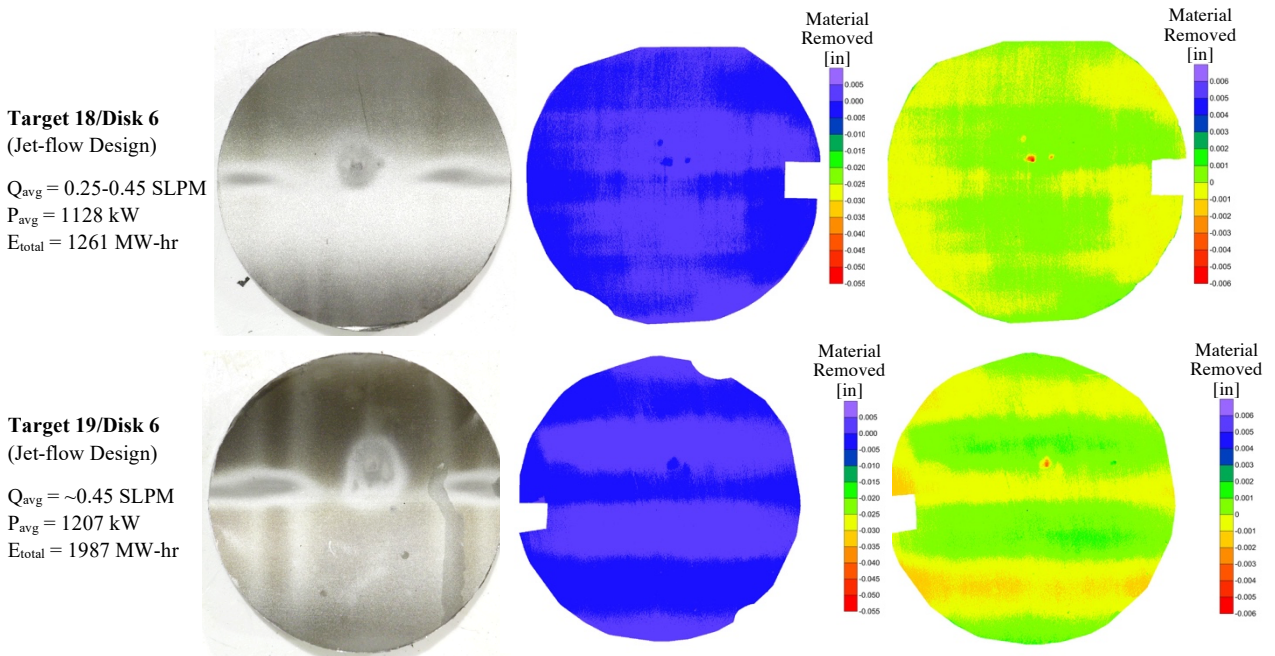
**Figure 33.** Images and erosion plots for Disk 6 samples from Targets 18 and 19 (jet-flow design with gas injection).
