Post-Irradiation Examination of High Fluence Baffle-Former Bolts Retrieved from a Westinghouse Two-Loop Downflow Type PWR

Light Water Reactor Sustainability (LWRS) Program
M3LW-19OR0402183

**POST-IRRADIATION EXAMINATION OF HIGH FLUENCE BAFFLE-
FORMER BOLTS RETRIEVED FROM A WESTINGHOUSE TWO-
LOOP DOWNFLOW TYPE PWR**

Date Published: July 31, 2019

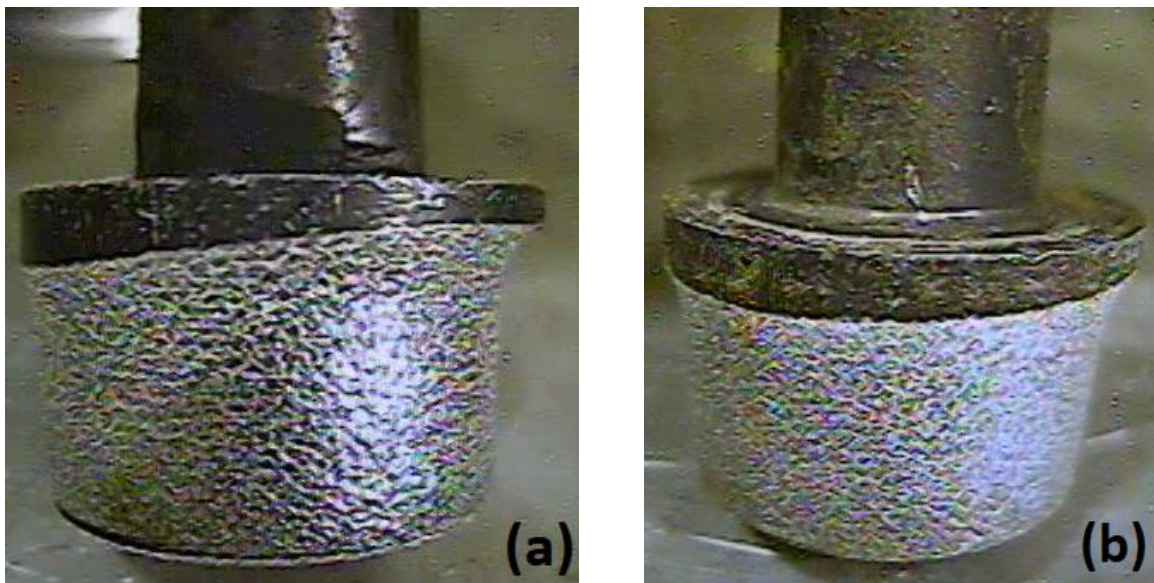
The retrieved BFBs are two of the highest fluence bolts available from the original type 347 austenitic SS bolts used in the reactor. Both bolts showed no indication of cracking during the ultrasonic inspection and in visual inspection following removal from service. However, the bolts required a lower torque for removal from the baffle structure than the original torque specified during installation. Figure 2.1 shows images of the bolt heads of two retrieved BFBs. No indication of surface cracking was observed in the transition region between shaft and head, although some surface debris scale flaked off from the bolt body. The shiny portion of the bolt head was due to electric discharge machining when the bolts were removed from the baffle wall. The ID number for the bolts follows a 4-digit code with the first number being the quadrant location in the reactor, then the associated baffle plate number, the column location of the bolt associated with the particular baffle plate number, and finally the former plate location where the bolt originated. While the exact elemental compositions of the two retrieved BFBs were not available at the time of preparation of this report, Table 2.1 shows compositions of three heats of type 347 SS used for the construction of the reactor in comparison with the material specification. The compositions of all three heats met the type 347 SS specification. Table 2.2 provides information on the range of fluences and estimated displacement damage along the length of the two bolts. The displacement damage values for the two bolts range from 15 to 41 displacements per atom (dpa) assuming a fluence to dpa conversion value of 6.7×10^{20} n/cm², $E > 1$ MeV per dpa [2]. Other important information for the two retrieved bolts not available at the time of preparation of this report includes the irradiation temperature profile and flux both of which require more complicated modeling and calculation and they can vary within each power cycle and from cycle to cycle. Nonetheless, calculations [3] from Point Beach Unit 2, which is another Westinghouse two-loop type PWR, showed that the irradiation temperature and flux for a BFB from a region next to the bolt 4416 studied in this work varied in the range of 323-344°C and 7.5×10^{12} - 1.8×10^{13} n/cm²-sec ($E > 1$ MeV) along the length of the bolt, respectively. It is worth noting that Point beach Unit 2 was originally a Westinghouse downflow two-loop PWR, but was converted to upflow in Nov 1986 [3].

Figure 2.1 Images of bolt heads for bolt #4412 in (a) and bolt #4416 in (b) [4]

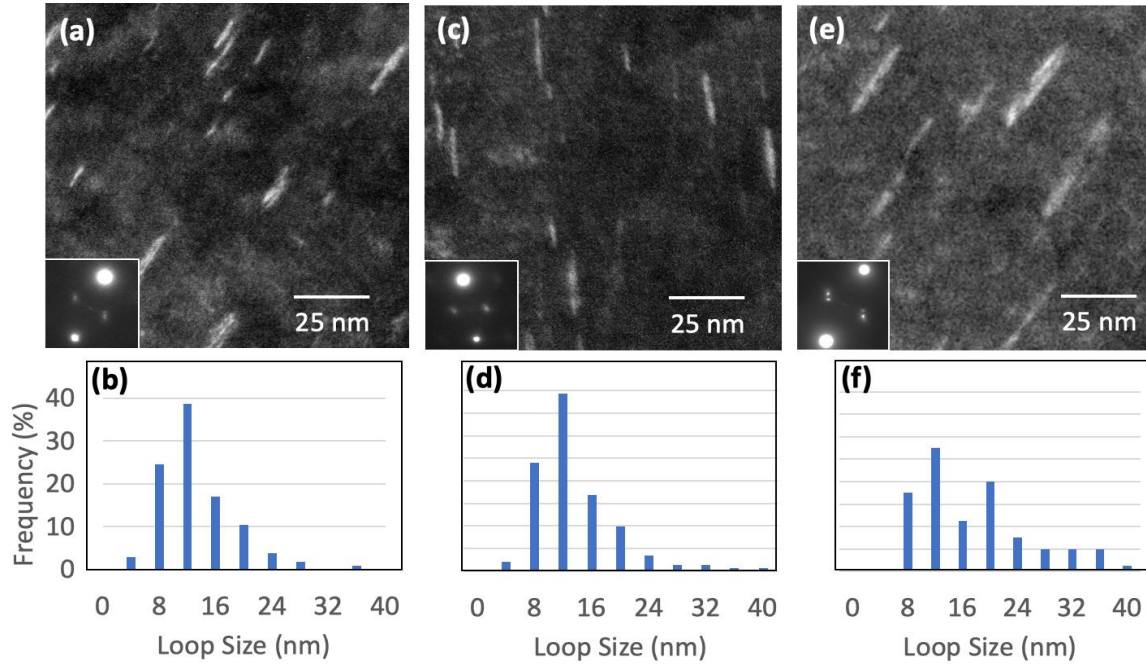
TEM characterization revealed dislocation loops in 4416 CS1, MS, and BS samples. Figure 3.1 presents the images and statistics of dislocation loops in the three samples. Similar size distributions of the loops were observed for CS1 and MS samples. The loops grew larger in the BS sample, as demonstrated by the higher frequency of loops with a diameter larger than 24 nm shown in Figure 3.1(f). By analyzing more than 80 loops per sample, obtained from different areas, the average sizes and densities of loops were calculated and listed in Table 3.1. The sample thicknesses were measured using the electron energy loss spectroscopy (EELS) technique. In Table 3.1, the uncertainties in the size data are the standard deviation; the uncertainties in the density data are the standard deviation accounting both the variances in measured densities and thickness. The changes in loop density along the bolt length profile were insignificant compared with experimental errors. Lastly, no NbC was observed in the TEM characterization which may be due to the small size of FIB-prepared samples.

Figure 3.1 DF images of dislocation loops and their size distributions for 4416 CS1, MS, and BS samples presented in (a-b), (c-d), and (e-f), respectively

Frank loops rather than network dislocations were observed in 4416 CS1, MS, and BS samples. This agrees with changes in the microstructure of austenitic SS irradiated between 300 and 400°C as reported by Chopra [2] and Maziasz [9]. The size of dislocation loops is also within but close to the high end of 4-20 nm range in the work of Bruemmer et al. [10] for austenitic SS neutron-irradiated at temperatures higher than 300°C. The observed number density of dislocation loops is lower than the reported value for types 304 and 316 SS irradiated in a boiling water reactor (BWR) at 275-300°C [11]. In general, an increase in irradiation temperature would increase the loop size while reducing their densities [12]. This confirms the irradiation temperature for bolt 4416 should be higher than 300°C. In addition, the change of irradiation temperature during different reactor cycles can lead to microstructural changes not accounted for by simply considering a constant temperature [13]. Gamma heating can also influence the variations in the temperature across the length of the bolt and over the long service exposure time, this can create variations in microstructural features at the nano- to micro-scale. However, data are still sporadic from samples examined from commercial reactors as well as from research reactors. The variations occurring in the bolts that have been seen in this work and in previous studies can be difficult to compare to each other due to uncertainty in temperatures/irradiation conditions from both research and commercial reactor test data as well as error associated with data taking. Lastly, the development of dislocation loops during irradiation can also be influenced by the material initial microstructure and reactor operating conditions. For example, the cold work could delay the growth of Frank loops [9] and the stress during service could increase the mean loop size as well as their density under neutron irradiation [14].

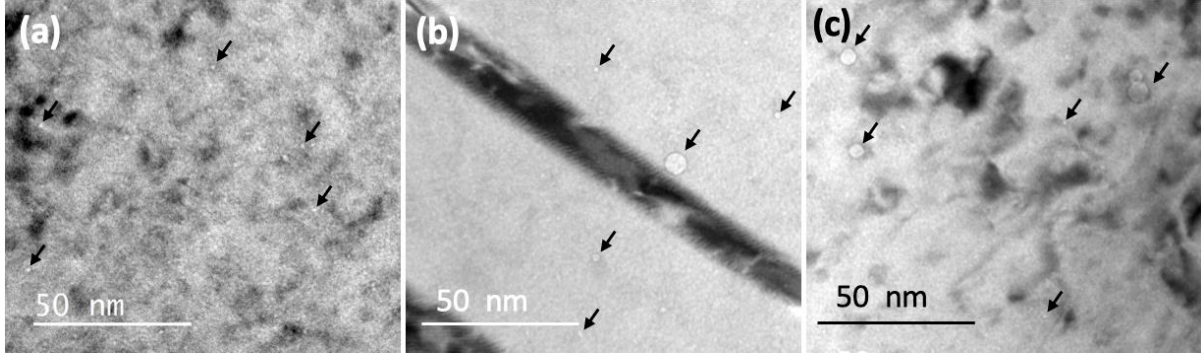
Besides dislocation loops, TEM characterization also revealed cavities in 4416 CS1, MS and BS specimens. Figure 3.2 shows cavities imaged at a focus of -400 nm and Table 3.2 summarizes the statistical results of cavities. From the bolt head towards the thread end, the average cavity size increased with a decrease in cavity density. Most cavities observed in the 4416 CS1 sample had sub-

nanometer sizes, which led to a very low swelling level, as shown in Table 3.2. On the other hand, cavities with diameters larger than 5 nm were observed in both 4416 MS and BS samples, with the latter showing a higher frequency of larger cavities. The overall swelling levels for MS and BS samples were similar and larger than that of the CS1 sample.

Figure 3.2 Cavities observed at an underfocused condition for the 4416 CS1 (a), MS (b), and BS (c) samples. Some of the cavities are marked with black arrows

Another distinctive microstructural feature after irradiation was cavity formation in 4416 CS1, MS, and BS samples as shown in Figure 3.2. The observed cavities were larger in MS and BS samples compared with the higher-dose CS1 sample, which was similar to the cavitation behavior of a cold worked type 316 SS BFB extracted from the Tihange PWR [13]. In that study, the bolt shank positions have higher irradiation temperatures in the range of 333-343°C than the irradiation temperature of the bolt head at 320°C [13]. The evolution of cavities is believed to be governed by the interactions between vacancies and gas contents of helium and hydrogen [13,15]. The coincidence in the growths of dislocation loops and cavities in the BS sample is consistent with vacancy emission from loops as an active loop growth mechanism [9], which led to a higher vacancy density in the matrix resulting in cavity growth [13]. This is also consistent with previous observations in neutron-irradiated stainless steels that the observed dislocation loops were interstitial loops [9]. Despite the cavities, swelling in 4416 CS1, MS, and BS samples was insignificant with maximum swelling of less than 0.02%. The result is in line with a compilation of swelling measurements for PWR core internal components subjected up to 80 dpa dose [2].

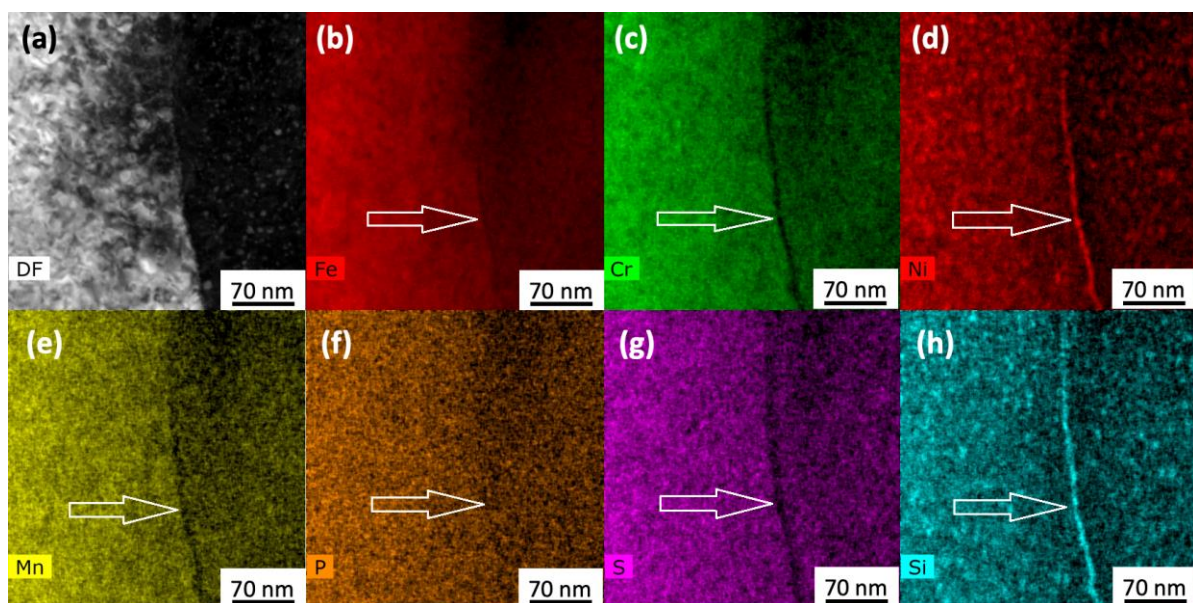
STEM/EDS-based composition maps were acquired for 4416 CS1, MS, and BS samples. As shown in Figure 3.3 to Figure 3.5, grain boundary (GB) segregation was observed in 4416 CS1 and MS, but not in 4416 BS, whereas fine precipitation was observed in all three samples. Intragranular precipitates with considerable densities showed enrichment in Ni and Si. For 4416 CS1 and MS samples, Fe, Cr, Mn, and S were observed to be depleted from GBs, while Ni and Si were observed to be enriched on GBs. The segregation of P in the CS1 sample showed a dependence on GB characters. For example, the vertical GB in Figure 3.3 did not show P segregation, whereas P segregated on the vertical GB but not the horizontal GB in Figure 3.6. For the MS sample (Figure 3.4), P segregation was observed in all studied GBs. No NbC was observed in STEM/EDS maps which may be due to the small size of FIB-prepared samples.

Figure 3.3 STEM/EDS-based composition maps for the 4416 CS1 sample. Arrows point to a GB

Radiation-induced segregation (RIS) was observed in GBs of 4416 CS1 and MS samples as shown in Figure 3.3 and Figure 3.4. The segregated elements, such as Ni and Si, and depleted elements, such as Fe, Cr, Mn, on GBs agrees with previously reported work [2]. However, RIS in GBs of the 4416 BS sample was not observed likely due to the small size of the FIB-prepared specimen. More investigation is needed to evaluate the RIS behavior in GBs of the 4416 BS sample. In addition, RIS of Ni and Si to sinks led to the formation of Ni-Si clusters in the matrix of 4416 CS1, MS, and BS samples. The possible phases for Ni-Si clusters are γ' (Ni_3Si) and G phase ($\text{M}_6\text{Ni}_{16}\text{Si}_7$) which needs to be confirmed by future study. In contrast to a common belief that minor elements, such as S, should segregate to the boundary, depletion of S was observed on GBs for 4416 CS1 and MS samples in this study. Additional work is needed to understand the mechanism for S depletion on GBs. Further, P has the tendency to thermally segregate to GBs prior to irradiation. The segregation of P can be enhanced by irradiation [16-17]. However, measurements of grain boundary P segregation in neutron-irradiated SS have not yielded consistent results [2]. Indeed, in this study, P segregation on GBs was observed

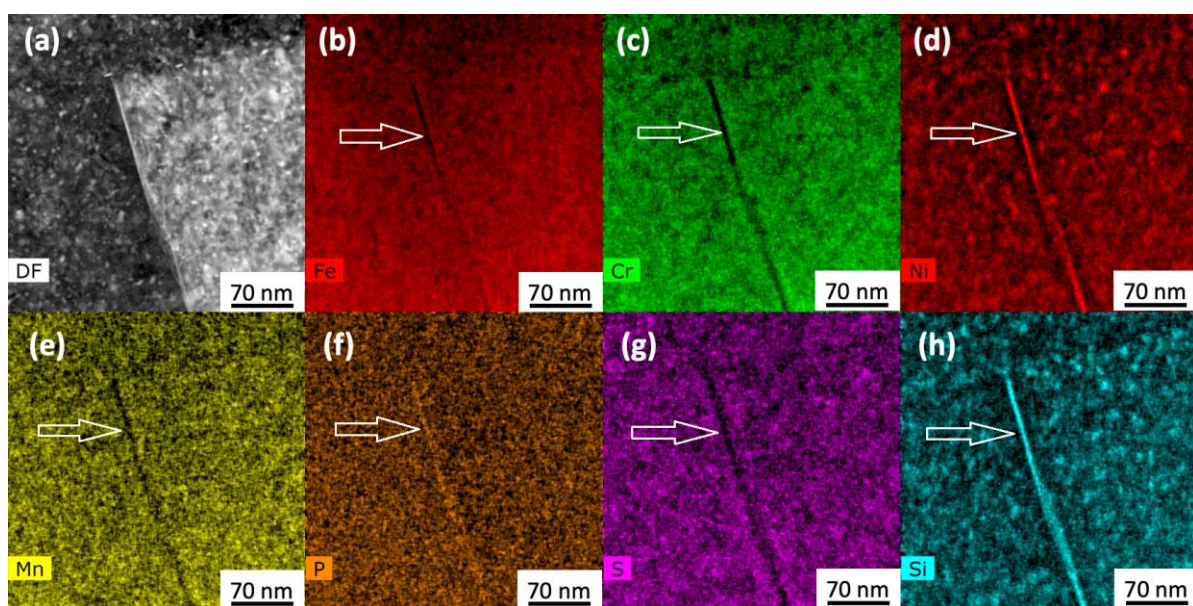
Figure 3.4 STEM/EDS-based composition maps for the 4416 MS sample. Arrows point to a GB

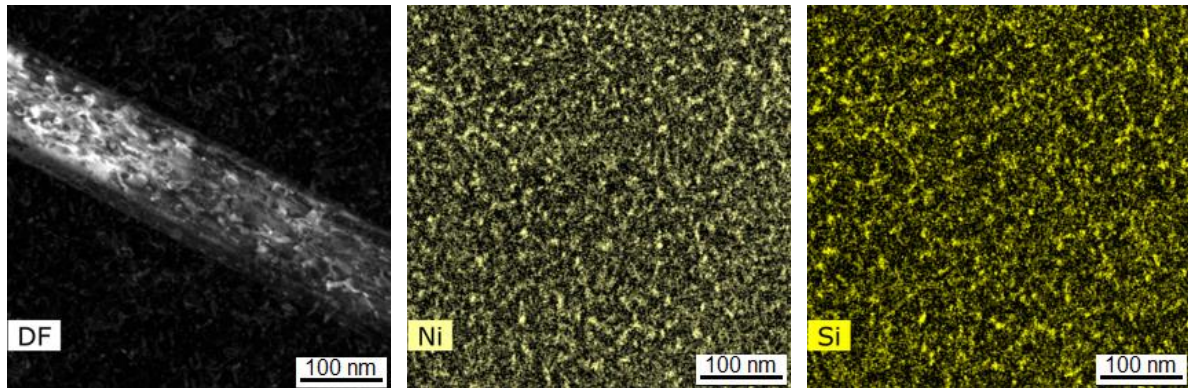
Figure 3.5 STEM/EDS-based composition maps showing Ni-Si precipitates in the 4416 BS sample

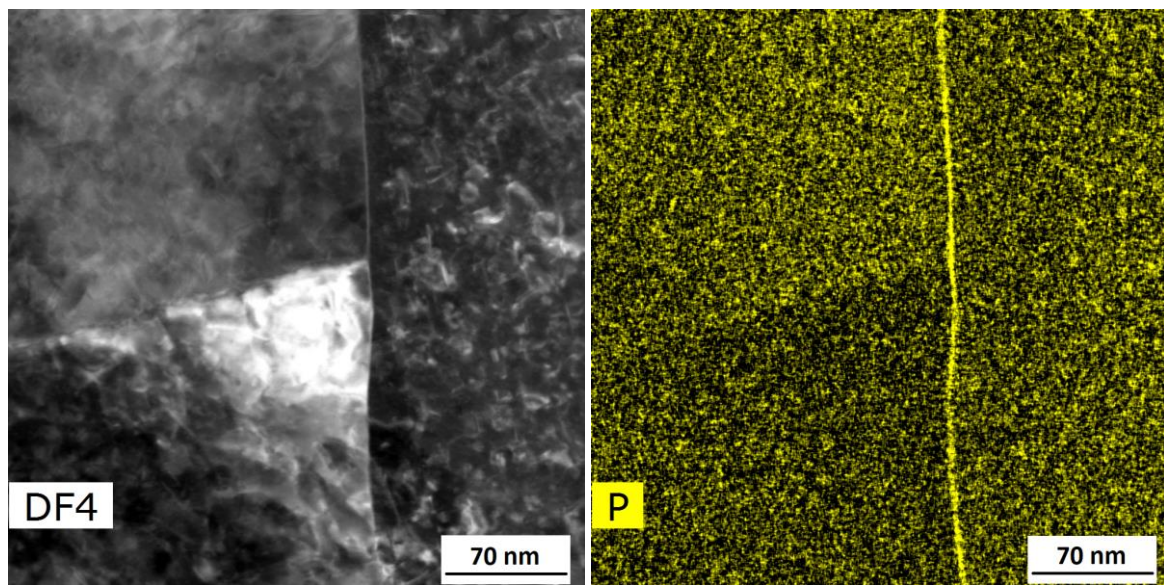
Figure 3.6 Segregation of P on the vertical GB, but not the horizontal GB of the 4416 CS1 sample

in the 4416 MS sample but only in one GB for the 4416 CS1 sample through the STEM/EDS survey of at least two GBs for each sample. Given the different irradiation conditions between the two samples, including but not limited to temperature, dose, gas content, stress [13, 15], and possible differences in the character of observed GBs, it is hard to determine the governing factor for P segregation via the current study. Future work to elucidate this topic will include quantification of segregation at more GBs and characterization of GB misorientation angles.

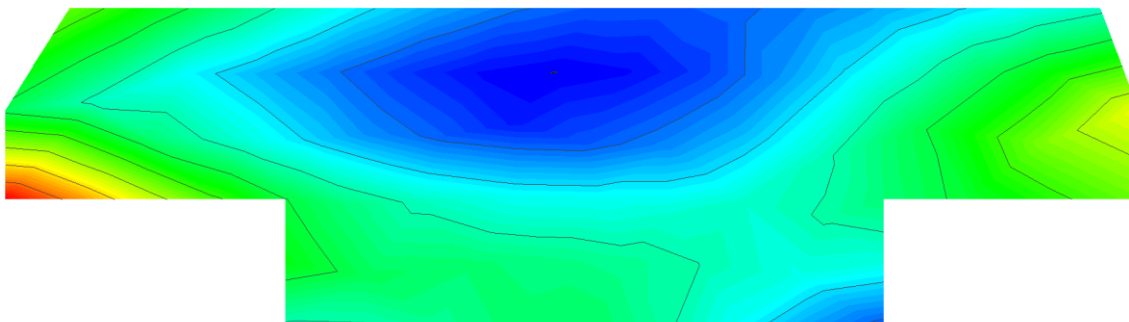
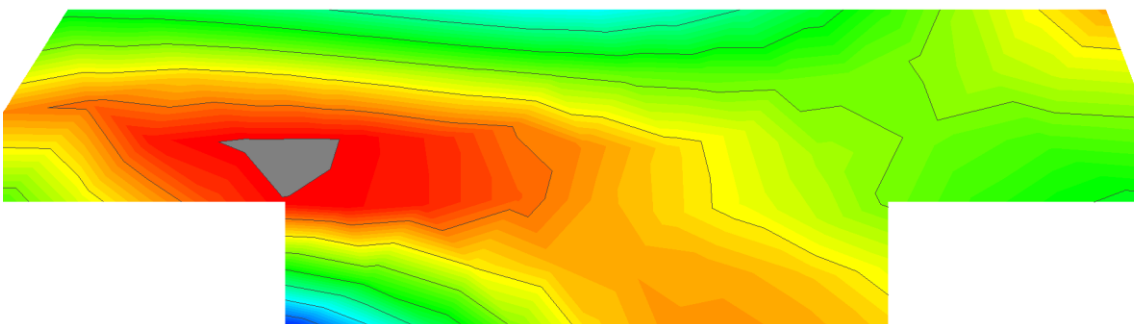
Microhardness results are combined with measurement coordinates to evaluate the spatial variation of hardness across the specimen surface. The results are shown in Figure 3.7 and Figure 3.8 for the bolt head thin slice and bolt shank and thread section bend bar specimens, respectively. Despite the spatial variation of hardness measurements for each specimen, no specific variation pattern was observed. Comparing hardness statistics results (Figure 3.9) reveals that for bolt 4412, hardness increased from the bolt head (high fluence region) towards the end of the thread section (low fluence region) whereas for bolt 4416, hardness variation was relatively small across the length of the bolt.

Figure 3.7 Microhardness maps for 4412 CS2 in (a) and 4416 CS2 in (b)

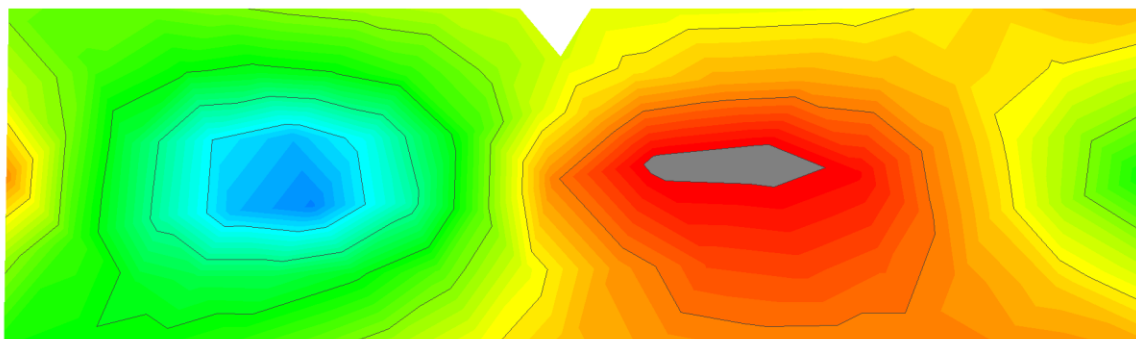
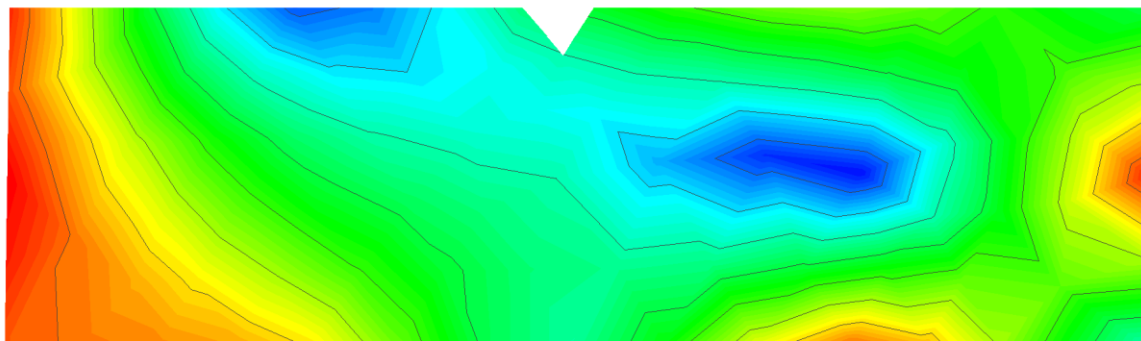
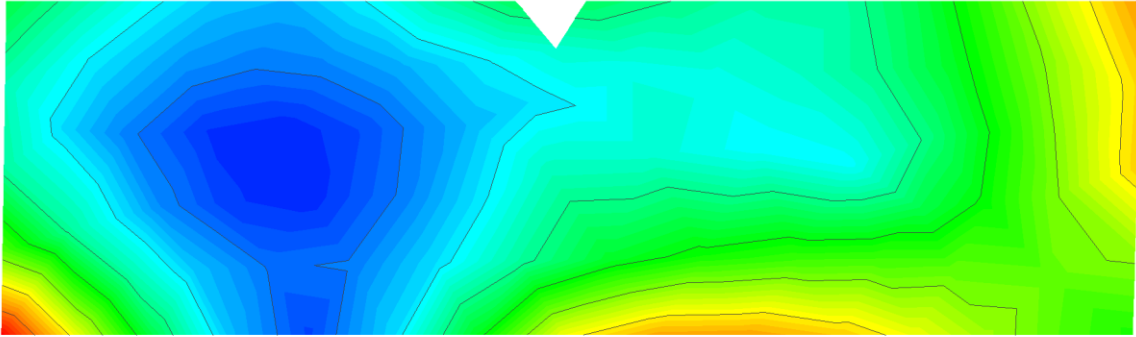
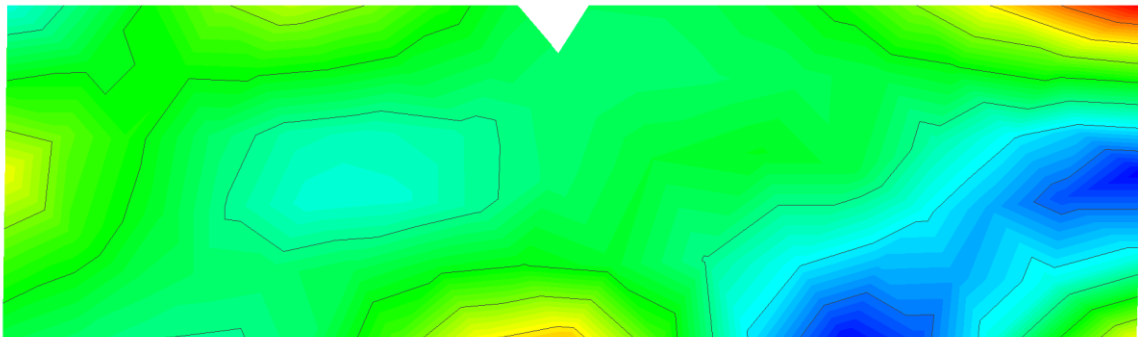
Figure 3.8 Microhardness maps for 4412 TBA in (a), 4412 BBA in (b), 4416 TBA in (c), and 4416 BBA in (d)

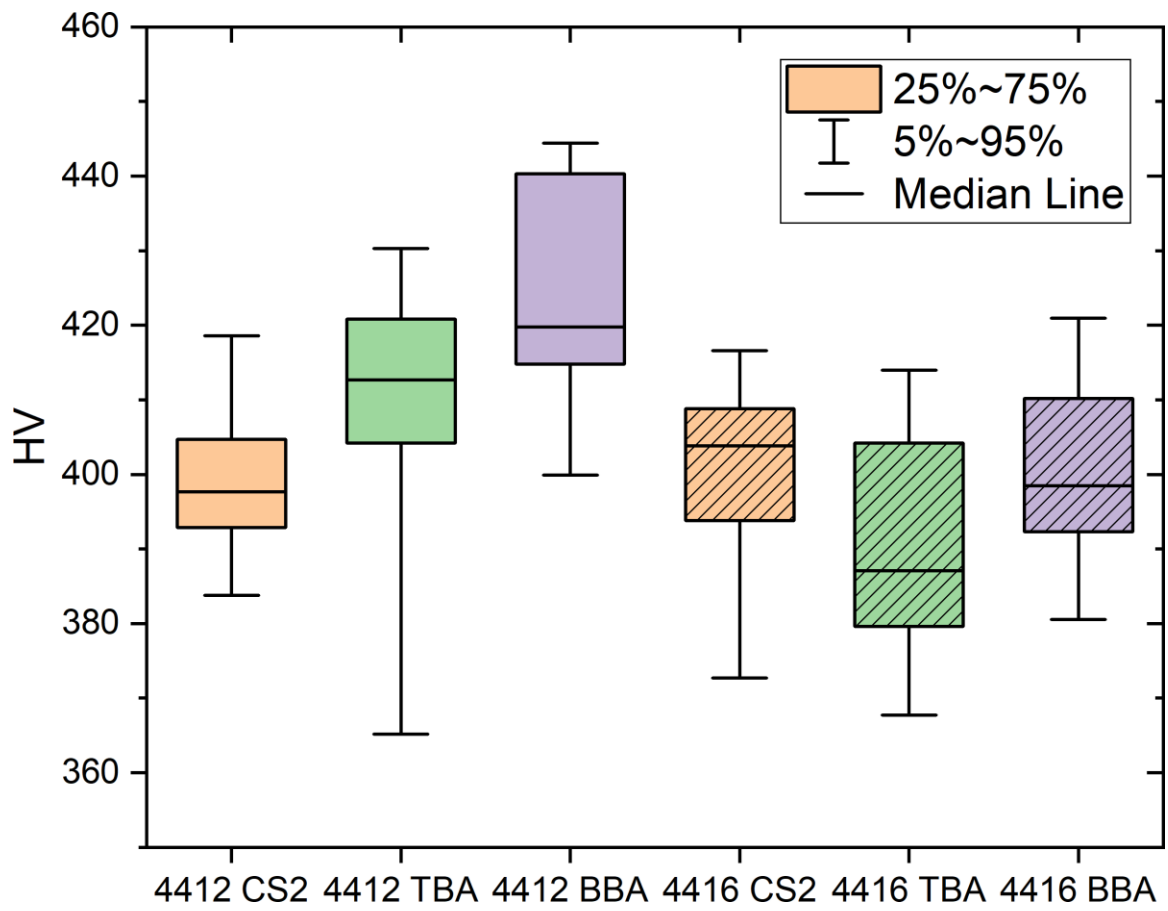
Figure 3.9 Statistics of microhardness measurements for bolts 4412 and 4416

Lastly, materials irradiation hardening behavior was evaluated by microhardness measurements. Despite the extensive characterization efforts, there was no clear effect of neutron fluence on hardness values. The spatial variation of the hardness of each specimen also did not indicate any clear trend. Based on Ref. [2], the yield strength of the 300-series SSs irradiated at approximately 300°C appears to saturate at a neutron dose of 5 dpa. BFBs studied in this work all exceeded that dose limit and hence the effect of neutron fluence on hardness values may be limited and many other factors, such as irradiation temperature, materials initial properties, in-service conditions, etc. may affect the materials irradiation hardening behavior.
