Federal Emergency Management Agency Mobile Housing Unit Running Gear Testing: Final Report

**FEDERAL EMERGENCY MANAGEMENT AGENCY MOBILE HOUSING UNIT
RUNNING GEAR TESTING: FINAL REPORT**

Date Published: August 2019

Prepared by
OAK RIDGE NATIONAL LABORATORY
Oak Ridge, TN 37831-6283
managed by
UT-BATTELLE, LLC
for the
US DEPARTMENT OF ENERGY
under contract DE-AC05-00OR22725

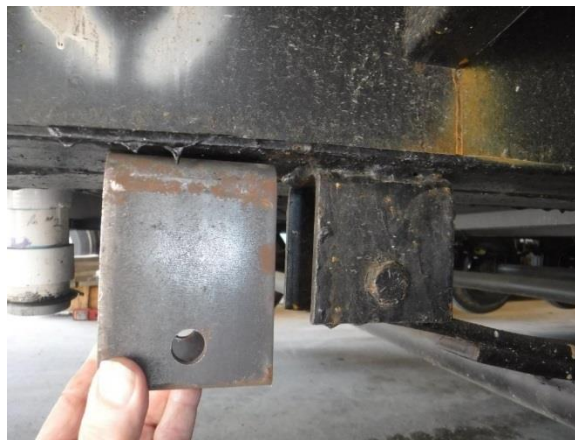
Figure 14. Four-inch Spring Hanger Compared to Existing Three-inch Spring Hanger.

Similarly, there were no issues immediately discovered with the Upgrade Unit other than the fact that this unit was going to be outfitted at the end of the testing regiment with 235/80R-16 wheels and radial tires. These wheels and tires are larger in diameter than the 8-14.5 wheels and tires with which the MHUs are normally equipped; therefore, to accommodate the larger radial tires so they can clear the outriggers and underpinning of the unit, four-inch spring hangers were required (see Figure 14).

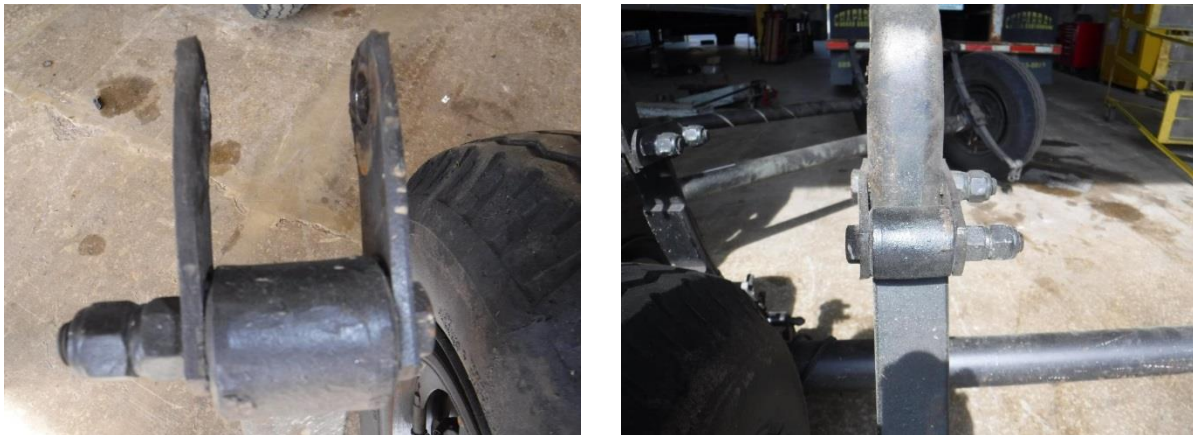
It was later determined that the double nutting was a manufacturer specification, which also required two threads to be exposed in order to achieve the correct fastener engagement. Trying to comply with these two specs simultaneously would again result in deforming (crushing) the equalizers as was done at the factory. To avoid this problem, it was recommended that the first nut be installed making sure that the components were free to move. And then the second nut would be installed, foregoing the two-thread clearance if this was not possible to achieve without overtightening the nuts.

Figure 15. Overtightened Equalizer Bolts.

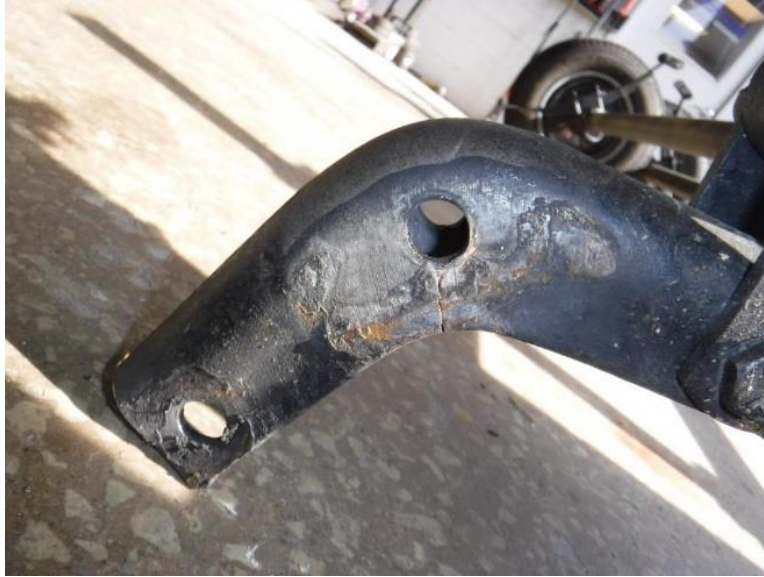
The mechanics found that the equalizer on Axle 3 was cracked at the apex (see Figure 16), most likely due to the overtightened nuts. Also, a tire on Axle 4 had two large bulges on the inboard side and appeared ready to fail (see Figure 17).

Figure 16. Cracked Axle 3 Equalizer.

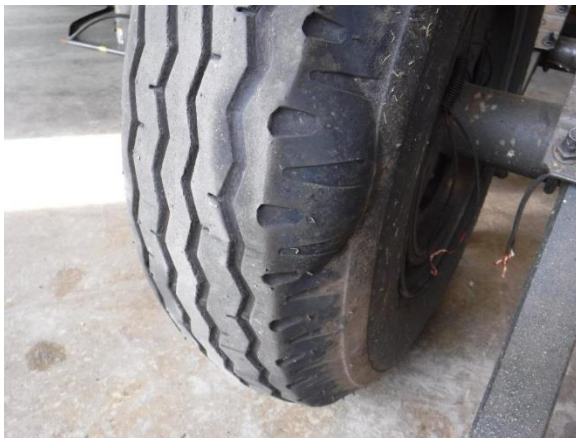
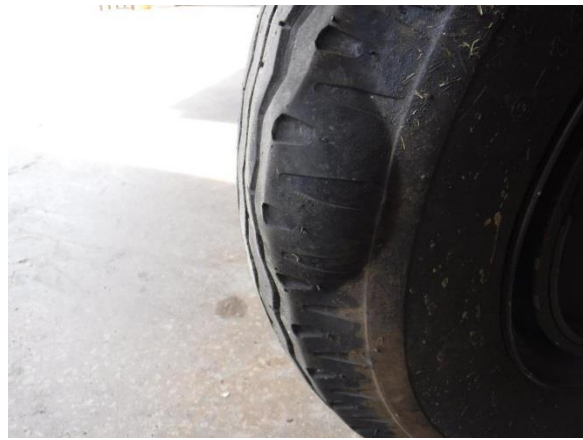
Figure 17. Bulges on One of Axle 4 Tires.

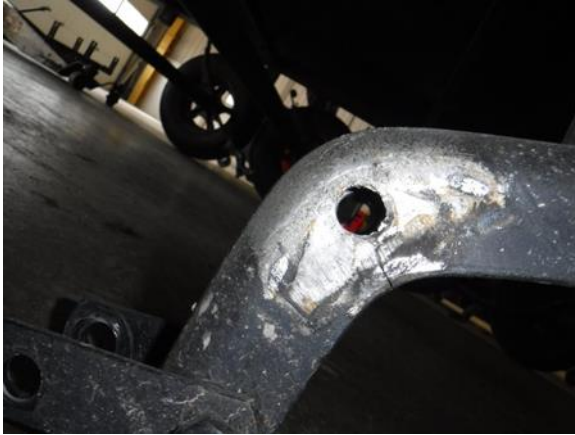
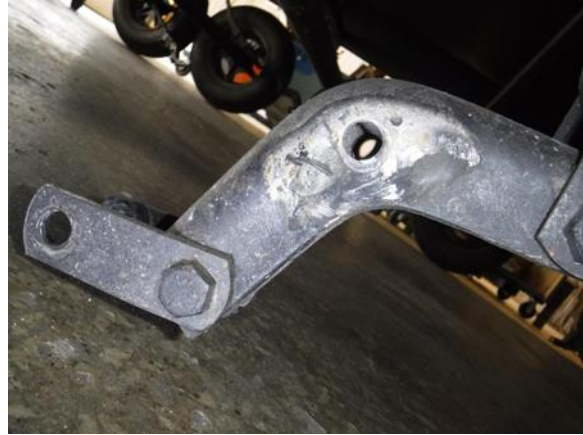
Similar issues were found during the outfitting of the Baseline Unit. As before, the suspension movement was severely limited due to overtightened fasteners. This also resulted in the equalizers' being distorted and/or cracked (Figure 18), as well as bent and distorted shackles (Figure 19). Also, the inside of all the spring hangers were distorted and abraded due to the overtightening of fasteners and the lack of proper clearance (Figure 20). The outboard flanges of the spring hangers were deformed due to wear and indentation from the bolt heads (Figure 21). There was also a mismatch between the 9/16-inch bushing and the 1/2-inch fastener that were used, resulting in the distortion of the spring-eye bushings (Figure 22). These issues were corrected before proceeding with testing.

Figure 18. Cracked and Distorted Equalizers.

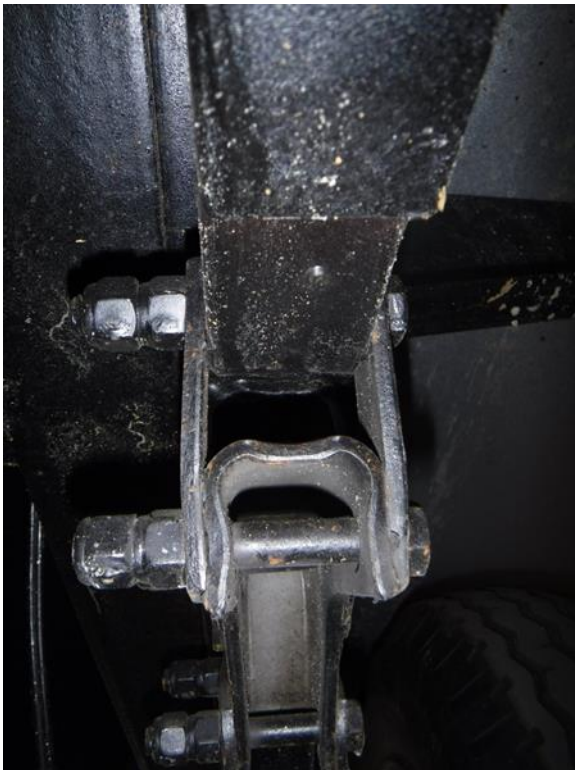
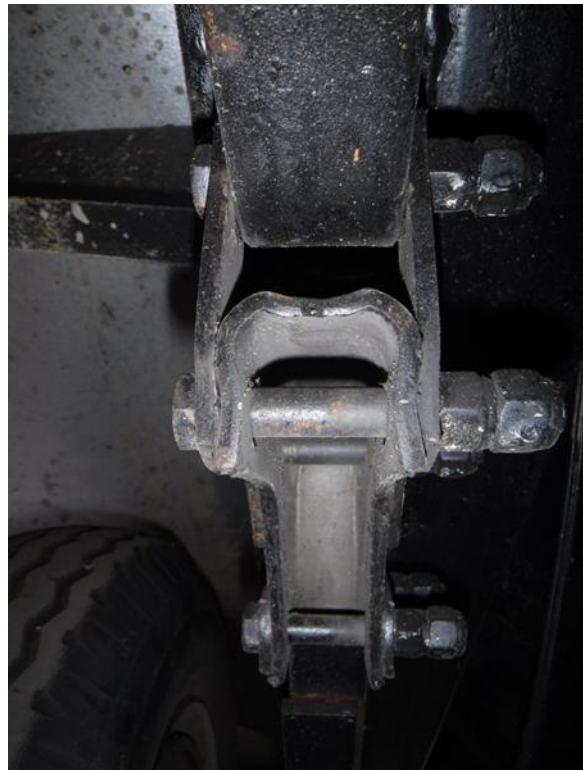
Figure 19. Bent and Distorted Shackles.

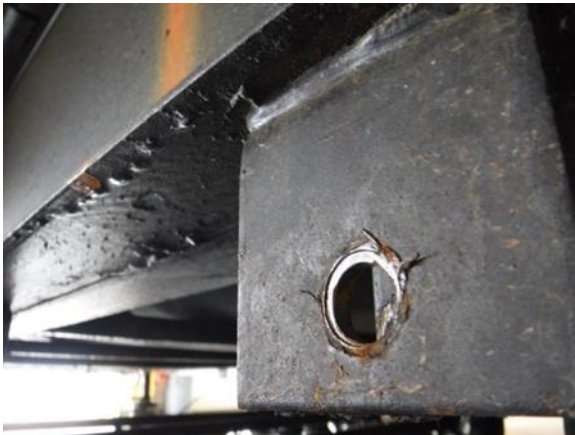
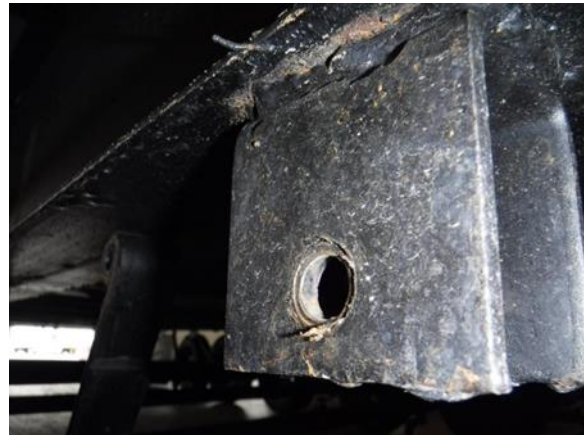
Figure 21. Wear and Indentation from Bolt Heads.
