Microstructural Analysis of Iron-Chromium-Aluminum Samples Exposed to LOCA-Type Conditions Followed by Quench

September 2021

Nuclear Energy and Fuel Cycle Division

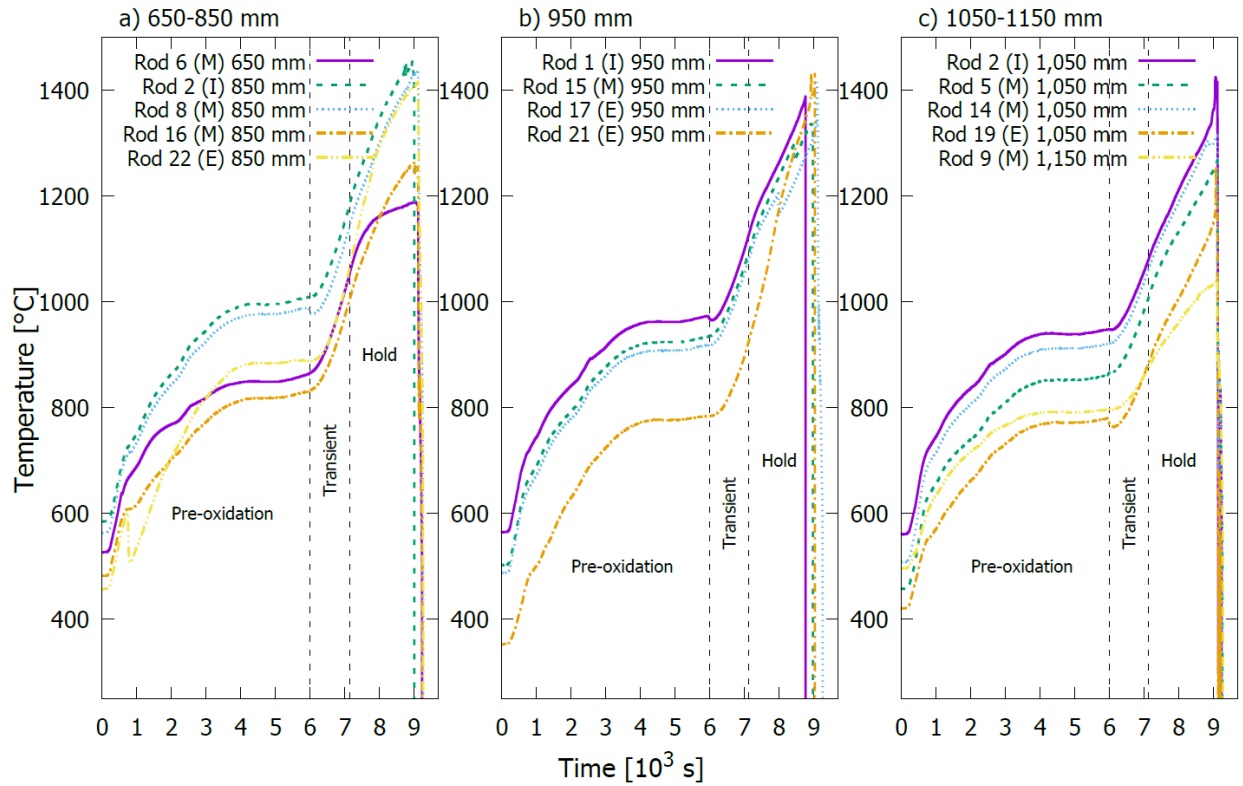
Figure 3. Thermocouple readouts from QUENCH-19 across the elevation ranges (a) 650–850 mm, (b) 950 mm, and (c) 1,050–1,150 mm. Each key entry shows the rod and elevation from which the thermocouple data came, along with a rod locator designation “(X),” where X is I, M, or E (standing for one of the internal rods [#1–4], one of the midrange rods [#5–16], or one of the exterior rods [#17–24], respectively). Three ranges—pre-oxidation, transient, and hold—are identified with labels on the plot and separated by dashed vertical lines.

First, comparing the curves in Figure 3a, there is a difference of 200–300°C between the midrange rod 6 at 650 mm and a similarly placed midrange rod 8 at 850 mm. Moreover, the midrange rod 8 at 850 mm

had a temperature profile very similar to that of internal rod 2. However, rod 16, which has fewer rods surrounding it than rod 6, has a temperature profile 100–200°C lower than that of rod 6. Interestingly, rod 22 at 650 mm has a temperature profile similar to that of rod 16 (albeit somewhat hotter during the transient) until the hold, at which time it achieves the same maximum as rods 2 and 8 at 850 mm. These data at 850 mm represent the maximum observed temperatures during the test.

Rods 1, 15, and 17, which represent each of the three rod sections (internal, midrange, and external), show surprisingly similar temperature profiles at 950 mm (Figure 3b). However, the thermocouple on rod 21, which is also external and on the opposite side of the other external rod, 17, reported a temperature consistently ~200°C lower than that of the other three rods until the hold time, when the temperature gradually rises to meet the temperature of the rest of the rods.

Above 950 mm, the system cools slightly, and more substantial axial variation is observed. Midrange rods 5 and 14 at 1,050 mm, separated by 90° rotation, are separated by 50–100°C over most of the temperature range, whereas rod 5 was separated only a few degrees from internal rod 2 over the same range. All three rods reached similar maximum temperatures at 950 mm; however, rod 14 does not ever reach that maximum and remains several degrees lower than rods 5 and 2. In contrast, external rod 19 at 1,050 mm and midrange rod 9 follow similar, lower-temperature paths with maximum temperatures of just over 1,200 and 1,000°C, respectively.

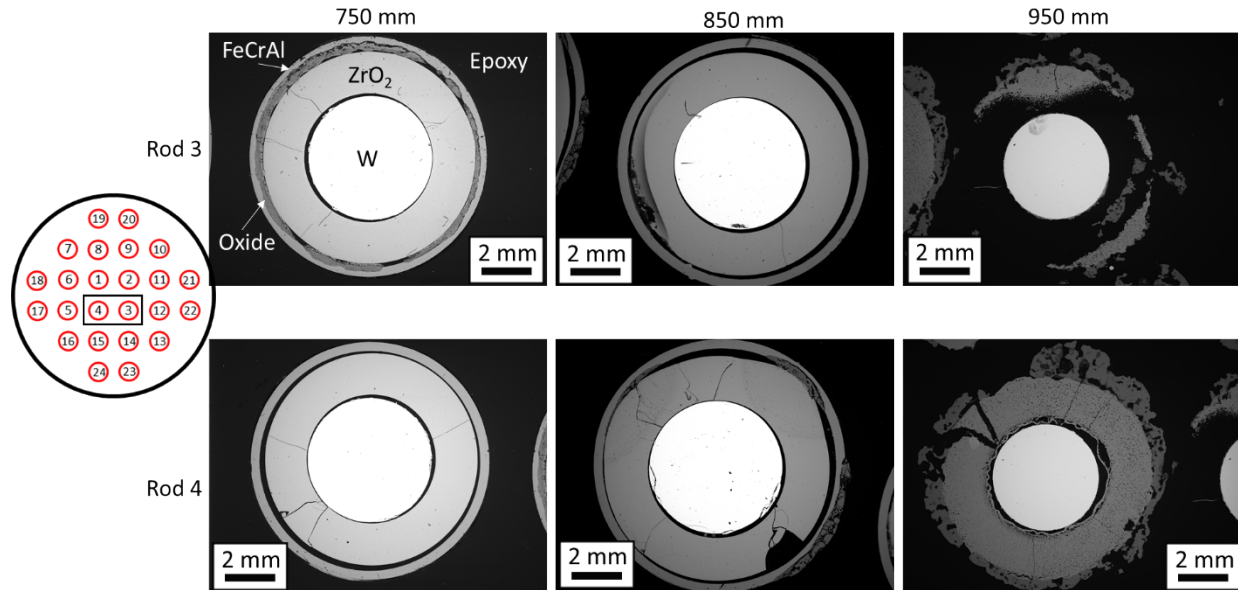
Figure 4 compares backscatter electron (BSE) images of the full rod cross section for rods 3 (top row) and 4 (bottom row) at 750 (column 1), 850 (column 2), and 950 (column 3) mm. Starting with the lowest elevation, rods 3 and 4 show significantly different microstructures. Rod 4 looks pristine on both the water and ZrO₂ sides. In contrast, the ZrO₂ side of rod 3 was attacked. In Figure 5 and Figure 6, this defected structure is shown to have two primary components. The one most clearly shown in Figure 6 is the diffusion of the components of at least Fe into the ZrO₂ insulator along with extensive oxide formation at the same location; the second is formation of a thin oxide layer where local attack was not observed. Figure 5a and 5c show significant contrast within the ZrO₂ pellet, stemming from the FeCrAl. In particular in Figure 5a and c, the contrasted region appears to be associated with the large internal oxide on the FeCrAl, implying that oxidation of the FeCrAl may be leading to diffusion between the ZrO₂ and FeCrAl. This is confirmed by Figure 6c–h. Figure 6c–d shows the same features as those in Figure 5. In addition Figure 6f–h shows small amounts of zirconium diffusing into the FeCrAl cladding and its oxides, whereas Figure 6e shows two features: (1) a thin, dense oxide containing aluminum on the water-side of the cladding; and (2) a thick aluminum-containing oxide on the interior of the coating. In Figure 6a–b similar oxidation behavior is observed on both the interior and exterior of the cladding. The internal oxidation behavior of this type is consistent with the other observations of internal oxide formation. Importantly, the presence of a thin external oxide is found at all elevations, implying that the uniform corrosion of FeCrAl is low compared with localized oxidation, which can be substantial. Therefore, if the localized corrosion effects can be properly accounted for as particular to this experiment, the cladding failures at 850 and 950 mm may not be observed in a real accident.

These observations extend to other locations and elevations, beginning in Figure 4. At 850 mm, no damage was found on rod 3, but significant internal and external oxidation is found on rod 4. Both of these observations are opposite of those at 750 mm. Additionally, the top right of the 850 mm, rod 4 image shows the same oxidation/diffusion behavior that was observed extensively on the interior of rod 3 at 750 mm. Figure 7 shows data from rods 1 and 2 at 850 mm, which supplement the observations from Figure 4. Interestingly, as with rod 3, rod 1 is shown to be undamaged. At 850 mm, none of rods 1, 3, or 4 were originally connected to thermocouples. Rod 2, by contrast, was connected to a thermocouple at 850 mm and is thoroughly destroyed. The tungsten element was entirely exposed with only a short segment of the ZrO_2 washer left behind and the washer was displaced toward the adjacent rod 11. Both the ZrO_2 remnant and the residual cladding oxide became extremely porous and were fused together.

Now, looking at 950 mm in Figure 4, the cladding and ZrO_2 for both rods 3 and 4 were fully destroyed; the ZrO_2 had partially disappeared and is fully porous. The cladding also fully converted to a porous oxide that is partially fused to the ZrO_2 washer. The other two rods were similarly destroyed at 950 mm. The reaction product structure is shown in Figure 8, where on rod 1 the cladding remnants are shown to have fused to the ZrO_2 in several places. Moreover, significant diffusion of zirconium into the FeCrAl oxides and FeCrAl into the ZrO_2 was observed with oxides heterogeneously mixed (Figure 8d–e).

Figure 4. Low magnification backscatter electron images of rods 3 (top row) and 4 (bottom row) at 750 (column 1), 850 (column 2), and 950 (column 3) mm. A rod diagram is shown on the left of the figure with a black box around rods 3 and 4.

Now turning to thermocouple-cladding interactions, the results show clearly that the most damage in this study was observed at 950 mm (see especially Figure 4 and Figure 7). Given that the temperature is slightly higher at 850 mm than at 950 mm (Figure 3), this behavior cannot be explained by enhanced oxidation rates. The destruction on rod 2 is best understood as caused by eutectic formation between the thermocouple and cladding followed by rapid local oxidation (Figure 2). This process would expose the ZrO_2 and FeCrAl to steam, which catalyzes the oxidation of FeCrAl and the diffusion of metals into the ZrO_2 . This can locally destroy both the cladding and zirconia, allowing steam ingress to the internal cladding directly above and below the ingress point, leading to the oxidation/diffusion attack at the cladding/ ZrO_2 interface. Because the steam flow is upward, the most significant internal cladding attack would occur at elevations above the eutectic formation point.

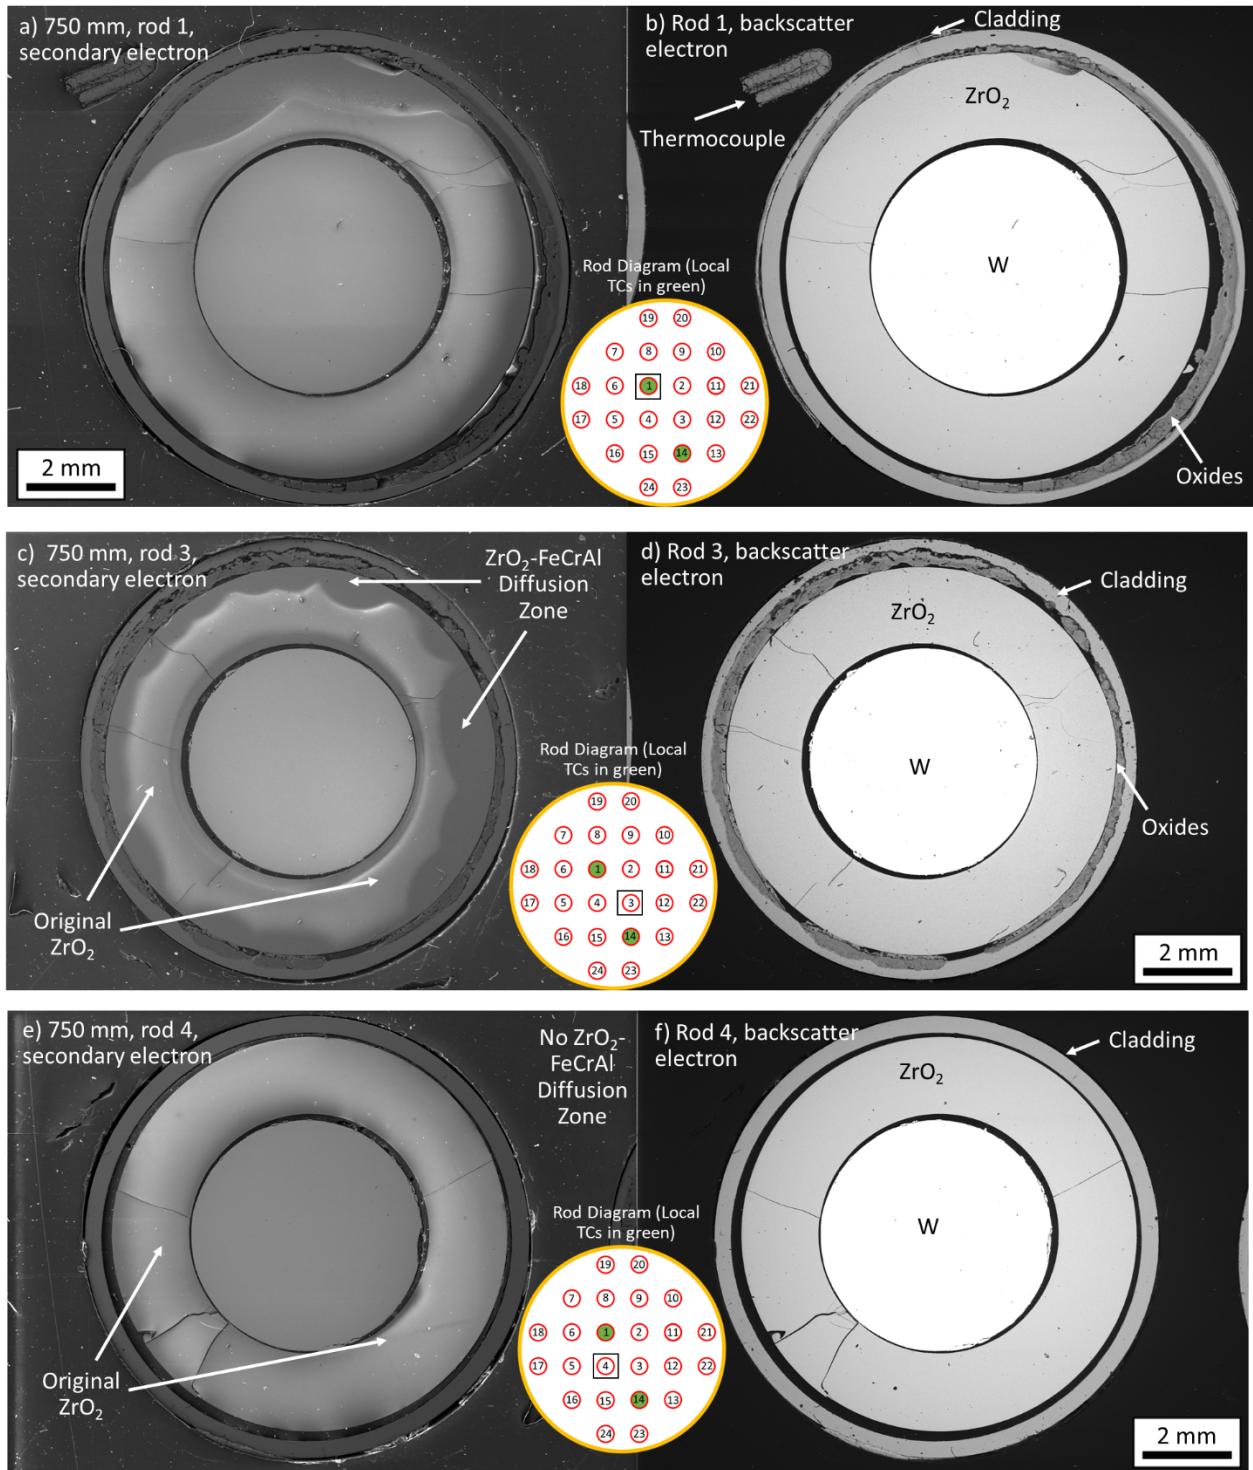
Figure 5. Low magnification secondary electron (a, c, e) and backscatter electron (b, d, f) images of rods 1 (a, b), 3 (c, d), and 4 (e, f) at 750 mm. Included with each pair of images is a rod diagram with a box showing the location of the rod. Important features are labeled appropriately.

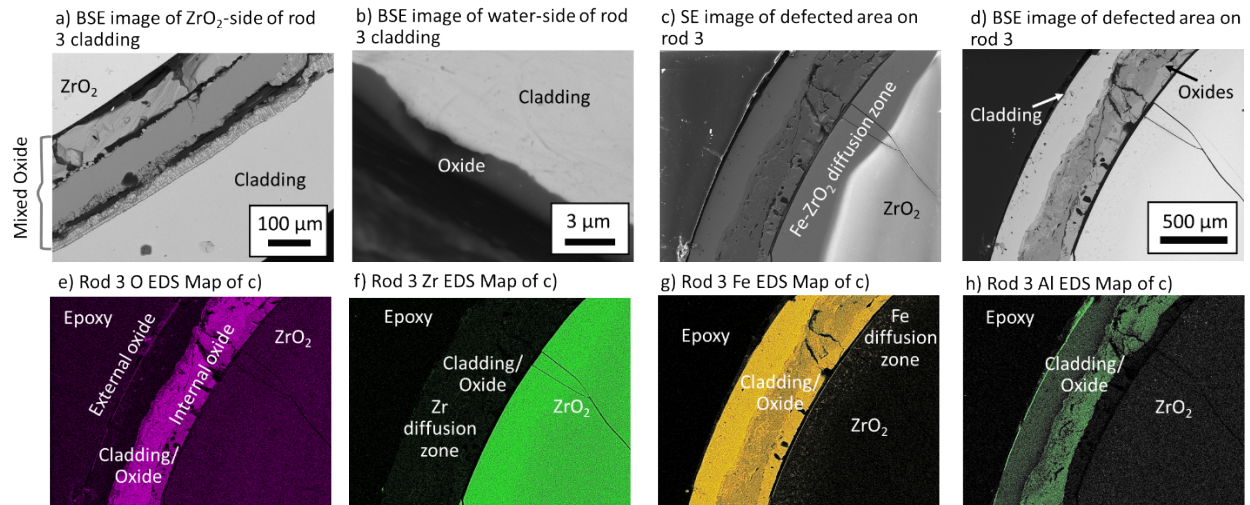
Figure 6. Oxide microstructure on segments of rod 3 at 750 mm. Part (a) shows a backscatter electron (BSE) image of the ZrO_2 side of the cladding, revealing a multicomponent oxide. In (b) a BSE image of water-side of the rod 3 cladding shows a single component thin oxide. Parts (c) and (b) show secondary electron (SE) and BSE images, respectively, of a defected cladding region. Parts (e)–(h) show the energy dispersive spectroscopy (EDS) maps of O, Zr, Fe, and Al, respectively, of the region in (c) and (d).

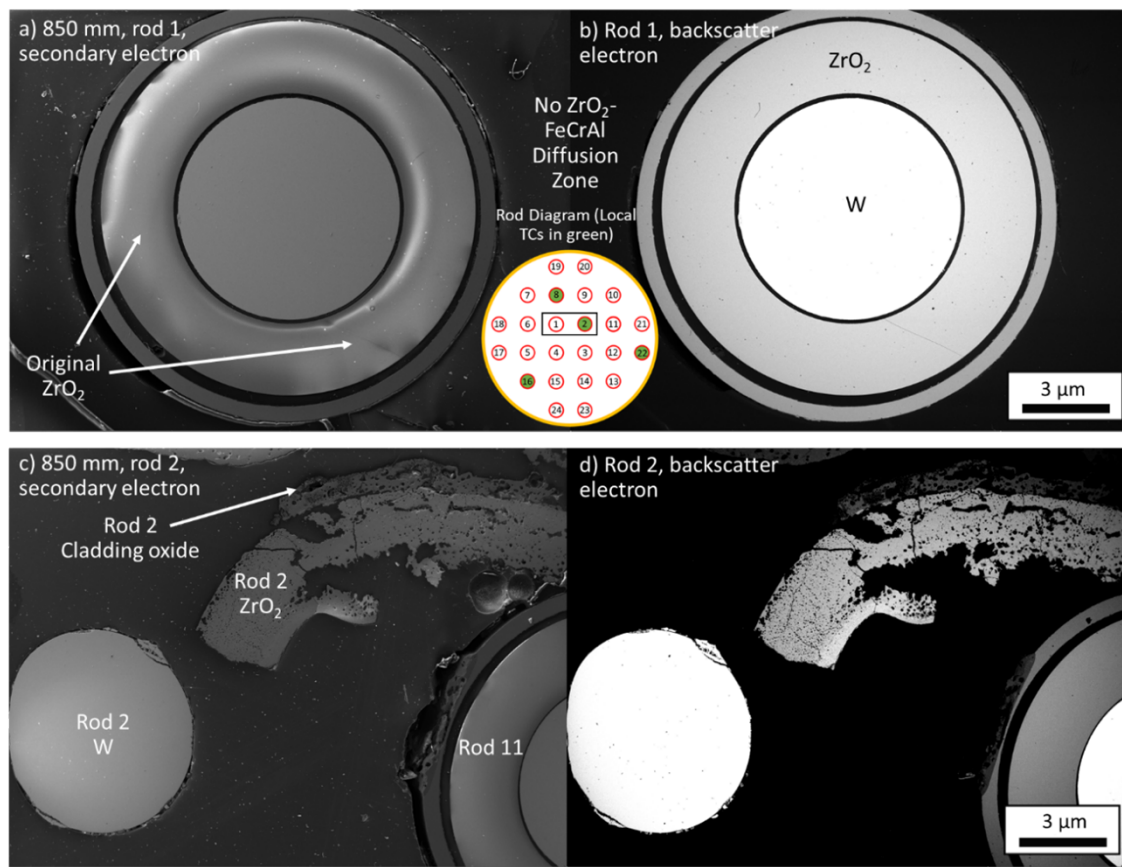
Figure 7. Low magnification secondary (a, c) and backscatter (b, d) electron images of rod 1 (a, b) and rod 2 (c, d). In (c) and (d), the rod was fully destroyed. The previous components of the rod are labeled, as is the adjacent midrange rod 11.

Figure 7, Figure 10, and Figure 13 show that each of the locations where significant destruction of the cladding occurred was related to placed thermocouples. However, it is interesting to note that at rod 16 and 850 mm (Figure 11), the rod shows no sign of localized attack, despite having had a thermocouple attached right at that location. This can be explained by Figure 3a, in which the rod 16 thermocouple at 850 mm reported a temperature that did not exceed 1,270°C; it is safe to conclude that the thermocouple-cladding interaction reaction requires a temperature above this value to proceed over this time frame.

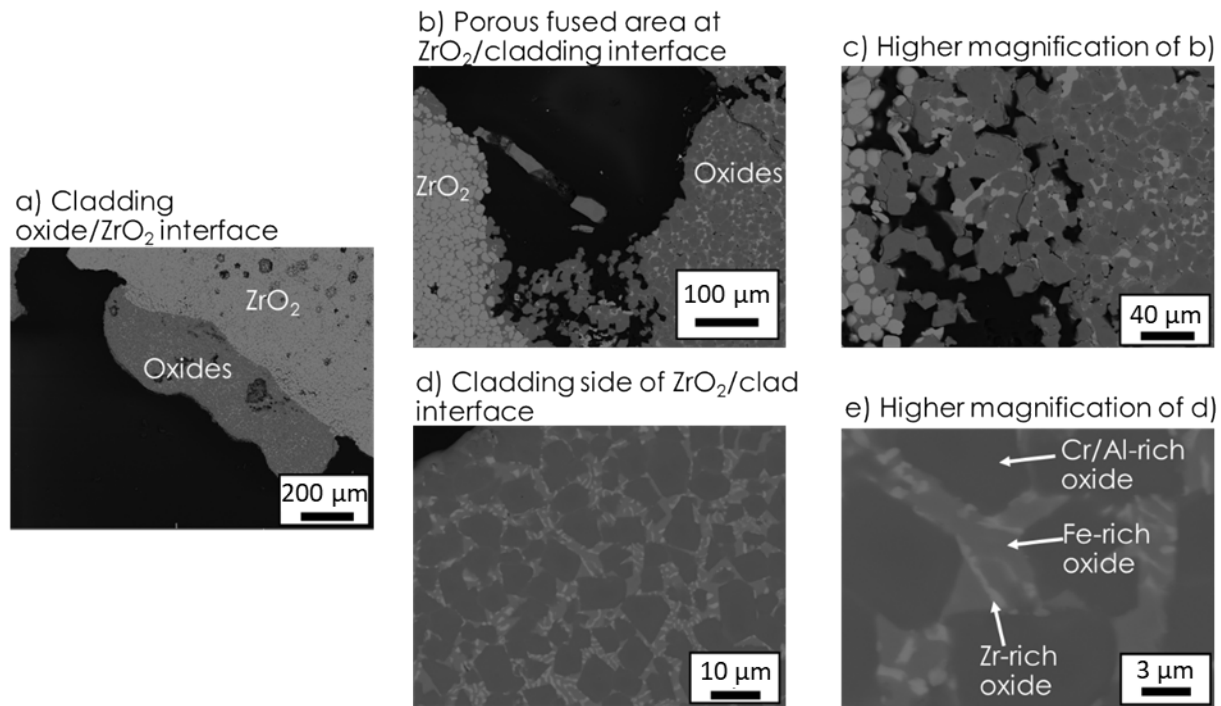
Figure 8. Backscatter electron images of internal rod 1 at 950 mm. Part (a) shows a low magnification image of the cladding/ZrO₂ interface, (b) and (c) show higher magnification images of a different region of fused interface, and (d) and (e) show further magnification of the cladding side of the interface.

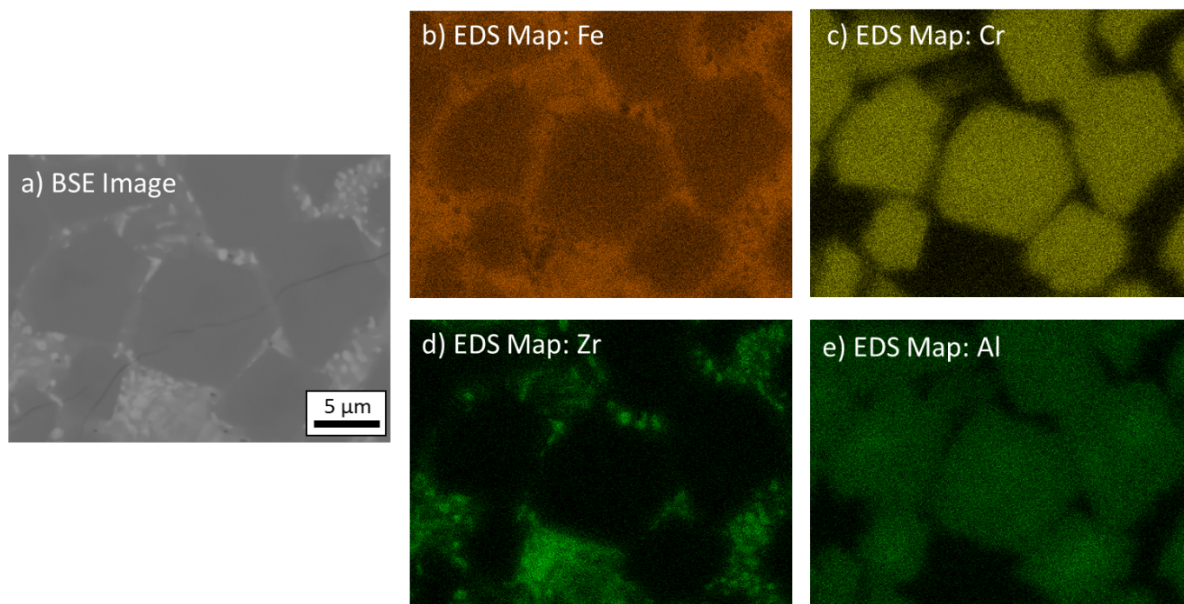
Figure 9: a) Backscatter electron images of internal rod 1 at 950 mm. b)-e) show elemental EDS maps of Fe, Cr, Zr, and Al, respectively of the image in a).

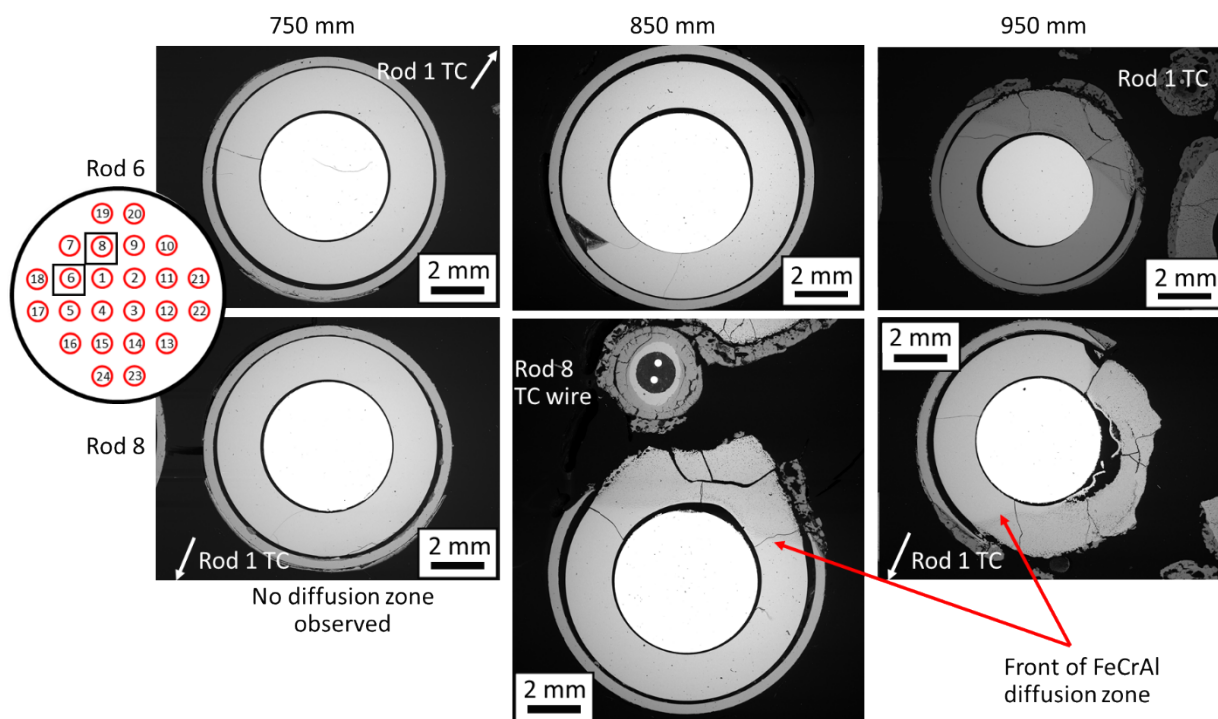
Starting with intermediate rods 6 and 8, Figure 10 shows entirely undamaged rods at 750 mm. Despite the presence of a thermocouple (at rod 1) at 750 mm, neither rod shows corresponding damage. At 850 mm, the eutectic behavior begins to operate. Rod 6, which had no thermocouples on or around it, was entirely undamaged. Rod 8, having a thermocouple welded to it at 850 mm, behaved quite differently. Over half of the rod and cladding remained fully intact, but there was an interaction region near the thermocouple connection point, which led to an attack of both the thermocouple sheath and FeCrAl/ZrO₂ on the rod. This behavior is replicated at 950 mm, where a thermocouple on rod 1 appears to have interacted with rods 1 and 6, as illustrated by the ~3/4 of rod 6 which is intact, whereas the remaining ~1/4 of the rod near the thermocouple was destroyed. On rod 8, about half of the rod is intact and the other half has been destroyed. On either side of rod 8 at 950 mm, rods 1 and 9 were both connected to thermocouples, which may have contributed to the extensive attack on rod 8. Rods 14 and 16 show less extensive damage at all levels, although there was extensive damage on rod 14 at 950 mm (Figure 11).

Figure 10. Low magnification backscatter electron images of rods 6 (top row) and 8 (bottom row) at 750 (column 1), 850 (column 2), and 950 (column 3) mm. A rod diagram is shown on the left of the figure with a black box around rods 6 and 8.

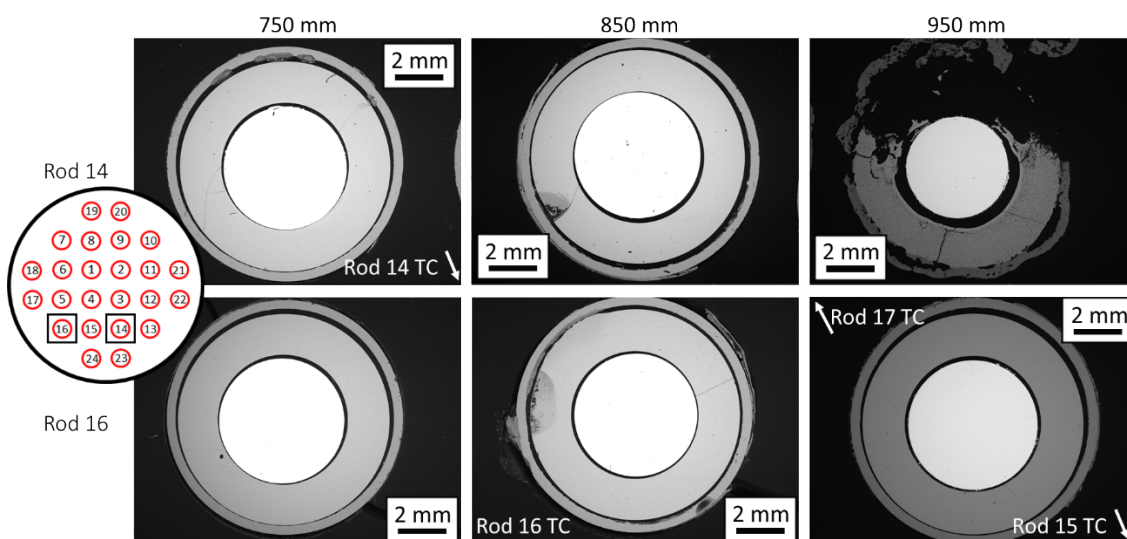
Figure 11. Backscatter electron images of rods 14 (top row) and 16 (bottom row) at 750 (column 1), 850 (column 2), and 950 (column 3) mm. A rod diagram is shown on the left of the figure with a black box around rods 14 and 16.

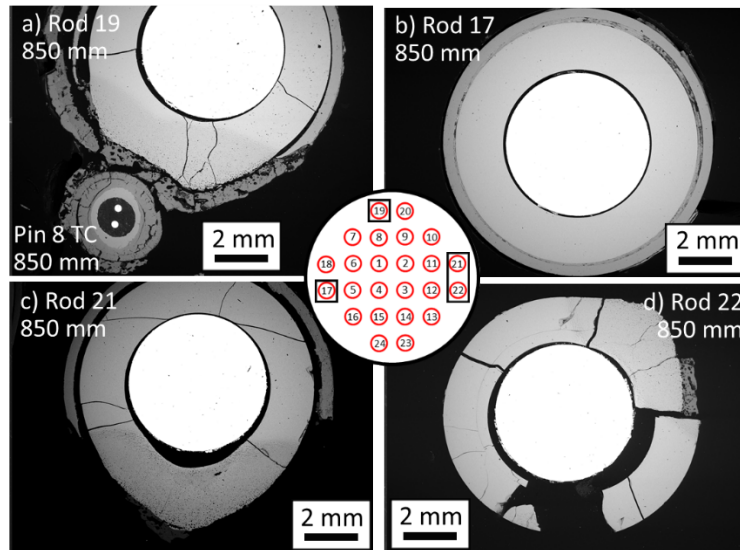
Figure 13. Backscatter electron images of the external rods 19, 17, 21, and 22 at 850 mm. A rod diagram is provided at the top of the figure along with black boxes showing the location of each of the rods in this figure.

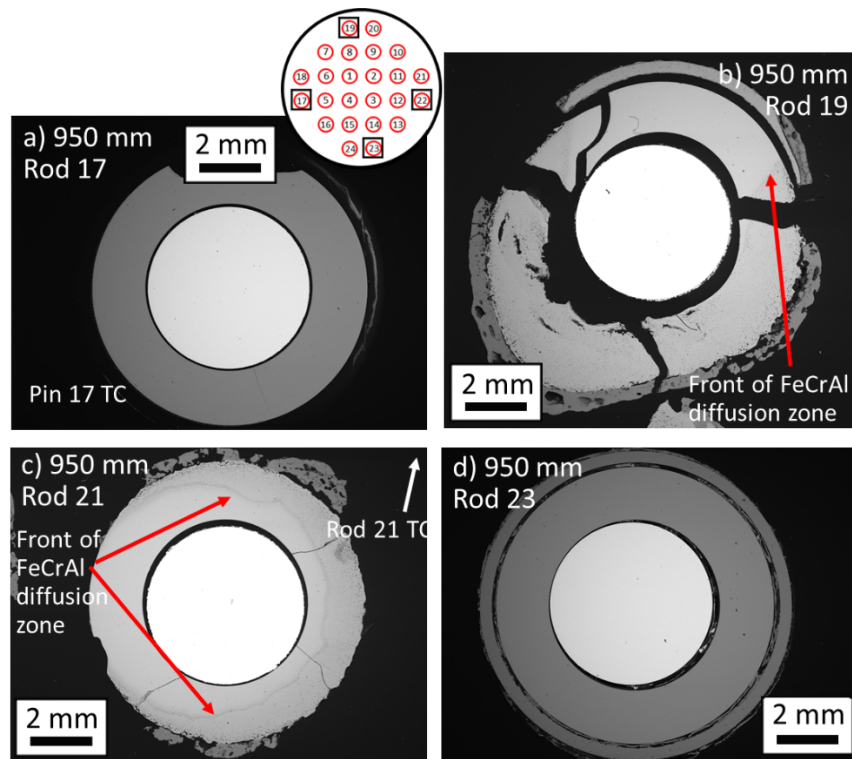
Finally, the observations at 950 mm (Figure 14) are broadly similar to the observations at 850 mm. Rod 17 (Figure 14a) appears to have lost its cladding, but there is no evidence of the chemical attack of ZrO₂ that was present in other locations. It is possible that the cladding was partially broken during post-experiment processing. In fact, some intact cladding can be observed visually to be under the surface of the clear epoxy. It is thus thought that the lack of cladding on rod 17 at 950 mm should be considered an artifact of the experiment, not an indication of quench-related failure. By contrast, rod 19 (Figure 14b) was significantly attacked on the ZrO₂ and FeCrAl toward the bottom of the image (facing the assembly center), whereas the top of the image shows intact cladding. There were no attachments at 950 mm, but substantial damage related to thermocouple-cladding interaction was noted at 850 mm on rod 19 (Figure 13). Rod 21, which was attached to a thermocouple at 950 mm, was fully stripped of its cladding with only some remnants remaining. Rod 23 (Figure 14d), which had no damage below and thermocouple attachments above and below it, was not observed to be damaged in any way.

Figure 14. Backscatter electron images of the external rods 17, 19, 21, and 23 at 950 mm. A rod diagram is provided at the top of the figure along with black boxes showing the location of each of the rods in this figure.
