OAK RIDGE NATIONAL LABORATORY

CF-61-3-11

DATE: March 3, 1961
SUBJECT: GC-ORR Loop II Filter Tests
TO: Distribution
FROM: F. A. Flint and R. E. MacPherson

ABSTRACT

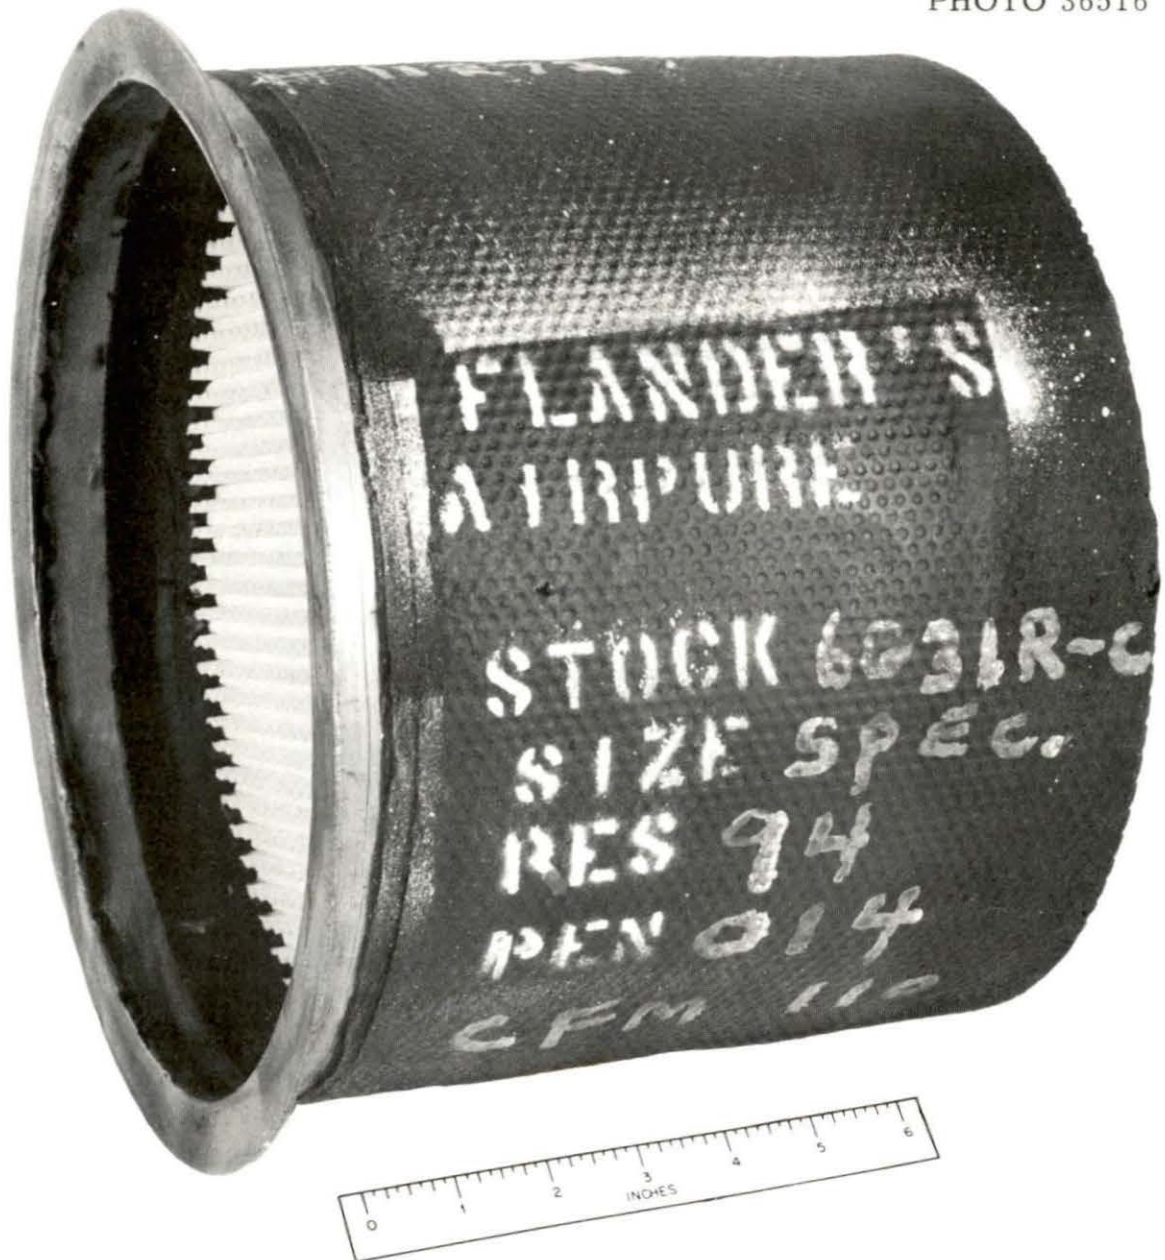
UNCLASSIFIED
PHOTO 36516

Fig. 1. Oblique View of Unmounted Filter Cartridge.

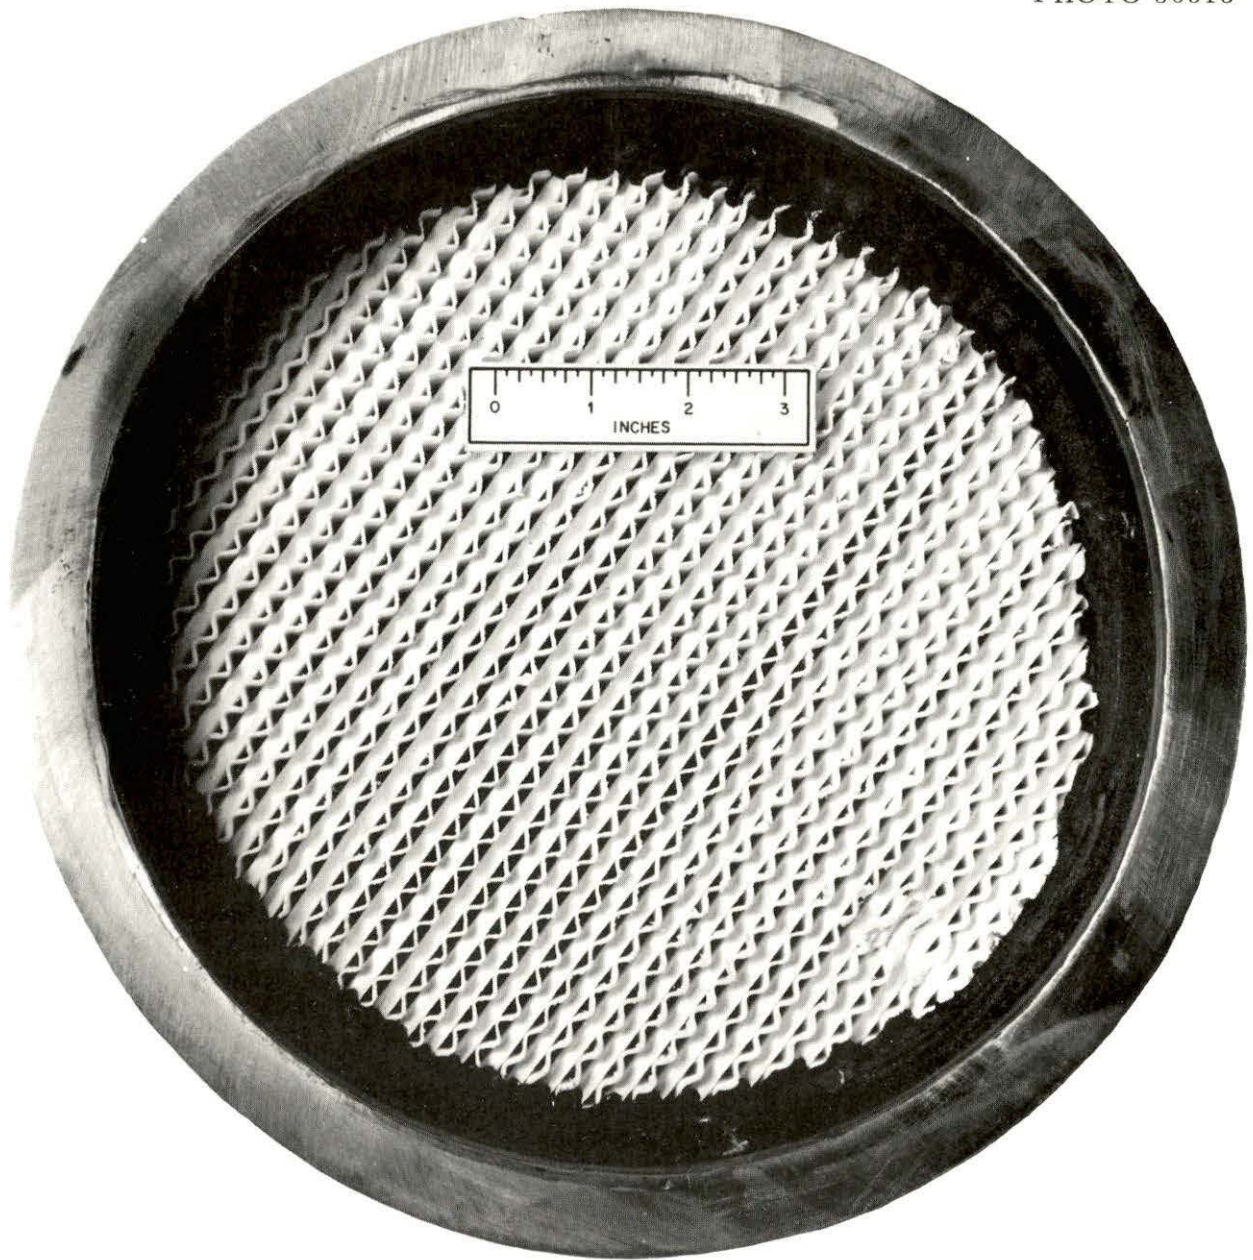
UNCLASSIFIED
PHOTO 36518

sealing the filtering material to the metal of the cylindrical wall, was cracked in several places (note Fig. 6). However, the bonding mastic of the spare, unmounted cartridge was also cracked in several places (note Fig. 2).

Fig. 2. View of Upstream End, Unmounted Filter Cartridge.

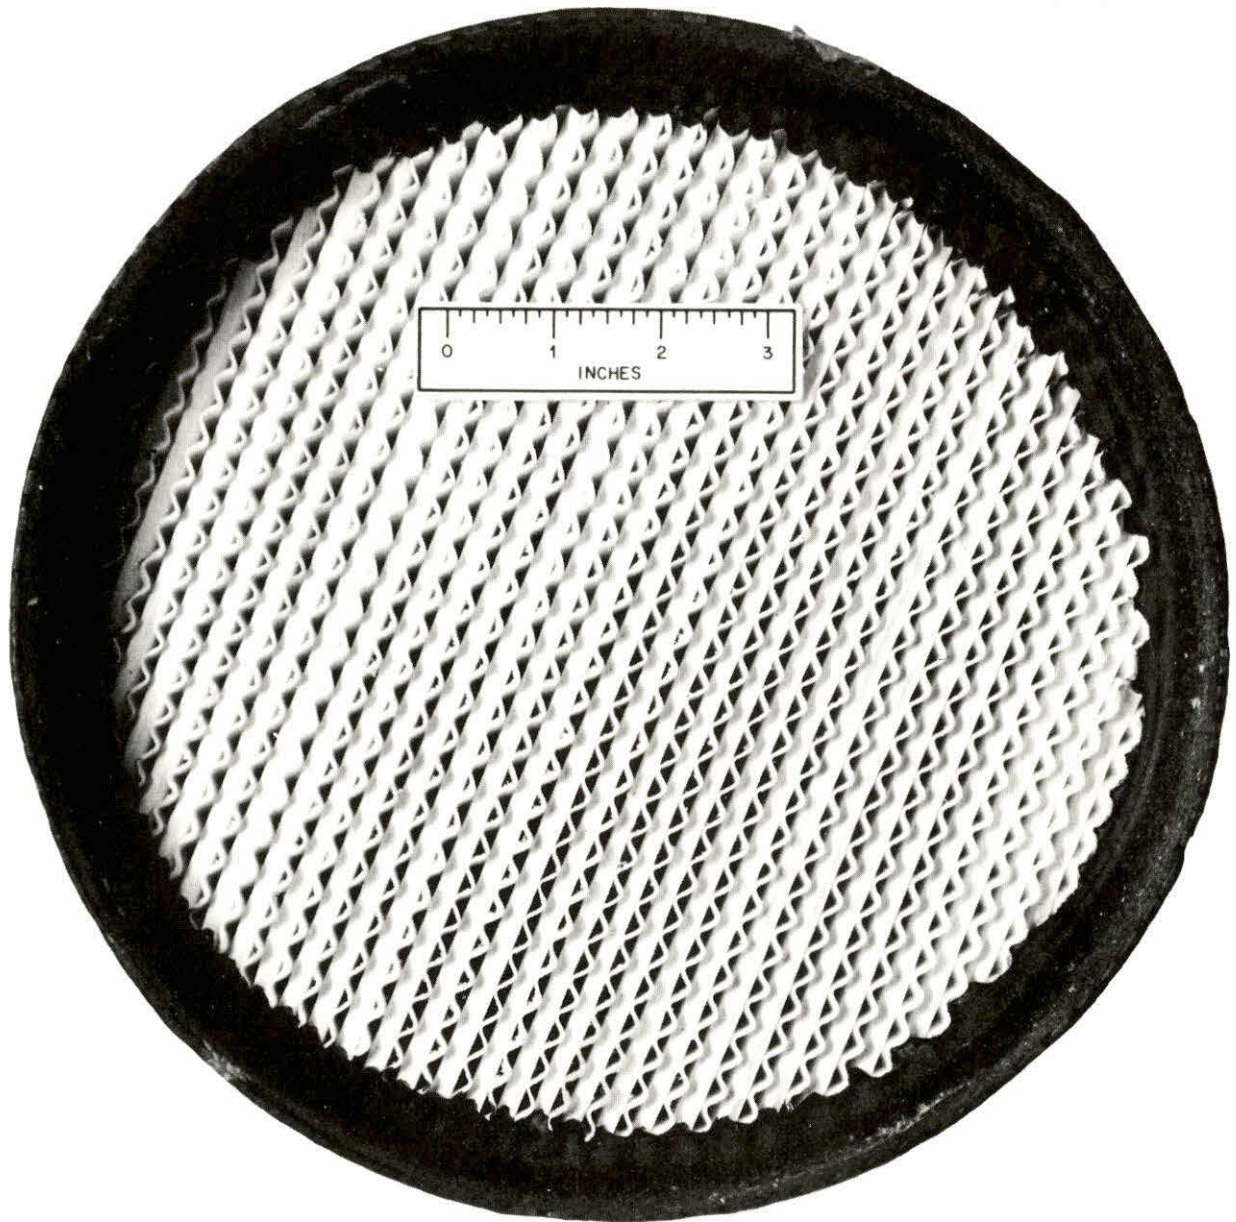
UNCLASSIFIED
PHOTO 36517

Fig. 3. View of Downstream End, Unmounted Filter Cartridge.

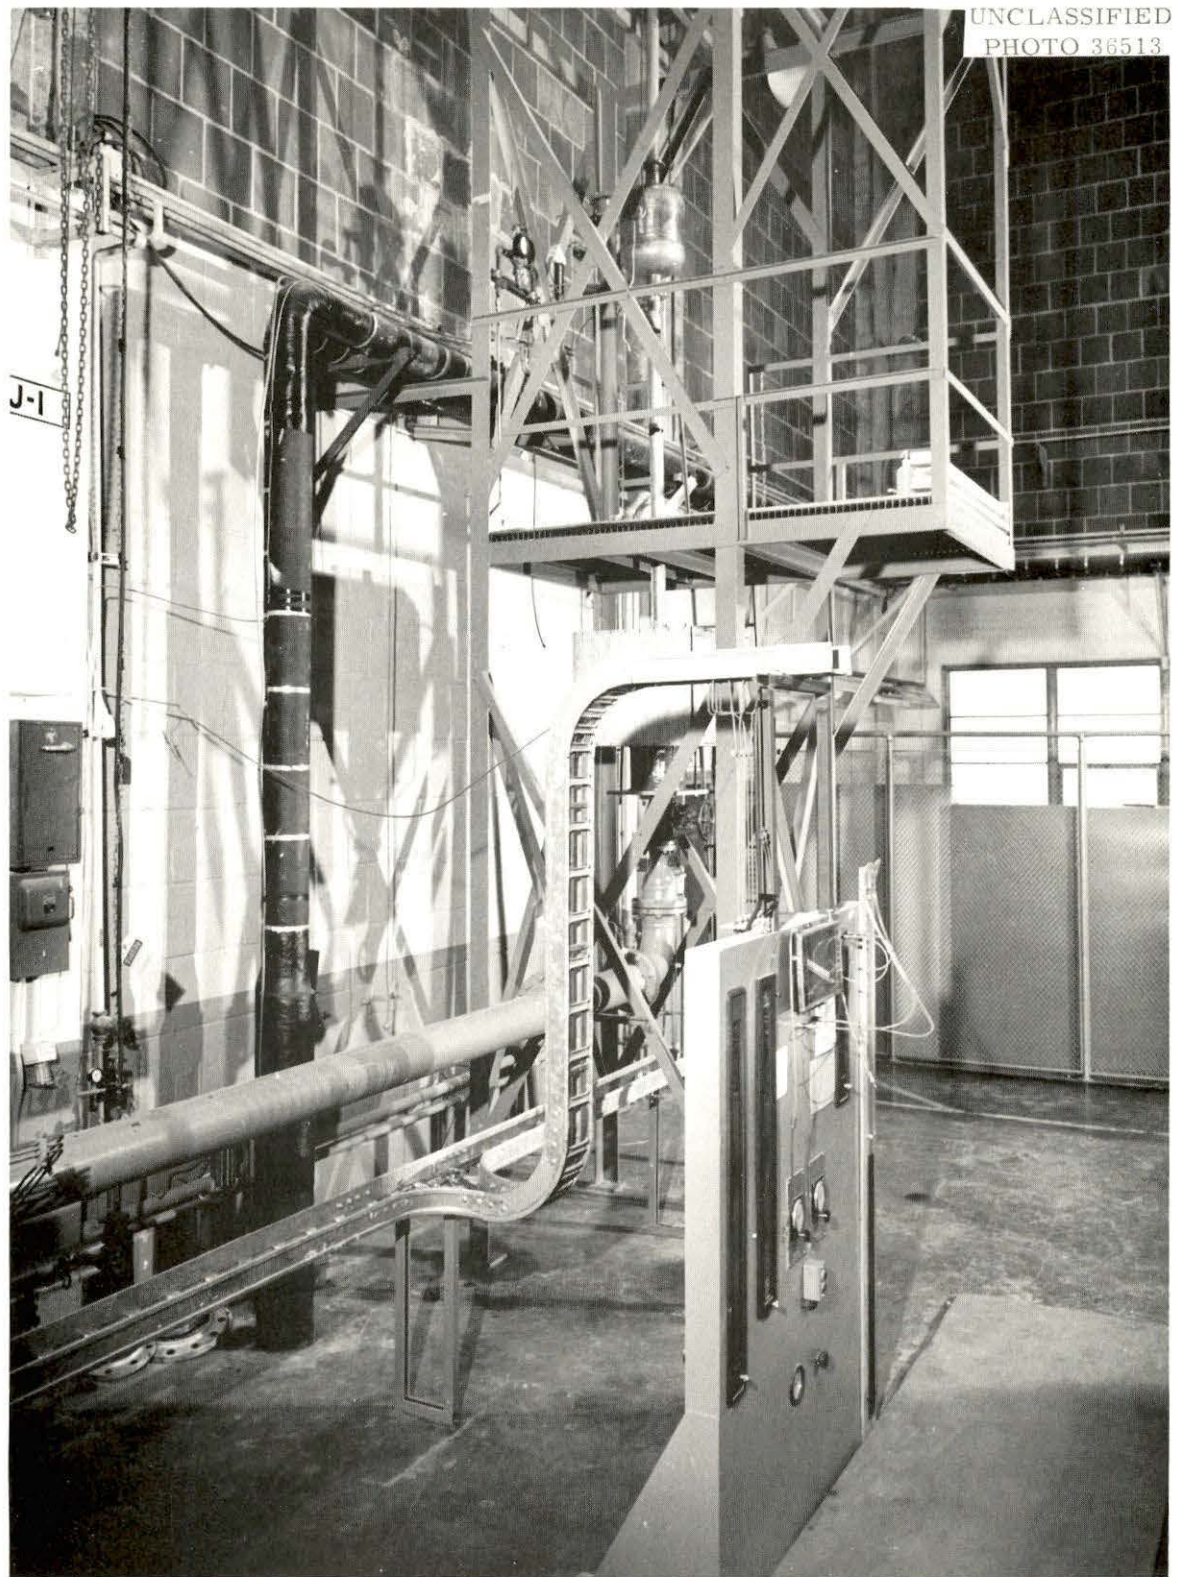
Fig. 4. View of Filter Installed in Test Rig.

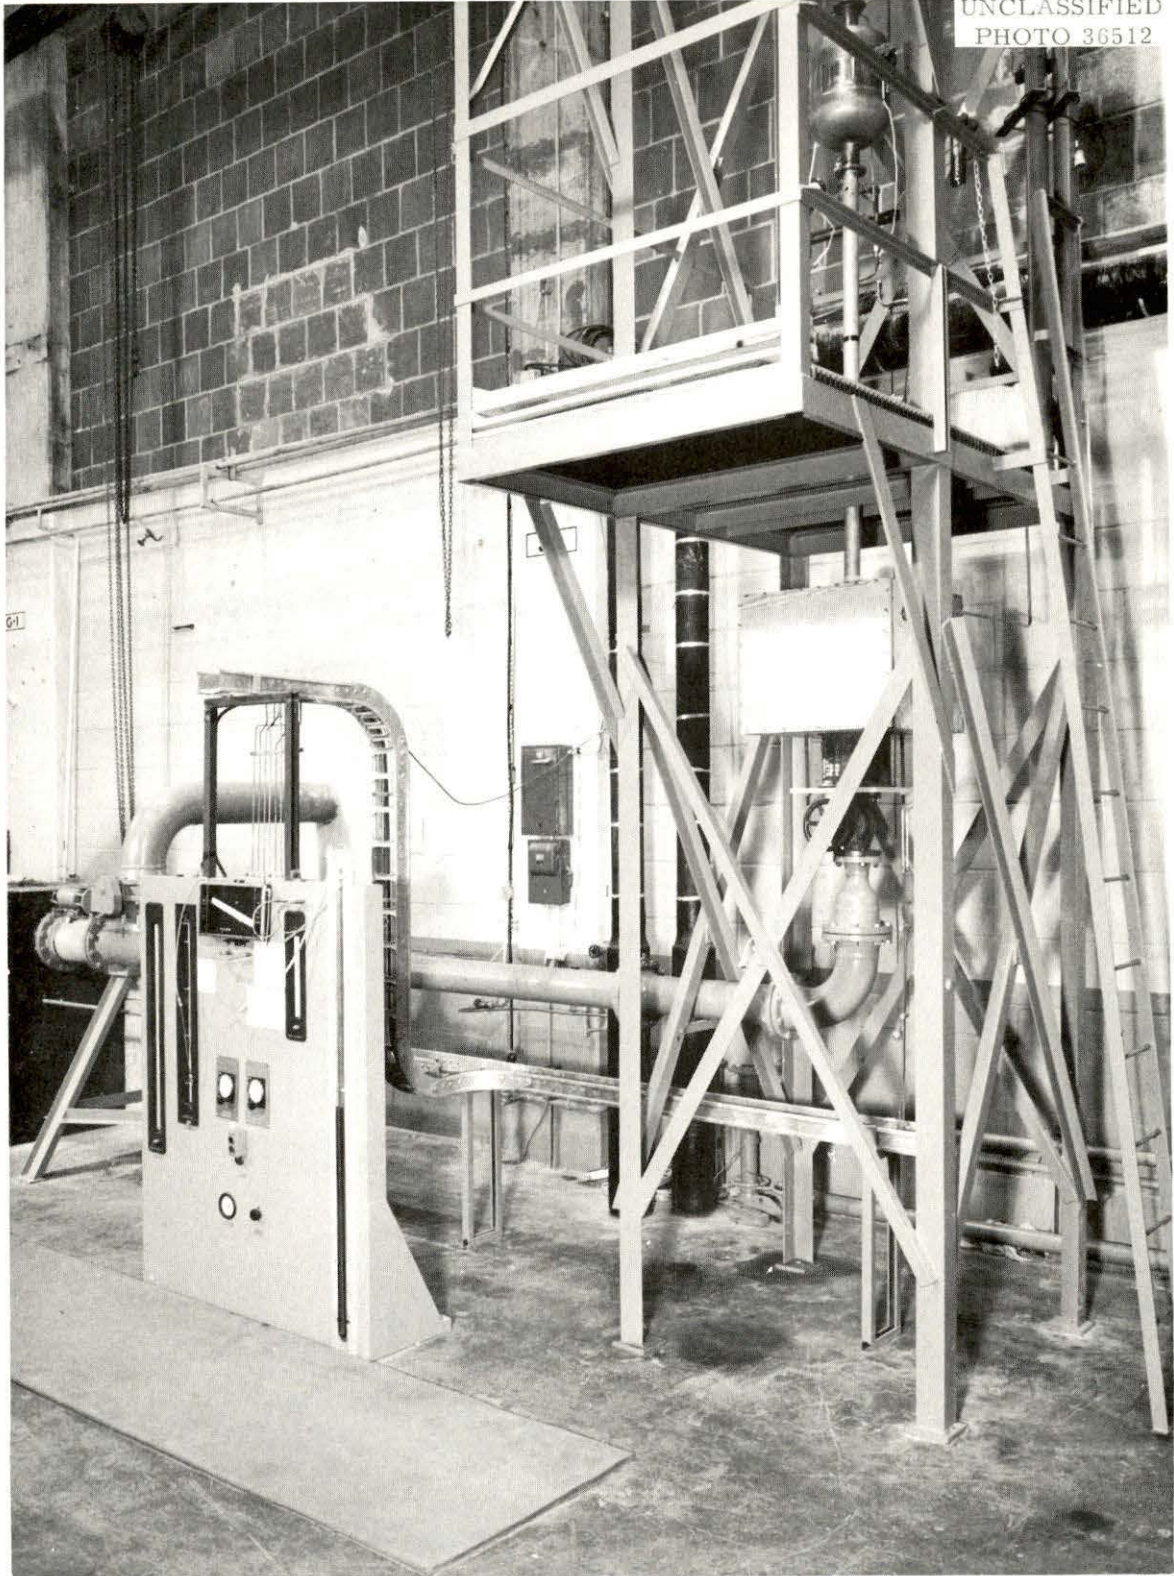
UNCLASSIFIED
PHOTO 36512

Fig. 5. Alternate View of Filter Installed in Test Rig.

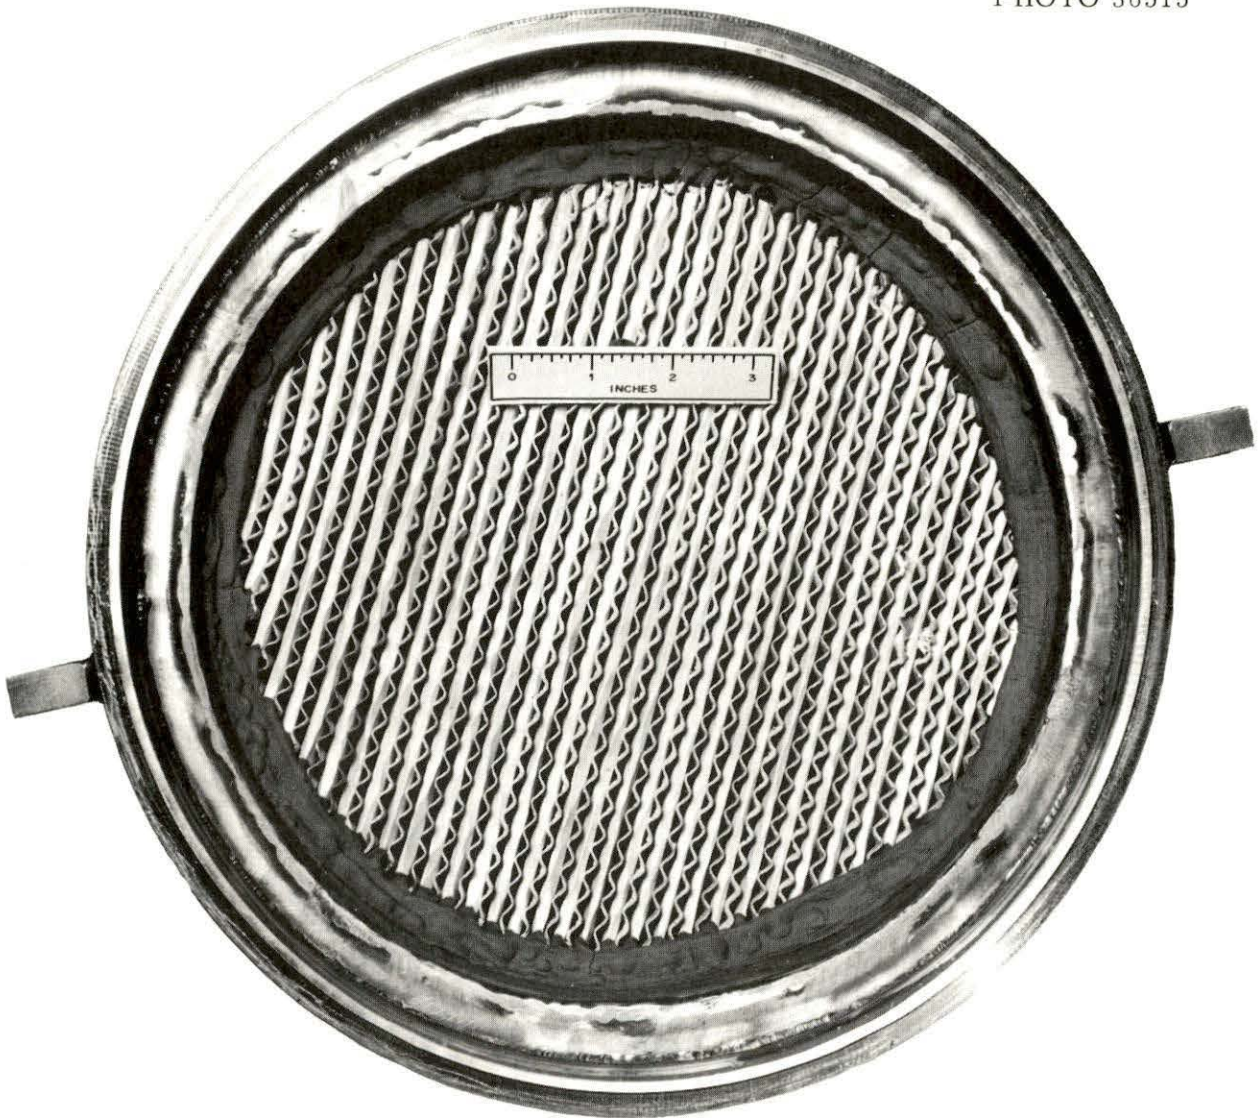
UNCLASSIFIED
PHOTO 36515

The pressure vessel of Filter Unit 2 was cut open, and the filter cartridge was visually inspected. The filtering material had a scorched appearance, as compared with the creamy-white appearance of the filtering material in a spare unmounted cartridge (compare Figures 2 and 6). This may have been due to the charring of D.O.P. picked up during the filter efficiency test. No fractures or tears were visible in the filtering material. The mastic,

Fig. 6. Cutaway View of Filter Unit 2.

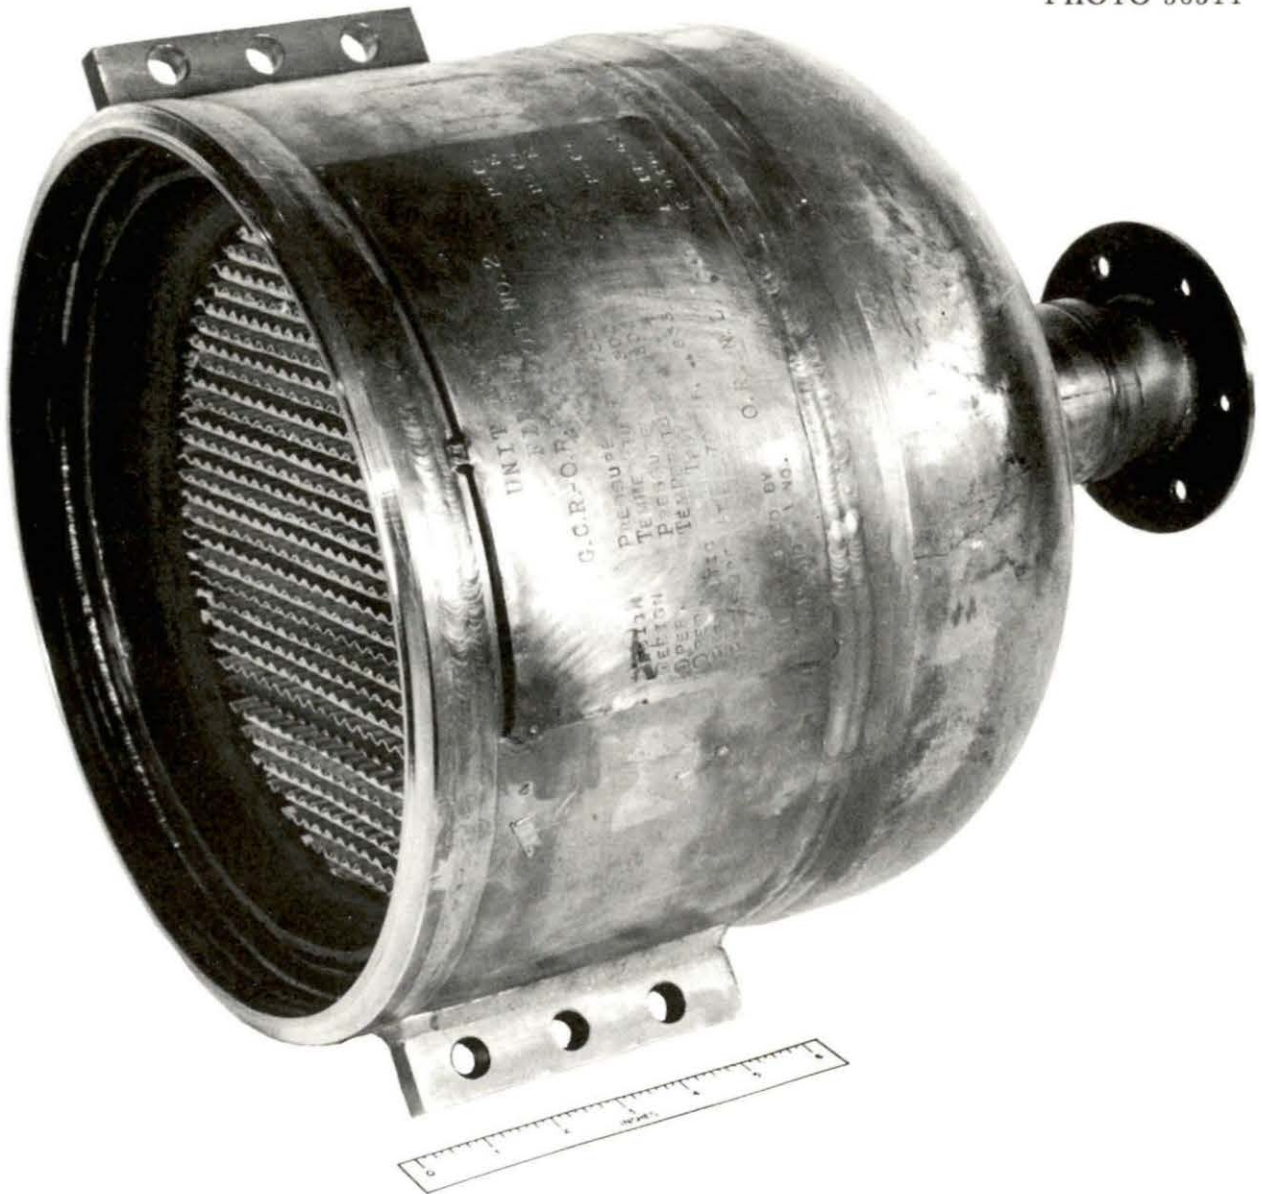
UNCLASSIFIED
PHOTO 36514

Fig. 7. Oblique Cutaway View of Filter Unit 2.
