ORNL/TM-2001/7

Montezuma Creek Stability Evaluation at Site of Former Monticello Tailings Pile

Final Report

Date Published: January 2001

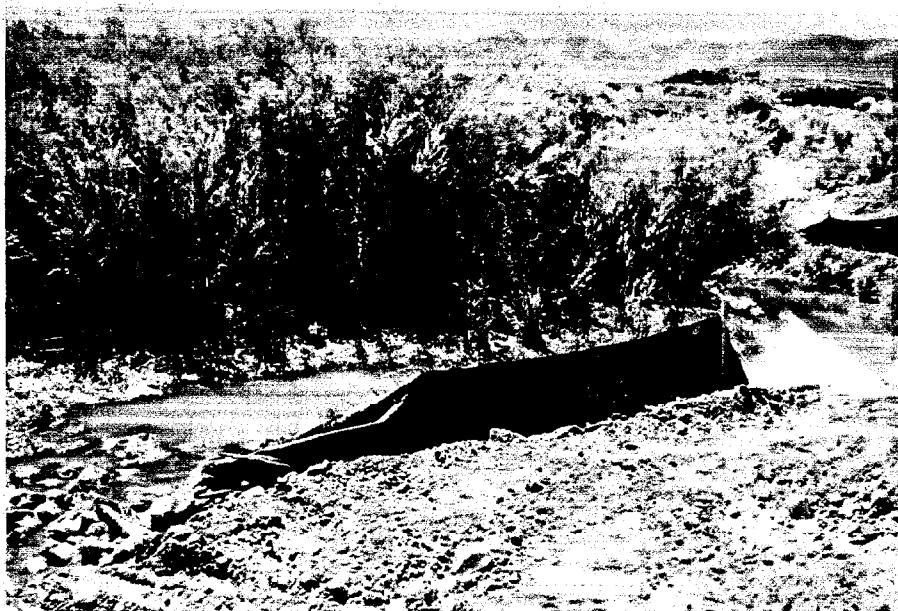
channelized section of Montezuma Creek (Fig. 1.2). The bare stream banks are contributing fine sediment that will accumulate elsewhere in the watershed and hinder aquatic life. Studies at other former mining and milling areas have shown that erosion of previously contaminated banks can become the chief contributor of contamination to a stream (Miller et al. 1998). Indeed, erosion redistributed the radioactive tailings deposited along Montezuma Creek. Radioactive contaminants were irregularly distributed for miles downstream. Expensive and environmentally damaging remedial action was required to remove these tailings (Fig. 1.3).

Fig. 1.3. Collapsed silt fence during the millsite remedial action.

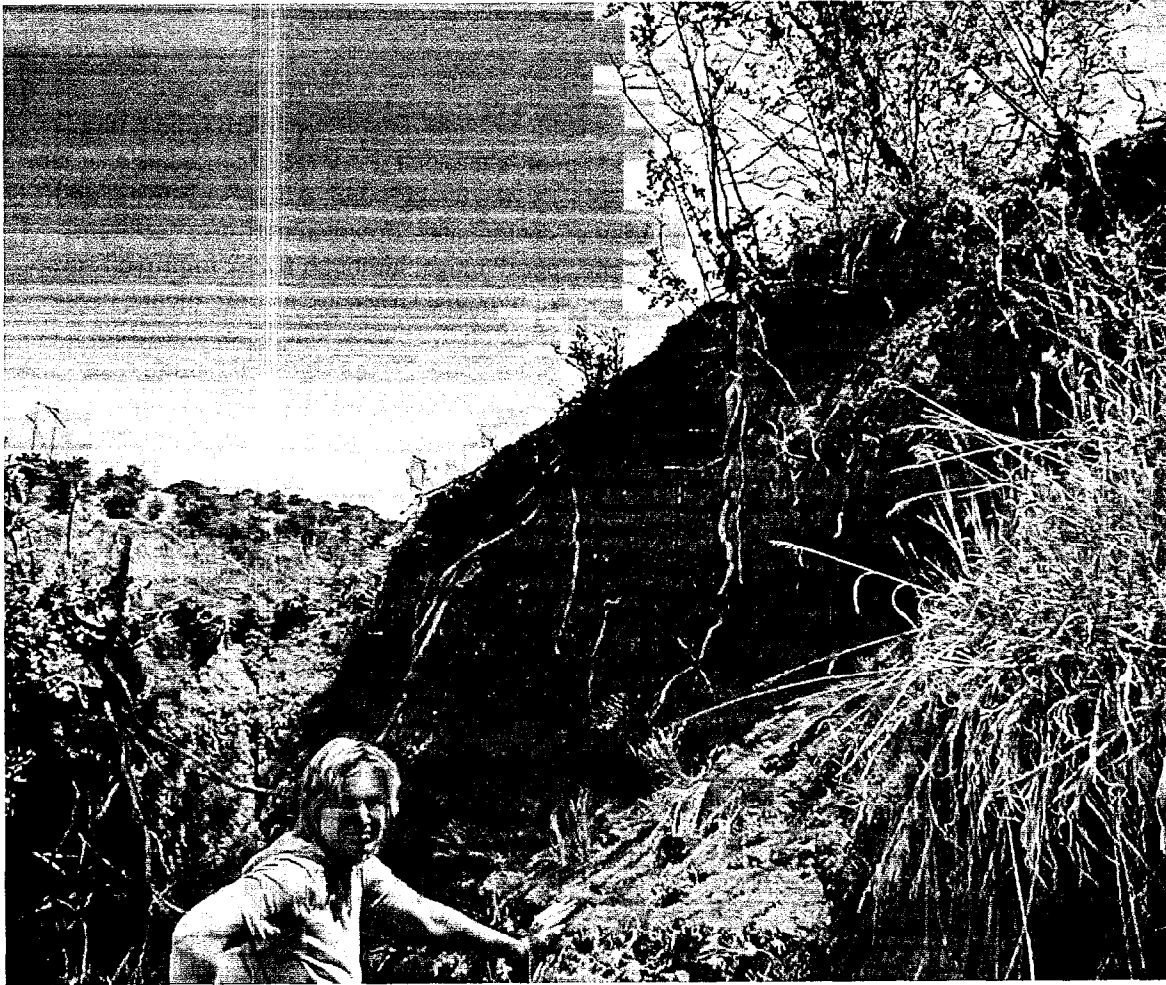
Fig. 3.1. Streambank near cross section MZ-2 subject to erosion.

The bank pins were not found by the field crew. At the cross section, it is likely that vegetation and mass wasting have covered the pins. At the downstream location, it appears that the pin may have fallen into the stream (Fig. 3.1). Note, however, that the area is better vegetated than in the past. Hence, the overall sediment loss at this cross section is less than in previous years.

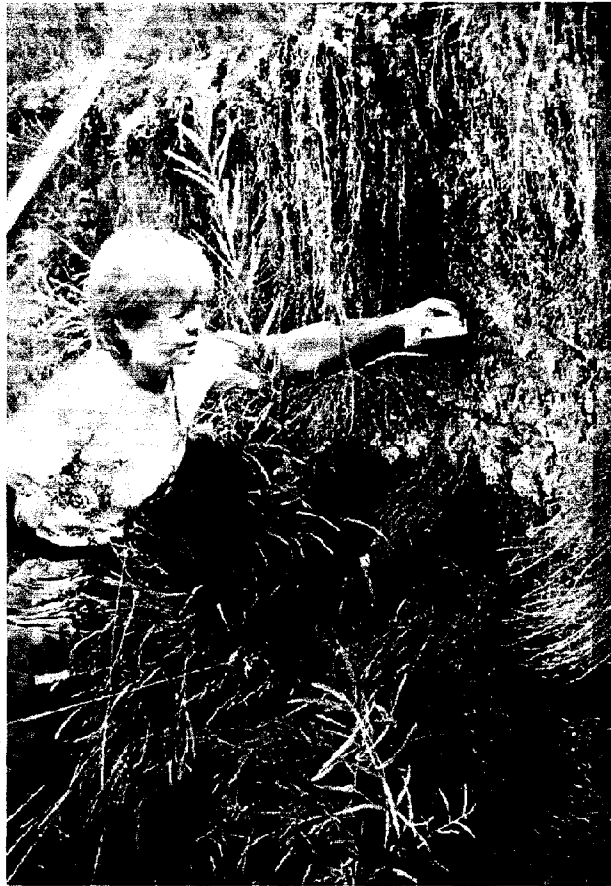
Figure 4.1 shows that 16 cm (6.3 in.) of bank collapsed at the Adam's downstream cross section. The exposed bank at this location was approximately 100 ft long and 6 ft high. Thus, the sediment produced in one year from this section was approximately 300 ft³ (23.4 tons). The center cross section, which was on the south bank, showed a loss of 12 cm (4.7 in.); thus, the land owner lost a section of pasture approximately 1 ft by 100 ft or 100 ft² from this small section of stream in 1 year.

Fig. 4.1. Bank pin showing erosional loss at the Adam's cross section.

Based on the significant mass wasting and associated changes in the channel, another bank pin was installed downstream of both the center and downstream cross sections.

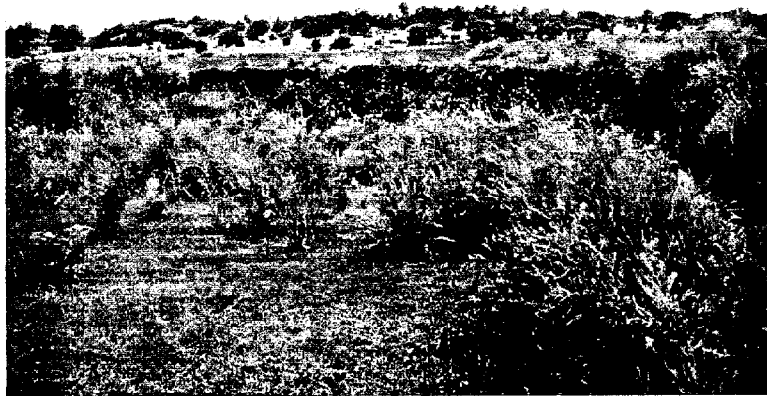
Mass wasting occurred at this location (Fig. 4.2). However, the bank pin was positioned too low on the banks and was covered by sediment. Thus, it was not possible to estimate the tons of sediment lost. Another bank pin was installed downstream of the cross section to obtain future measurements.

Fig. 4.2. Extensive bare stream banks at the MZ-2 cross section.

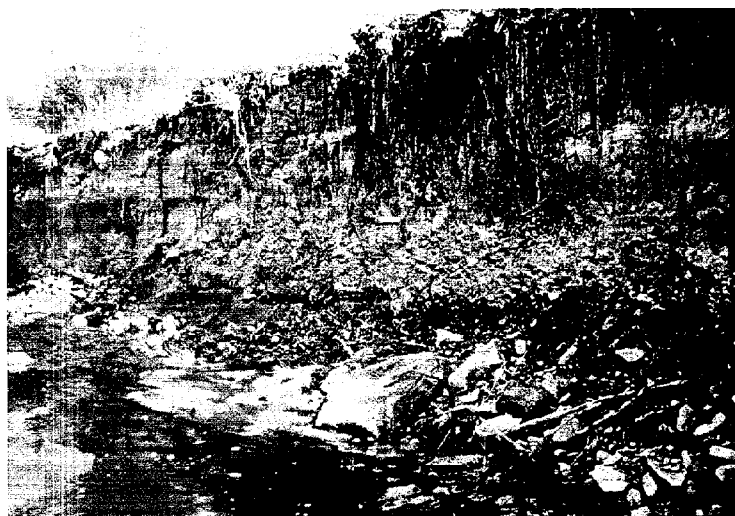
Figure 4.3 shows that 18 cm (7 in.) of sediment was removed at the D. S. Owl Barn location (Fig. 4.4). Also, the exposed cutbank is longer—approximately 200 ft with banks 4 ft high. Thus, the sediment produced in 1 year from this section was approximately 467 ft³ (36 tons).

Fig. 4.3. Bank pin showing sediment removed at the D. S. Owl Barn location.

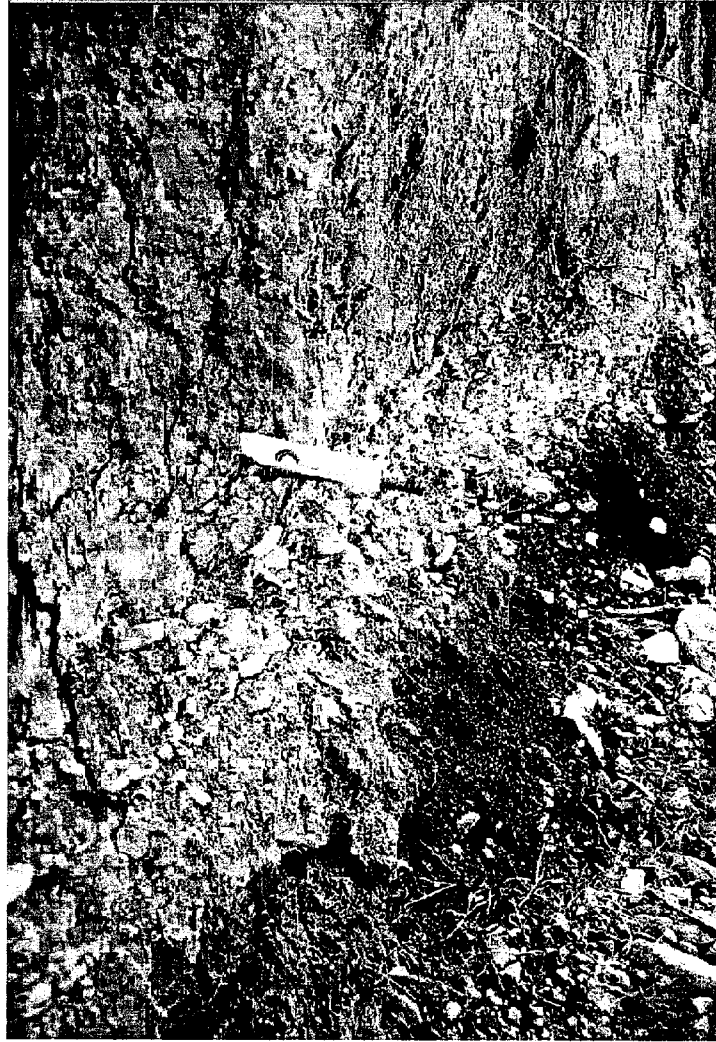
Fig. 4.4. Exposed cutbank at the D. S. Owl Barn cross section.

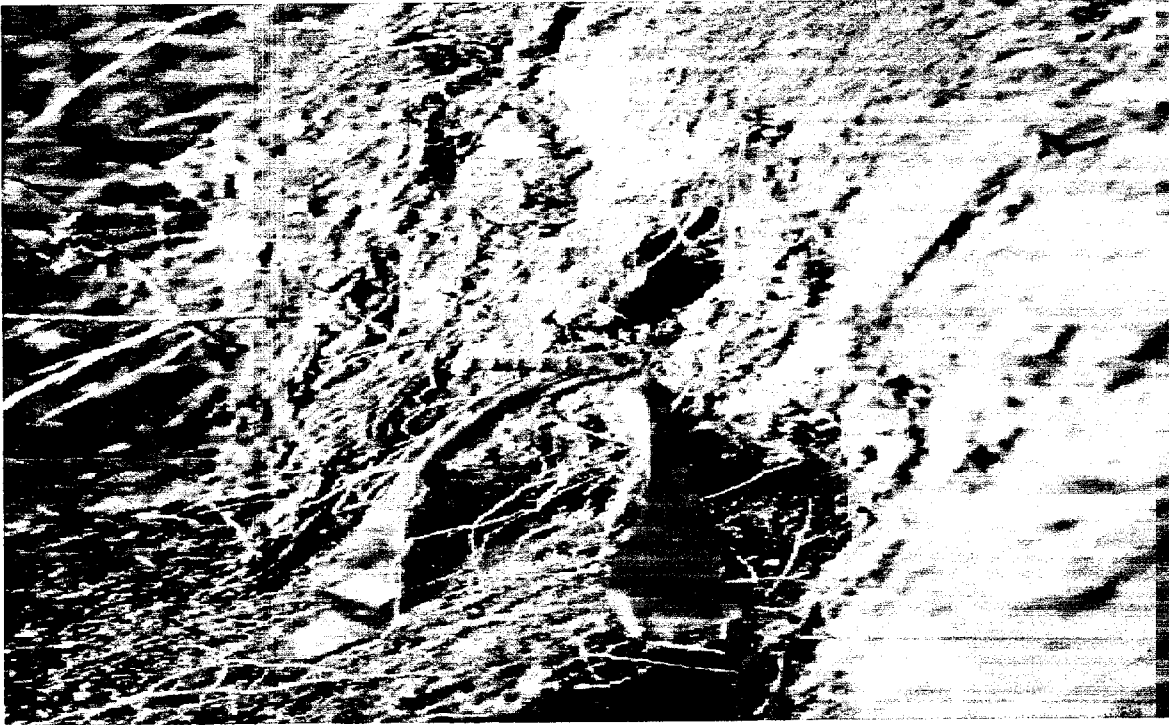
Fig. 4.5. Bank pin exposed at the confluence cross section.

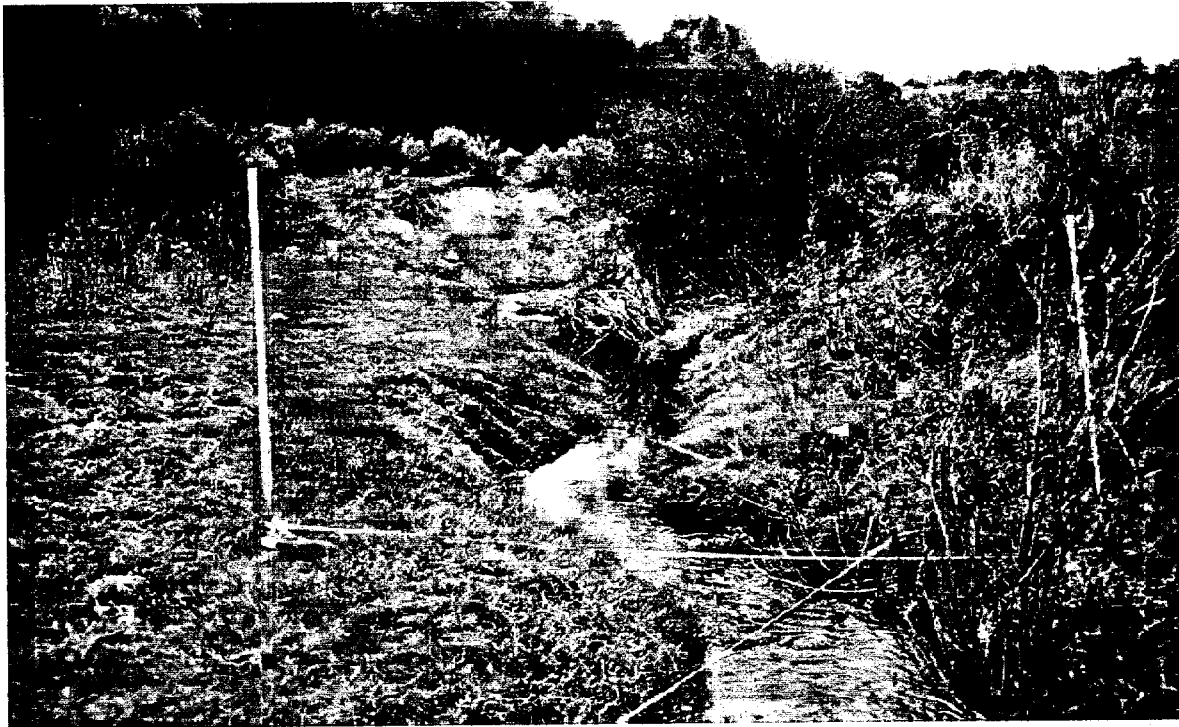
Fig. 4.6. Confluence cross section streambanks.

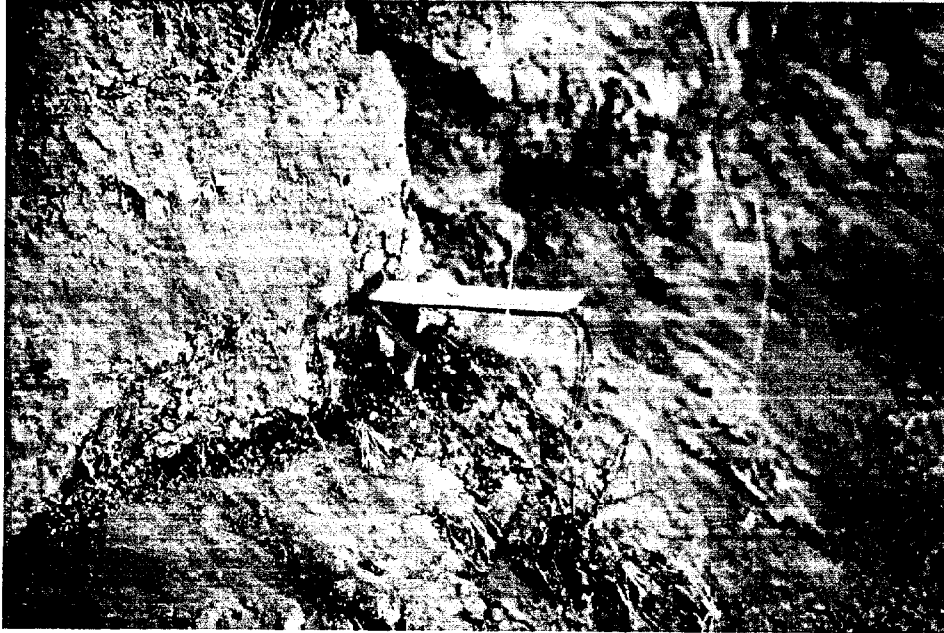
Work at the millsite and within Montezuma Creek employed BMPs to control sediment. However, as shown in Figs. 5.1, 5.2, and 1.3, these practices were not successful. The quantitative proof that remedial activities have affected the creek is provided by the pebble counts and the increase in erosion when remedial activities were at their maximum. The change in substrate from gravel to silt-clay indicates that the sediment supply increased dramatically.

Fig. 5.1. Exposed bank pin showing effects of remedial activities.

It is recommended that DOE not rely on rote application of BMPs for sediment control and stream routing. A review of appropriate erosion and sediment control methods is beyond the scope of this report, but many available approaches would have prevented the damage to the downstream environment described in this report. Although regulatory agencies are required to accept BMPs, there is ample recognition in the engineering and construction community that the practices are usually ineffective or provide only temporary benefit. The International Erosion Control Association or the National Resource Conservation Service has materials that can be used to design effective projects that take into account geomorphic principles and provide significant advantages over conventional engineering practices (NRCS 1998).

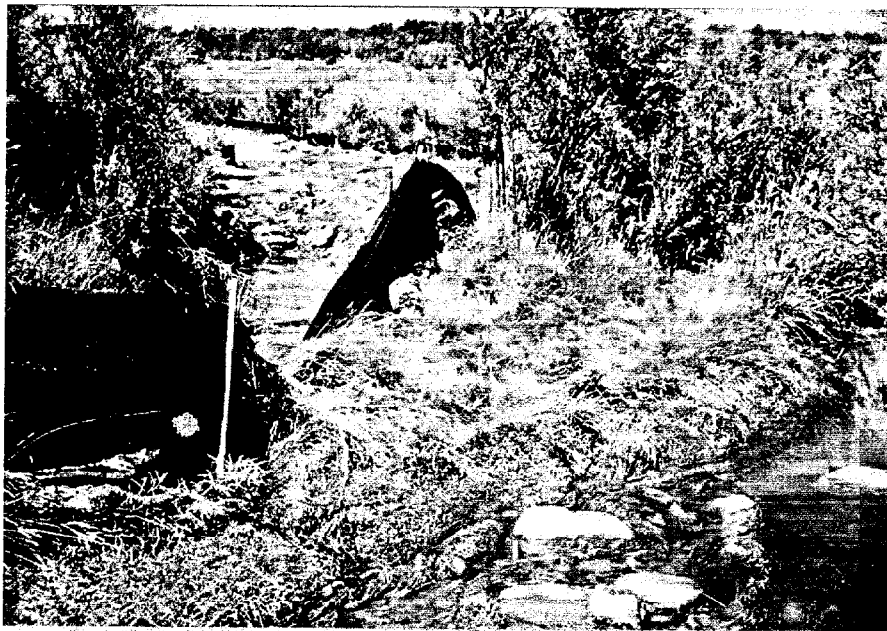
Fig. 5.2. Collapsed silt fence in Montezuma Creek during remedial activities.

Although an officially recognized BMP, it is becoming widely recognized that silt fences do not work (Kasperson 2000, Kaufman 2000). For example, the following two quotes from Kasperson (2000) are from contractors who said they commonly use silt fences:
