Metals and Ceramics Division

**Correlation of Process Data and Electrochemical Noise to Assess Kraft Digester
Corrosion: Spring Grove Experiment**

‡Glatfelter Company, Spring Grove, PA

Date Published: April 2003

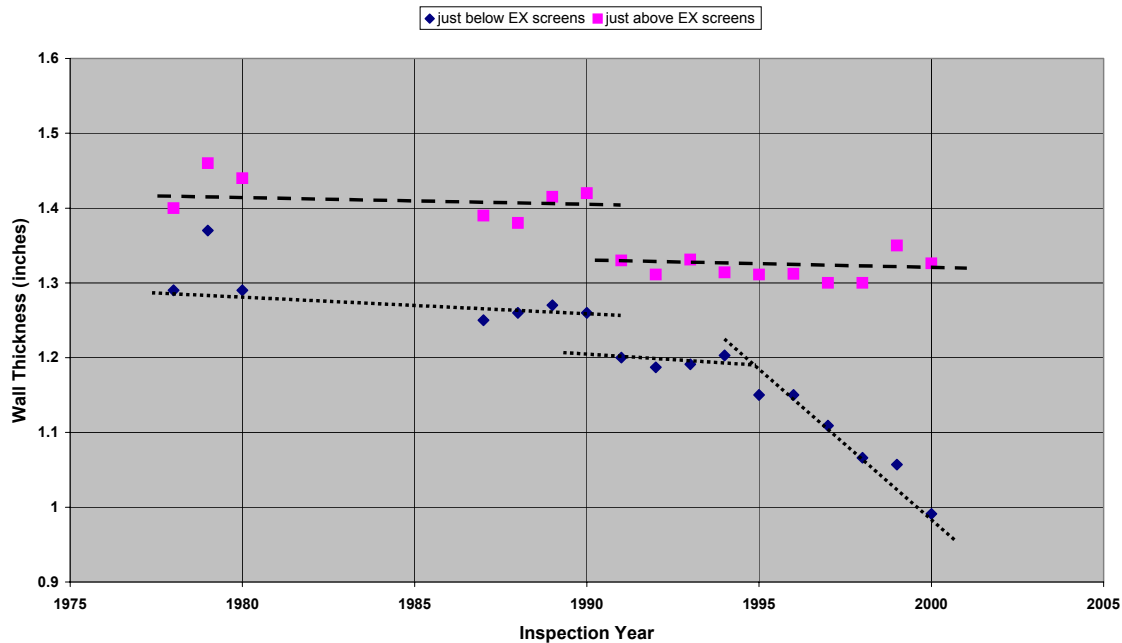
Figure 2 shows the wall thickness as a function of time measured externally at two specific points on the digester. The location indicating the greatest extent of thinning is on ring section 6 just below the extraction (EX) screens, where the corrosion rate has been historically higher than other locations in the vessel. The other location is just above the EX screens (ring section 12), where corrosion has been historically much more modest than below the EX screens.

Figure 2 is representative of several important features in the wall thickness data. Fundamentally, it indicates that the wall thickness measurements are somewhat erratic. For example, the significant wall thickness increase indicated from 1978 to 1979 (observed for all of the data collected in 1979 – not just the two locations discussed here) is certainly not real and likely indicates a systematic measurement/calibration error. [Data for 1979 was not used in the placement of the trend line.] Smaller wall thickness increases were also periodically observed indicating the sensitivity of the measurement technique to practical factors such as surface conditions, skill of the craftsman, and calibration details. It also shows the importance of using data that span several years to determine an overall trend rather than relying on data from consecutive years to judge the condition of the vessel or the current rate of thinning.

Fig. 2. Wall thickness as a function of time for a position on ring 6 (just below the extraction screens) and ring 12 (just above the extraction screens).

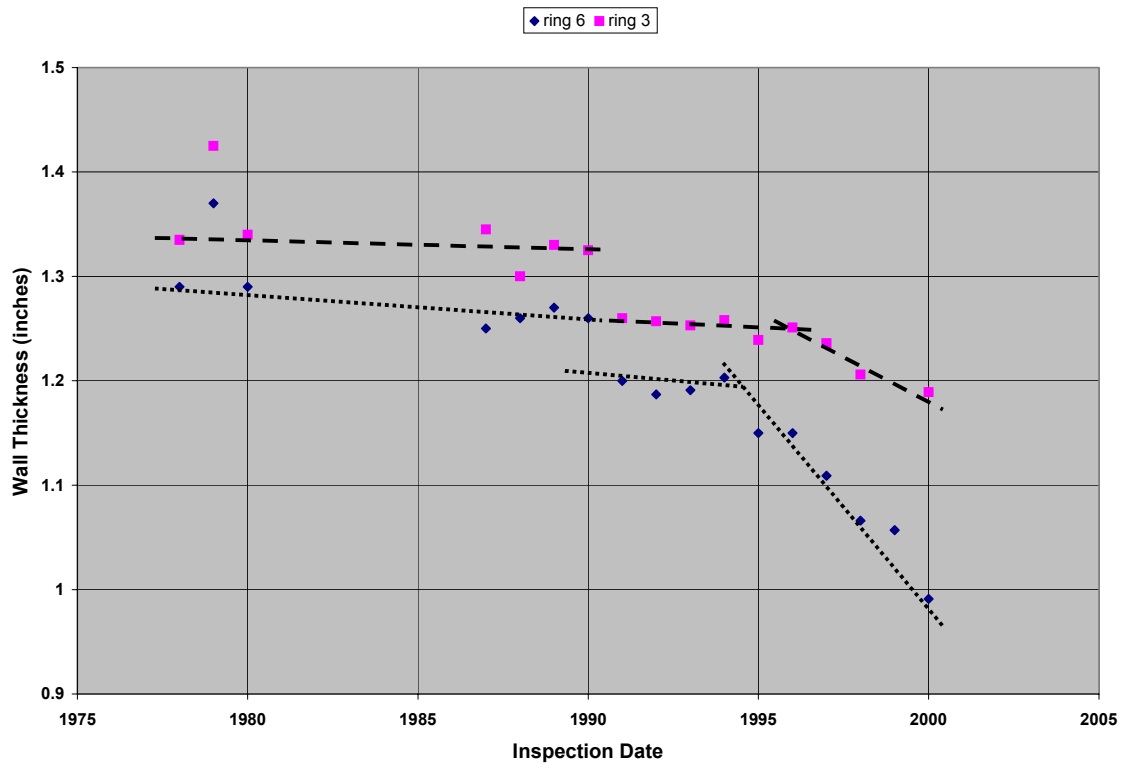
the EX screens (and perhaps begins at a different time). Based on the data shown in Fig. 3, the general thinning rate over the last few years appears to be about 15-20 mils/y at ring 3.

Fig. 3. Wall thickness as a function of time for a position on ring 6 (just below the extraction screens) and on ring 3 (just above the wash screens).

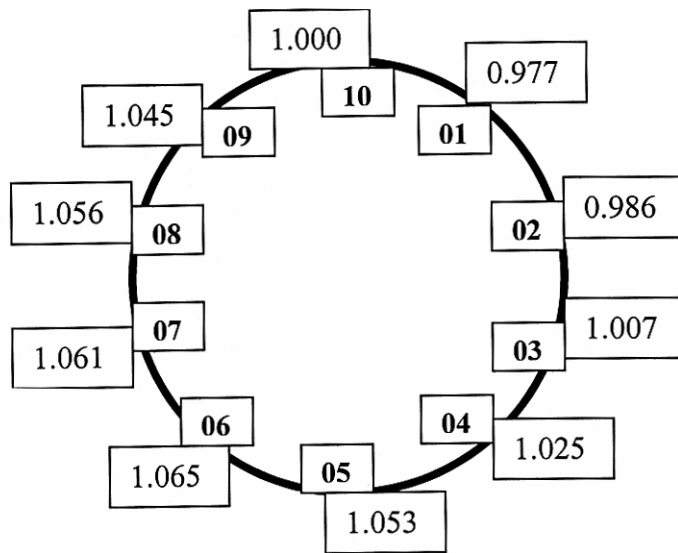
The result of this assessment indicated that wastage of the vessel was not uniform on these sections of the digester. A representative survey for an elevation just beneath the EX screens (top portion of ring 6, similar to the elevation of the point below the EX screens in Fig. 2) is shown in Fig. 4. The thickness variation among the ten measurement locations at this elevation is significant, and the difference between the maximum (point 6) and minimum (point 1) thickness is 88 mils. The average difference between maximum and minimum thickness for the six different elevations in the measurement array was 82 mils, with the minimums (point 1 or 2) and maximums (points 6, 7, or 8) always occurring at the same general longitude.

Fig. 4. Schematic diagram representing the wall thickness measurement pattern at a series of elevations on rings 5 and 6. The numbers inside the circle represent the fixed measurement location numbers, and the values associated with each outside the circle are the specific wall thickness values (in.) collected near the top of ring 6.

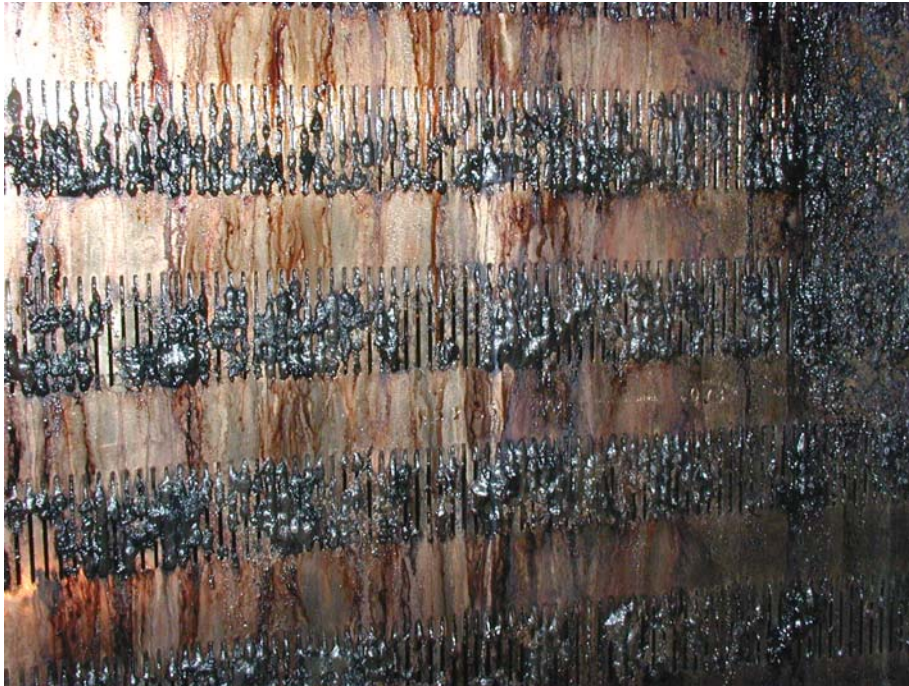
The digester shell between the cold blow screens and the wash screens exhibited a variety of colors ranging from black to red/orange resulting from residual black liquor and flash rusting, but only very minor surface relief and roughness – with no pitting – was observed. The visible portion of the wash screens appeared new and completely unattacked but, despite the recent acid cleaning, significant portions of the wash screens were clogged (Fig. 5) with a gray “crud” that was quite viscous and pasty. Mill personnel believed the material to be soap.

Fig. 5. Appearance of wash screens (ring 1). For scale, the vertical slots in the screens are about 6 inches long.

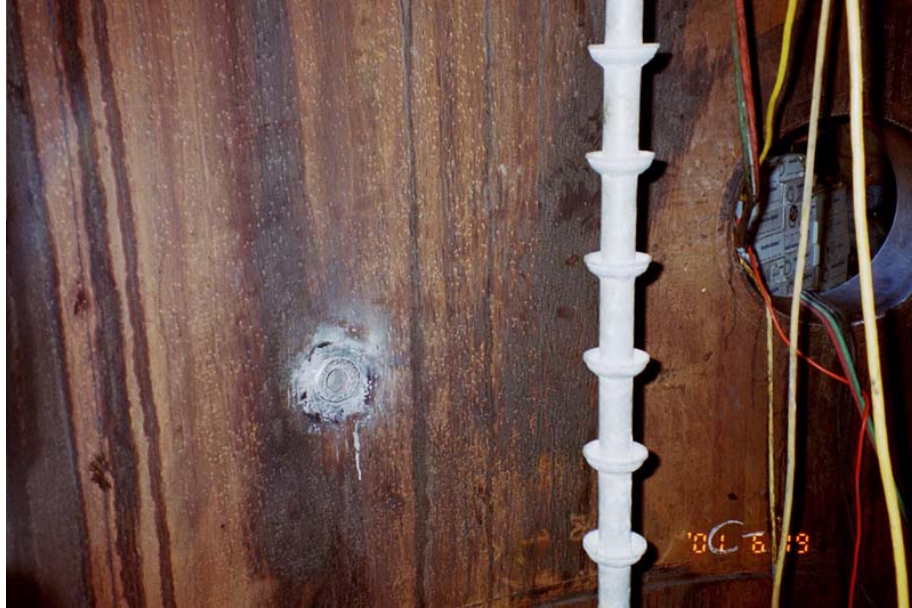
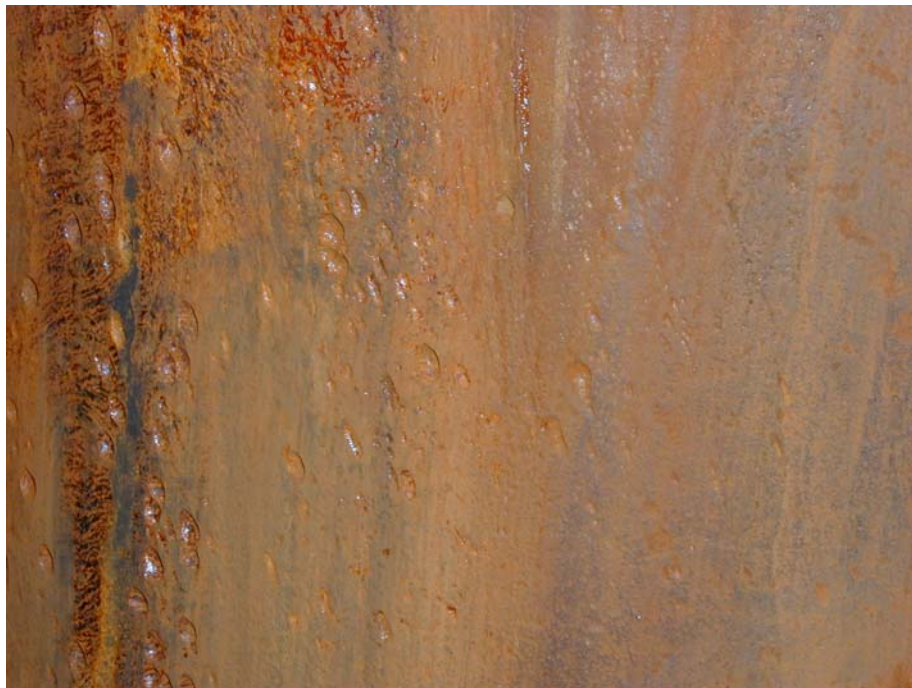
On the shell surfaces at the elevation of the service manway (ring 3) just above the wash screens, scattered light “pitting” was observed in some areas (Fig. 6). The bottom and sides of the roughly circular pits were smooth and well-rounded and, based on depth gage measurements, approximately 40-50 mils deep. As has been observed in some other digesters [1], the pits in this particular area were generally the same depth and the shell surfaces between pits were smooth and uniform. There is little support documentation, but anecdotal evidence suggests these pits first appeared several years ago and have not obviously spread or become significantly deeper since the initial observation. One of the ECN probes was located on ring 3 near the manway.

Fig. 6. Light pitting observed on the shell in ring 3 at the June 2001 inspection. At top, the general area around the port for the ring 3 probe is shown (with manway at far right). At bottom, a close-up view showing typical pits about 40-50 mils deep and 0.5 inch diameter. The bottom photograph was taken at high incidence angle to reveal pit depth.

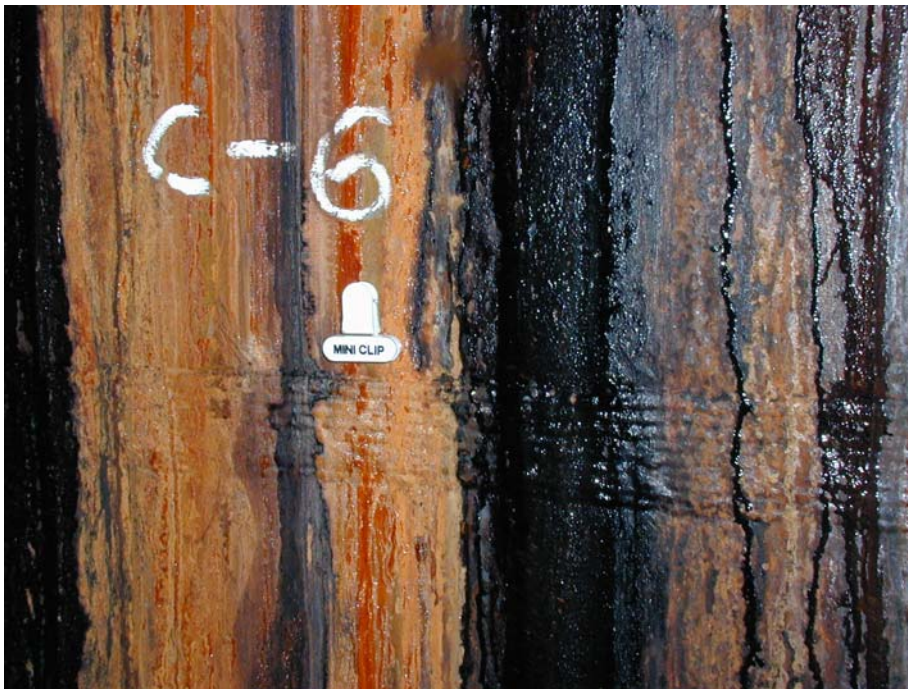
Fig. 7. Circumferential weld C6 at the June 2001 inspection. The weld joins ring sections 5 and 6 and is approximately 12 ft. below the bottom extraction screen. At this location, the weld bead crown retains some solidification detail and protrudes slightly above the shell ID. In other positions around the circumference, this weld appears to have suffered general wastage such that it no longer protrudes above the shell ID. The 1.5 in. wide mini-clip is present to indicate relative magnification.

In the absence of additional wall thickness data, the only apparent sign of degradation in this portion of the digester was recession of portions of the weld at C-6 (round seam weld between rings 5 and 6). Mill personnel indicated that the entire round seam weld at this location was repaired in June 2000 to build-up the weld crown such that it stood above the shell ID by about 1/16 in. However, only one year later (at the time of the present inspection), this round seam weld had suffered wastage such that the weld surface was again recessed below the shell ID by about 1/16 in. over approximately half of the circumference. Curiously, the side of the digester suffering the most significant weld wastage is not the same side of the vessel that has suffered the highest average rate of shell thinning over the past few years. This observation suggests the area/side of the vessel subject to the most intense corrosion may move periodically as a function of an unidentified variable associated with irregular flow or process chemistry. Alternatively, the composition/structure of the weld may be sufficiently different from the shell material that different factors influence corrosion.

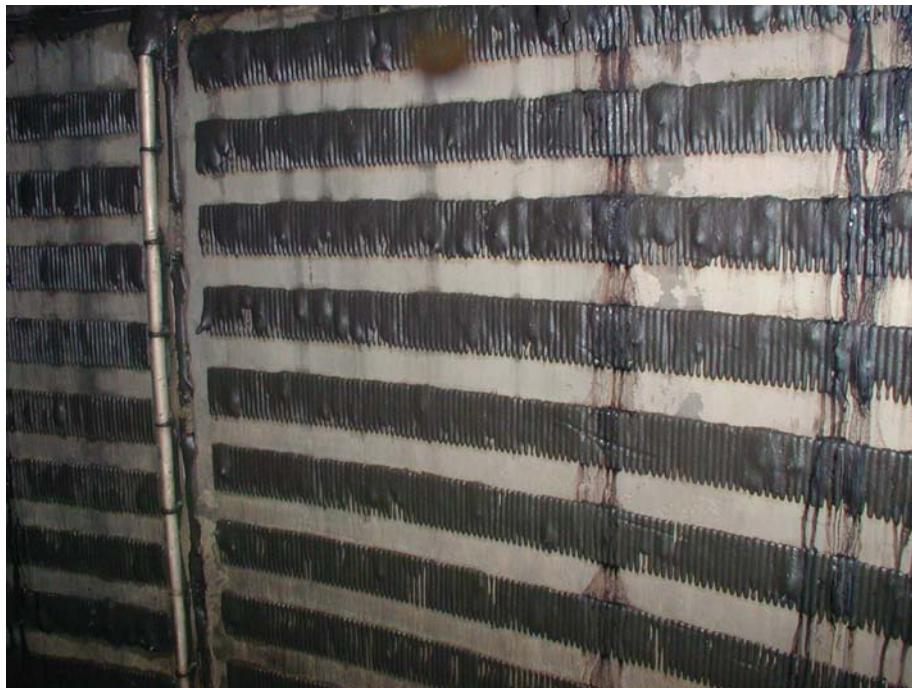
The extraction screen surfaces were smooth and unattacked but a thick and viscous paste waste clogged most of the EX screen surface (Fig. 8). Mill personnel collected a specimen of this material for analysis, and identified the material as fatty acids, esters, organic pitch, and soap.

Fig. 8. View of extraction screens showing extensive clogging.

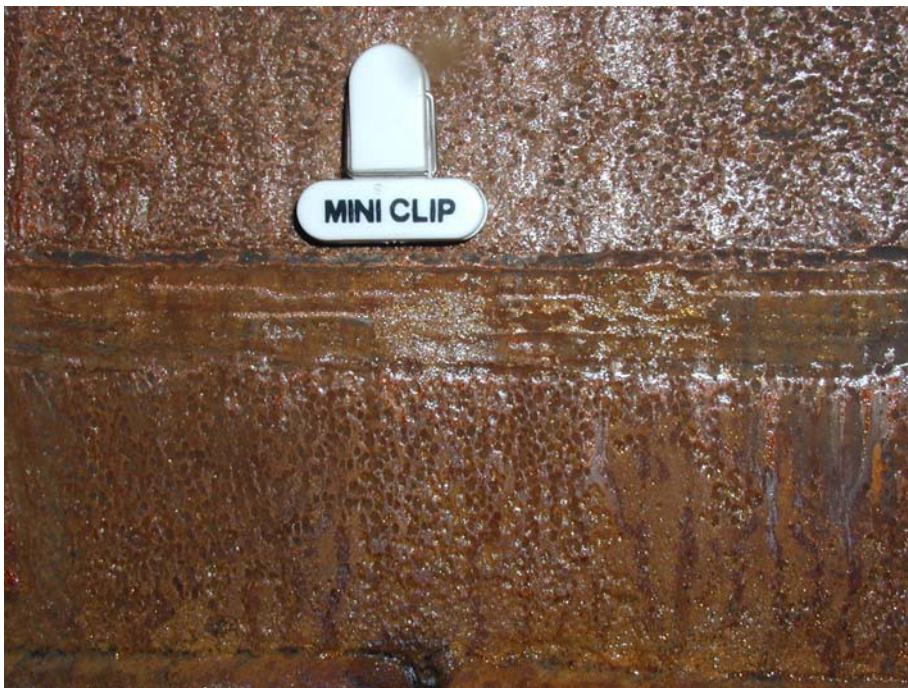
The shell between the EX screens and the cooking screens (rings 12-14) exhibited a relatively uniform light pitting, which had not been observed previously. In most areas, the pit depth was approximately 20-25 mils (Fig. 9), although it was possible to find isolated pits that were somewhat deeper. While not a precise trend, the area fraction of the pitting seemed to increase without a corresponding increase in pit depth as elevation in the digester increased from ring 12 to ring 15 (compare Fig. 9 with Fig. 10). The circumferential seam welds in this region did not stand above the shell ID, indicating at least some amount of wastage has occurred since the most recent repair date (approximately 1995). The center pipe at this elevation of the digester also showed scattered light pitting (Fig. 11).

Fig. 9. Circumferential weld C12 at the June 2001 inspection. The weld joins ring sections 11 and 12 just above the extraction screens. The weld is uniformly corroded such that the surface is recessed slightly compared to the shell ID. Light pitting (20-25 mils deep) is generally present on the shell surfaces at this location. The scale marker (mini-clip) is 1.5 in. wide.

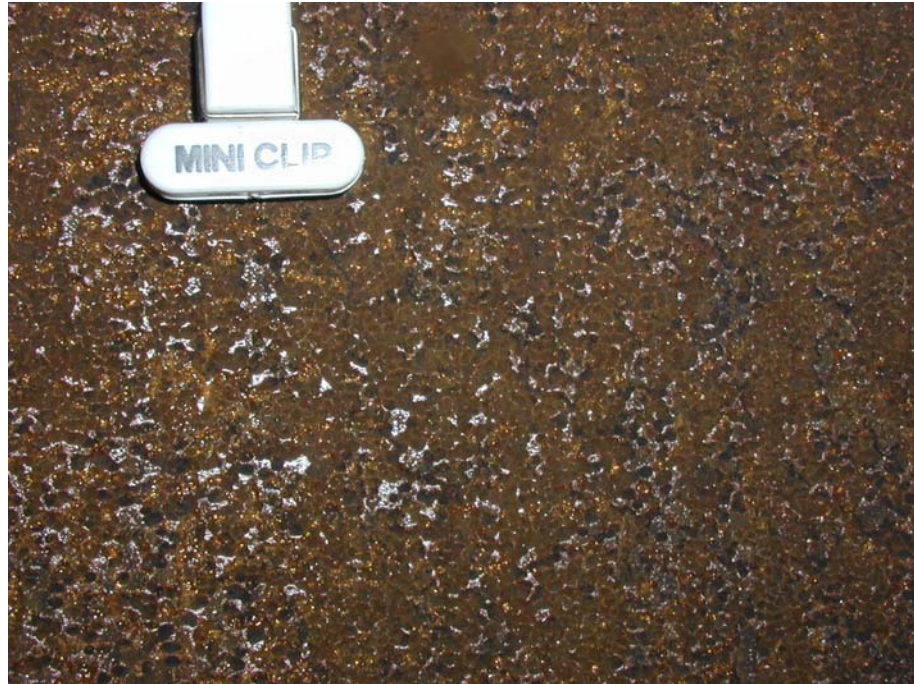
Fig. 10. Appearance of shell wall on ring 13 at the June 2001 inspection. The unpitted area (raised, slightly shiny in the photograph) has agglomerated such that it is a small fraction of the total area at this elevation. However, based on the height of the “islands,” the depth of pitting has not increased and remains 20-25 mils. Scale marker (mini-clip) is 1.5 in. wide.

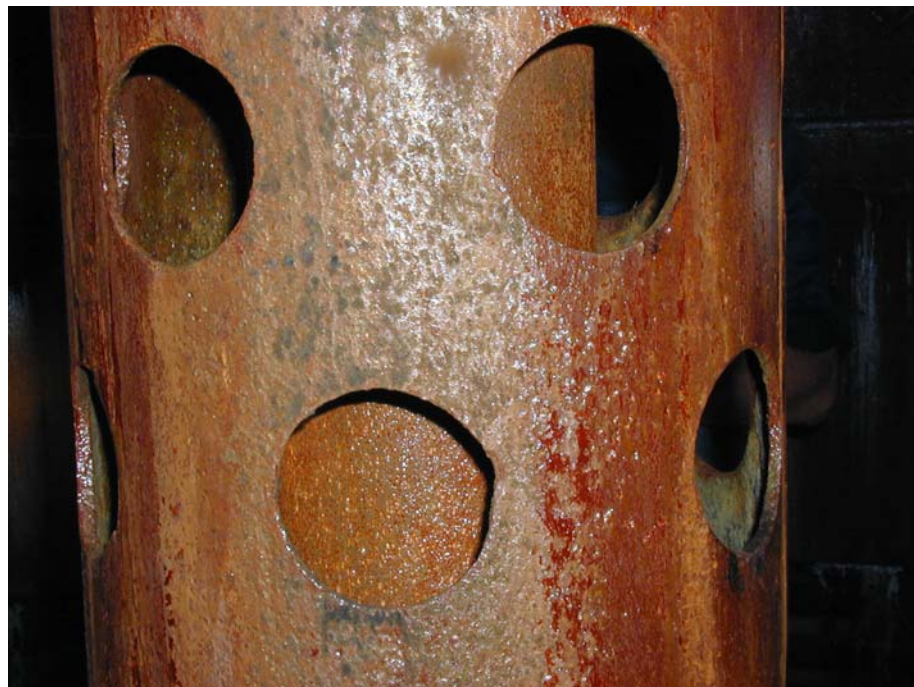
Fig. 11. Appearance of the center pipe at the elevation of ring 12 (just above the extraction screens). Light pitting similar to that observed in the digester shell at this elevation is apparent.

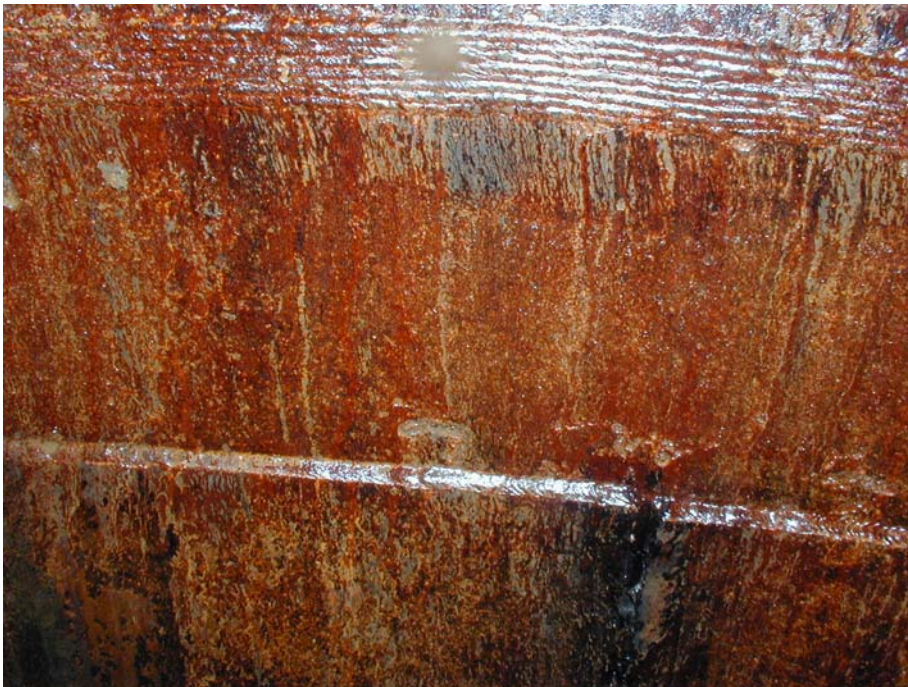
Fig. 12. Near the top of the vessel (C20), deep gouges were observed with a size/shape and location indicative of the position of fixtures associated with construction. From the June 2001 inspection.

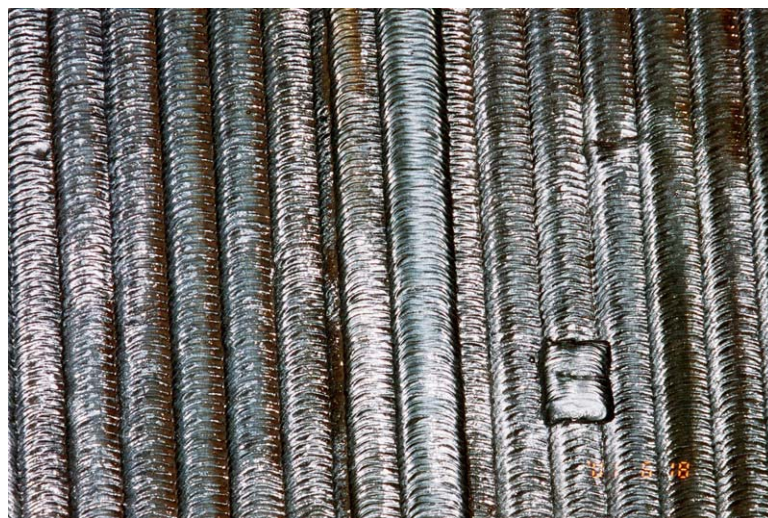
Fig. 15. General region of overlay showing a patch applied to a region where a flaw was detected. June 2001 overlay application.

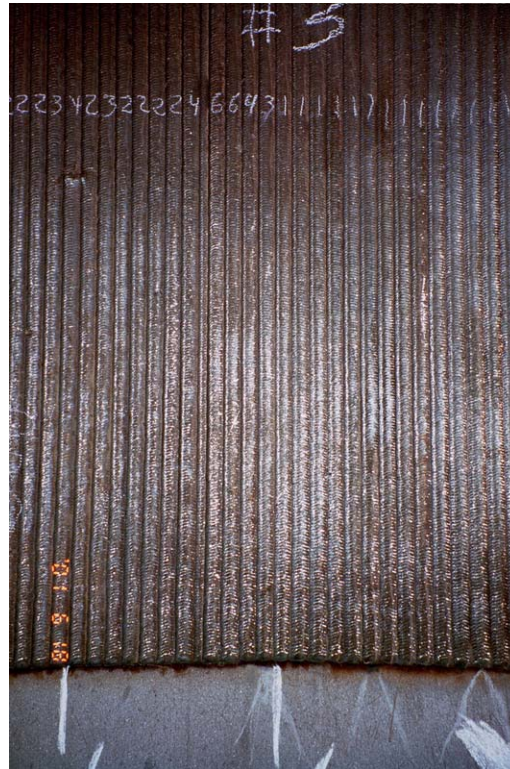
Fig. 18. Average ferrite contents (determined by magnetic measurement device) are noted on the crown of each vertical pass of the overlay. The values range from 1-6 in this section.

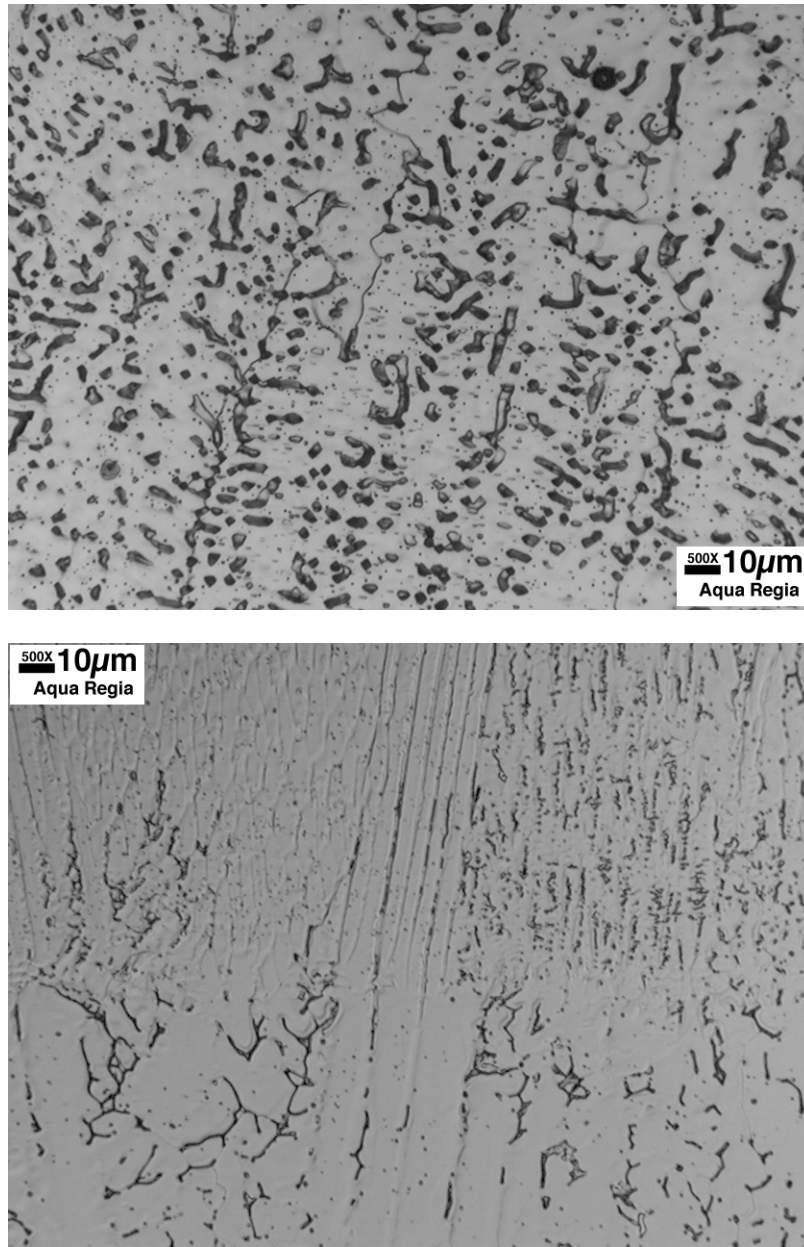
Fig. 20. Cross sections of the 309LSi field weld overlay. The ferrite content and morphology varies significantly in this material as indicated by the pair of micrographs shown here. The relatively low ferrite content shown in the bottom photo is the predominant condition for the field overlay, and appears similar to that of the test overlay (Fig. 19).

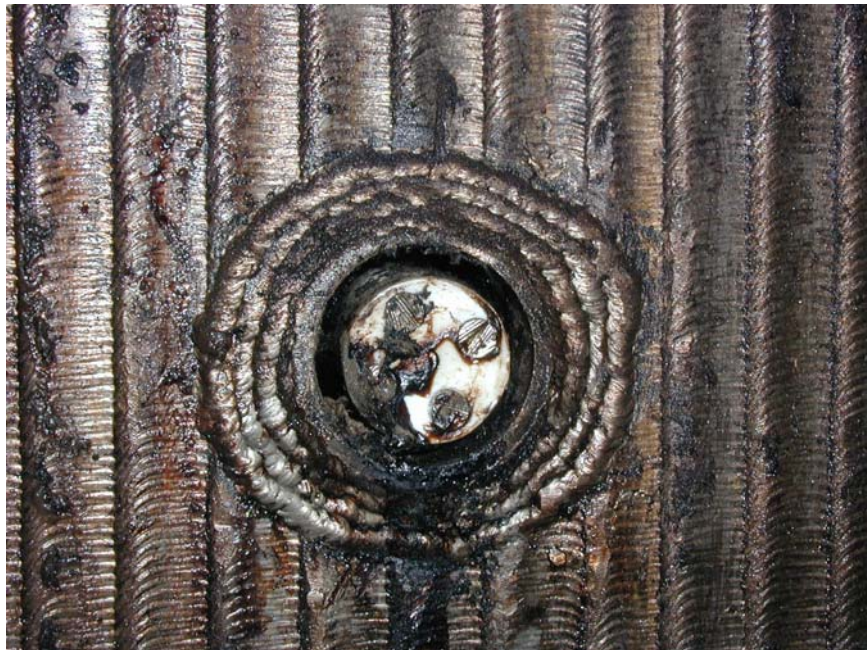
Fig. 23. ECN probe in the ring 6N port. Residual black liquor slightly obscures the generally excellent condition of the overlay at this position. Photo from June 2002.

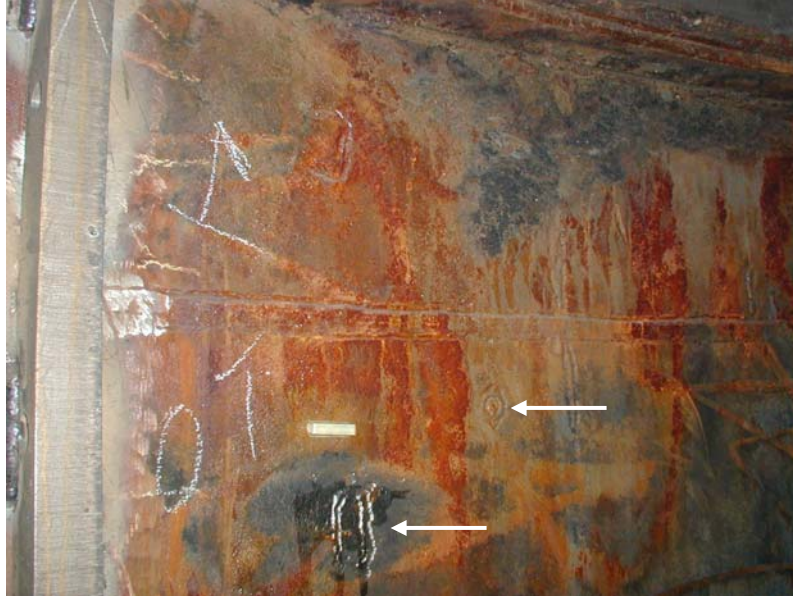
Fig. 25. Blank plate corrosion pattern. The gouge shapes here suggest accelerated corrosion associated with former internal (or present external) attachment positions. The scale marker (white magnetic bar) is 1.5 in. long. Photo from June 2002.

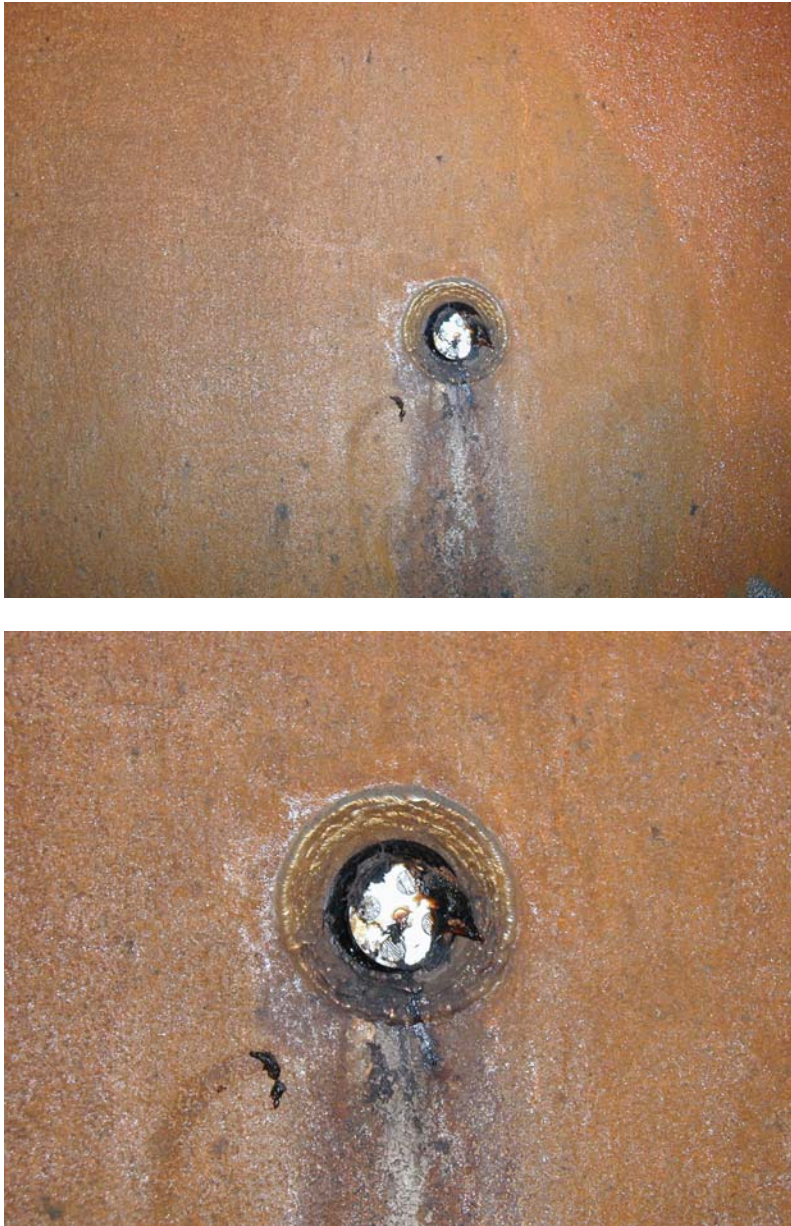
Fig. 27. ECN probe at ring 12 port. Top: general view. Bottom: close-up. The shell corrosion pattern adjacent to this probe remains unchanged from the previous inspection. June 2002 photo.

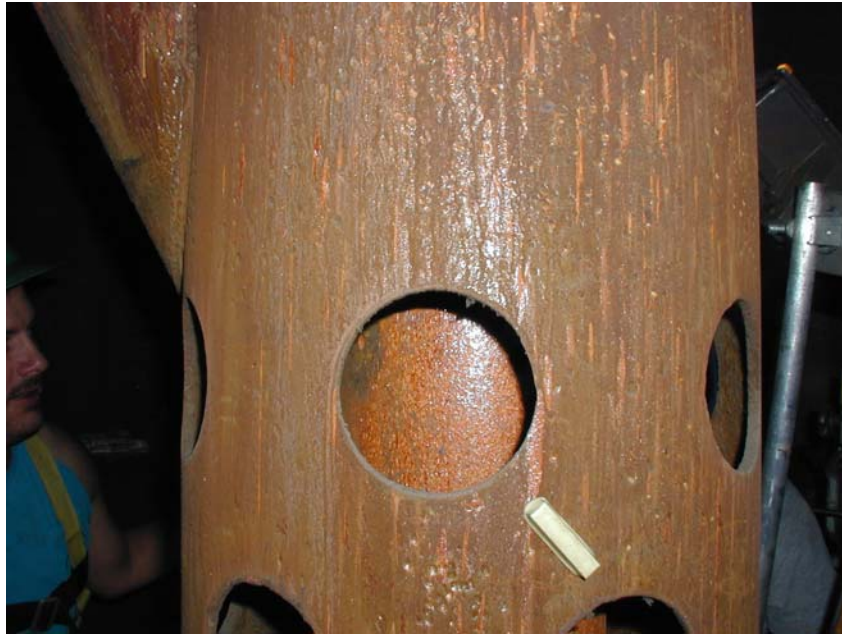
Fig. 28. Center pipe near the elevation of the ring 12 probe. Pits are approximately 20-30 mils deep with a smooth, hemispherical shape and not obviously different from the previous inspection. Scale marker (white magnetic bar) is 1.5 in. long. June 2002 photo.

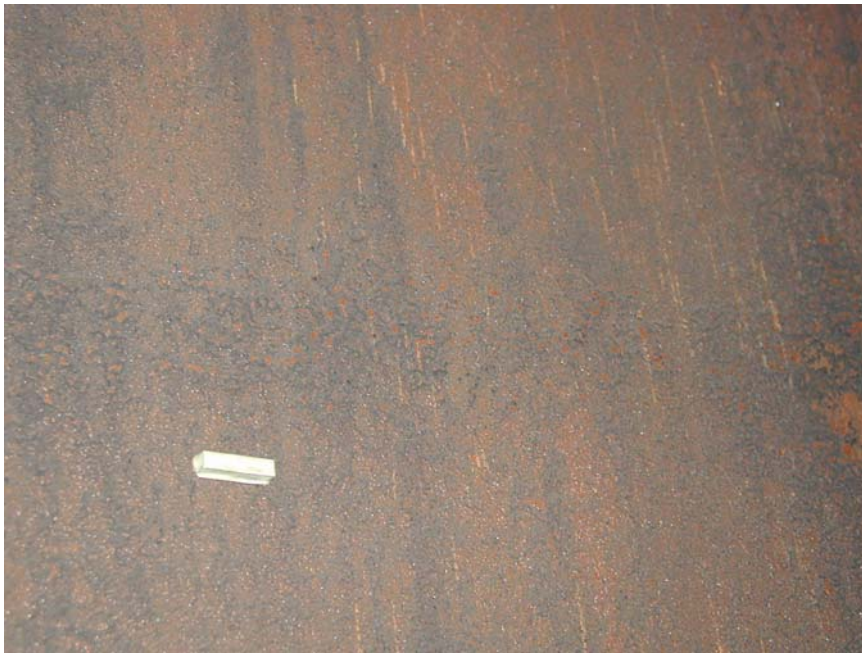
Fig. 29. The shallow “oceans-and-islands” corrosion pattern appears more intense at this location on ring 13. June 2002 photo. Scale marker (white magnetic bar) is 1.5 in. long.

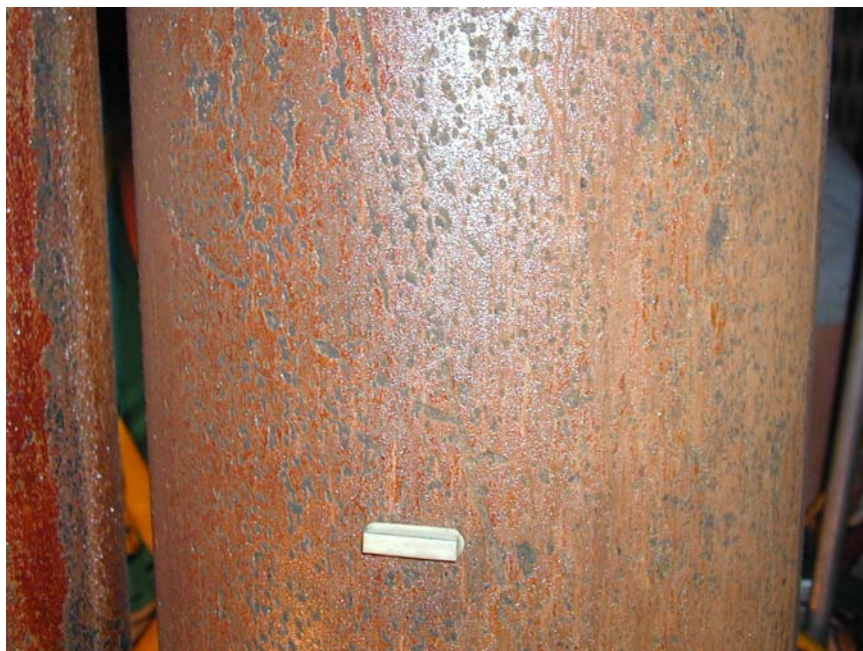
Fig. 30. Center pipe just below the cooking screens. Light pitting seems accelerated in patterns suggesting damage to mill scale from the handling chains when the center pipe was lifted into place. Scale marker (white magnetic bar) is 1.5 in. long. June 2002 photo.

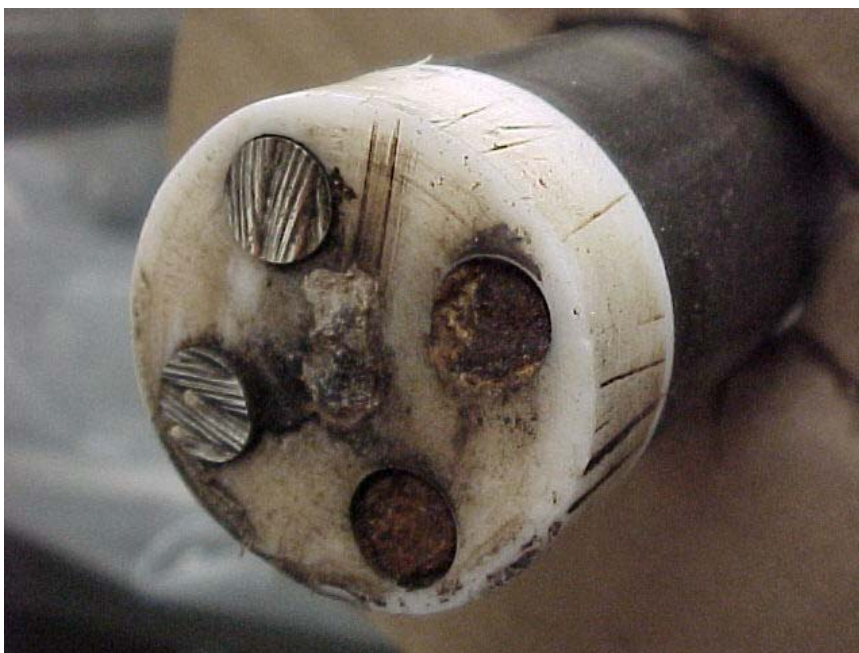
Fig. 31. Ring 6N probe after one year of exposure. The 309LSi electrodes appear unchanged from the initial condition, but the mild steel electrodes exhibit significant wastage.

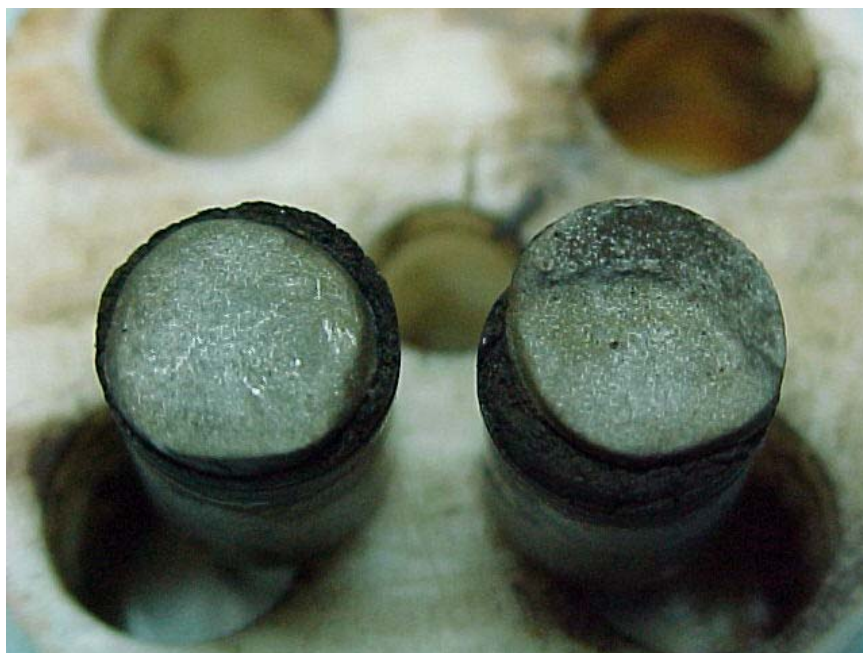
Fig. 33. Close-up of the mild steel electrode specimens from ring 6N probe. The steel electrode on the right has a crater-like profile over a portion of the surface rather than being flat.

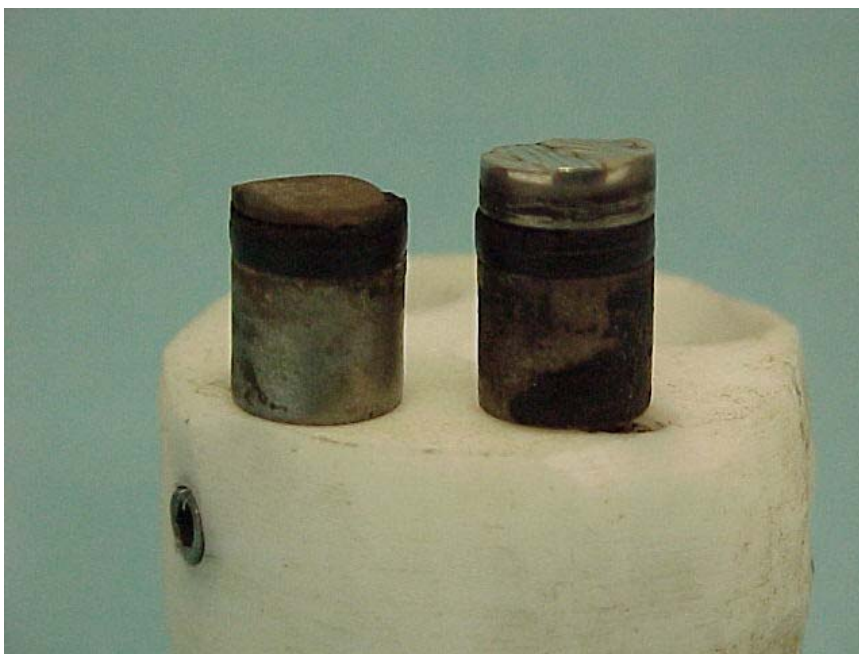
Fig. 34. Length comparison of ring 6N electrodes. The mild steel on the left has suffered about 80 mils more corrosion than the 309LSi electrode on the right.
