**EVALUATION OF CORROSION FAILURE
IN
TRACTOR-TRAILER BRAKE SYSTEM**

July 2002

Metals and Ceramics Division

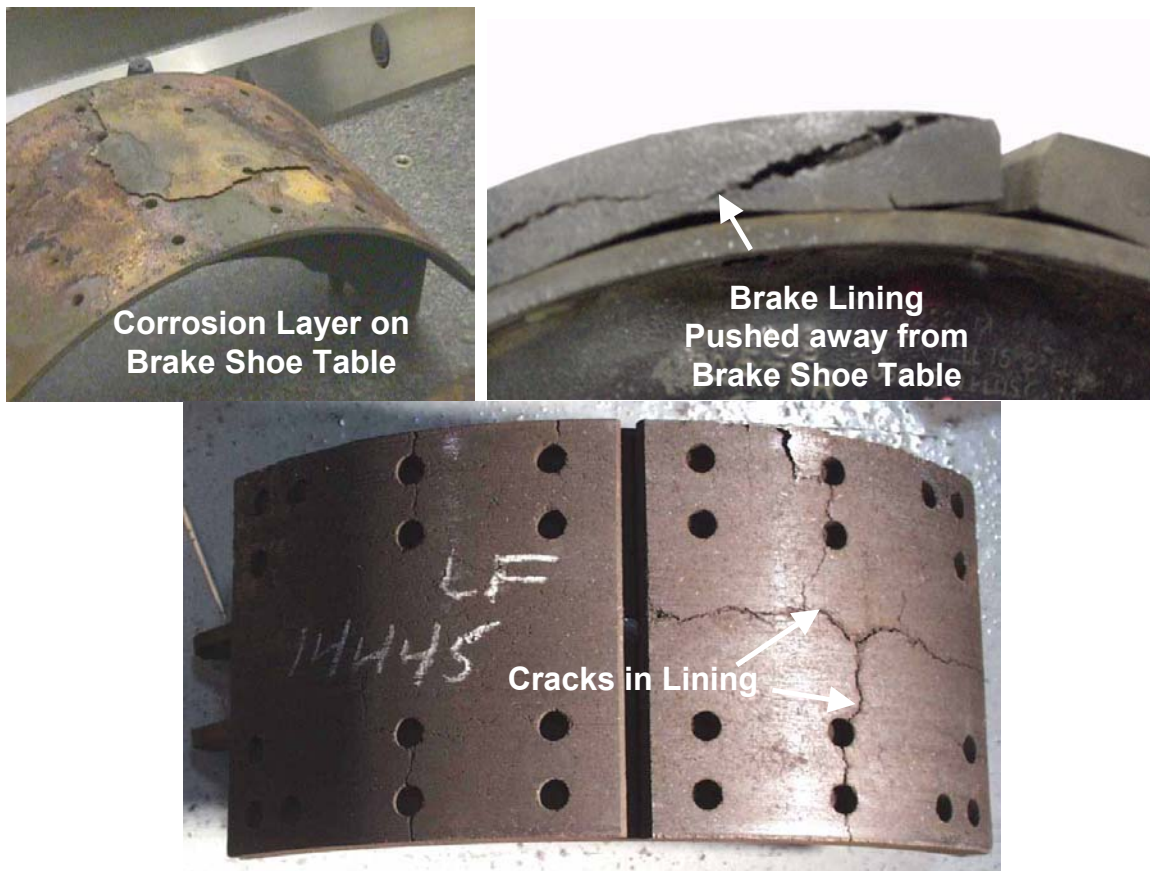
Fig. 2. Brake shoe table and lining showing corrosion product on the table, separation of lining from table and cracking of the lining.

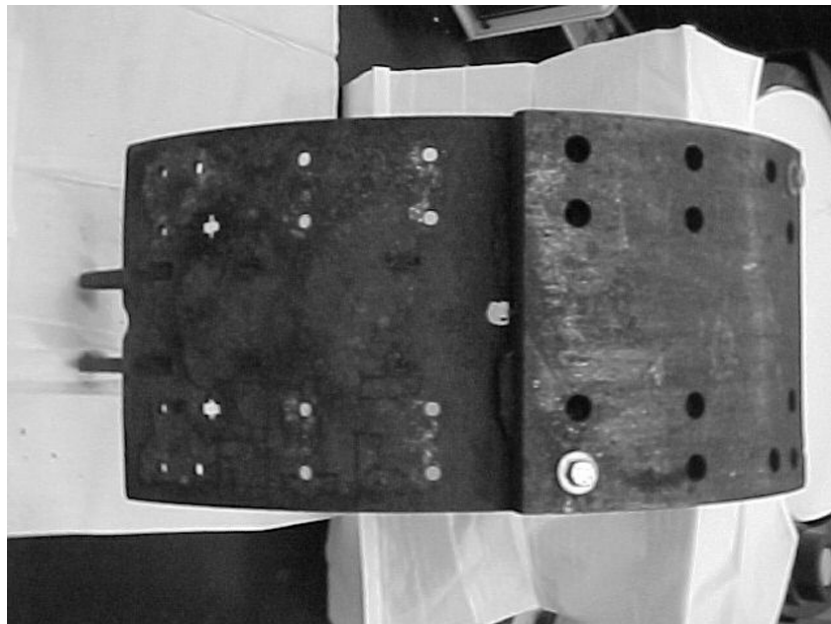
02-2026-02

Fig. 3. Partially disassembled brake system showing shoe table, lining and layout of rivet and ancillary holes.

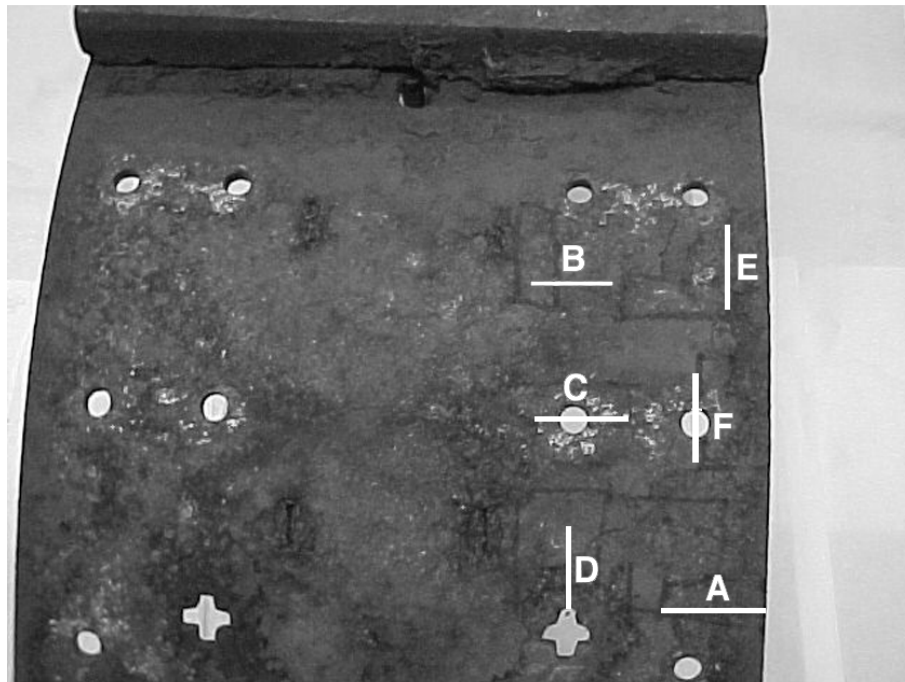
02-2026-04

Fig. 4. Layout of sites on the brake table that were sectioned for evaluation. Transverse sections are from sites A, B, and C, and longitudinal section are from and sites D, E, and C.

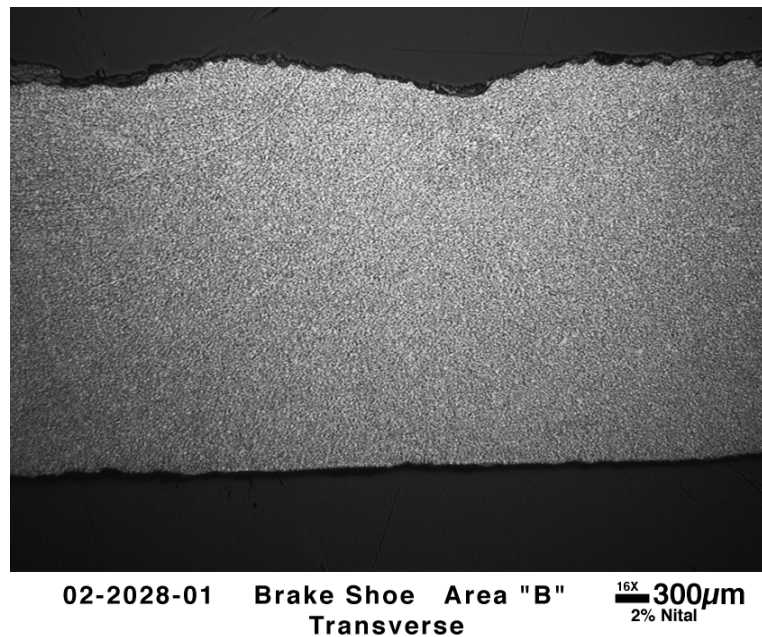
Fig. 5. Typical appearance of cross section showing non-uniform corrosion at the brake table/lining interface (top of picture).

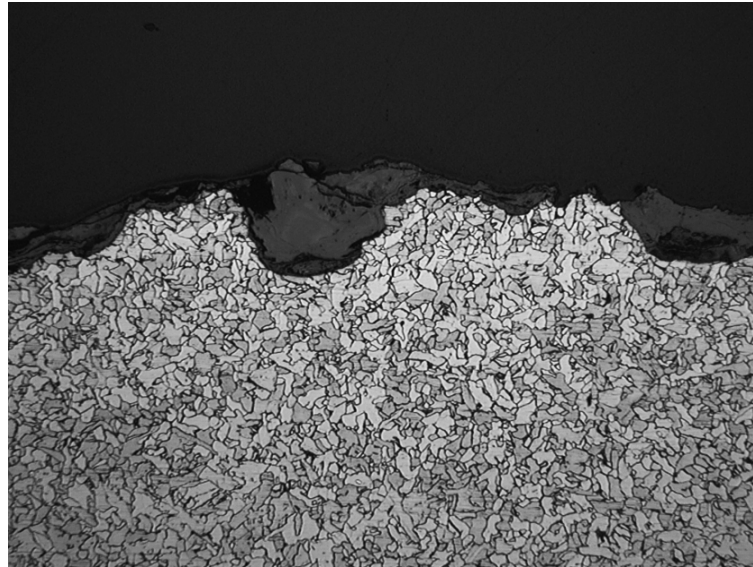
02-2028-03 Brake Shoe Area "B"
Transverse 100X 50μm
2% Nital

Fig. 6. Higher magnification image showing details of the non-uniform corrosion.

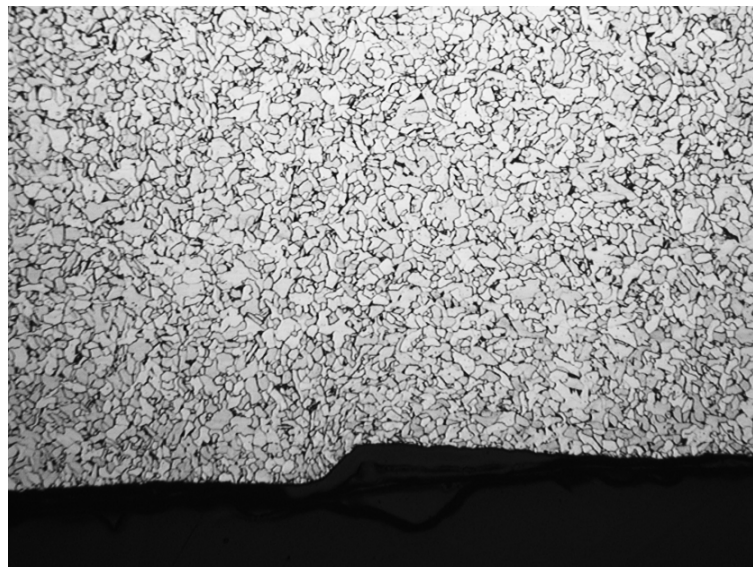
02-2029-07 Brake Shoe Area "C"
Transverse, Hole area 100X 50μm
2% Nital

Fig. 7. Cross-section across a rivet hole showing relatively smooth surface of the surface that was not in contact with the brake lining.

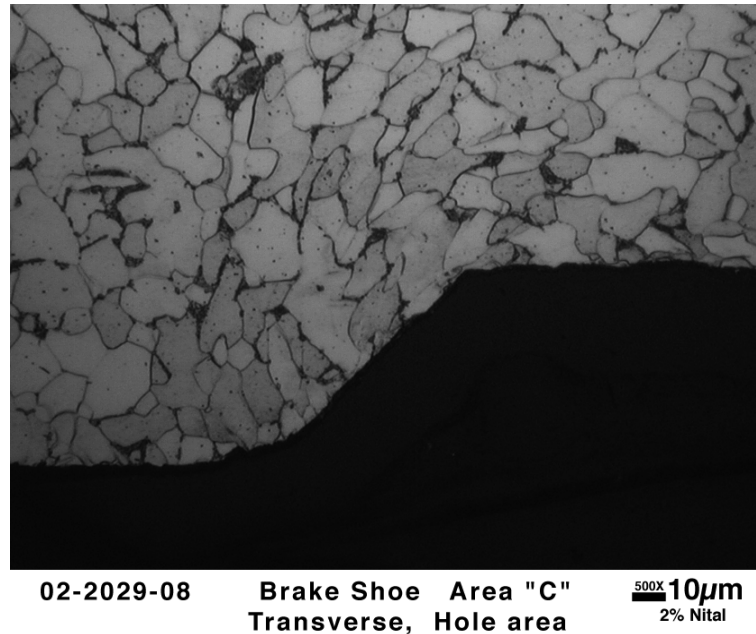
Fig. 8. Higher magnification image of the surface that was not in contact with the lining shows a delineation of the shoulder of the rivet hole.

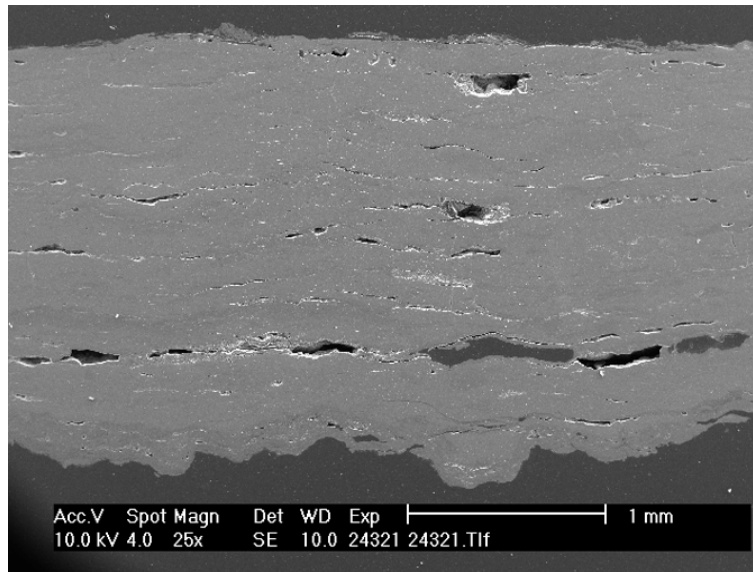
Fig. 9. Secondary electron image of the spalled scale showing banding, cracking, and porosity.

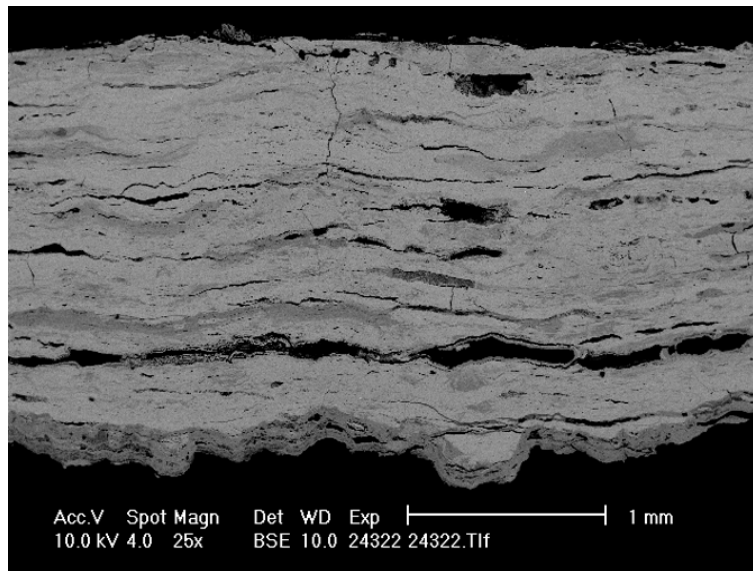
Fig. 10. Backscattered electron image revealed light (Fe_3O_4) and dark (Fe_2O_3) gray regions of different compositions.

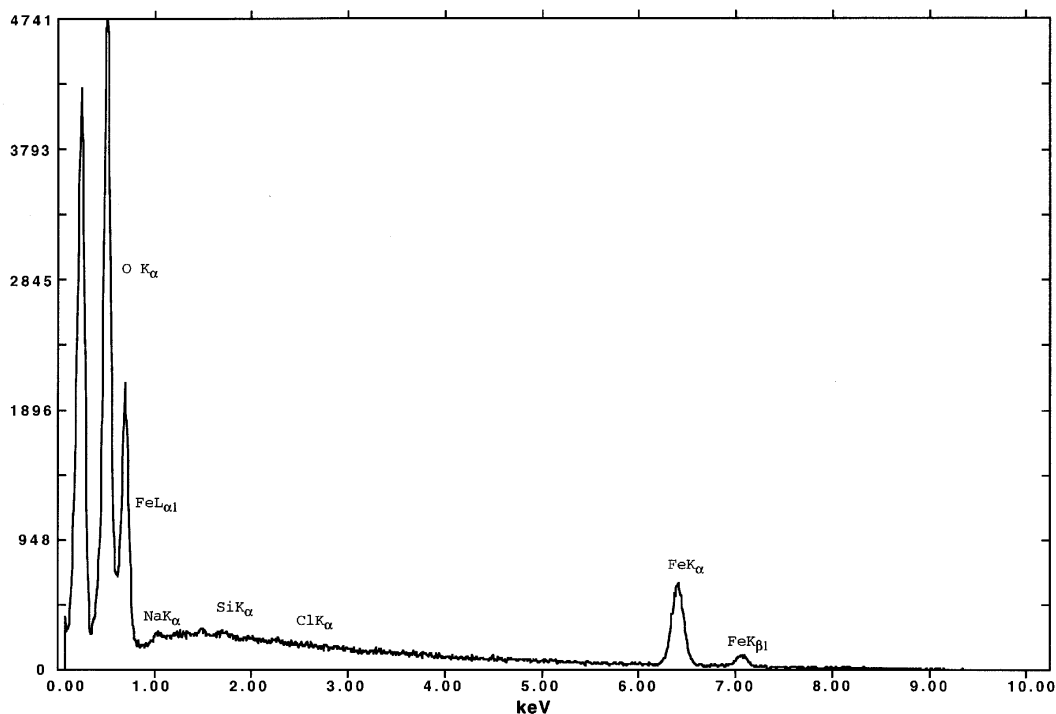
Fig. 11. X-ray spectrum of light gray area showing a lower O/Fe ratio as compared to the spectrum for the dark gray area (following figure).

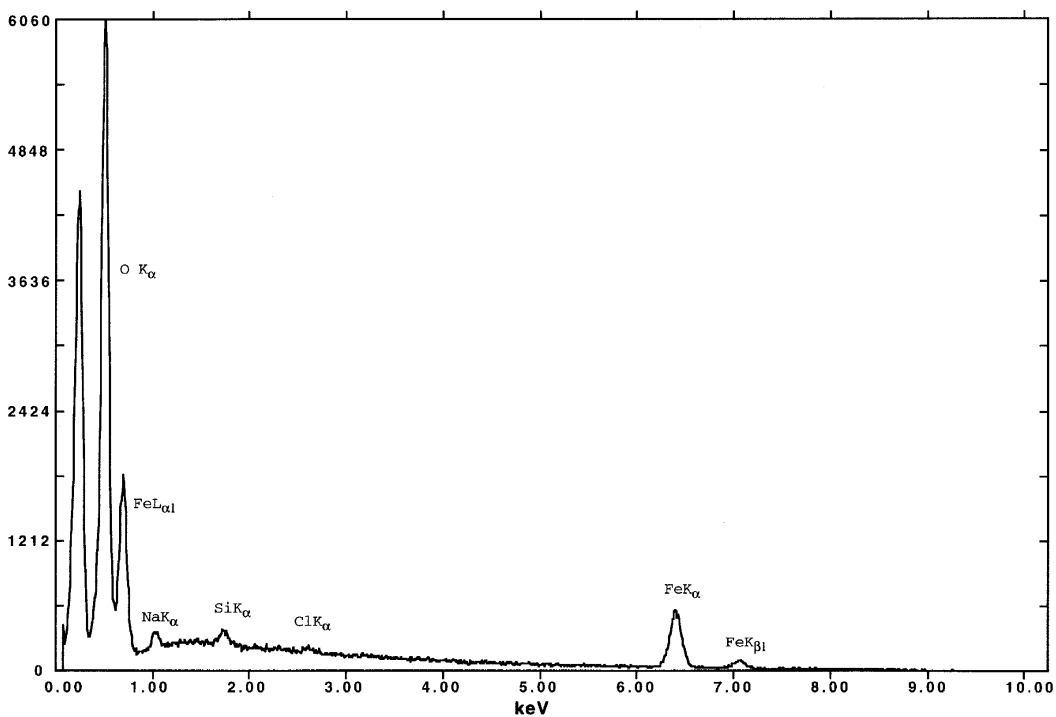
Fig. 12. X-ray spectrum of the dark gray area showing a higher O/Fe ratio as compared to that for the light gray area (previous figure).

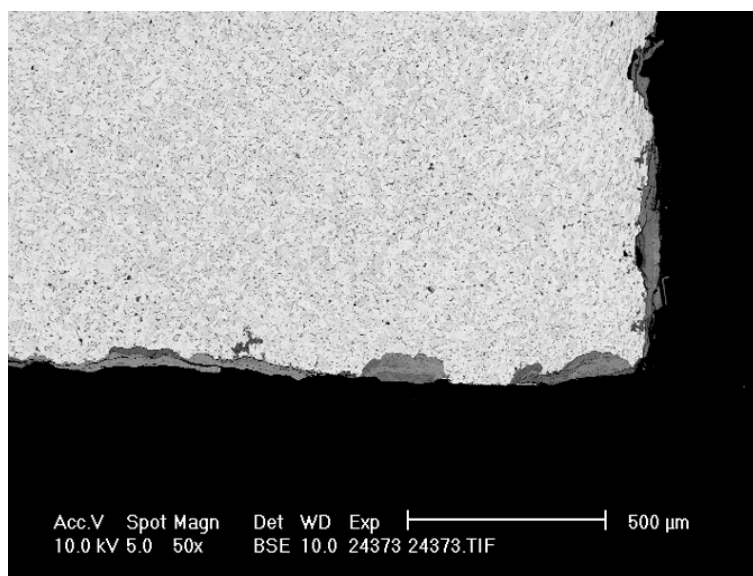
Fig. 13. Backscattered image showing scale attached and spalled areas.

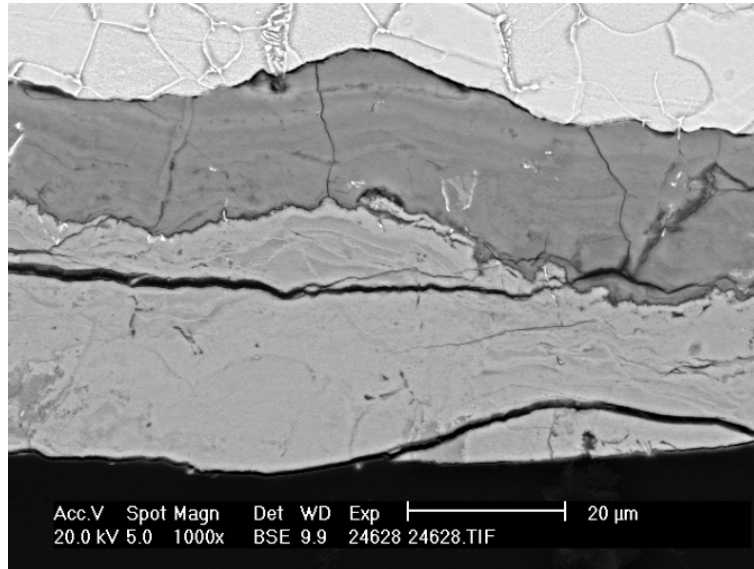
Fig. 14. Backscattered image showing banding in the adherent scale. The light region at the top of the scale is plain carbon steel, the middle dark gray region is Fe_2O_3 , and the bottom light gray region is Fe_2O_4 .

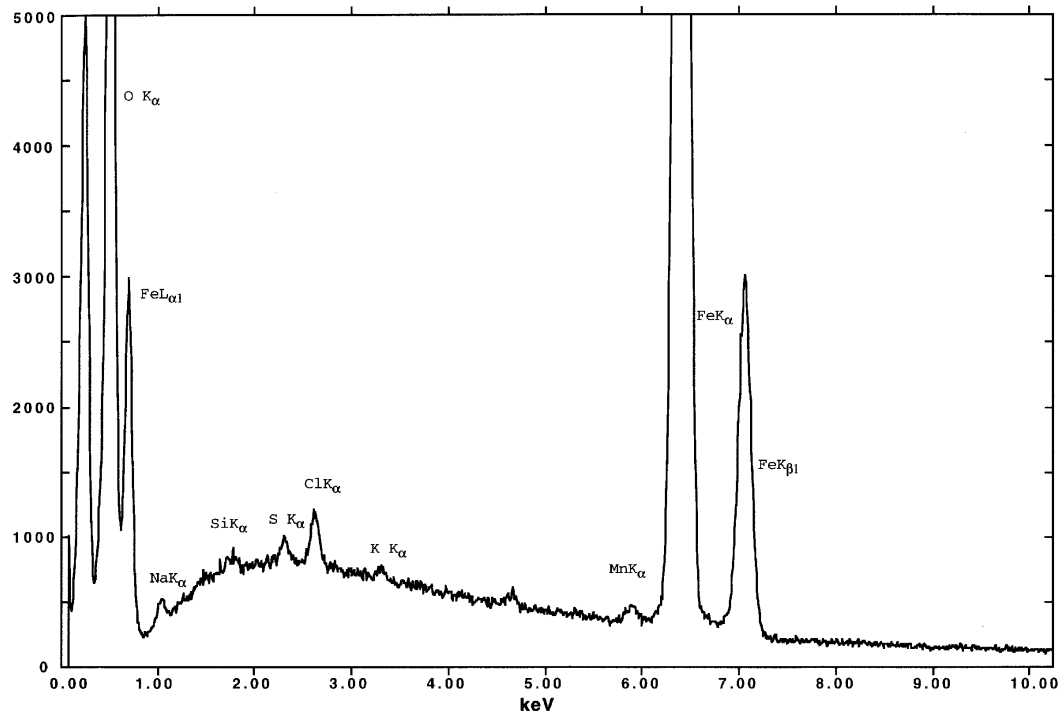
Fig. 15. X-ray spectrum of attached (dark gray) scale showing the presence of sodium, potassium, and chlorine. The manganese and sulfur are assumed to arise from inclusions.

As reported to ORNL, concomitant with the introduction of different deicing and anti-icing compounds, there was an increase in the brake failure rate. This initial analysis found no evidence for the chlorides of calcium and magnesium, which are less soluble in water than the identified chlorides of sodium and potassium, in the scale. While this can be due to the vehicle having not been used in states that use calcium and magnesium, it is also possible that the corrosion products that form in the presence of calcium and magnesium are more friable and were readily lost once the lining was removed from the brake table.
