Correlation of Process Data and Electrochemical Noise to Assess Kraft Digester Corrosion: Kamloops Experiment

ORNL/TM-2002/33

**Correlation of Process Data and Electrochemical Noise to Assess Kraft Digester Corrosion:
Kamloops Experiment**

Date Published: April 2002

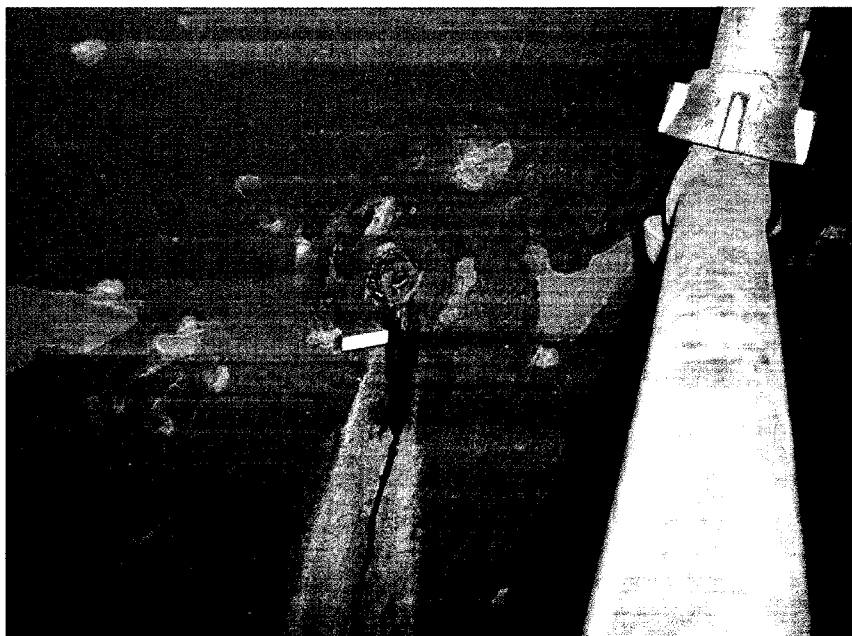
The digester shell near the topmost probe location (for Probe #1) is shown in Figs. 4-5. The port is located about 0.5 m below the dome-to-shell transition weld – which is also termed RS22, or the 22nd round seam from the bottom of the vessel – and about 46 m above the bottom of the vessel (RS 1). Much of the surface in this area retained a loosely adherent carbonate scale that was relatively thick (~1.5 mm). In places where the carbonate scale had become dislodged, the substrate carbon steel was smooth and exhibited a uniform dark coloration (deep blue to black). The smooth area – apparently free of anything except very modest general corrosion – extends several meters down the digester wall from this location. Based on visual assessment of the area represented by Probe #1, cumulative corrosion in this location has been very minor or even nil.

Fig. 4. General view of the digester shell in the area of Probe #1. At the time of this photograph, the probe port was occupied by a potential monitor. Only small amounts of residual carbonate scale (relatively light colored areas) remain on the shell, and some residual black liquor is draining from the annular area of the port. The white “scale indicator” just below the port is 3.5 cm long. A piece of scaffold rigging appears in the foreground.

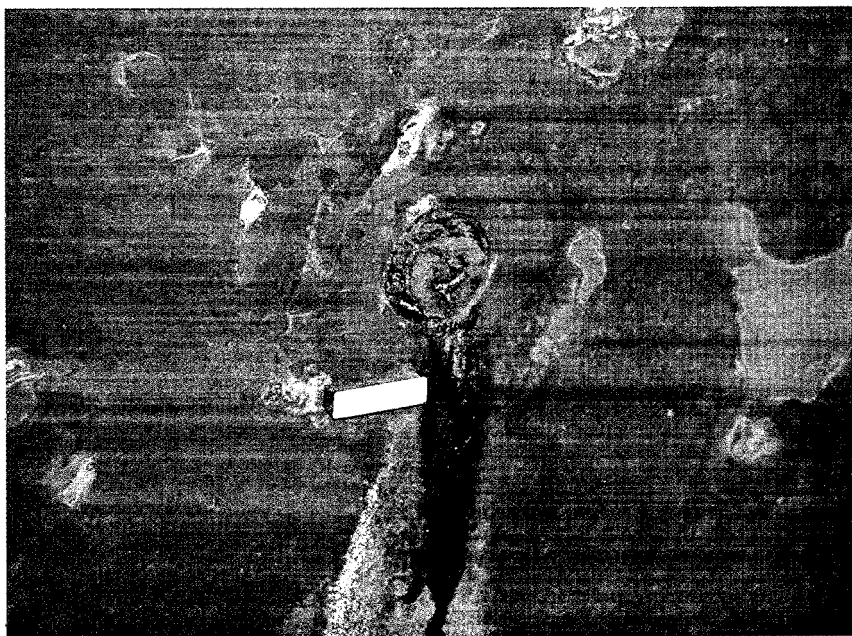
Fig. 5. Closer view of the shell surface surrounding the port for Probe #1. The boss area encircling the port is very slightly raised above the shell contour and is stainless steel overlay. Note that the shell in this location is smooth – no pitting or surface roughening. Small areas of light brown carbonate scale remain on the shell.

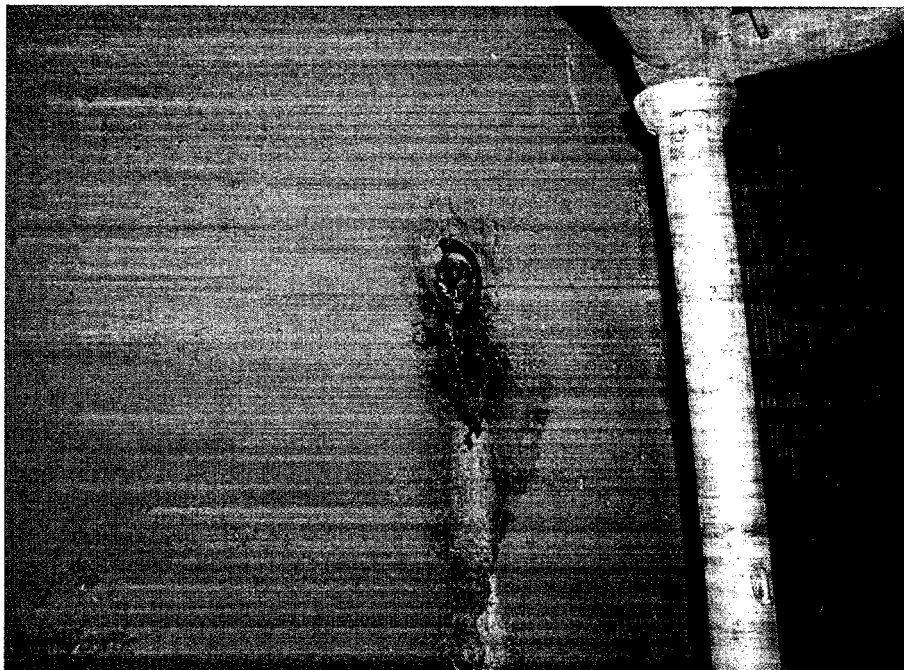
Fig. 6. General view of the digester shell surrounding the port for Probe #2. At the time of this photograph, the port was occupied by a potential monitor and residual black liquor was draining from the port annulus. Most of the area is covered by a thin, tan-colored carbonate scale. At right, a scaffolding support and a partially obscured trim screen are visible. For scale, the port diameter is about 3.5 cm.

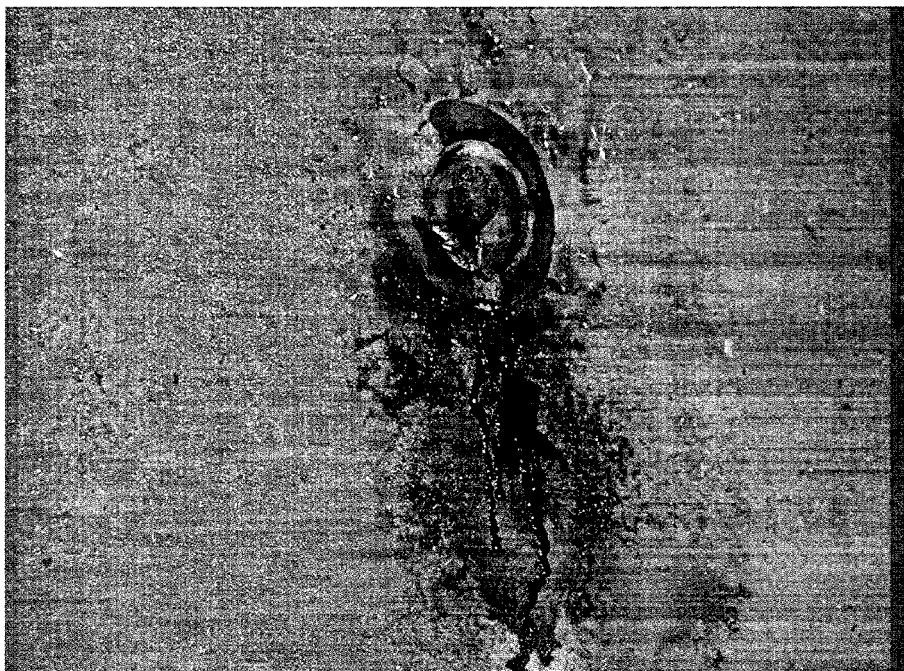
Fig. 7. Close-up view of view of the shell surface surrounding the port for Probe #2. In general, some minor surface relief and scattered light pitting are evident on the shell surfaces in this area, but the largest pits – approximately 0.5 mm (20 mils) deep – are immediately adjacent to the stainless steel port boss. Many of the pits exhibit red-orange flash rusting.

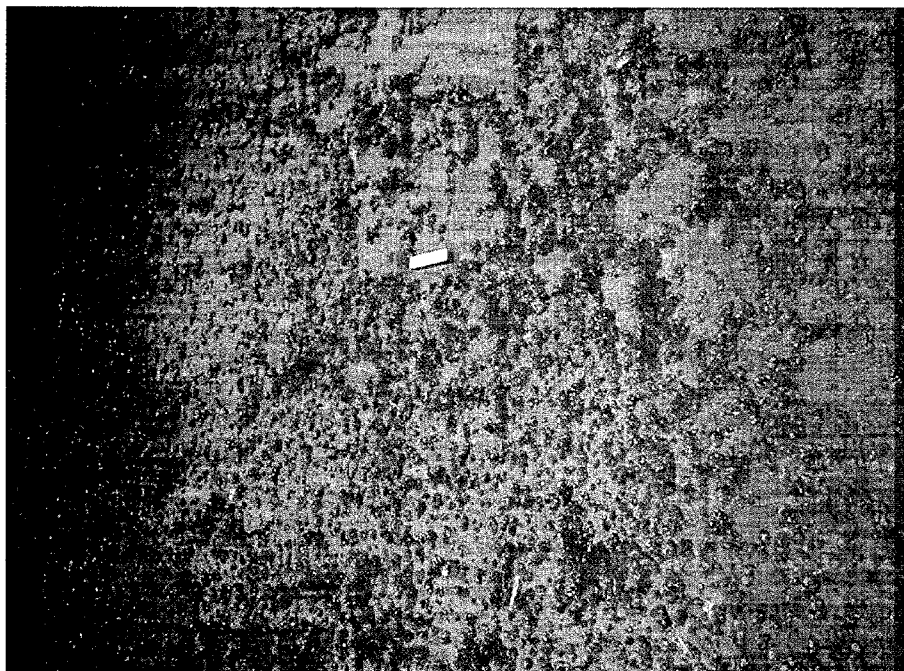
Fig. 12. General view of digester shell between extraction screens and modified cooking screens. The white “scale indicator” is 3.5 mm long and rests on a smooth, unattacked surface while much of the surrounding area is significantly pitted.

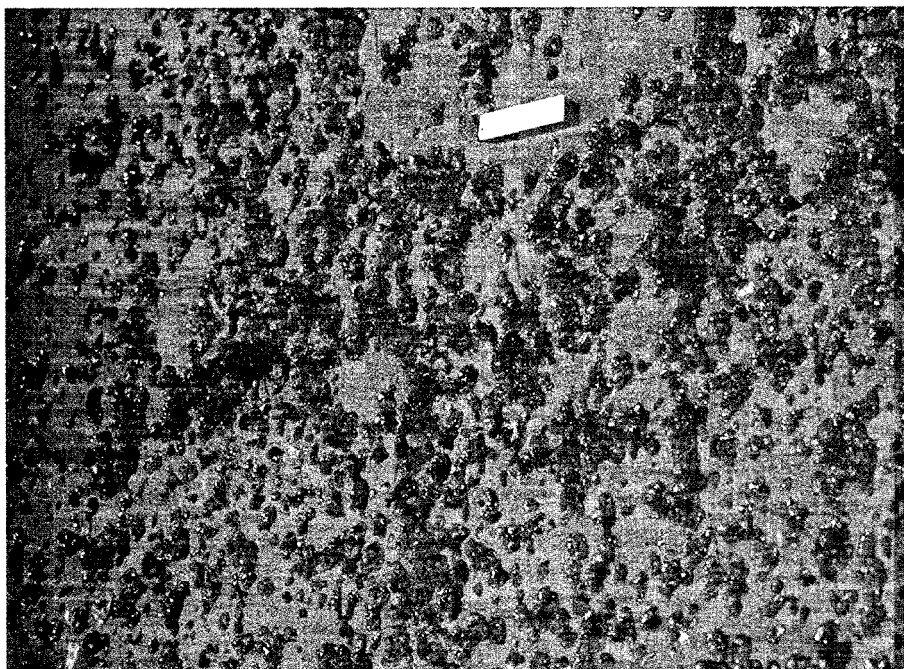
Fig. 13. Magnified view of the area depicted in Fig. 12. The pits in this region tend to overlap to form sizeable areas exhibiting a wall thickness decrease of 1.6-1.7 mm (60-70 mils) compared to the smooth surfaces nearby.

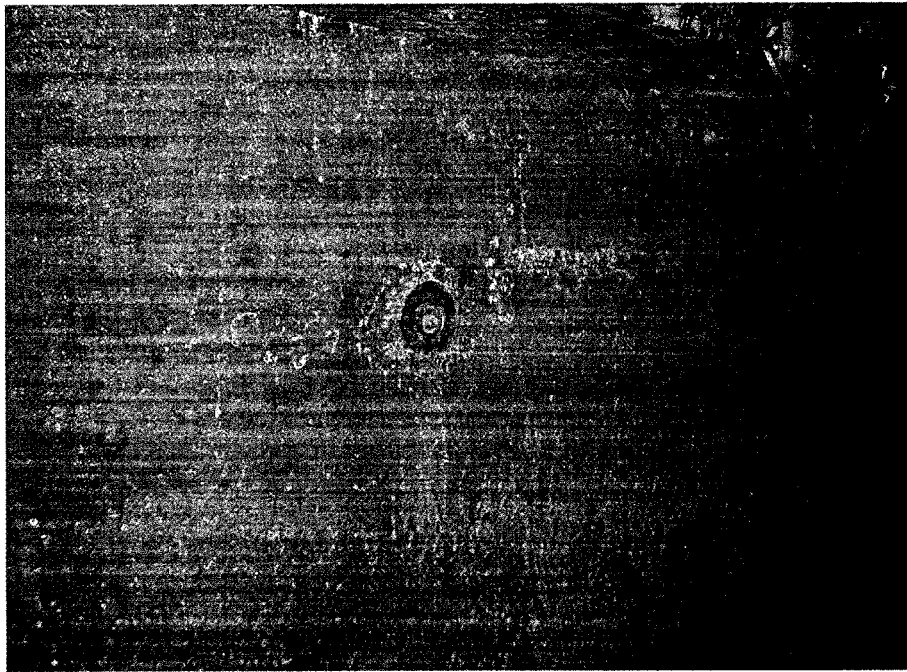
The fourth probe from the top of the vessel is located just below the modified cooking (MC) screens. Similar to the situation for Probe #3, the probe location is about 0.5 m below a shelf associated with the MC screens. Shell corrosion in this area at the time of probe installation was somewhat scattered, and no large clusters of pits were observed except those immediately adjacent to the probe port. Figures 14 and 15 are representative of these observations; the pit depth at this location is uniformly 1.5-1.7 mm (60-70 mils).

Fig. 14. General view of the digester shell in the vicinity of the port for Probe #4. The internal header box (“shelf”) associated with the modified cooking screens is just visible at the top of the photograph. The shell surfaces exhibit very little pitting in the immediate vicinity of this port.

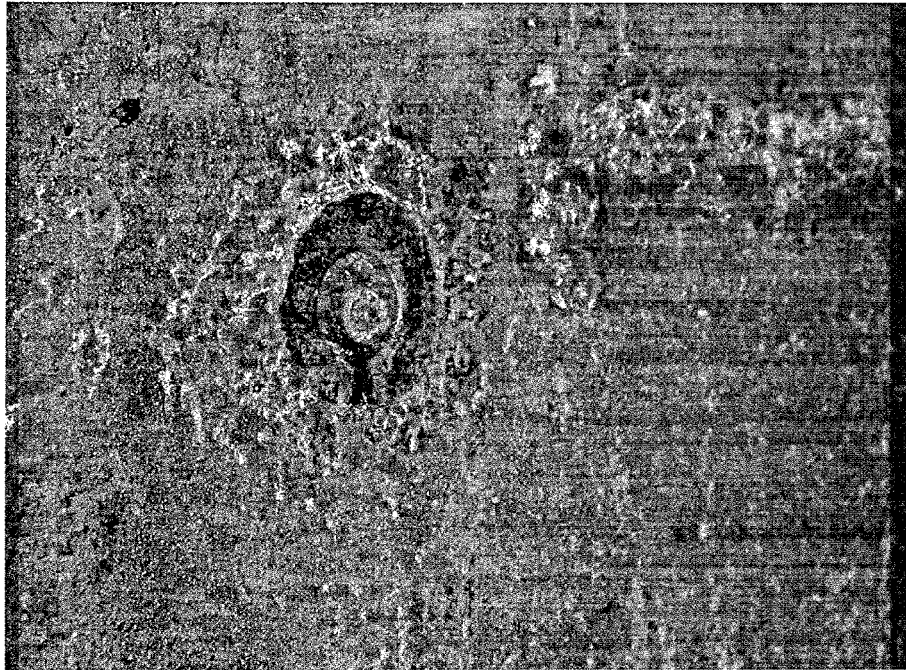
Fig. 15. Closer view of the area immediately surrounding the port for Probe #4. The pits observed here – generally adjacent to the port boss and associated with the former position of an L-shaped bracket just to the right of the port – are uniformly 1.6-1.7 mm (60-70 mils) deep.

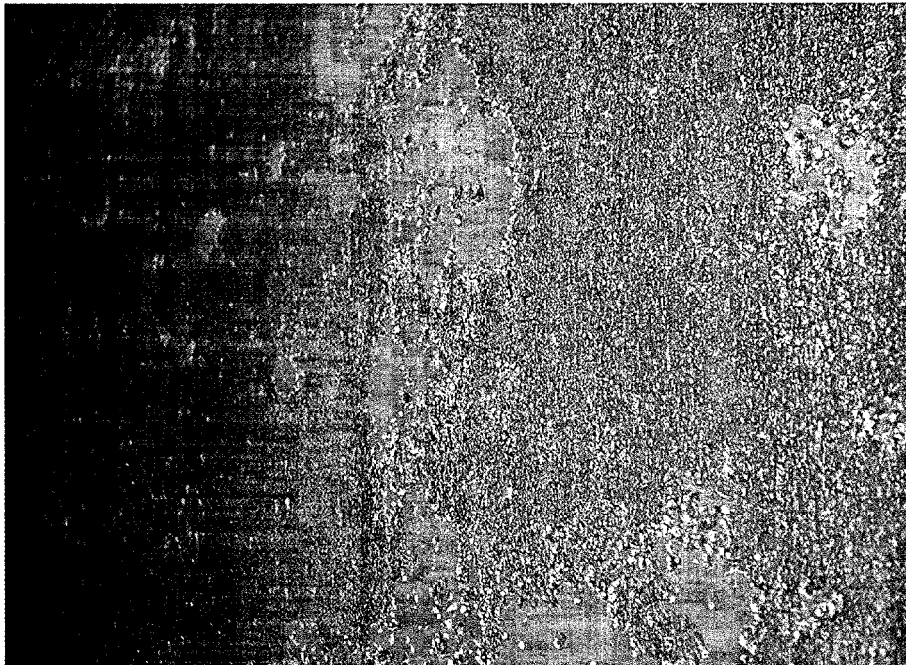
Between the MC screens and the wash screens, the relative fraction of corroded shell surface increases significantly – and fairly abruptly – compared to higher in the vessel. Figure 16 is representative of this observation. Compared to the somewhat isolated areas in which corrosion appears to be minimal (the “islands” portion of the oceans-and-islands pattern), the depth of “ocean” region of corrosion is about 1.7 mm (about 70 mils), which is consistent with the depth of more isolated corrosion spots observed higher in the vessel.

Fig. 16. Region of the digester shell below the modified cooking screens showing extensive pitting. This specific region, near RS5, shows the tendency for pits (red-orange rust colored) to grow together laterally leaving only relatively small areas (gray) of smooth digester shell. The regions without rust stains stand uniformly about 1.7 mm (70 mils) above the bottom of the pitted/recessed area.

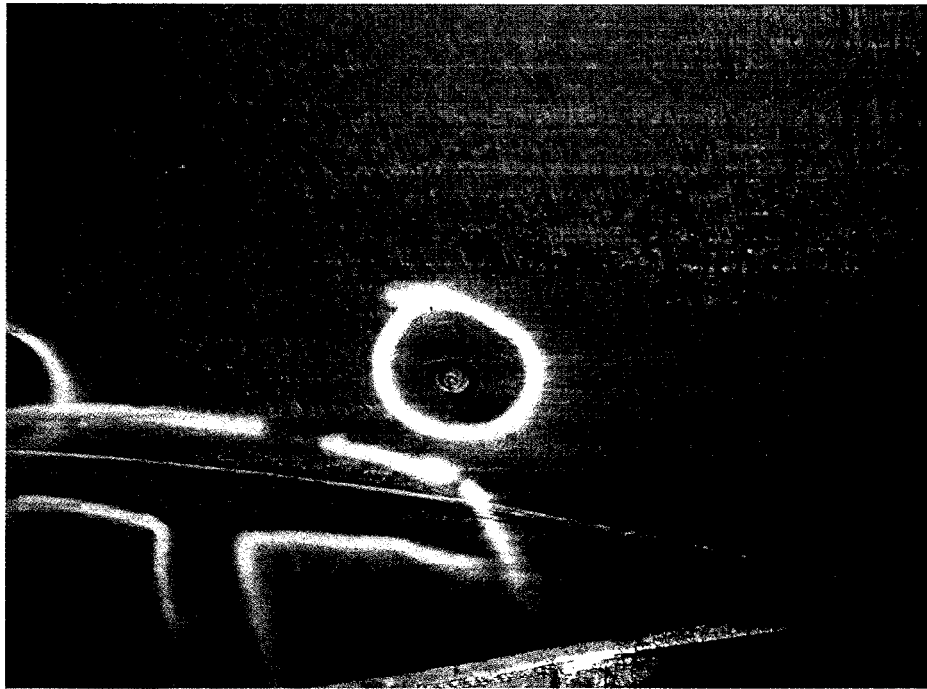
The lowest probe port is below the wash screens and just above RS1 (the lowest circumferential weld). Scattered pitting across much of the shell surface was present at the time of the inspection, but the pitting (OS-0.7 mm deep) was much more shallow than slightly higher in the vessel. Figures 17 and 18 document the pre-test condition of the digester shell near Probe #5.

Fig. 17. General view of the digester shell in the vicinity of the port for Probe #5. Just below the port for Probe #5, RS 1 is visible, as well as a portion of the rake.

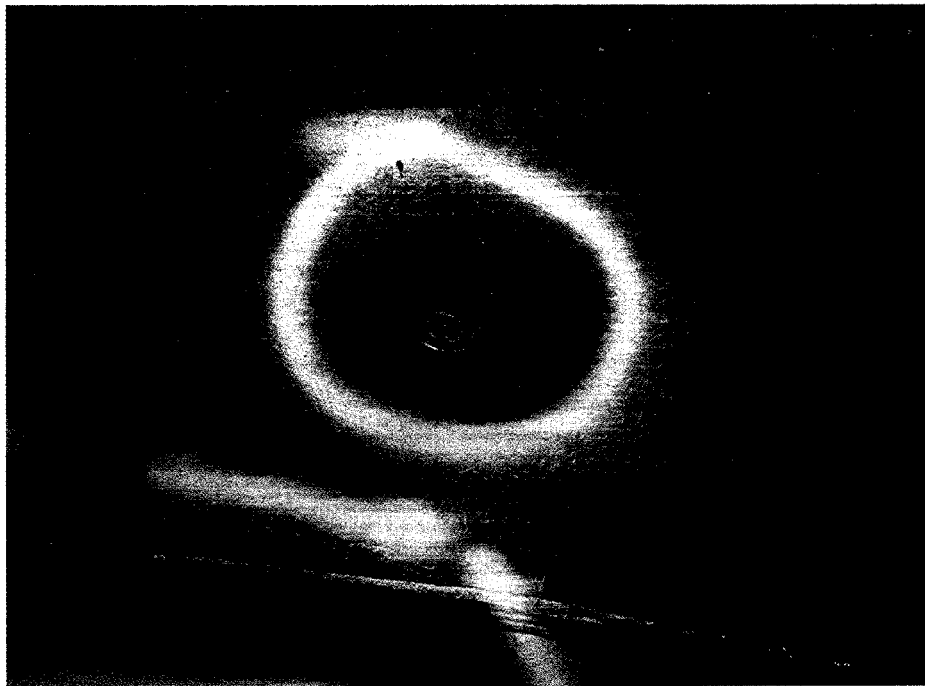
Fig. 18. Close-up view of the area immediately surrounding the port for Probe #5. The pits observed here are scattered but uniformly 0.5-0.7 mm (20-30 mils) deep.

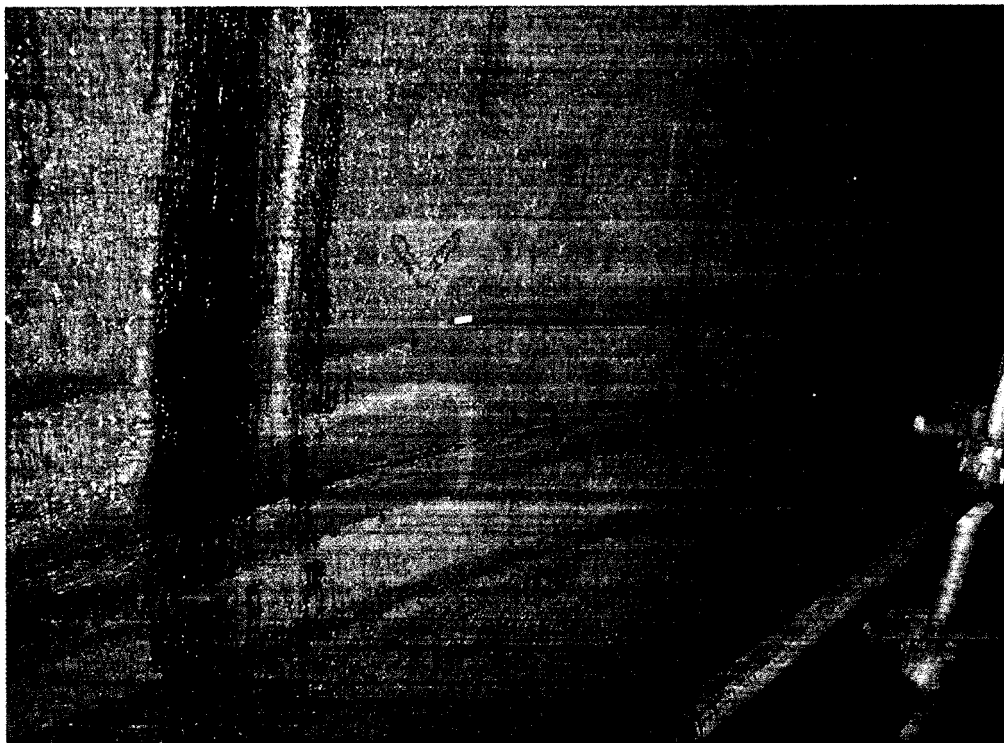
Also in Fig. 19, there is a small “V” shape just above the topmost track indicating similar accelerated corrosion to that observed in the welder tracks. These “V” shapes (sometimes “L” shapes – see, for example, Figs. 14 and 15) are located in a number of places inside the vessel and apparently represent locations where a fixture was welded to the digester wall to support construction activities. Areas that were ground in order to remove the fixture (as well as areas ground to prepare the area for welding) apparently became susceptible to accelerated corrosion or at least accelerated initiation of the process. In a few cases, patterns consistent with individual grinding marks were also observed to exhibit accelerated corrosion.

Fig. 19. Digester shell near RS6. RS6 is parallel to and partly included in the horizontal portion of the orange inspection “T” and the white scale marker (3.5 cm long) is on the uppermost of the “tracks” parallel to RS6 on top and bottom. There is significant indication of pitting in the entire area – individual pits tend to be approximately 1.0-1.2 mm (40-50 mils) deep, but the surface of the tracks and the weld at RS6 have receded further. The black material in the vertical portion of the “T” is residual black liquor. Also note the “V” shaped indication of significant corrosion just above the scale marker.

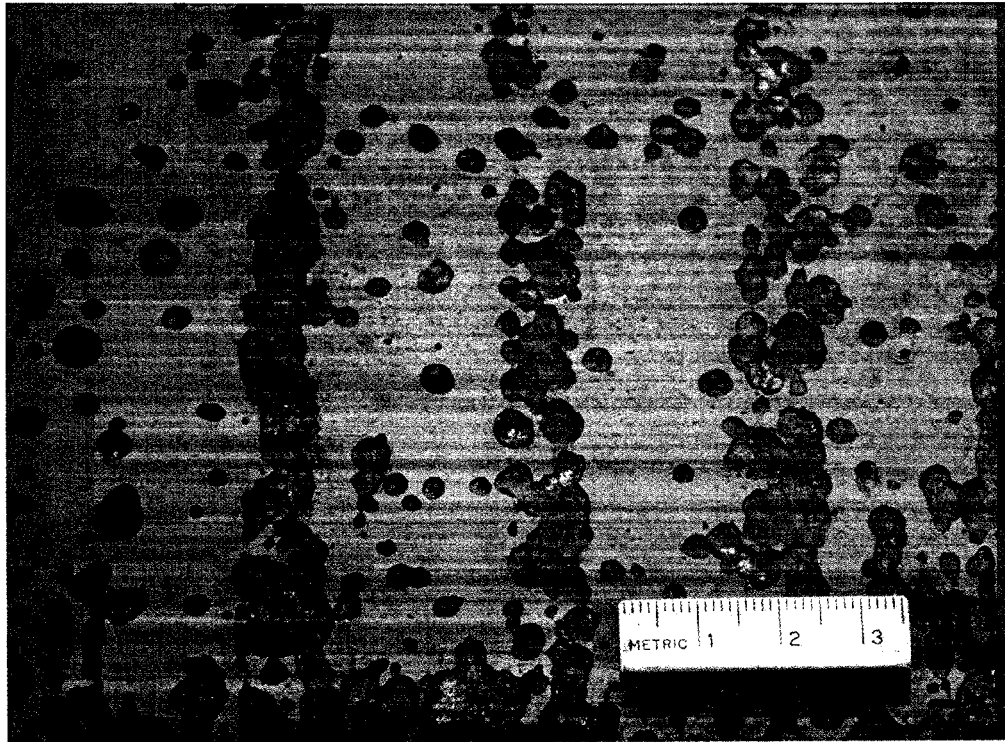
One section of dummy plate, which was removed in 1996, was made available for metallographic analysis. The analysis confirmed that the pits had smooth, rounded sides with an abrupt transition to apparently uncorroded material (Fig. 21). In addition, all the pits on the plate were very close to precisely the same depth (Fig. 22). No microstructural patterns – such as gradients in hardness, grain size, composition, or inclusion density – could account for the precise depth of pitting or for the vertically oriented rows of pits. One possibility is that rolling of the flat plate to form the slightly curved shell contour cracked/crumpled the mill scale along lines of accumulated stress. The surface film was indeed different at the pit locations than in/on the pit surfaces, but none of the film(s) seemed to retain typical mill scale composition, so it was not possible to confirm the hypothesis regarding the vertical rows of pits.

Fig. 21. Section of dummy plate removed from the digester in 1996.

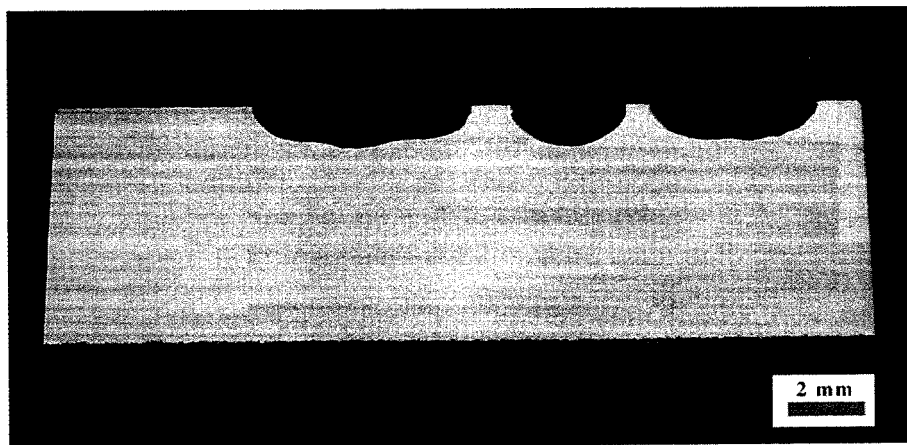
Fig. 22. Representative horizontal (circumferential) cross-section of the dummy plate shown in Fig. 21. Note that all the pits in this view have smooth bottoms and are the same depth.

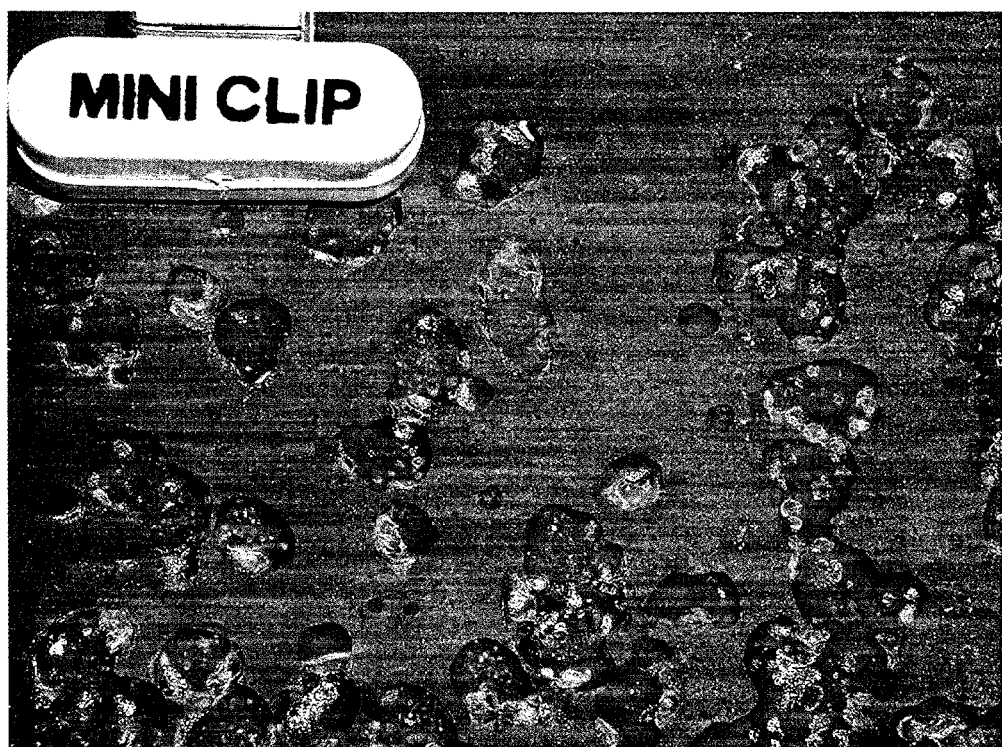
Fig. 24. Close-up view of isolated pitting on the digester shell. The magnetic clip at top left is 4 cm long at the widest point. Note that the flash rust locations are not always at the bottom (low point, as determined by gravity flow for moisture) of each pit.

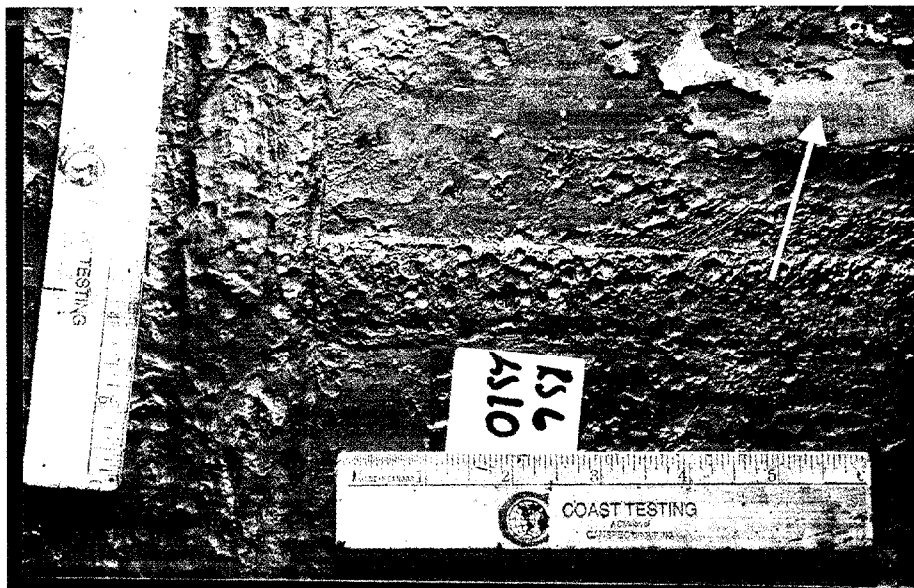
Fig. 28. 1999 inspection photograph of the RS6/LS10 intersection. Note the “island” of smooth shell surface in the upper right of the photograph, which stands about 1 mm (40 mils) above the surrounding corroded area.

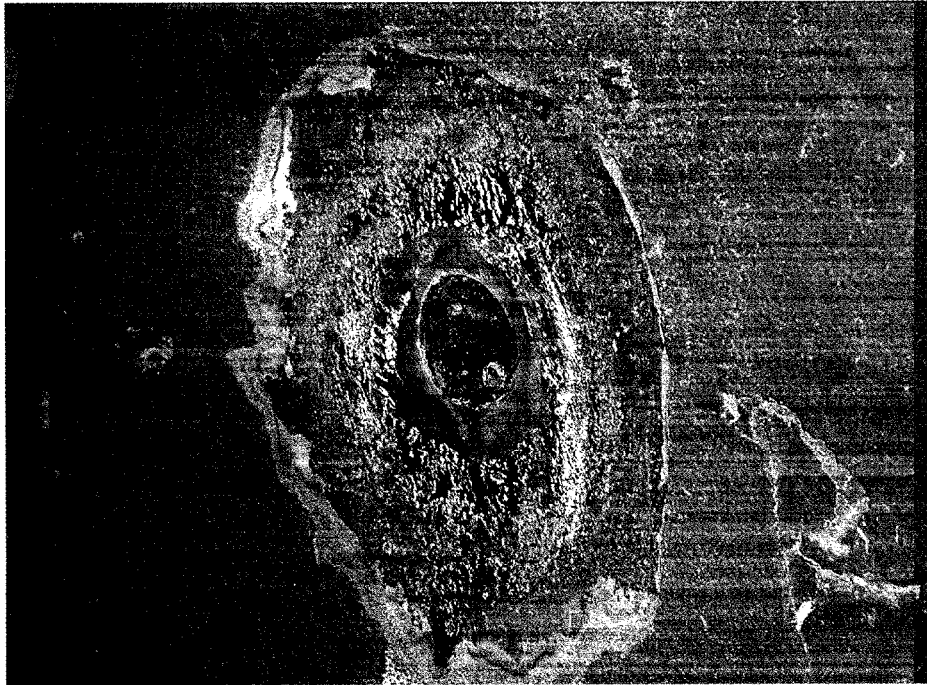
Fig. 40. Post-test view of Probe #1. The area 10-12 cm around the probe position has been cleaned of carbonate scale. Red/orange regions are rust stains associated with low spots in the surface relief and shallow pitting.

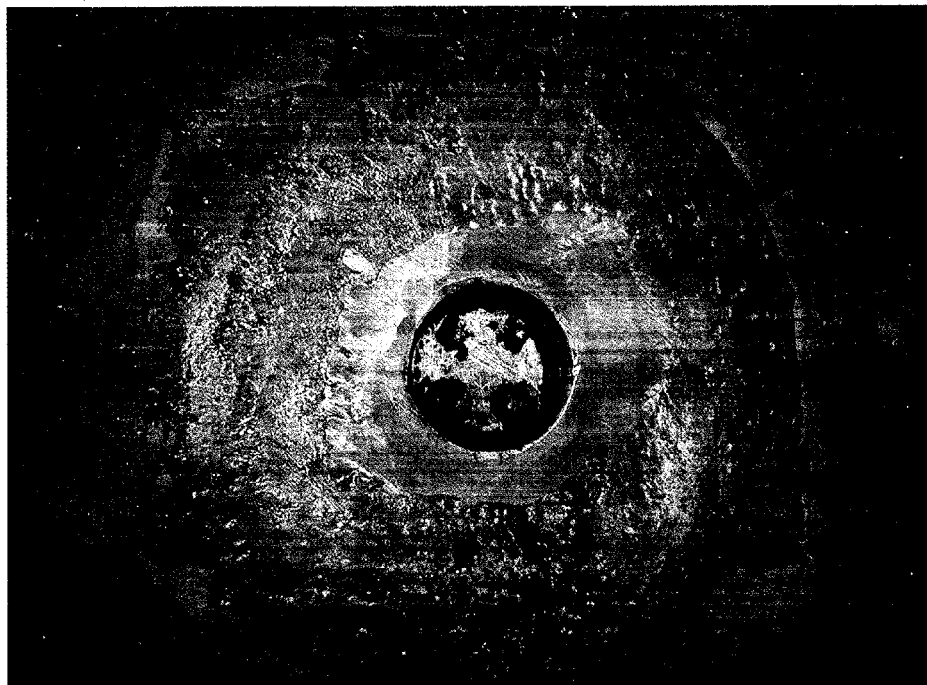
Fig. 41. Post-test view of Probe #1 following removal of accumulated "crud" in the port opening.

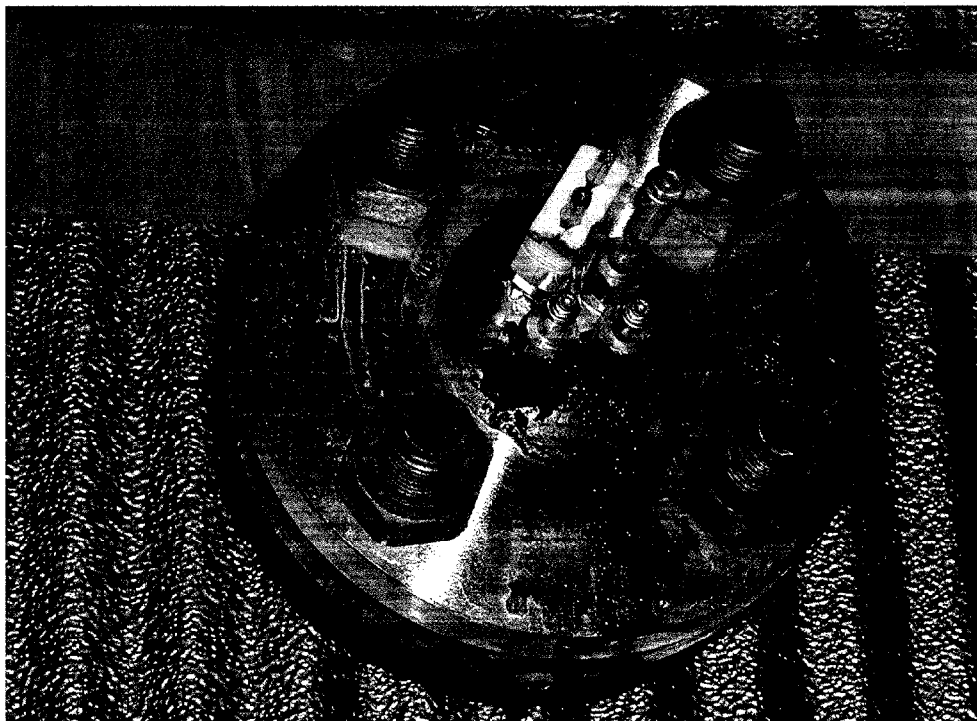
Fig. 42. View of the external flange associated with Probe #1. None of the other flanges showed any sign of leakage.

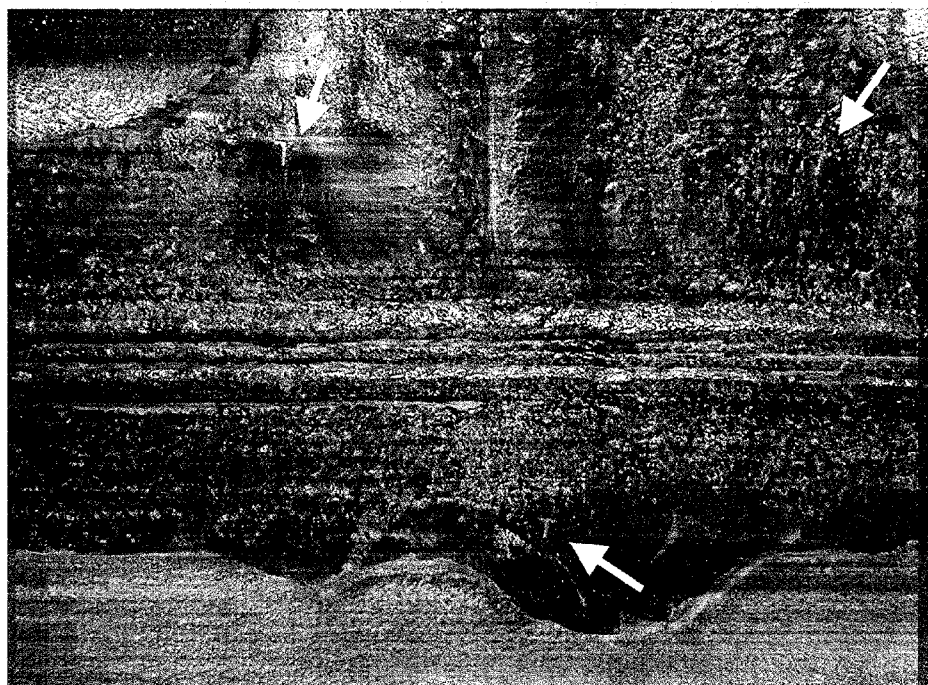
Fig. 43. Intersection of RS21 with LS33 or LS34. Gray material – particularly evident at the bottom of the photo – is carbonate scale.

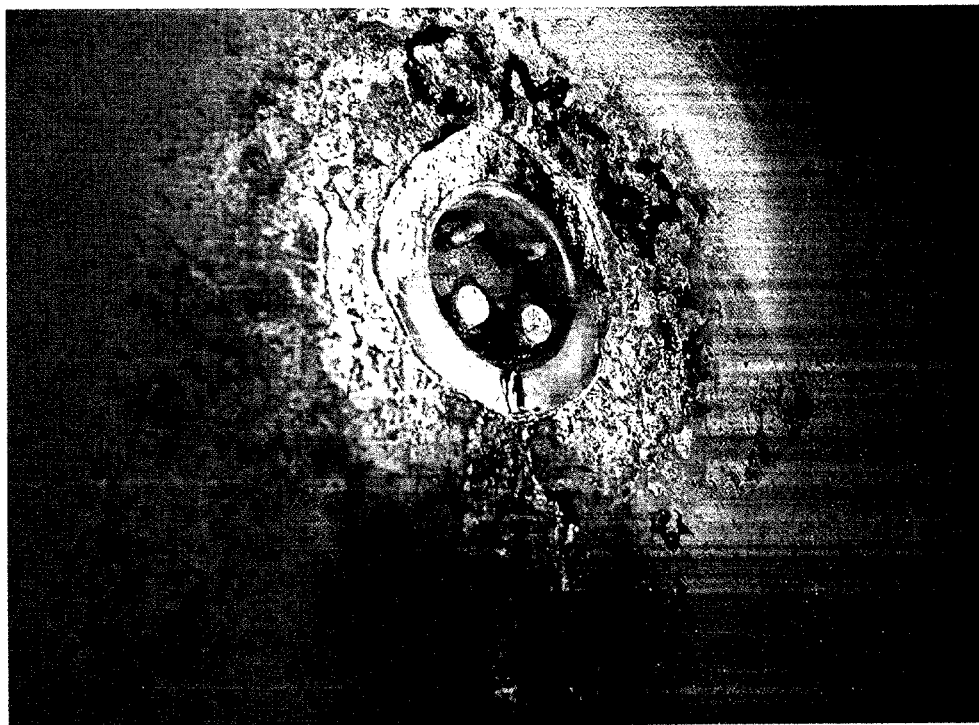
Fig. 44. Post-test view of Probe #2. Significant corrosion and surface relief is confined to the area adjacent to the port boss. Residual carbonate scale covers most of the shell at this position, but it is sufficiently thin to reveal surface relief contours.

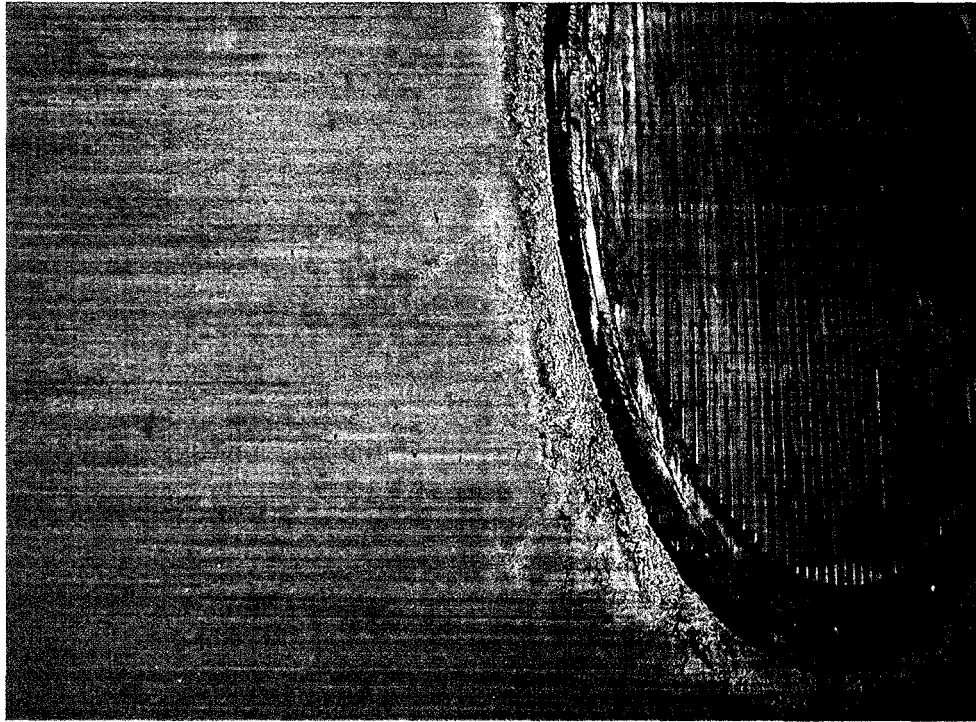
Fig. 45. Shell and trim screen near the position of Probe #2. The most significant corrosion is adjacent to the port boss.

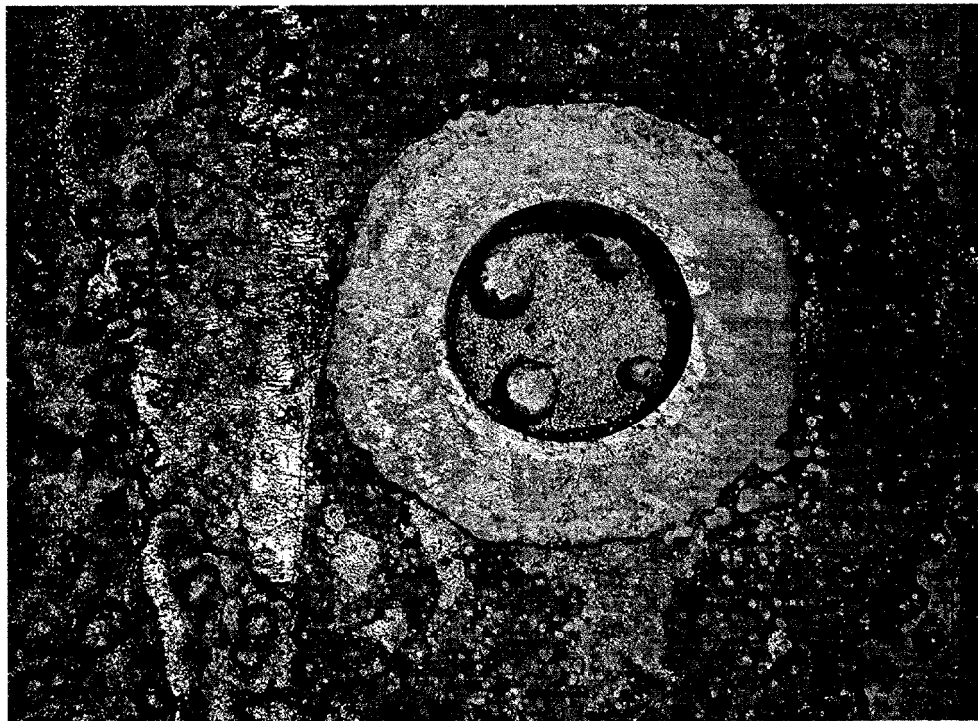
Fig. 47. Closer view of Probe #3. The teflon has recessed from its original position flush with the process at the mouth of the port by about 1 cm.

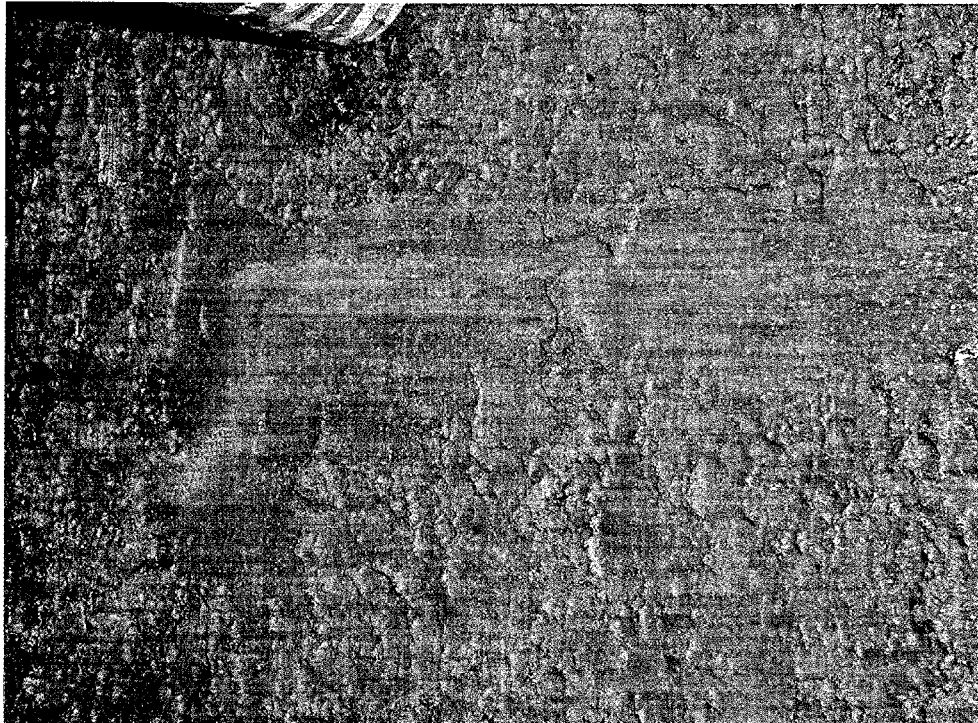
Fig. 49. A recessed area associated with grinding the shell surface to remove an attachment.
