THORIUM NITRATE STOCKPILE DRUM CHARACTERIZATION REPORT

**THORIUM NITRATE STOCKPILE
DRUM CHARACTERIZATION REPORT**

Prepared for
U.S. Defense Logistics Agency
Defense National Stockpile Center
Fort Belvoir, Virginia

Prepared by
OAK RIDGE NATIONAL LABORATORY
Oak Ridge, Tennessee 37831
managed by
UT-BATTELLE, LLC
for the
U.S. DEPARTMENT OF ENERGY
under contract DE-AC05-00OR22725

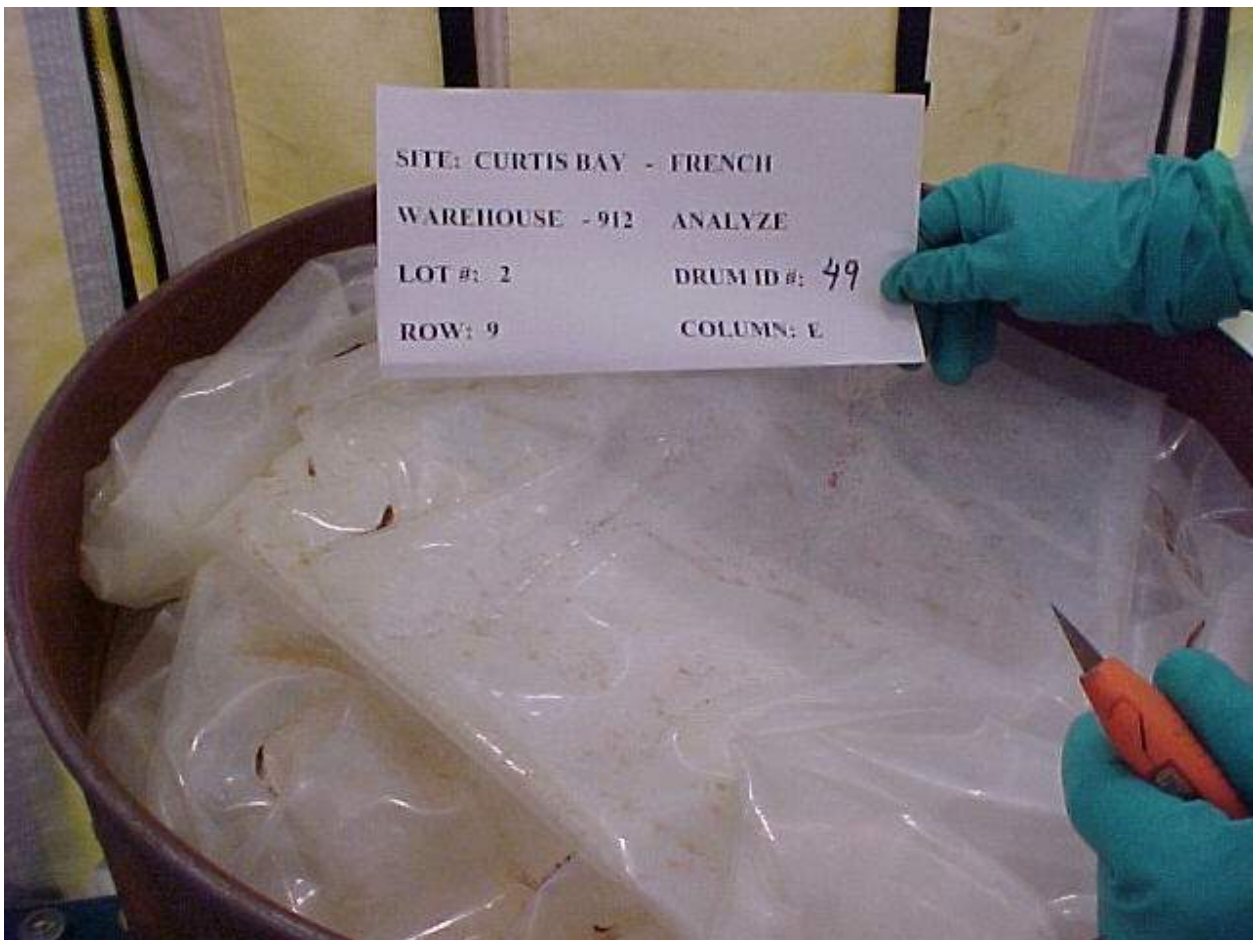
1st poly liner/bag – good condition
No gasses present

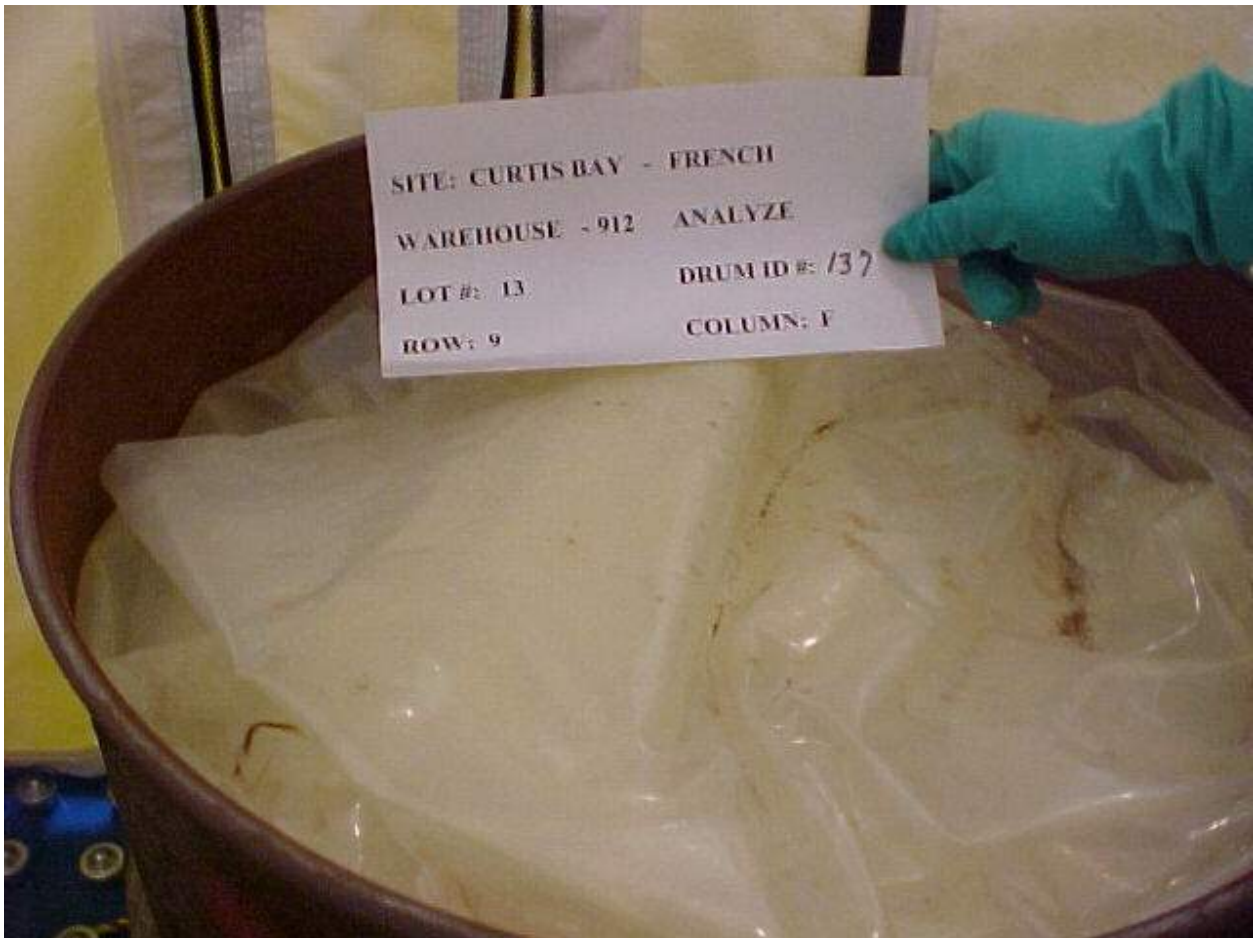
1st poly liner/bag – good condition
No gasses present

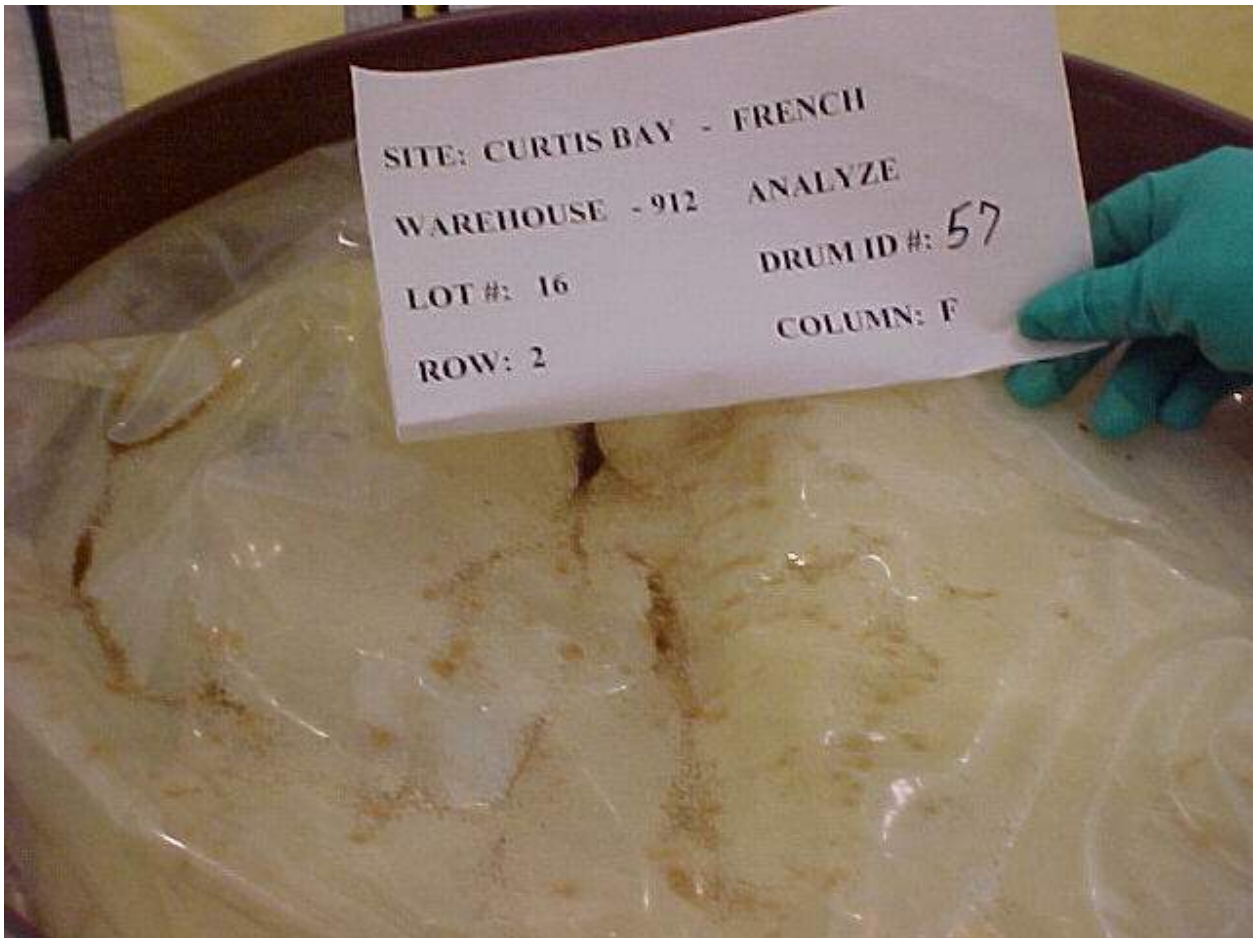
1st poly liner/bag – good condition
No gasses present

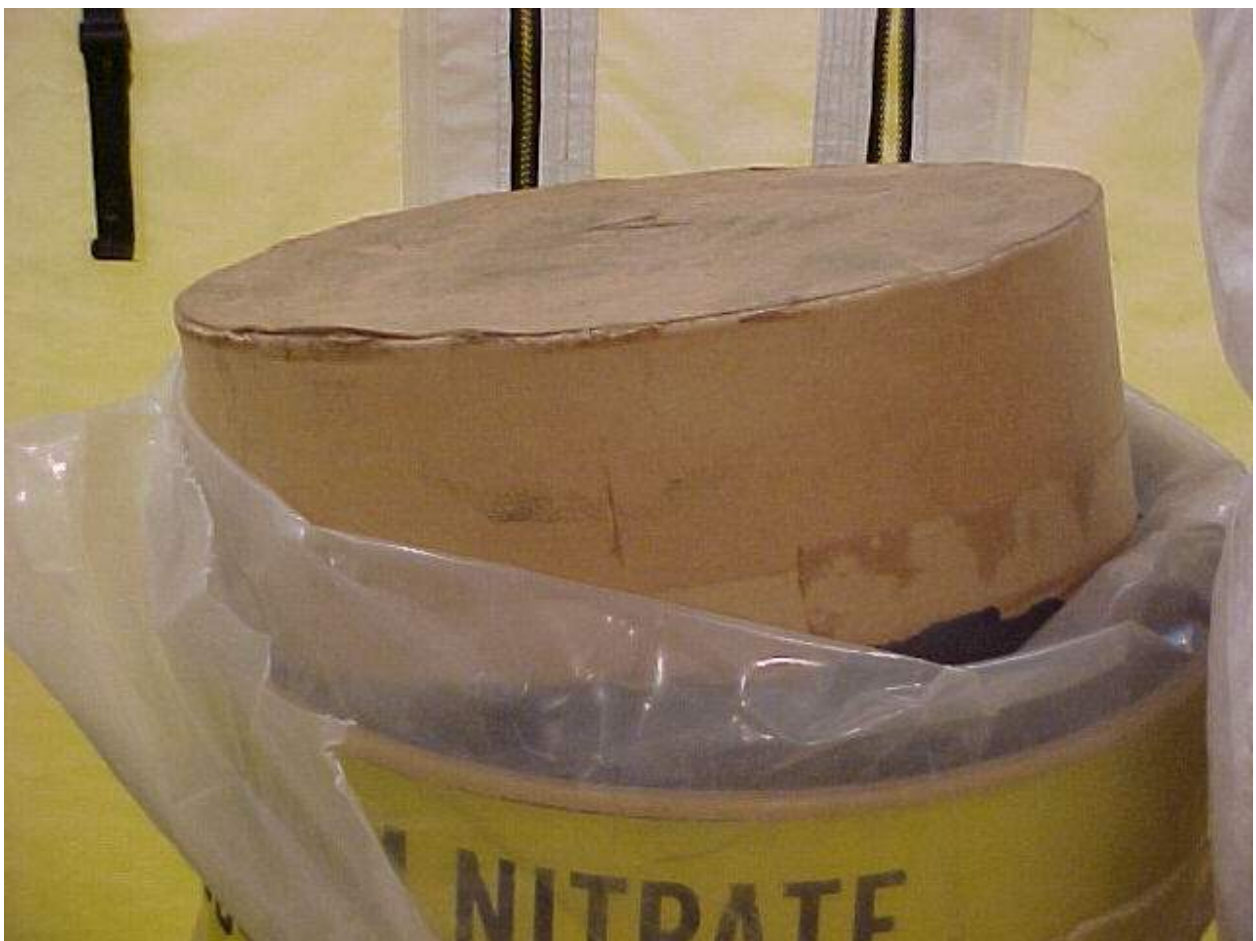
Fiber lid on outermost fiber drum – good condition
Pressure buildup inside container raises poly liner/bag
No gasses present

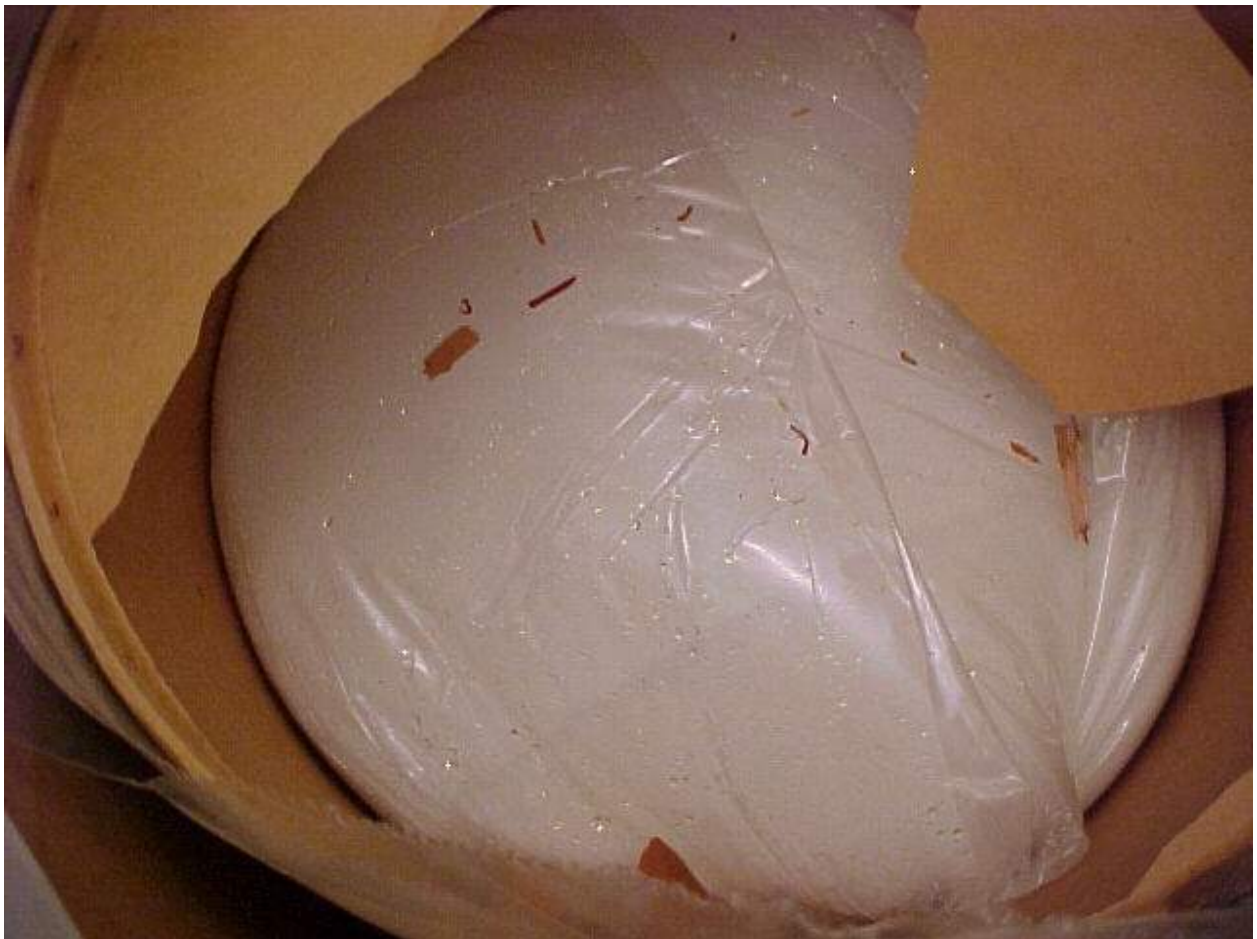
4th poly liner/bag (thin film) - good condition – shows slight pressurization indicating gas generation from ThN monolith block
No gasses present

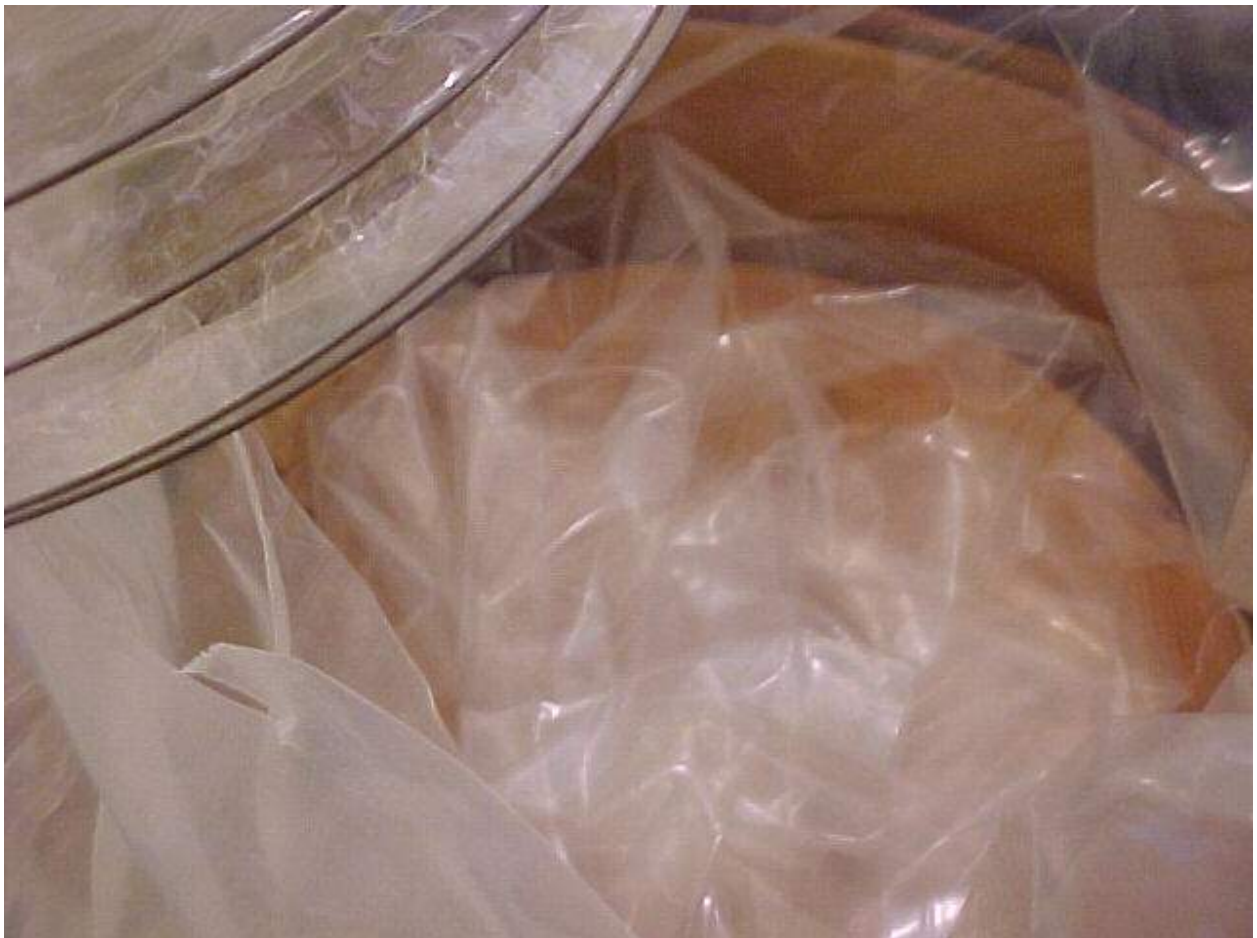
4th poly liner/bag – good condition
No gasses present

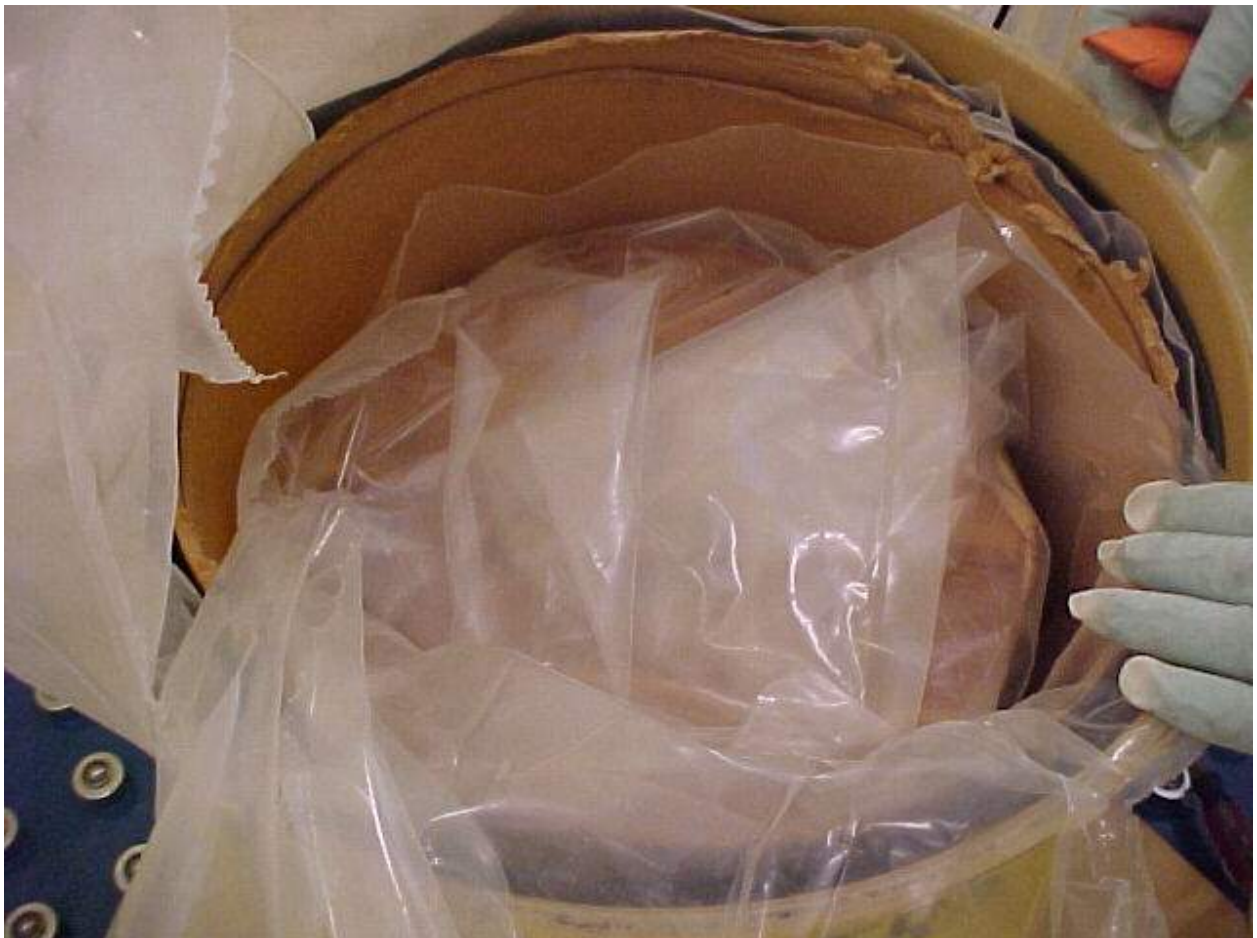
3rd poly liner/bag – good condition
No gasses present

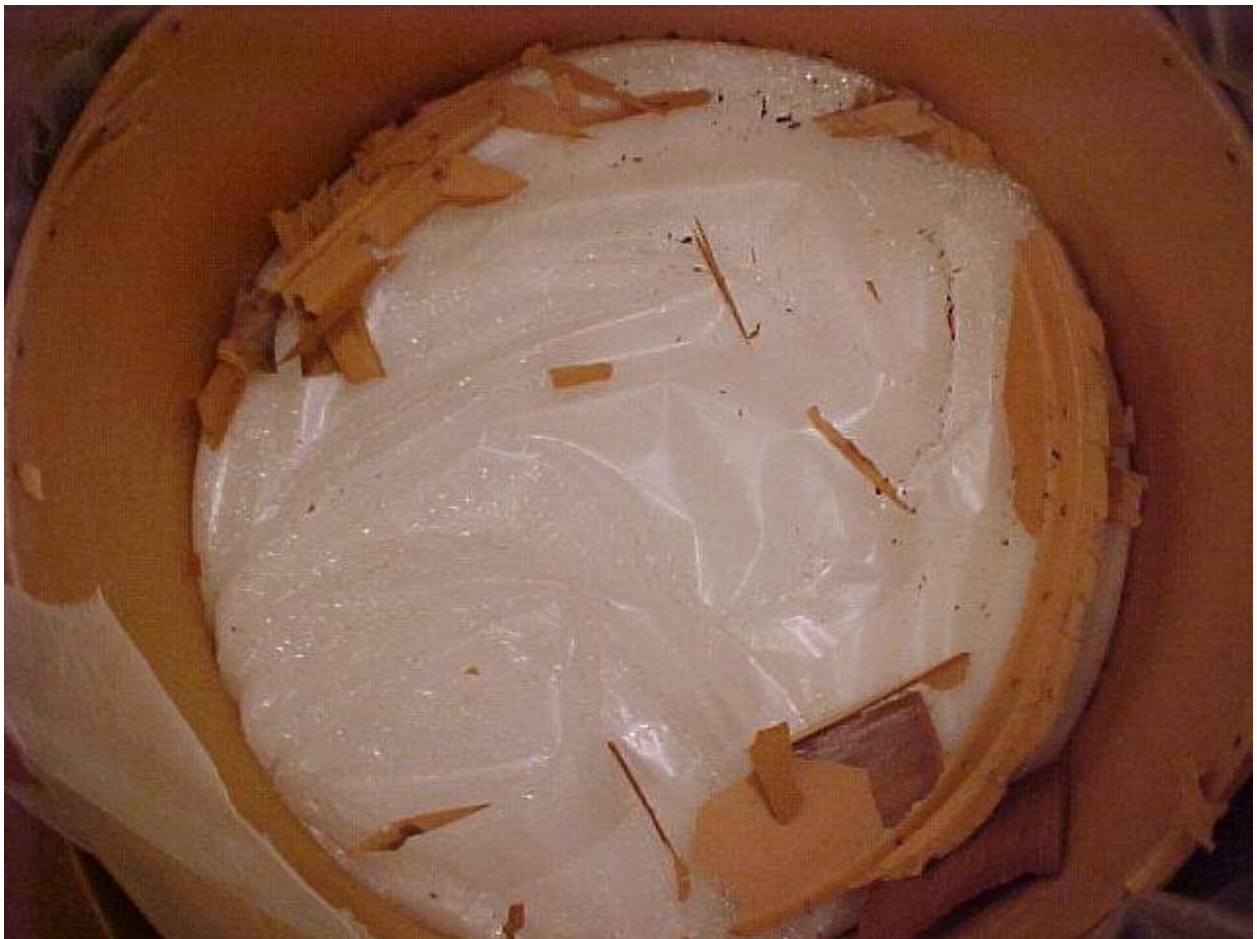
4th poly (thin film) liner/bag – good condition
No gasses present

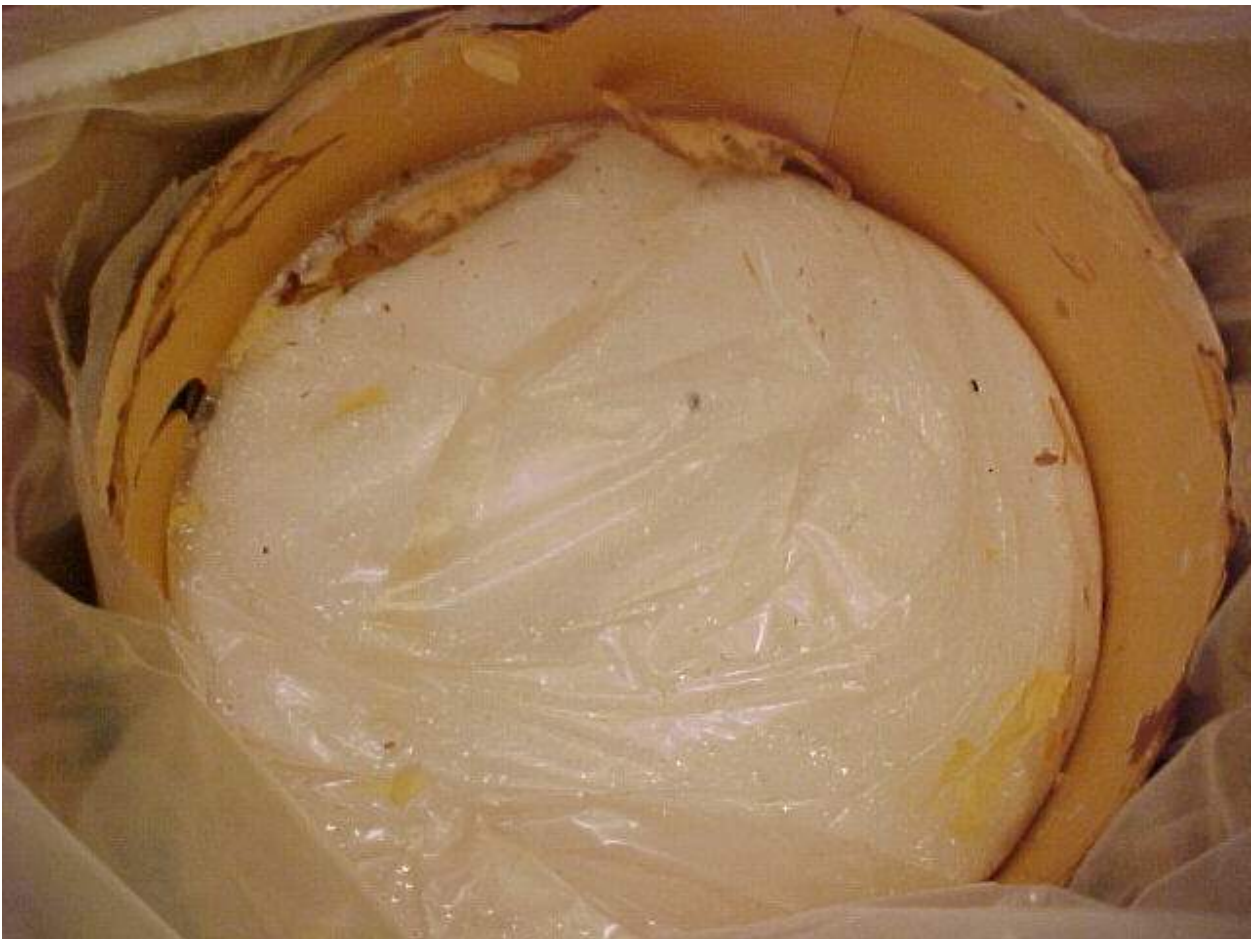
4th poly liner/bag ("thin film" plastic) – good condition
No gasses present (in breathing zone)

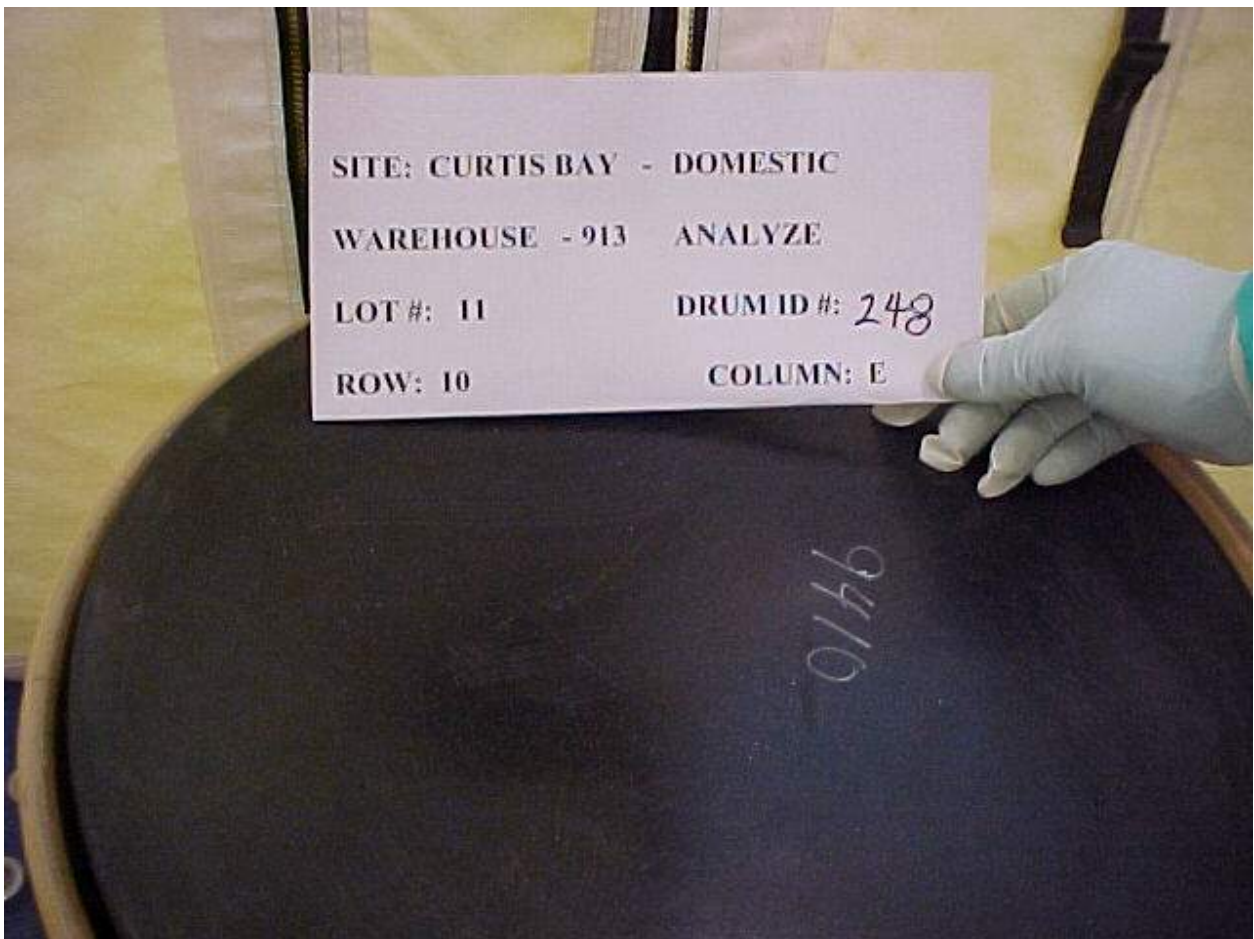
Black plastic lid on drum liner – good condition
No gasses present (in breathing zone)
