**Correlation of Process Data and Electrochemical Noise to Assess Kraft Digester
Corrosion: Second Year at Spring Grove**

S. J. Pawel*
D. W. Townley†
D. E. Roy‡
D. F. Wilson*

Date Published: April 2004

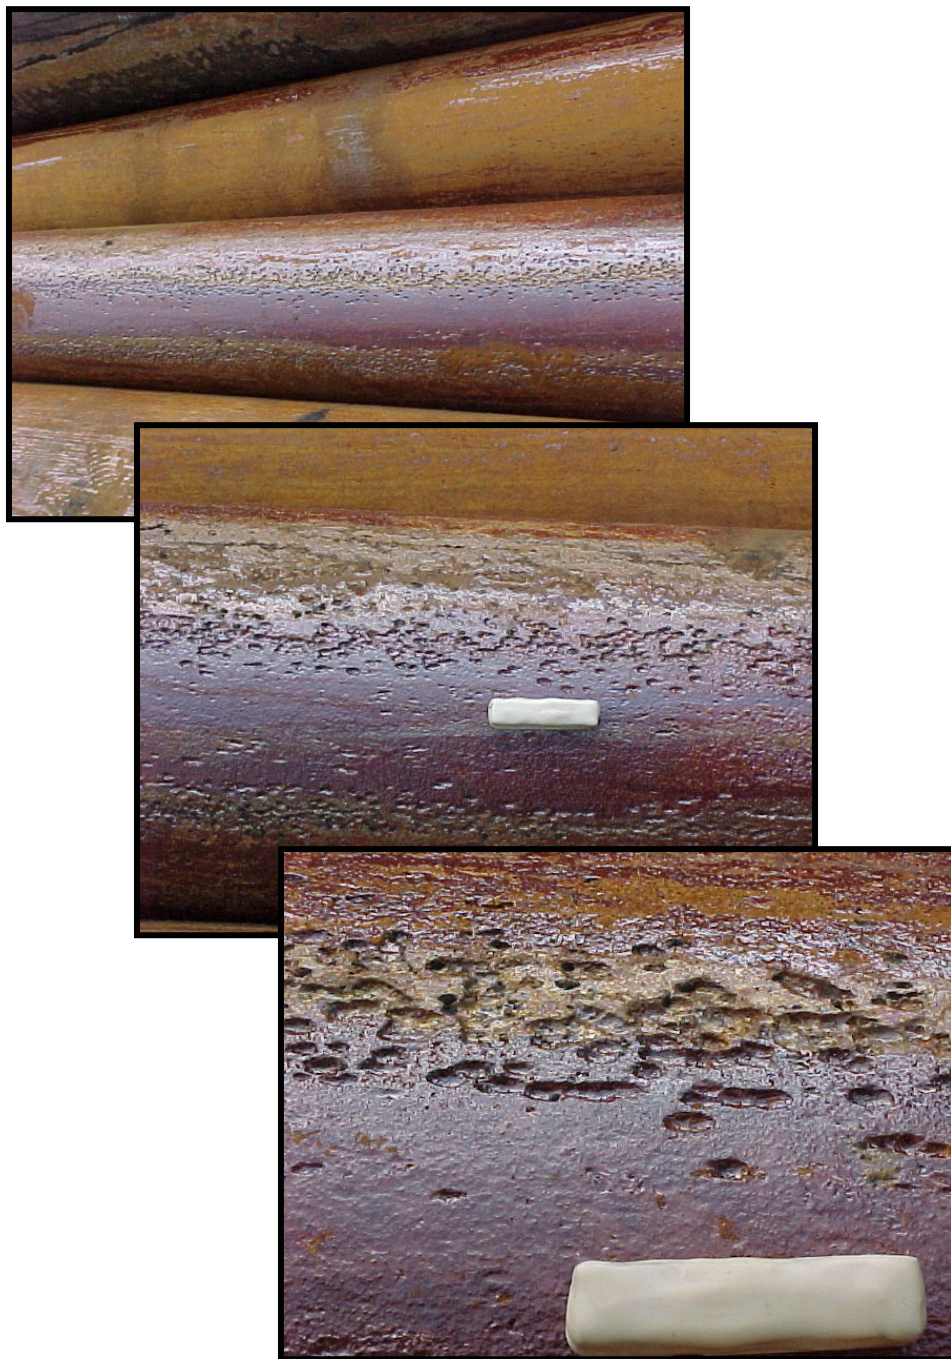
Figure 3 shows a series of photographs of the center pipe after removal from the digester. These photographs highlight the localized corrosion that has been observed on the center pipe in the last few inspections. In particular, note that the pits on the small diameter sections of the center pipe surface appear to be oriented as least generally in longitudinal rows separated by remarkably smooth and unattacked regions. As estimated with a pit-depth gage, the majority of the pits shown in Fig. 3 – and on other areas of the center pipe following its removal – are nominally 40 mils deep (compared to estimates of 20-25 mils deep as a generality for this manifestation of pitting in the previous annual inspection). However, small clusters of pits in the range 60-75 mils deep were noted on the large diameter sections of the center pipe in previous inspections, so it is not obvious if the pitting at any specific location has become significantly deeper over the last few years. It does appear, however, that the extent of pitted areas has spread somewhat.

Fig. 3. Three views of a small diameter section of center pipe removed from the digester in June 2003. Note the parallel rows of pits separated by relatively smooth areas. Pits here are generally 40 mils deep and slightly elongated in the longitudinal direction rather than being hemispherical. The white scale marker is 3.5 cm long.

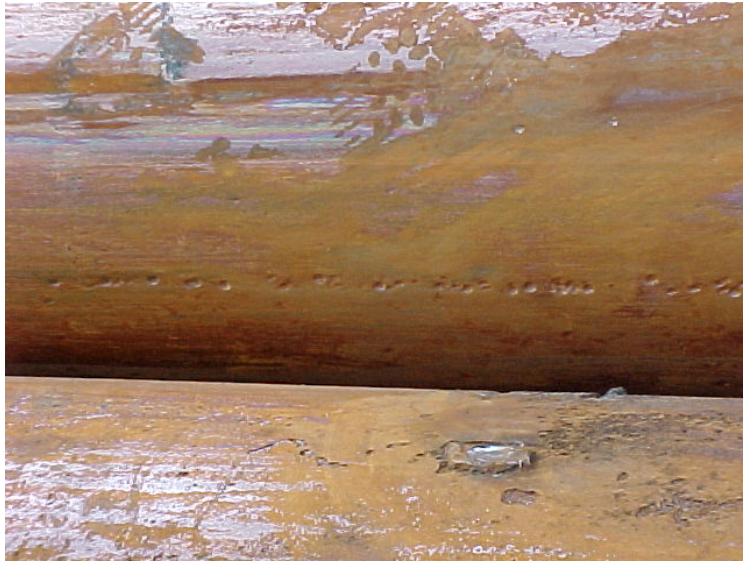
Fig. 4. Large diameter section of the center pipe with a single row of hemispherical pits about 60 mils deep.

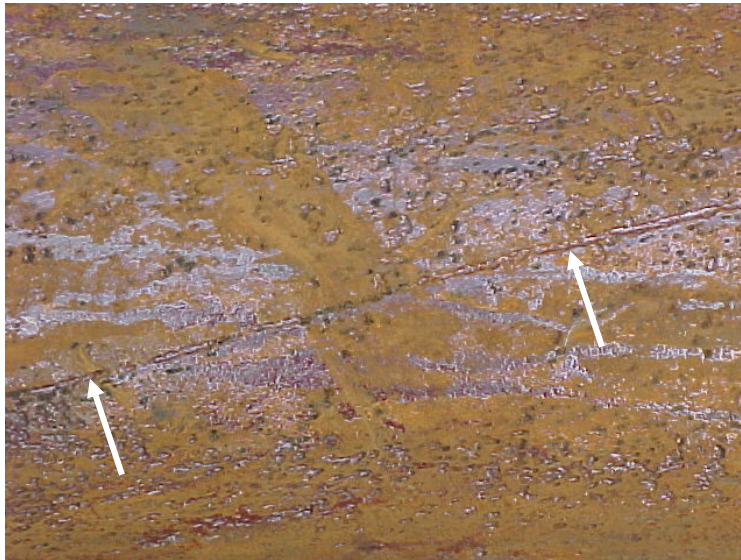
In a few locations on the large diameter sections of the center pipe, gouges like the one in Fig. 5 were observed. Typically, the gouges were aligned approximately 45° to longitudinal, and, like the example in Fig. 5, were about 60 mils deep and 0.125 in. wide. Similarly oriented gouges were documented in past inspections, but there is no practical method to determine whether this particular gouge was previously examined.

Fig. 5. A gouge on a large diameter section of center pipe. The gouge shown here is oriented about 45° to longitudinal and is about 60 mils deep and 0.125 in. wide.

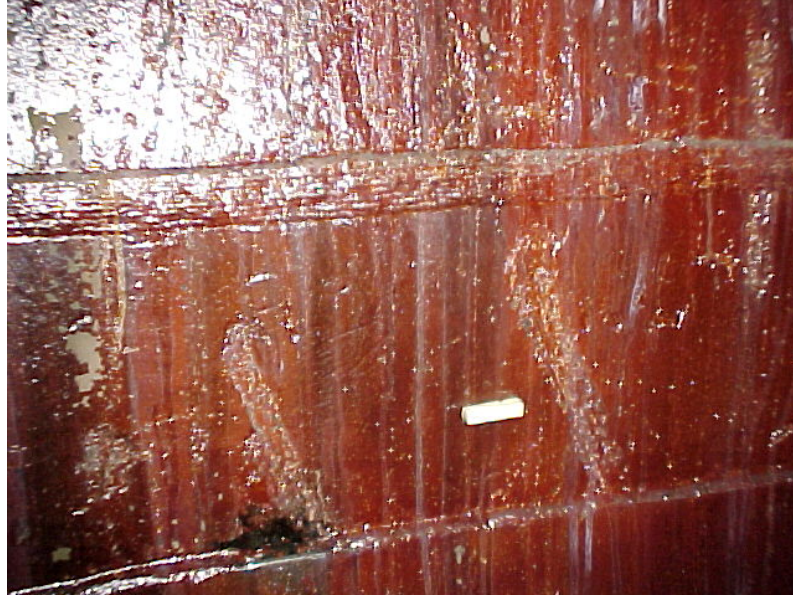
Another result of the June 2003 inspection is evidence that localized corrosion has spread over the prior year to higher regions in the vessel than previously observed. For example, in previous inspections, the vessel ID was largely smooth and unattacked above the cooking screens, with only minor exceptions noted on the transition piece from the shell to the top dome. These exceptions were shaped like “L” brackets, and appeared to be locations where grinding was once used to remove an attachment. However, in the June 2003 inspection, isolated pitting in the range of 60-75 mils deep was observed just above the cooking screens at the round seam designated H18 (transition piece immediately above the cooking screens) as shown in Fig. 6. The round seam at this location (the horizontal weld toward the top of Fig. 6) appeared to be in excellent condition, with a uniform crown above the shell surface and little or no indication of general wastage or pitting. It is possible that previous inspections of this area were hindered by residual black liquor, or failure to inspect/view the topmost position in the vessel with the “sky-climber” inspection platform, but the consensus of Glatfelter personnel is that localized corrosion of this type was not previously detected at this location.

Fig. 6. Transition piece (ring 17) and the round seam weld H18 at the June 2003 inspection. Localized corrosion at this location was not previously documented. Pits near the white scale marker (3.5 cm long) are generally 60-75 mils deep.

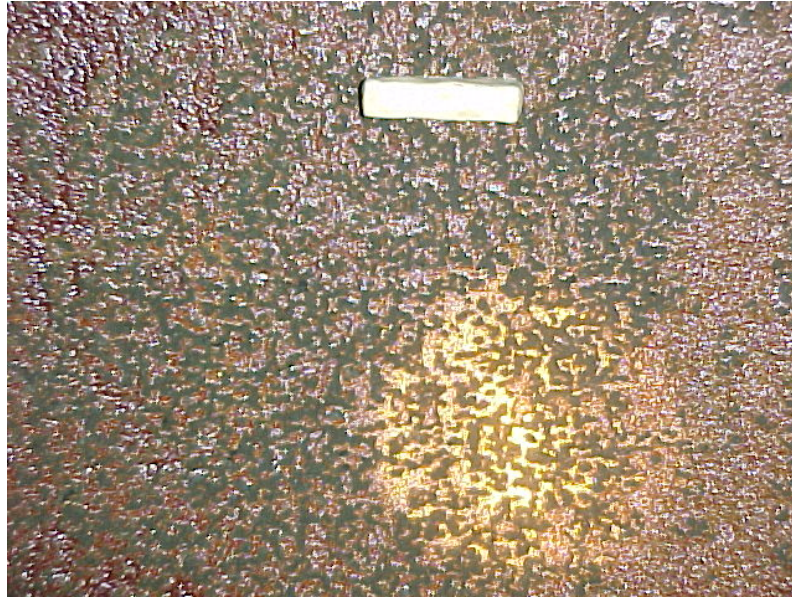
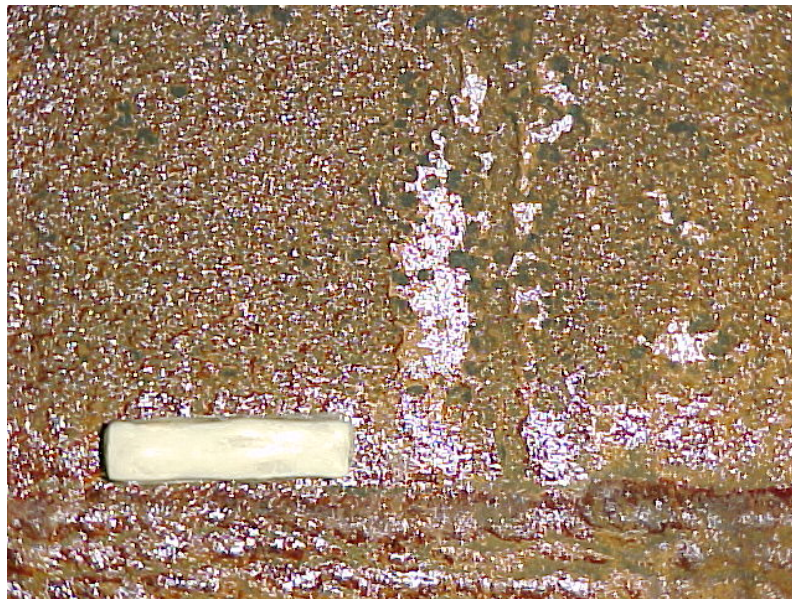
Most of ring section 13 (just above the ring 12 probe) exhibited relatively shallow “oceans-and-islands” pitting patterns on a fine/close spacing. The nominal shell thickness change from the top of the “island” to the bottom of the “ocean” was very abrupt and mostly at the higher end of a 45-60 mil range. While difficult to evaluate precisely, it is suspected that the thickness differential at these locations has increased slightly (from ~ 25 mils) compared to the previous inspection. Figure 7 contains representative photographs.

Fig. 7. Views of the ring 13 surface during the June 2003 inspection. Top: oceans-and-islands pitting on a relatively fine/close spacing. The flashlight beam spot improves contrast between the elevated surface (bright, "island") and the recessed (dark, "ocean") positions. Bottom: close-up view of a relatively large "island" at the bottom of ring section 14. In both photos, the white scale marker is 3.5 cm long.

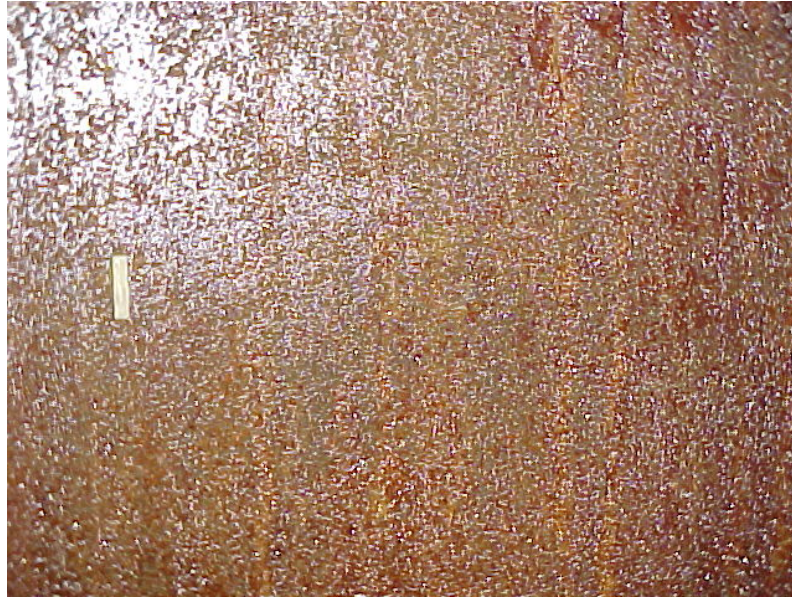
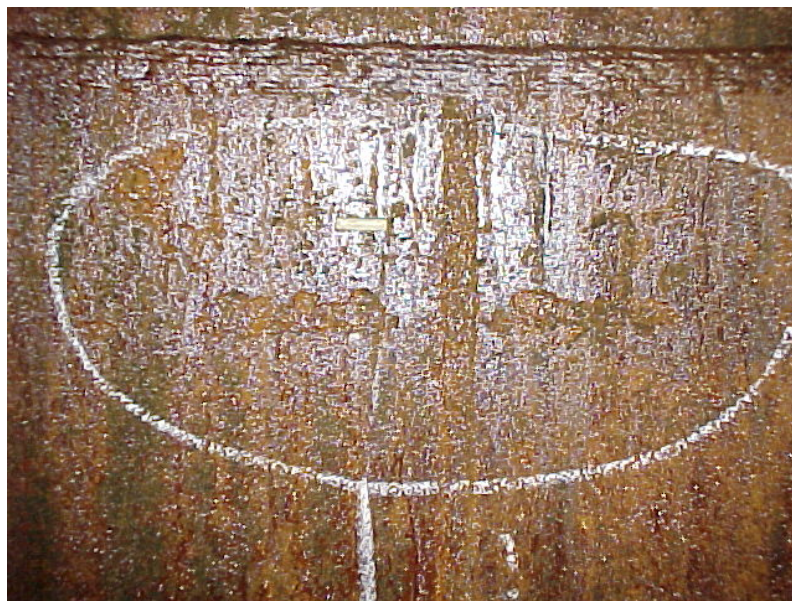
The oceans-and-islands pitting pattern was also observed on ring section 12. At this location (top of Fig. 8), the majority of the elevated surface is relatively smooth and the pits are relatively shallow (25 mils, similar to the previous year) and isolated. In one location that was not documented in previous inspections (shown at the bottom of Fig. 8), the pitted areas seem to have agglomerated in a pattern reminiscent of a former attachment weld location. Less specific patterns of agglomerated pits oriented mostly in a vertical “swath” were observed over several large areas of ring section 12. The area around the ring 12 probe was essentially unchanged from the previous year, and the probe itself was in good condition with no obvious signs of attack on the electrodes.

Fig. 8 Views of ring section 12 at the June 2003 inspection. Top: general appearance, showing shallow pits scattered in a mostly unattacked surface. Bottom: some pits appear to have agglomerated in patterns suggesting the location of a former bracket just below the H13 seam weld. White scale marker is 3.5 cm long.

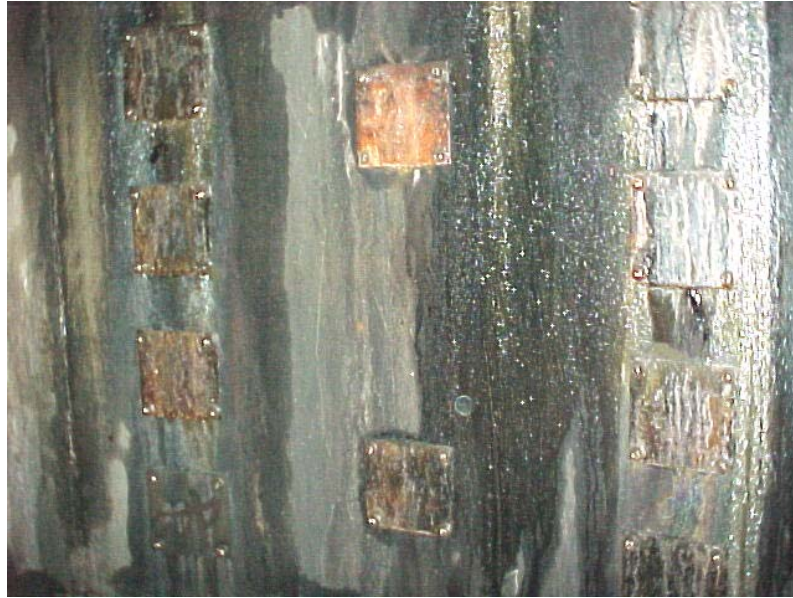
The stainless steel extraction screens and new blank plates in rings 8-10 looked smooth and unattacked. All of the test panels on the two blank plates at this elevation remained firmly attached. Despite the cleaning of the vessel for inspection, there were indications of a “mash” of residual pulp and black liquor behind most of the panels. Figure 9 shows one of the test plates with coupons from the middle row of section 9 (from the side of the vessel opposite the manway).

Fig. 9. Stainless steel blank plate with steel test panels after one year of exposure.

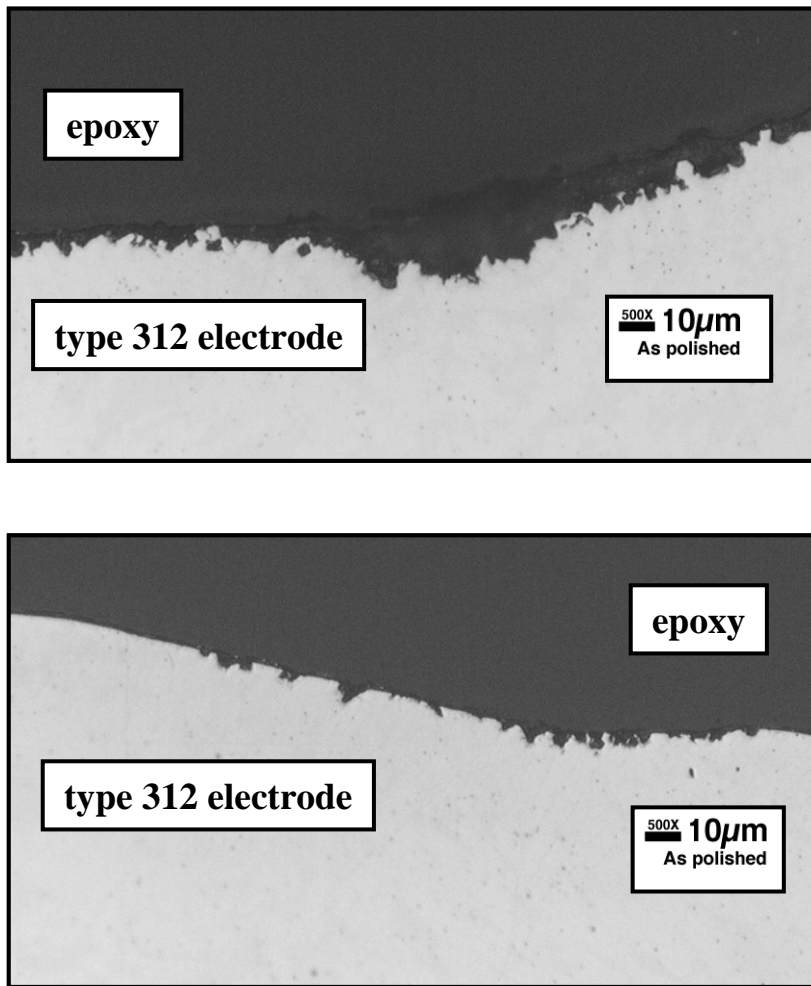
suffered similar shallow attack as shown in Fig. 13, which shows the post-test surface of two of the 312 electrodes. The attack is very shallow – on the order of 5 μm or less – and limited study of etched microstructures suggests that the attack initiates at interdendritic regions in the cast structure, with perhaps some tendency to attack austenite preferentially. The appearance of the unexposed 312 electrodes (Fig. 14) included a very thin (1-2 μm) surface oxide, and perhaps dissolution of the oxide is a part of the apparent surface roughening observed for the 312 electrodes. In any case, the extent of “attack” appears inconsequential for practical concerns.

Fig. 13. Post-test cross-sections of type 312 stainless steel electrodes after exposure for one year. Top: from the ring 12 probe. Bottom: from the ring 3 probe.

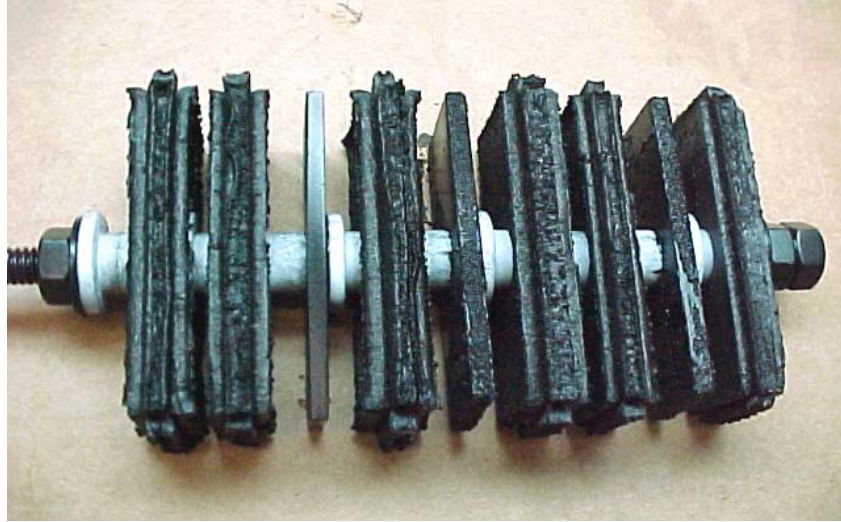
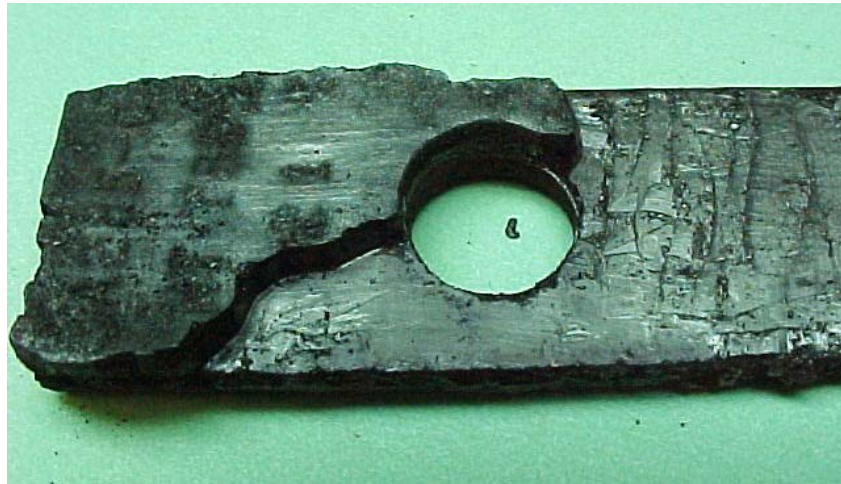
Fig. 40. Appearance of specimens following autoclave testing for 14 days at 165°C in synthetic white liquor solution. Top: specimen rod with all the specimens; the one with no corrosion product is the 304L coupon, and the two Corten A specimens have relatively less corrosion product. Bottom: A285C coupon with the corrosion product partially removed.
