ORNL/TM-2005/34

Field Testing of Energy-Efficient Flood-Damage- Resistant Residential Envelope Systems Summary Report

June 2004

Oak Ridge National Laboratory, Oak Ridge, Tennessee

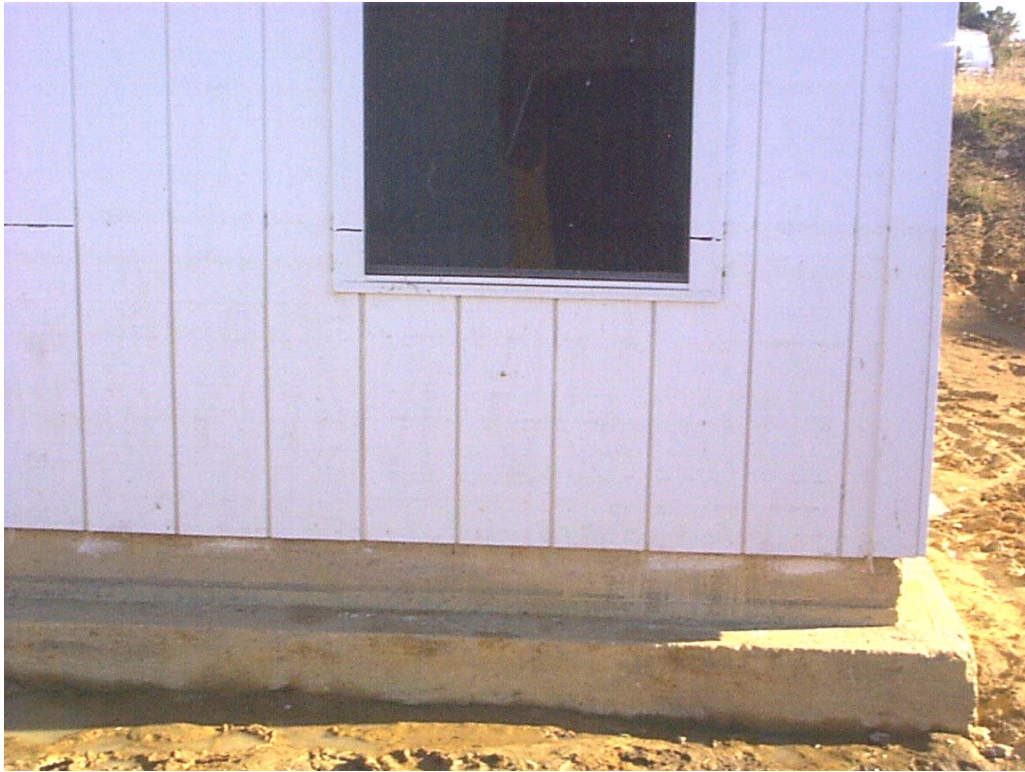
Figure 4-15 Module S-1 (Wall 1, North Exterior Wall) Post-flood, Day 8 (before washing).
Walls are stained below flood level.

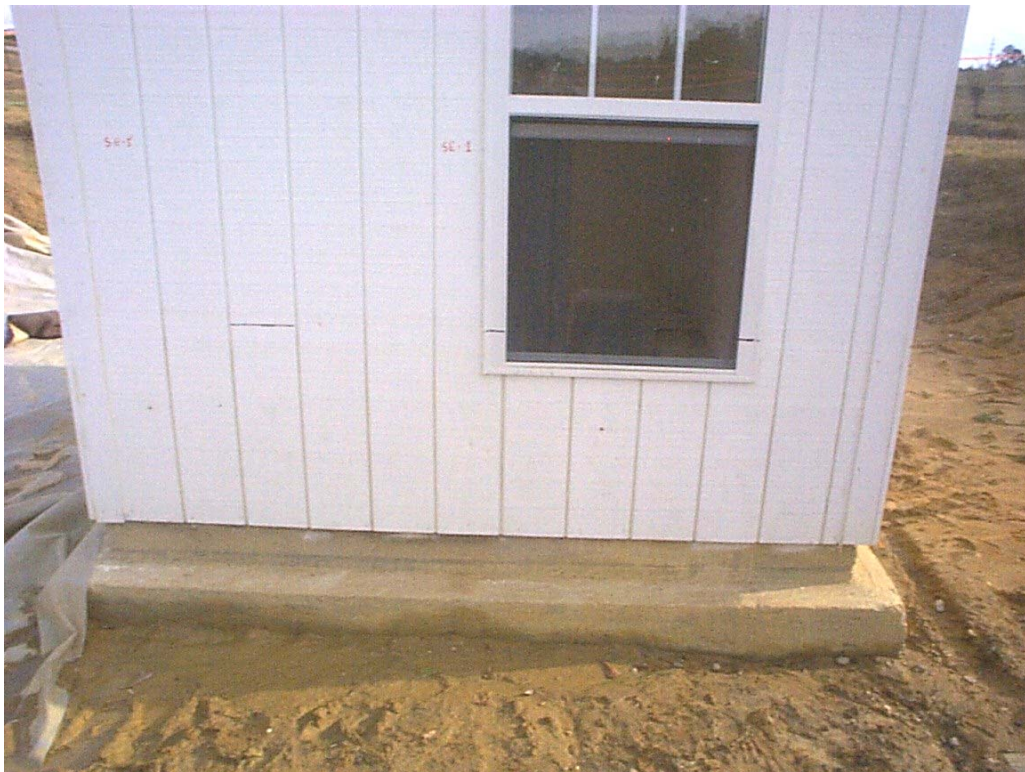
Figure 4-16 Module S-1 (Wall 1, North Exterior Wall) Post-flood, Day 15 (after washing).
Wall remains slightly stained.

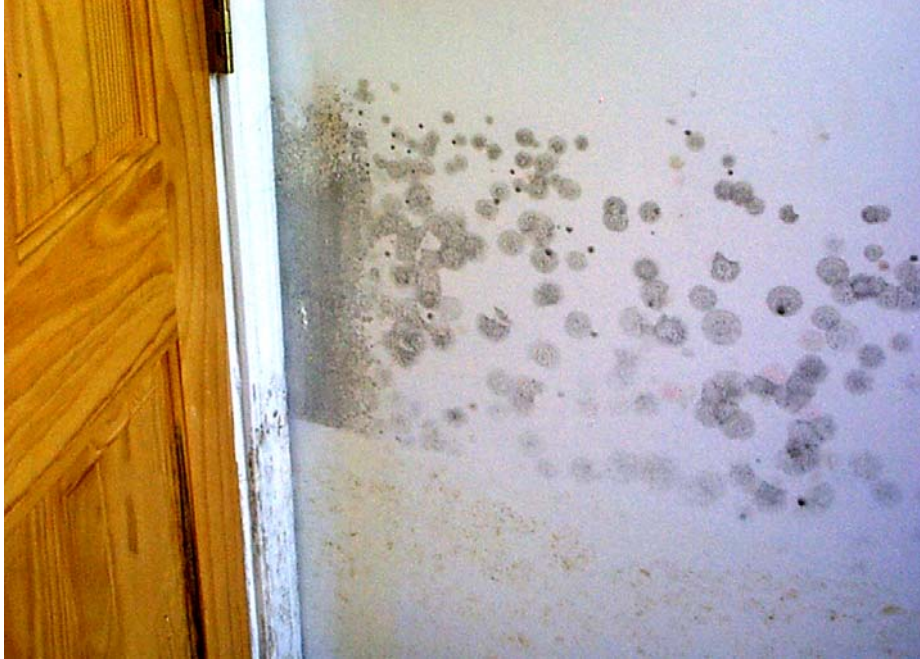
Figure 5-6 Module S-2 (Wall 4) Day 10 - After washing with water. Mold growth and staining on walls

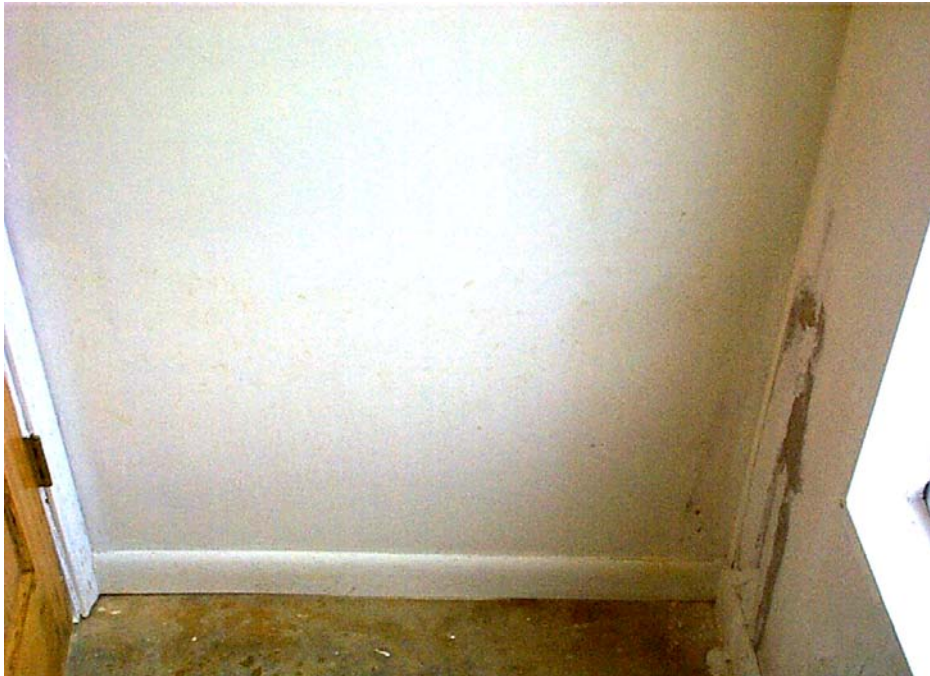
Figure 5-7 Module S-2 (Wall 4) Day 15 - After sanitizing. Mold discoloration gone, some staining remains

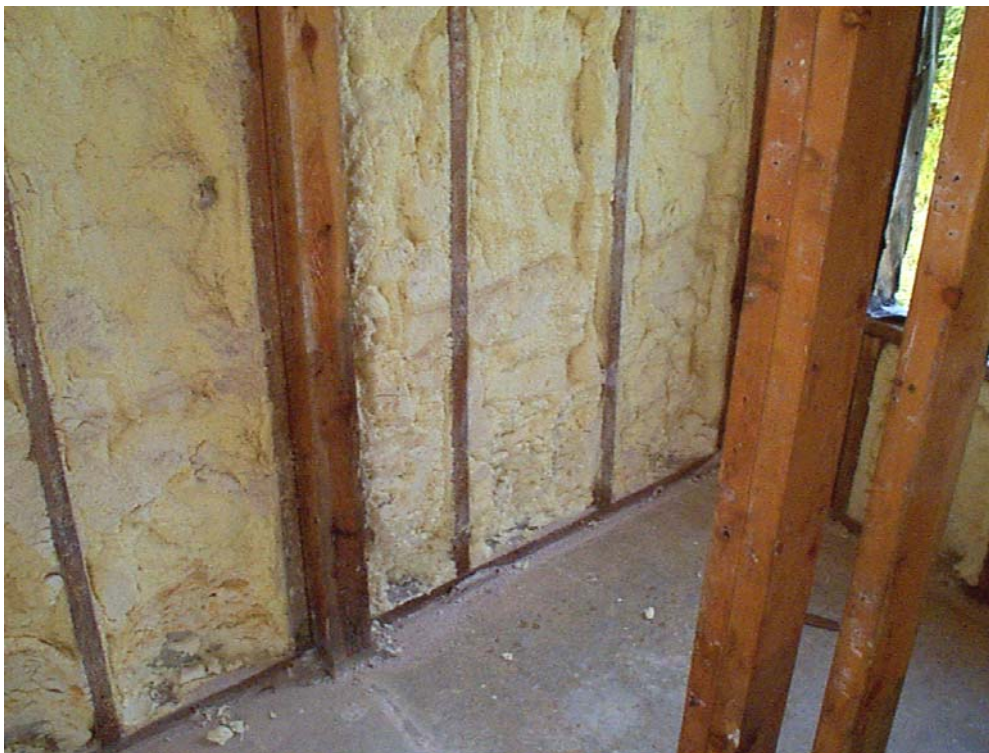
Figure 6-17 Inside of Module S-2 (Wall 4) at autopsy. Insulation and wall cavities are dry and in good condition

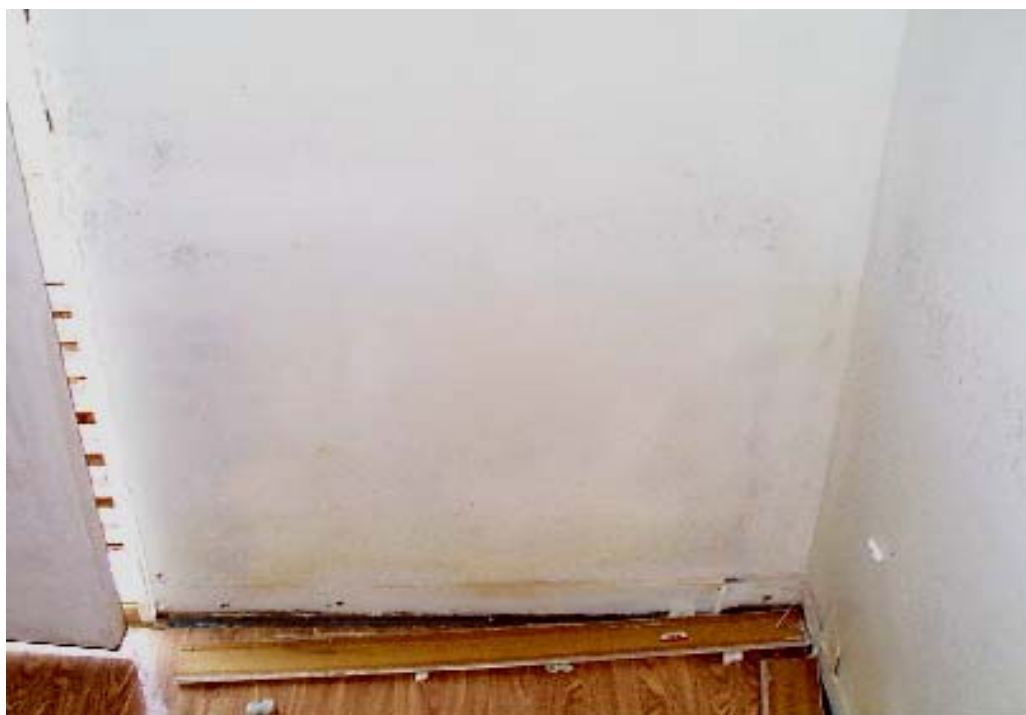
Figure 6-8 Module S-3 (Wall 3) Day 8 – Before washing. Wall is stained and there is mold growth.

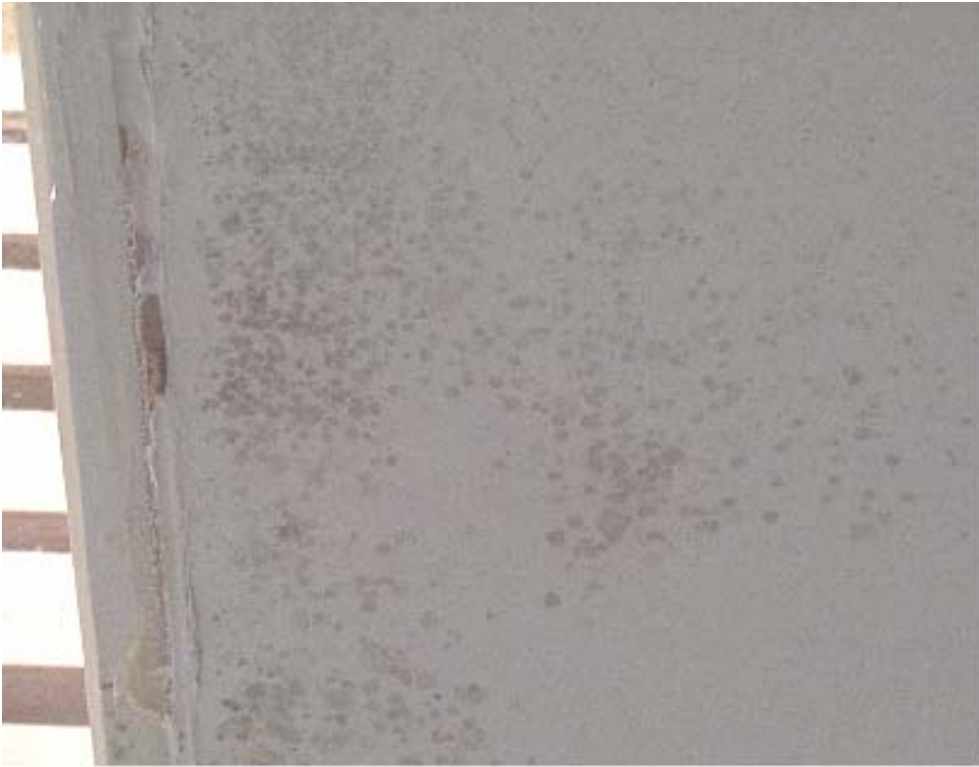
Figure 6-9 Module S-3 (Wall 3) Day 10 - After washing with water. Mold remains

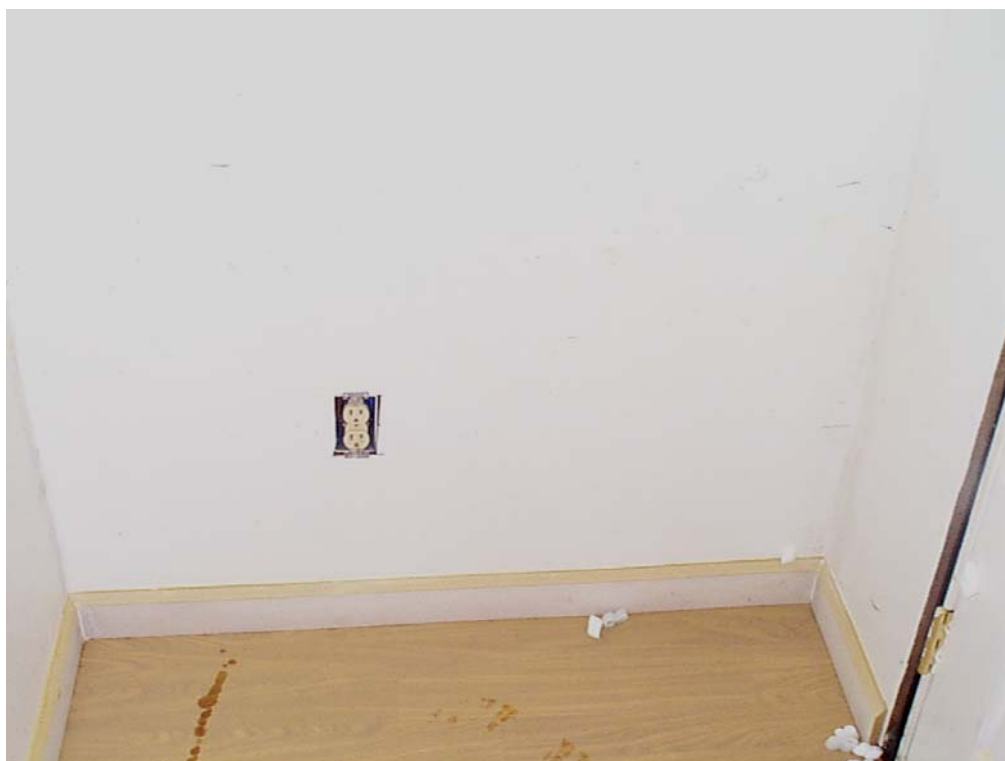
Figure 6-12 Module C-3 (Wall 2) Day 8 – Before washing. *Note: "Pellets" on the floor at right bottom are Styrofoam which was placed on the floor of the unit prior to flooding. As floodwater rose, the pellets floated, and cameras could record locations where water appeared to flow into the unit.*

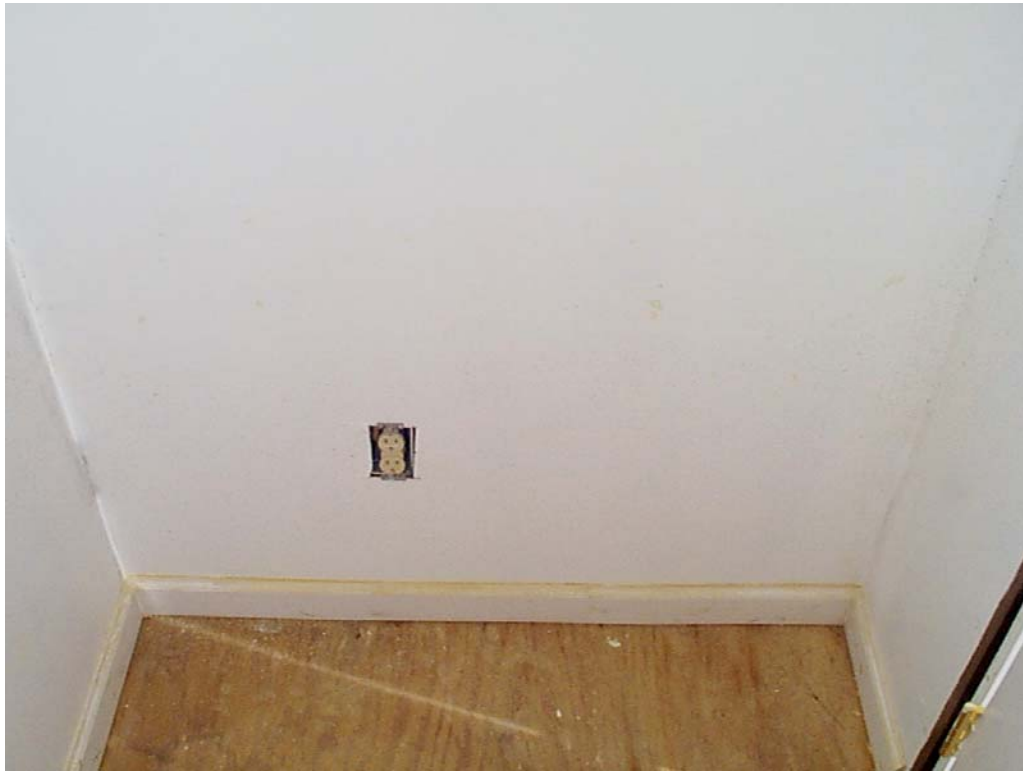
Figure 6-13 Module C-3 (Wall 2) Day 10 - After washing with water. No visible mold stains.

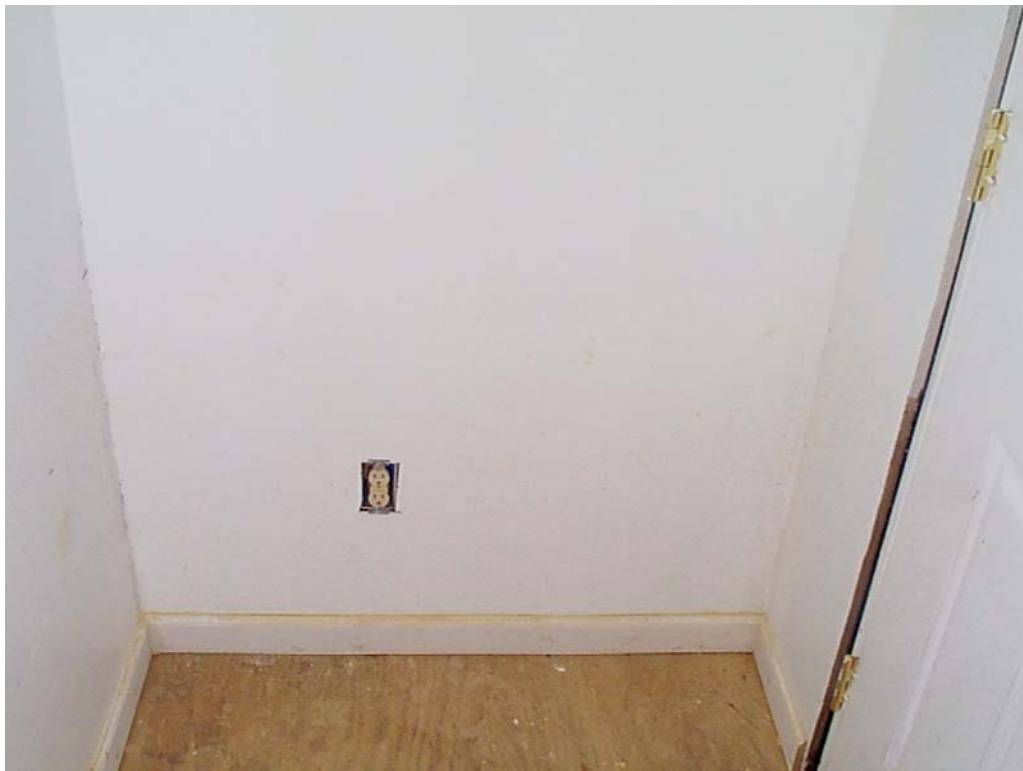
Figure 6-14 Module C-3 (Wall 2) Day 15. No sanitization occurred and no mold growth appeared; wall is restorable.

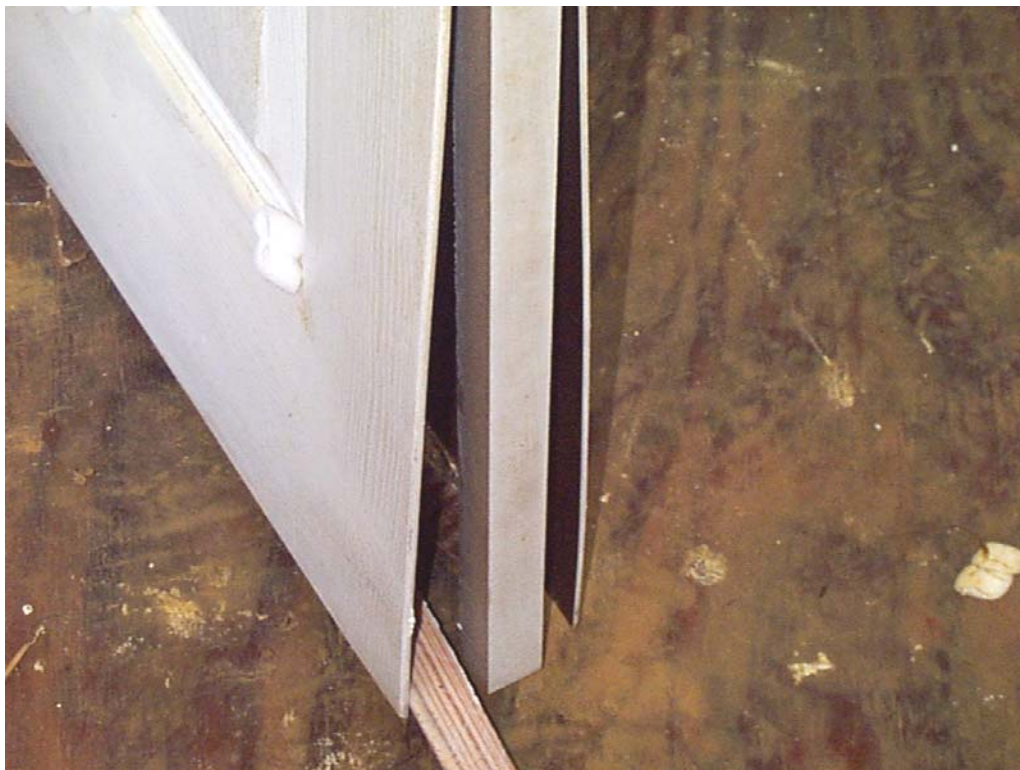
Figure 6-16 Module C-3 Interior door – Day 8. Door surface is delaminating.
