**SUPPORT SERVICES FOR CERAMIC FIBER- CERAMIC MATRIX COMPOSITES**

Final Annual Technical Progress Report

September 28, 2001

Report Prepared by  
John P. Hurley and Charlene R. Crocker  
Energy & Environmental Research Center  
University of North Dakota  
PO Box 9018  
Grand Forks, North Dakota 58202-9018  
under  
Subcontract No. 19X-SS 112V

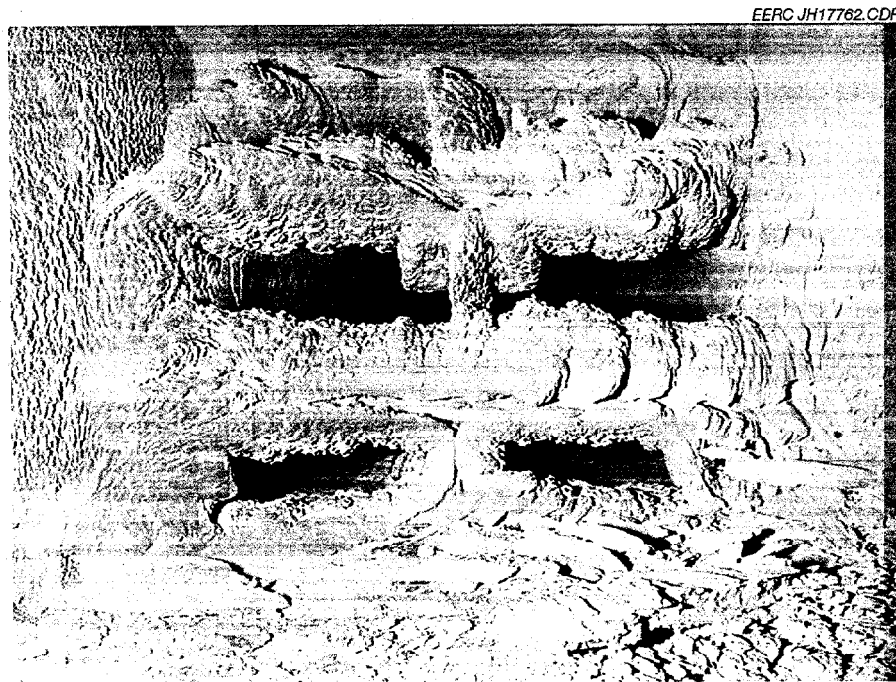
During the run, the samples were observed via site ports located throughout the SFS convective pass. The samples, which initially swung in the force of the flue gas, became cemented in place by the ash deposits by Day 4 of the 9-day test. Figure 5 shows the extent of ash deposition on the upstream surfaces of samples at the end of the test. In addition, ash filled the open areas in the center of each ceramic ring. Downstream deposition on the samples, shown in Figure 6, was lighter.

Figure 5. Upstream view of samples with ash deposition.

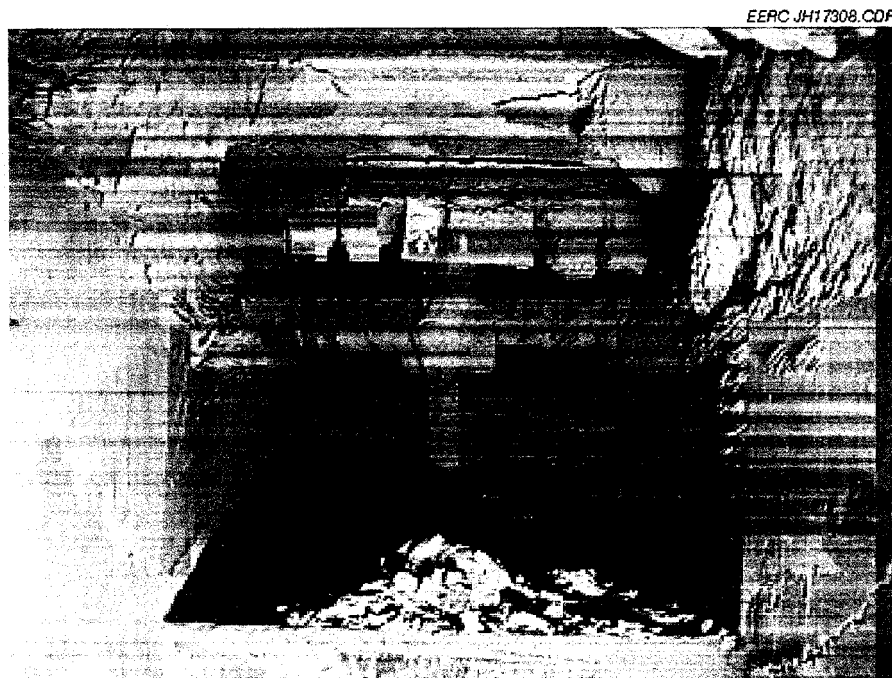
Figure 6. Downstream view of samples with ash deposition.

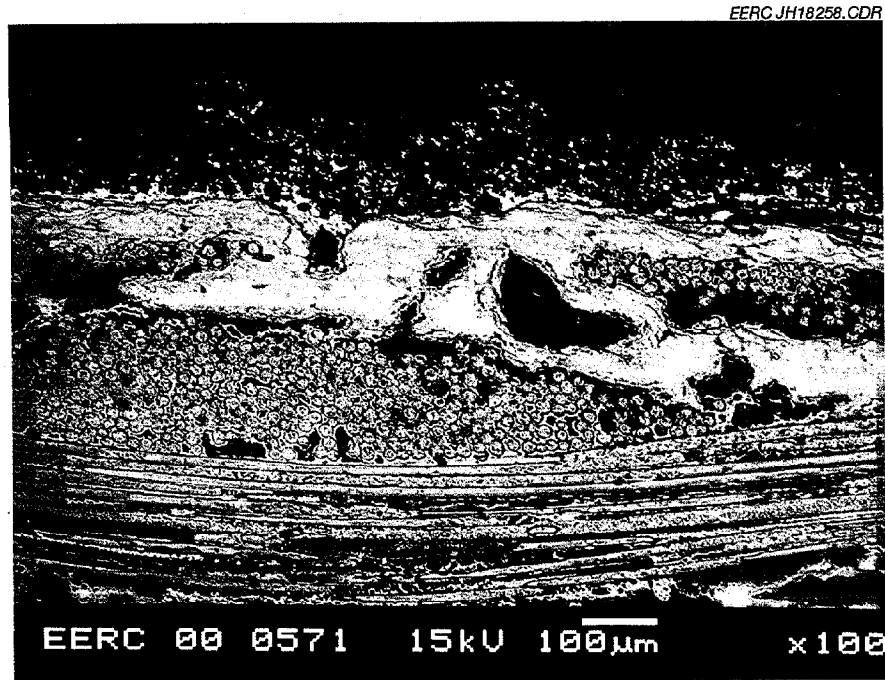
No subsurface corrosion was observed in the cross section. The material-ash interface appears limited to the surface of the ring. The depth of the ash deposit ranged from less than 1  $\mu\text{m}$  to greater than 70  $\mu\text{m}$ . Figure 9 includes a natural divot in the surface (left of center in the photo) that filled with ash. It did not penetrate or otherwise degrade the material. Composition of the deposited ash layer was consistent with that of the convective pass ash deposit described in Table 1. No signs of corrosion or erosion were indicated throughout the sample cross section, although a thin surface layer less than 5  $\mu\text{m}$  thick was rich in calcium and silicon which may indicate very limited attack.

Figure 9. Honeywell SiC-SiC material and ash deposit at 100× magnification.  
Divot in sample surface (HACI #0257-0 1-001 -2-5).

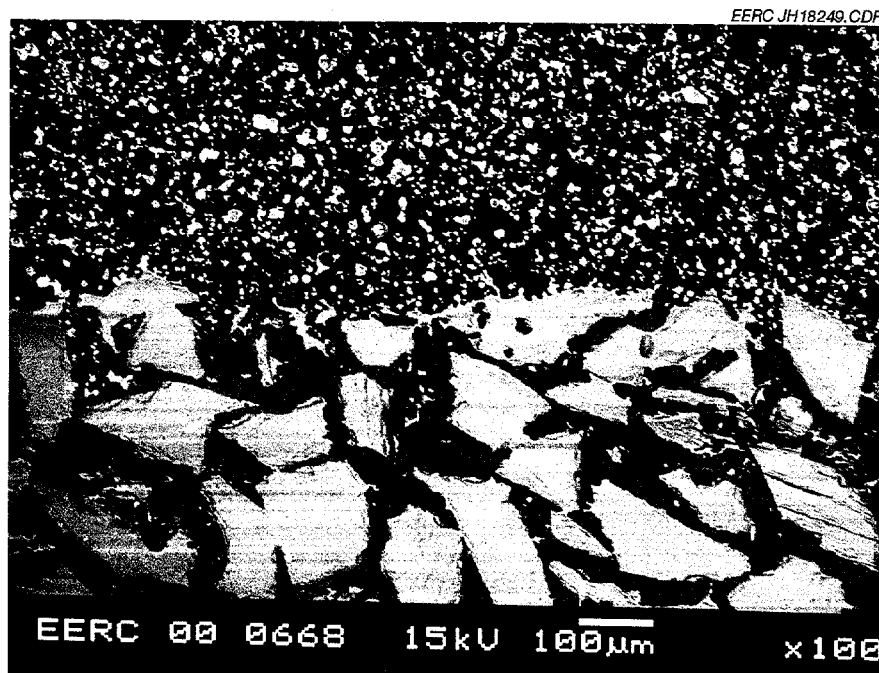
Figure 13. ORNL mullite composite and deposited ash at 100× magnification (ORNL #B).

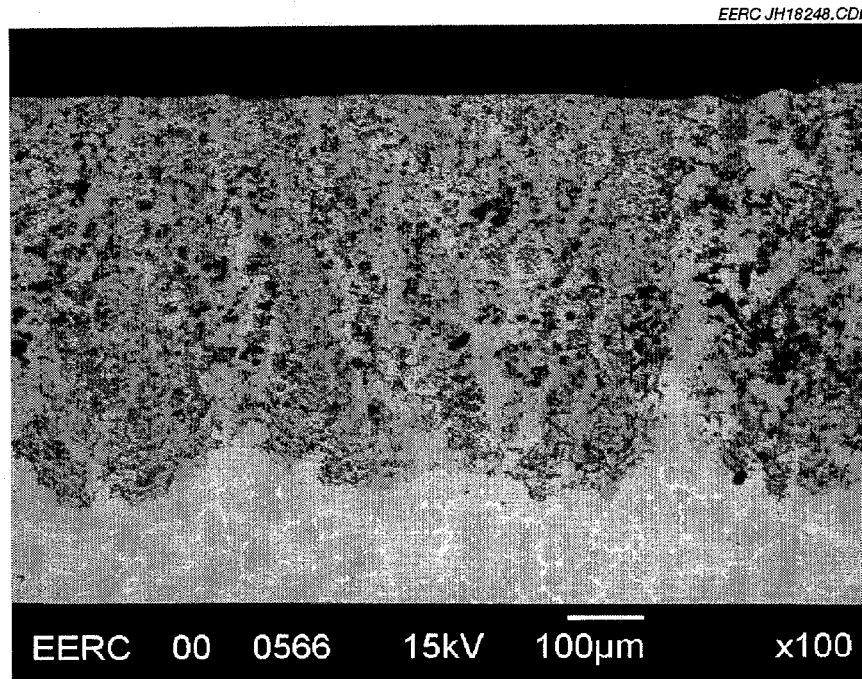
Figure 14. Surface corrosion at 100× magnification (ORNL #17638).

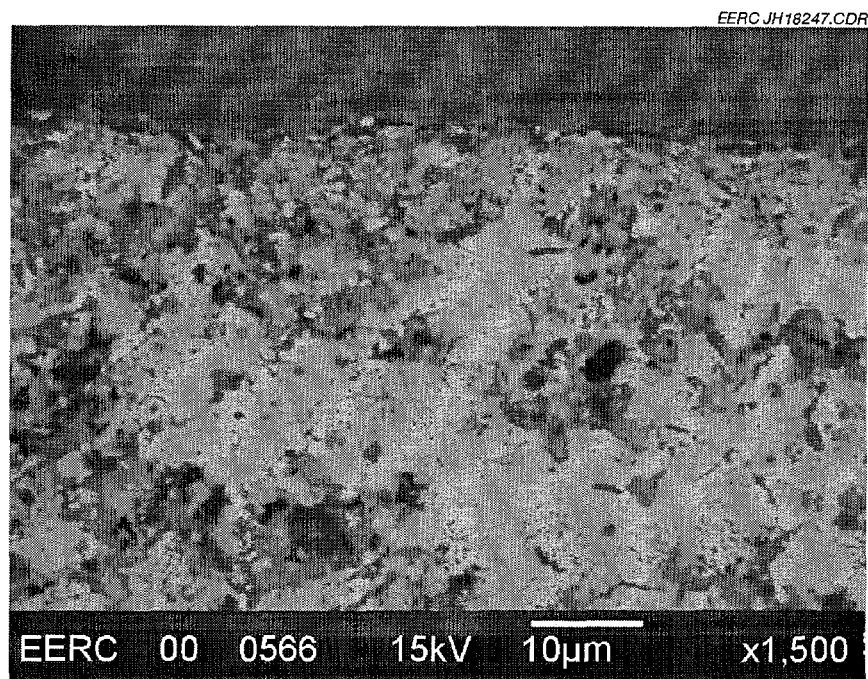
The corrosion product is heterogeneous, with pockets of metals and oxides. The corrosion product near the alloy interface (<120 µm from the alloy) included pockets similar to the alloy matrix described above and areas enriched in Ni. Examples of variations include regions with 37-47 wt% Ni, 20-48 wt% Cr, 4-24 wt% Al, trace Fe (<0.5 wt%), and 9 wt% O; Ni-rich (77-81 wt%) regions containing 5-14 wt% Cr, 7 wt% Al, 1-2 wt% Fe, and 1-3 wt% O; and nearly pure Ni-rich (90-97 wt%) regions associated with 1-5 wt% O, 1-3 wt% Cr, and trace (<1 wt%) Al, Fe, and Mo. Many of these combinations are found throughout the corrosion product. In contrast to the virgin alloy, Mo concentrations in the corrosion product are at most 3 wt%.

Figure 15. Surface corrosion at 1500× magnification (ORNL #17638).

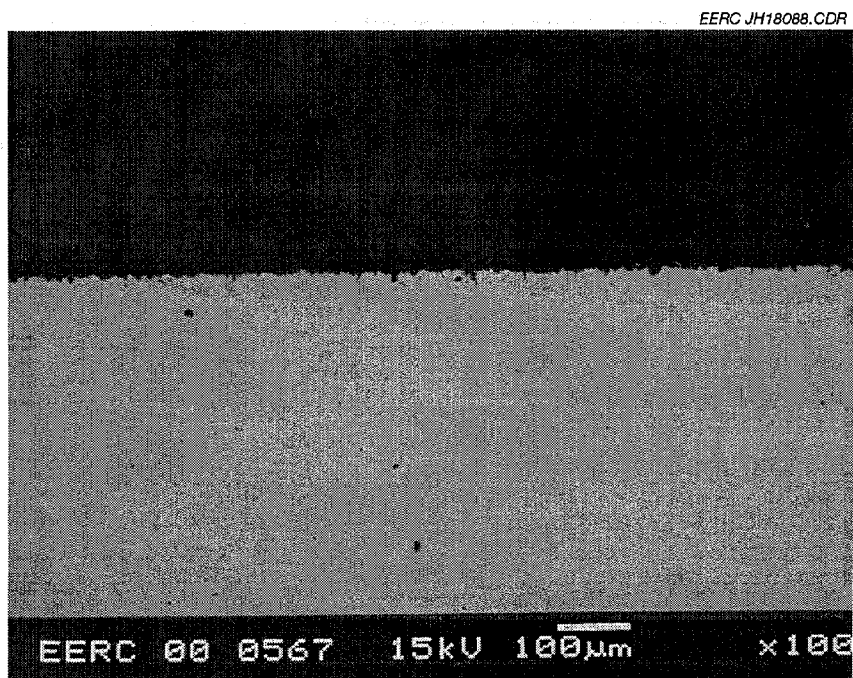
Limited smooth oxidation was also visible on the sample cross section. Depth of penetration was <10  $\mu\text{m}$ . Content of the corrosion product varied from oxidation of Al and Fe (73 wt% Al, 24 wt% O, and 2 wt% Fe) to Al and Fe with ash constituents (54 wt% Al; 7-8 wt% Fe; 11-23 wt% O; 0-13 wt% P; 0-3 wt% Ca, Cl, Mg and Si; and 1 wt% Na).

Figure 16. Cross-sectioned virgin material, corrosion product, and ash deposit at 100× magnification (ORNL #17638).

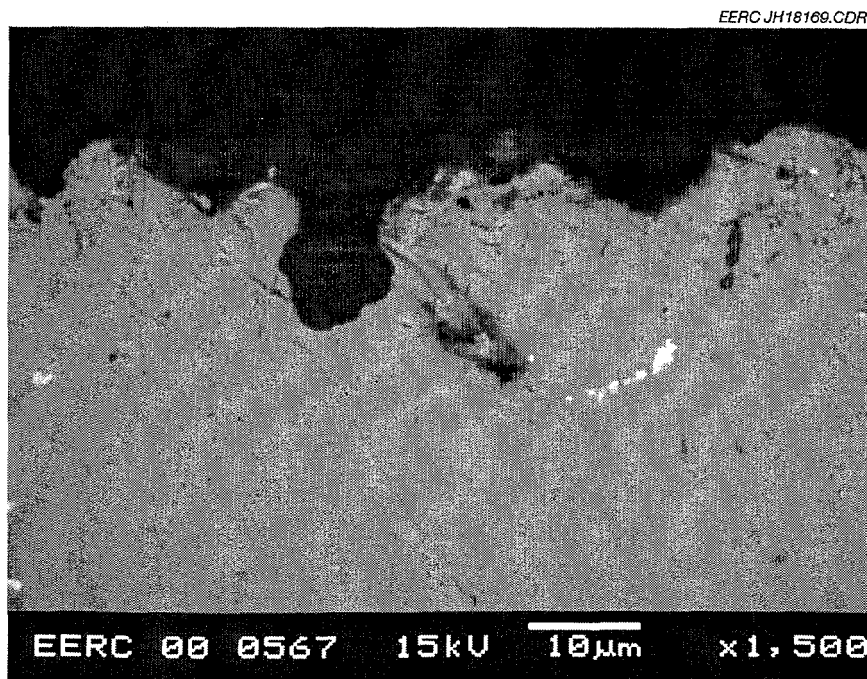
Figure 17. Pit in sample surface at 1500× magnification (ORNL #17638).

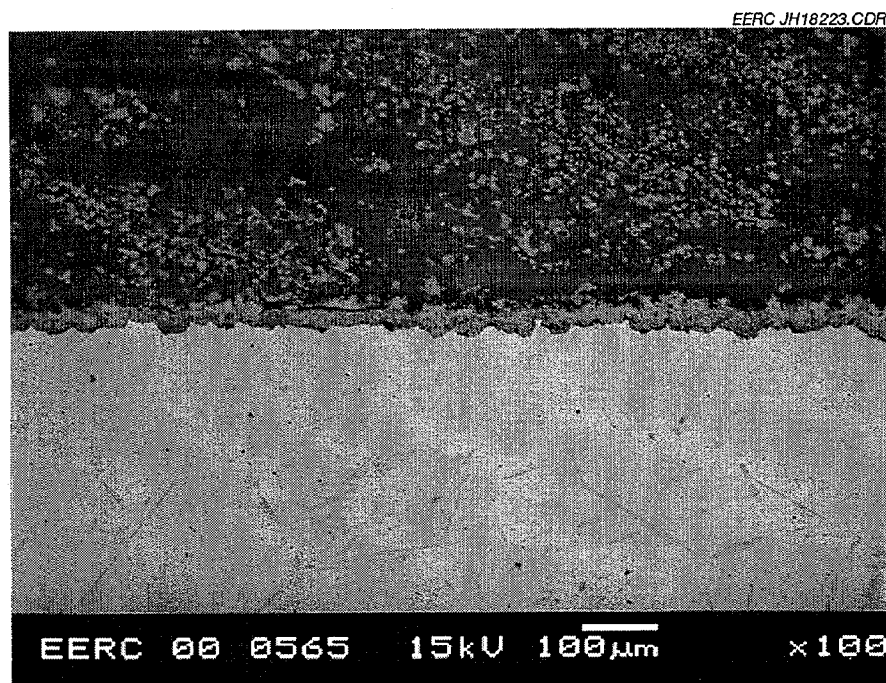
Figure 18. Cross-sectioned virgin material, corrosion product, and ash deposit at 100× magnification (ORNL #17681).

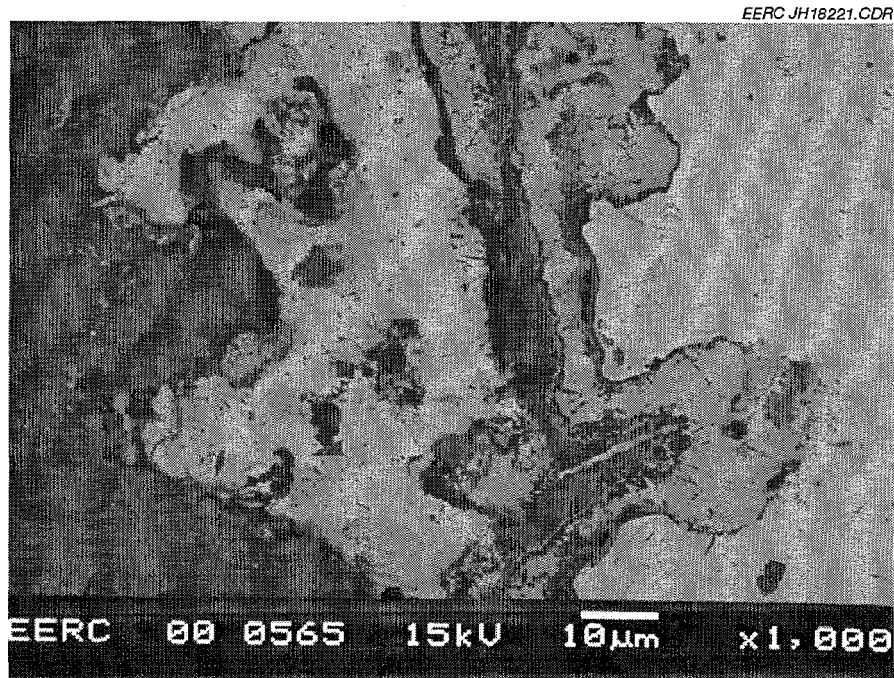
Figure 19. Subsurface pitting at 1000× magnification (ORNL #17681).

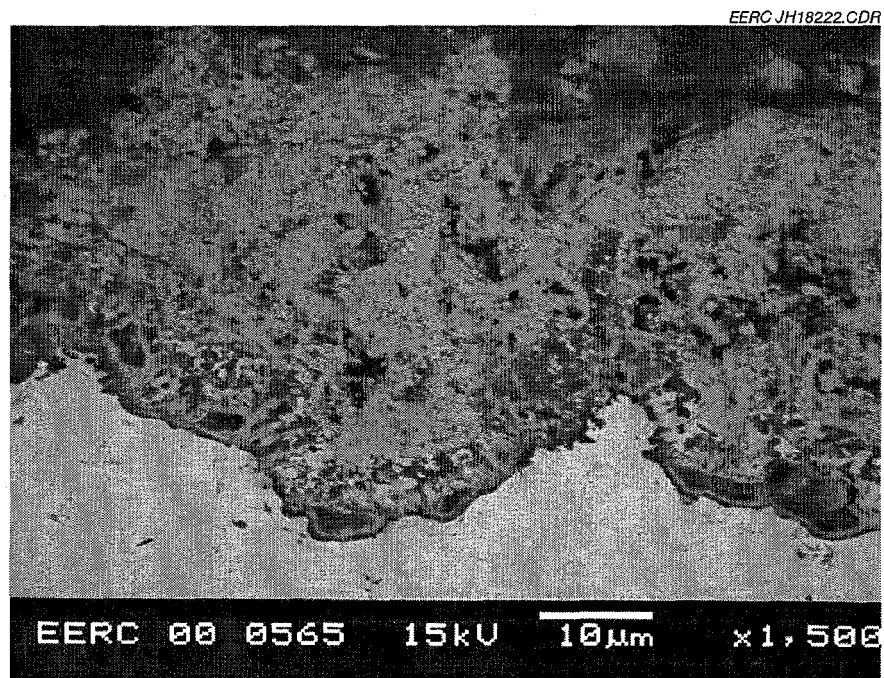
Figure 20 shows surface pitting at 1500× magnification. The depth of the recession is approximately 50  $\mu\text{m}$ . The alloy-corrosion product interface contains heterogeneous pockets of alloy elements and flue gas and ash components O, Al, and S. Constituents include Fe-rich pockets (94 wt% Fe with 1-2 wt% Al and Si); slightly oxidized Cr-rich alloy (80-92 wt% Cr, 2-5 wt% Fe, 4-16 wt% O, and 0-2.3 wt% Si); oxidized alloy (45 wt% Cr, 29-34 wt% Fe, 12-16 wt% O, and 6-9 wt% Si); Si-Cr-O pockets (31-39 wt% Si, 30-36 wt% Cr, 20-29 wt% O, and 3-4 wt% S); and Al-Cr combinations (44 wt% Al; 27 wt% Cr; 15 wt% O, 9 wt% Fe; 3 wt% Si; and <1 wt% S). The presence of Al and S at the interface suggests that ash and flue gas constituents assisted O in the corrosive degradation of the alloy materials.

Figure 20. Virgin material and corrosion product at 1500× magnification (ORNL #17681).

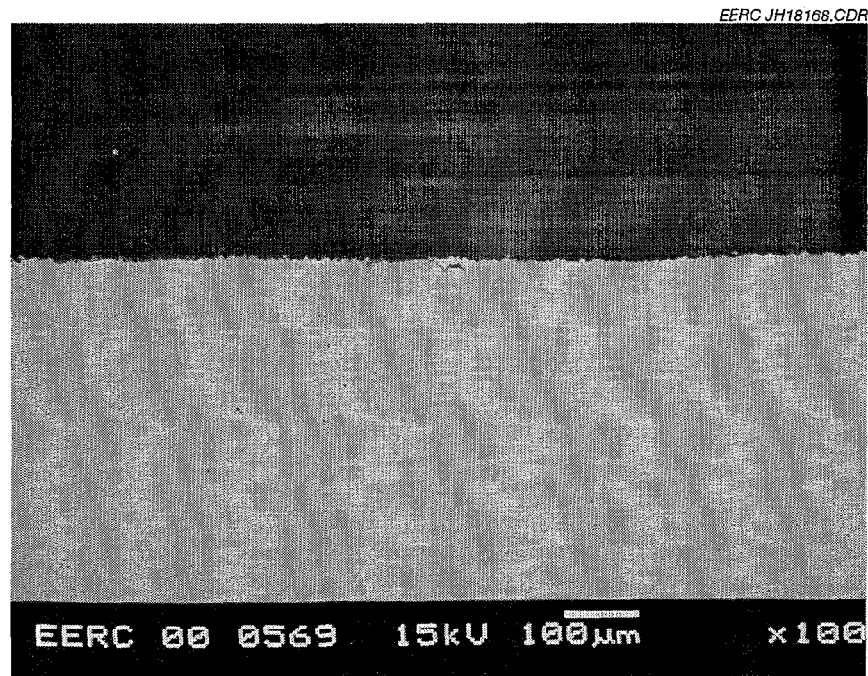
Figure 21. Cross-sectioned virgin material, corrosion product, and ash deposit at 100 $\times$  magnification (ORNL #17682).

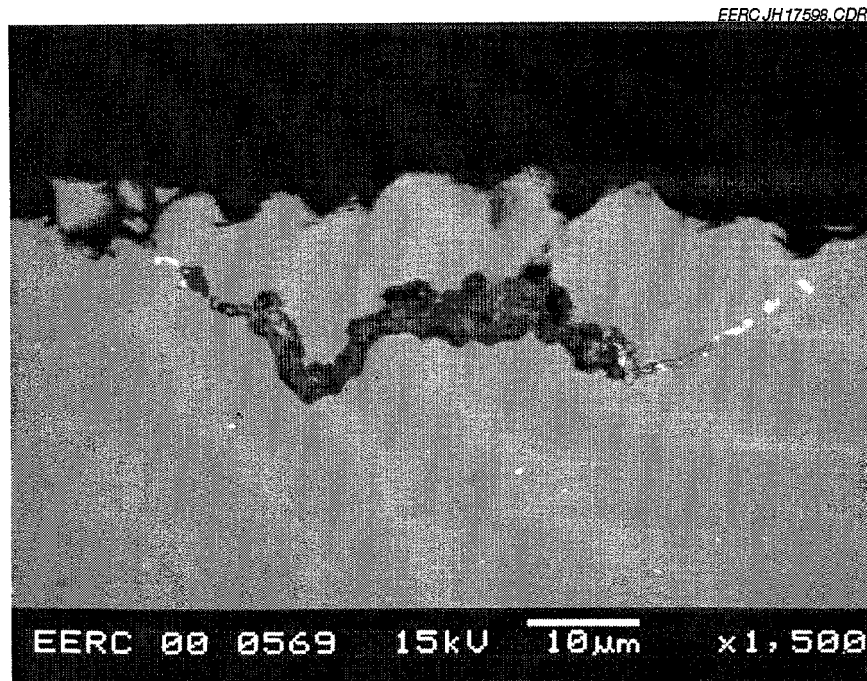
Figure 22. Subsurface corrosion at 1500× magnification (ORNL #17682).

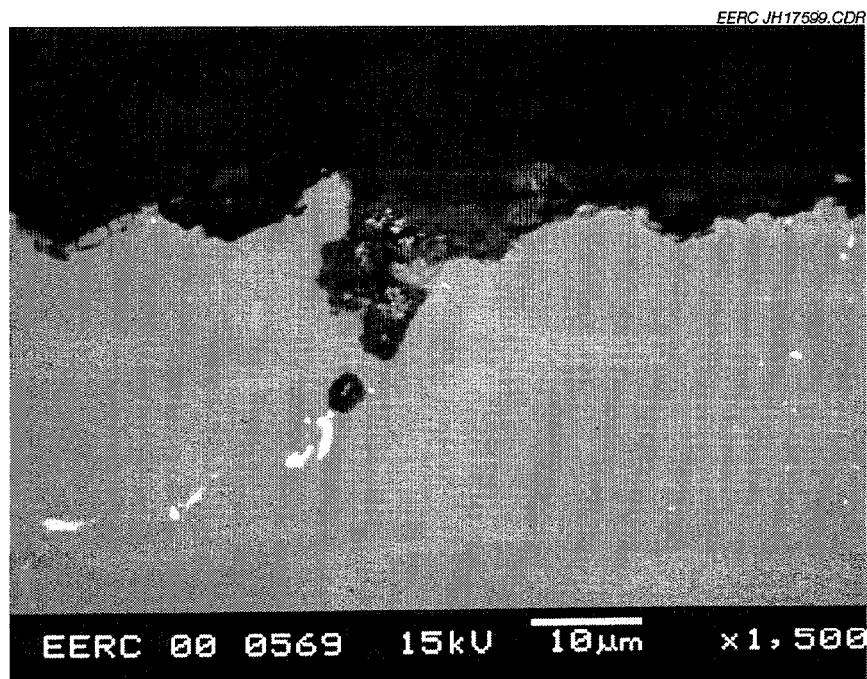
Figure 23. Surface corrosion at 1500× magnification (ORNL #17682).

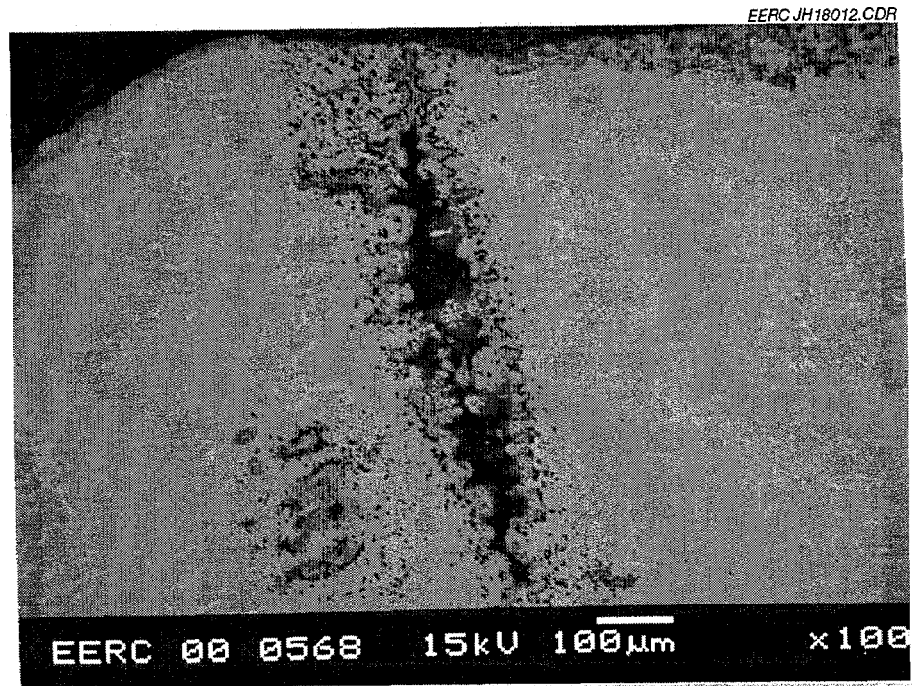
Corrosion penetration into the alloy, shown in Figure 24, was visible at one location in the sample cross section examined. That area included a deep, narrow pit 200-300  $\mu\text{m}$  wide extending 800  $\mu\text{m}$  into the sample and a smaller adjacent site 200 by 300  $\mu\text{m}$  that appeared to be the fringe of another pit. Both followed a corrosion conduit path parallel with the bright high-Mo-content streaks noted above. Figure 25 shows the upper end of the exposed pit at 1500 $\times$  magnification. The figure reveals dark boundaries of Al (58 wt%), O (39 wt%), and Ni (2 wt%) surrounding lighter patches of Cr (73 wt%), O (23 wt%), and Ni (3 wt%). The composition of the alloy interspersed among and adjacent to the corrosion products resembles the virgin metal except for the absence of Al. At this depth, oxidation of the alloy constituents appears to be the only corrosion source. The metal constituents have separated into two metal oxide complexes.

Figure 24. Virgin material, corrosion pit, and surface corrosion at 100× magnification (ORNL #17682).

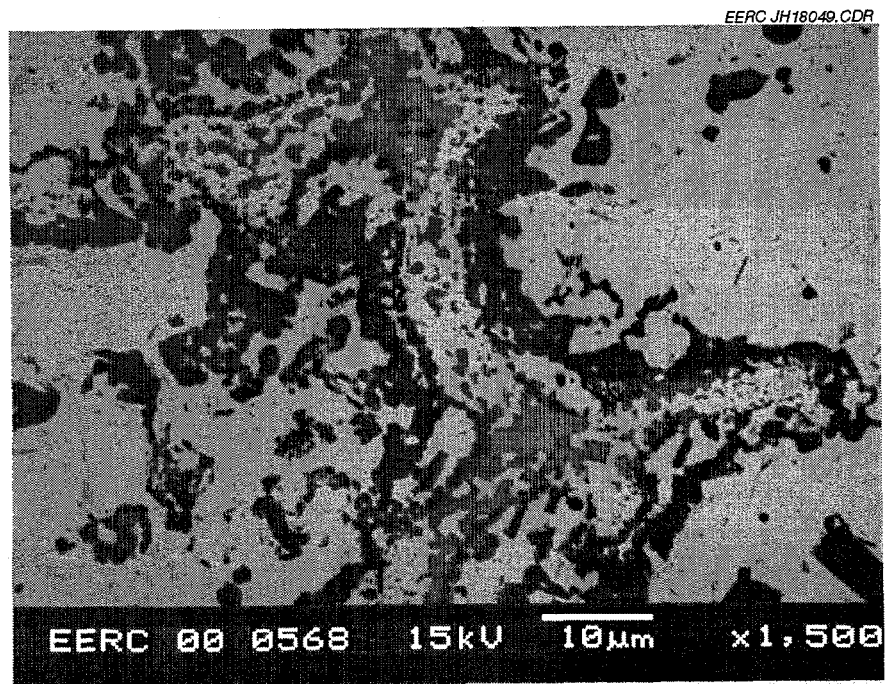
Figure 25. Outer end of exposed pit in Figure 24 at 1500× magnification (ORNL #17682).

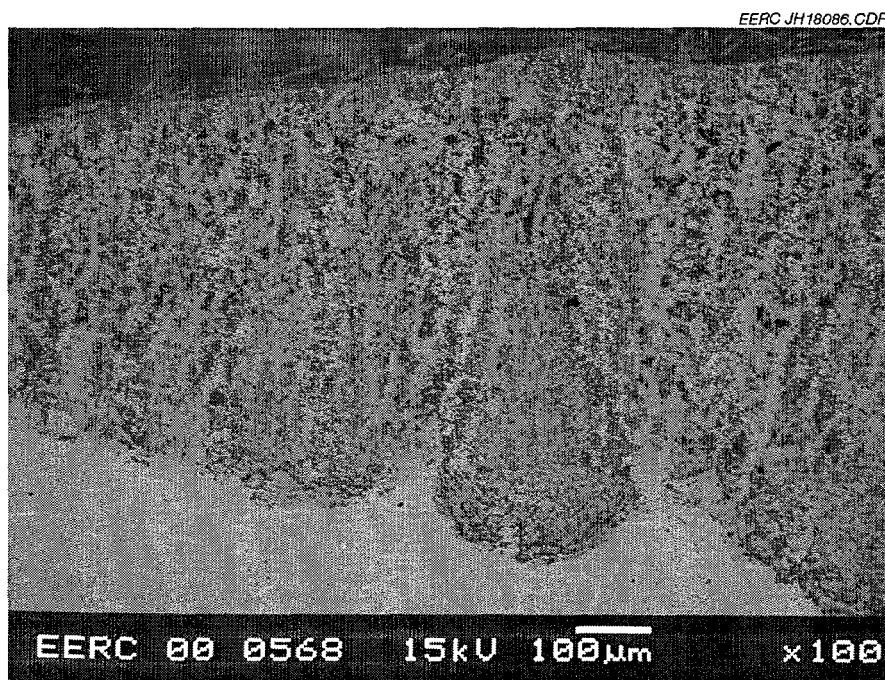
The constituents of the outermost layer of corrosion product include pockets of oxidized Ni, high MO content, and a new proportion of metals and O in addition to the high Ni content described above. These combinations are found from about 150  $\mu\text{m}$  from the surface outward. The oxidized Ni (80 wt% Ni, 14 wt% O) pockets also contained 2 wt% Cr, <5 wt% MO, and trace amounts (<0.3 wt%) of the ash constituents Si, S, Cl, P, K, and Ca.

Figure 26. Corrosion product at thickest point at 100 $\times$  magnification (ORNL #17682).

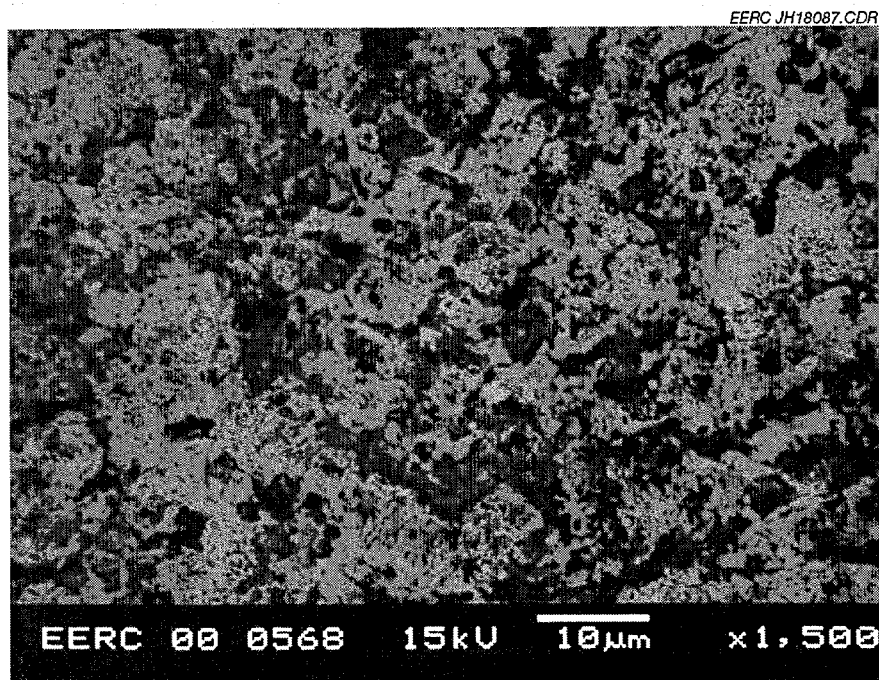
Figure 27. Corrosion product heterogeneity at 1500× magnification (ORNL #17682).

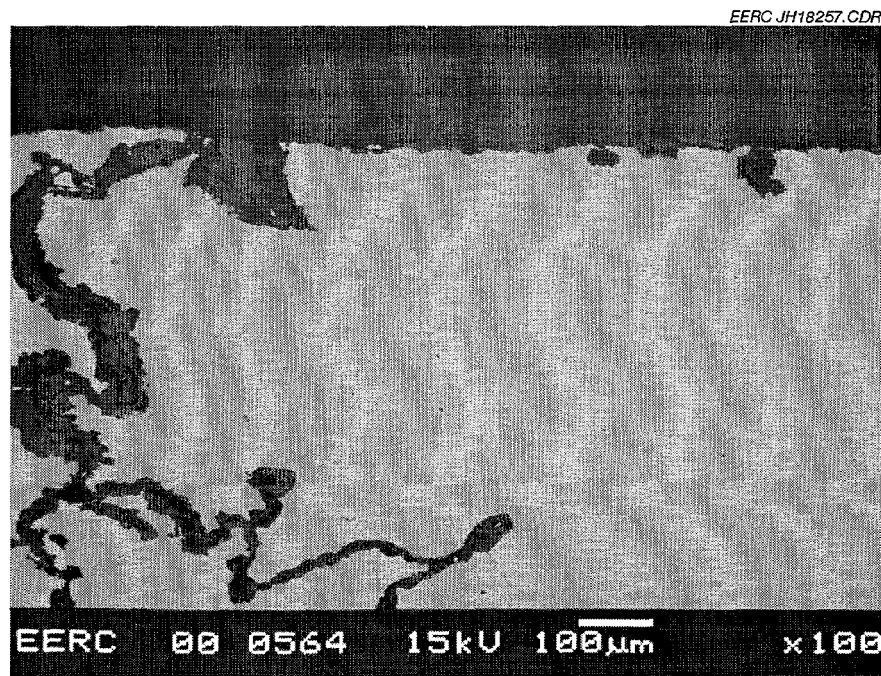
Figure 28. Cross-sectioned virgin material, corrosion product, and ash deposit at 100× magnification (ORNL #17433).

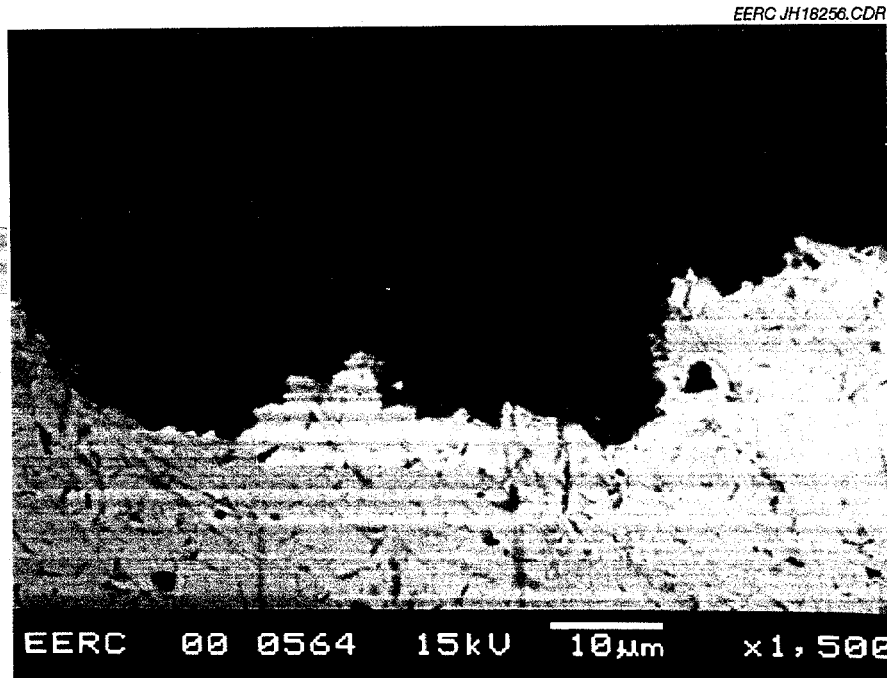
Figure 29. Typical pit at 1500 $\times$  magnification (ORNL #17433).

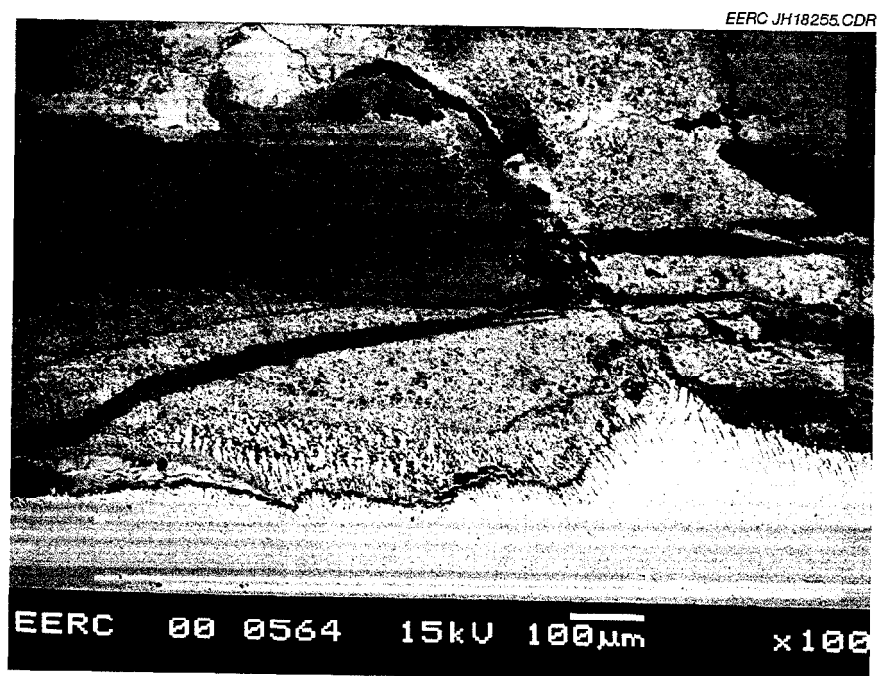
Figure 31. Alloy--corrosion product interface at 100x magnification (ORNL #17433).

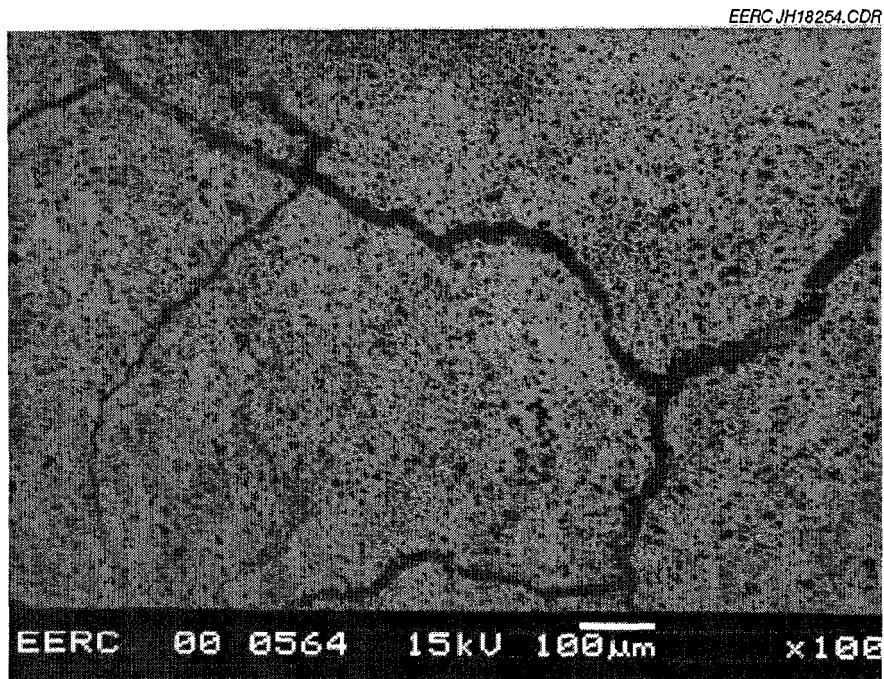
Figure 32. Porous region of corrosion product mass (ORNL #17433).

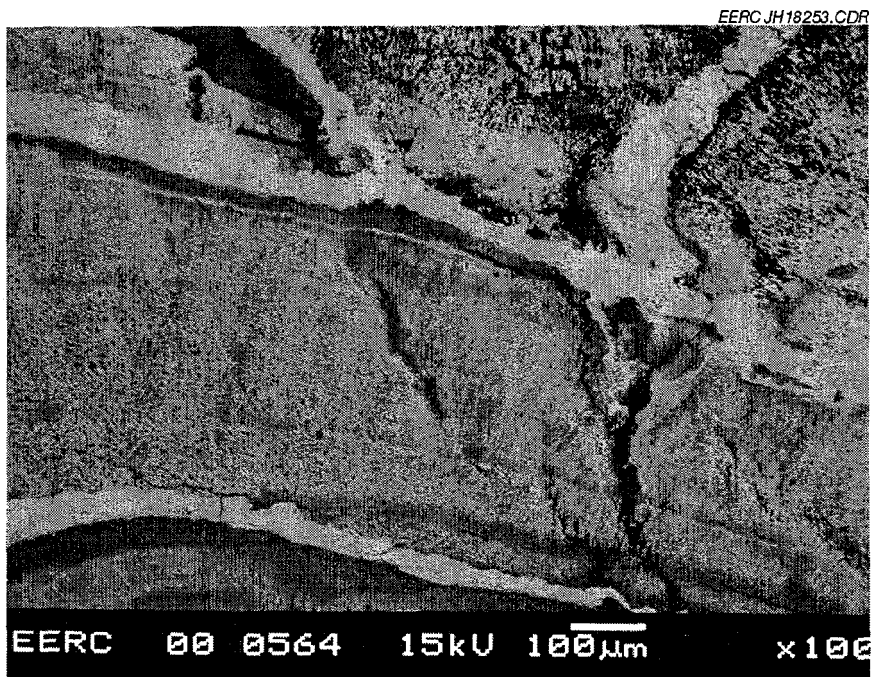
Figure 33. Stratified region of corrosion product mass (ORNL #17433).

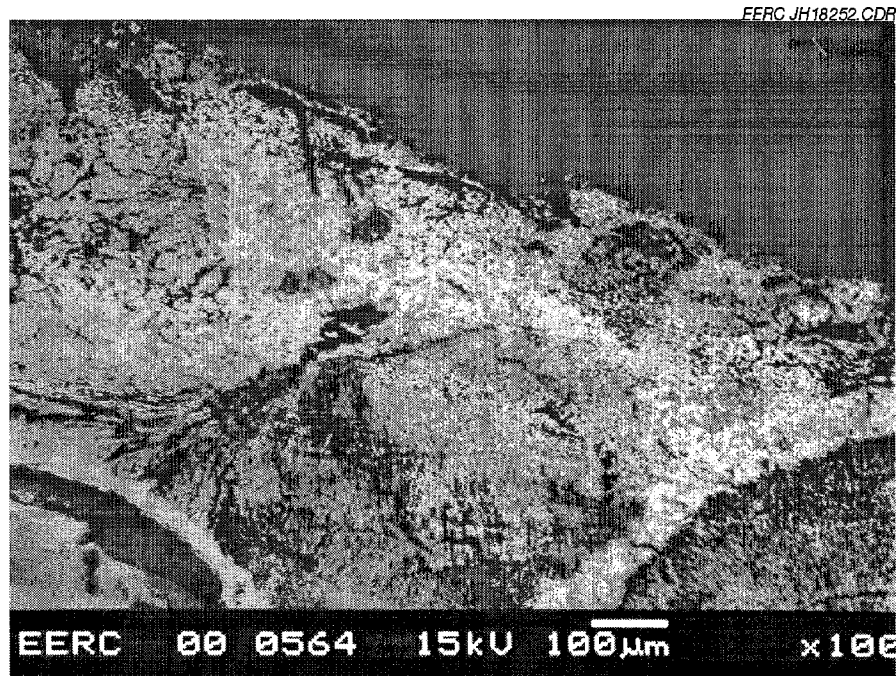
Figure 34. Corrosion product mass at the surface-ash interface (ORNL #17433).

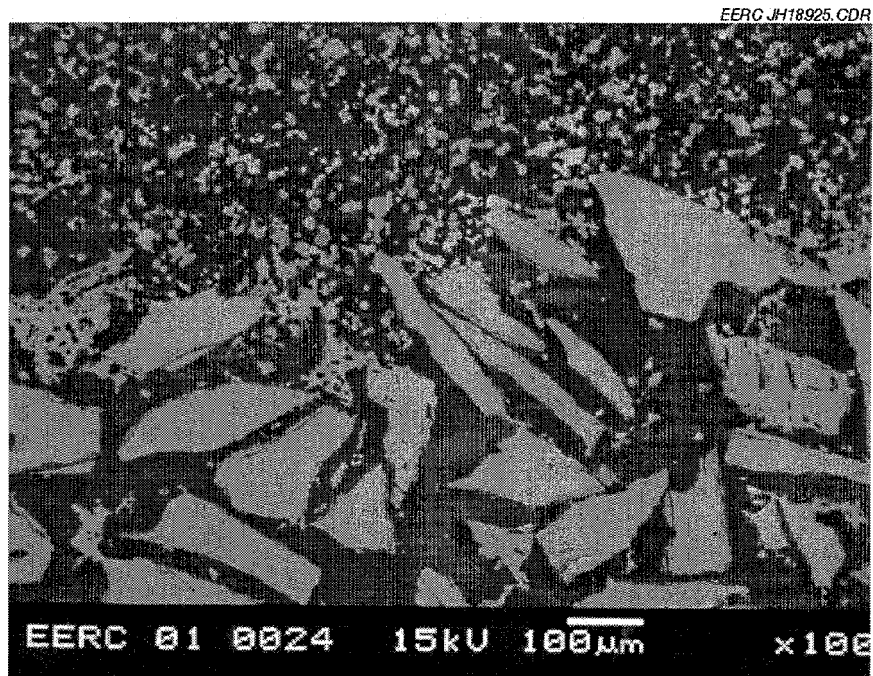
No subsurface corrosion was observed in the sample cross section. Ash filled the voids between the material at the surface to a depth of <215 μm. It did not penetrate or otherwise degrade the sample interior. The material-ash interaction appears limited to the surface, although there was no gas flow through the ring. Evidence of very minor surface corrosion was present as occasional patches at the sample-ash interface. Figure 54 shows at 1500× magnification an example area of corrosion 14 μm deep by 36 μm wide formed on a piece of ceramic aggregate to the right of the more porous aggregate piece at the far left of Figure 53. SEM analysis of the very light gray and white regions embedded in the perimeter of the light gray ceramic base material indicates a reduction in Al (15-28 wt%), an increase in Si (28-32 wt%), and inclusion of ash components Ca (6-10 wt%) and Fe, Na, Mg, P, Ti, and Ba at trace levels (<1 wt% each).

Figure 53. Example of material and deposited ash at 100× magnification (ORNL #3-2).

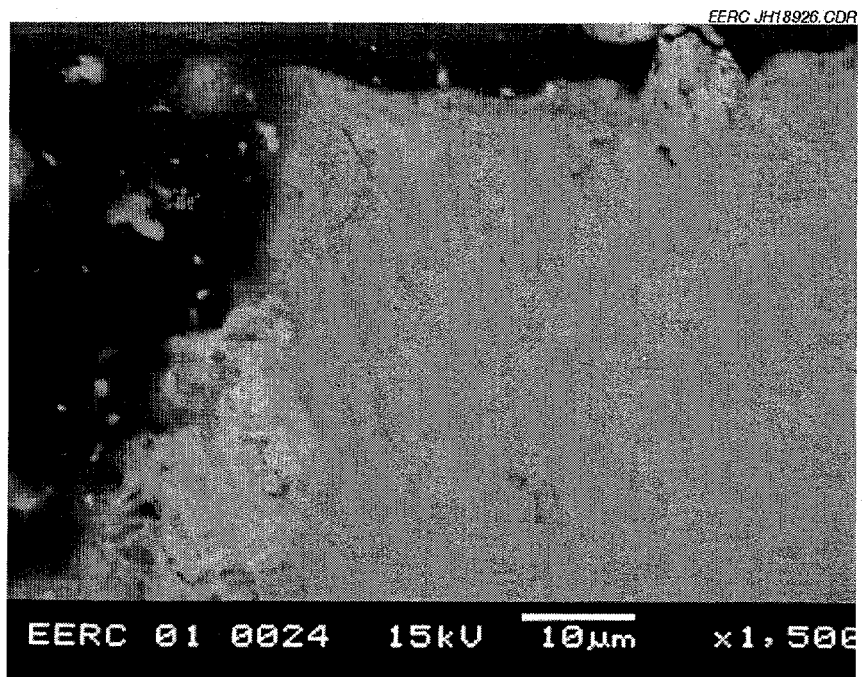
Figure 54. Typical appearance of surface corrosion at 1500× magnification (ORNL #3-2).

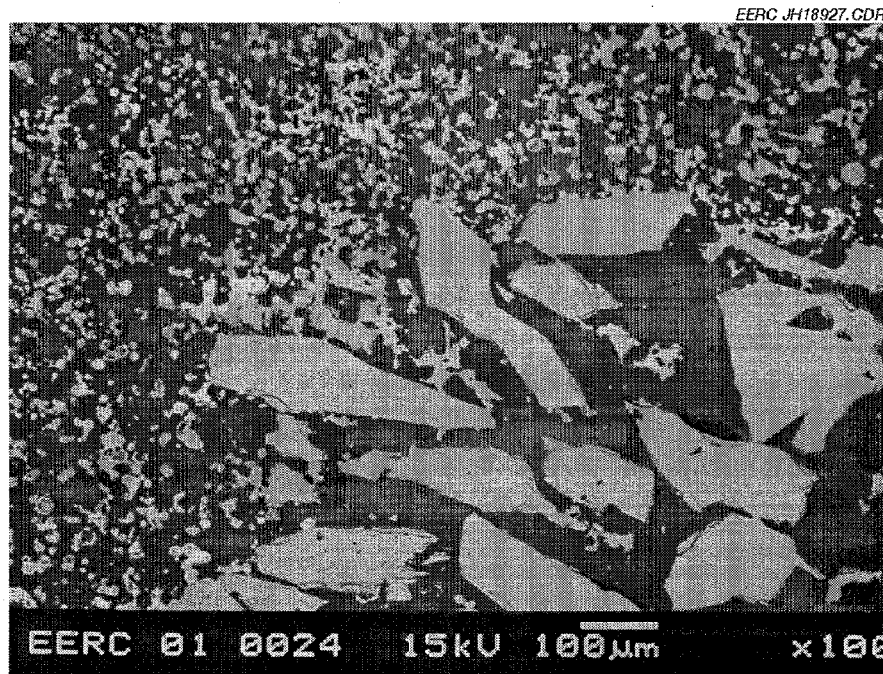
Figure 55. Typical appearance of surface corrosion at 100× magnification (ORNL #3-2).

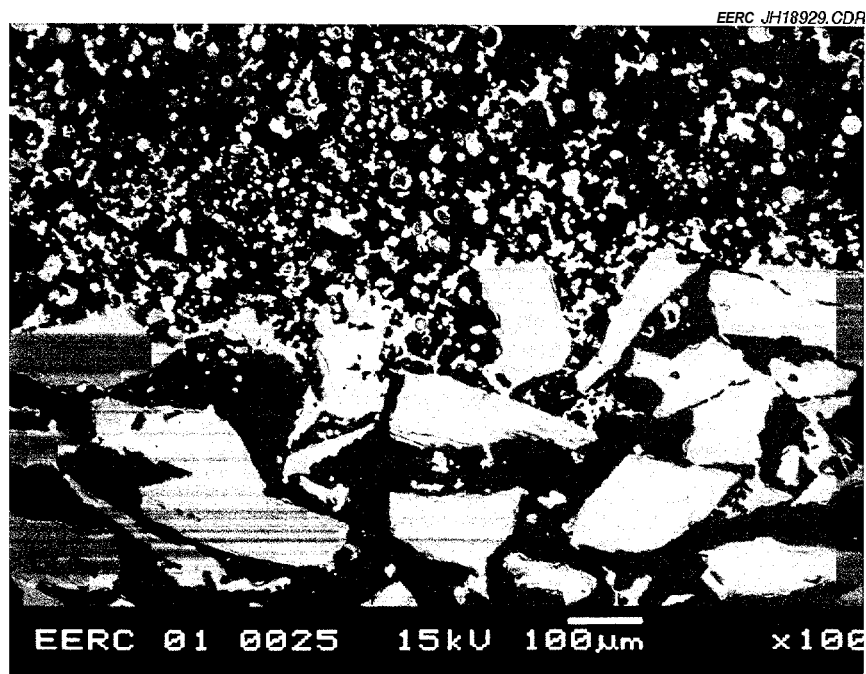
No subsurface corrosion was observed in the sample cross section. Ash filled the voids between the material at the surface. Rare ash particles were observed at a depth of 260  $\mu\text{m}$ ; most filled pores to a depth of only 50-60  $\mu\text{m}$ . The ash did not penetrate or otherwise degrade the sample interior, although there was no gas flow through the sample. The material-ash interface appears limited to the surface. Evidence of very minor corrosion was present as thin coatings or blobs of corrosion product at the sample-ash interface. Figure 58 shows at 1500 $\times$  magnification a typical area of corrosion on the ceramic chunk to the right of center in Figure 57. SEM analysis of the center mass of corrosion product showed that darker gray areas were ceramic material with 2 wt% Ca incorporated, whereas light gray and white regions contained greater percentages of ash constituents Ca (16-35 wt%), Fe (2-8 wt%), Ti (3-5 wt%), and Na, Mg, P, S, and K at trace levels (<2 wt% each). This example, with dimensions of 43  $\mu\text{m}$  by 28  $\mu\text{m}$ , was the largest cross

Figure 57. Example of material and deposited ash at 100× magnification (ORNL #3-3).

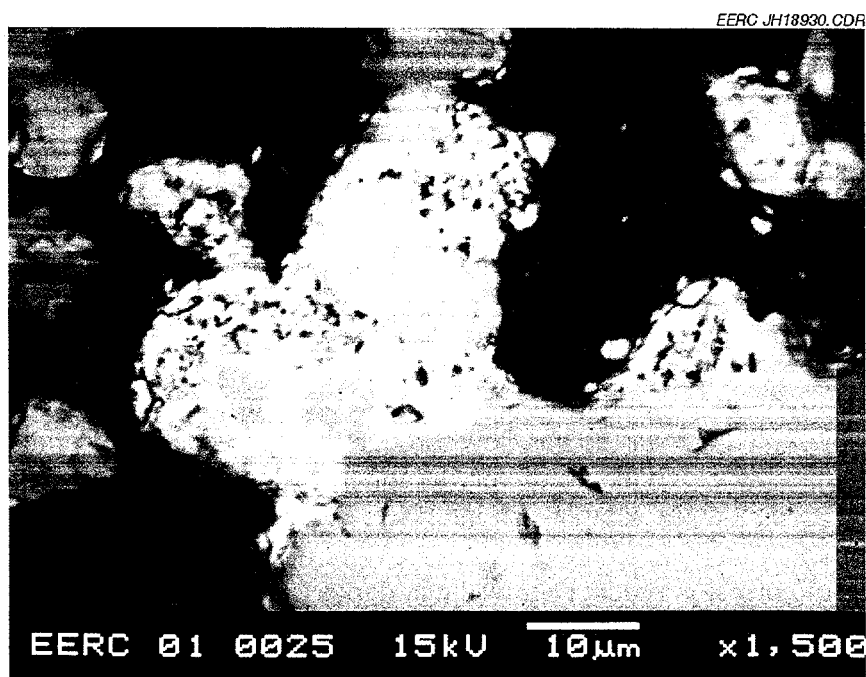
Figure 58. Typical appearance of surface corrosion at 1500× magnification (ORNL #3-3).

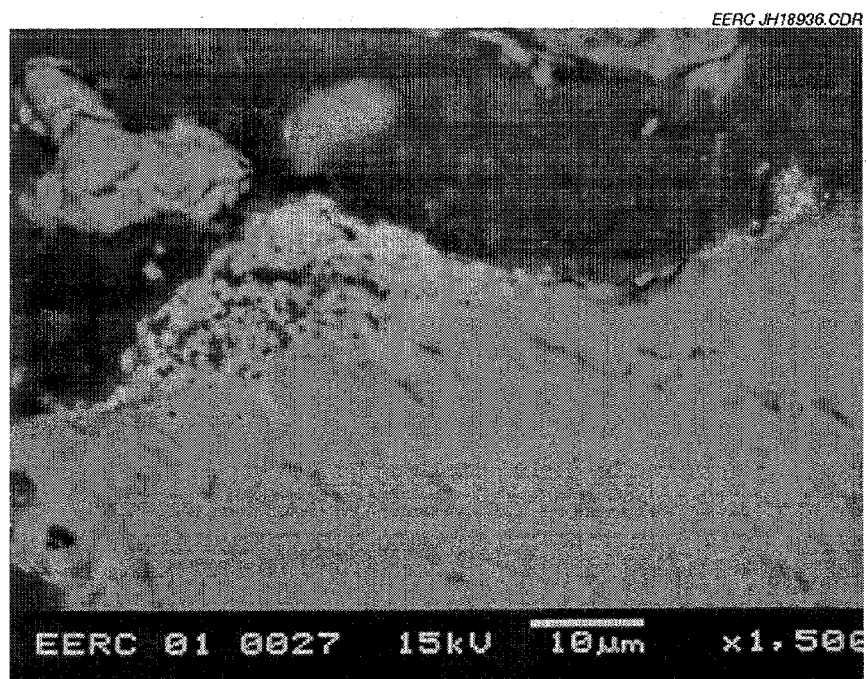
Figure 64. Typical appearance of surface corrosion at 1500× magnification (ORNL #5-1).

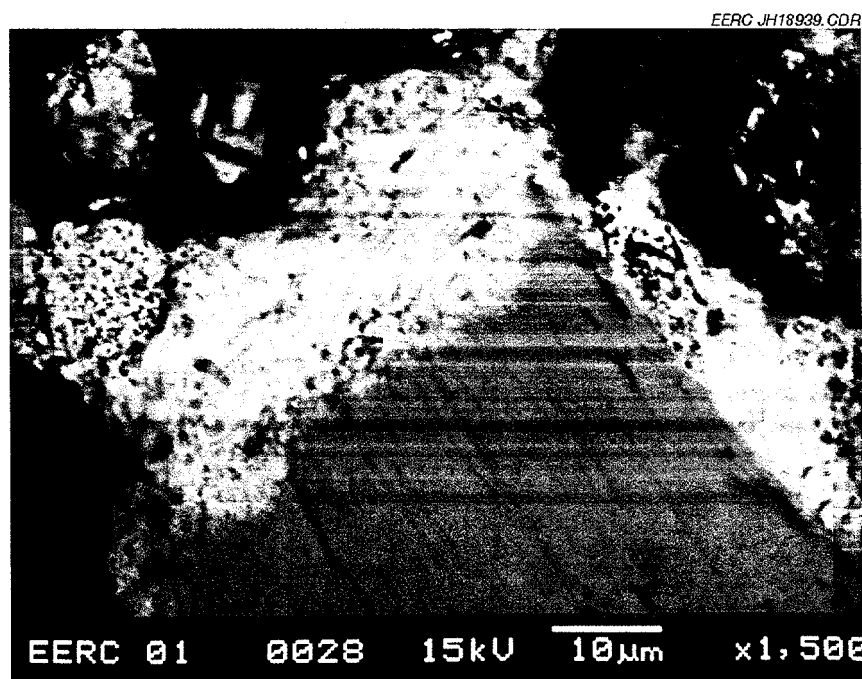
Figure 67. Typical appearance of surface corrosion at 1500 $\times$  magnification (ORNL #5-2).

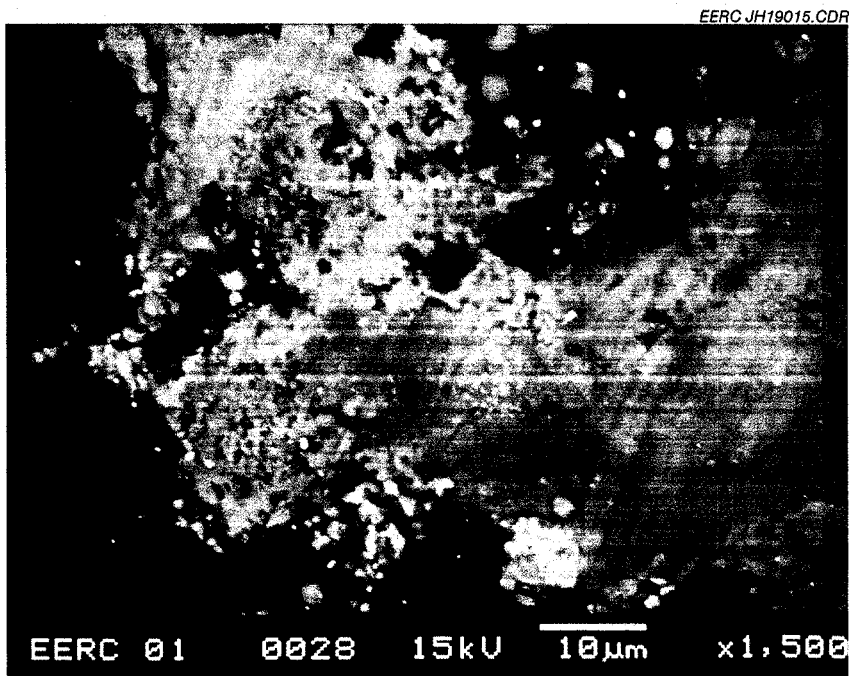
Figure 68. Surface corrosion site at 1500× magnification (ORNL #5-2).

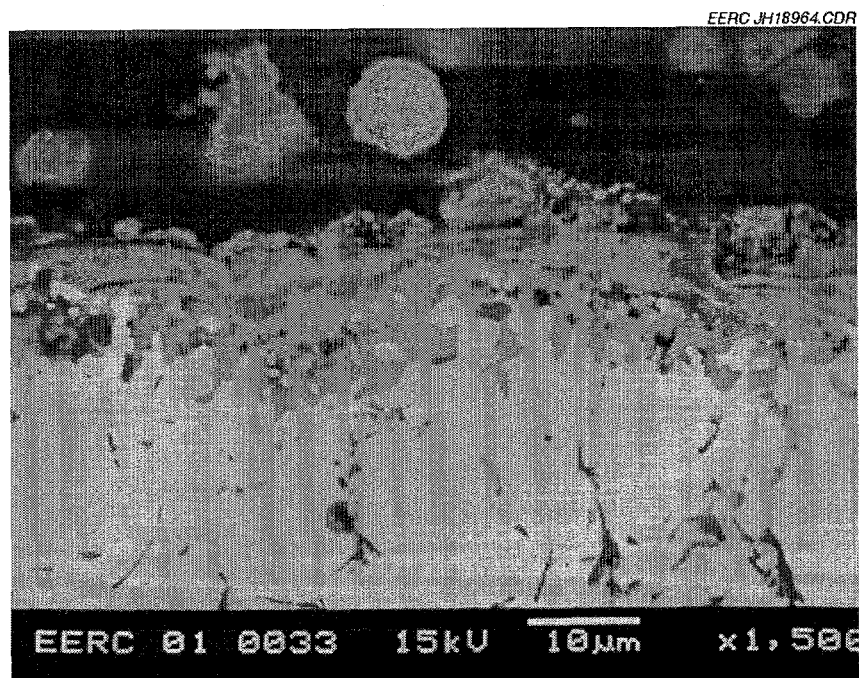
Figure 74. Example of cross-sectioned alloy material, products of corrosive activity, and ash deposit at 1500× magnification (#Thermie-020-1).

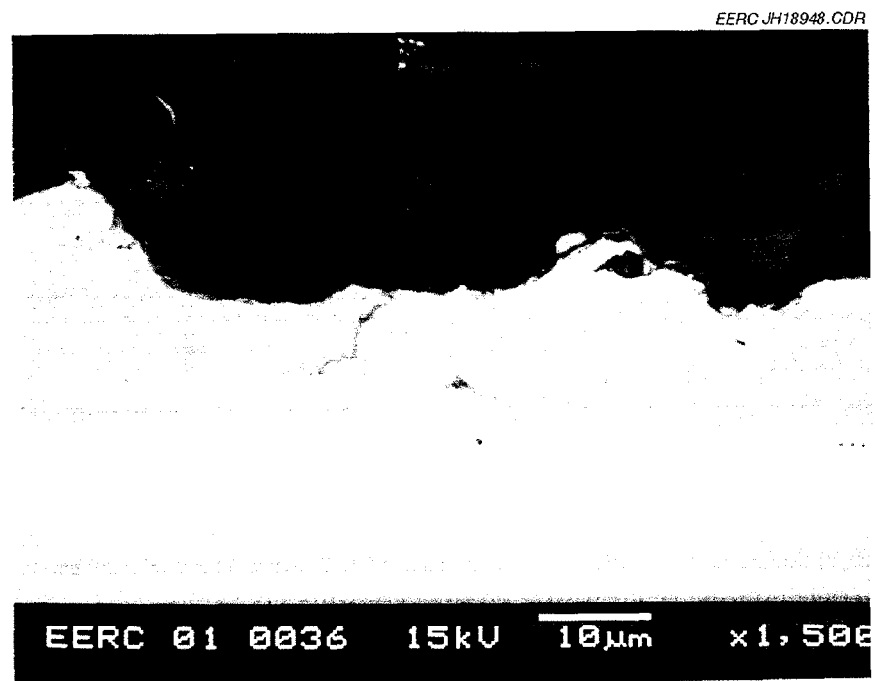
Figure 90. Sample surface at 1500× magnification (ORNL #310HCbN SS [HR3C Weld]-1).
