**SUPPORT SERVICES FOR CERAMIC FIBER- CERAMIC MATRIX COMPOSITES**

Final Annual Technical Progress Report

September 28, 2001

Report Prepared by  
John P. Hurley and Charlene R. Crocker  
Energy & Environmental Research Center  
University of North Dakota  
PO Box 9018  
Grand Forks, North Dakota 58202-9018  
under  
Subcontract No. 19X-SS 112V

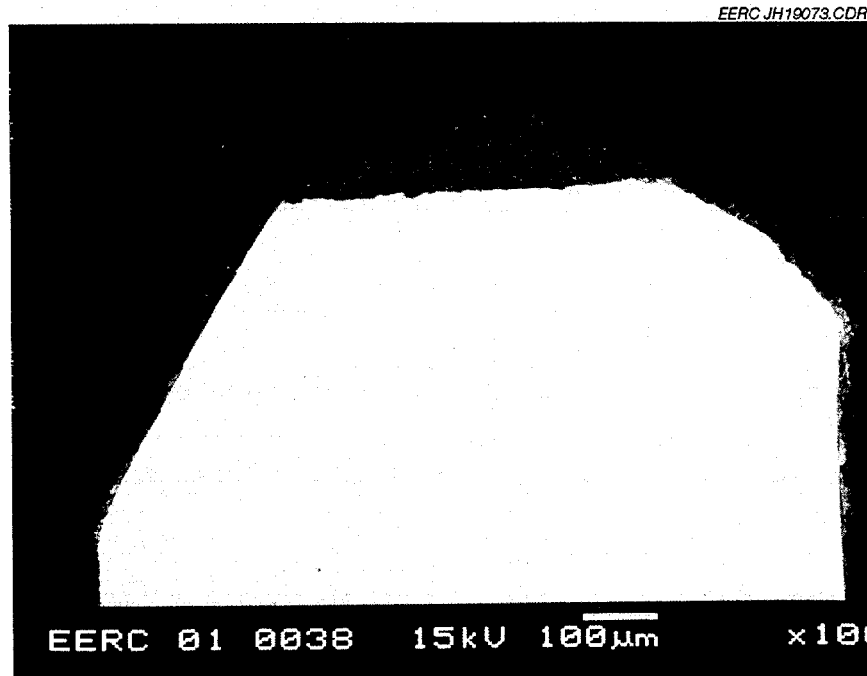
Ash constituents Ca and S were occasionally present at high concentrations (O-26 and 1-13 wt%, respectively), suggesting ash interaction in the development of the corrosion layer.

Figure 95. Cross-sectioned alloy material, corrosion layer, and ash deposit at 100× magnification (ORNL #NF709-1).

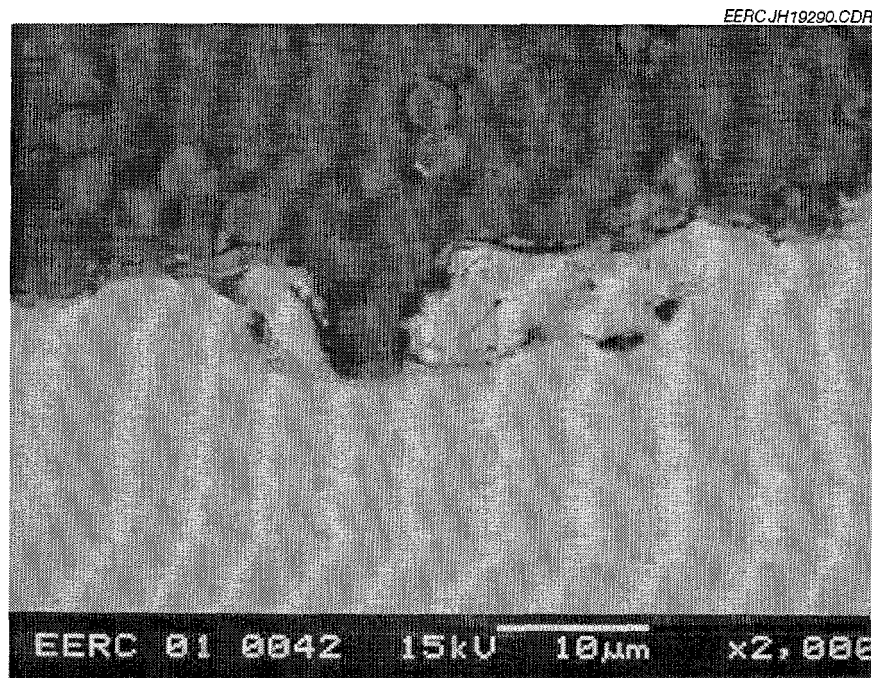
Figure 109. Typical surface pit at 2000× magnification (ORNL #310HCbN- 1).

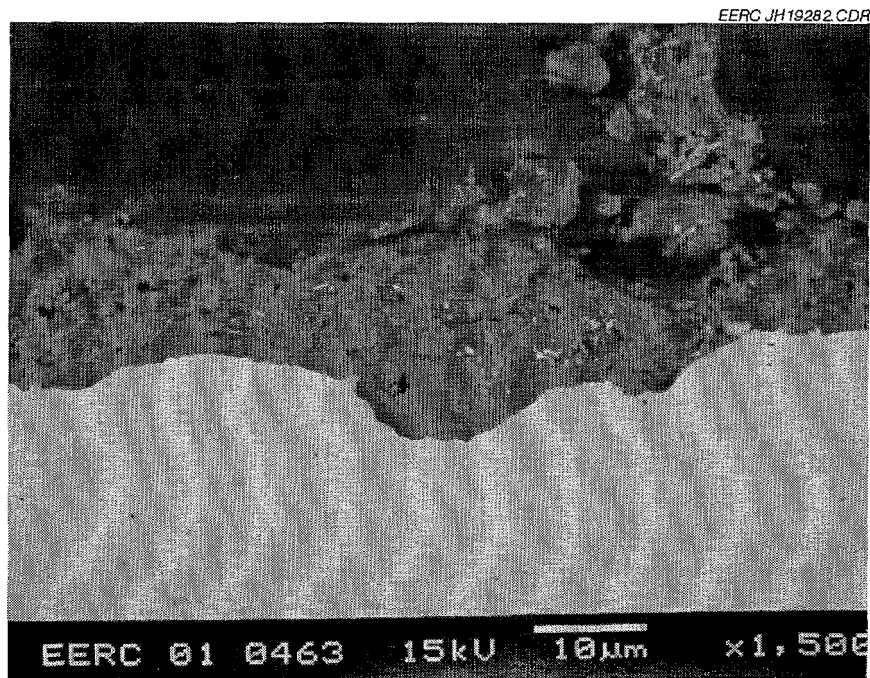
Figure 111. Typical example of corrosion product at 1500× magnification (956).

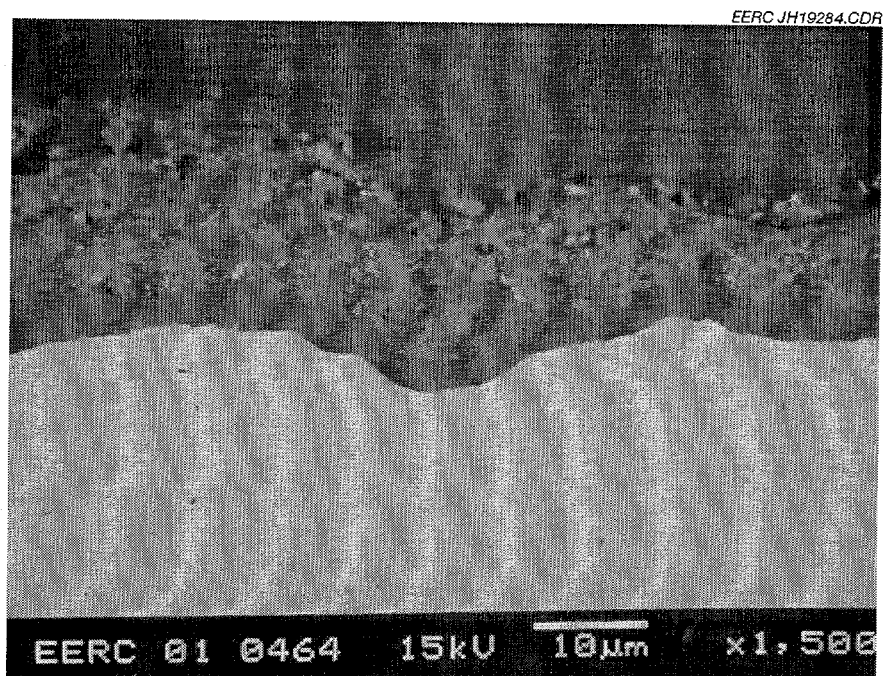
Figure 113. Typical example of corrosion product at 1500× magnification (956HT).

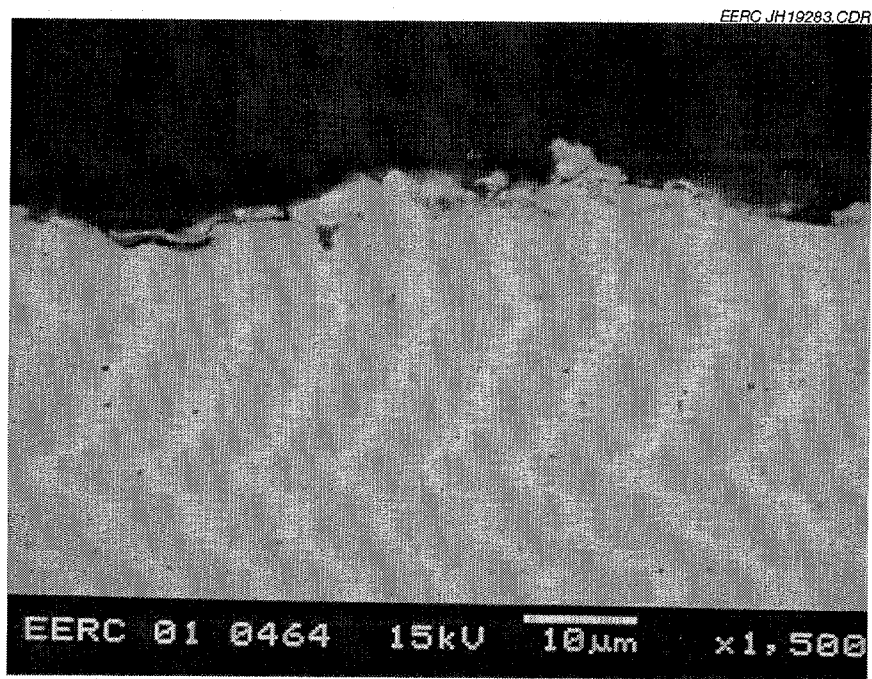
Figure 114. Sample surface without corrosion product at 1500× magnification (956HT).
