# **Wear Analysis of Wind Turbine Gearbox Bearings**

**P. J. Blau, L.R. Walker, H. Xu, R. Parten, J. Qu, and T. Geer  
Materials Science and Technology Division  
Oak Ridge National Laboratory**

## **Final report**

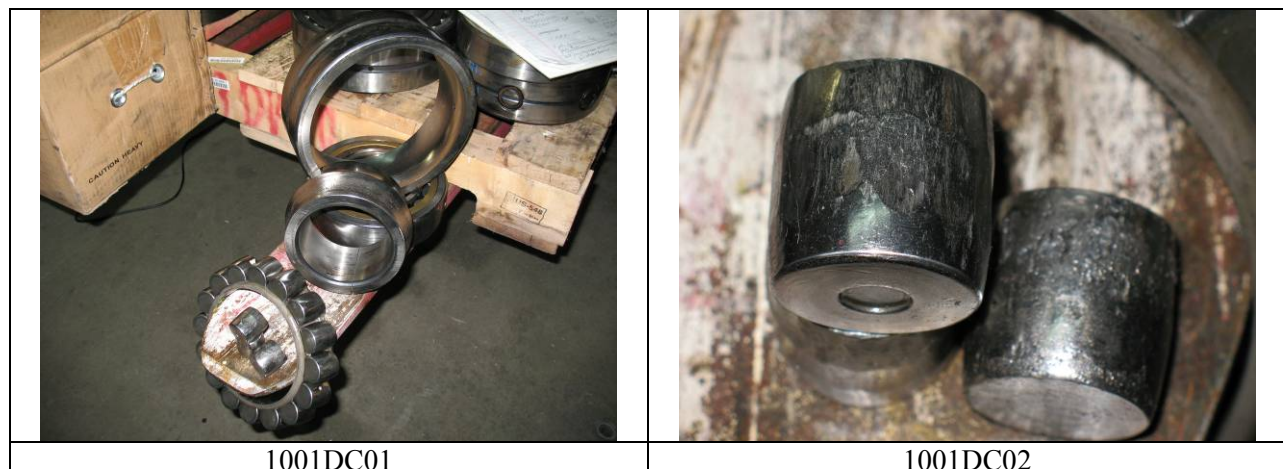
(1001DC02) Loose rolling elements showing severe contact damage. Less-badly worn components comprise the full ring or rollers shown in 1001DC01. (image courtesy of NWTC, Boulder, CO)

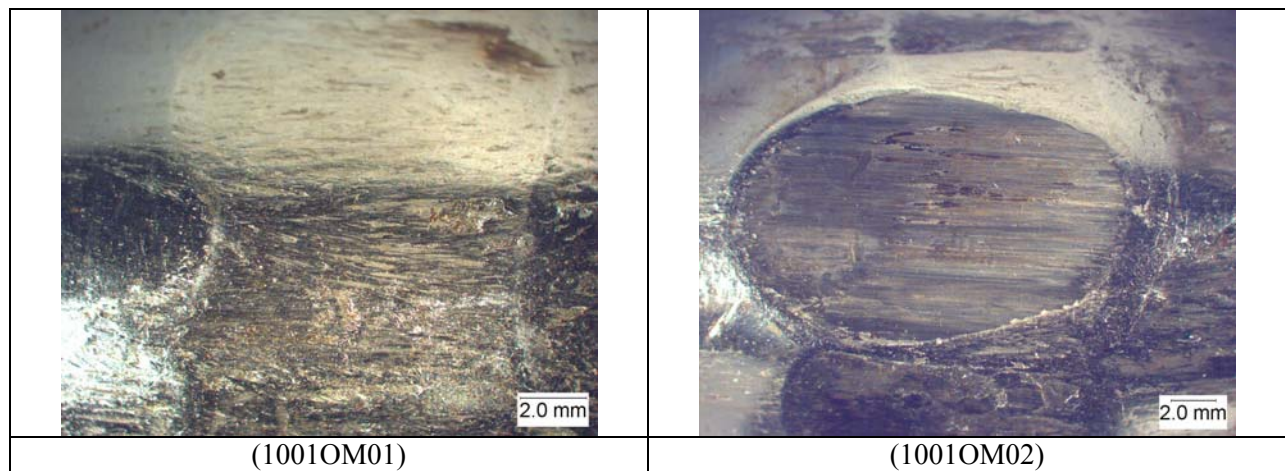
(1001OM01) MacI of flow lines on the smeared equatorial region of a spherical rolling element.

(1001OM02) MacI of a smeared dish depression on the equatorial region of a spherical rolling element (SRE). Smears are approximately parallel to the longitudinal axis of the SRE. An extruded lip has formed at the left edge of the dished region.

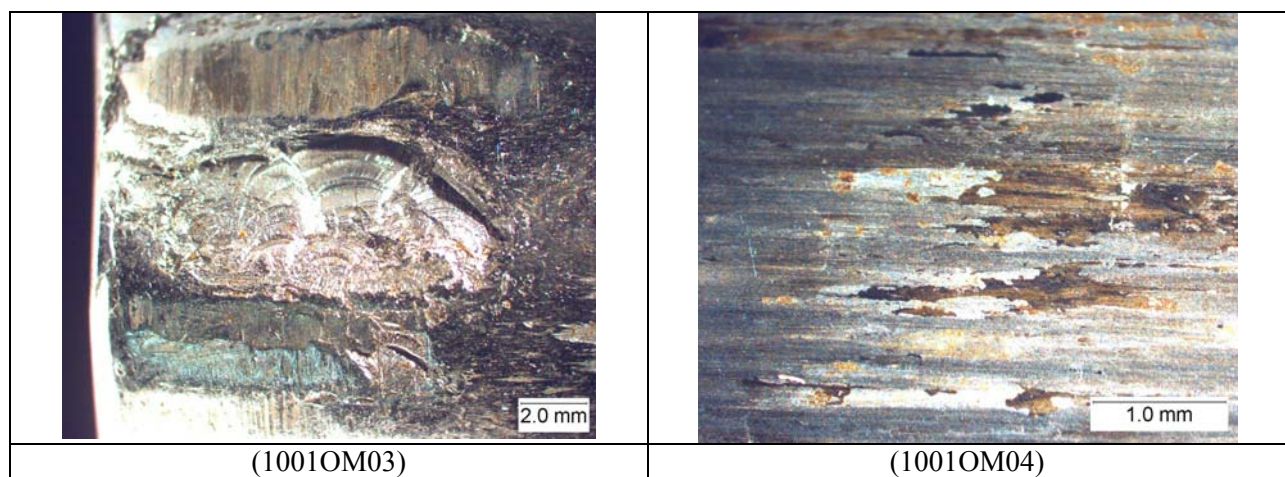
(1001OM03) MacI of clam-shell fatigue indications inside a near-edge spall on a spherical rolling element. There seem to be at least two independent origins for the clam-shell markings. The

spacing of the fatigue striae seems to increase with radial distance from the fracture origin, suggesting a rapid last-stage of growth, prior to the detachment of the overlying flap.

(1001OM04) MacI of a brownish deposit at the center of the smeared dish in 1001OM02. This film, which was not removed by light brushing or an air jet, may be a residue (boundary film) from the lubricant additive package. It does not have the normal appearance of general corrosion products, and was present only at sparse, streaked locations on the dished areas along the roller's equator.

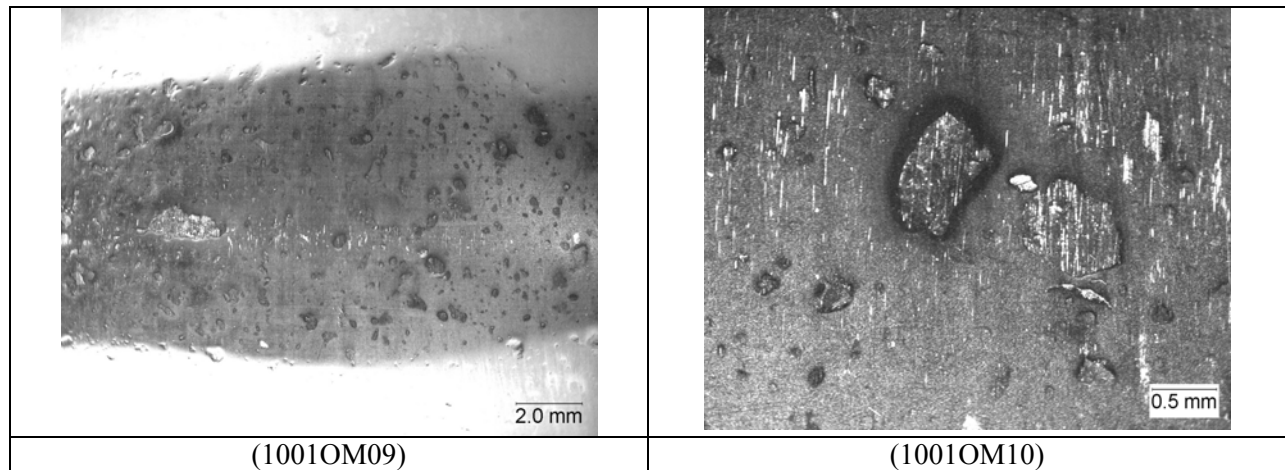
(1001OM09) MacI of embedded debris particles and indentations on the surface of a rolling element removed from the 16 roller complement that was less damaged. The axis of the roller is approximately horizontal.

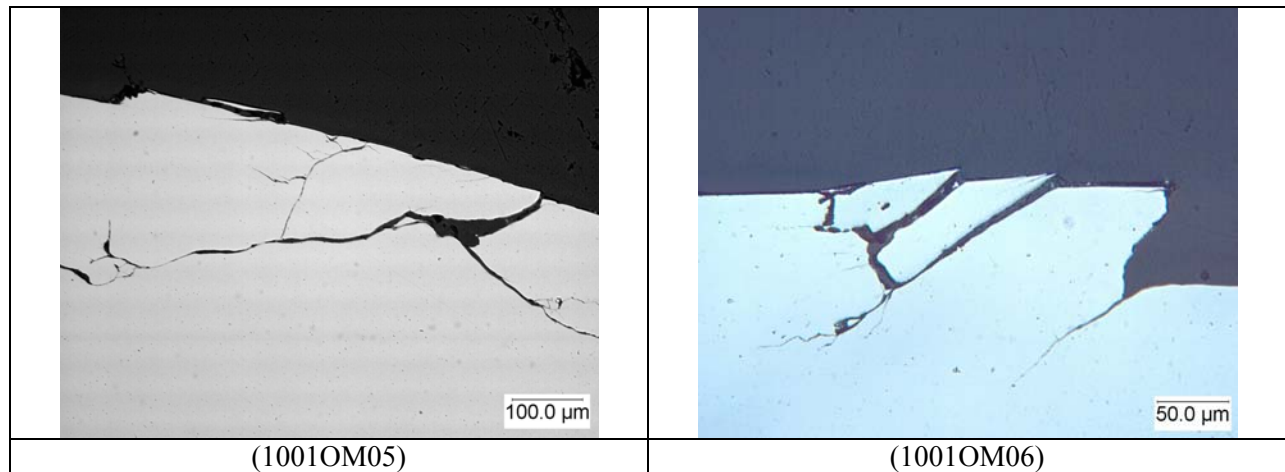
(1001OM05) Unetched PXS of cracks on a roller, approximately 1/3 the distance from one end. The plane of polish is perpendicular to the axis of rotation. It shows a series of branched subsurface micro-fractures. Fine networks of such micro-fractures join the major fissures with the surface. Depths of cracking as much as 200-300  $\mu\text{m}$  are common. Apparently, cantilevered segments break off when micro-fractures coalesce and meet the free surface.

(1001OM06) Unetched PXS of cracks on the roller shown in 1001OM05. It shows a series of stacked micro-fractures. The direction of these inclined fractures seems to be consistent around the entire circumference of the roller, suggesting they were caused by shear tractions (from right to left.) Stress concentrations at the roots of the segments can help to propagate fatigue fine fractures as the upper lip of the segments repeatedly contact the opposing surface. It is likely that the higher features ‘sprang up’ after the bearing surface lost contact.

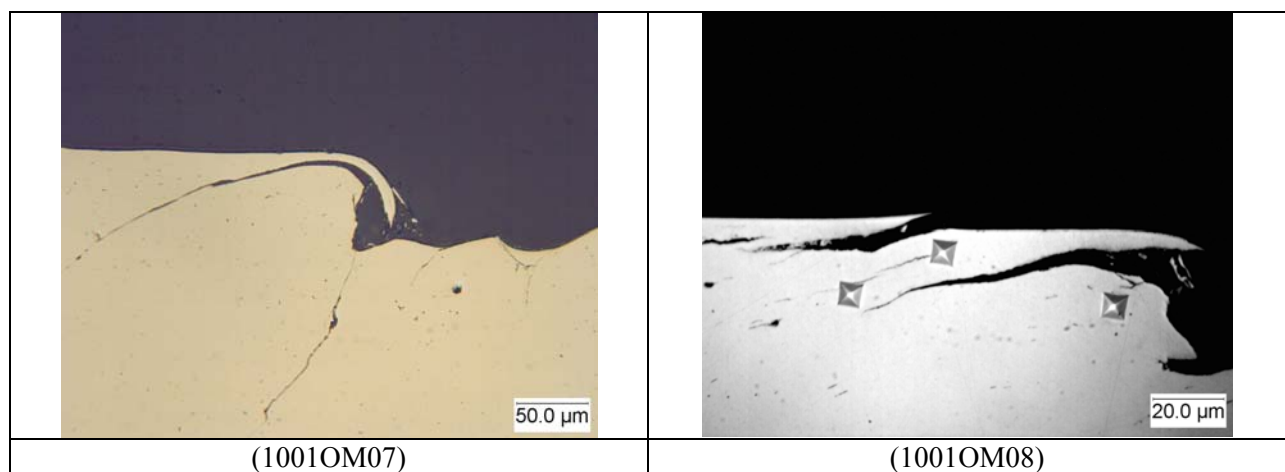
(1001OM08) Vickers microindentations (25 g-f load) on shear-strained surface layers on roller shown in Image 1001OM05. The Vickers hardness (HV) of these features was lower than the HV at the same load measured at the center of the cross-sectioned rolling element. The micro-fracture bridging the two left-most indentations was observed only after indenting, suggesting that it was caused by the HV procedure or was opened up by the pyramidal diamond indenter. Further HV measurements on white-etching regions, however, did show that such deformed regions were considerably harder than the bulk material below (see Section 14.2).

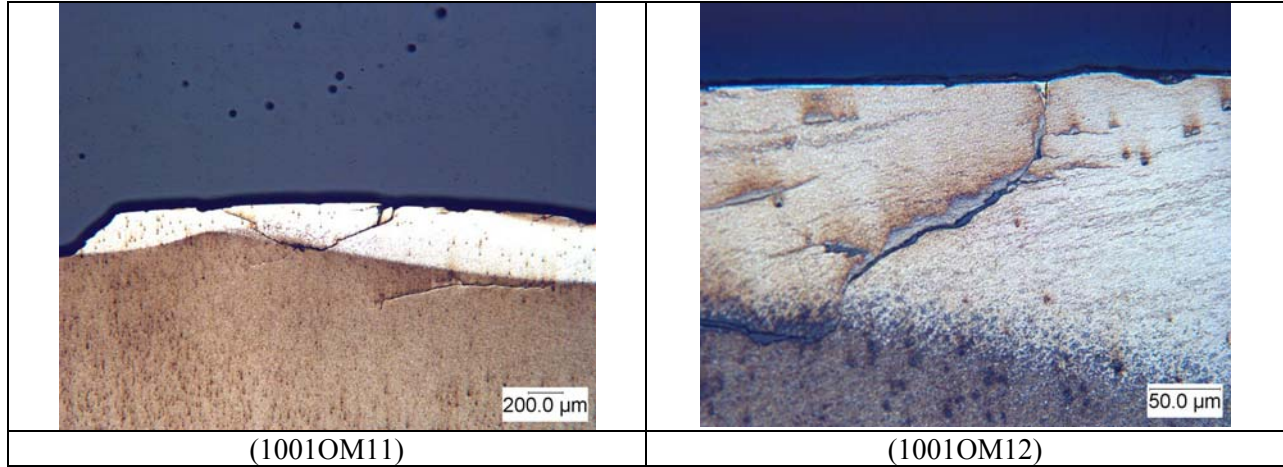
(1001OM12) White-etching layer showing localized shear flow and micro-cracks (5% nital etch).

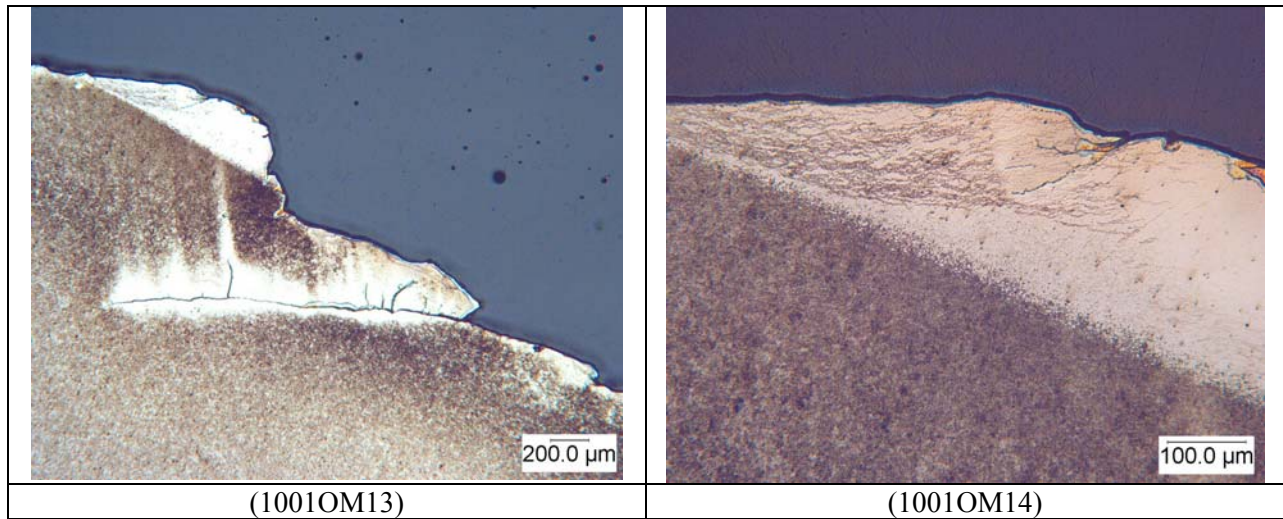
(1001OM13) Etched PXS showing white-etching features paralleling micro-cracks. (Ralph's etch).

(1001OM14) Detail of flow lines in a white-etching layer showing a surface crack from a shallow pit turning into the direction of the flow (Ralph's etch).

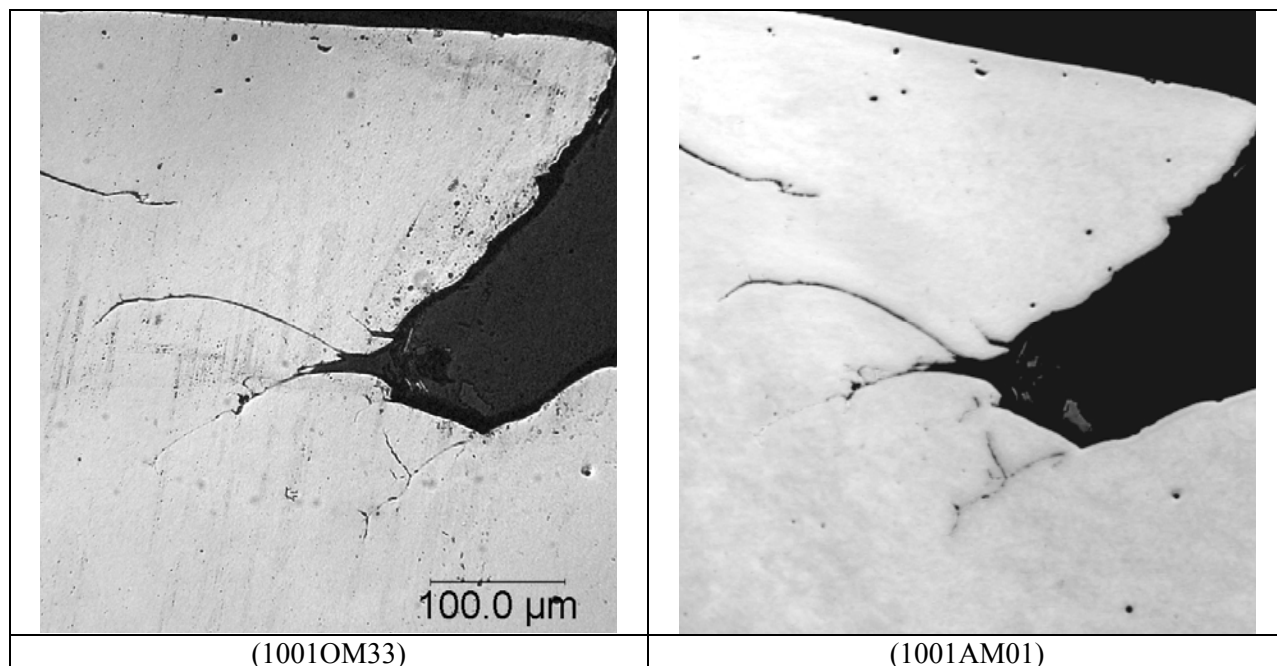
(1001AM01) Scanning acoustic microscope image of the edge of a spall taken at 1 GHz frequency in 60 °C water ( $z = 0 \mu\text{m}$ ). The magnification is the same as that for Fig. (1001OM33) at the left

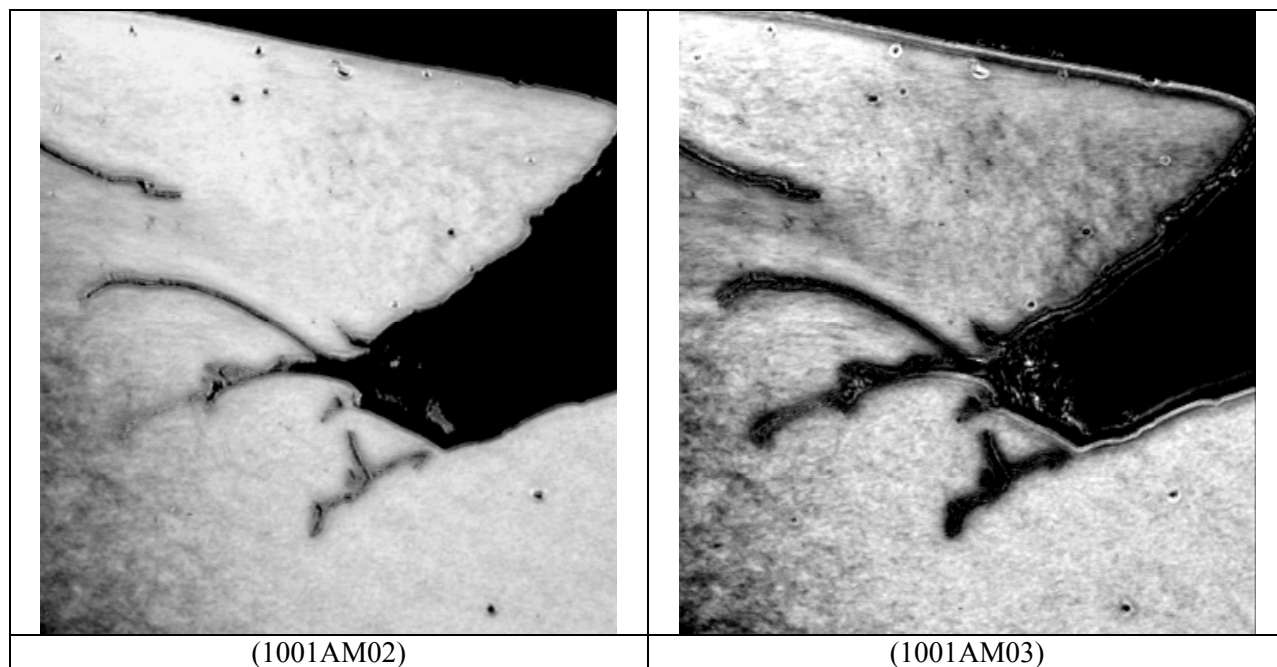
(1001AM03) Scanning acoustic microscope image of the edge of a spall at 1 GHz frequency and with a focus of  $z = -3.0\mu\text{m}$ . The magnification is the same as that for Fig. (1001OM33)

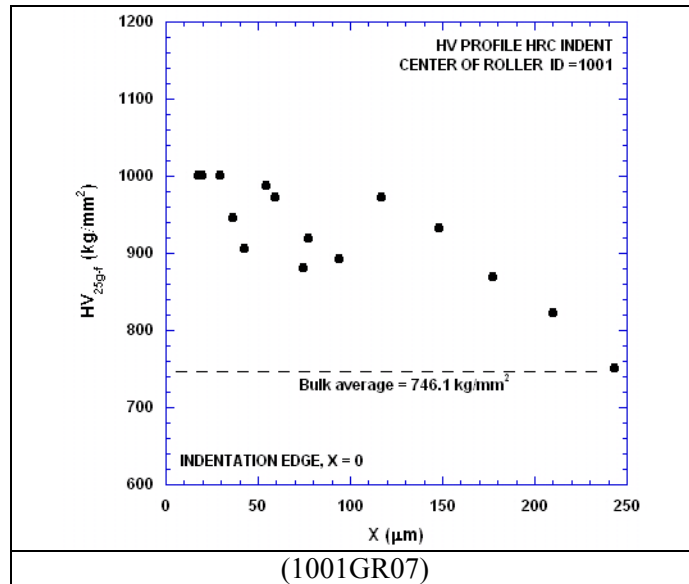
Caption: (1001GR07) Plot of HV versus distance from a Rockwell hardness impression.

The fact that lighter-etching zones had increased deformation was demonstrated using low load (25 g-f) Vickers indentations near a Rockwell C indentation [see Figure (1001OM22) for an image of the microindentations]. As shown in Figure (1001GR07), the lighter etching regions adjacent to the Rockwell impression are harder than the surrounding, darker-etching matrix. In addition, the hardness of the lighter-etching regions near edges the Rockwell C impression is similar to that of white-etching regions at the surfaces of the worn bearing surfaces, particularly when the effect of applied indenter load on hardness number is taken into account. Compensating for the effects of hardness on HV, as shown in Figure 1001GR01, the hardness of the area near to Rockwell impressions at 100 g-f load would be about 8% lower than that obtained at 25 g-f load, so the peak values of ~1000 kg/mm² (as shown in 1001GR07) would be reduced thusly:  $(1000/1.08) = 926 \text{ kg/mm}^2$  for a 100 g-f load. This value compares favorably to the average HV of white layers ( $\text{HV}_{100\text{g-f}} = 932 \text{ kg/mm}^2$ ).

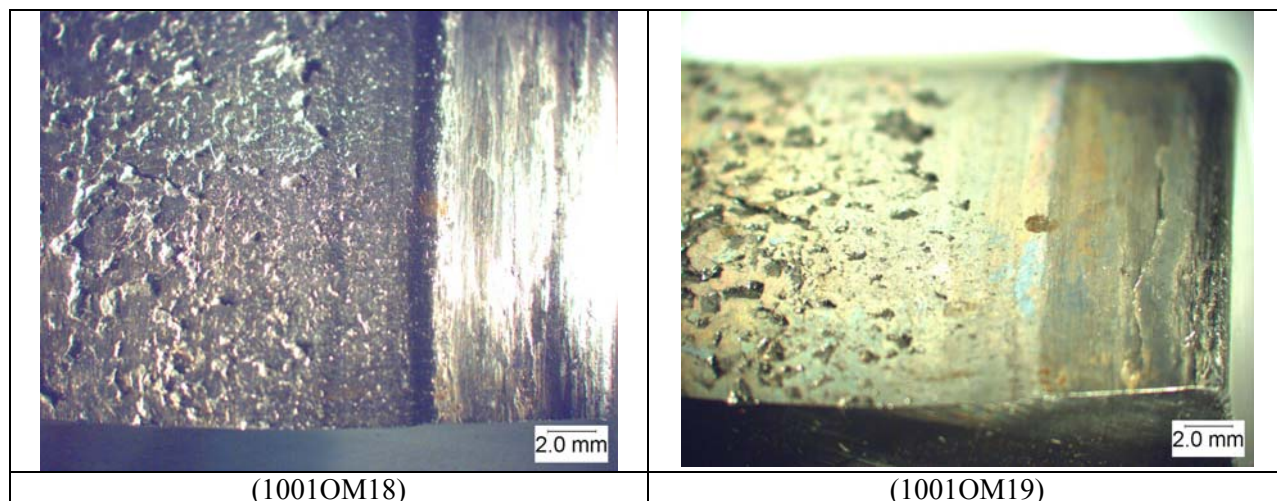
(1001OM19) Tilted view of the same area as 1001OM13 showing the wear step and a 'flap' of sheared material (to the left and above the scale bar) that indicates severe deformation near the edge of the contact.

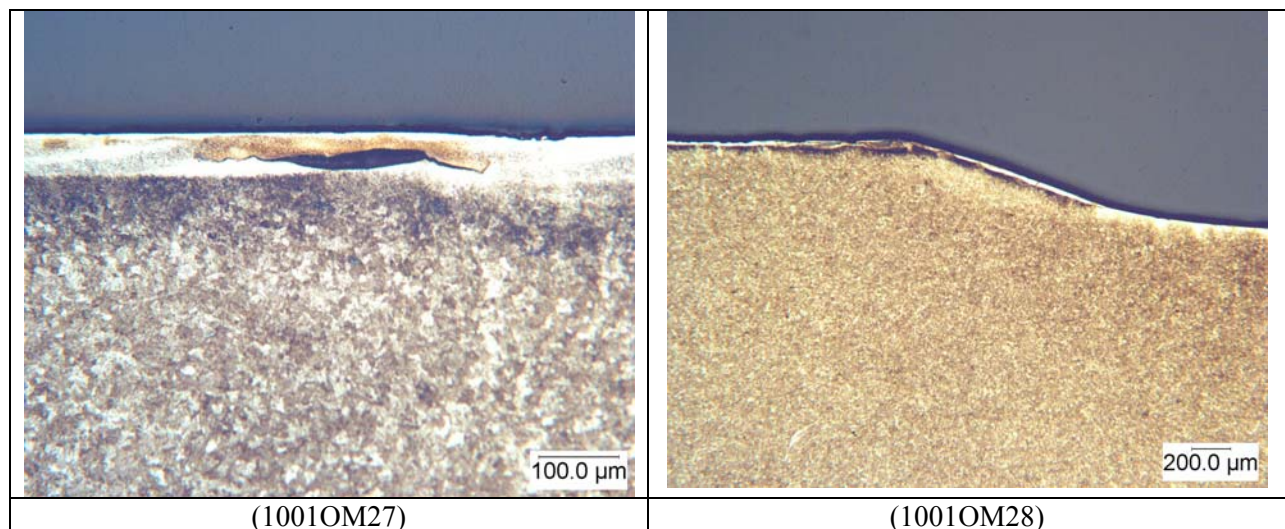
White layers with plastic flow lines within them were also present at the surface of the wear step, indicating that severe sliding contact occurred there. These are shown in Figure (1001OM28)

(1001OM28) White-etching layer on the side of the wear step and plateau region outboard of the wear step. An enlargement of the layer is shown in (1001OM29).

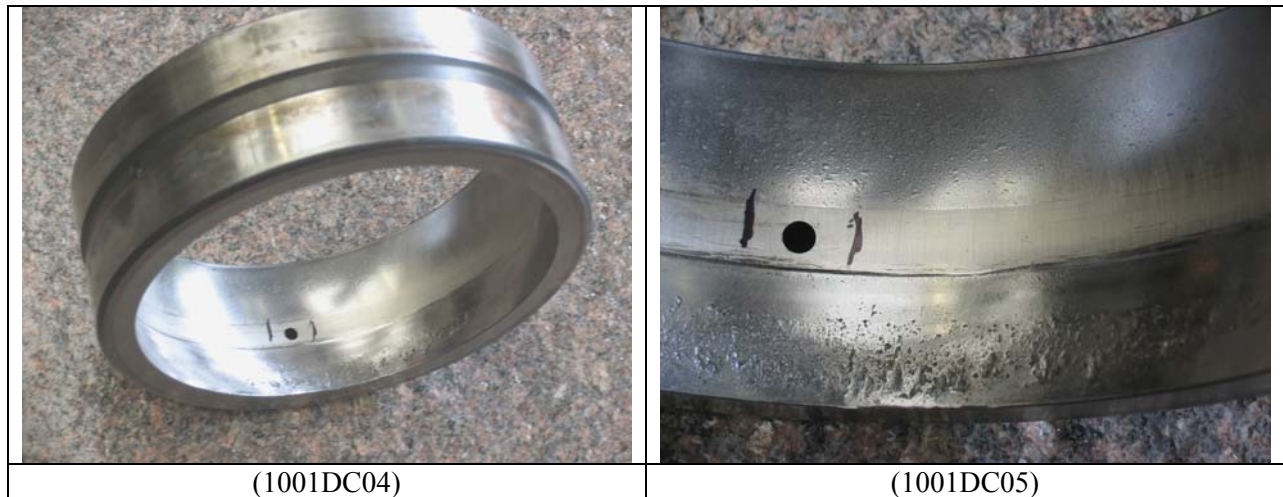
(1001DC05) Close-up view of the differences in surface damage on the twin races (lubrication hole clearly visible).

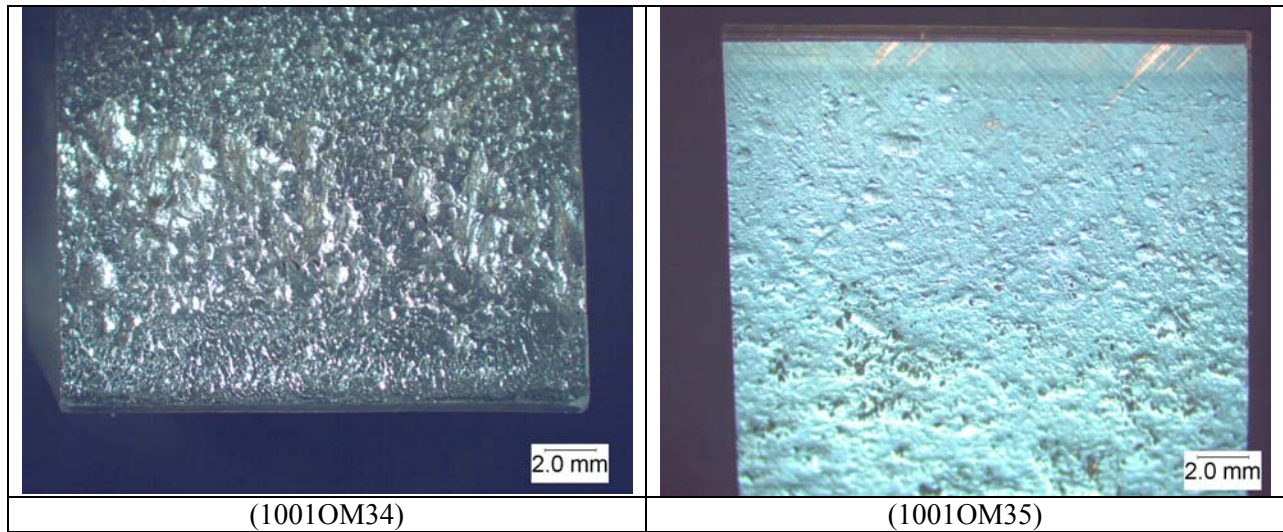
(1001OM35) Enlarged area of the less worn race on Side A, 180 degrees from the higher wear location. Denting and surface distress are evident even though the pitting is not as deep as on the more worn side.

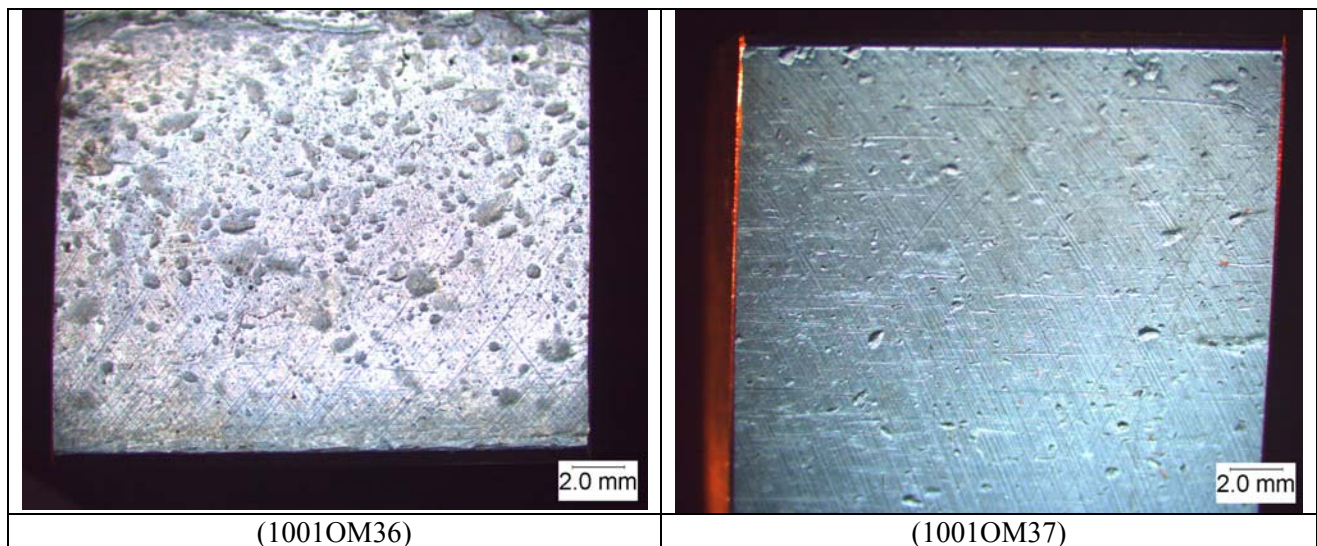
(1001OM37) Enlarged area of the less worn race on Side B. There was less damage than on the same race on Side A.

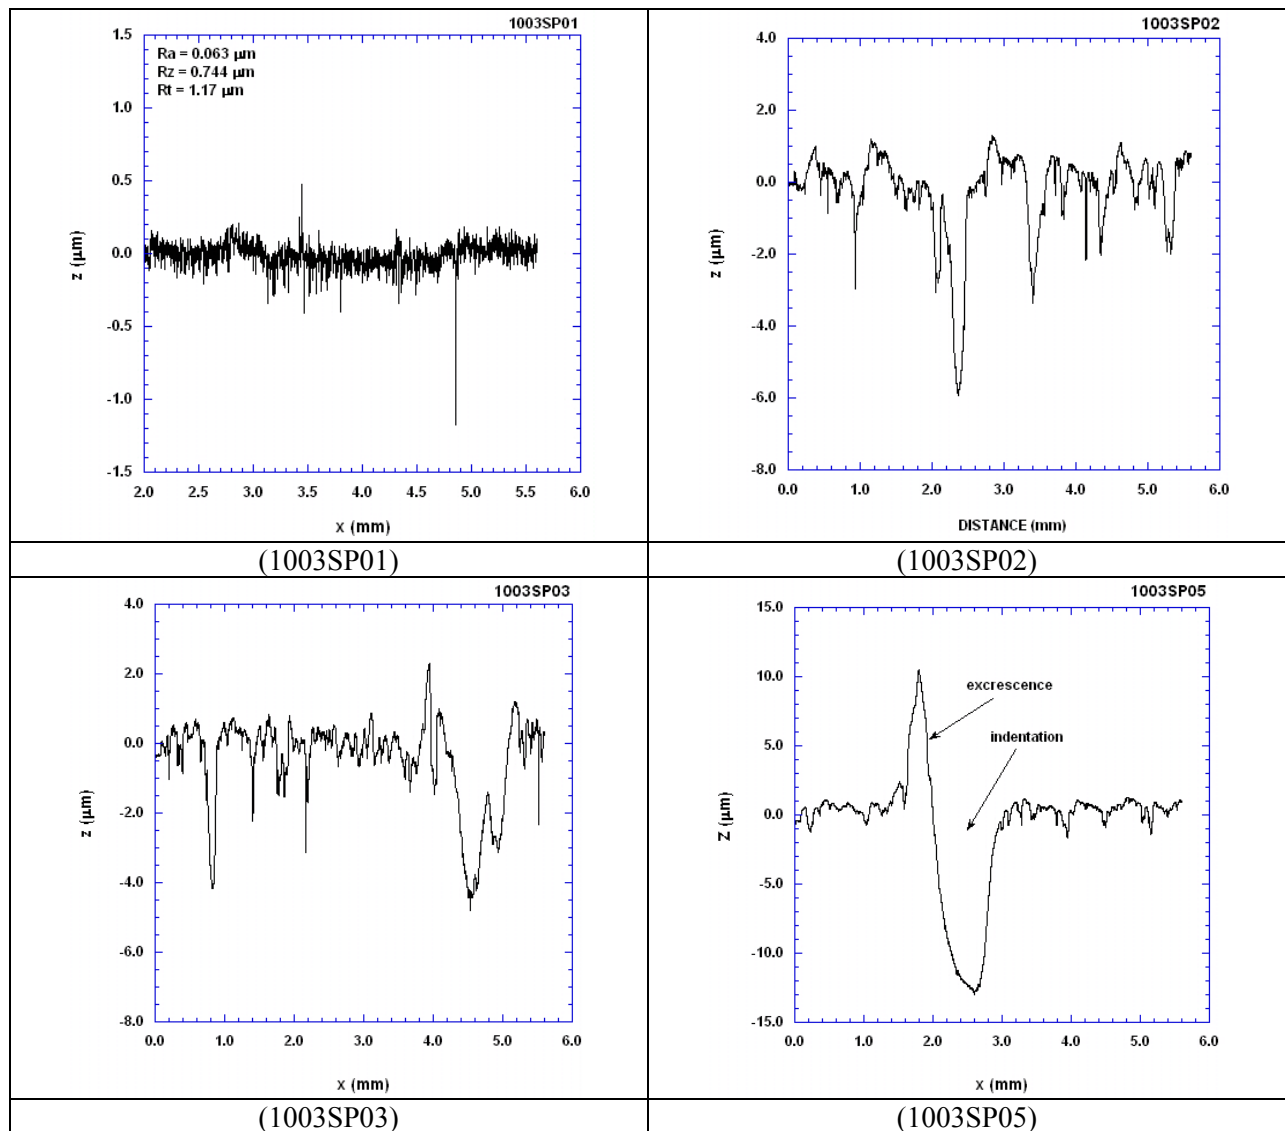
(1003SP01) Roughness measurement of the shiny, non-indented area of the inner race OD.

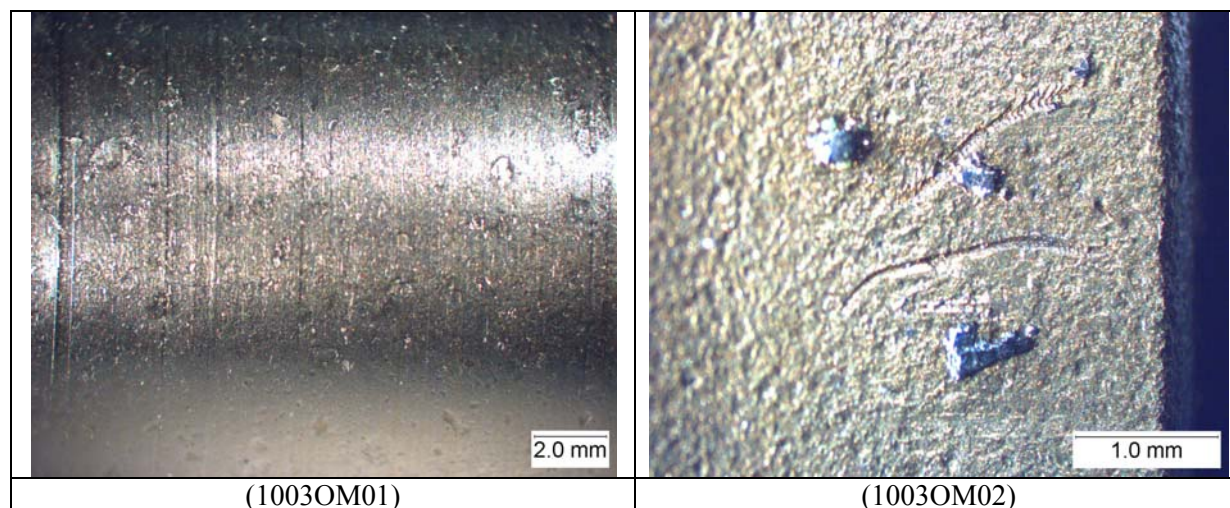
Figure (1003OM02) shows several fragments of steel embedded into the surface of the separator. Chatter marks in the softer bronze show how the fragments were dragged into the space between the roller and separator as the assembly turned, causing irregular, curved scratches in the bronze.

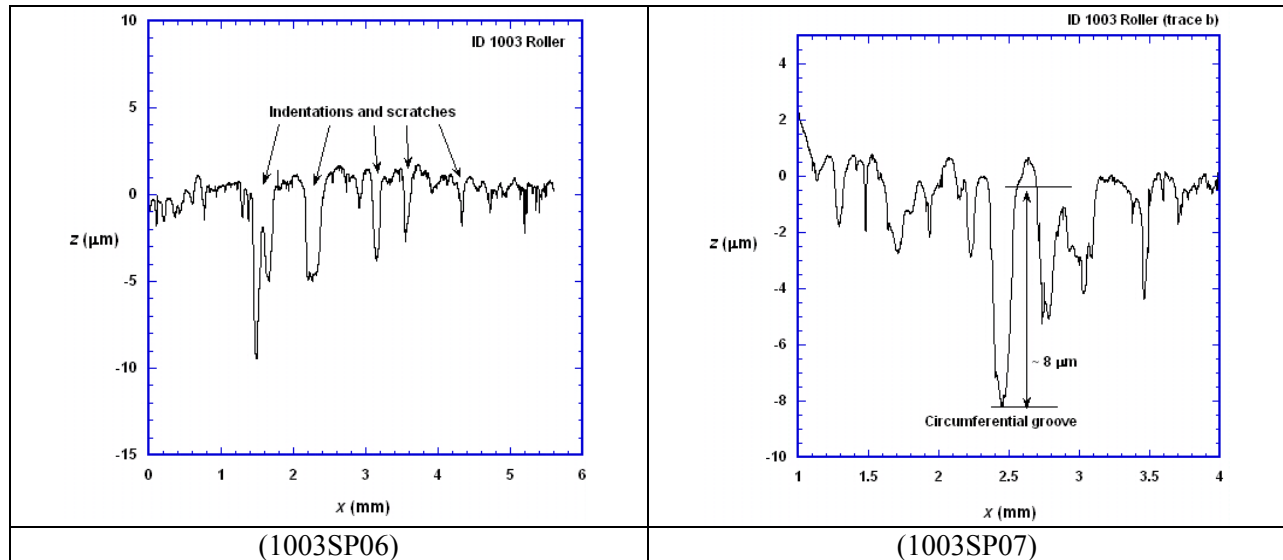
Typical surface profile traces are shown in Figures (1003SP06, 07, and 08). The first shows a typical trace and the second shows profiles of one of the deeper circumferential scratches. Figure (1003SP08) shows a rather deep indentation from debris.

(1003SP07) Profile across one of the more prominent circumferential scratches on the roller.
