Aircraft Propeller Hub Repair

ORNL/TM-2015/056
CRADA/NFE-14-05024

Materials Science and Technology Division
Advanced Manufacturing Office

Date Published:
February 13, 2015

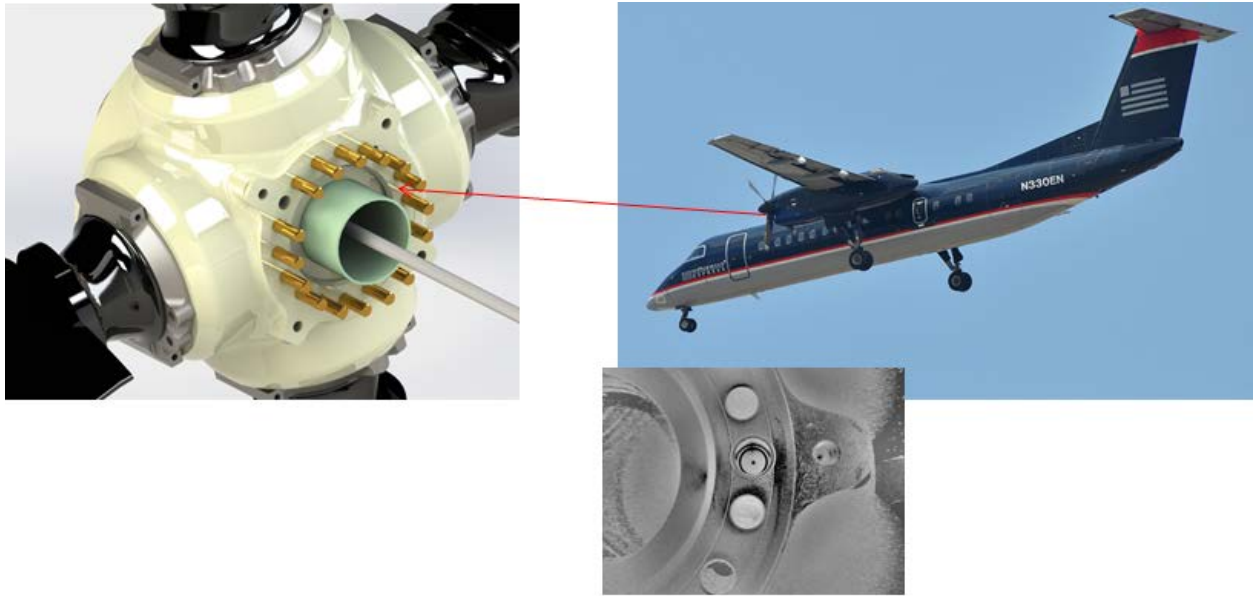
Fig. 1 shows the location of a propeller hub on a turboprop aircraft, with an image showing the typical area of anomalous indications causal for rejection of the hub for flight service. Five propeller hubs were provided to ORNL; one was a refurbished unit that was acceptable for return to service, one was as-removed from an aircraft just prior to performing maintenance refurbishment and the three others were at the minimum material condition (MMC) having just completed maintenance refurbishment, but had deleterious die penetrant indications precluding return to service. A summary of the hub conditions and actions performed by ORNL are in Table 1.

Fig. 1. Depiction of a propeller hub from a turbo-prop aircraft.

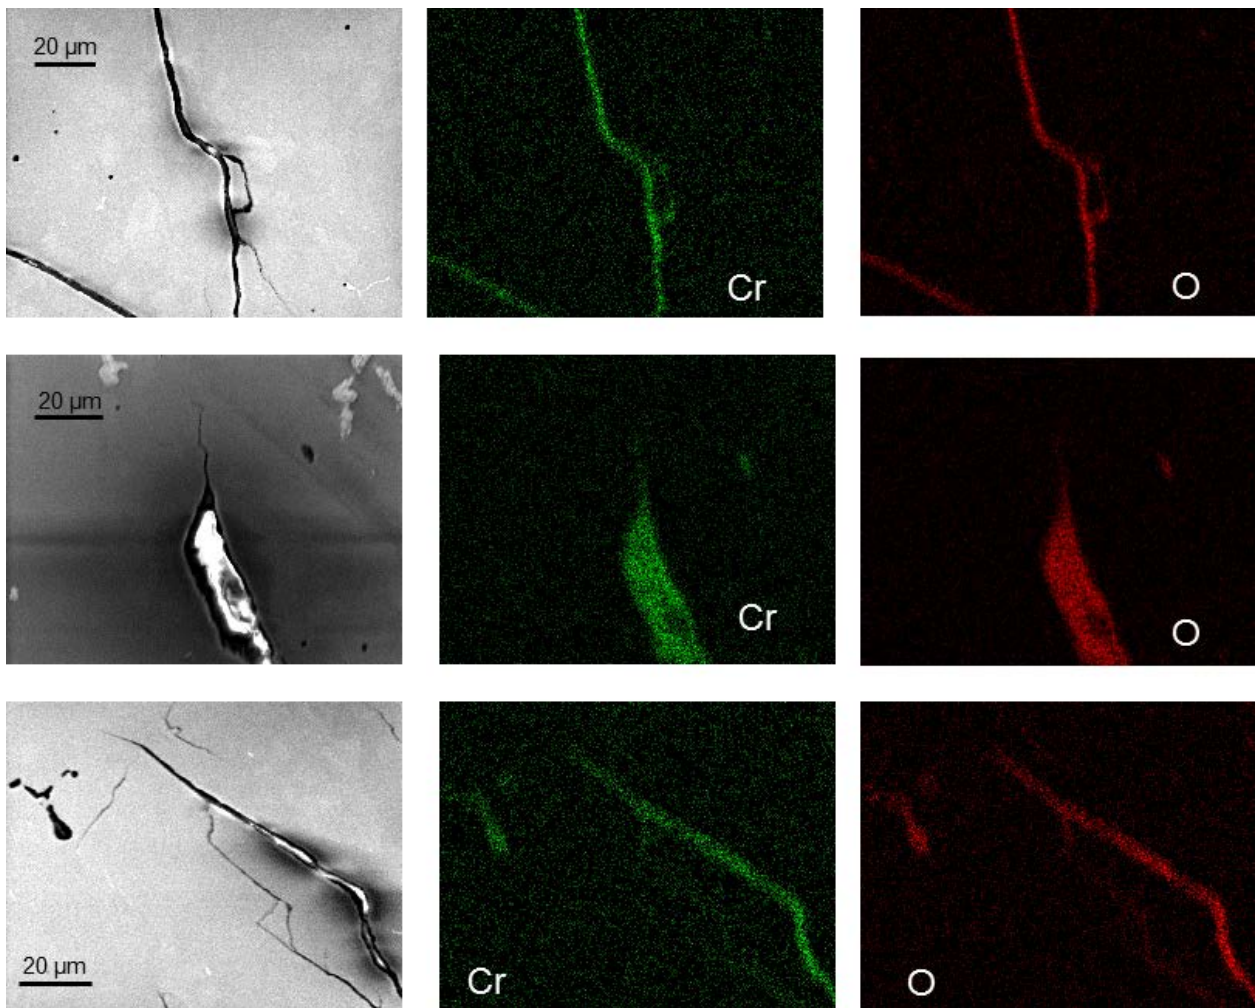
In conjunction with the NTSB information, and the examination of hub A where smearing was observed, fretting was deemed the likely source as a crack initiation event prior to propagation. The observation that the anomalies / cracks were all located adjacent to the dowel pin holes, lead the team to categorize the observations on the five hubs examined as a progression of fretting damage with eventual crack propagation.

initiator, based on the similarities with hub A. It is hypothesized that fretting damage lead to stress concentration and that stress concentration in the zone adjacent to the dowel pin holes, where expected misalignment occurred, resulted in higher structural loads. The crack initiation was followed by propagation during the load cycles in service. The crack propagation in the case of hubs C, D, and E was sufficient to be present after refurbishment machining to MMC.

Two of the hubs with die penetrant indications at MMC were sectioned for examination. Samples were prepared and observed under the optical and the scanning electron microscopes (SEM). The SEM analysis utilized the energy-dispersive x-ray spectroscopy module to identify elements at observed crack openings and discontinuities. The base microstructure was typical of AMS4141 aluminum. In areas where cracks and anomalies were observed, accretions high in chromium and oxygen were identified. Fig. 2 depicts a typical finding. Chromium likely results from the chromate conversion treatment applied to inhibit corrosion of the hub in service.

Fig. 2. Example of typical anomalies identified and associated with fretting in base metal adjacent to one of the dowel pins in one of the examined hubs. There is a noticeable concentration of chromium and oxygen in the crack opening likely associated with the chromate conversion process used to mitigate corrosion.

Because of the common proximity of the die penetrant indications to the dowel pin holes and the damage observed in the same location on the as-removed hub, solutions relating to repair were targeted at the area on the flange face adjacent to the dowel pins. For fretting prevention in new hubs, it was recommended that a recess in the mounting face be machined to simply prevent contact in the fretted area.

For repair of existing flanges, two approaches were recommended. Both methods require removal of all detectable damage, prior to attempting a repair. If damage removal left the hub above the MMC, then a silver cladding applied via electromagnetic pulse (EMP) technology was recommended. If damage removal left the hub below the MMC then a thin foil aluminum alloy patch, applied via ultrasonic welding was recommended to bring the flange face above the MMC.

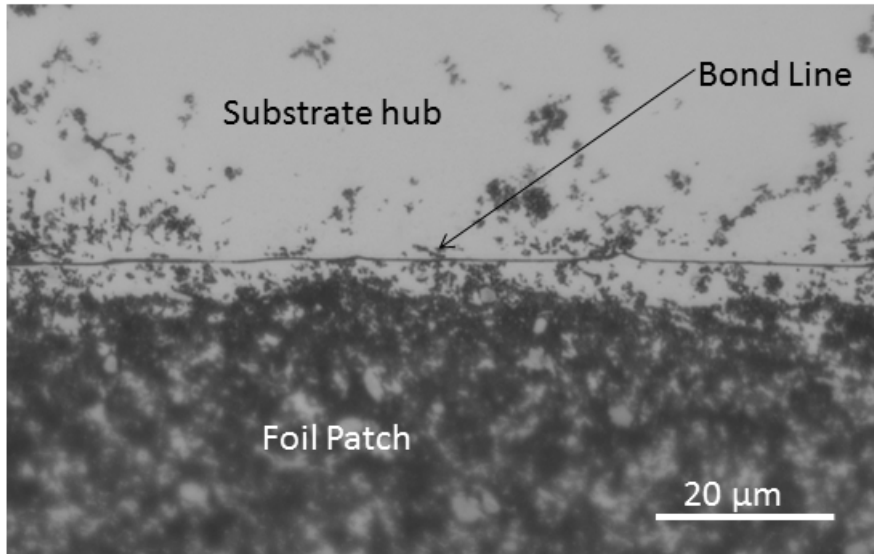
The ultrasonic welding method on the flange face was attempted at Fabrisonics in Columbus, OH, using samples removed from a scrapped hub. Mechanical bonding was observed upon sectioning of the weldment as depicted in fig. 3. The results indicate some promise toward achieving a metallurgical bond with further research.

Fig. 3. Cross section of an aluminum alloy foil being attached via ultrasonic welding to a sample of a hub. The substrate hub is white, and the foil attachment is dark (bottom). The bond line is visible as a linear feature indicating mechanical bonding.
