**POST-DEFORMATION EXAMINATION OF SPECIMENS SUBJECTED TO
SCC TESTING**

Prepared under the direction of the
U.S. Department of Energy
Office of Nuclear Energy
Light Water Reactor Sustainability Program
Materials Aging and Degradation Pathway

Prepared by
OAK RIDGE NATIONAL LABORATORY
Oak Ridge, TN 37831-6285
managed by
UT-BATTELLE, LLC
for the
U.S. DEPARTMENT OF ENERGY
under contract DE-AC05-00OR22725

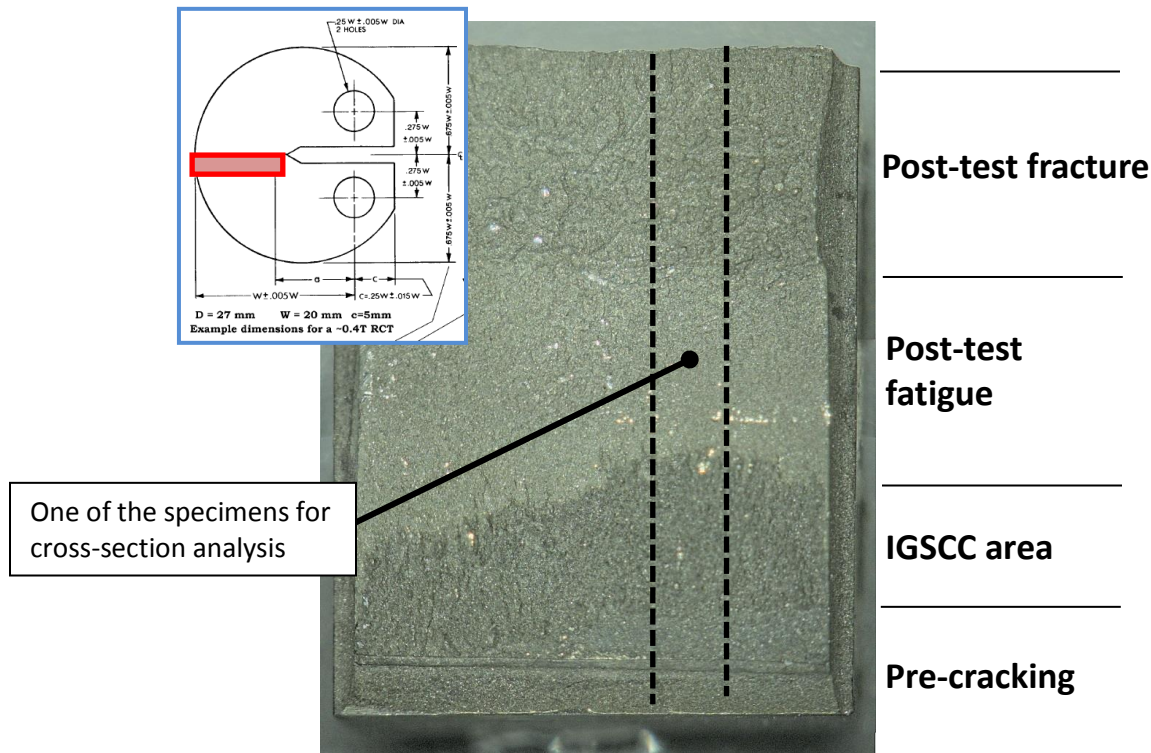
Figure 2. The appearance of the fracture surface of the MS-01 specimen after crack growth test. All specific areas (pre-cracking, corrosion crack growth, etc.) are clearly distinguishable from each other. The insert features a line drawing of the RCT specimen, showing the location of the cut fracture surface specimen.

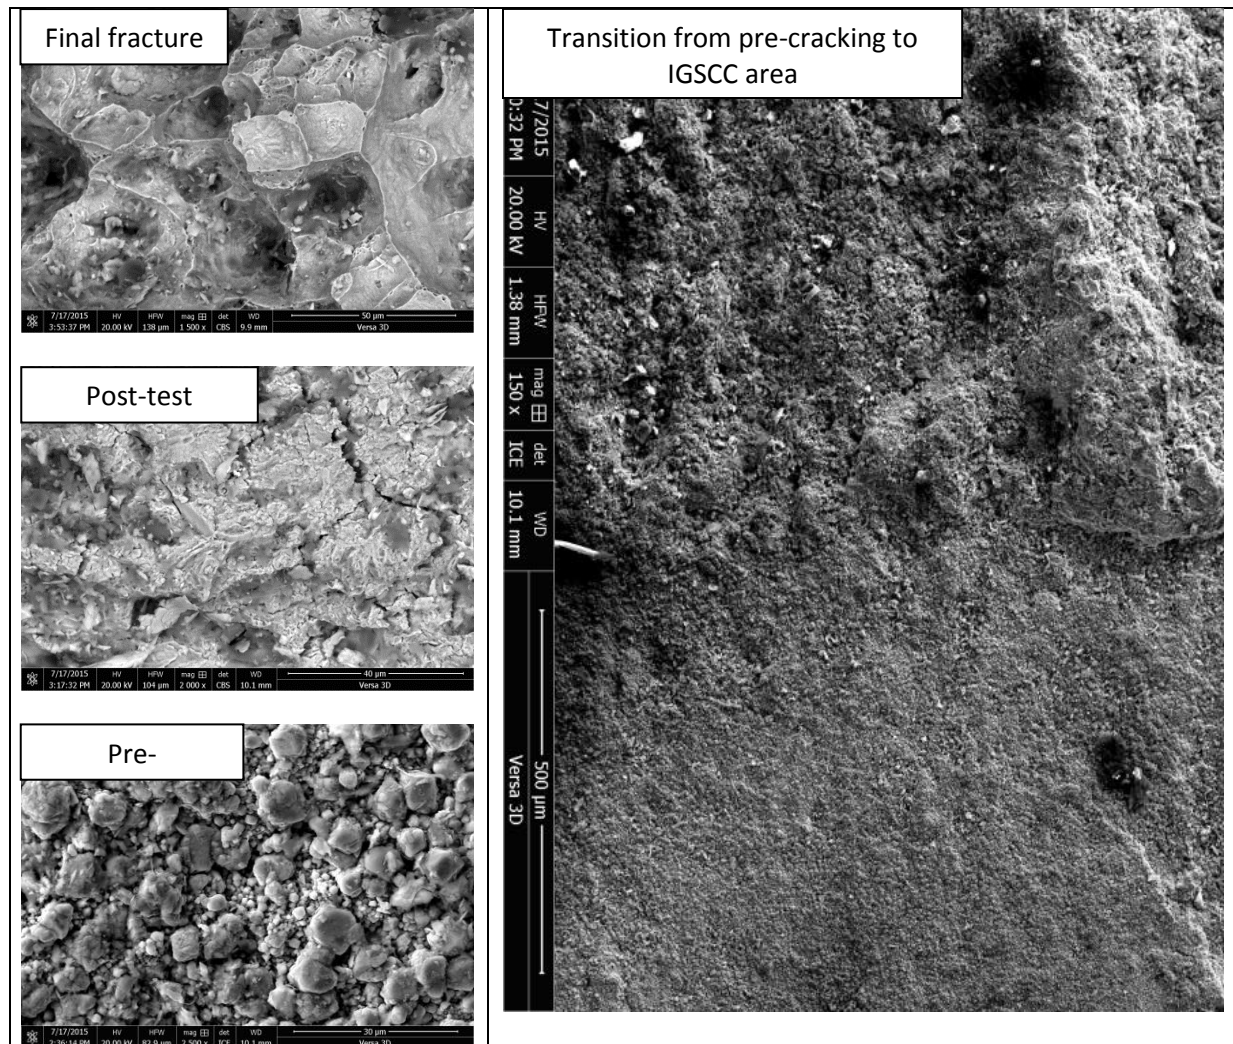
Figure 3. SEM images of specific areas on the specimen surface. Note the strong oxidation of the pre-cracking area and pronounced ductile fracture surface in the final fracture area.

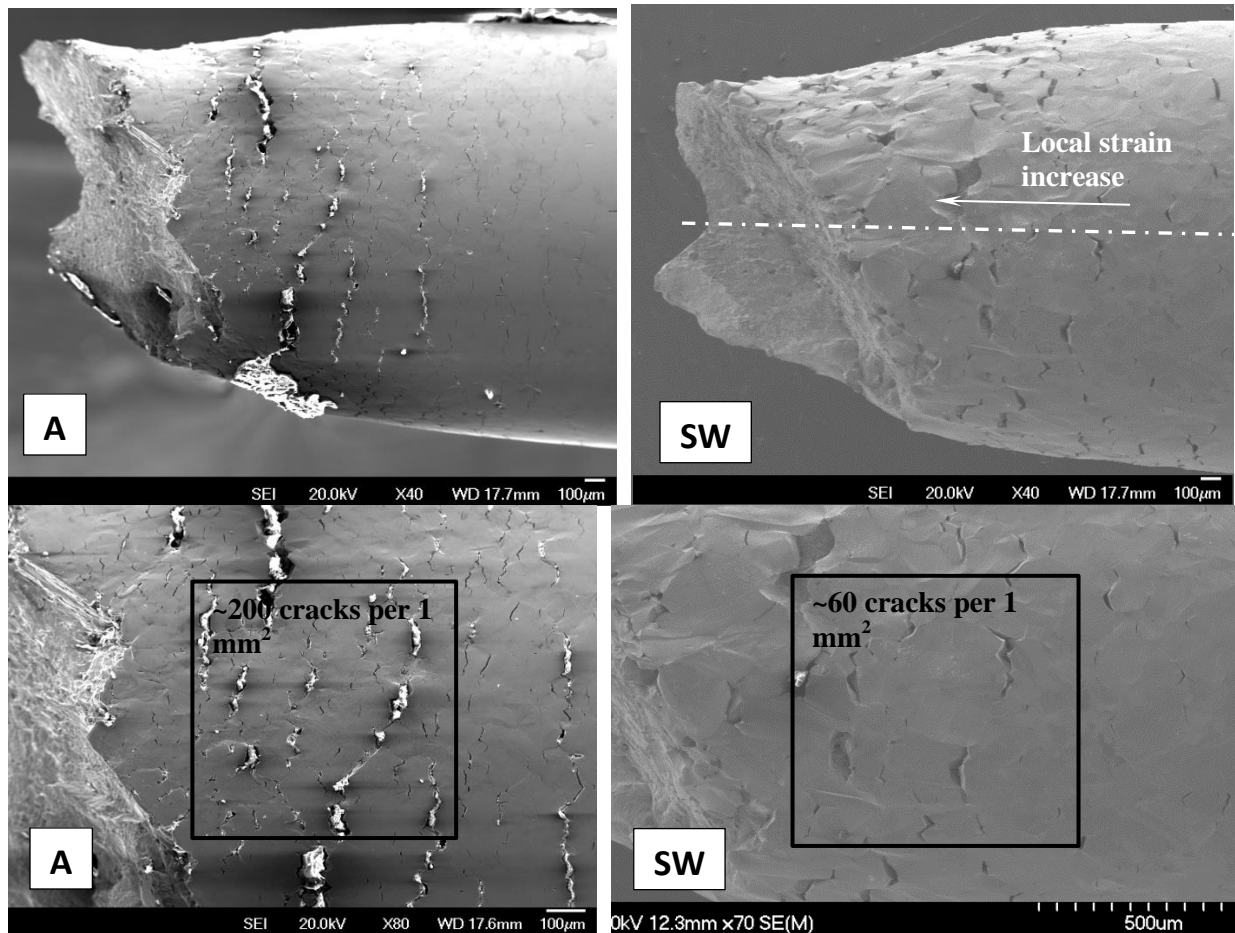
Figure 8. Specimens after CERT evaluations and oxide cleaning. The top images show a general view of the specimen neck. The gradient in plastic strain and in crack density can be seen. The bottom images illustrate the difference in crack density between the alloys. Bright material filling some cracks in the A-alloy is the remaining epoxy after replica preparation. It could not be removed without significant sample surface damage.

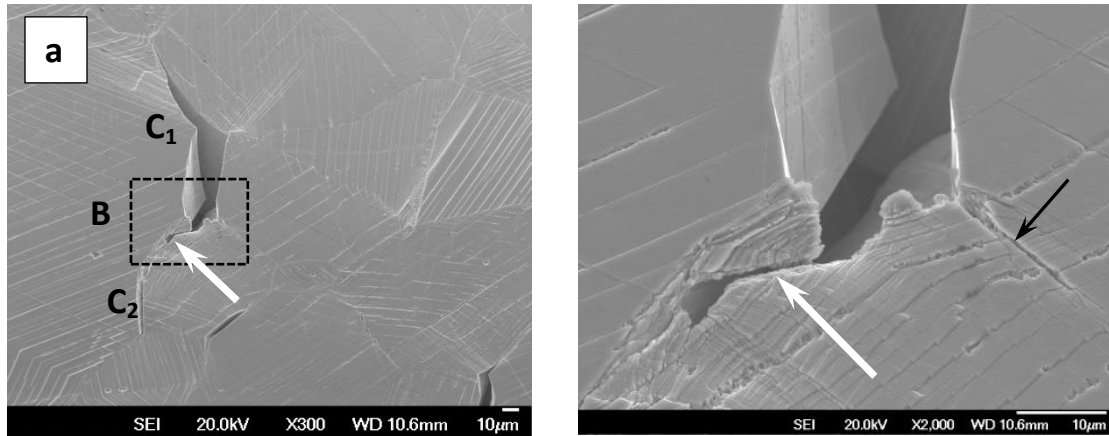
Figure 10. (a) Cracks C1 and C2 demonstrate a tendency to coalescence via ductile or transgranular fracture (white arrows) of the bridge area (B); (b) image showing a high degree of plastic strain and channel density at the blunted crack tip. Note also oxidized grain boundary (black arrow).

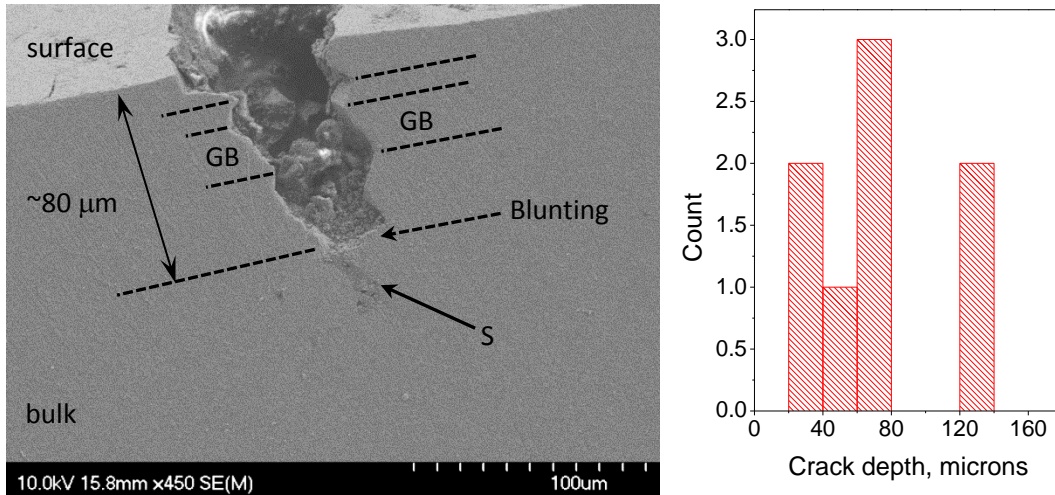
Figure 11. An intergranular crack in a 10.2 dpa A-alloy. A view of the specimen cross section is pictured on the left, and the crack depth distribution is on right. GB is an example of the cracked grain boundary segment. S represents a secondary crack, most likely filled with oxide products. CERT evaluations were completed in PW conditions.

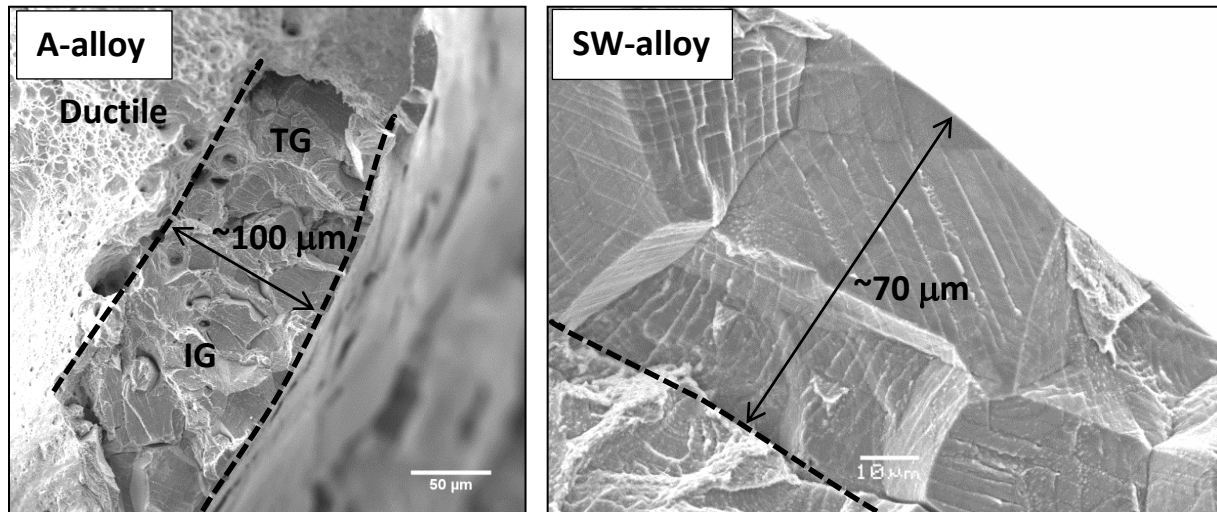
Figure 12. Cracks observed at the fracture surface for both alloys. TG = transgranular, and IG = intergranular.

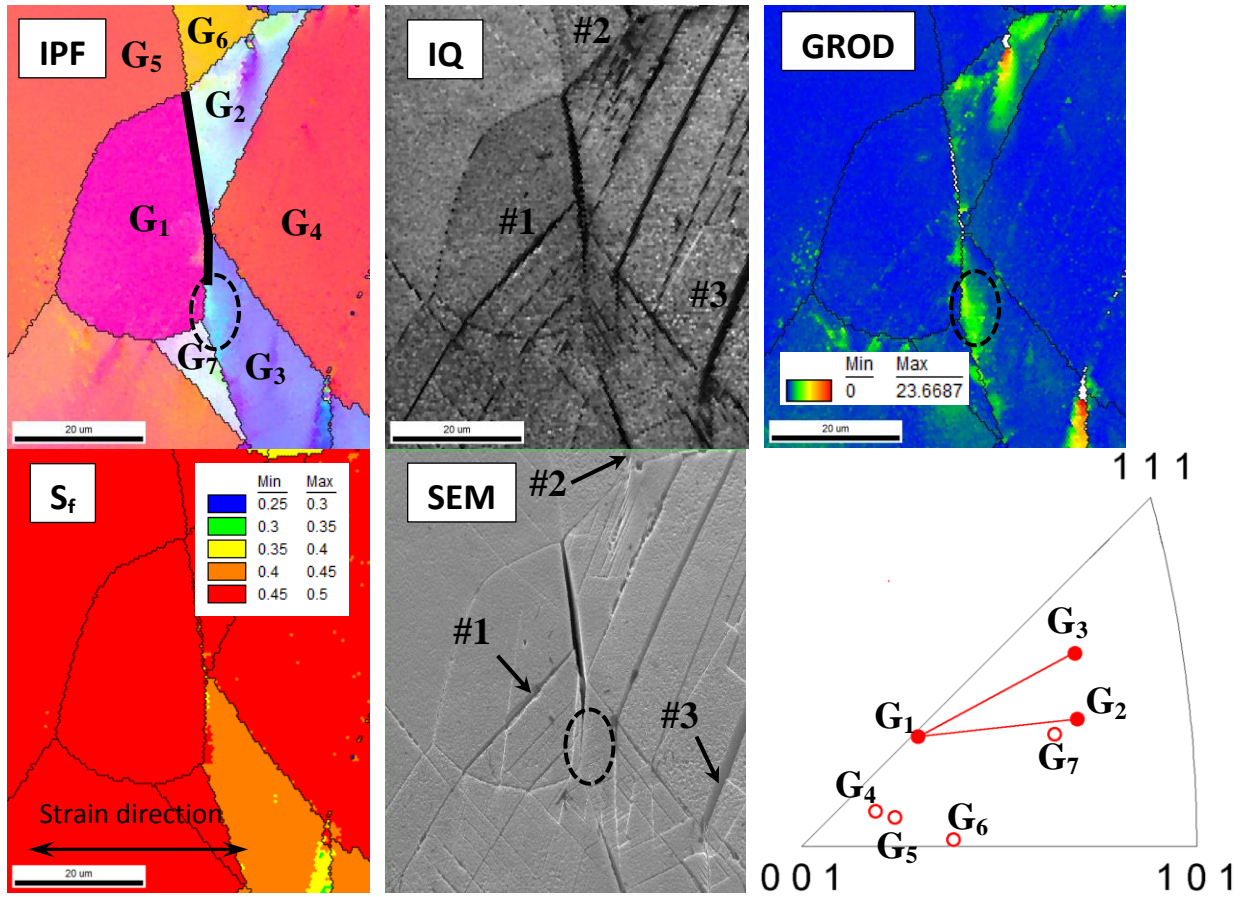
Figure 13. EBSD-acquired information for a typical crack in an SW-alloy. IPF colored in the tensile direction, IQ, GROD, and Schmid factor (S_f) maps with corresponding 70° tilted SEM image. The unit triangle at the right shows the orientation of G_1 – G_7 grains in the crack vicinity relative to the tensile direction. Solid circles are grains adjacent the crack, and open circles are grains not involved in cracking.

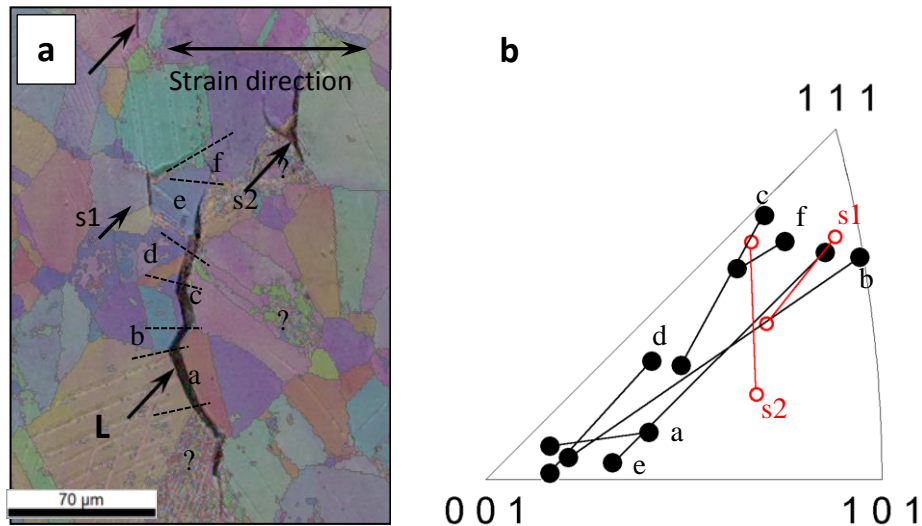
Figure 15. Grain orientation data for a relatively large crack (L) in an A-alloy. (a) [010]-IPF map overlapped with SEM image. (b) [010]-IPF, [010]-load direction. A–f represent segments of crack L. S1 and s2 are small satellite cracks. Question marks designate grains for which orientation cannot be defined because of heavy surface damage. The local strain value is ~2.3%.

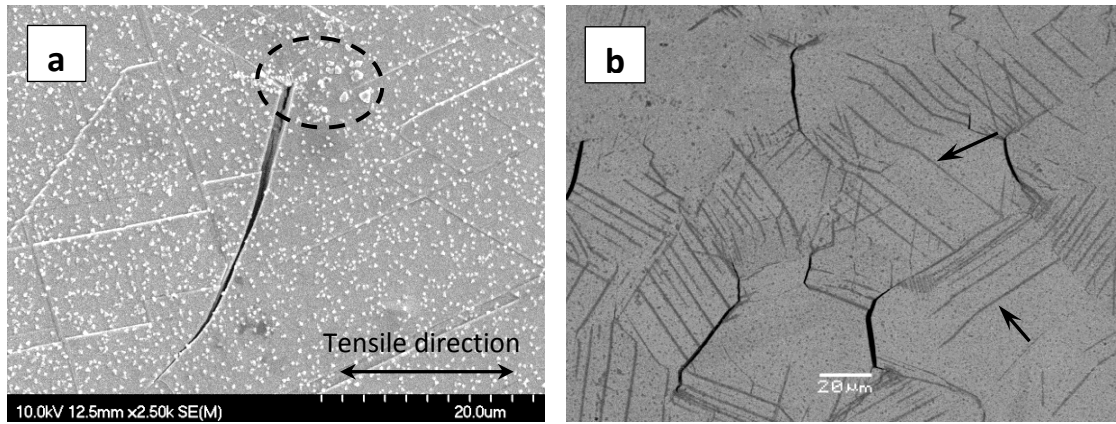
Figure 27. (a) Localized oxide distribution near a crack initiation site in the SW-alloy. The dashed oval highlights local variations in oxide particle morphology. (b) An SEM-BSE image of the specimen surface. Black arrows point to channels, and a few cracks are visible on the right side. Both images show the as-tested surface without oxide cleaning. The BSE image was provided by K. Stephenson.

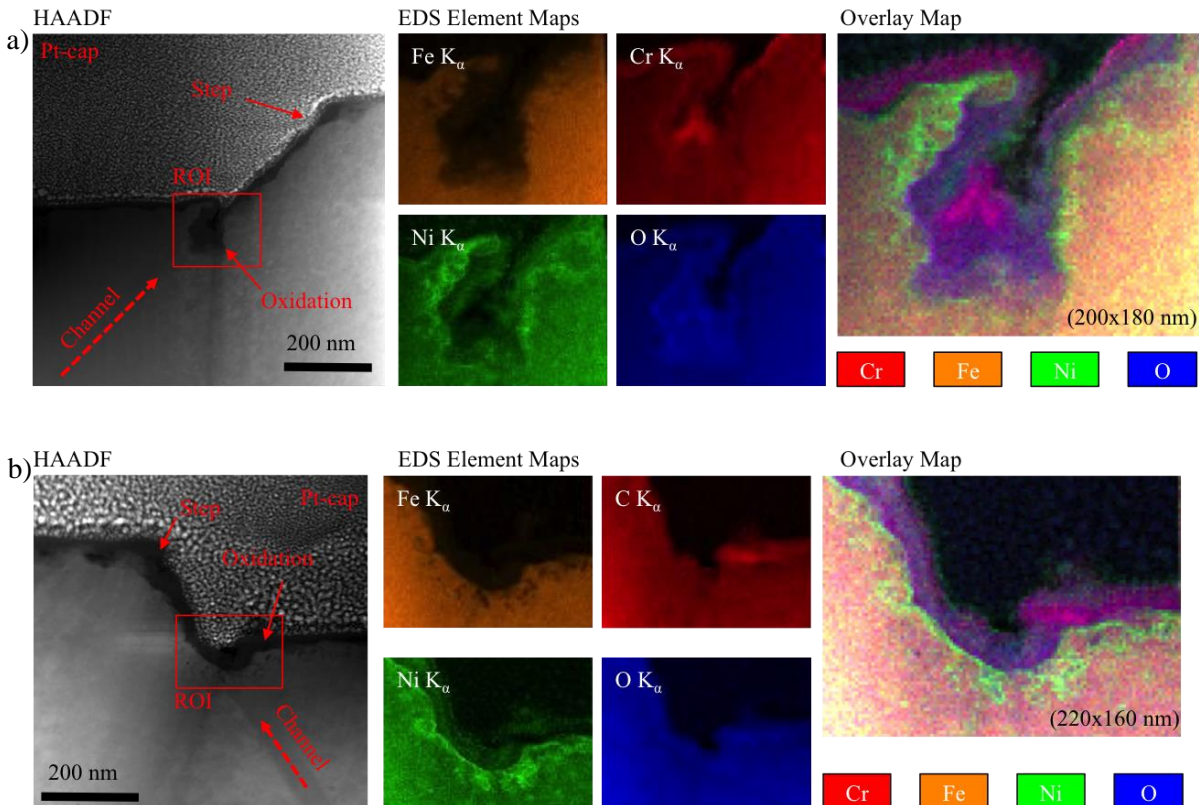
Figure 28. High-angle annular dark field (HAADF) image, EDS element maps, and color-overlay maps of two dislocation channels. (a) Shows localized erosion at the base of the surface step, and (b) shows a dislocation channel with the limited attack at the base of the surface step. In the HAADF images, the channel location and direction are highlighted as the composition contrast limits their visibility in this particular imaging mode.

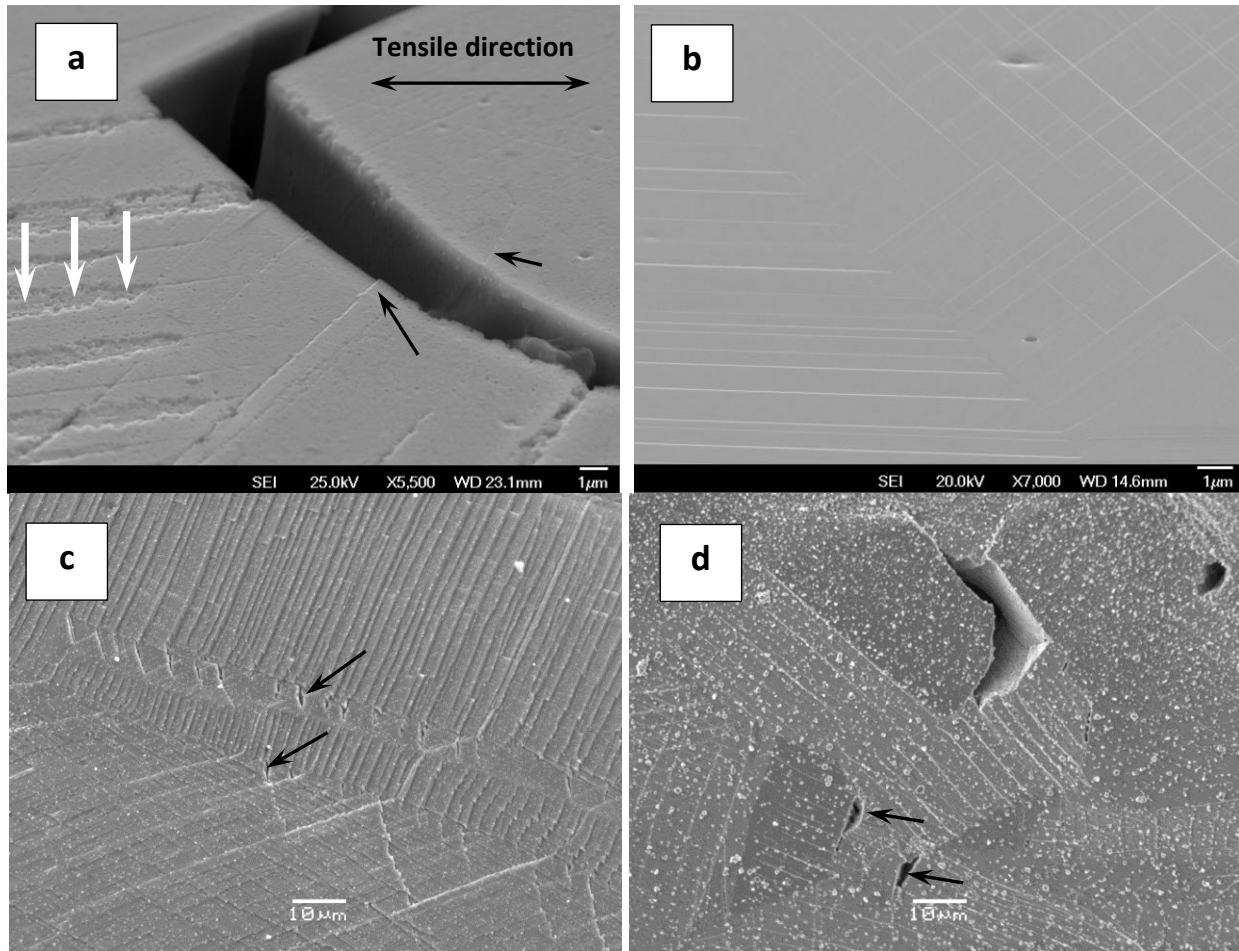
Figure 29. (a) Enlarged view of the cracked grain boundary and slip lines at the surface. One can see surface steps caused by dislocation channels (black arrows). The surface is eroded along the channels (white arrows). Local strain $\sim 1.3\%$. A-alloy. (b) Surface relief example for non-irradiated commercial 304 steel strained at 1% at RT and strain rate 10^{-3} s^{-1} (for comparison). The slip line density is higher and the height is lower compared with the irradiated case. Images (c) and (d) are examples of transgranular cracks (pointed by arrows) for (c) SW- and (d) A-alloys.

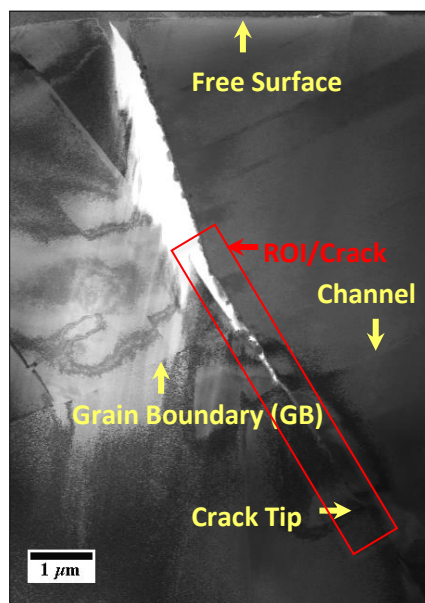
Figure 30. Near-surface crack in the SW-alloy (commercial AISI 304L steel irradiated to 4.4 dpa) tested at PW conditions. Some specimen loss is apparent on the left side of the crack as a result of preferential thinning of this area during FIB preparation.

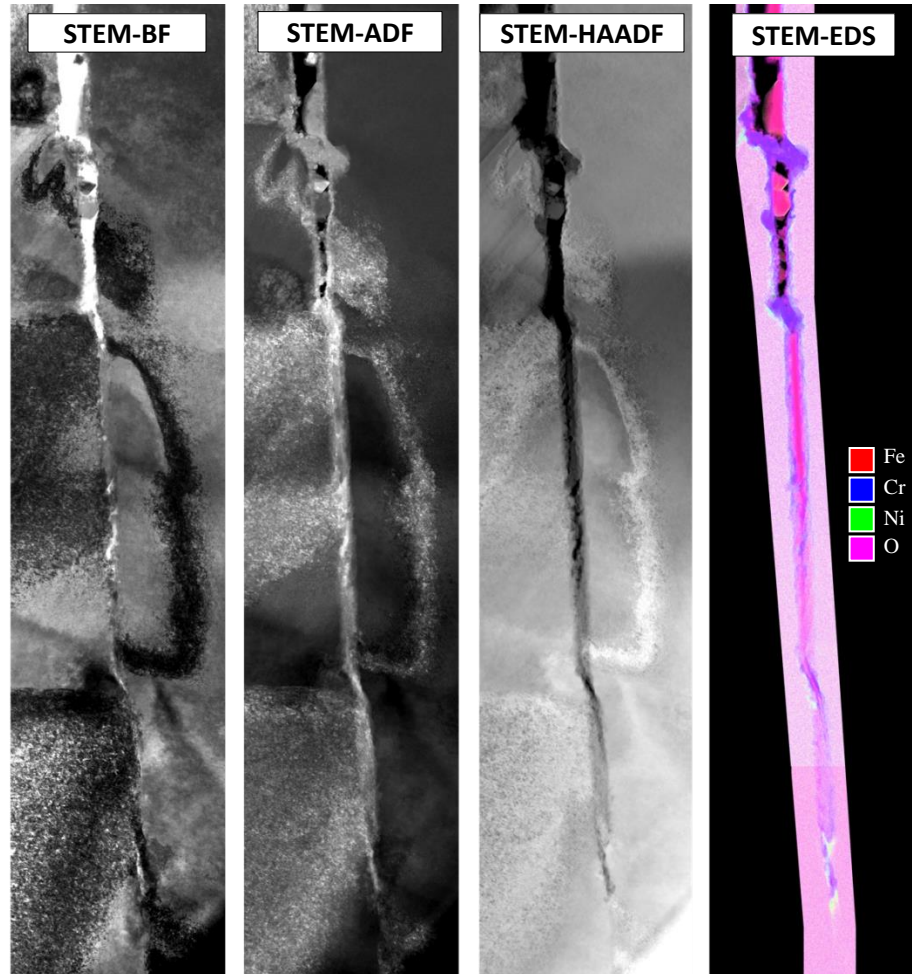
Figure 31. The internal structure of the bottom portion of the crack shown in Figure 30. Images are formed by joining several data sets together and blending them to form a more uniform contrast image. Because of the large size of the crack, only regions directly adjacent to the crack were analyzed using STEM-EDS.

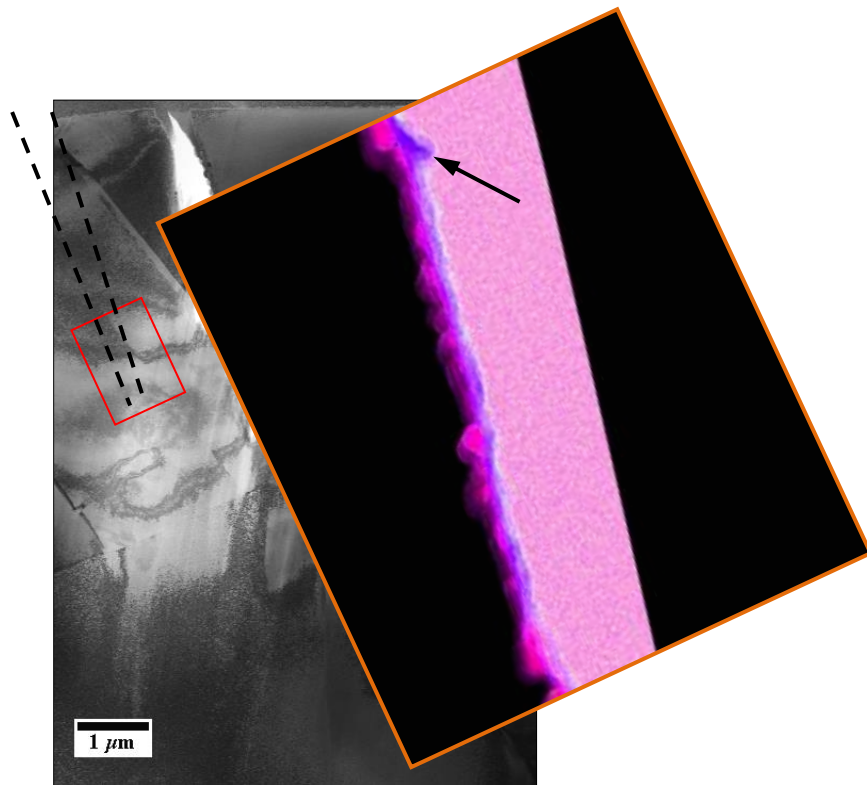
Figure 32. Oxide layer in the widely open (top) portion of the crack. The black arrow points to oxide penetration in the matrix.

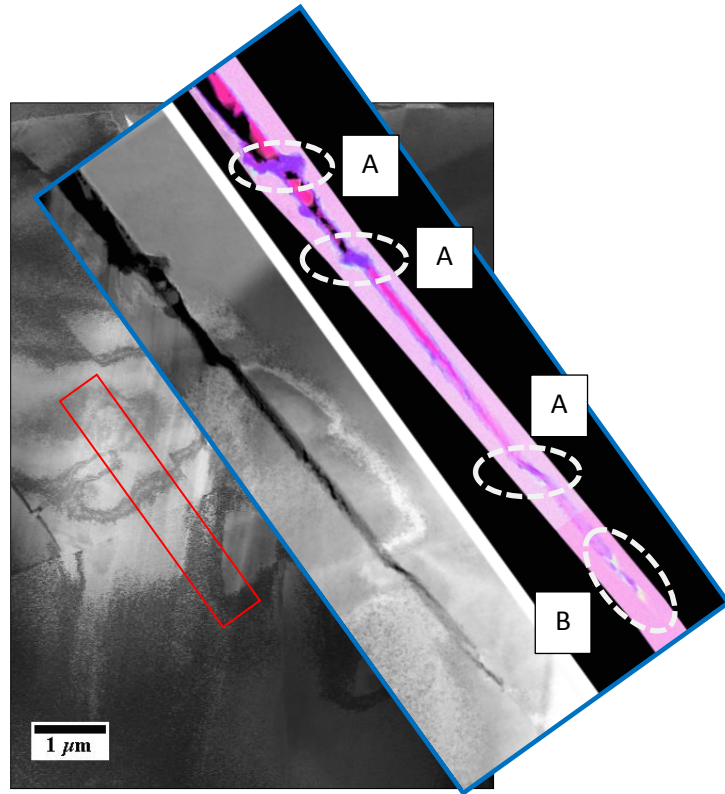
Figure 33. Specific oxide morphology at the channel-crack intersection (A) and the crack tip (B).

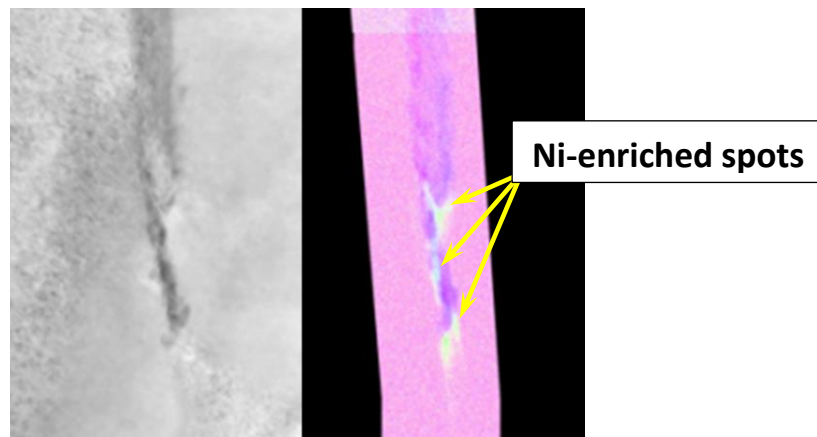
Figure 34. An enlarged view of the crack tip shown in Figure 33.

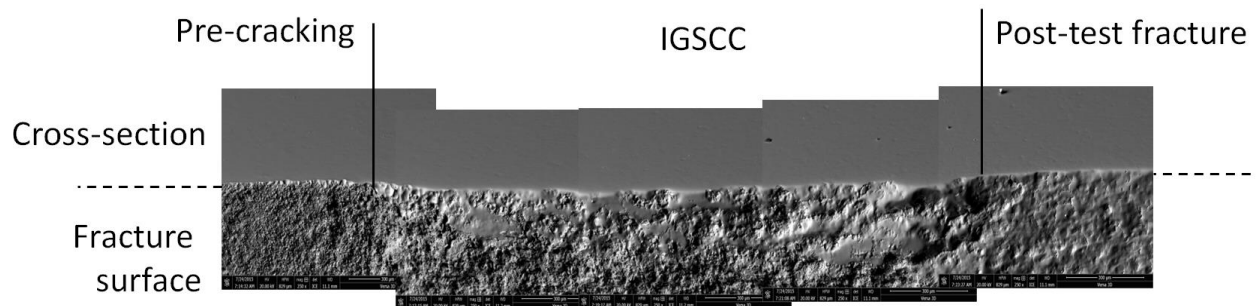
Figure 40. The enlarged view of the IGSCC area (MS-01 specimen) showing the absence of crack branching.

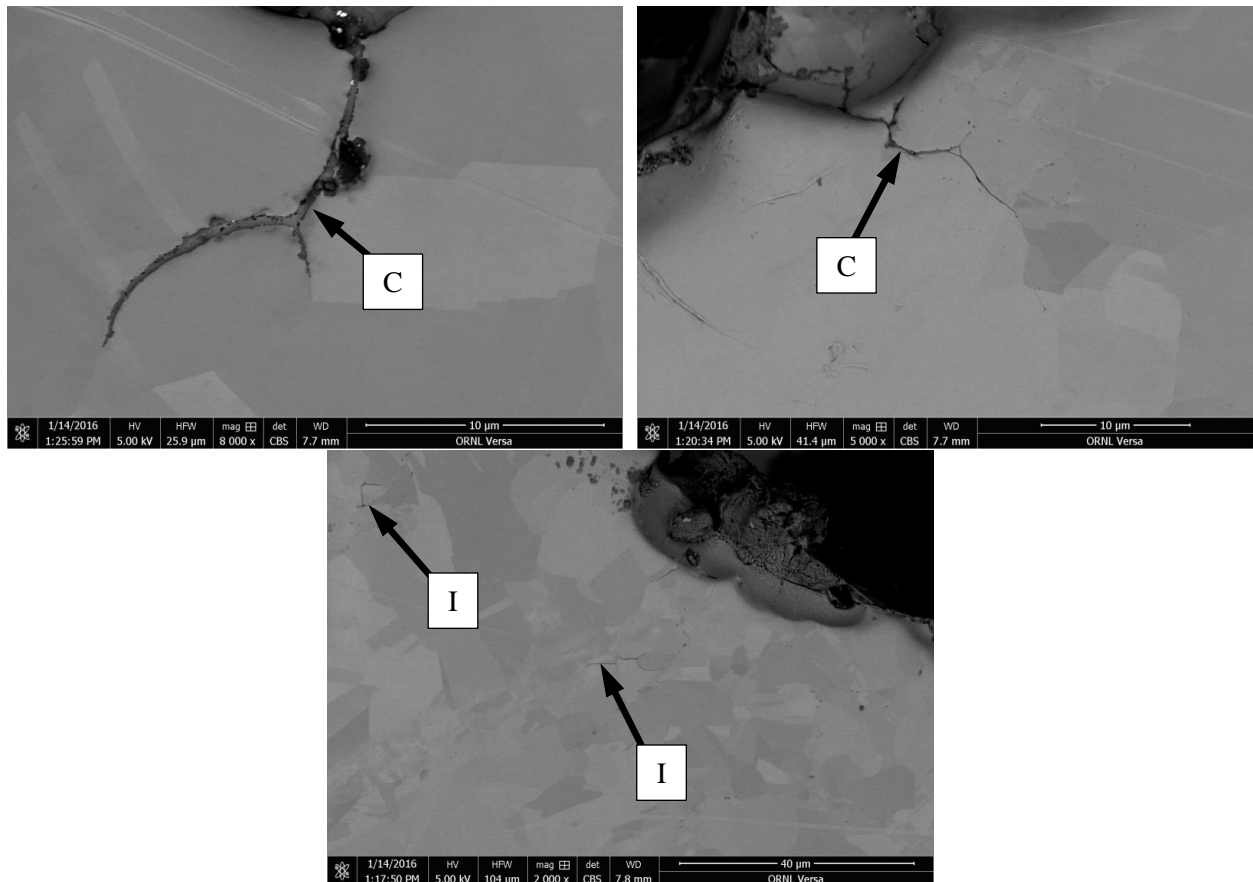
Figure 42. Secondary cracks (indicated with black arrows) in the M-alloy specimen. C: cracks with visible connection to the main crack; I: isolated cracks, without visible connection to the main (parent) crack.

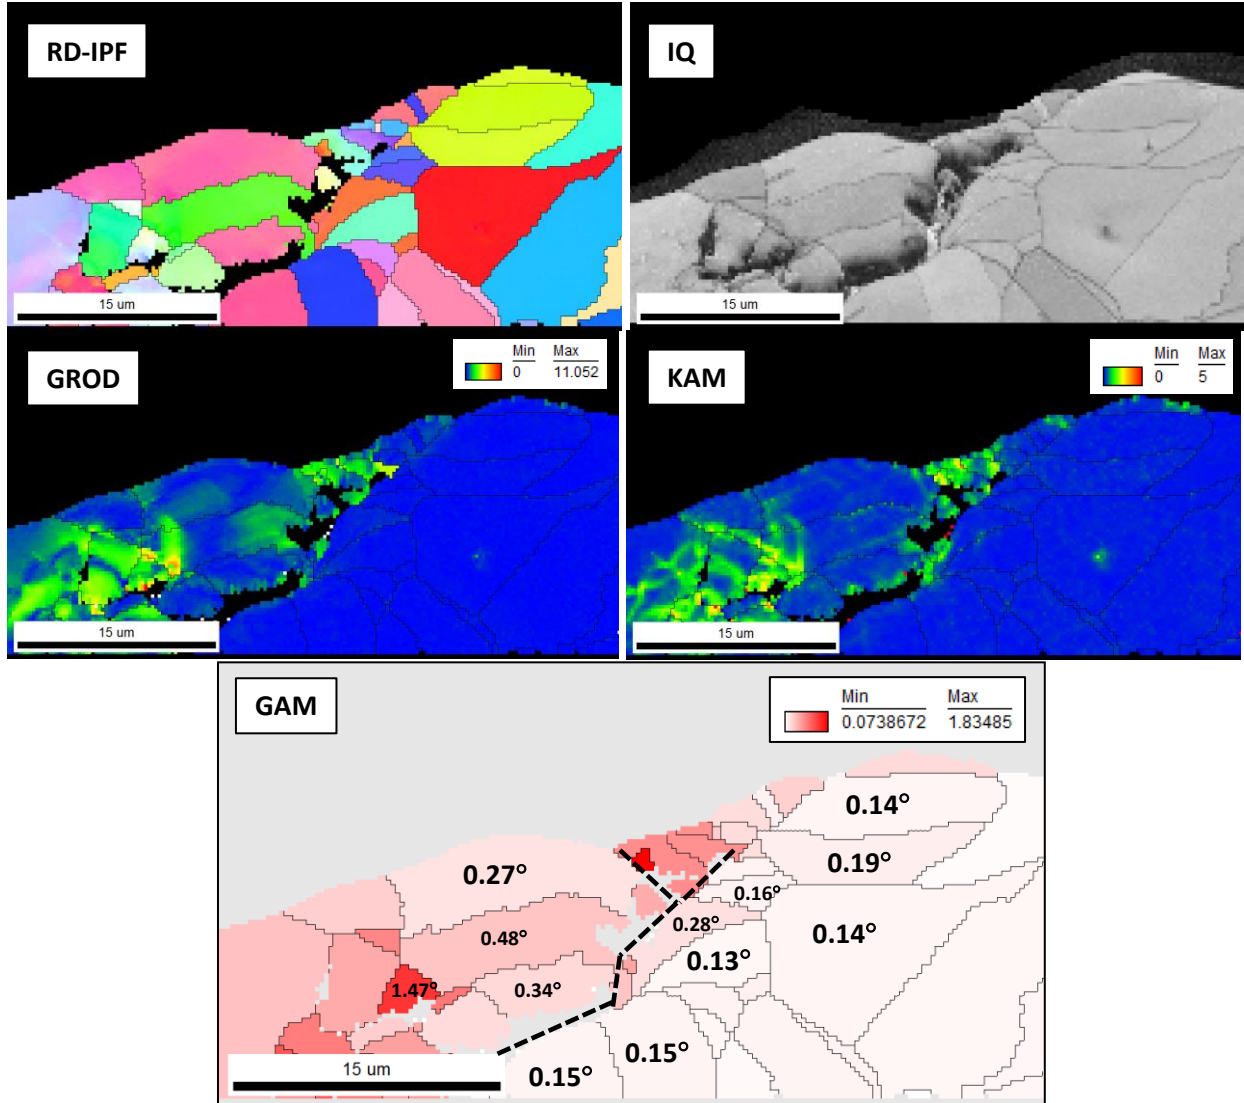
Figure 60. EBSD dataset for the area with small secondary crack (dashed black line). Step size is 125 nm, 70°-degree tilt. The GAM map also indicates the GAM value for some crack-adjacent grains.
