Cracking and Corrosion of Composite Tubes in Black Liquor Recovery Boiler Primary Air Ports

October 2006

Materials Science and Technology Division

**CRACKING AND CORROSION OF COMPOSITE TUBES
IN BLACK LIQUOR RECOVERY BOILER
PRIMARY AIR PORTS**

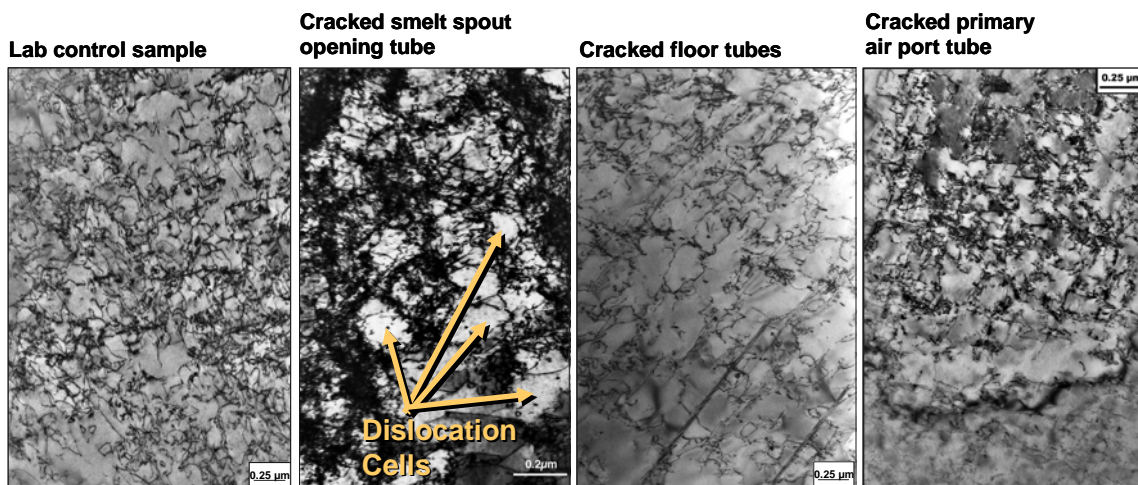
Fig. 3. TEM examination of tube sample shows differences between spout opening tube, floor tube and air port tube. The spout opening tube shows obvious evidence of thermal fatigue while the others only show evidence of thermal cycling.

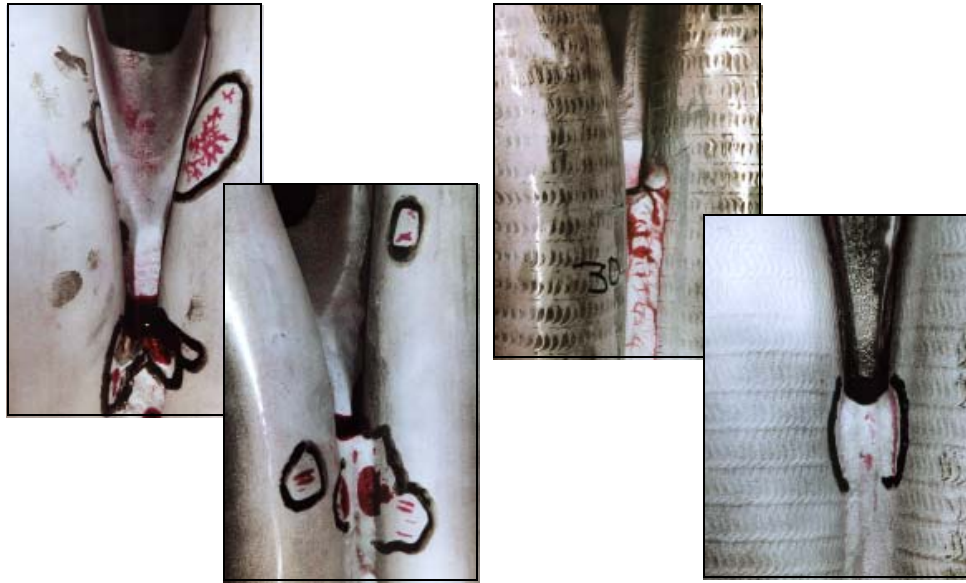
Fig. 4. Examples of cracked primary air port opening tubes with (left to right) craze cracking, circumferential cracking, membrane cracking and cracking in the membrane to tube weld.

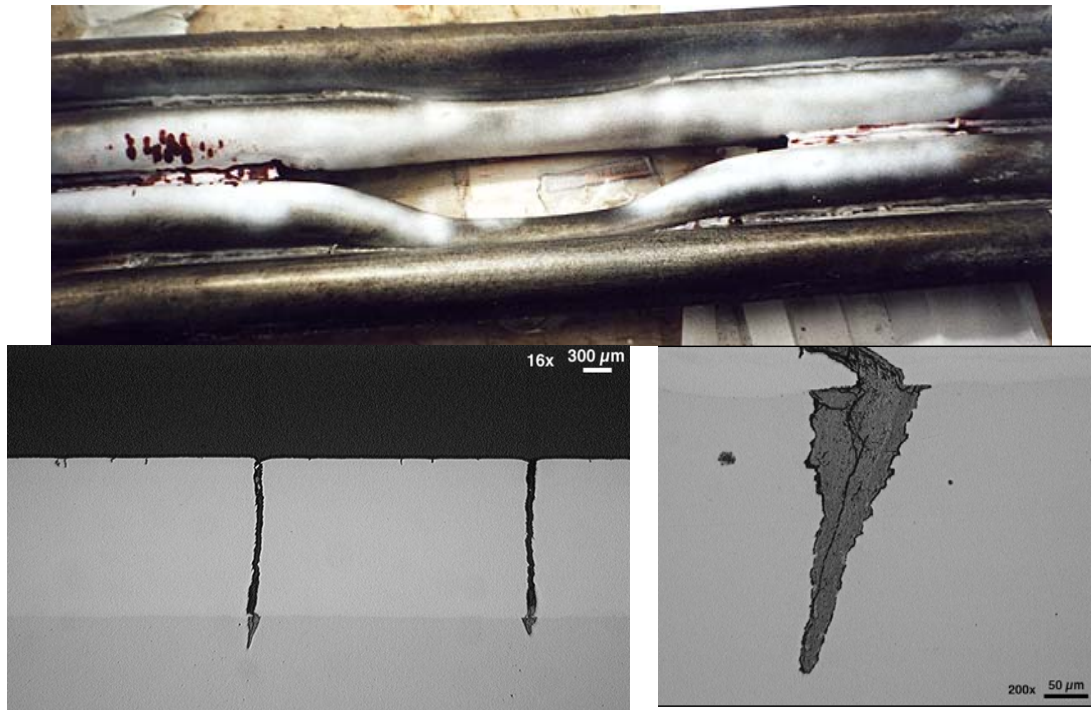
Fig. 5. Cracks in 304L stainless steel clad tubes just below the air port opening. Micrographs of the cross section of the tube show that these cracks penetrate into the carbon steel.

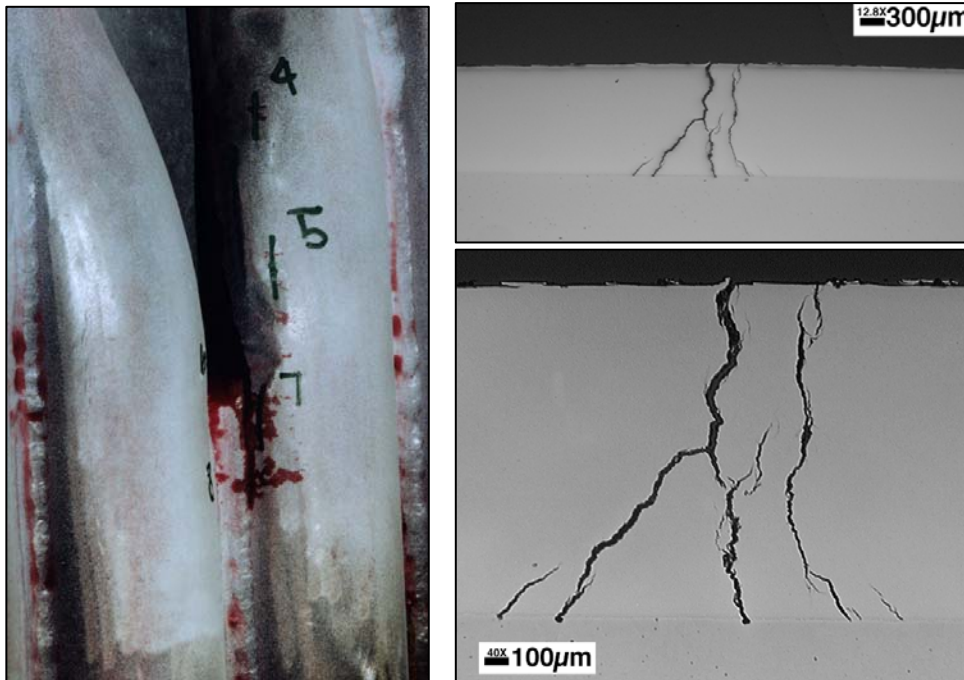
Fig. 6. Cracks in a 304L stainless steel clad air port opening tube. The cracks in location 4 are shown in cross section in the micrographs on the right. Note that many of these cracks terminate in a corrosion “pit” at the stainless steel/carbon steel interface.

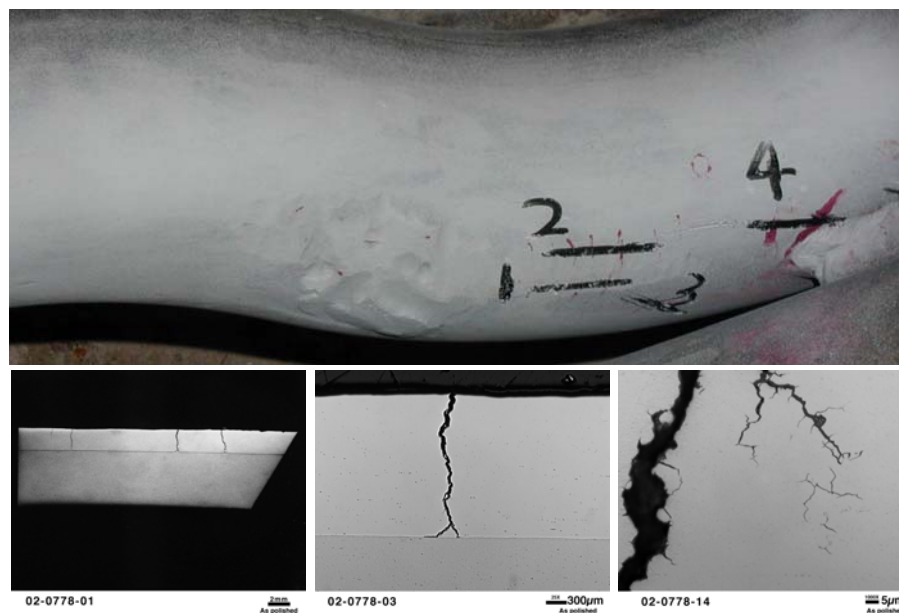
Fig. 7. Cracks in an alloy 625 clad air port opening tube. Many of these cracks continue through the alloy 625 layer to the interface. Note that the cracking is intergranular in nature.

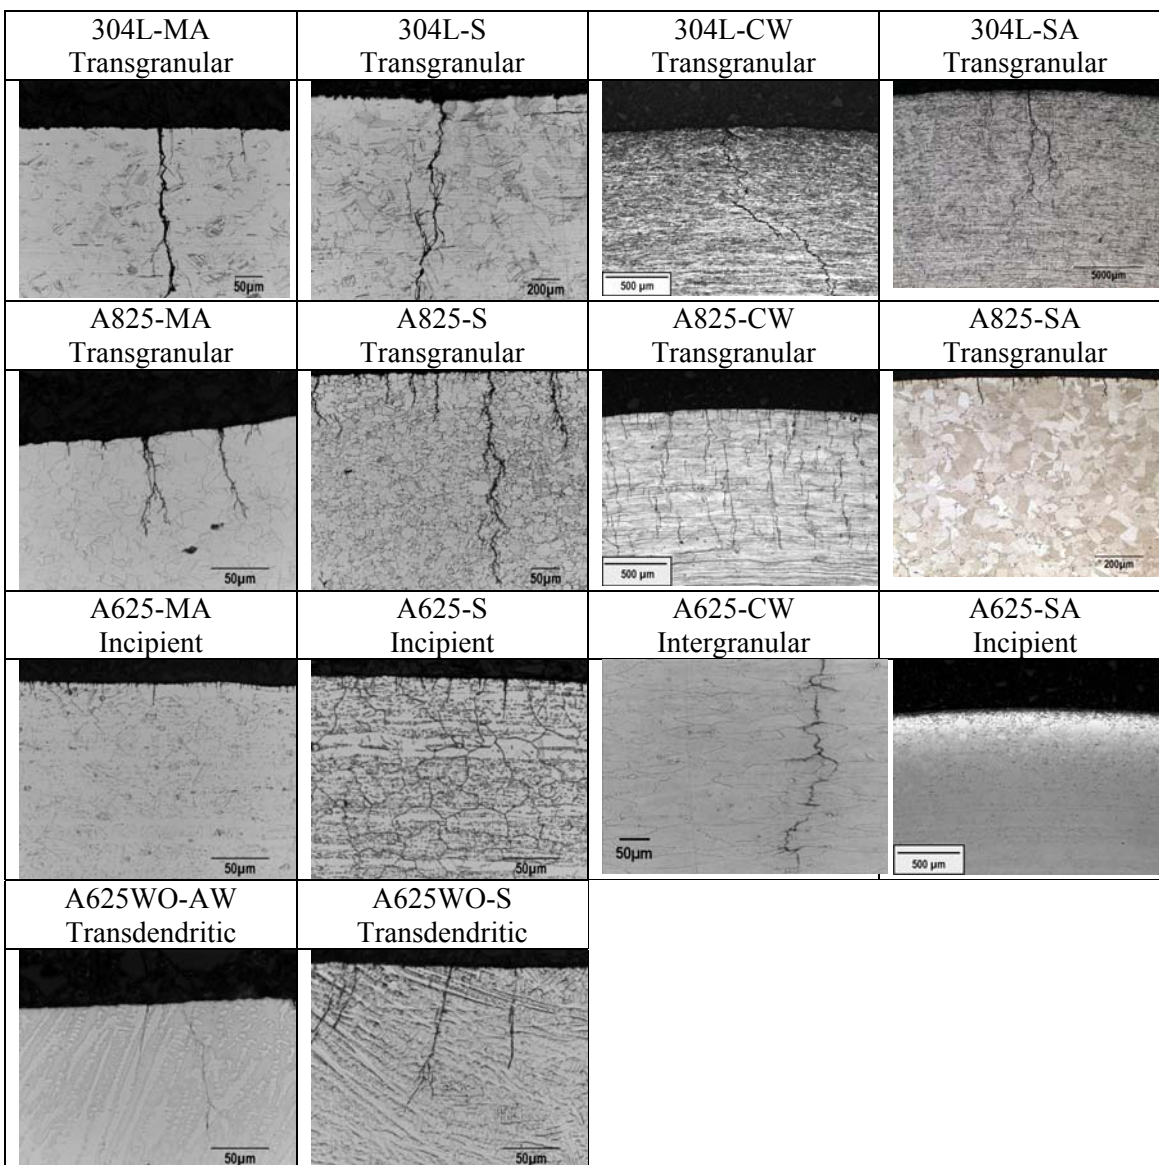
Fig. 104. Micrographs showing nature of cracking found in U-bends after exposure to 75%/25% Na₂S/NaOH molten hydrate mixture at 180°C for 48 hours.

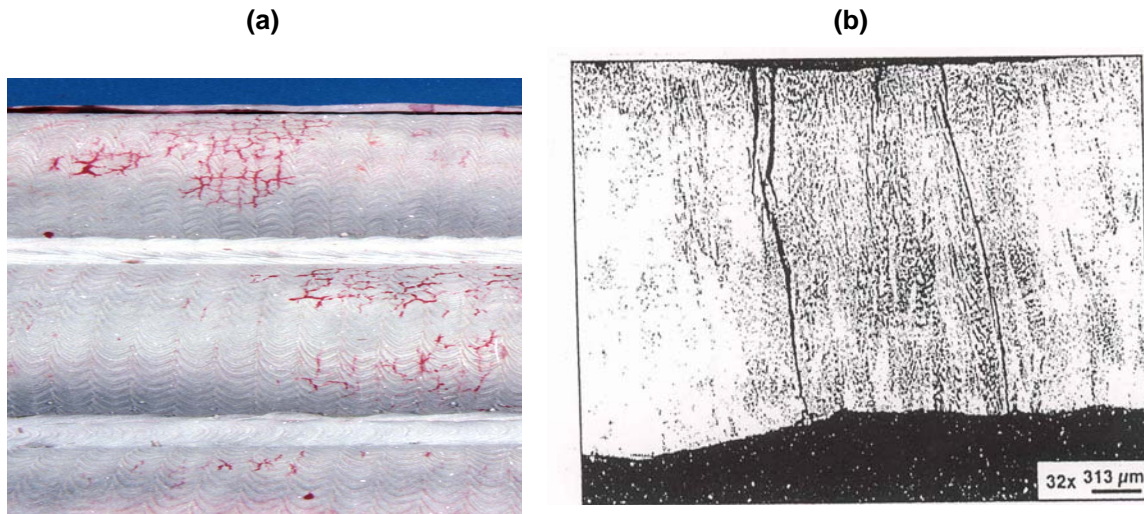
Fig. 106. Cracks formed in weld-overlaid UNI309/CS composite floor tubes installed in Boiler 18 after 24 months of exposure. (a) Crack indications as revealed by liquid dye penetrant inspection of the tube surface. (b) Micrograph of polished cross-section showing cracks, which have propagated through the weld overlay and terminated at the carbon steel interface.

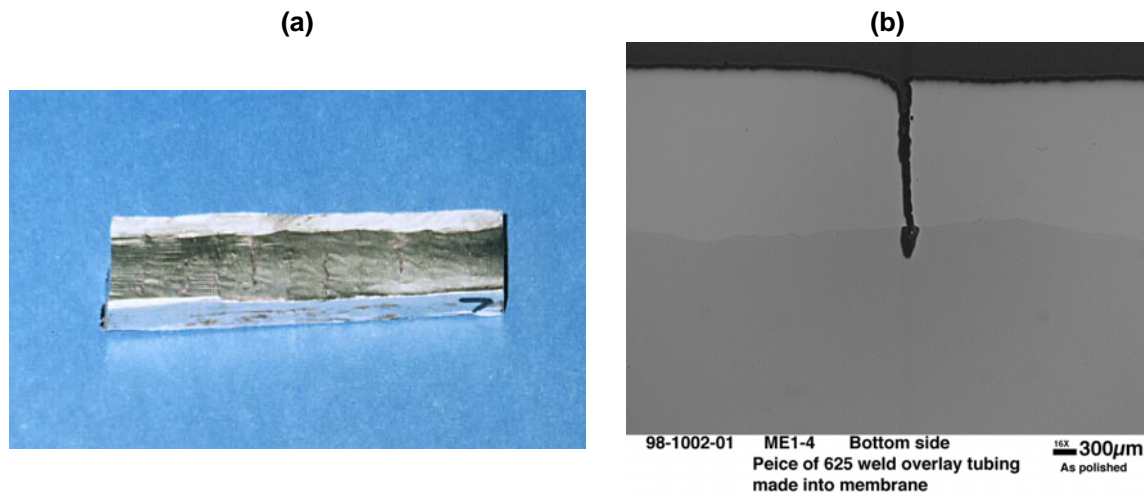
Fig. 107. Cracks in weld-overlayed UNI625/CS composite floor membrane installed in Boiler 11 after 12 months exposure. (a) Crack indications as revealed by liquid dye penetrant inspection of the membrane surface. (b) Micrograph of polished cross-sections showing a crack, which has propagated through the weld overlay and formed a corrosion “pit” at the crack tip in the carbon steel substrate.

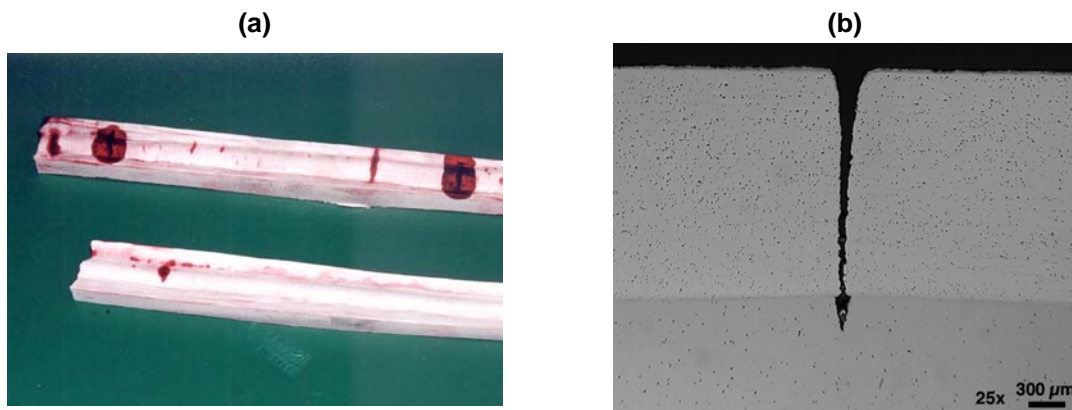
Fig. 108. Cracks in co-extruded SAN65/CS composite floor membrane installed in Boiler 11 after 12 months exposure. (a) Crack indications as revealed by liquid dye penetrant inspection of the membrane surface. (b) Micrograph of polished cross-sections showing a crack, which has propagated through the cladding and formed a corrosion “pit” at the crack tip in the carbon steel substrate.

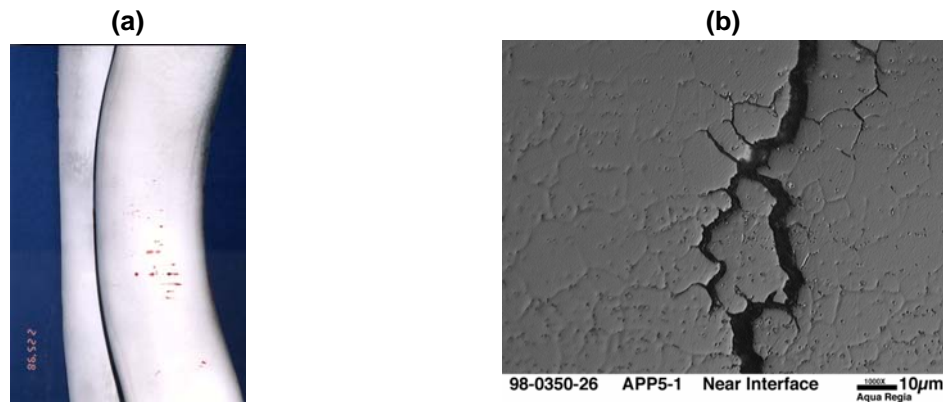
Fig. 109. Cracks in co-extruded A625/CS composite tube installed in a spout opening after 48 months of exposure in Boiler 3. (a) Crack indications as revealed by liquid dye penetrant inspection of the tube surface. (b) Micrograph of polished cross section showing a crack and its intergranular propagation mode. Examination of carbon steel microstructure reveals evidence of overheating.

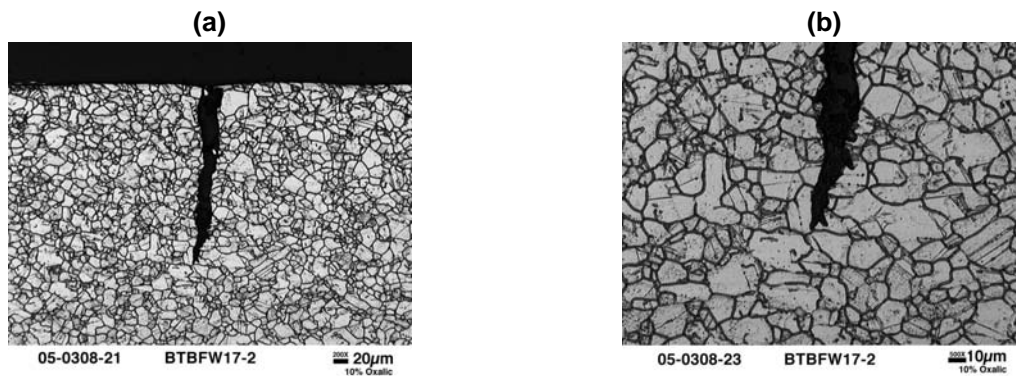
Fig. 111. Cracks in co-extruded SAN38/CS composite tube fabricated into primary air port installed in Boiler 1 after 42 months of service. (a) Micrograph of etched cross section showing crack indication found in SAN38 exterior layer. (b) Micrograph showing ditched structure, surrounding the crack tip, typically associated with sensitization.

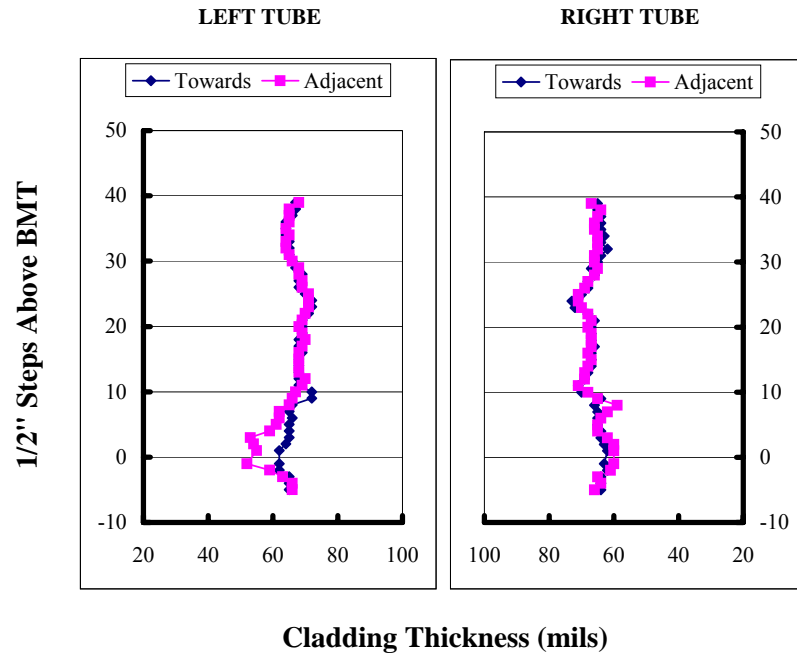
Fig. 112. Cladding thickness of SAN38/CS composite tubes fabricated into Port B installed in Boiler 10 after 12 months of service. (BMT = bottom membrane termination, adjacent and towards = measurements made adjacent to membrane/casting, and towards fireside crown, respectively) (1 mils = 0.001 in = 0.0254 mm).
