MANAGED BY UT-BATTELLE
FOR THE DEPARTMENT OF ENERGY

Investigation of Pipelines Integrity Associated with Pump Modules Vibration for Pumping Station 9 of Alyeska Pipeline Service Company

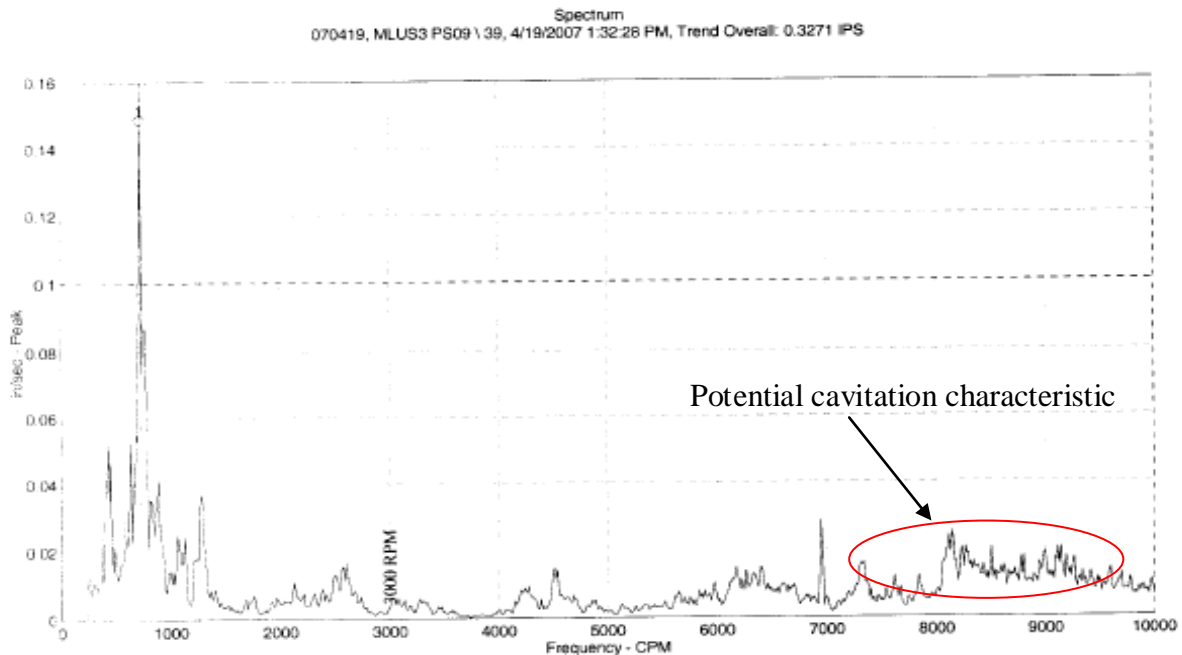
Figure 1 Velocity spectrum from Module 2 data

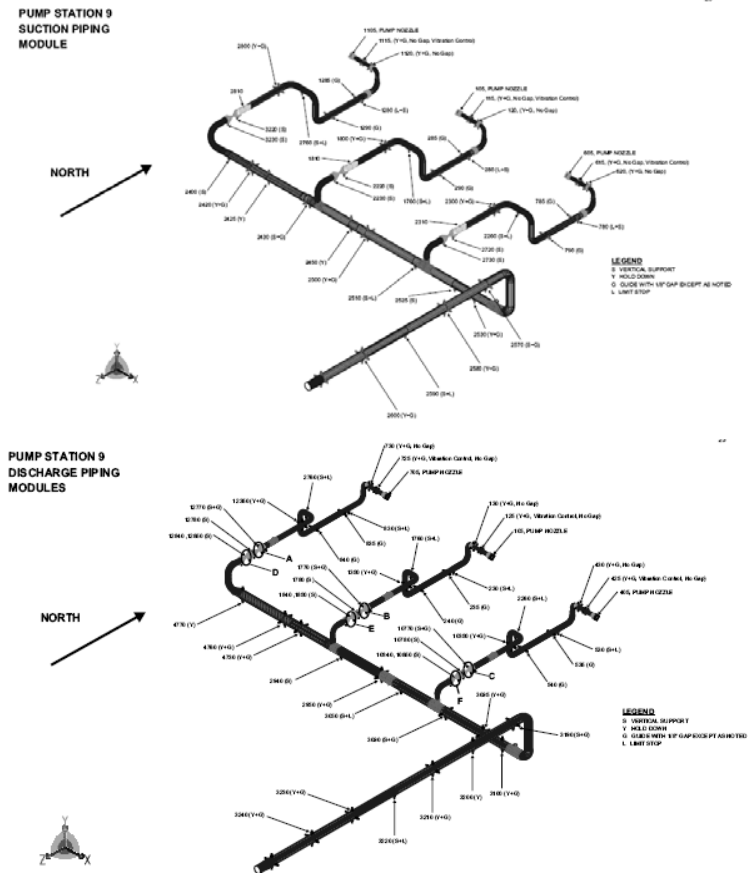
Figure 2 Suction and discharge piping systems

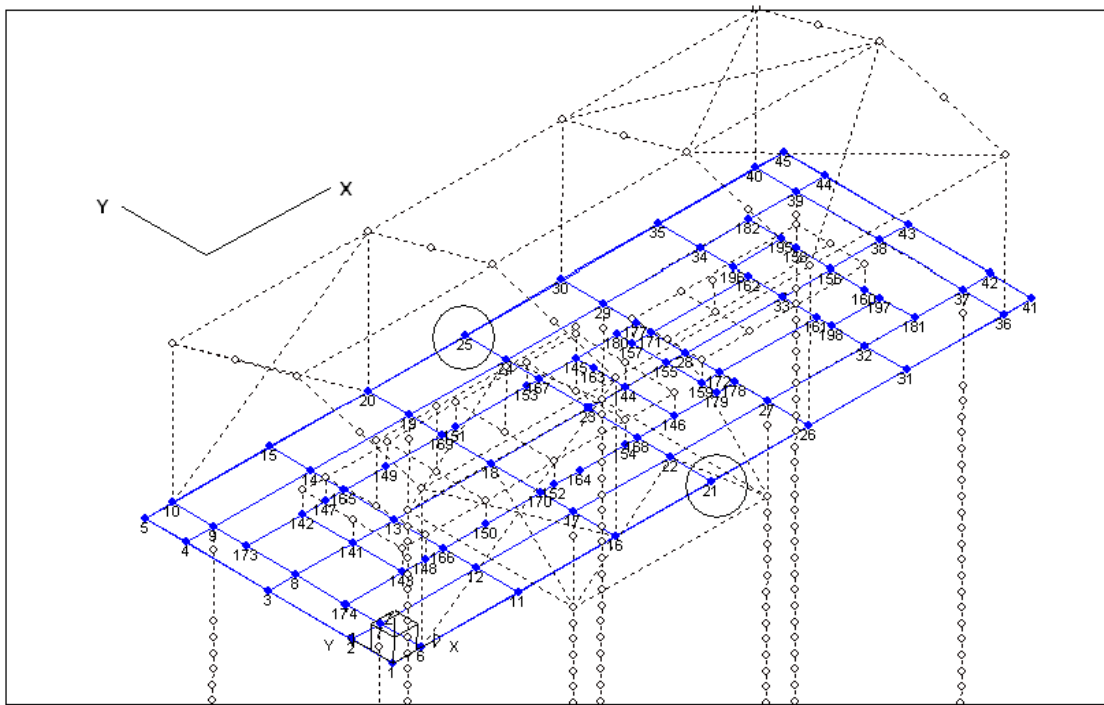
3.3 Mixed-Mode Fatigue Damage Consideration

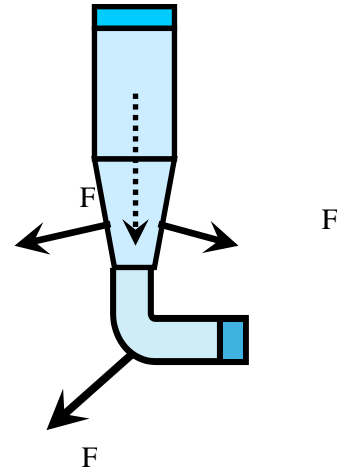
Figure 5 Fluid dynamic forces.

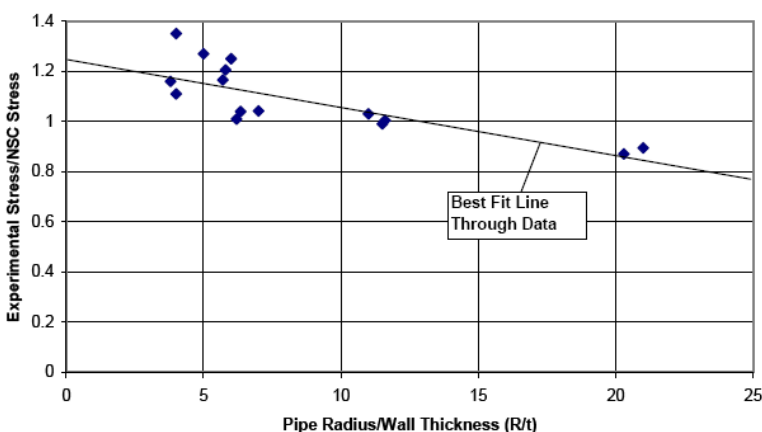
Figure 2.6 Plot of the ratio of the experimental stress to the predicted NSC stress as a function of pipe R/t ratio for pipes expected to fail under limit-load conditions

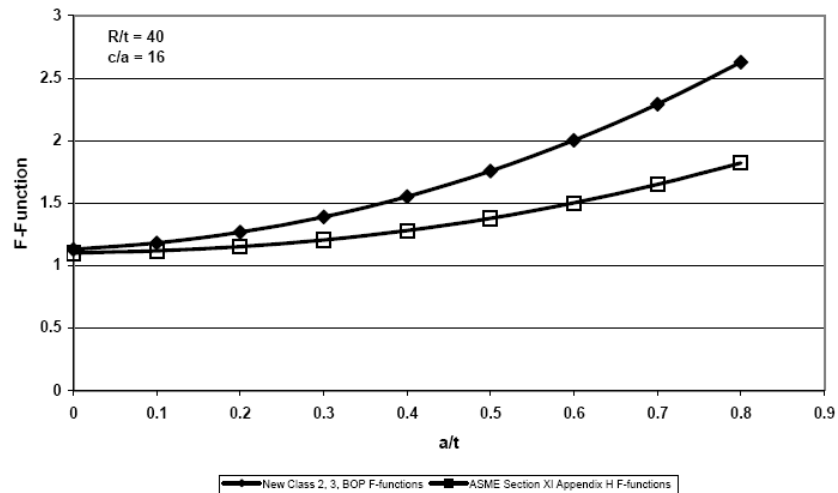
Figure 2.7 Comparison of new Class 2, 3, and BOP F-functions and F-functions in ASME Section XI Appendix H for a crack aspect ratio (c/a) of 16 and a pipe with an R/t ratio of 40 for internal circumferential cracks subject to pure bending.

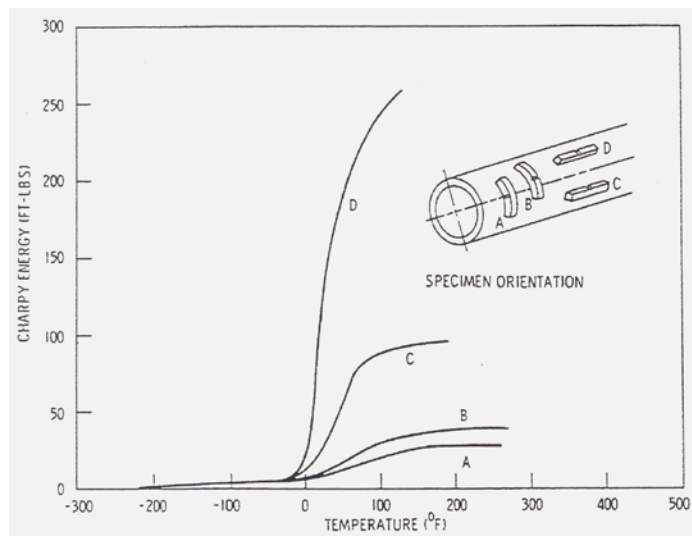
Figure 6 Toughness anisotropy of ASTM A106 Grade B pipe
