Spray Foam in Accessible Spaces: Best Practices and Case Studies for Retrofit in Mixed-Humid Climates

October 2011

**Prepared by
Jeffrey E. Christian
Kathy S. Gant**

Prepared by
OAK RIDGE NATIONAL LABORATORY
Oak Ridge, Tennessee 37831-6283
managed by
UT-BATTELLE, LLC
for the
U.S. DEPARTMENT OF ENERGY
under contract DE-AC05-00OR22725

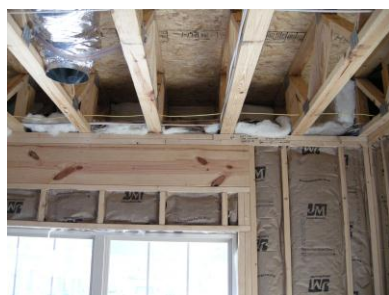
Fig. 12. Cantilevered floor improperly insulated and sealed.

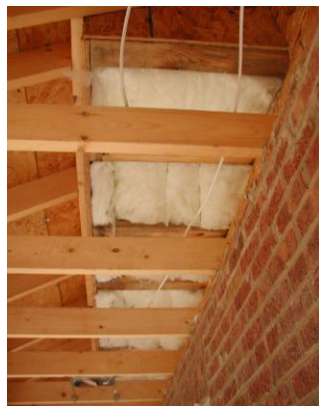
Fig. 13. Improperly insulated cantilevered floor from outside.

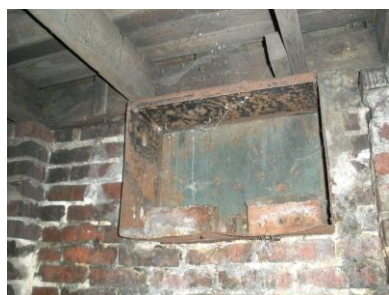
Fig. 15. Uninsulated rim joists.

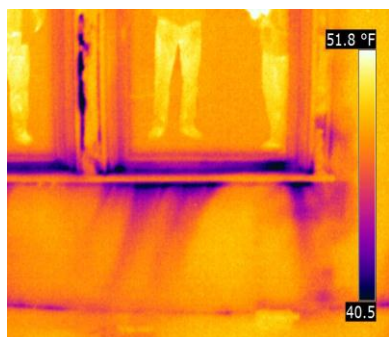
Fig. 18. Infrared image showing colder air drawn in around window by blower door. (Note wispy fingers-like extensions of purple color indicating air intrusion.)

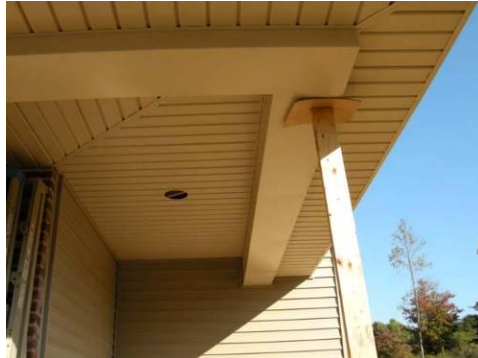
Fig. 29. Front porch box beam.

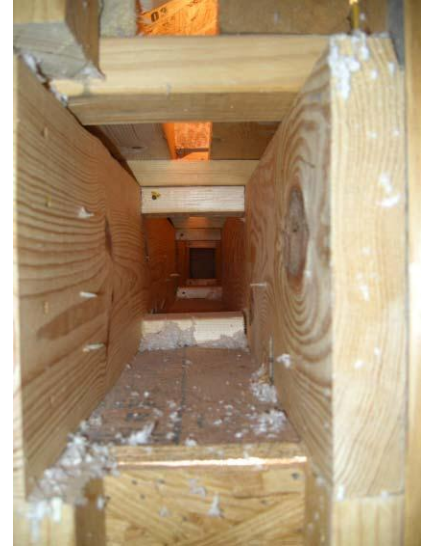
Fig. 30. Box beam penetrating house.

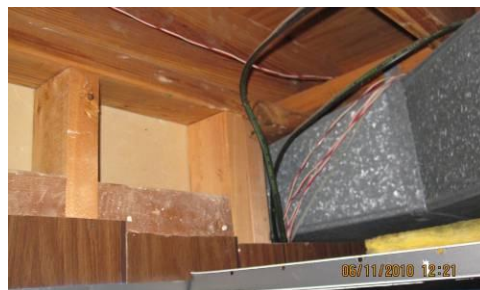
Fig. 34. Open wall cavities, ductwork, and electrical penetrations support unwanted air flow.

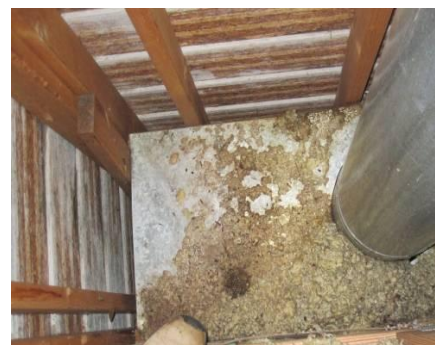
Fig. 40. Uninsulated chimney enclosure.

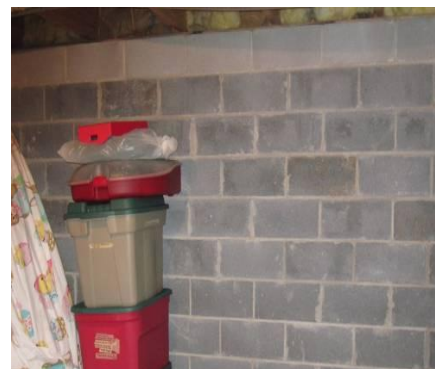
Fig. 41. Uninsulated cinder block basement and band joist.

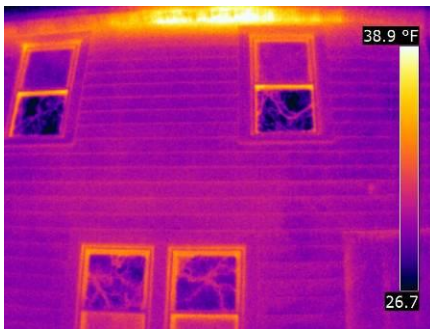
In Fig. 53, there is a bright area under the eave on the east end of the rear of the house. During the retrofit, soffit vents under the eaves were stuffed with fiberglass insulation and then sealed with spray foam. The insulation seems to be missing in this location. The contractor redid this area from the attic.

Fig. 53. Bright area indicates less effective insulation and sealing of soffit vent.

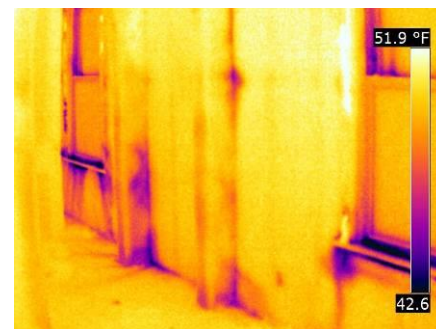
Fig. 56. Air intrusion at junctures and studs with blower door at 40 Pa.

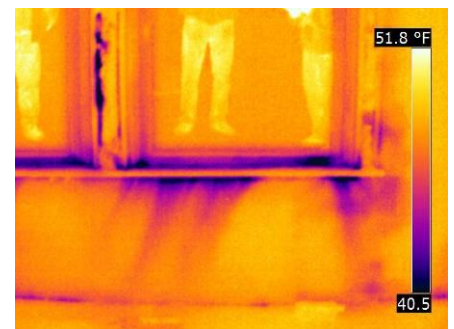
Fig. 57. Thermal "fingers" from air intrusion around windows. (Body heat from data takers is reflected from window.)

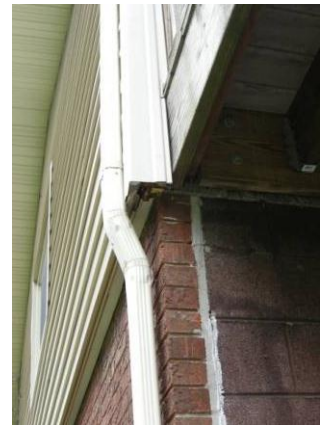
Fig. 60. Rim joist/sill area needs to be sealed and insulated.

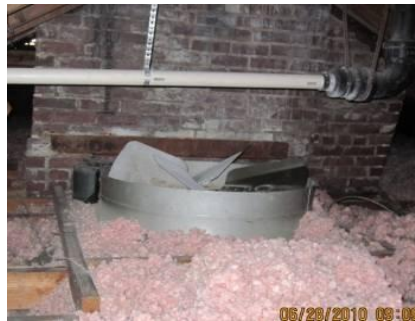
Fig. 65. Fan and gaps around chimney allow air to move freely between house and attic.

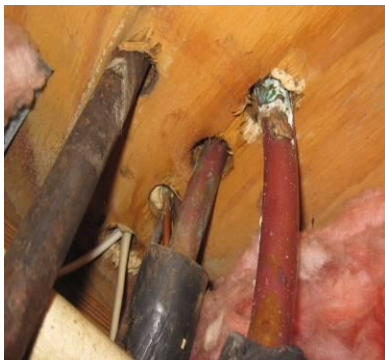
Fig. 68. Electrical and plumbing penetration provide airways between the house and the crawl space.

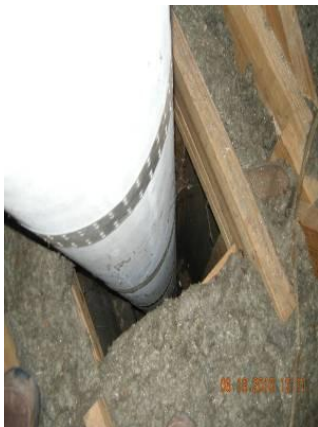
Fig. 71. Utility penetration into unconditioned attic.

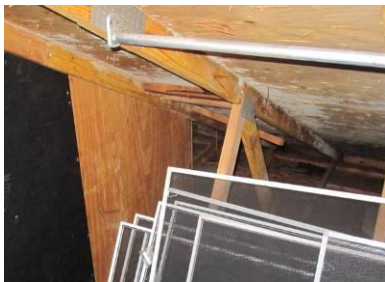
Fig. 75. Open chase into home from attic.

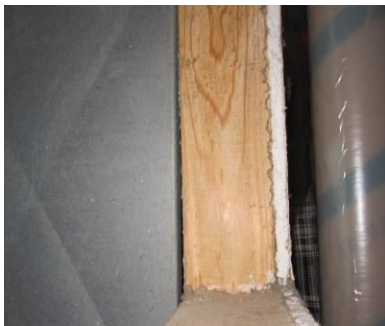
Fig. 76. Crack in return plenum (between metal and wood).

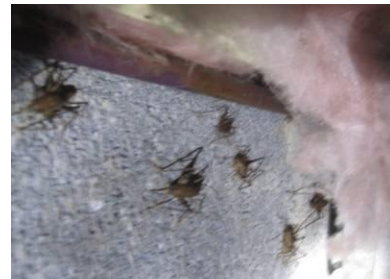
Fig. 78. Uninsulated ductwork in crawlspace with crickets feeding on mold growth.

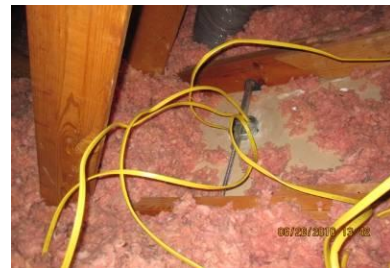
Fig. 79. Patchy, loose insulation in the attic.
