Response of the Fukushima Dai-ichi Nuclear Plant to the March 11, 2011 Earthquake in Japan

Dr. George Flanagan

Oak Ridge National Laboratory

Presented to the EERI/NEC
Meeting

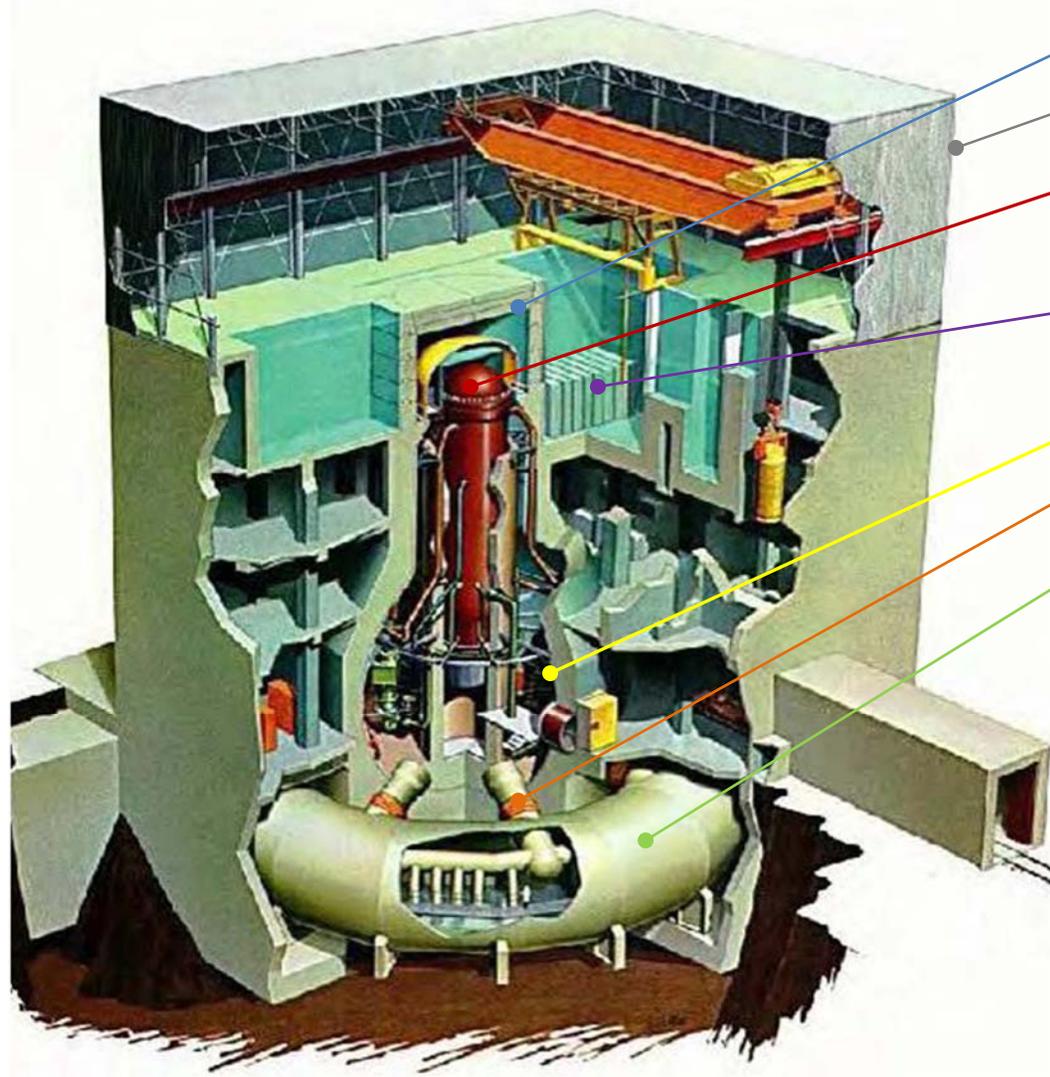
Mark 1 Boiling-Water Reactor Containment Design

Major Structures

Biological Shield

Secondary Containment Building

Reactor Pressure Vessel

Reactor Containment (Dry Well, Duct, Suppression Chamber or Pool-torus)

Spent Fuel Pool

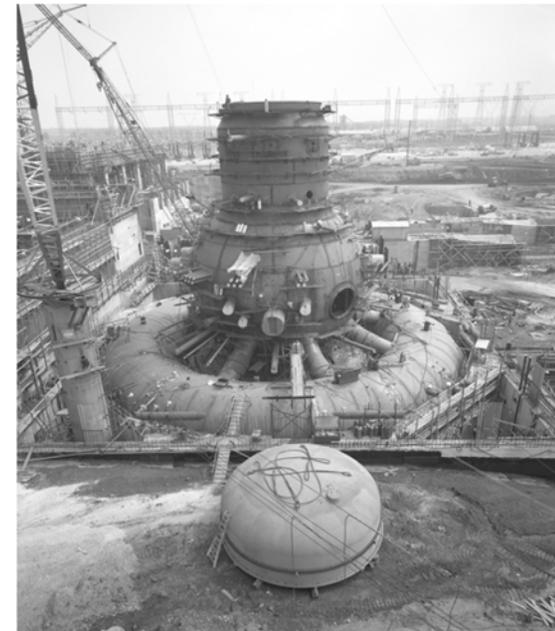
GE BWR Mark 1 Containment

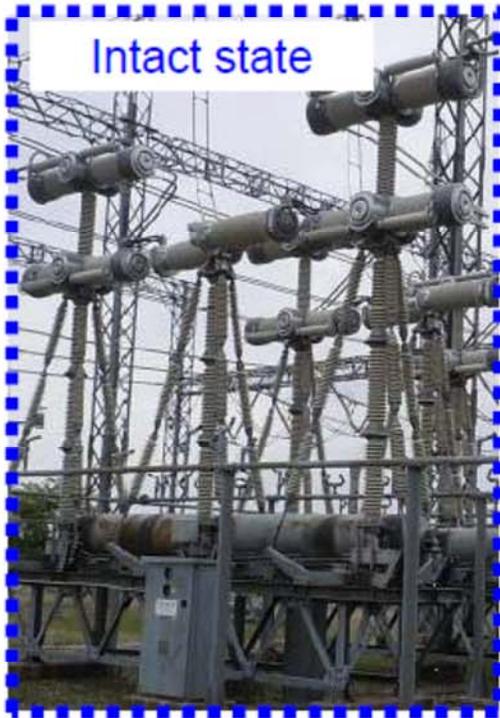
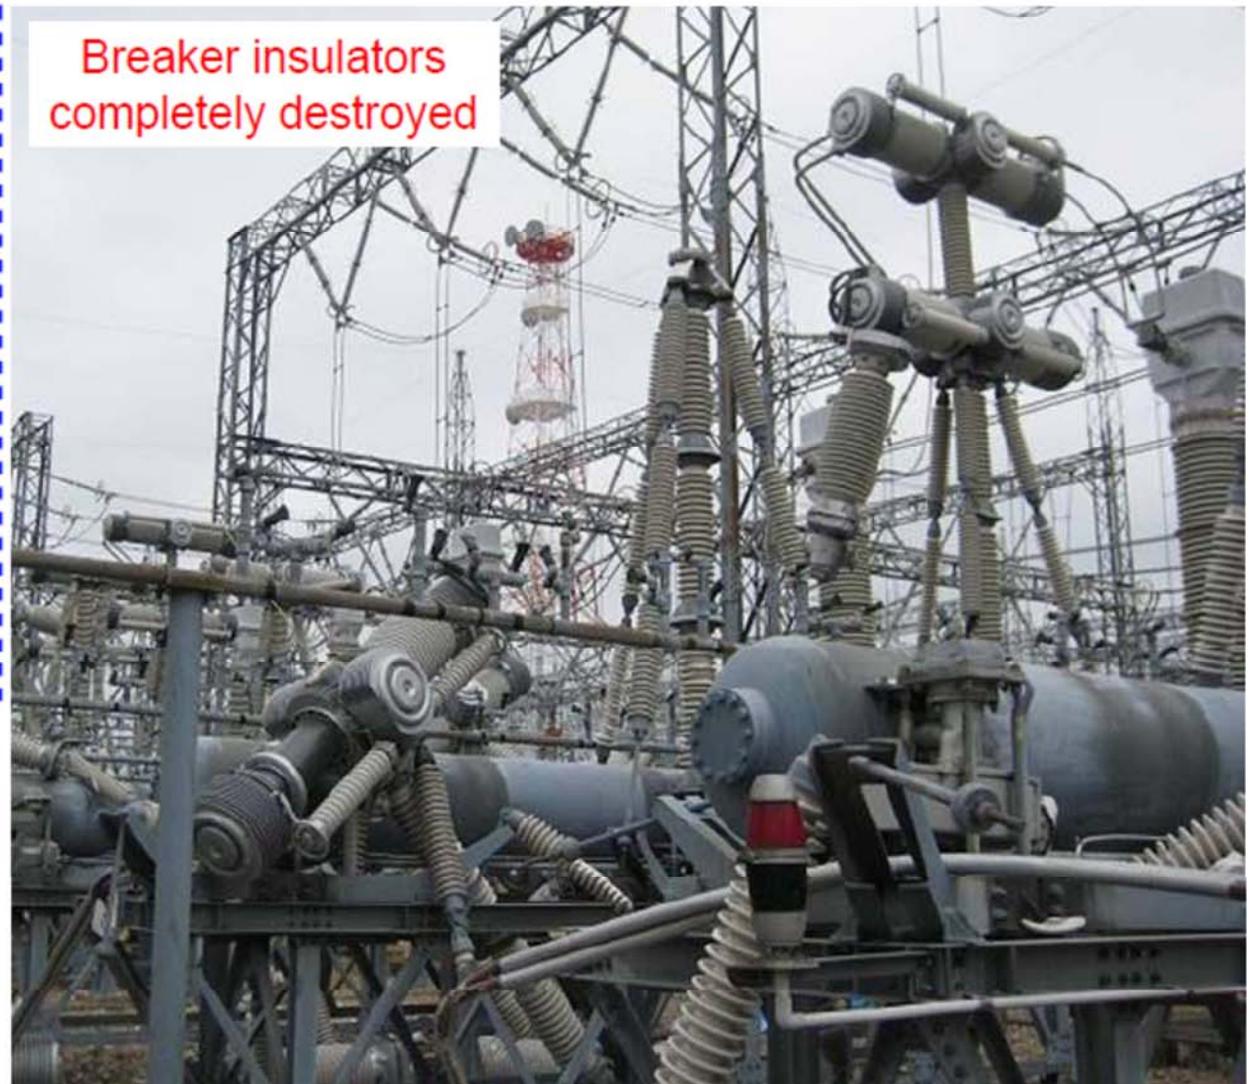
Damage at Switchyard at Fukushima Dai-ichi NPS

[275kV air blast breaker: completely destroyed]

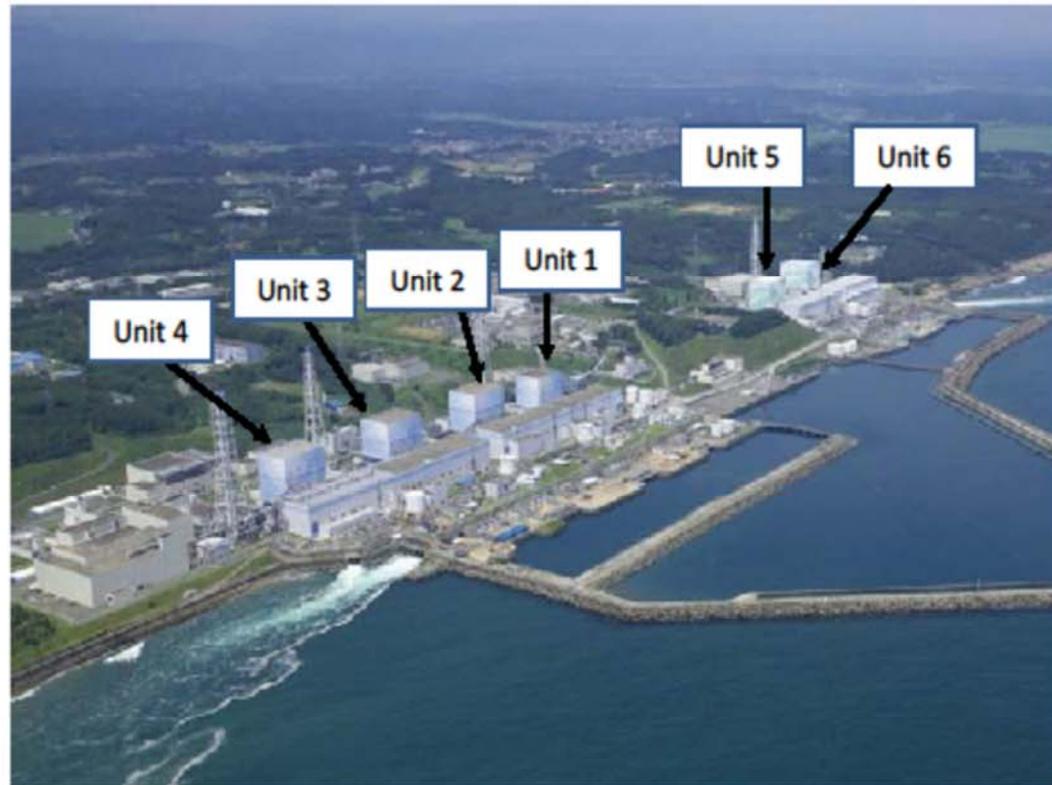
2. Outline of Fukushima Dai-ichi NPS

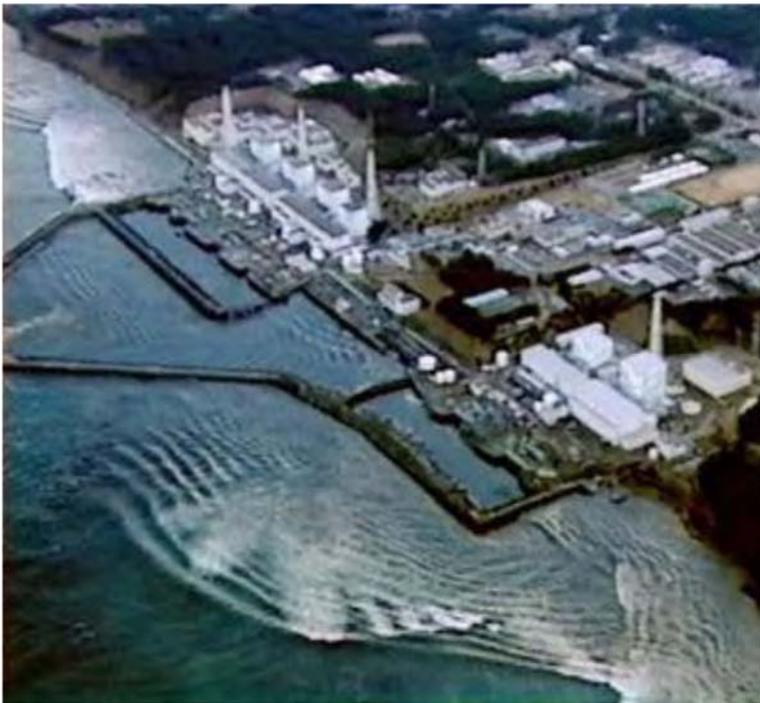
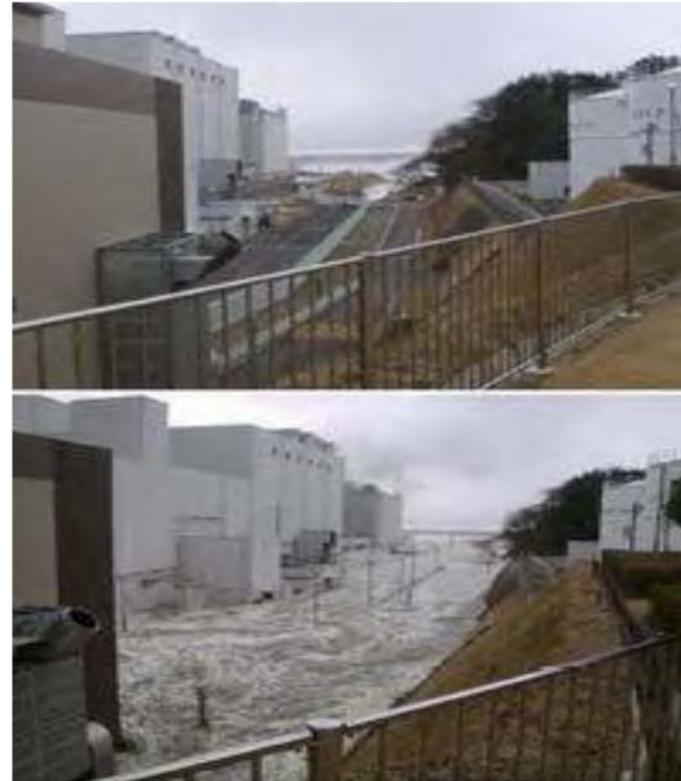
Tsunami Waves (47 feet) Hit Fukushima 1 Plant About 1 Hour After the Earthquake

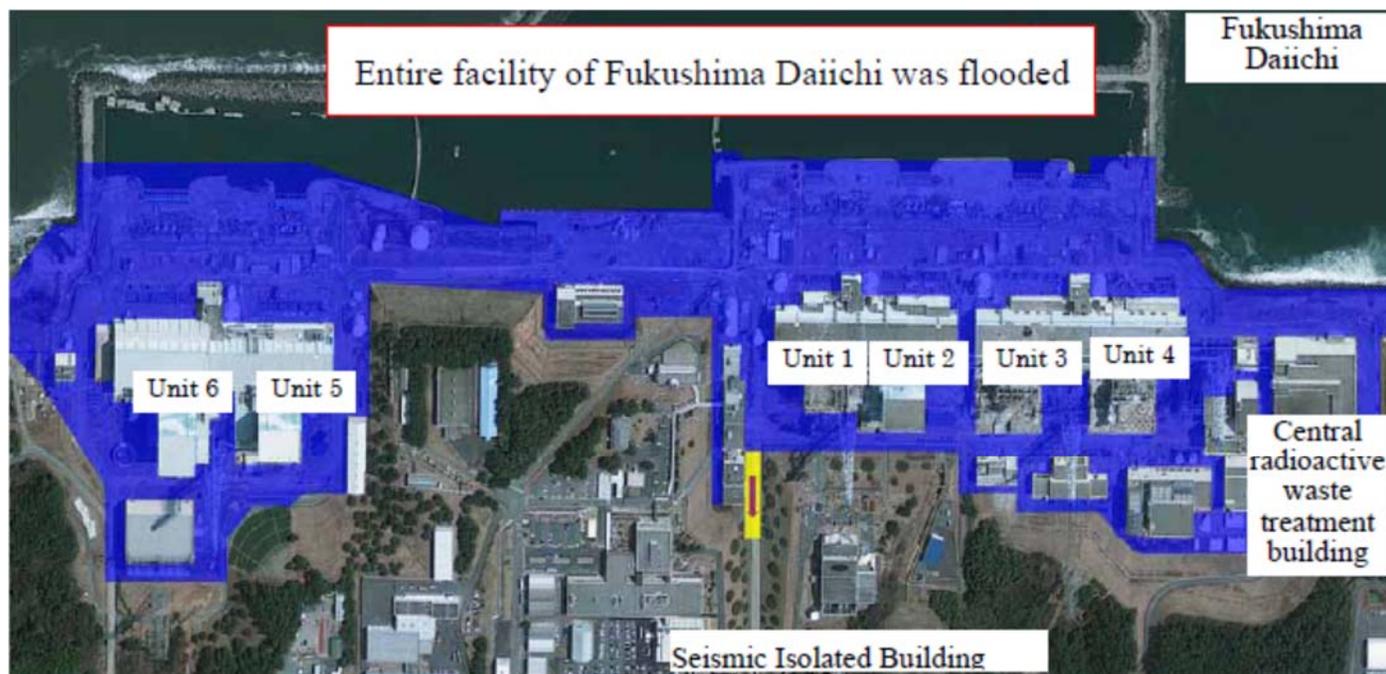
Nearly all the Dai-ichi Site was Flooded

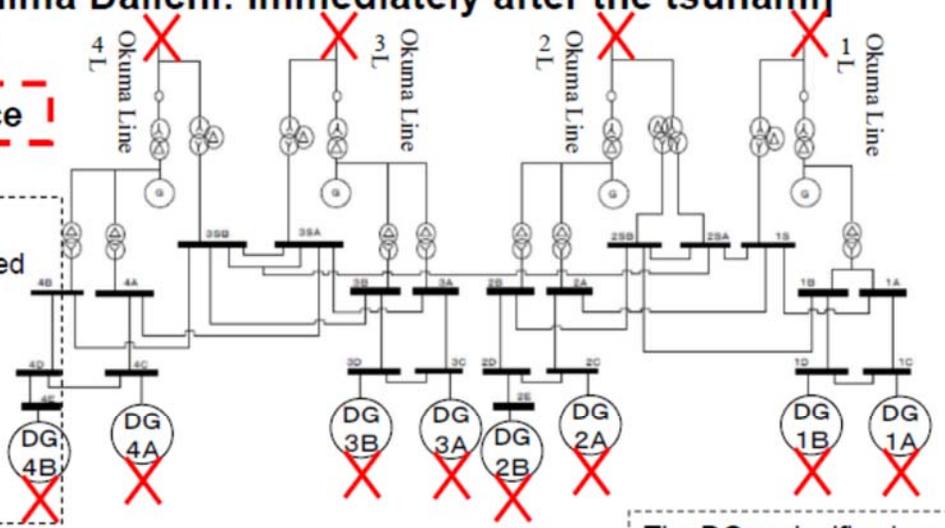
Fukushima Daiichi Units 1-4

No surviving power source

- Okuma Line 1L, 2L
Receiving circuit breaker damaged in earthquake
- Okuma Line 3L
Renovation work in progress
- Okuma Line 4L
Cause of shutdown is currently being investigated

The DG × signifies loss of function due to either "M/C failure," "loss of sea water system," or "DG main unit failure."

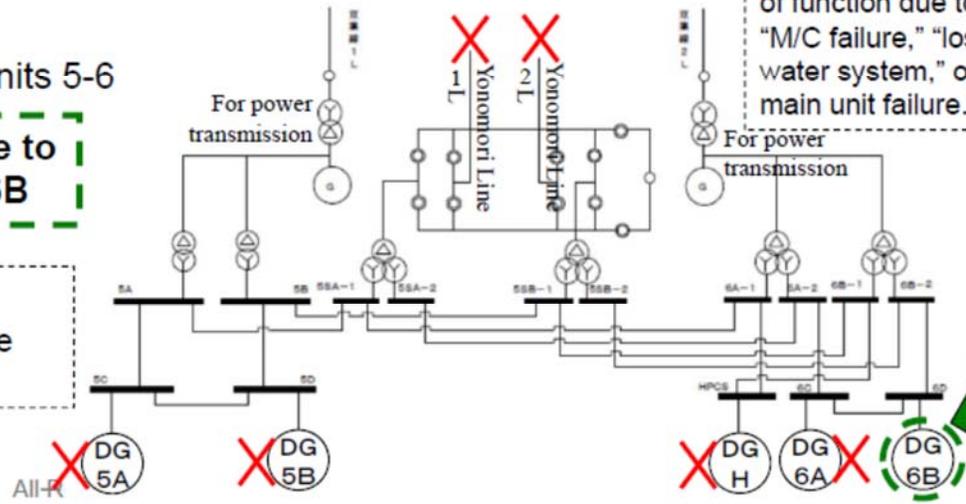
Fukushima Daiichi Units 5-6

Only power source to survive was DG6B

- Yonomori Line 1L, 2L
Partial collapse of the iron tower

Survived

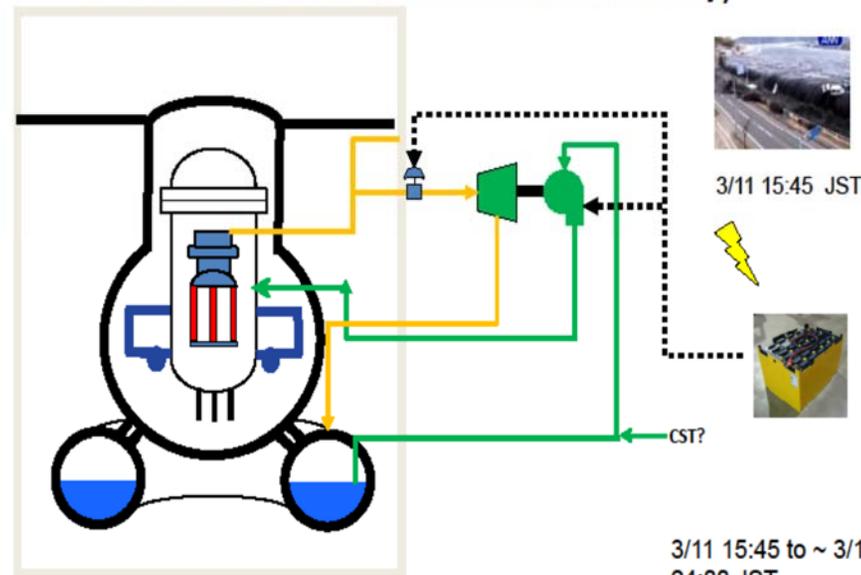
Battery Power Control of Steam-Driven Reactor Core Isolation Cooling System In Units 2 & 3 (Unit 1 Had Isolation Condenser which Boiled Dry)

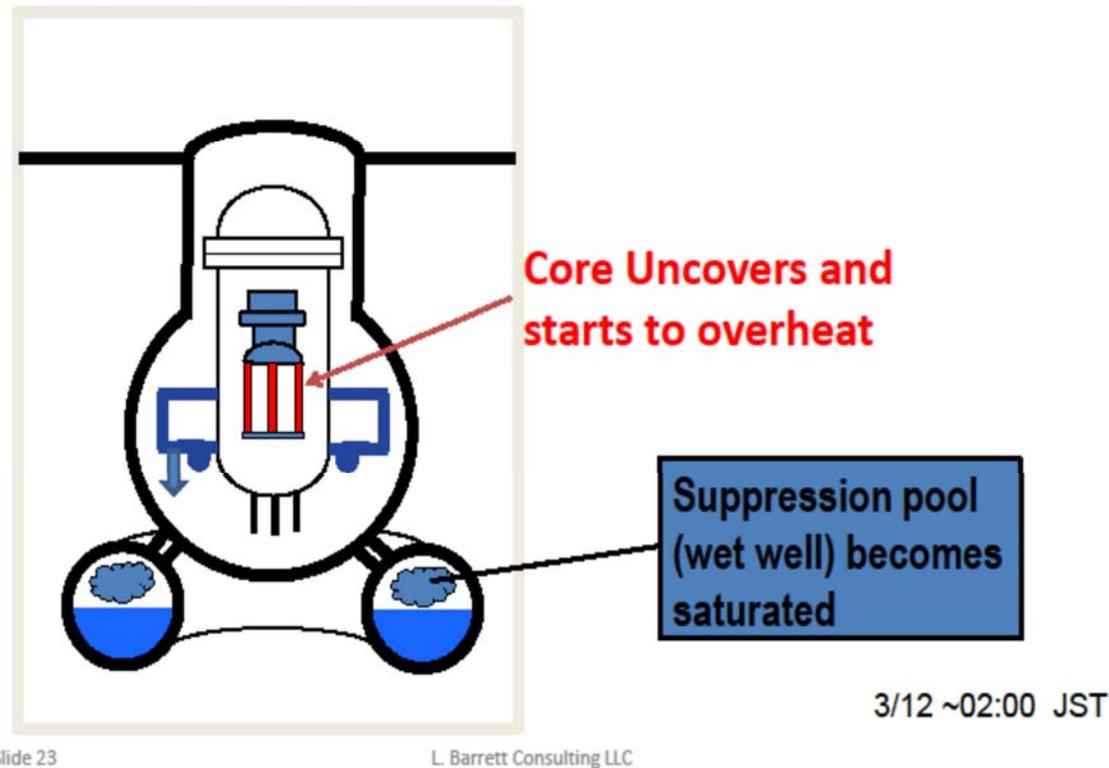
Loss of Battery Power Results in Loss of Ability to Remove Decay Heat From the Core

Battery Power Exhausted

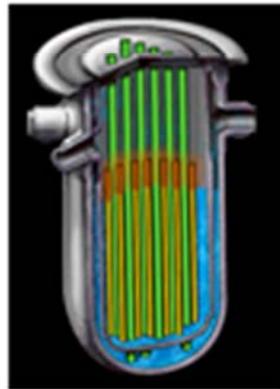
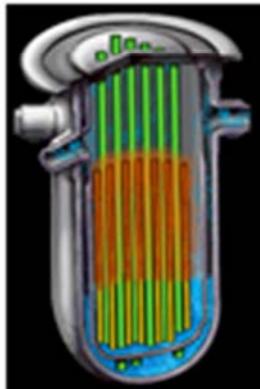
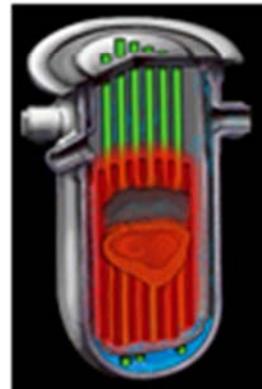
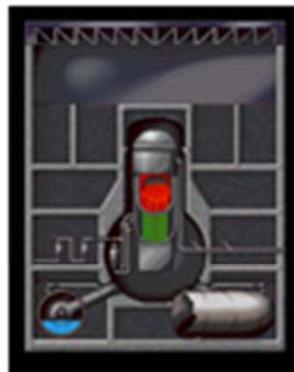
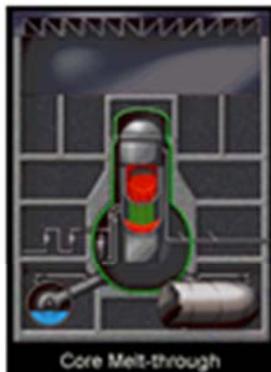
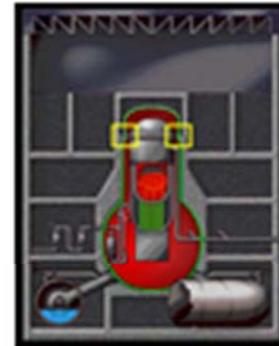
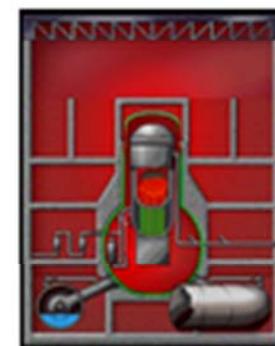
Core Damage Sequence

Core Uncovered

Fuel Overheating

Fuel melting - Core Damaged

Core Damaged but retained in vessel

Core Melt-through
Some portions of core melt into lower RPV head

Containment pressurizes.
Leakage possible at drywell head

Releases of hydrogen into secondary containment

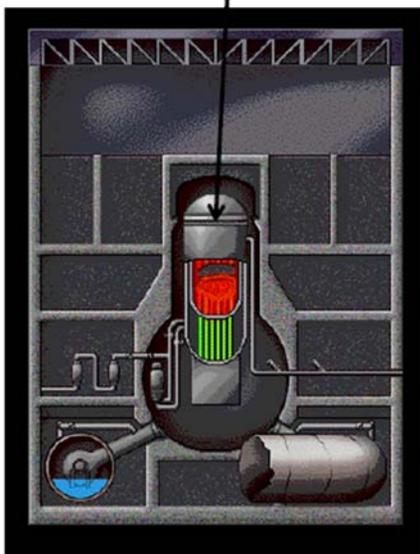
Primary Coolant System

Core Over Heat
 -Clad Burst ~900C
 -Clad Oxidize ~1200C
 -H2 Release
 -Partial Melt~1800C-2700C
 -Primary Coolant System
 Overpressure

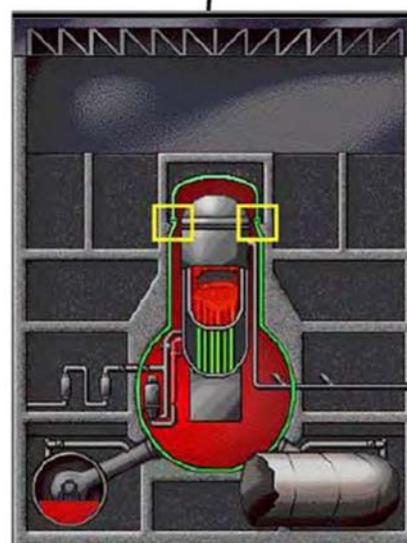
Primary Containment

Vent from Primary
 Coolant Sys to Primary
 Containment- H2,
 Steam, & Fission
 Products (Xe, Kr, I, Cs
 etc)

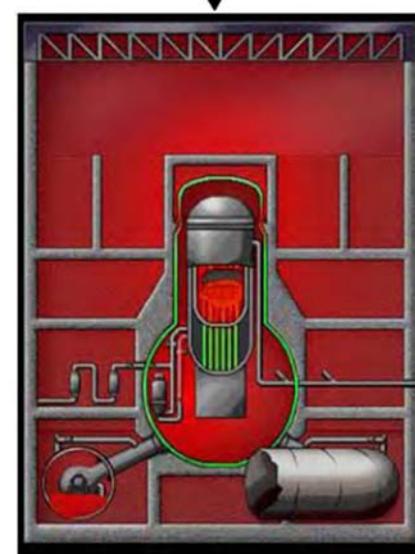
No Primary Containment
 Cooling therefore Primary
 Containment Overpressure-
 Vent to Secondary
 Containment

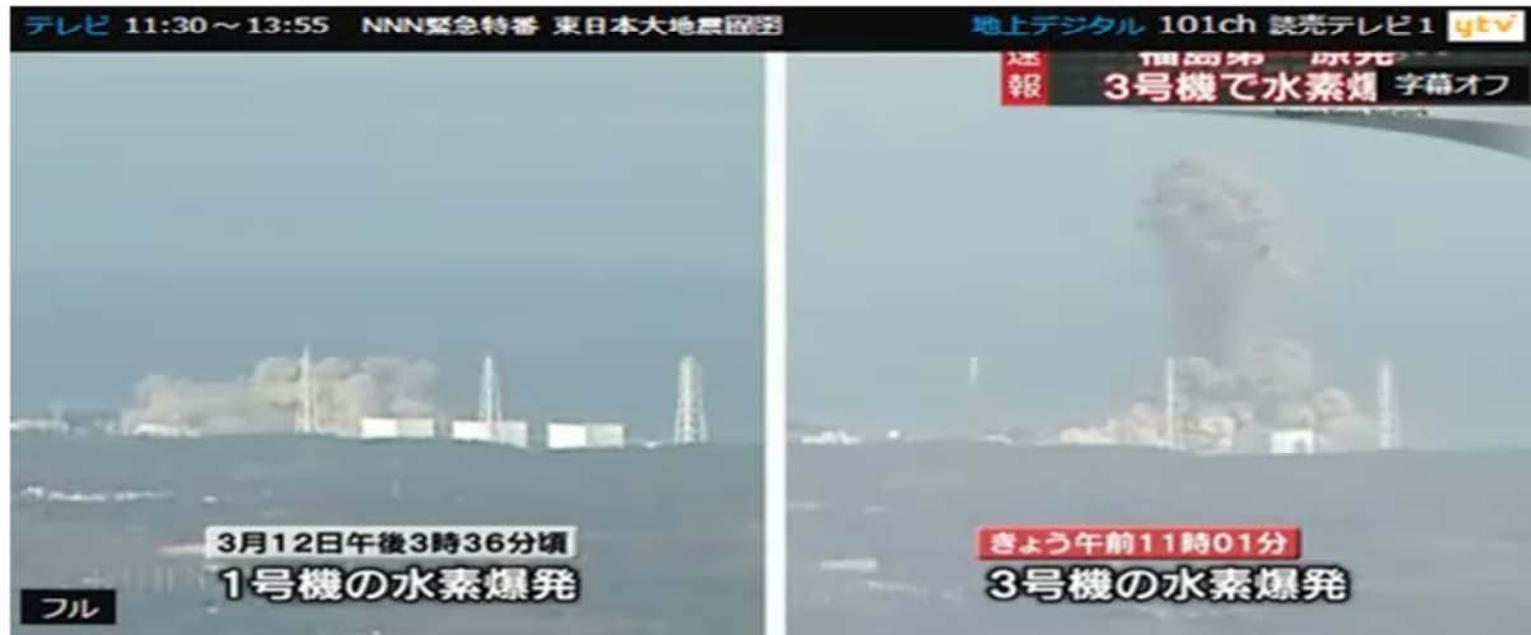
Result was an Explosion in Units 1 and 3 Destroying Parts of the Reactor Buildings

Unit 1

Unit 3

Overpressure of the Containment Resulted in Opening Leakage Pathways for Some Steam and Hydrogen to Enter the Reactor Building—Bypassing the Vent Lines

- Resulted in explosive mixture of hydrogen gas to accumulate in the reactor buildings of Units 1 and 3
- A panel was removed from Unit 2 to vent the building
- A fire and explosion occurred in Unit 4 (reactor was defueled)
 - Thought to be a result of uncovering of the spent fuel
 - Appears this was not the case
 - Cause of Unit 4 explosion is now thought to be from hydrogen generated in Unit 3 being carried into Unit 4 through a shared vent line

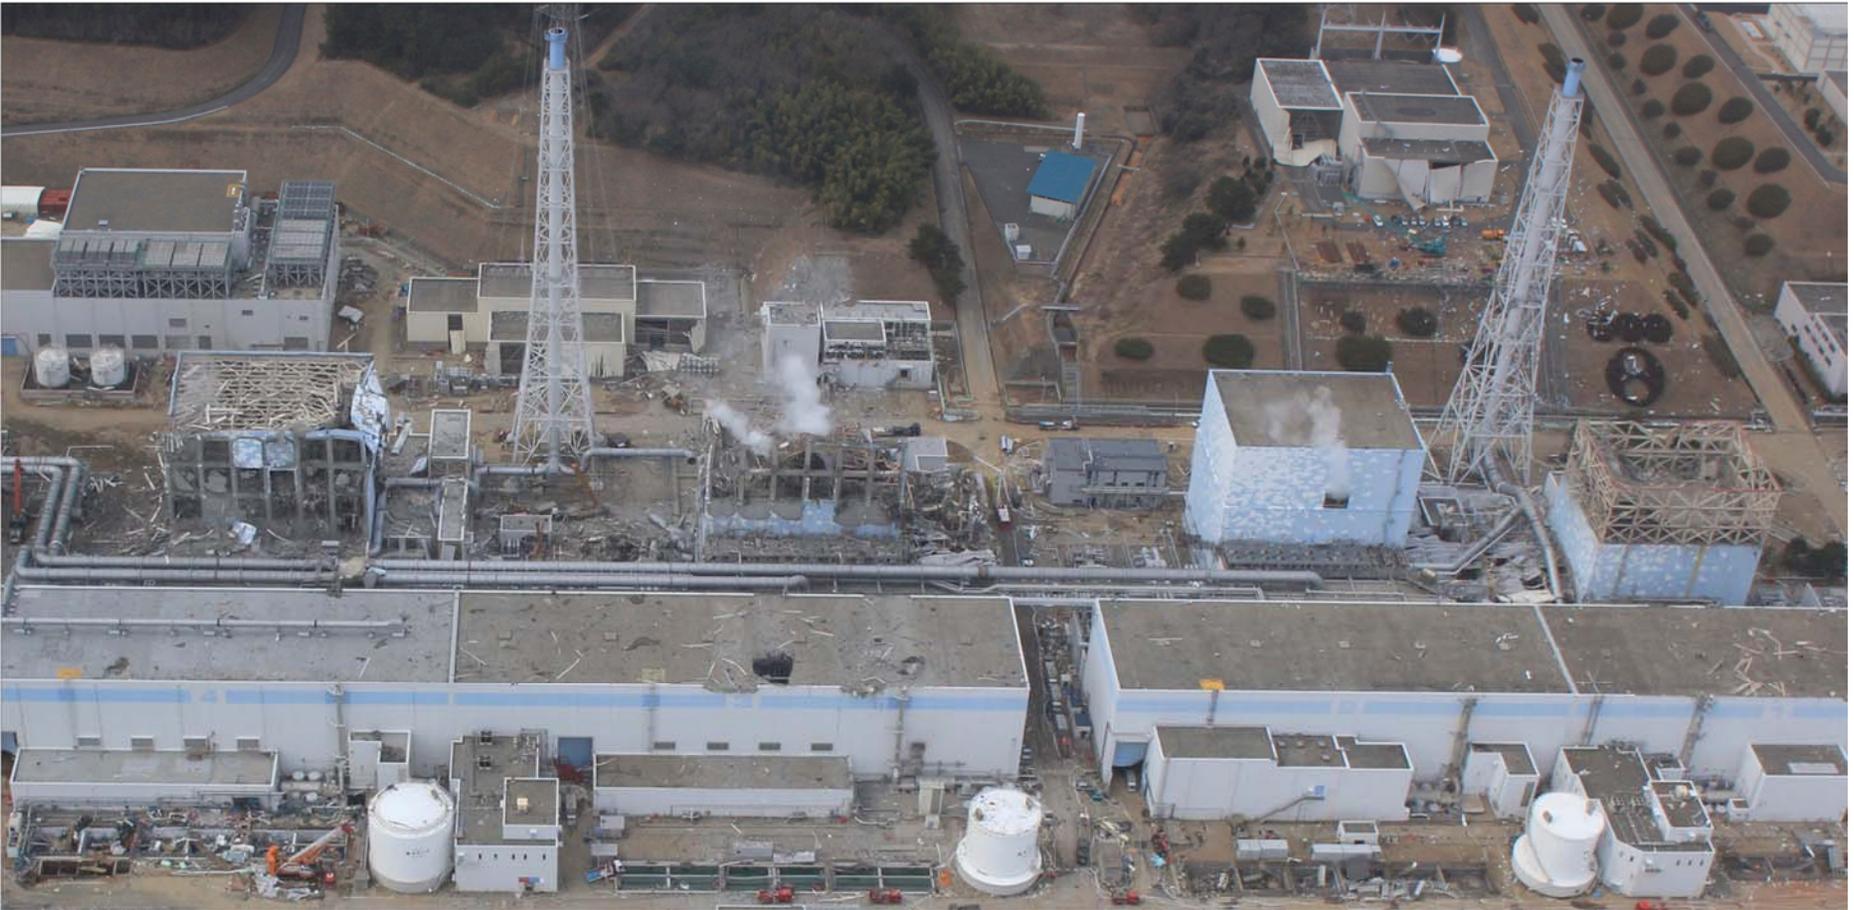
Aftermath Destroyed the Secondary Containment, Some Vent Lines — Allowed Uncontrolled Release of Radioactivity to the Atmosphere, to the Site, and to Areas Surrounding the Site—Resulting in an Evacuation (20 km)

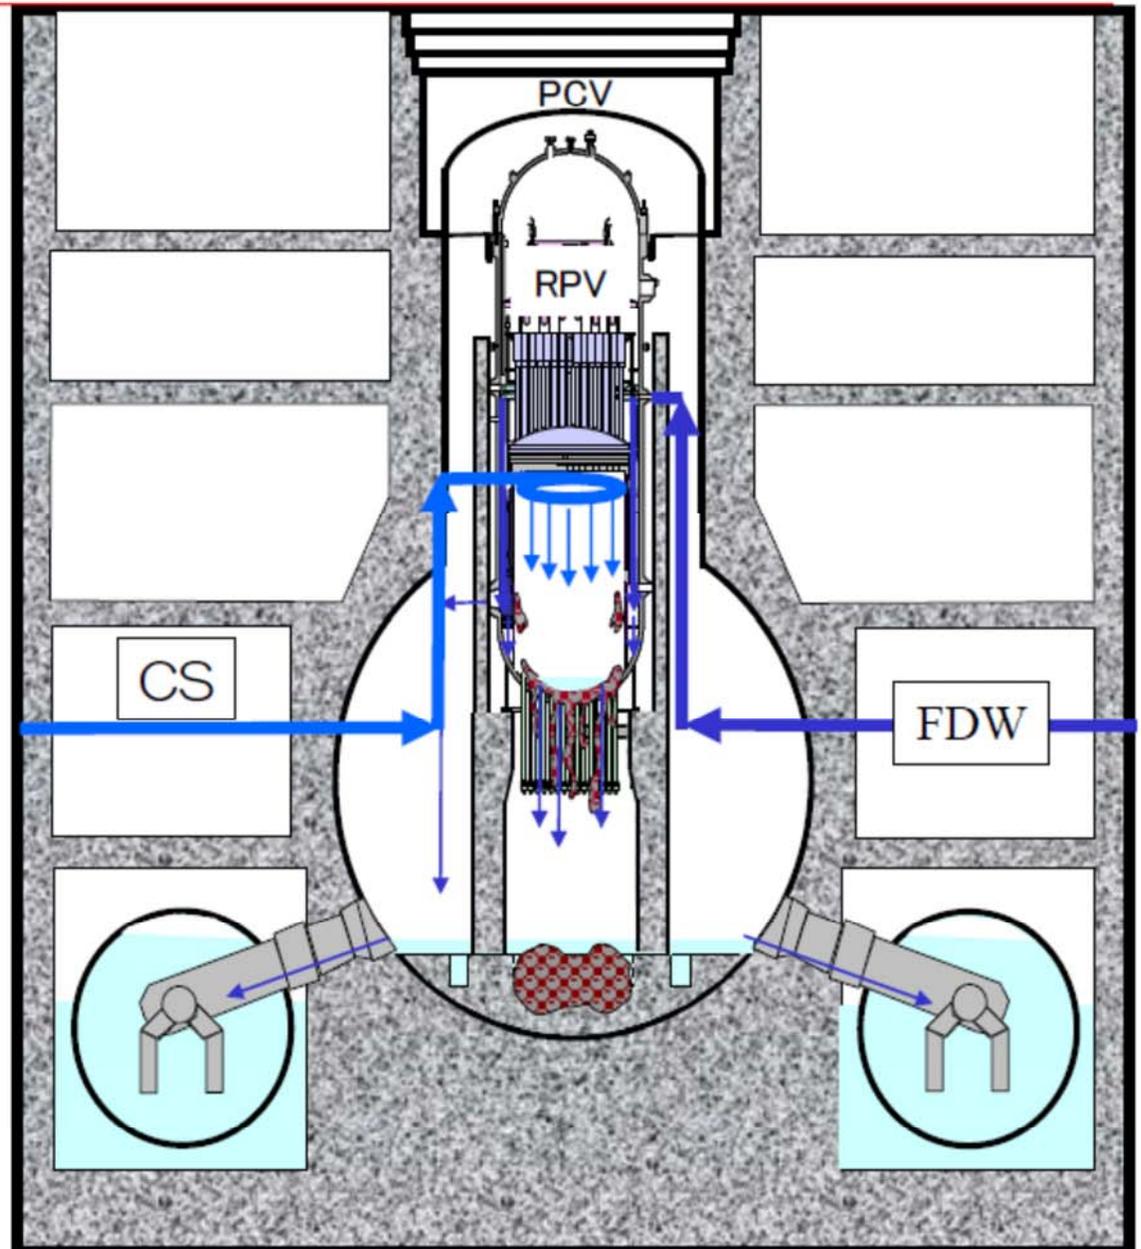
Presumption of reactor core statement (Unit 1)

- Almost no fuel was left at the original position, and completely moved downward after it melted.
- The moved fuel likely damaged PCV and assumed that most of it had dropped to the bottom. (Details for dropped fuel is unknown)
- Dropped fuel is assumed to have caused core concrete reaction.
- Therefore, it is evaluated that all the moved fuel is expected to be cooled directly by water injection. It is also evaluated that the core concrete reaction has been stopped.

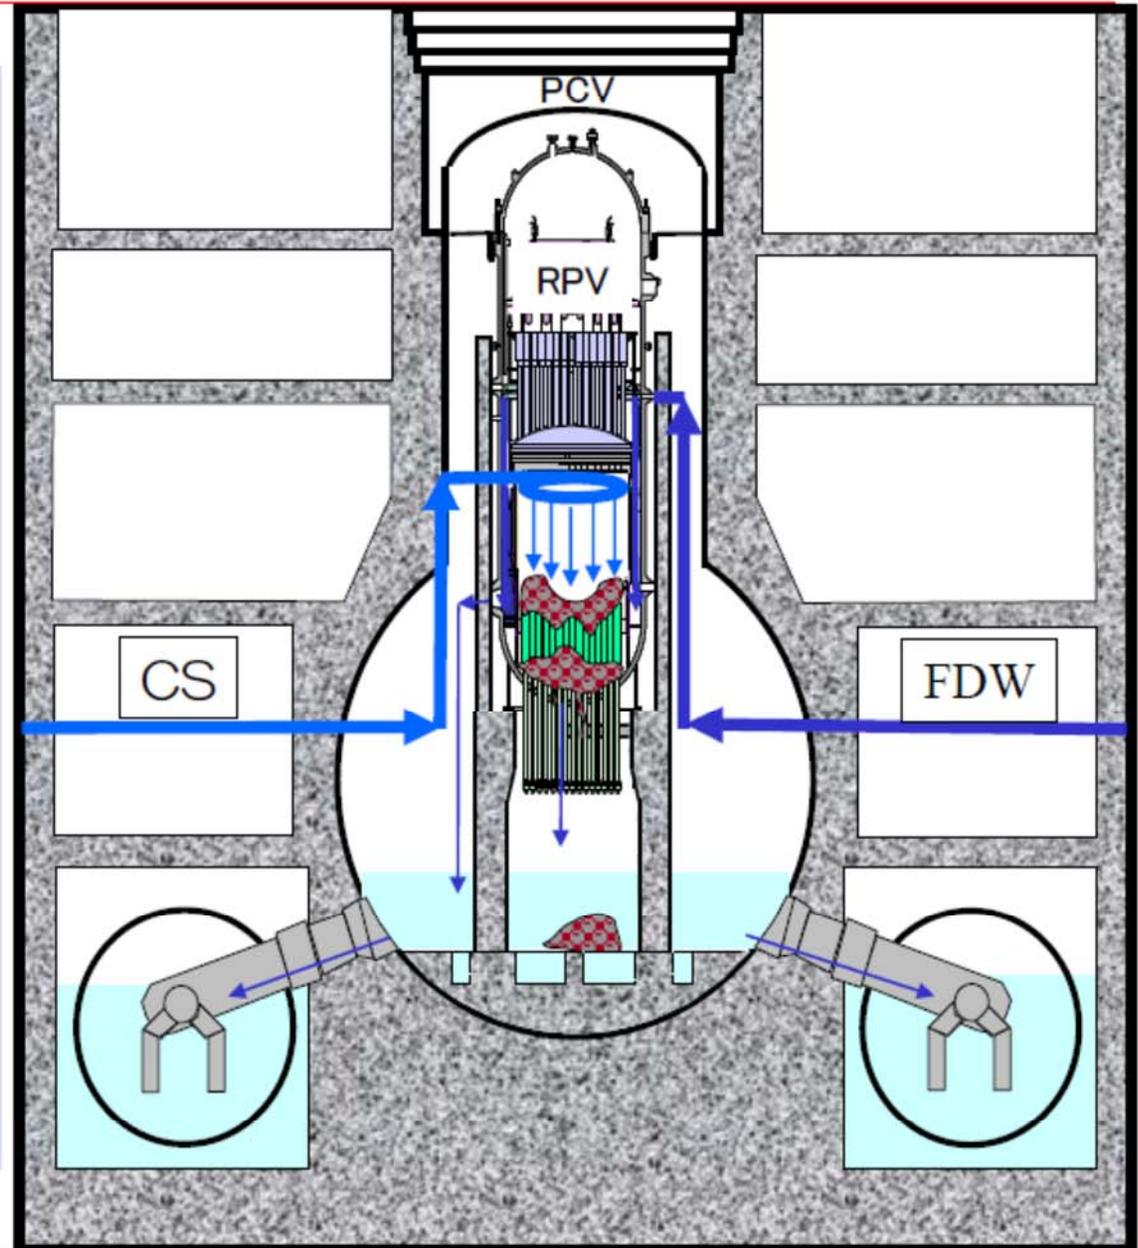
Presumption of reactor core statement (Unit 2 and 3)

- There is a range in the evaluation result from “damaged fuel dropped to part of the bottom of PCV” to “Almost all the fuel is left inside RPV”.
- If the part of damaged fuel were to have dropped to the bottom of PCV, it can be assumed that core concrete reaction was caused.
- Therefore, it is evaluated that all the moved fuel is expected to be cooled directly by water injection. It is also evaluated that the core concrete reaction has been stopped.

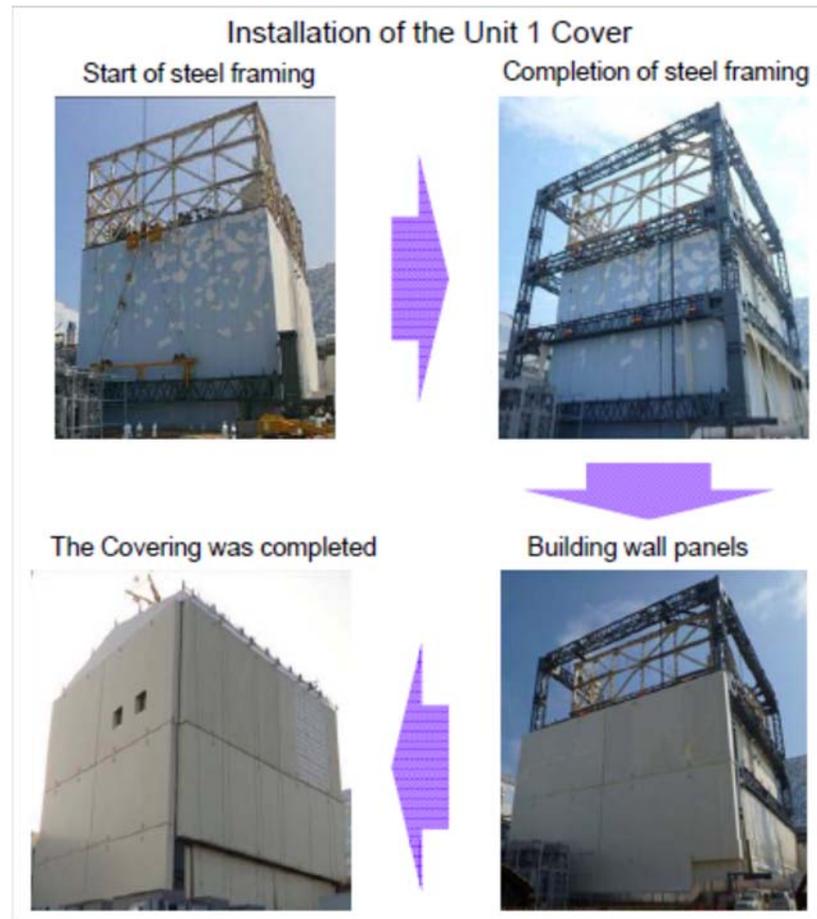
Cover has been Installed Around Unit 1 Debris is Being Removed Before Covering Units 3 and 4
