# Thick Concrete Specimen Construction, Testing, and Preliminary Analysis

**THICK CONCRETE SPECIMEN CONSTRUCTION, TESTING, AND  
PRELIMINARY ANALYSIS**

Date Published: March 2015

Prepared by  
OAK RIDGE NATIONAL LABORATORY  
Oak Ridge, Tennessee 37831-6283  
managed by  
UT-BATTELLE, LLC  
for the  
US DEPARTMENT OF ENERGY  
under contract DE-AC05-00OR22725

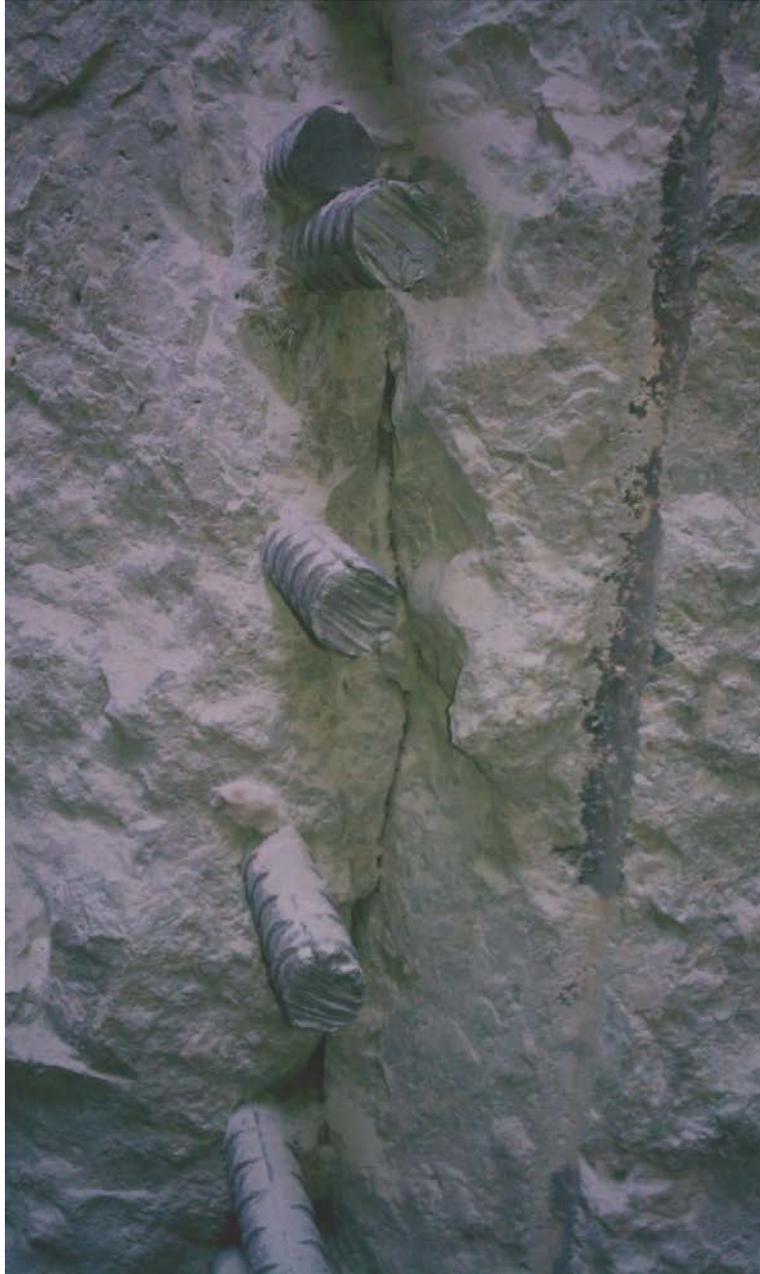
**Fig. 6. Laminar cracking at reinforcements from an interface cut out by hydrodemolition [43].**

Figure 4 shows the Davis–Besse Nuclear Power Station [43]. Figure 5 shows the general layout of the structure with reinforcements. Figure 6 shows example laminar subsurface cracking at the depth of the reinforcement. This interface was visible due to hydro demolition to create an opening in the shield building, and the crack width is possibly larger than the delaminated condition prior to the cutting. Core bore samples, such as that shown in Fig. 7, show the crack condition unaffected by the hydro demolition process.

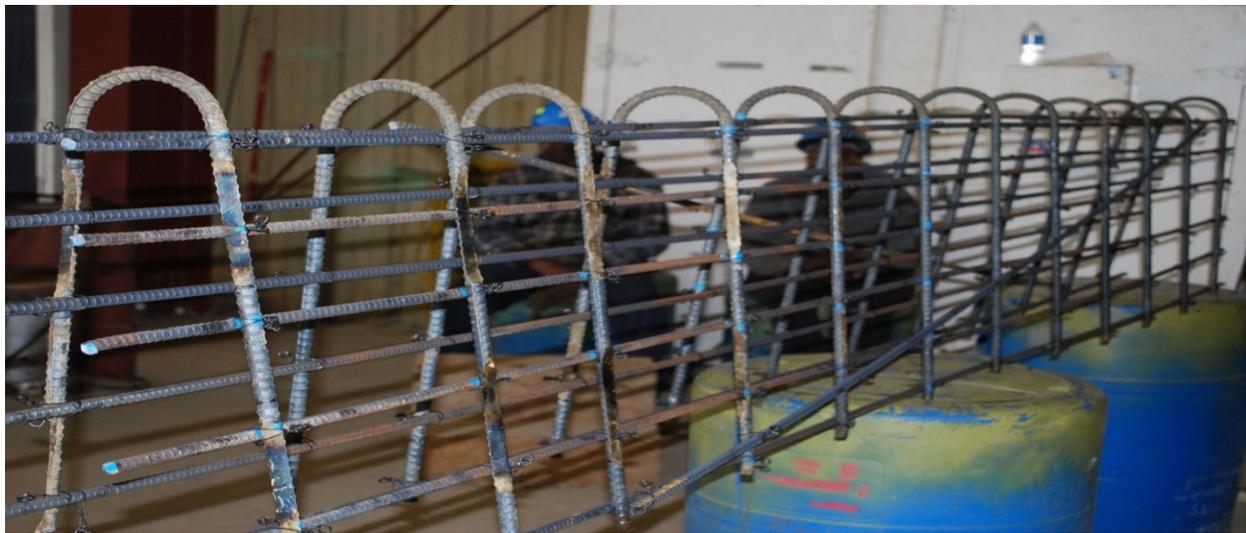
**Fig. 17. F-shaped bolt-down barrier fabrication with simulated corrosion.**

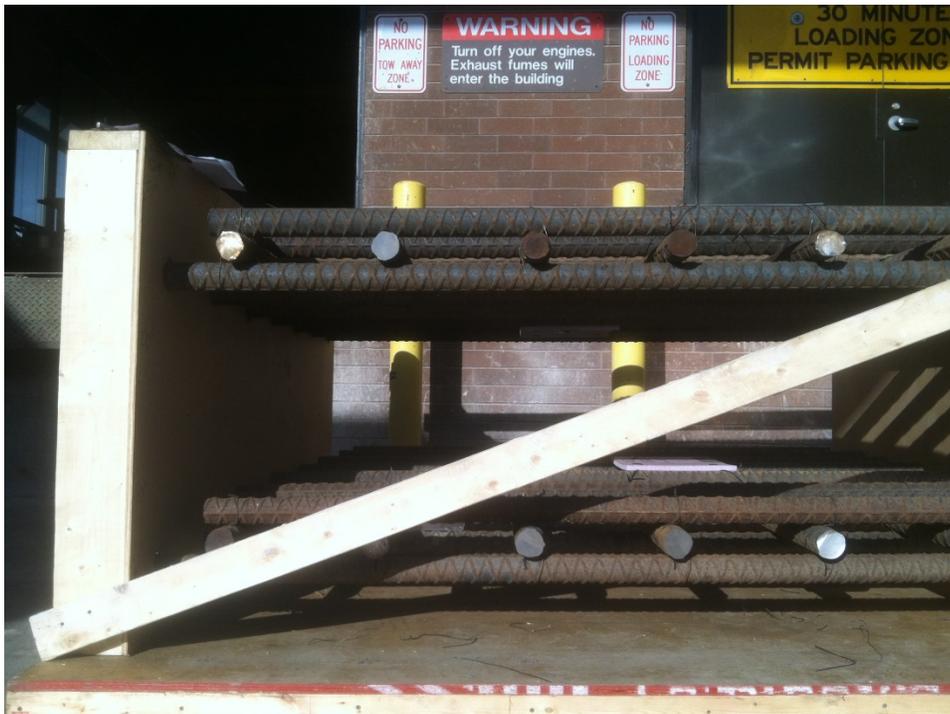
Fig. 25. #18 reinforcement used to replicate the large diameter mesh used in NPP containment walls.

NPP concrete is normally embedded with heavily reinforced cross sections using mild steel #18 bars (2.257 in. diameter, 4.00 in.<sup>2</sup> cross-sectional area) and #8 bars (1.000 in. diameter, 0.79 in.<sup>2</sup> cross-sectional area) at 6 to 12 in. spacing. The type and spacing of the reinforcement has a significant effect on the shielding evaluation of defects below the level of reinforcements, especially when using GPR, since electromagnetic waves are extremely sensitive to metal. While elastic wave-based methods are less sensitive to reinforcement than GPR, characterization of defects within more heavily reinforced structures are more difficult than for less heavily reinforced structures. The constructed specimen contained #18 rebar at 12 in. spacing in both horizontal and vertical orientation. This provides a realistic reinforcement size that also allows for space between reinforcement for semi-controlled evaluation of the effects of concrete depth on defect characterization. This will also allow for differentiation between complexities caused by dense levels of reinforcement versus complexities caused by depth of penetration within concrete, while still observing the effects of the uniquely large diameter reinforcement used in NPP structures. Figure 25 is a photograph of the #18 reinforcement size and arrangement at an intermediate stage of the formwork process.

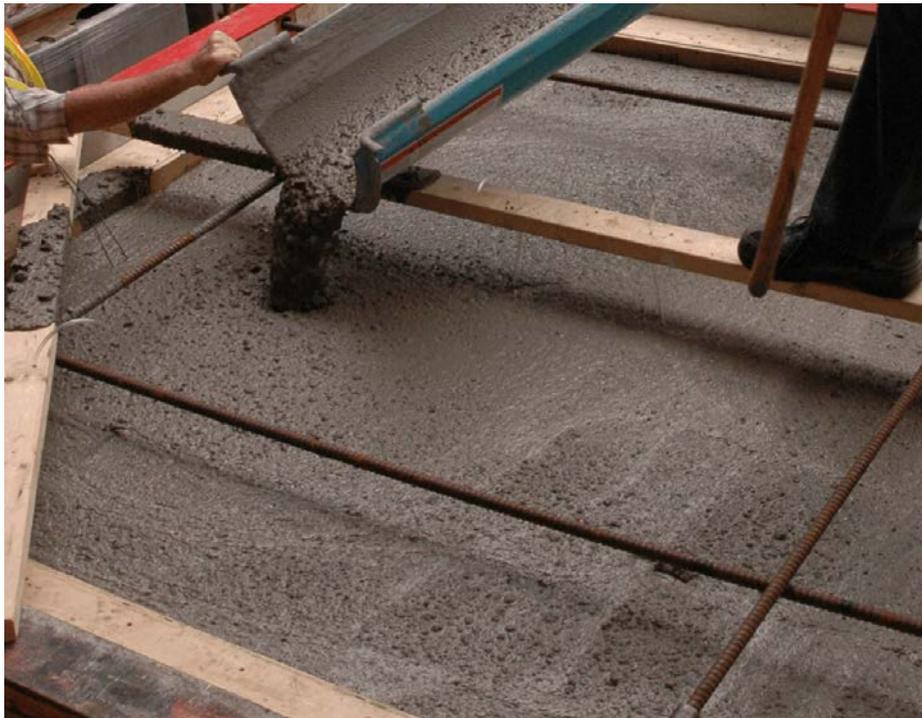
**Fig. 29. Use of SCC to allow for consolidation without affecting simulated defects.**

Concrete material properties of the various NPP concrete structures depend on the materials used during construction of the specimen. The material used at each NPP site is variable depending on the distance from aggregate and cement sources in the area. Additionally, the early age material properties resulting from each mix design are different than the material properties 50 years after the beginning of the curing process. Theoretically, the mix design of example NPP locations could be replicated to determine the effect of material properties on NDE techniques. However, since the mix designs are variable from site to site, materials from 50 years ago are not easily obtained, and early age properties are not representative of older concrete, the proposed mix was designed to make the PCC matrix surrounding the simulated defects and reinforcement pattern as controlled and consistent as possible. By taking into account the large size of the specimen, complex nature of the reinforcement and simulated defects, and goals of limiting the variables other than the known defect and reinforcement locations, a self-consolidating (SCC) performance-based mix was chosen. The placement of the proprietary Cemstone SCC mix provided consistent consolidation and low stress on embedded defects without the need for vibration. This also mitigated concerns of the simulated defects damaging or moving from their desired location during the pour. A photograph of the SCC pouring process is shown in Fig. 29. The spread of the SCC mix allowed for minimal movement during placement.

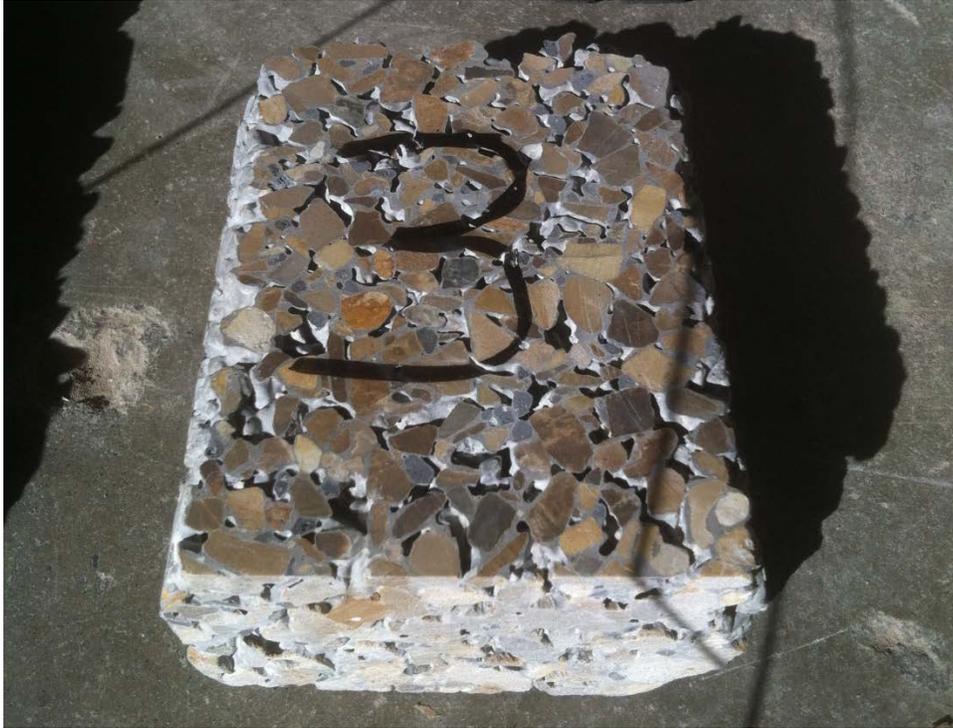
**Fig. 35. Example realistic defect simulating concrete damage with embedded porous concrete (D03).**

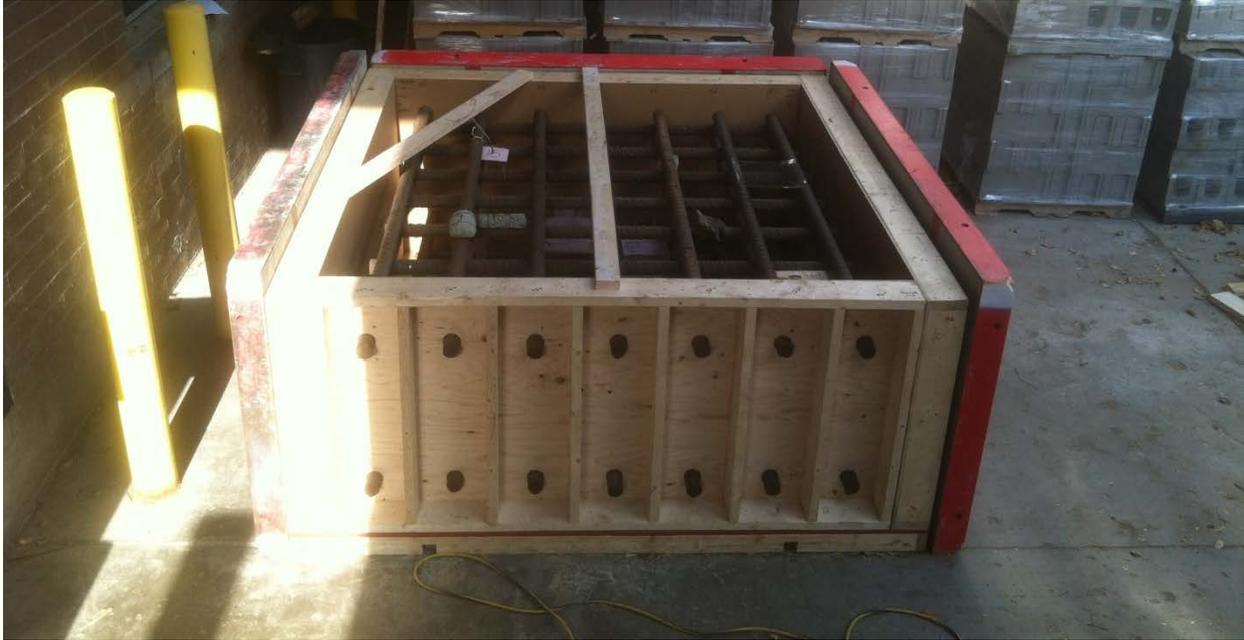
**Fig. 37. Photograph of the formwork required to cast the wall lying down.**

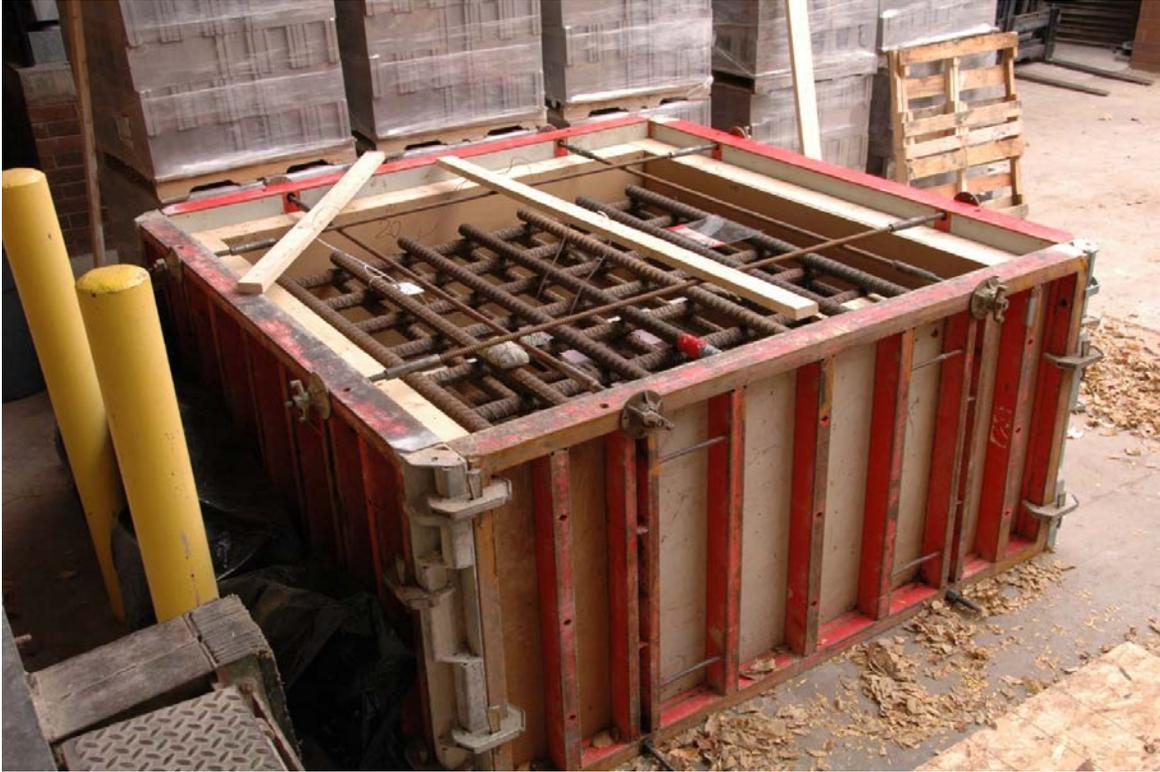
**Fig. 41. Fully secured formwork.**

The form was assembled ahead of time to ensure that all simulated defects could be properly secured prior to casting of the specimen. Figure 41 shows the final clamped formwork setup after assembly, including lumber and fixing mechanisms for the defects and associated features. The temperature was around 41 °F during casting, with overnight temperatures approaching freezing. To mitigate negative effects on the hydration process, additional insulation was added to the top of the specimen after the pour to supplement the plywood blockout insulation (see Fig. 42). Ultrasound velocity measurements and the warm surface after two days suggested proper hydration of the specimen.

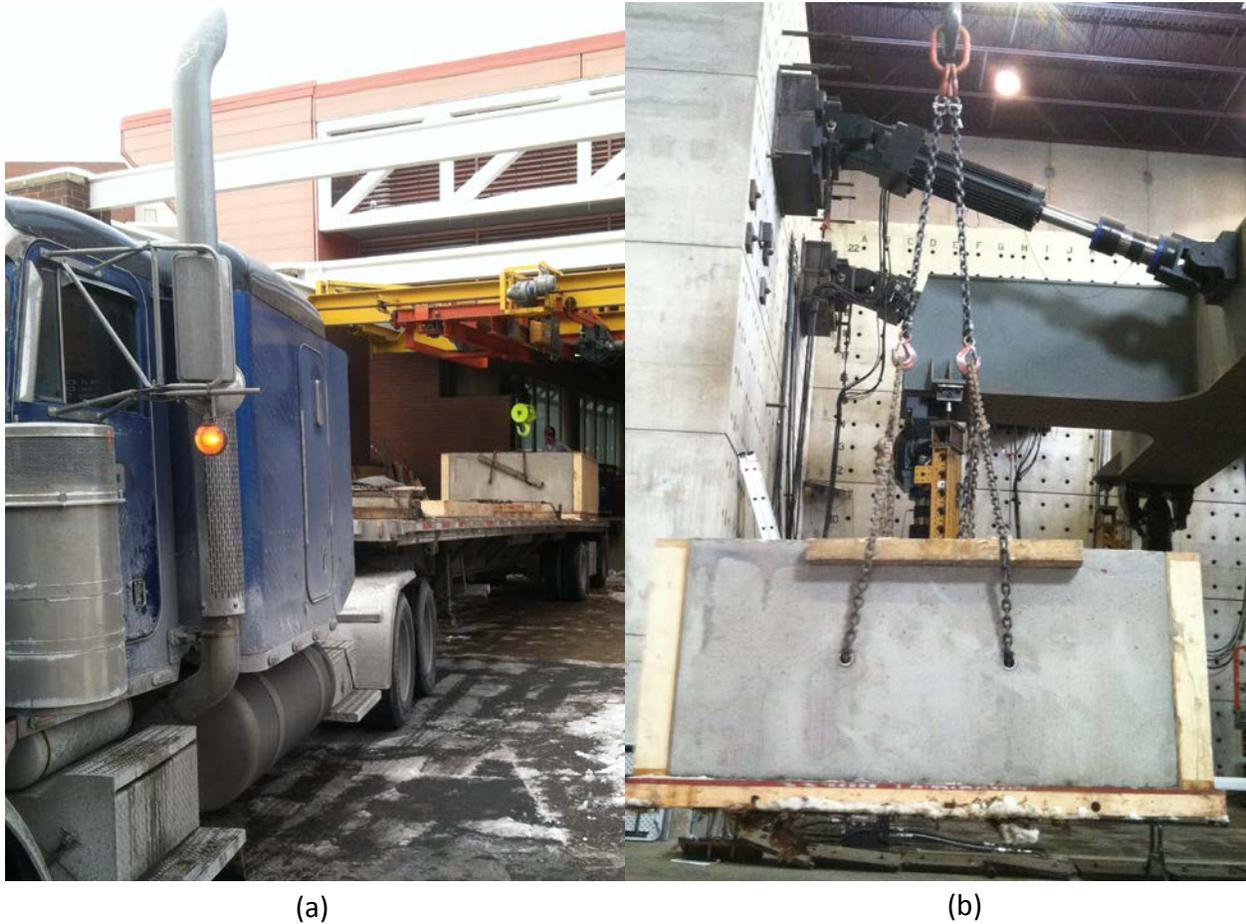
**Fig. 43. Movement of the specimen from the casting location to the testing location.**

Detailed planning of the formwork and associated fixtures allowed for safe mitigation of the complexities involved with construction and movement of a large reinforced concrete specimen. Placement of the PVC pipe within the specimen allowed for the crane operation required to move and tilt the specimen. As can be observed from Fig. 43, transport involved use of a flatbed truck to crane the specimen into the testing location at the MAST lab. The tilting process also required special precaution since there is no confining force along the depth axis of the wall, and there was a potential for laminar cracking to occur (similar to the distresses observed in Fig. 3, Fig. 6, and Fig. 7) along the reinforcement and simulated defect locations during the crane tilting and transport process. Tilting was controlled by including a second crane to pick up the bottom of the specimen while the top was tilted up (see Fig. 44). Once the specimen was placed in position, it was secured to prevent potential tipping of the specimen (see Fig. 45).
