Linear Array Ultrasonic Test Results from Alkali-Silica Reaction (ASR) Specimens

**LINEAR ARRAY ULTRASONIC TEST RESULTS FROM ALKALI-SILICA
REACTION (ASR) SPECIMENS**

Dwight Clayton, Oak Ridge National Laboratory
Lev Khazanovich, University of Minnesota
Lucio Salles, University of Minnesota

Date Published: April 2016

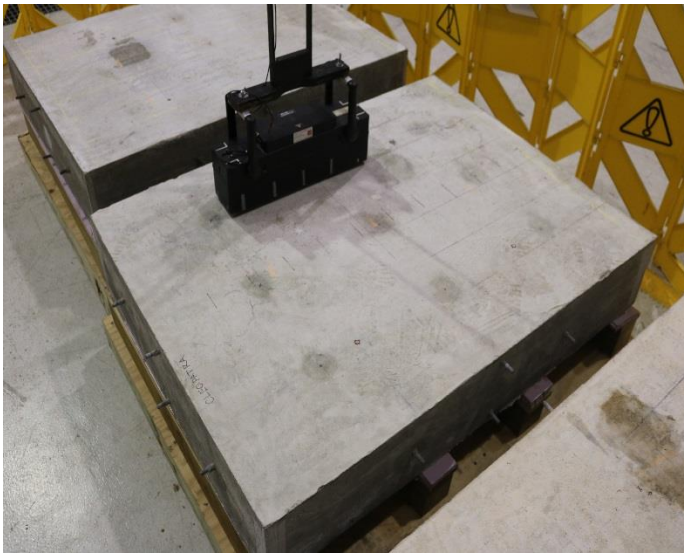
Fig. 4. (a) Device positioned at Panoramic 6 on specimen Cleopatra; and (b) Readings layout

Fig. 5 shows the device used for this study along with a layout of scan locations. The scans were taken in sets of 11 positions in 50 mm step sizes moving north to south. The device was placed 50 mm off the north edge of the slab. These overlapping scans were used to create extended Synthetic Aperture Focusing Technique (SAFT) subsurface panoramic reconstructions (SAFT-Pan) along the specimen length. It can also be observed that this set of 11 scans was taken in six panoramic locations in 125 mm step sizes moving east to west, corresponding to the width of the device. This allowed for the creation of six SAFT-Pan reconstructions per set of 66 measurements on each slab. The measurement procedure was adopted based on a similar analysis on specimens with freeze and thaw damage [10].

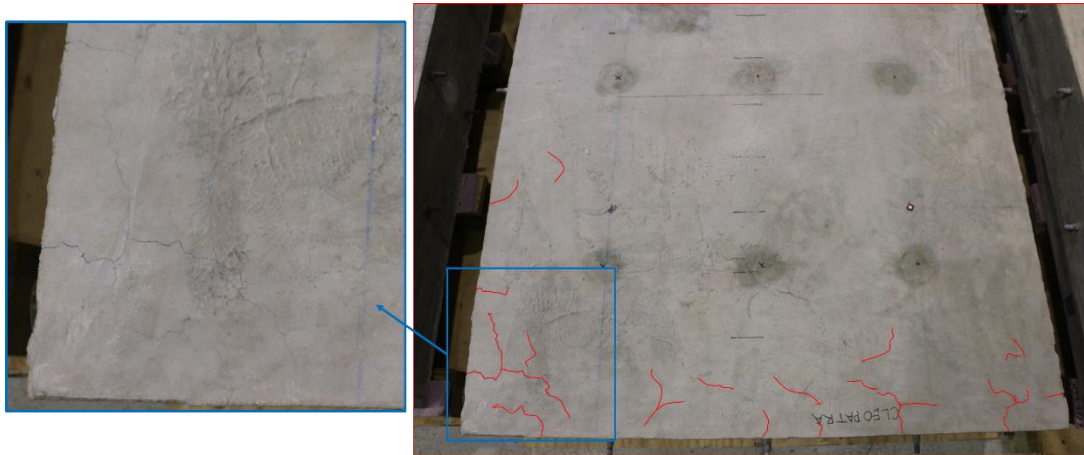
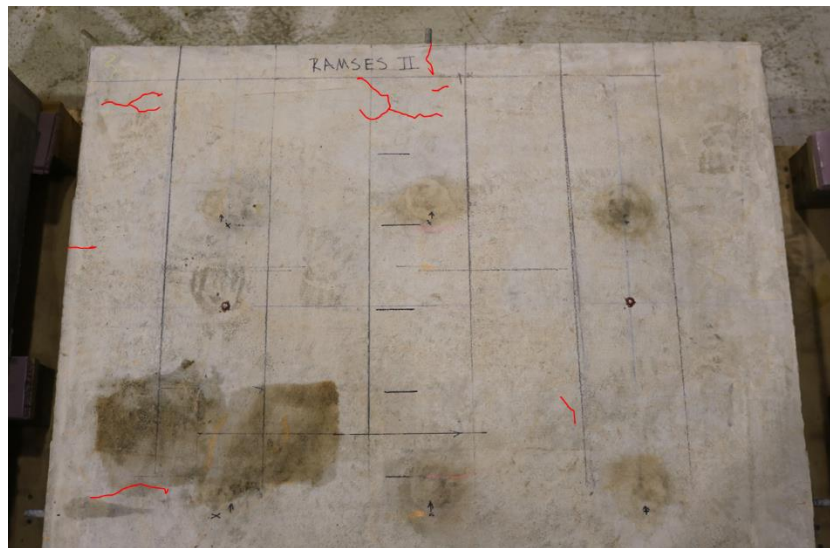
Fig. 13. Visible cracking in specimens (a) Cleopatra (south) and (b) Ramses (north)

Examination of surface cracking in all specimens confirms the damage presence on specimens Cleopatra and Ramses, as shown in Fig. 13 with cracks highlighted for greater ease of identification. The blue rectangle on Fig. 13(a) shows an enlarged section of the specimen in order for cracks to be more easily visible. Fig. 13 shows minimal visible cracking on the King Tut specimen. Specimen Nefertiti did not have any visible surface cracks.

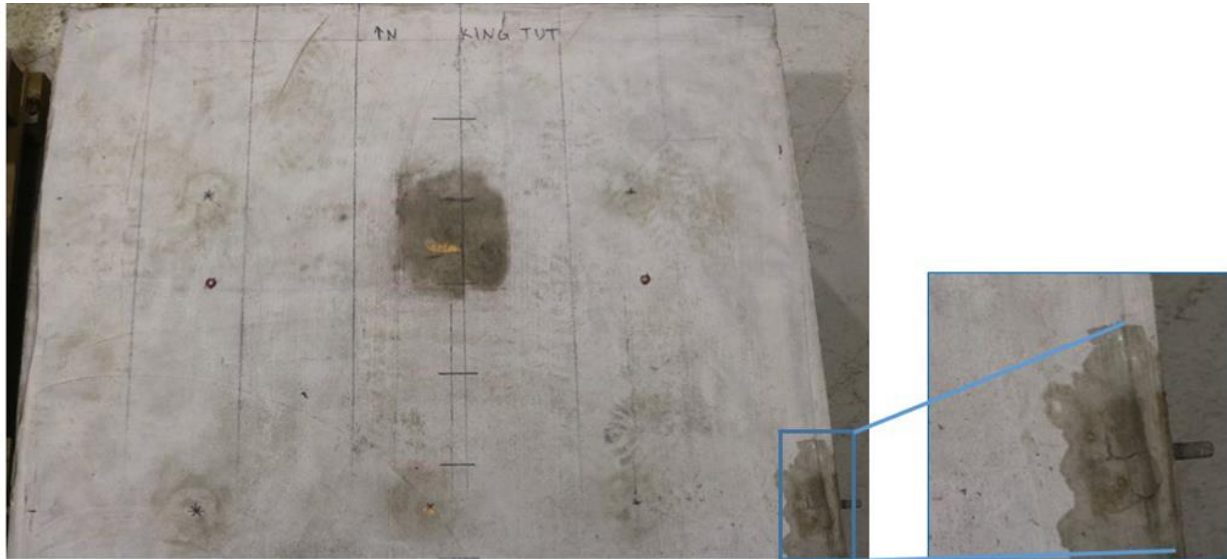
Fig. 14. Visible cracking in specimen King Tut.

Schematics of the two damaged cases are shown below in Fig. 14
