**INSPECTION OF NUCLEAR POWER PLANT
STRUCTURES – OVERVIEW OF METHODS AND
RELATED APPLICATIONS**

May 2009

D. J. Naus

D. J. Naus
Materials Science and Technology Division
Oak Ridge National Laboratory
Oak Ridge, TN 37831

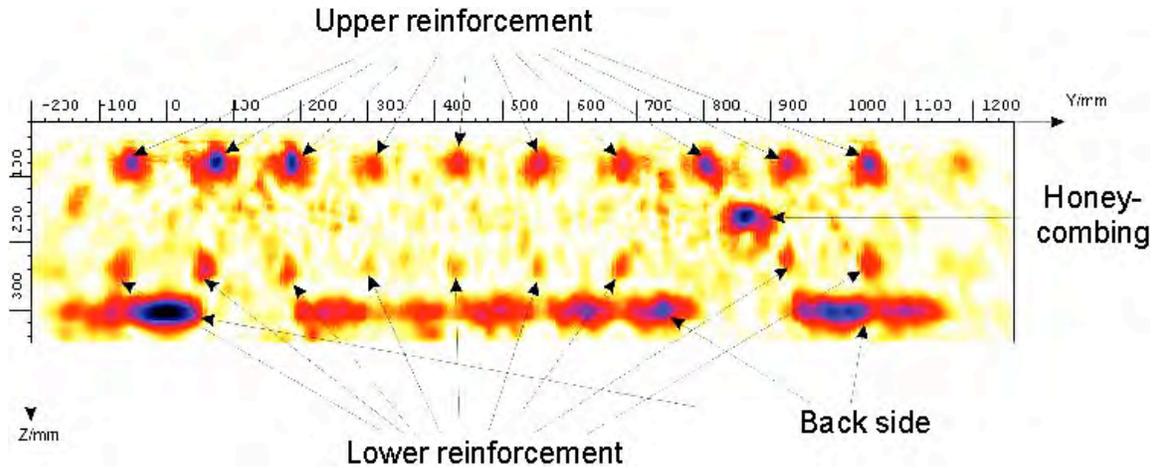
Figure 3.5 Pulse-echo results showing concrete honeycomb below steel reinforcement.

measurements of a tunnel wall (3.28). Figure 3.5 illustrates identification of honeycombed concrete located below steel reinforcement after synthetic aperture focusing technique (SAFT) reconstruction of data obtained from an ultrasonic array (3.29). The ultrasonic pulse-echo method can be used for thicknesses up to 1000 to 1200 mm if the maximum size aggregate is 16 mm or less (3.30).

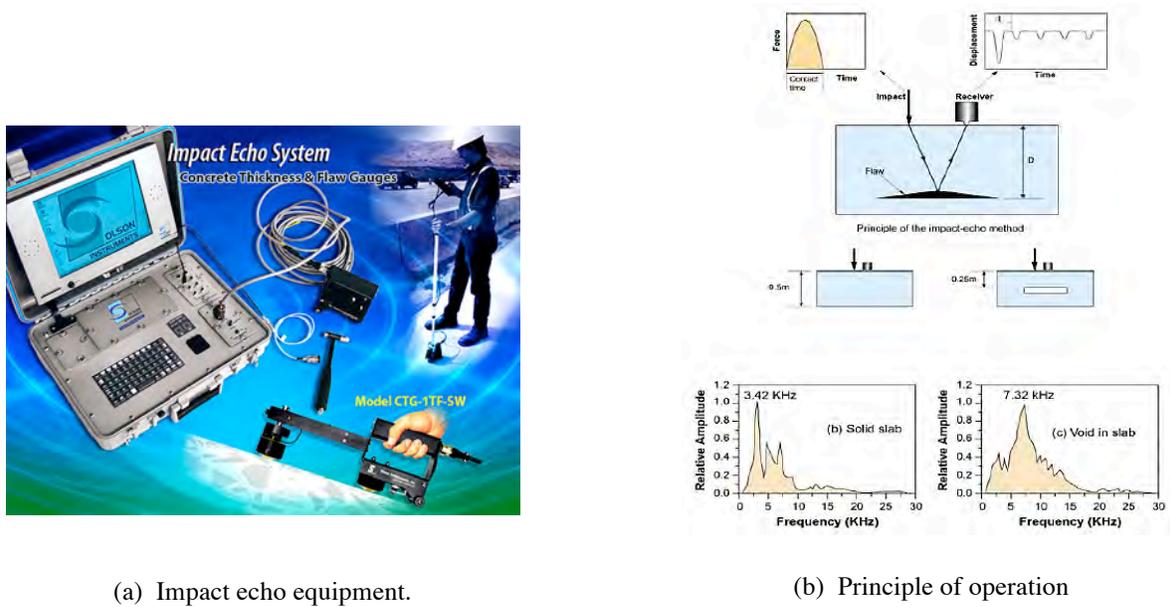
Figure 3.6 Impact-echo equipment and operation principle.

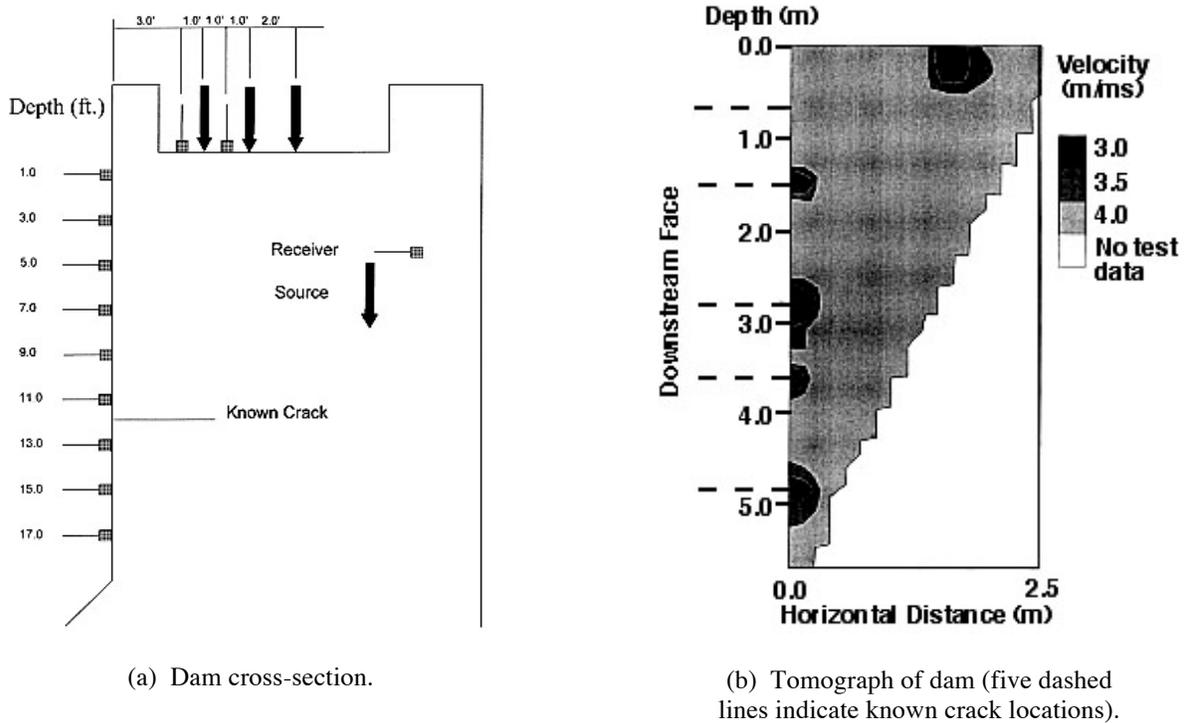
Fig. 3.8 Illustration of acoustic travel time tomography.

of propagating mechanical waves through the surveyed plane section from different source locations to different receiver positions. During the propagation between sources and receivers, mechanical waves interact with the material. Local variations in the elastic properties of the material result in corresponding variations in the characteristics of received signals. Information from stress wave transmissions is used to reconstruct a map of velocities on a slice through the interior of a body. Results are analyzed with sophisticated computer software that has been developed especially for this application. Defects usually observed in concrete (e.g., microcracks, honeycomb, and voids) generally have a greater effect on the concrete modulus than on the density and the Poisson's ratio (3.39). Thus the variations of velocity give a useful and indirect measurement of the variations of the dynamic modulus over the concrete mass. The advantage of this method over radiography is that it provides the possibility of internal inspections through development of three-dimensional displays from a series of reconstructed digitized detector measurements obtained from planes or slices through the thickness of the object inspected. The primary limitations of this method are that if a complete examination is not possible because of geometrical boundary conditions, additional calculations must be made for those areas, and the method is presently costly to perform. Figure 3.8 illustrates the application of acoustic travel time tomography to detect cracks in a dam structure.

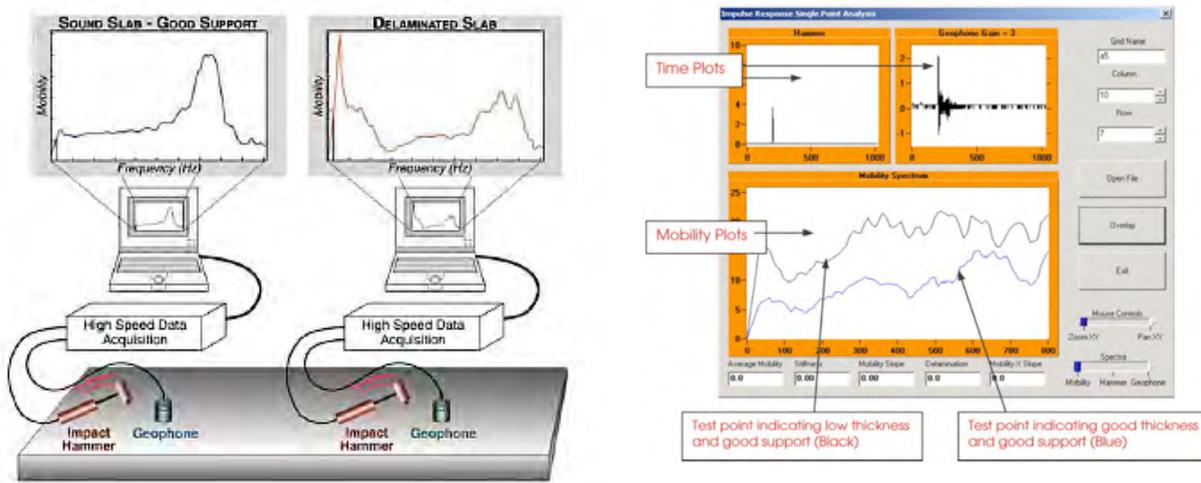
(a) Test setup

(b) Application to tunnel liner.

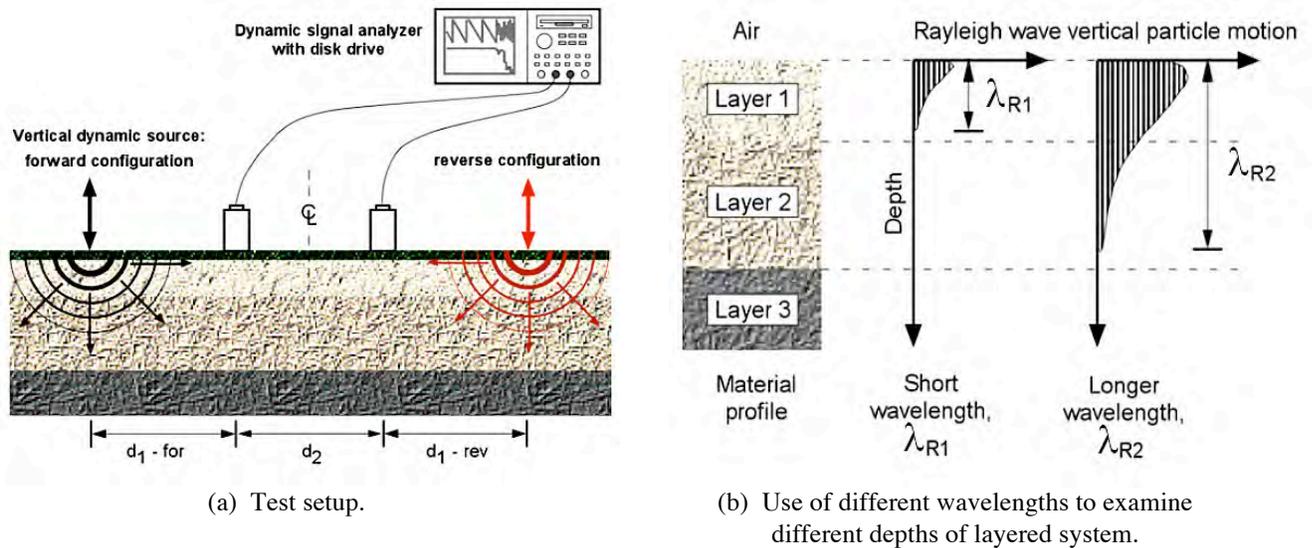
Fig. 3.10 SASW test setup and example application.

stiffness of the top layer of a pavement system, or liner thickness (3.44). Figure 3.10 provides a schematic of the basic test setup and the use of wavelength to investigate different depths of a layered system.

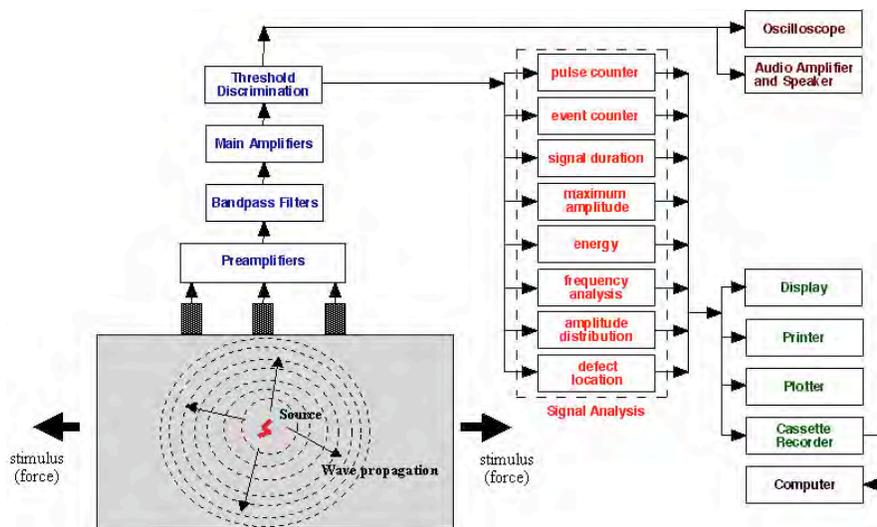
Figure 3.11 Acoustic emission principle and schematic of data acquisition.

Acoustic emission monitoring is passive in that it listens for sound waves generated by stresses within a material. Acoustic emission is the class of phenomena whereby an elastic wave, in the range of ultrasound usually between 20 KHz and 1 MHz, is generated by the rapid release of energy from a source within a material (3.45). Acoustic emissions in concrete are due primarily to cracking processes, slip between concrete and steel reinforcement, and fracture or debonding of fibers in fiber reinforced concrete. The elastic wave propagates through the solid to the surface where it can be recorded by one or more piezoelectric sensors and analyzed (Figure 3.11). The sensor is a

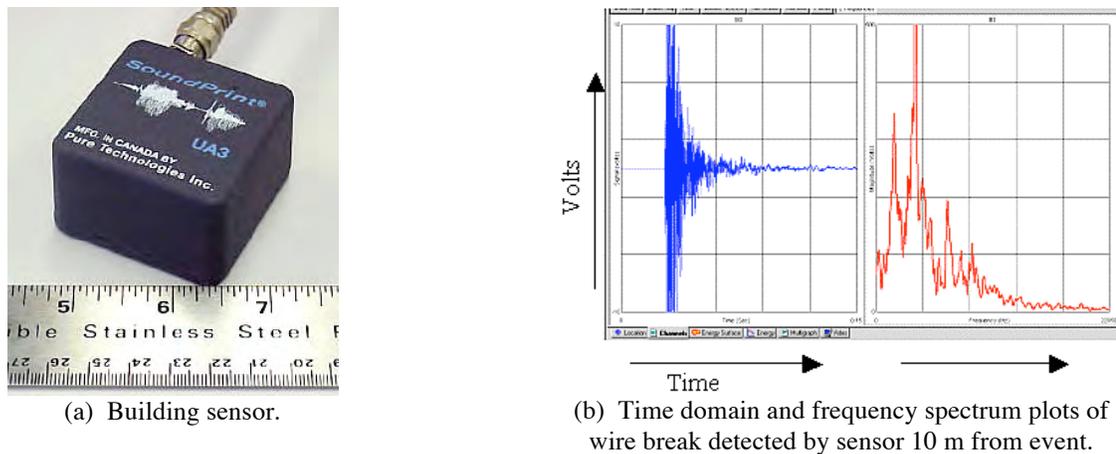
Fig. 3.12 Acoustic monitoring of tendons in post-tensioned structures.

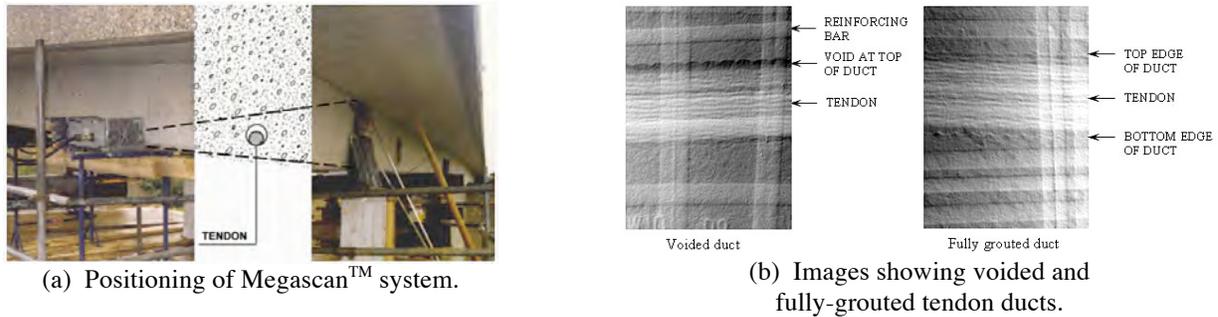
Fig. 3.14 Application of Megascan™ imaging capture system.

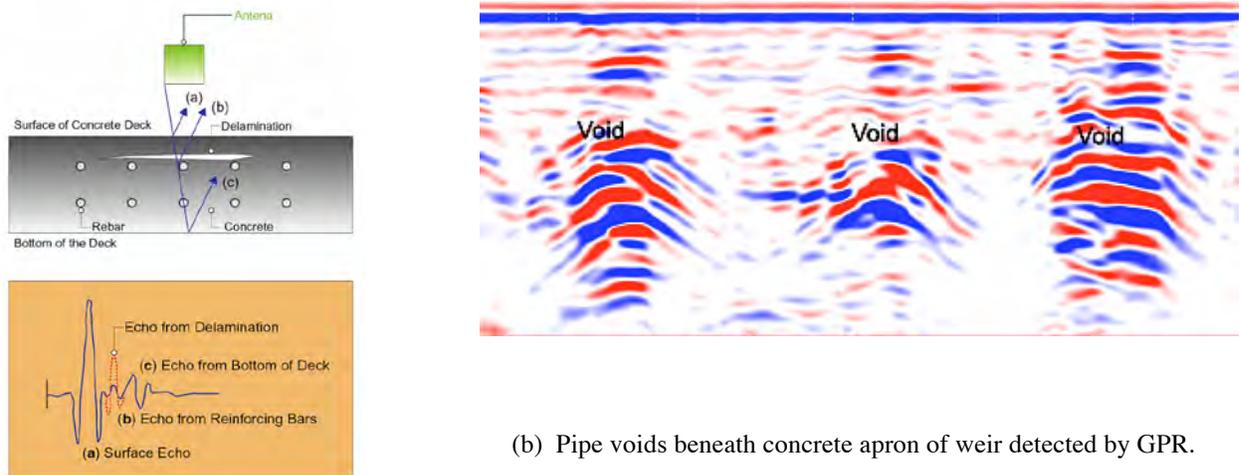
Fig. 3.18 Application of GPR to detect concrete delamination and near-surface voids.

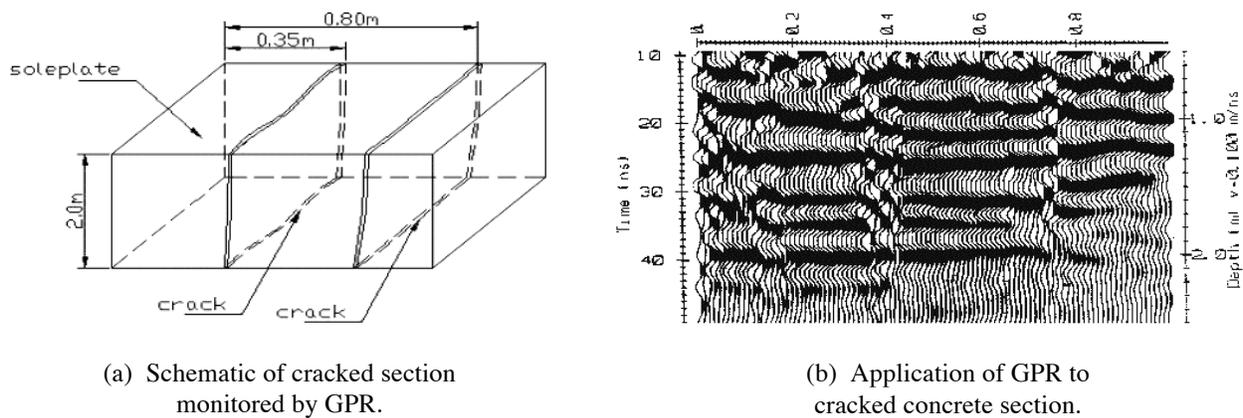
Fig. 3.19 Application of GPR to detect concrete cracking.

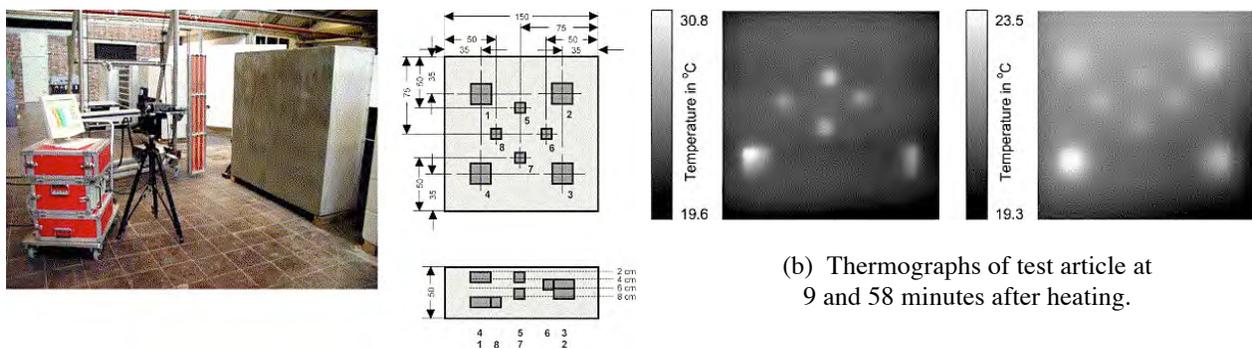
(a) Experimental setup and test article for impulse thermography.

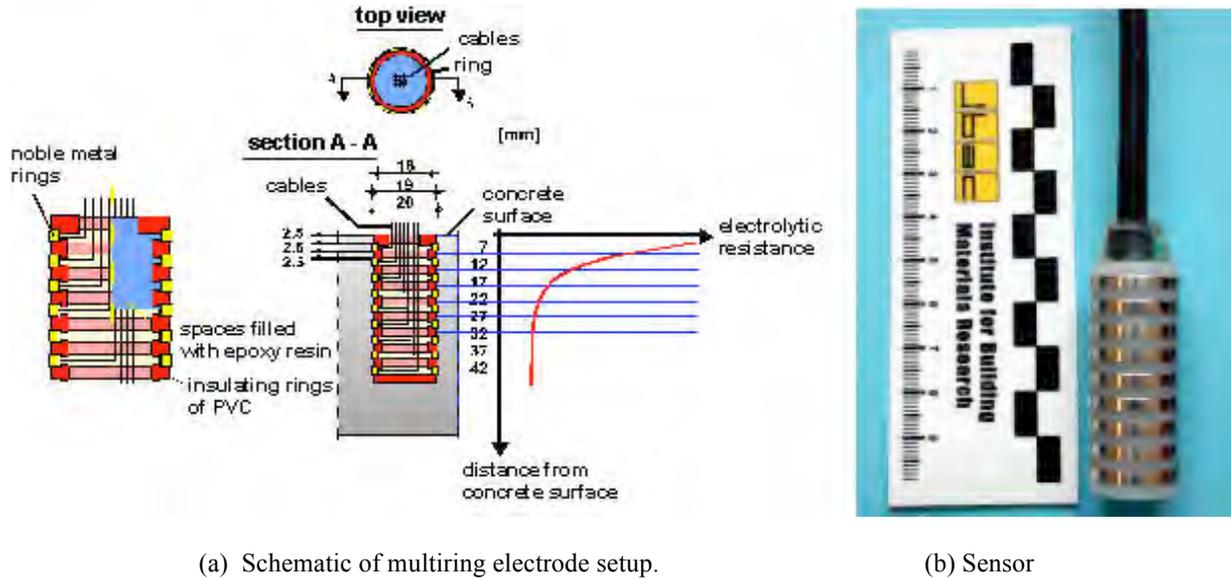
Fig. 3.28 Schematic of multiring electrode setup and photograph of sensor.

A multiring-electrode method has been developed that can be embedded in new construction or placed into existing structures and uses measurements based on resistivity in conjunction with temperature measurements to determine moisture distribution in the concrete cover zone (3.78). Figure 3.28 presents the multiring electrode and sensor. Moisture and salinity of concrete can also be evaluated based on determination of dielectric permittivity in the microwave frequency range of 1 to 10 GHz using a microwave resonator, but this requires positioning of the antennas on opposite sides of the concrete or into two parallel boreholes (3.79).

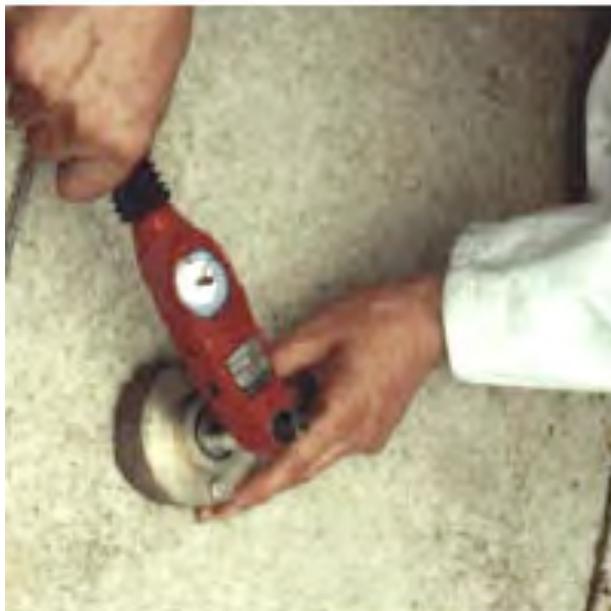
(a) Internal fracture test fixture.

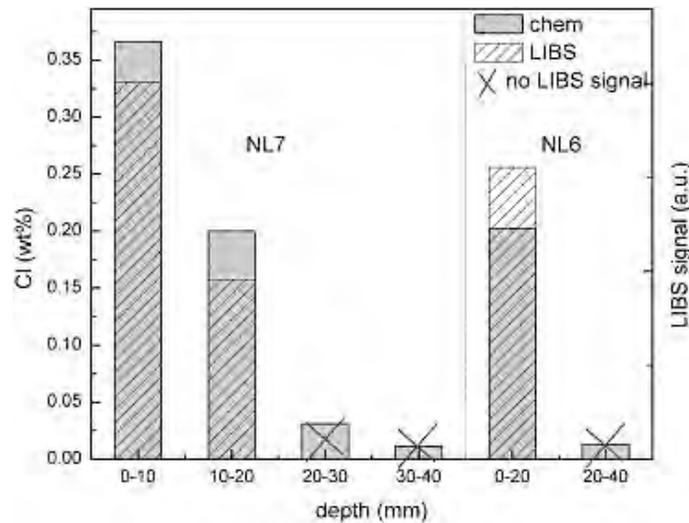
Figure 3.38 Comparison of LIBS results with those from standard chemical analysis.

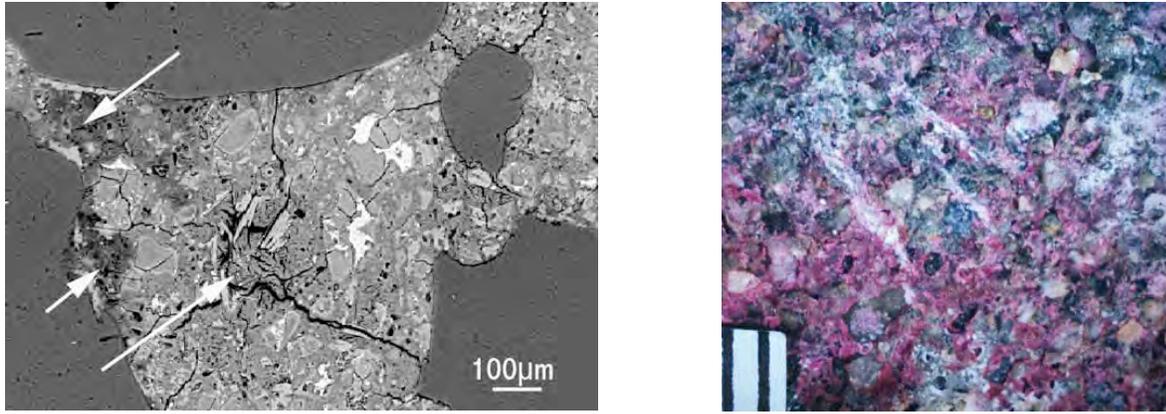
(a) Scanning electron microscope image of sulfate attack in concrete where ettringite (arrows) has replaced some of the calcium silicate hydrate in the cement paste.

microscopy, scanning electron microscopy, electron probe microanalysis, differential thermal analysis, and x-ray powder diffraction. Sulfate compounds often exist as cryptocrystalline clear to white secondary deposits in voids or cracks and can be distinguished using a barium chloride-potassium permanganate solution (3.103). If sulfate ions are present, BaSO_4 will precipitate trapping permanganate in the crystal structure, thus staining purple as shown in Figure 3.42.

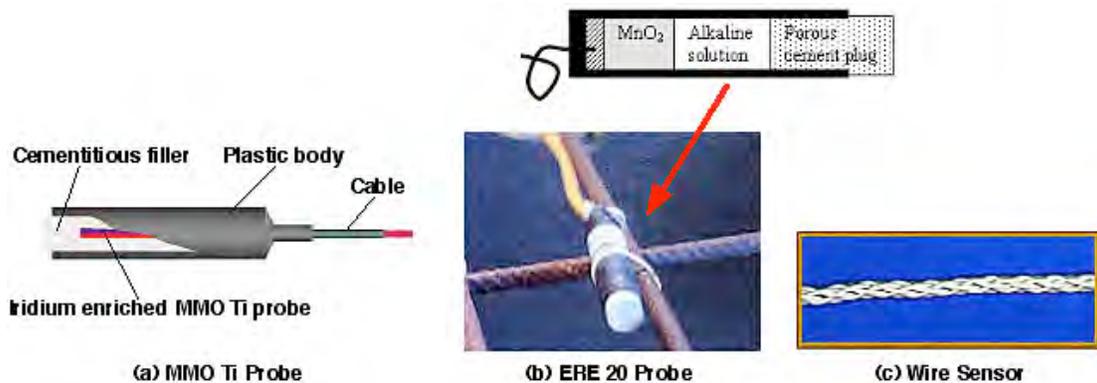
Figure 3.54 Examples of embeddable reference electrodes.

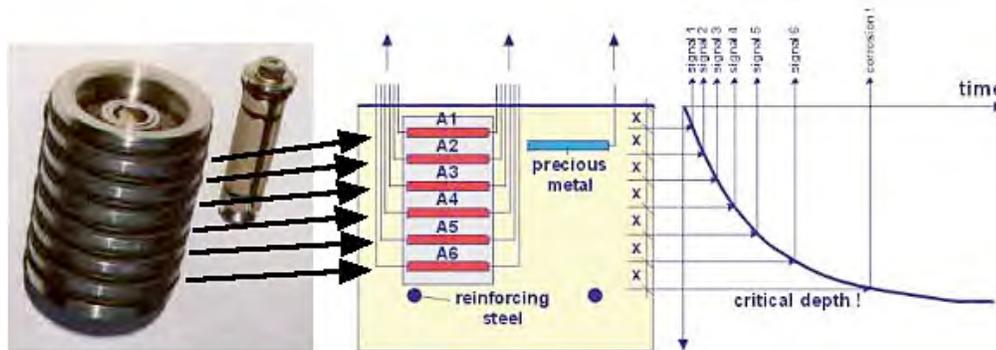
Figure 3.57 Expansion-ring system and its use to determine time to corrosion.

1-cm steps from 1 to 6 cm. The expansion-ring anodes and cathode bar are inserted into holes that have been drilled into the concrete and a turning nut used to expand the expansion rings in a way that the sensors make good contact with the concrete. All inner open spaces are then filled with a resin-sealing material to ensure that water or chlorides do not penetrate the inner part of the sensor. The expansion-ring system is recommended for non-submerged conditions only. The basic principle to determine the time to corrosion for the multianode systems is also illustrated in Figure 3.57. The Embedded Corrosion Instrument (ECI), Figure 3.58, is comprised of sensor electrodes and processing electronics integrated within a molded plastic enclosure (3.143). It is installed during construction at the top level of the steel reinforcing with its electrodes facing up and monitors five key factors related to the corrosion of steel embedded in concrete: linear polarization resistance, open circuit potential, resistivity, chloride ion concentration, and temperature. Linear polarization resistance is measured by using a steel working electrode, stainless steel counter electrode, and manganese dioxide reference electrode. The unit initiates measurement of open circuit potential between the working and reference electrodes in the potentiostat circuit, and applies an appropriate

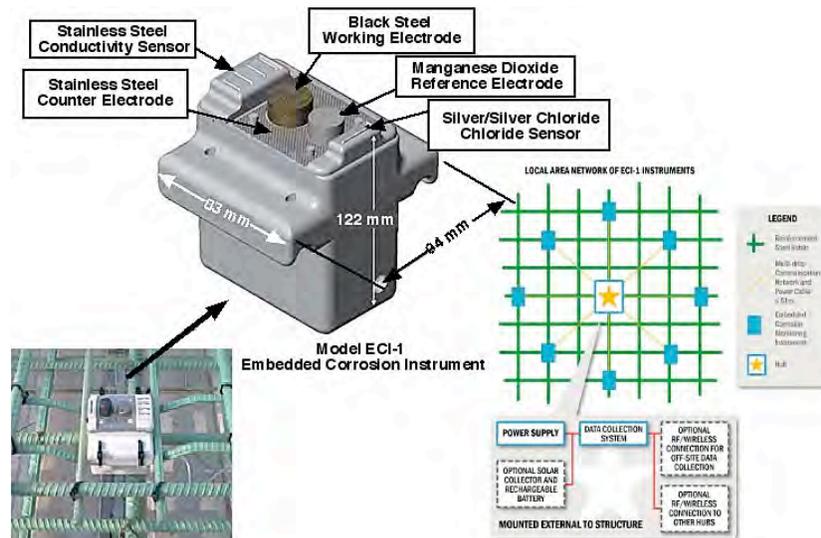
Figure 3.58 Embedded corrosion instrument.

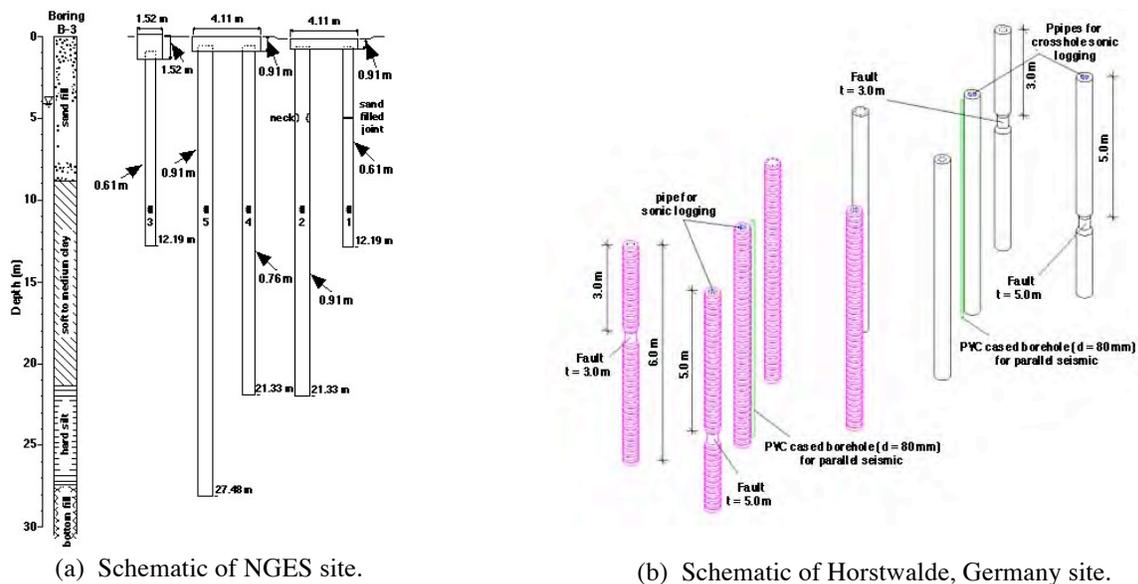
Figure 3.59 Large-scale deep foundation test facilities.

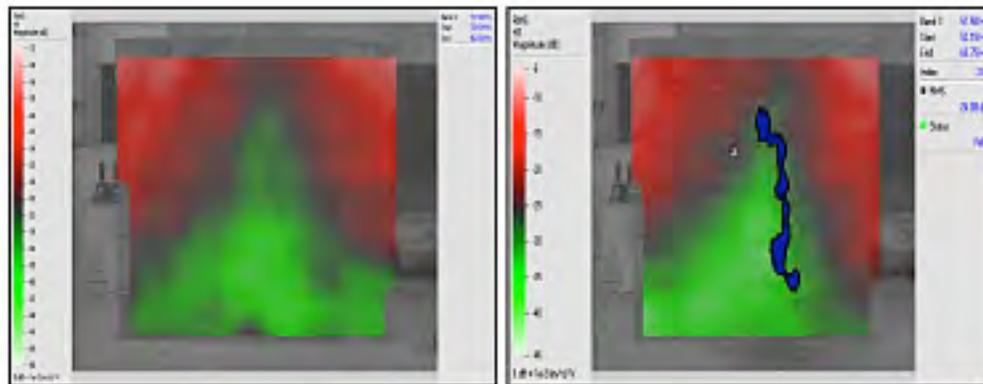
(c) Undamaged wall vibration map.

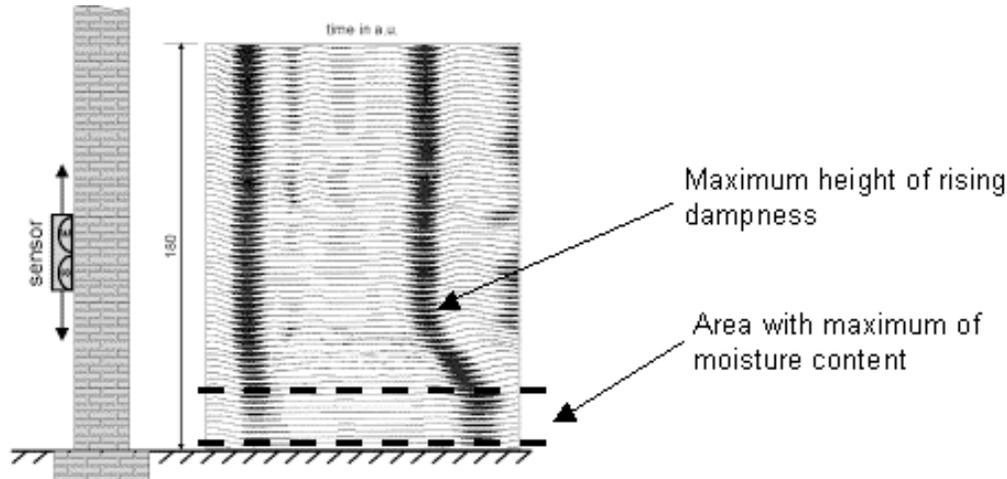
Figure 3.67 Application of GPR to detect moisture level.

detect rising moisture levels in brick work as illustrated in Figure 3.67 (3.169). In this application the delay of the signal due to the higher dielectric constant resulting from the presence of moisture provides a visualization of the qualitative effect of rising moisture and moisture content. In order to determine moisture contents quantitatively calibration of the dielectric constant and moisture content have to be performed (3.170). The influence of dissolved salts also needs to be considered.

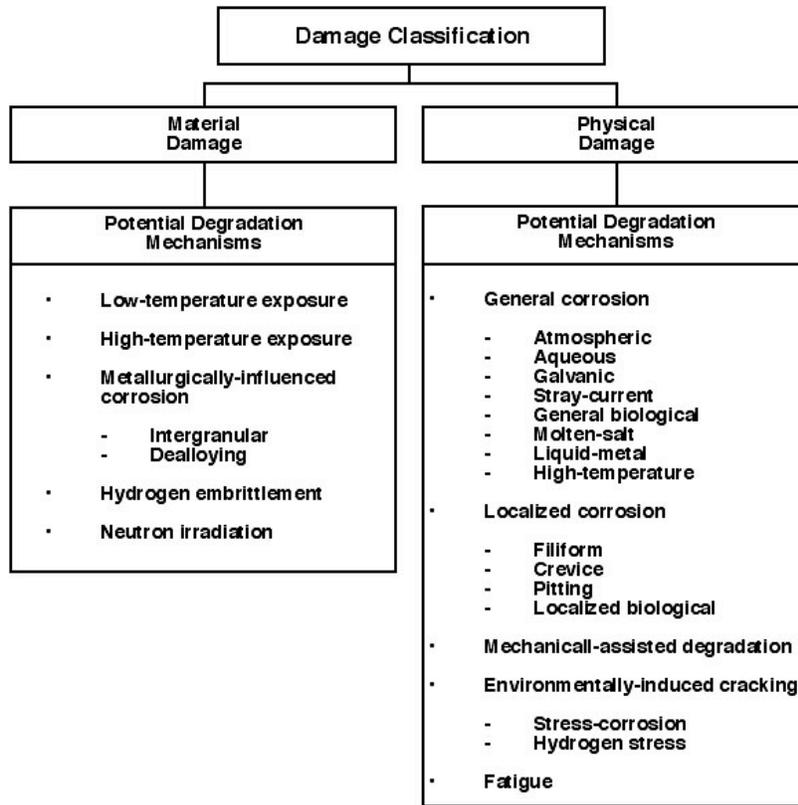
Figure 4.3 Damage categories and potential degradation mechanisms.

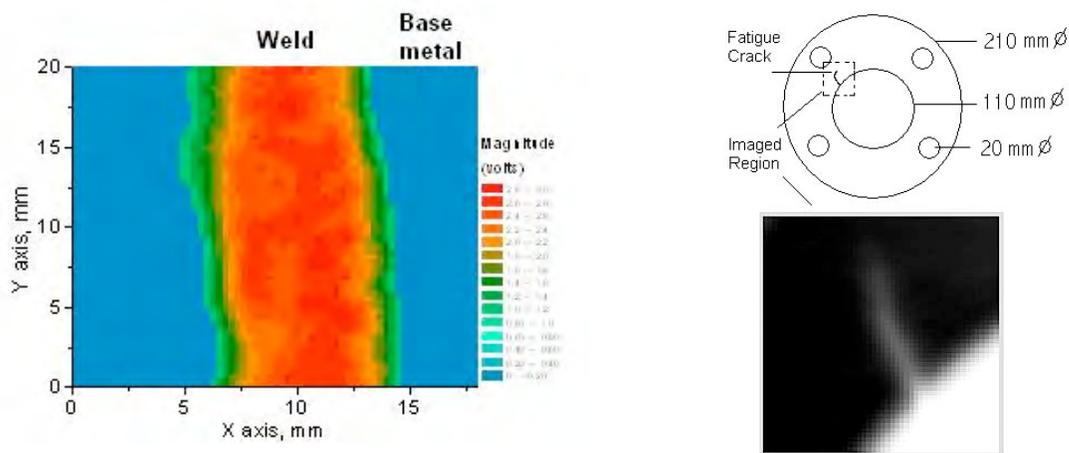
(a) Eddy current image of stainless steel weld.

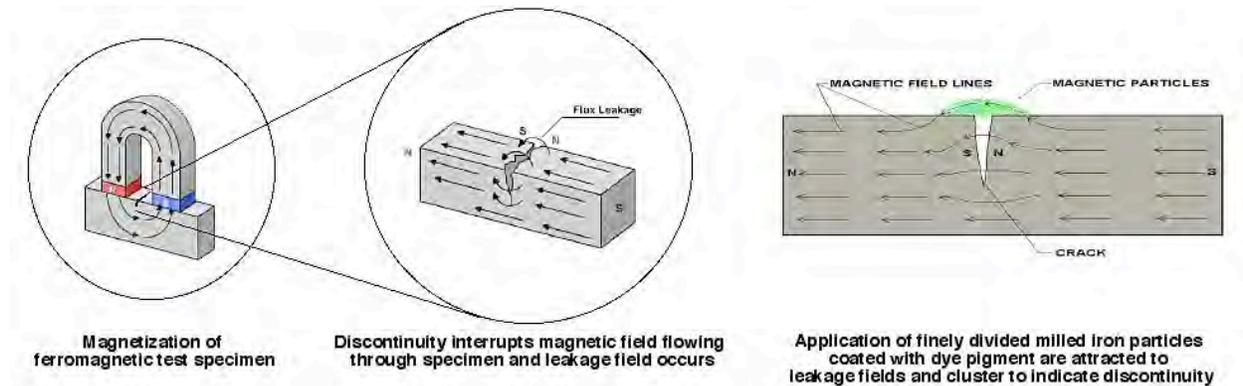
Figure 4.12 Magnetic particle testing.

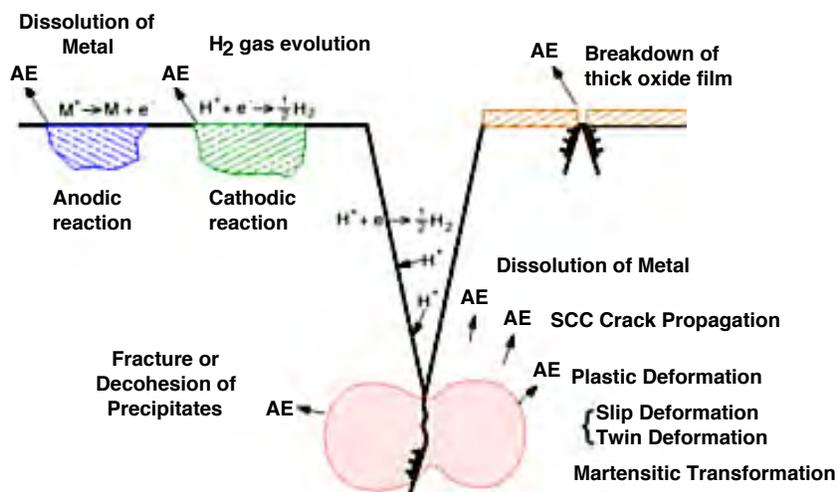
Figure 4.25 Schematic of acoustic emission sources due to corrosion.

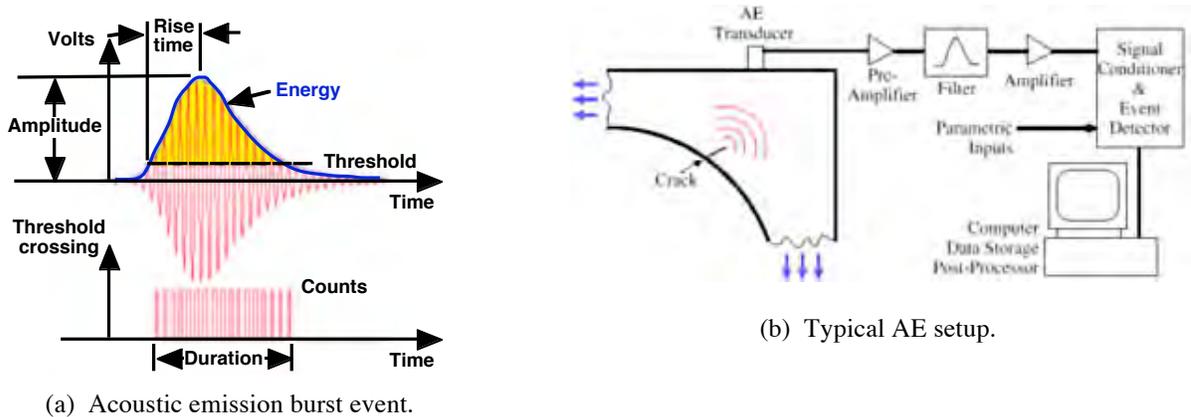
Figure 4.26 Acoustic emission technique.

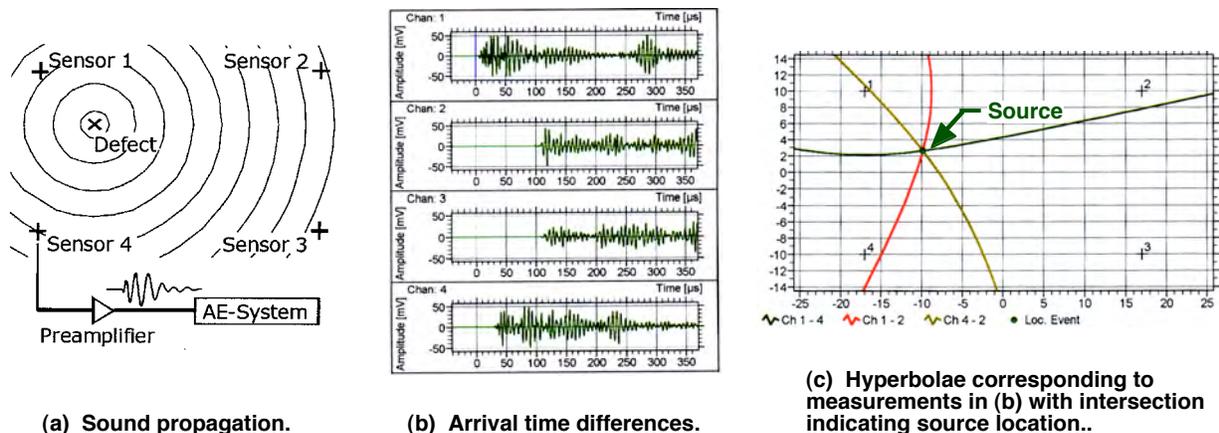
Figure 4.27 Example of use of acoustic emission testing to locate a source.

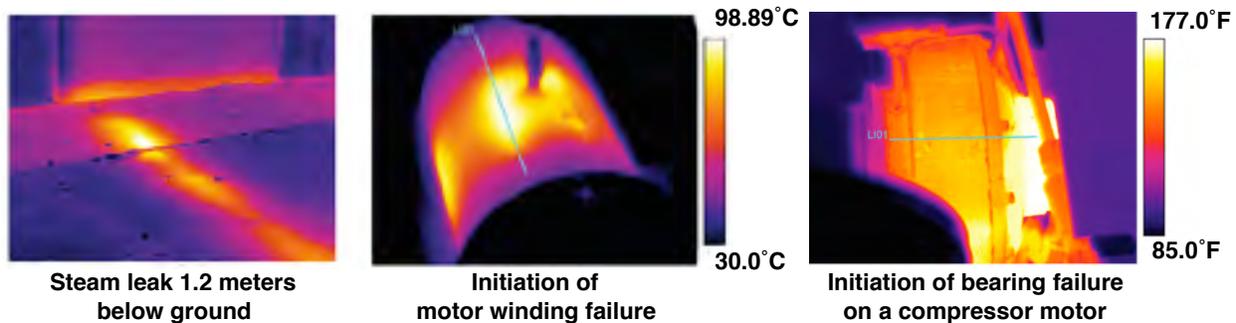
Figure 4.30 Example applications of infrared thermography.

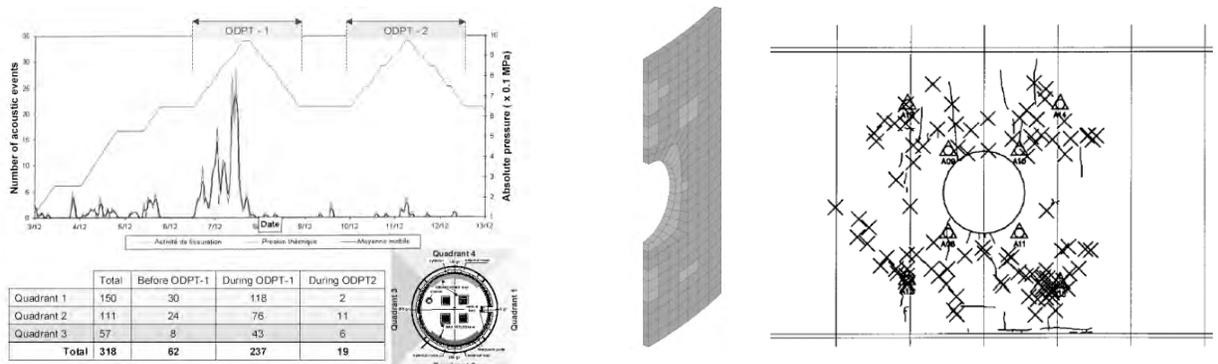
(a) Pressurization and detection of crack events. (b) Comparison of cracking in Quadrant 1 deduced by finite-element analysis and by acoustic events.

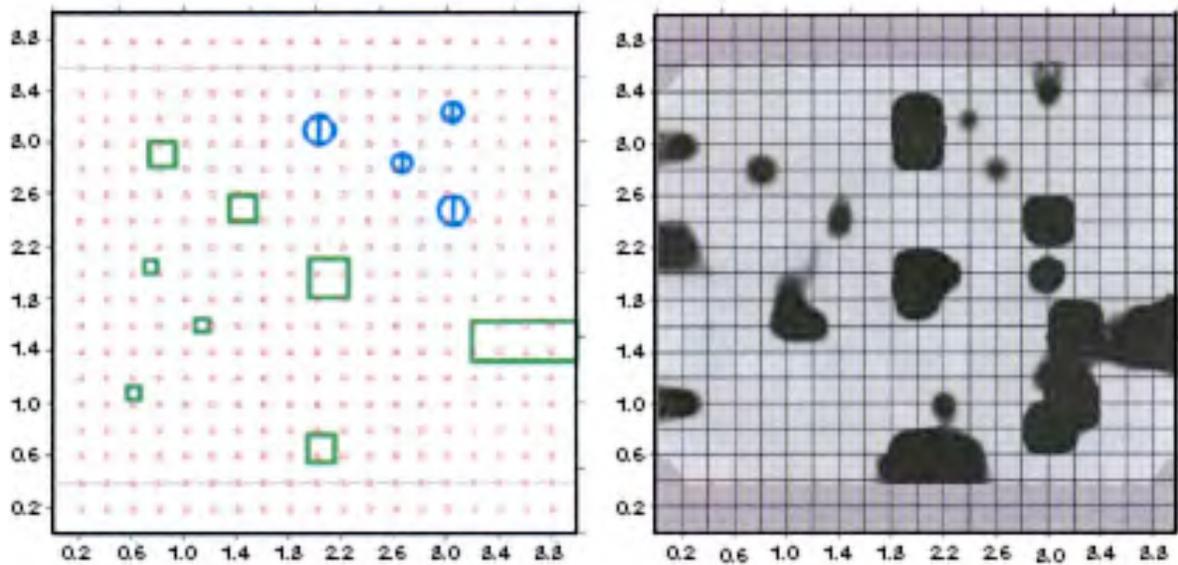
Figure 5.9 Ultrasonic pulse echo results for Block 1.

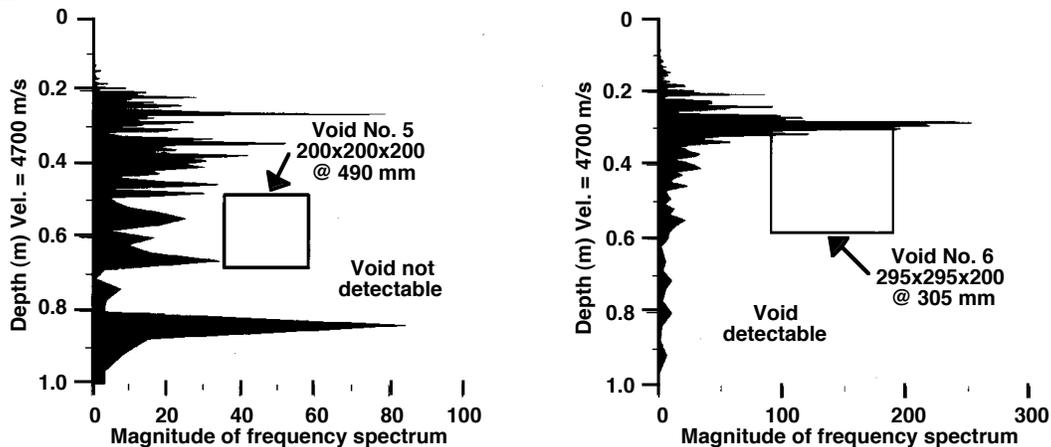
Figure 5.11 Impact echo results for void nos. 5 and 6.

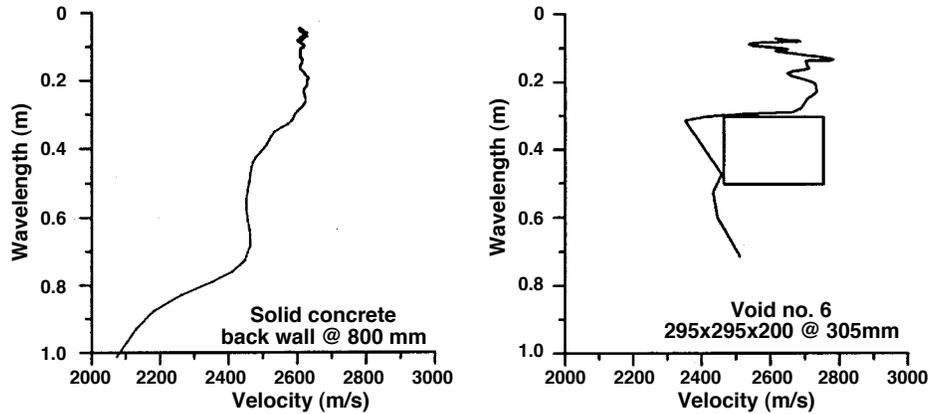
Figure 5.12 Spectral analysis of surface waves results for solid concrete and void no. 6

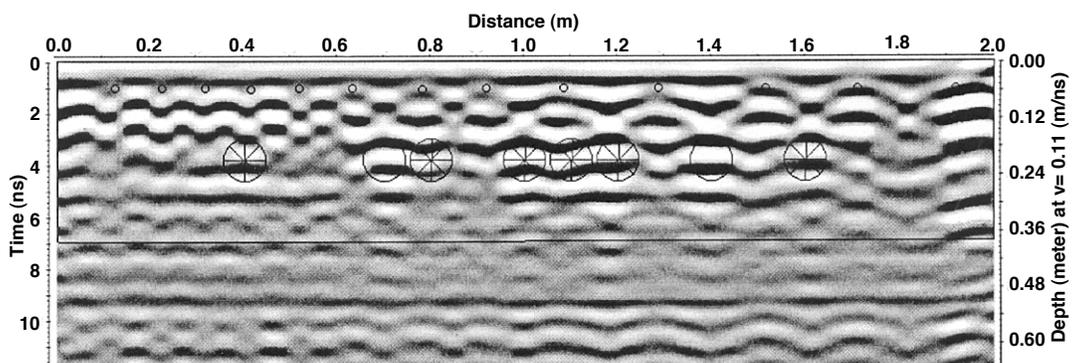
Figure 5.15 Ground-penetrating radar profile of Block 2.

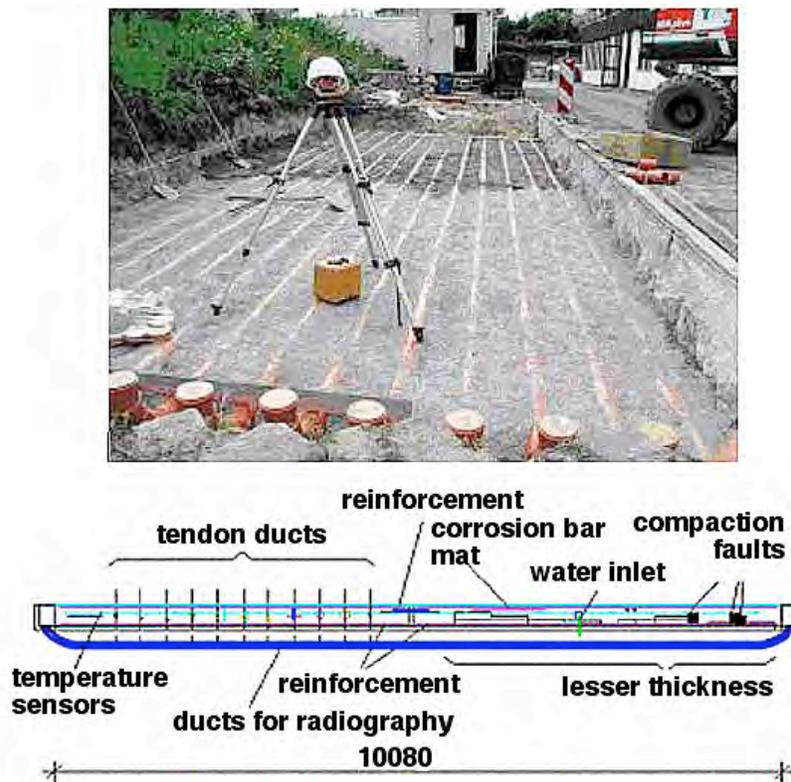
Figure 5.18 Foundation slab for large scale concrete test specimen.

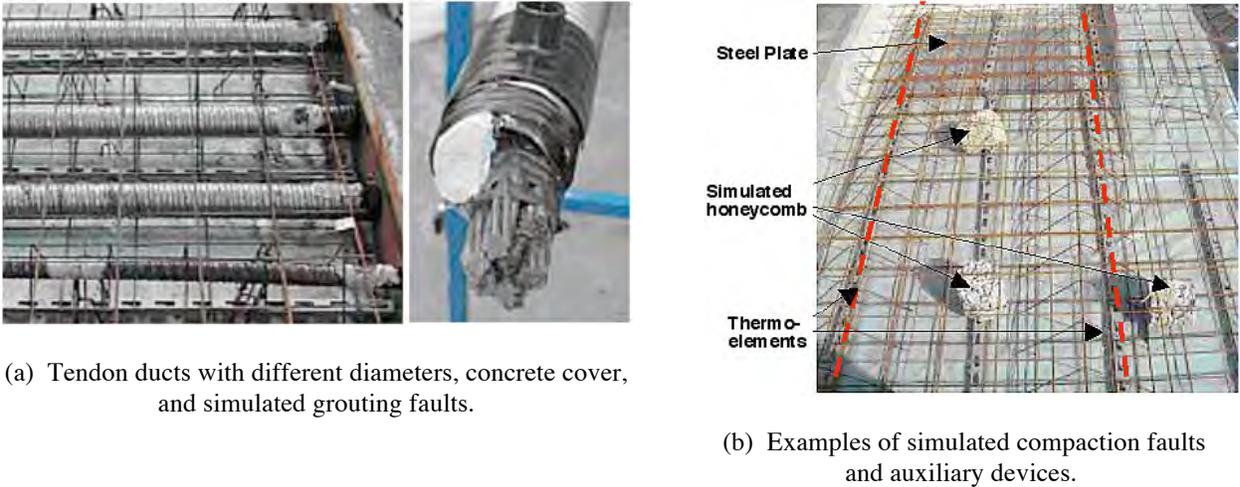
Figure 5.19 Examples of simulated faults in sections 1 and 2 of large concrete slab.

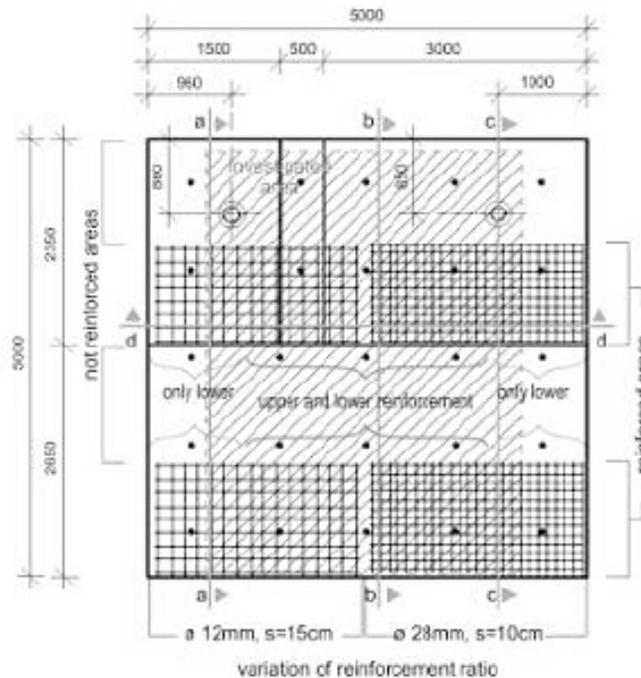
Figure 5.27 Area of foundation slab investigated by C-scans.

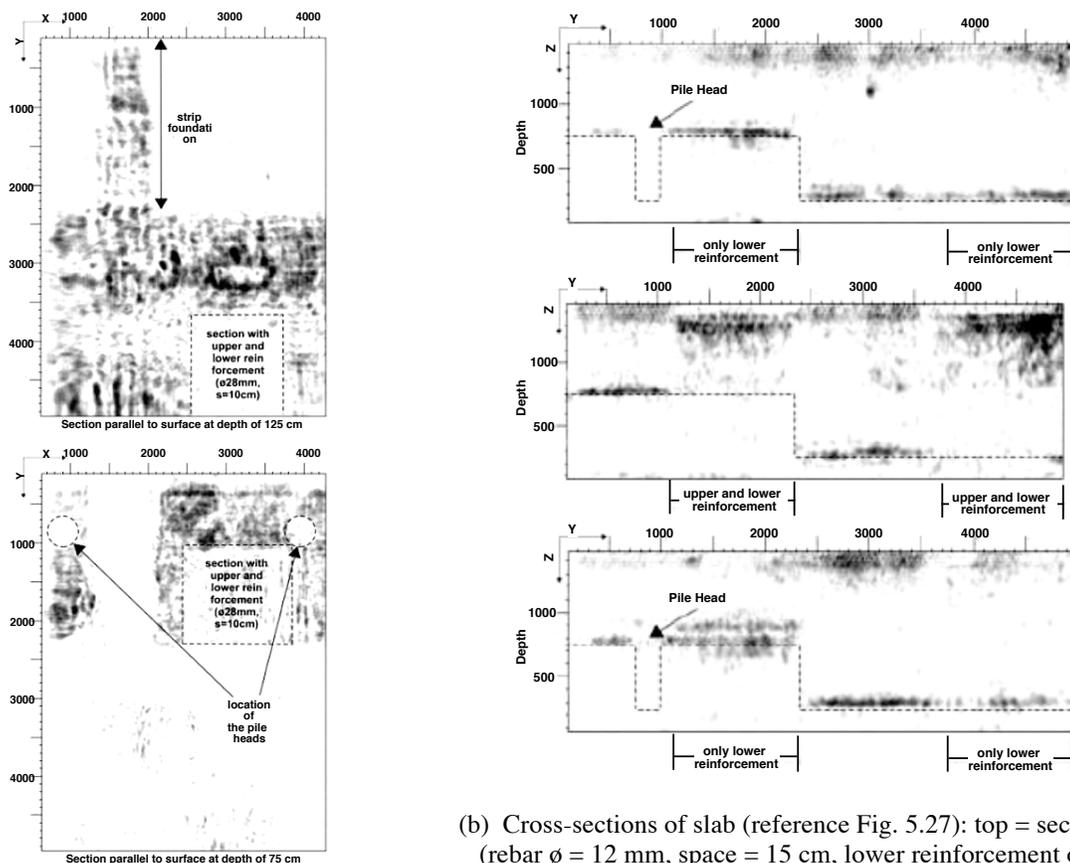
(a) Sections of foundation slab parallel to surface at depths of 125 cm and 75 cm.

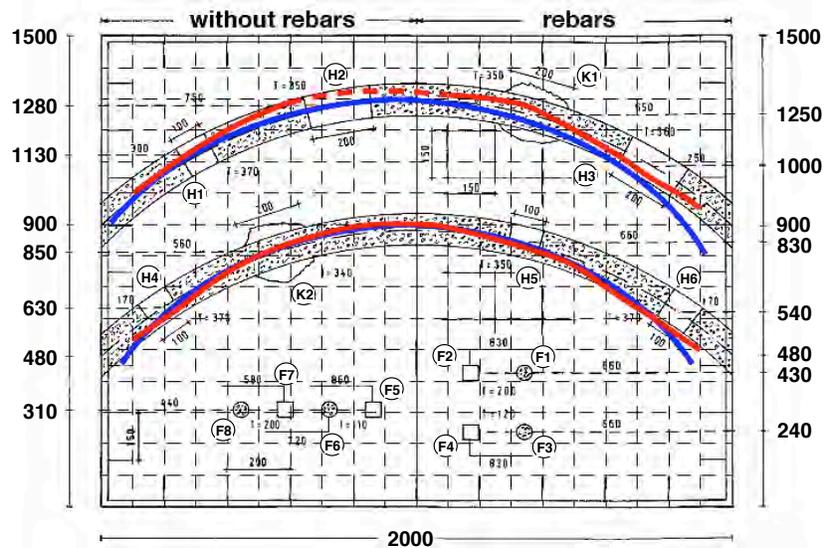
Figure 5.31 Construction drawing of simulated bridge section slab with ducts localized by impulse radar.

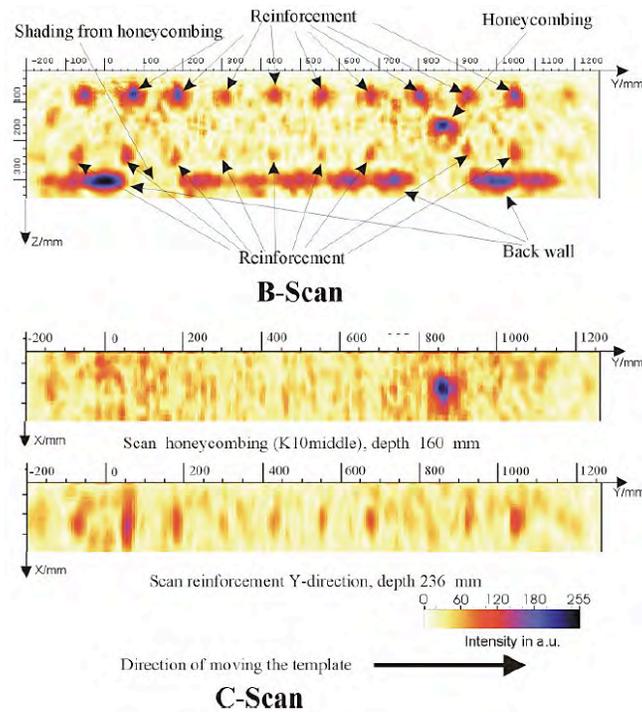
Figure 5.34 Results along scanning line 1.

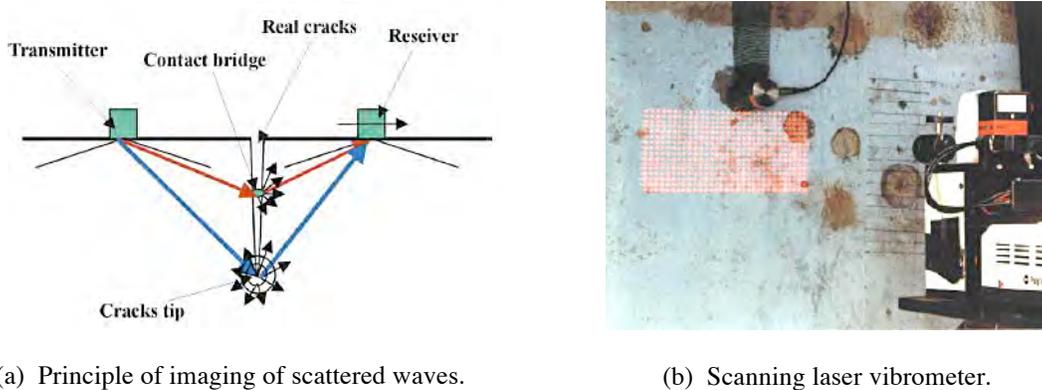
(a) Principle of imaging of scattered waves.

(b) Scanning laser vibrometer.
