**INSPECTION OF NUCLEAR POWER PLANT
STRUCTURES – OVERVIEW OF METHODS AND
RELATED APPLICATIONS**

May 2009

D. J. Naus

D. J. Naus
Materials Science and Technology Division
Oak Ridge National Laboratory
Oak Ridge, TN 37831

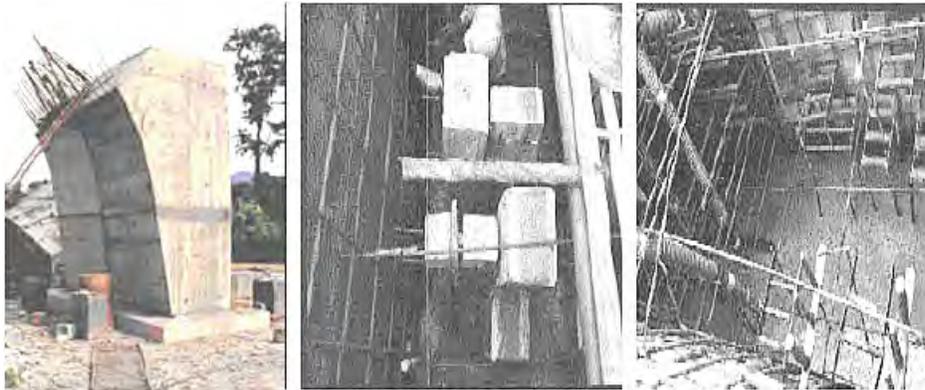
Figure 5.49 Details of ring beam mock-up.

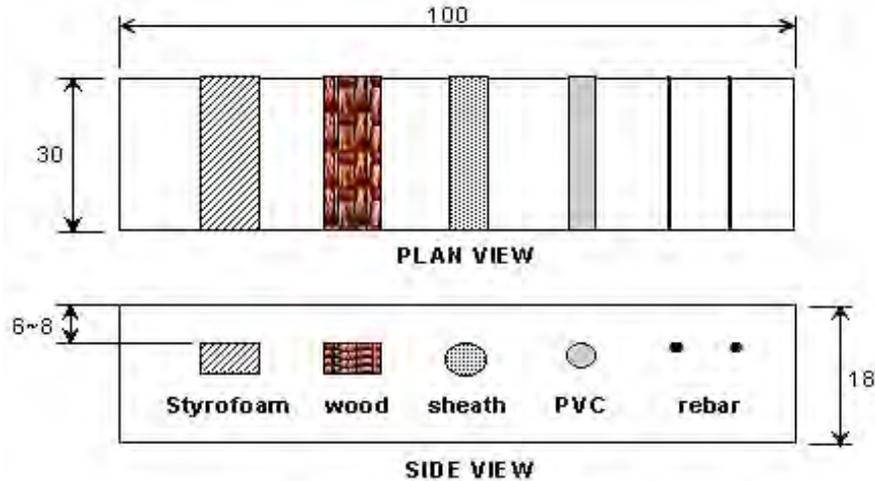
Figure 5.50 Test article containing embedded materials.

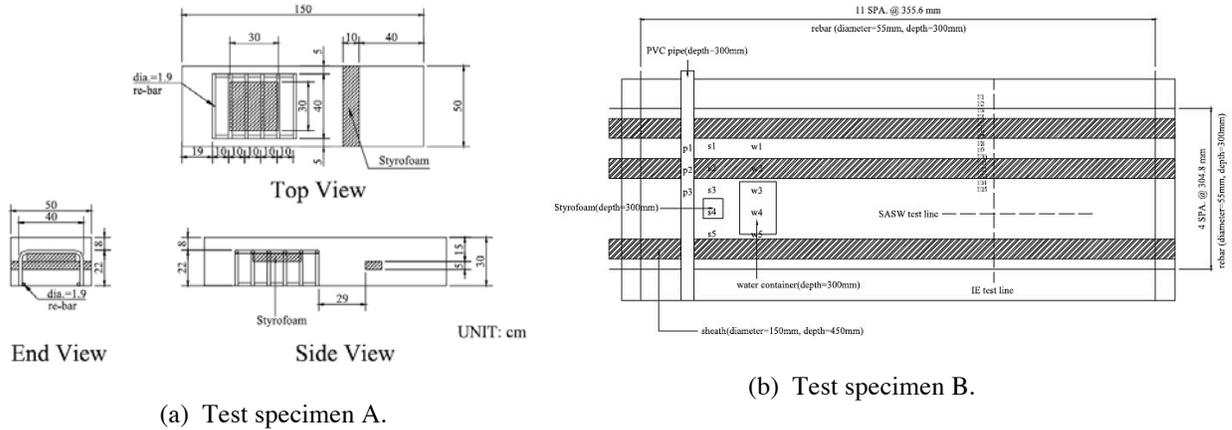
Figure 5.51 Schematics of test specimens.

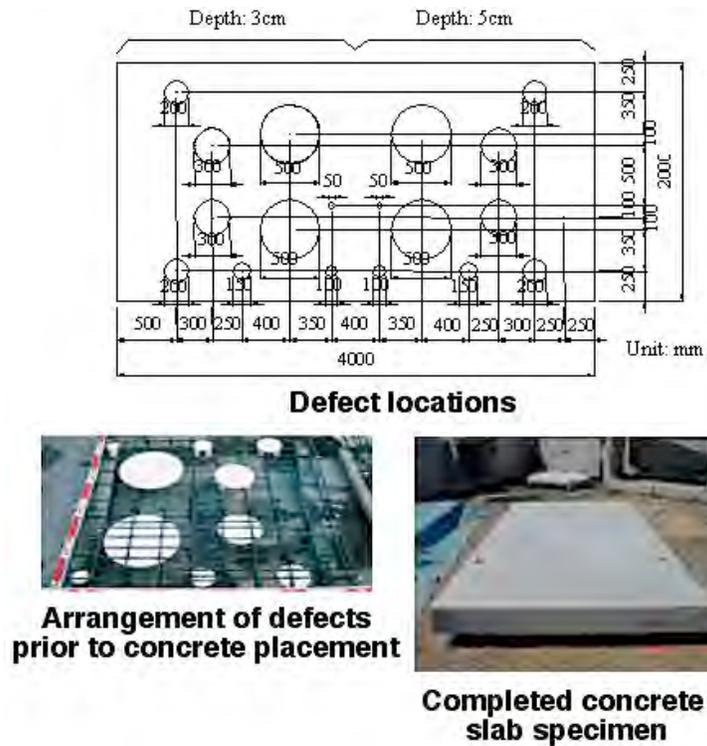
Figure 5.55 Arrangement of concrete slab with artificial defects.

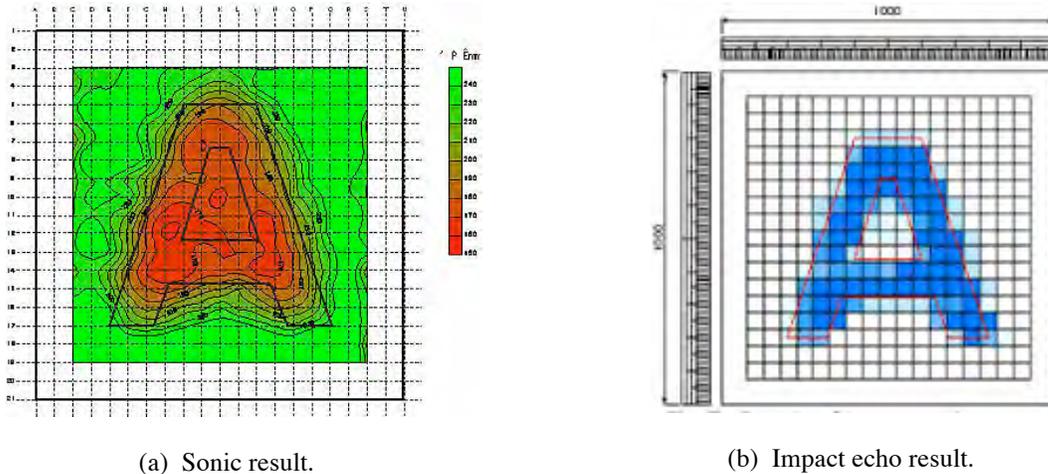
Figure 5.60 Sonic and impact echo results for specimen 7.

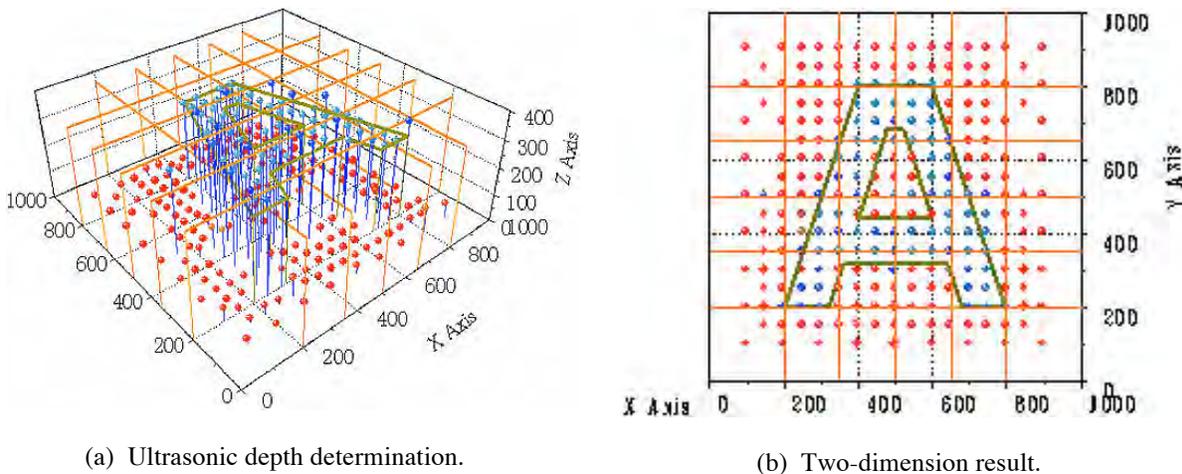
Figure 5.61 Sonic and impact echo results for specimen No. 7.

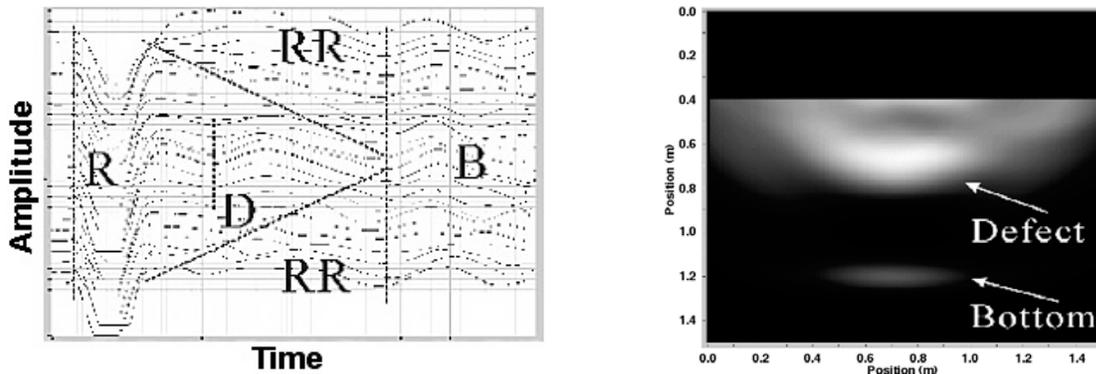
(a) B-scan displacement result.

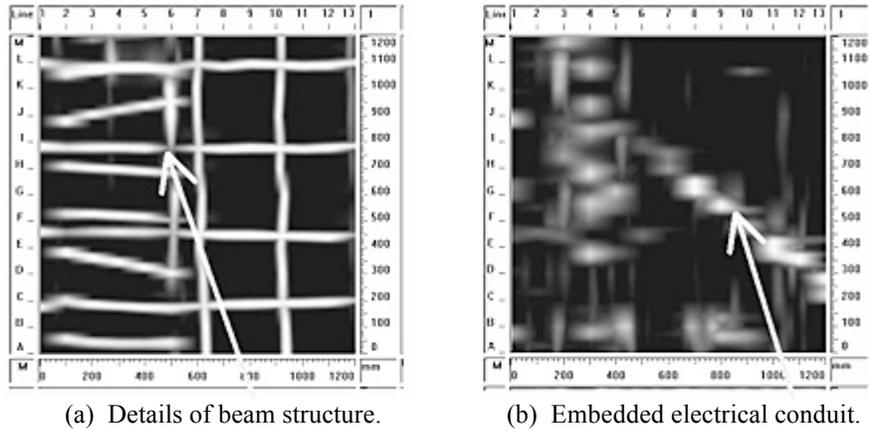
Figure 5.68 More detailed view of radar results in top right grid in Figure 5.67.

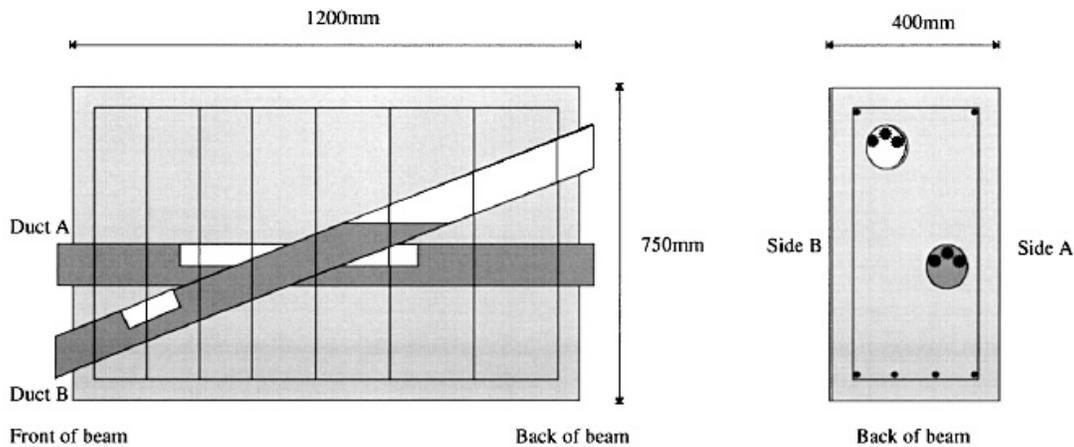
Figure 5.69 Bridge beam model with tendon duct defects.

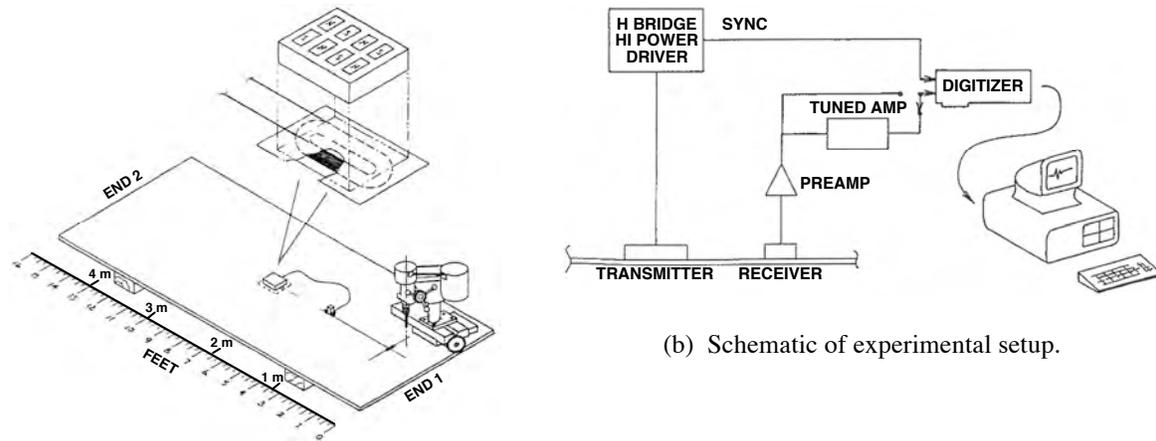
(a) General plate, defect, and EMAT layout.

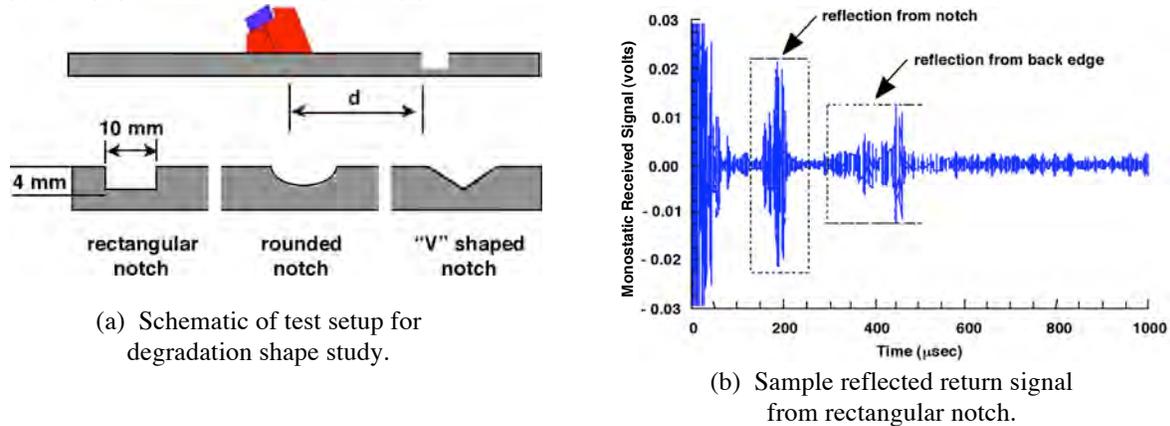
Figure 6.7 Test setup and sample reflected signal for signal loss experiments.

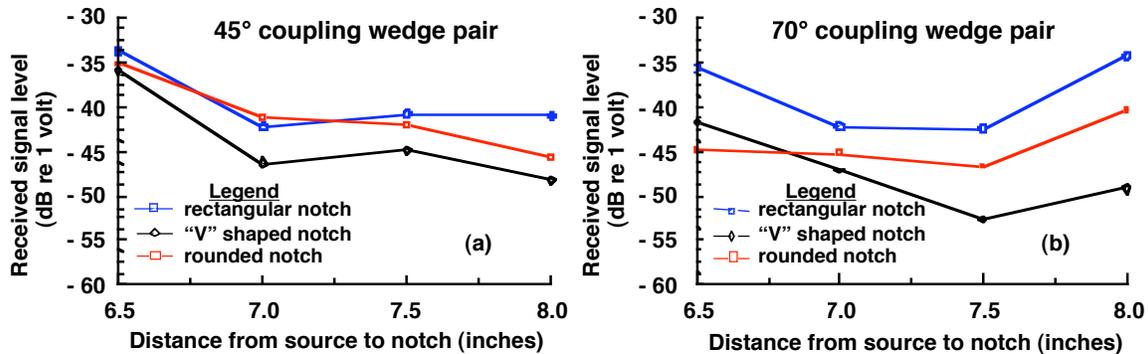
Figure 6.8 Results of degradation shape study.

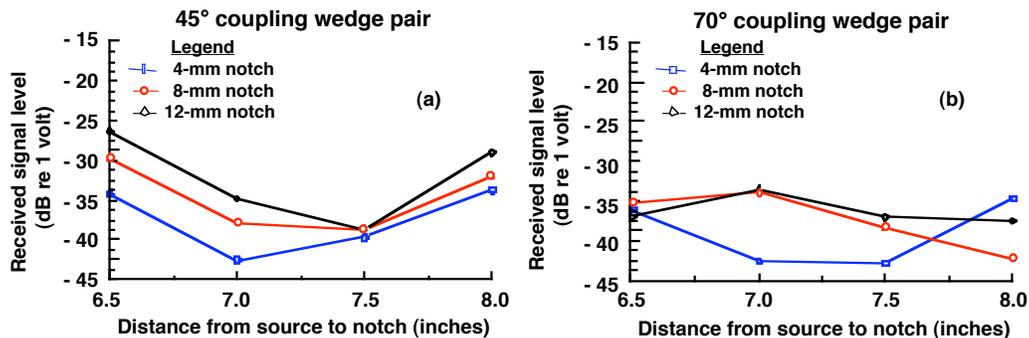
Figure 6.10 Results of degradation depth study.

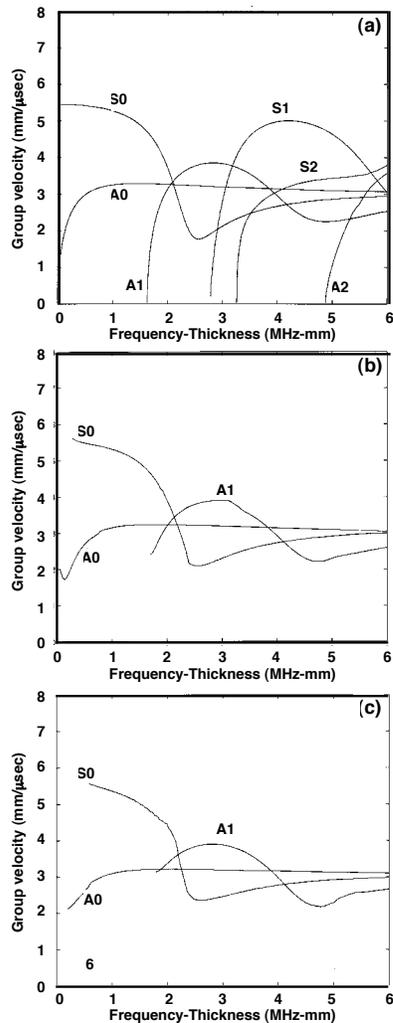
Figure 6.15 Calculated dispersion curves for longitudinal guided waves in a plate for three conditions: (a) plate is free, (b) plate is backed by concrete on one side, (c) plate is backed by concrete on both sides.

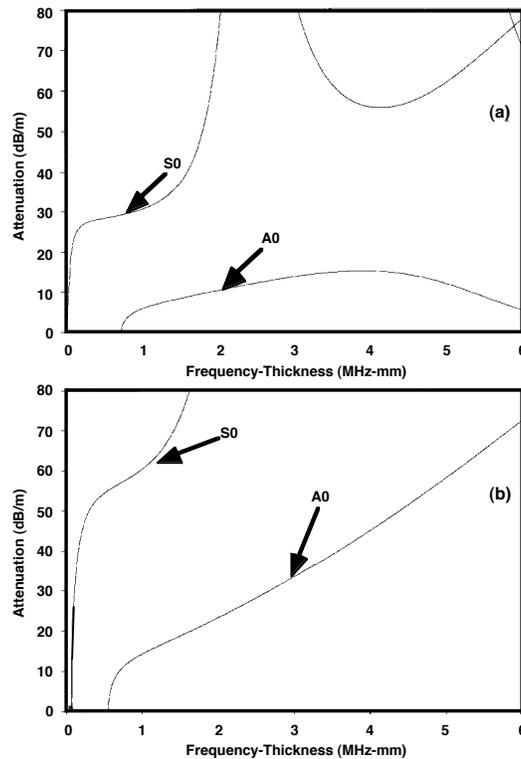
Figure 6.17 Calculated wave attenuation for: (a) plate backed by concrete on one side and (b) plate backed by concrete on both sides.

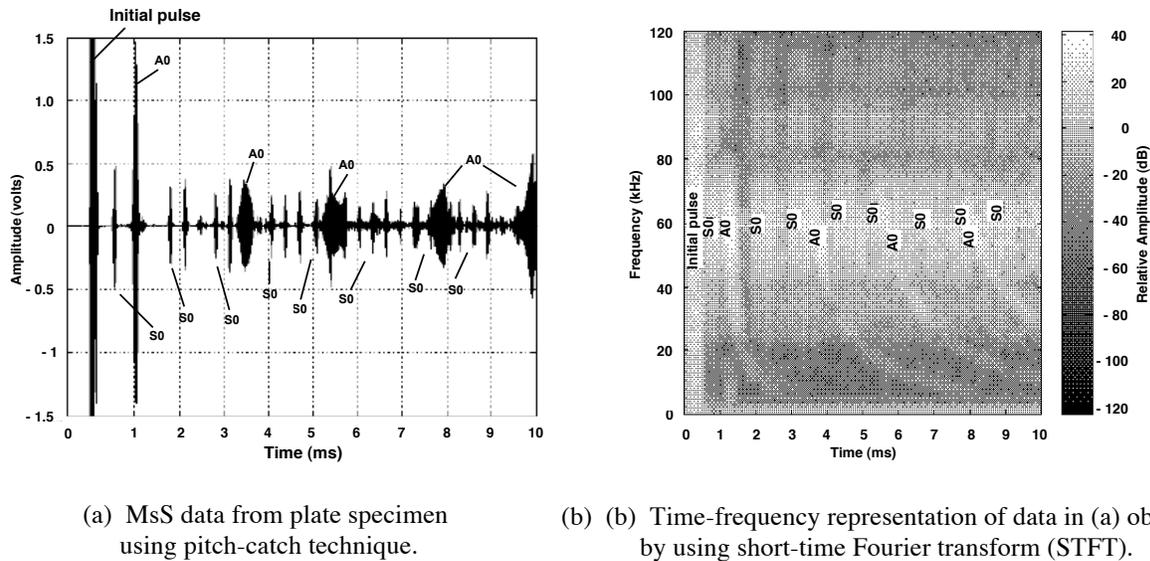
(a) MsS data from plate specimen using pitch-catch technique.

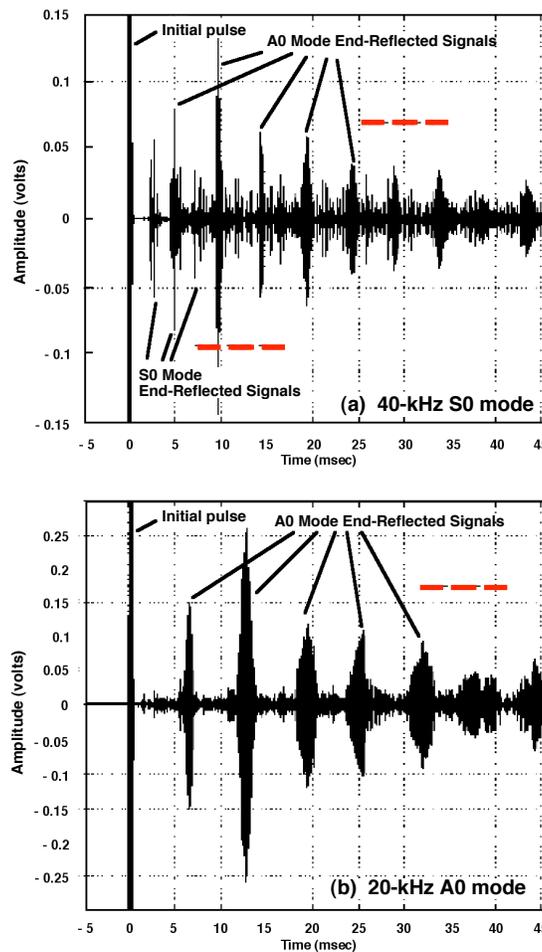
Figure 6.22 MsS data using pulse-echo mode for steel plate prior to introducing a defect (Dotted lines indicate signals continue to occur).

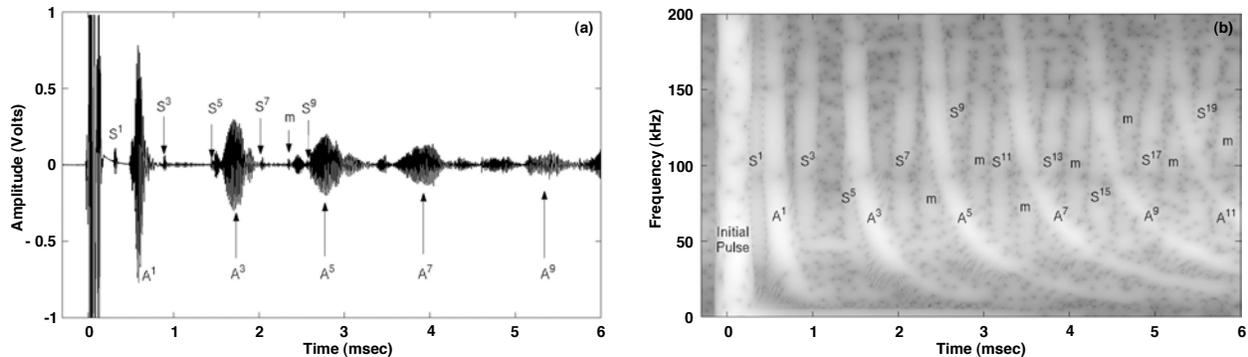
Figure 6.26 MsS data for 60-kHz A0 and S0 waves from bare plate: (a) detected signals and (b) spectrogram.

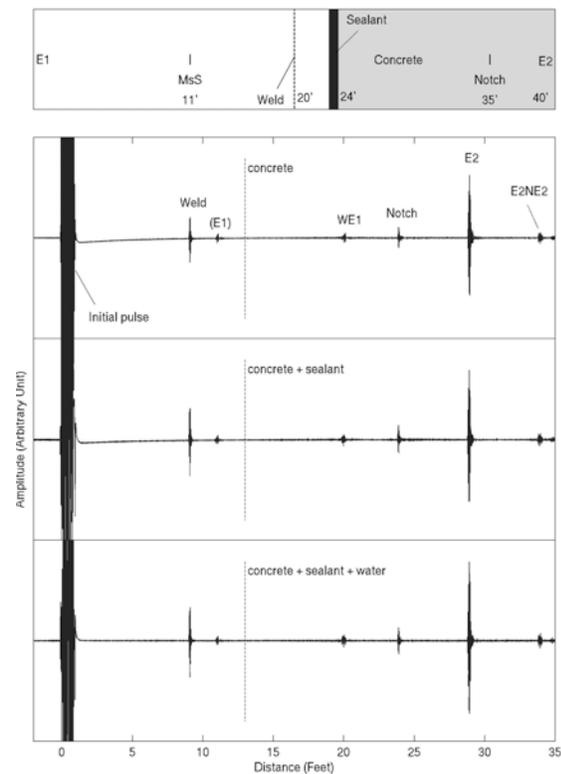
(a) Welded plate specimen.

(b) Schematic diagram of experimental setup and 128-kHz SH wave data obtained under different plate conditions.

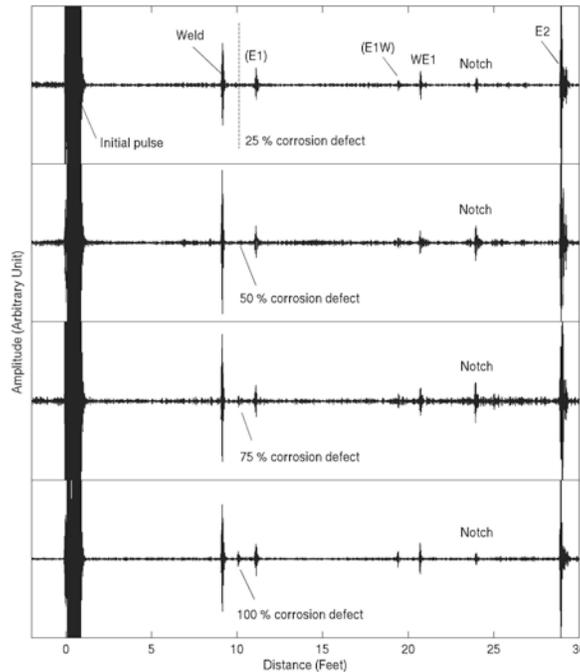
Figure 6.32 128-kHz SH wave data for simulated corrosion defect study.

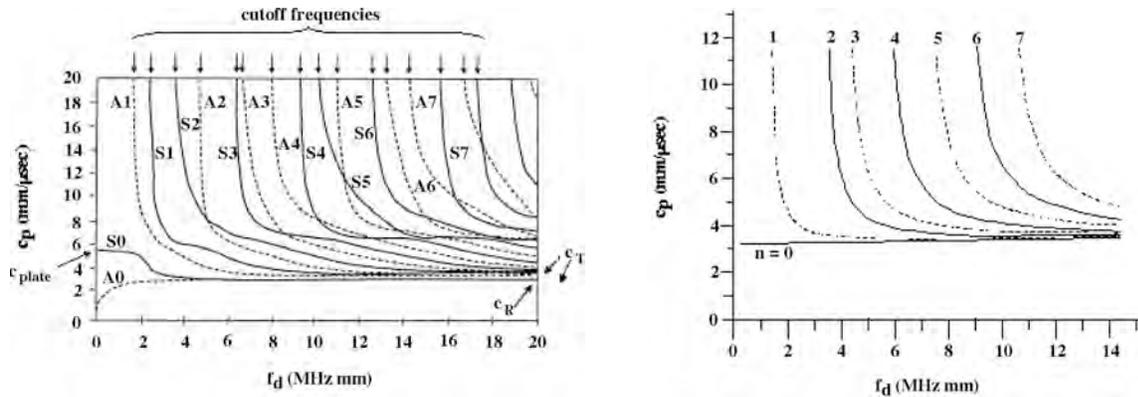
(a) Sample Lamb wave phase velocity dispersion curves.

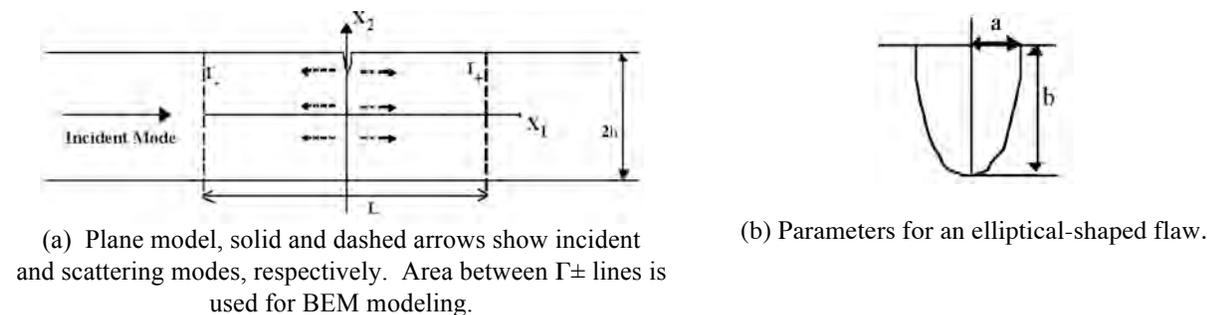
Figure 6.40 Boundary element method (BEM) wave scattering model.

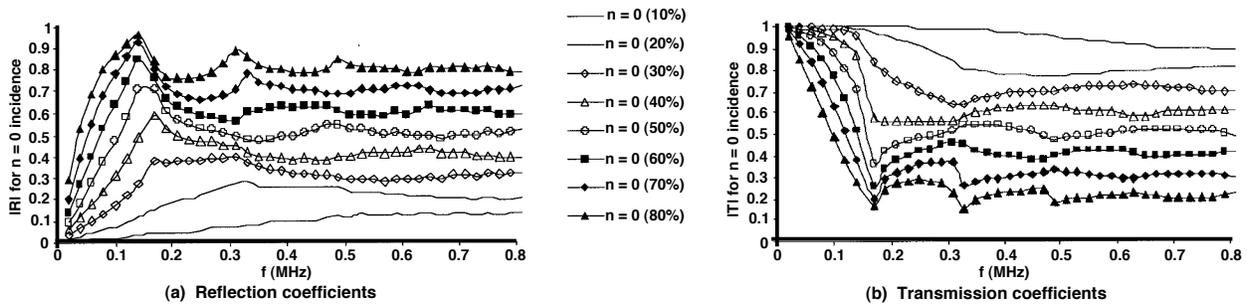
Figure 6.42 Reflection and transmission coefficients.
($N = 0$ mode under $n = 0$ incident mode for 0.3-mm elliptical notch width and 10 to 80 percent through-plate thickness depth.)

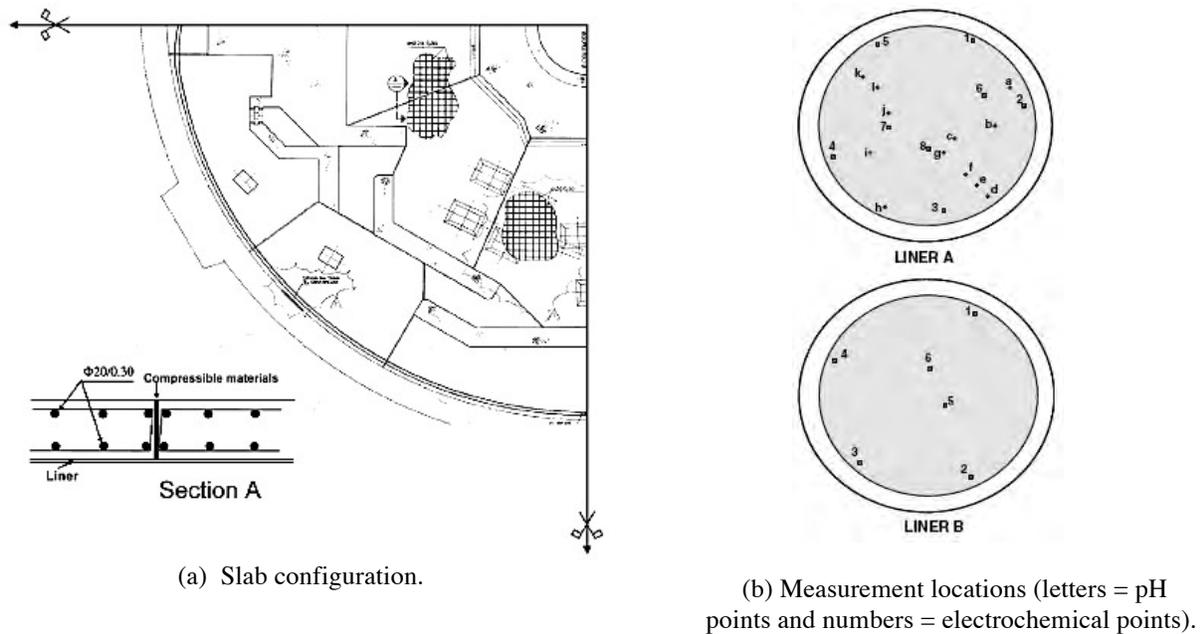
Figure 6.53 Drawing of nuclear power plant slab configuration and identification of measurement locations.

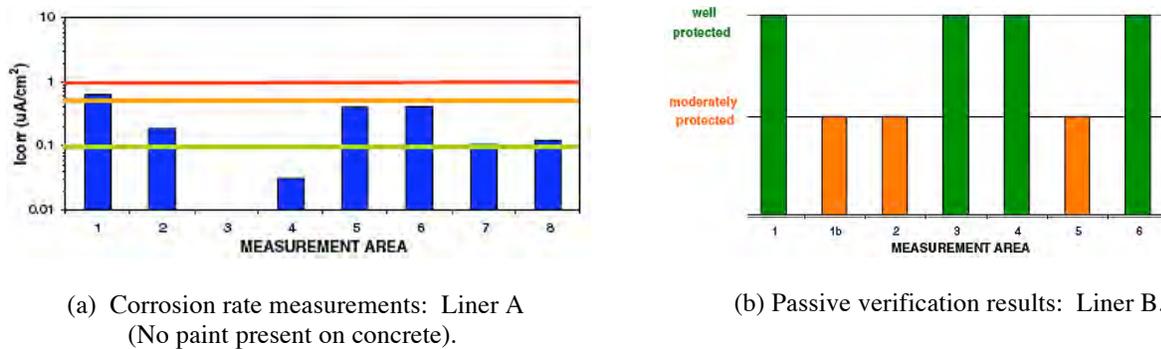
Figure 6.54 Corrosion rate and PVT measurements. (No paint present on concrete).

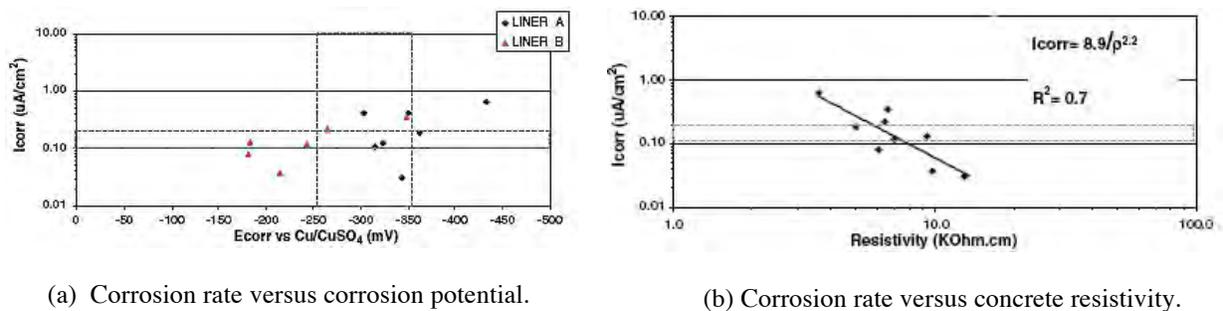
Figure 6.55 Corrosion rate versus corrosion potential and concrete resistivity.
