Tennessee Valley Authority's Campbell Creek Energy Efficient Homes Project: 2010 First Year Performance Report July 1, 2009–August 31, 2010

November 2010

Prepared by
OAK RIDGE NATIONAL LABORATORY
Oak Ridge, Tennessee 37831-6283
managed by
UT-BATTELLE, LLC
for the
U.S. DEPARTMENT OF ENERGY
under contract DE-AC05-00OR22725

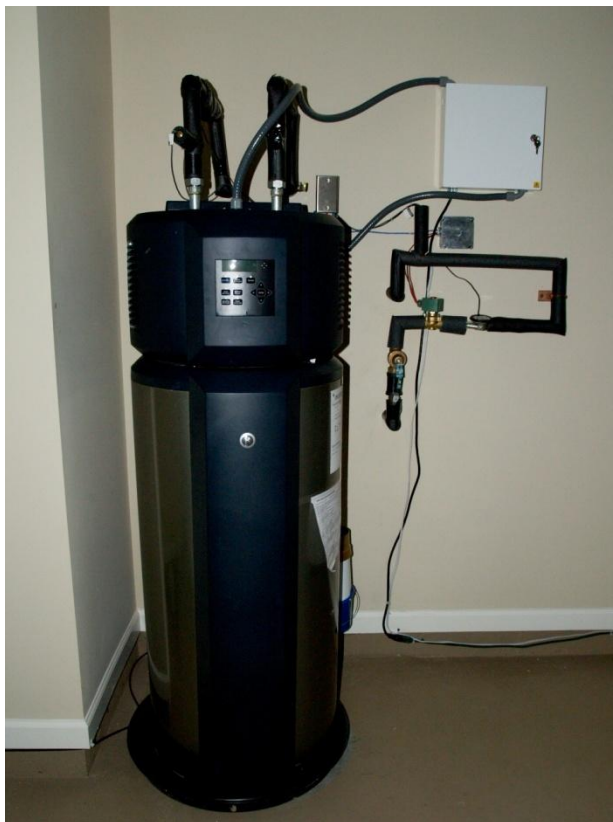
Figure 38. The GE Hybrid Electric Water Heater in the unconditioned garage.
