# Shakedown Tests for Refurbished and Upgraded Frames and Initiation of Alloy 709 Creep Rupture Tests

Materials Science and Technology Division

Prepared by  
OAK RIDGE NATIONAL LABORATORY  
Oak Ridge, TN 37831-6283  
managed by  
UT-BATTELLE, LLC  
for the  
US DEPARTMENT OF ENERGY  
under contract DE-AC05-00OR22725

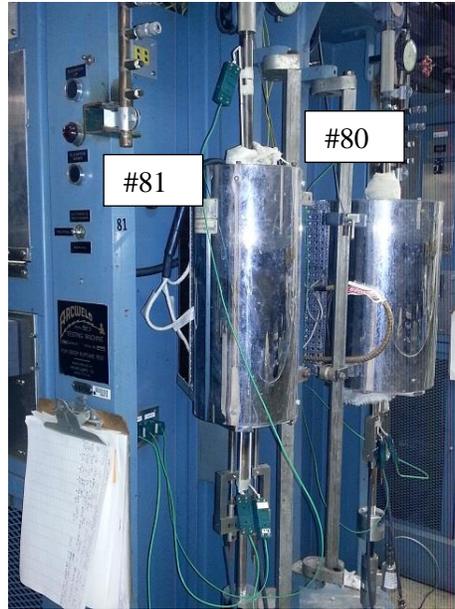
**Fig. 2. Tests on 316H are ongoing on frames #78 (not shown), #80 and #81 with three Type S TCs installed in each frame.**

The attachment of TC on the specimen surface caused a malfunction of the temperature limit. This issue was eventually resolved after a number of cycles of debugging. At the same time, the load cell on frame #81 was discovered to be working abnormally with a very low reading in load cell channels wired to frames #81 and #80. It has been found out that the inline amplifier in the load cell was defective and that load cell replaced. Shown in Fig. 2 are frames #80 and #81 with tests ongoing on SS 316H.
