New Air- and Water-Resistive Barriers – Technology Verification

December 2017

**New Air- and Water-Resistive Barriers
Technology Verification**

Prepared by
OAK RIDGE NATIONAL LABORATORY
Oak Ridge, TN 37831-6283
managed by
UT-BATTELLE, LLC
for the
US DEPARTMENT OF ENERGY
under contract DE-AC05-00OR22725

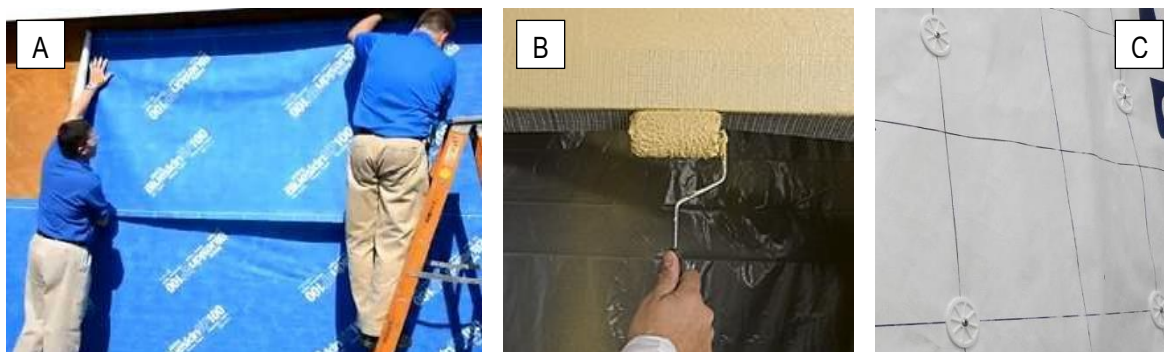
Figure 1. Common air barrier types for commercial buildings. (A) Self-adhered membrane with primer. (B) Fluid-applied membrane. (C) Mechanically-fastened membrane.

The effectiveness of an air barrier system highly relies on its ease of installation. In general, the larger the number of components and installation steps, the more likely it is for a mistake to occur that affects performance of the air barrier system. Self-adhered membranes and fluid-applied membranes have emerged as air barrier materials that are potentially more robust than the commonly used mechanically-fastened membranes. Self-adhered membranes are films that have an adhesive on their back, and are applied on a substrate after the surface has been primed (Figure 1A). Fluid-applied membranes are installed on a substrate either with a roller or a sprayer (Figure 1B) and most of the available products require two passes. Mechanically-fastened membranes are films that are attached to substrates using fasteners with caps and are taped at their joints or edges (Figure 1C). The non-continuous attachment of the mechanically-fastened membrane to the substrate makes it vulnerable to wind as it can tear or detach from the substrate before the cladding is in place (Figure 2).

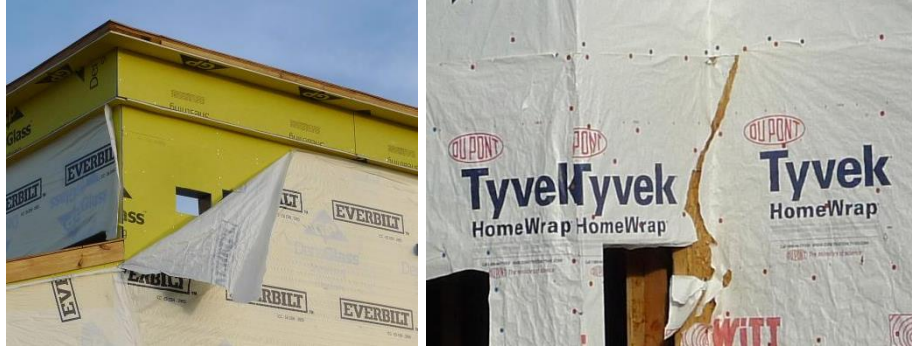
Figure 2. Mechanically-fastened membrane that detached from the substrate likely because of wind.

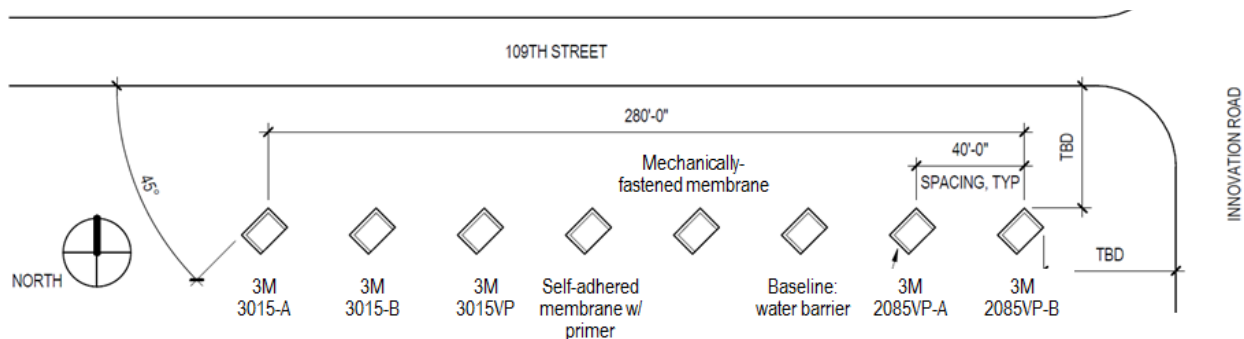
Figure 4. Layout of test facilities at 3M plant in Cottage Grove, MN. The drawing indicates the air and water resistive materials that were installed in each of the huts.

ORNL partnered with 3M to evaluate the performance of the new air- and water-resistive barriers. To this end, eight test facilities or huts were built offsite and transported and installed at the 3M plant in Cottage Grove, MN, as illustrated in Figure 4. The huts are 10 ft wide, 14 ft long, and the floor-to-roof deck height is about 8 ft. Table 1 lists the material assembly of the envelope, which comply with the 2015 IECC. As shown in Figure 4, the 3015 and 2085VP membranes were installed in two of the facilities and 3015VP in one. To compare the performance of the new technologies against that of typical membranes, a mechanically-fastened membrane (MFM) and a self-adhered membrane with primer (SAM) were each installed in one facility. Moreover, the baseline consisted of a mechanically-fastened membrane that was installed as a water barrier; that is, the edges of the membrane were not taped but were ship lapped to reduce the potential for water intrusion. This type of installation is still followed by some builders, especially in the residential sector, who don't understand that air leakage leads to higher energy consumption and that the way to prevent this is with a continuous air barrier system in which mechanically-fastened membranes have taped joints. Figures 5 to 6 show the installation of these membranes. The long sides of the buildings had double pane low-e windows. Cooling and heating were provided by mini-splits and baseboard heaters, respectively. Figure 7 shows buildings after construction was completed.

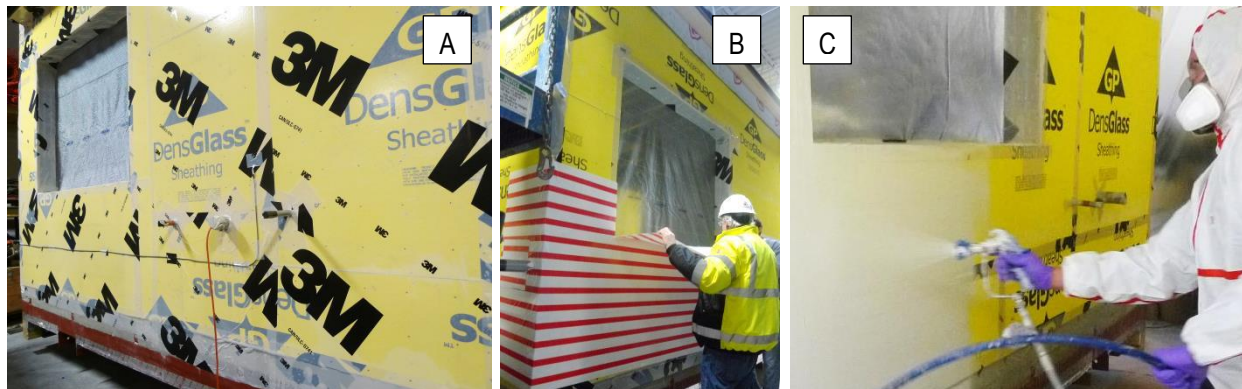
Figure 5. Installation of air- and water- resistive barriers on the test facilities at Cottage Grove, MN. (A) 3M 3015 primer-less self-adhered membrane, (B) 3M 3015VP vapor permeable primer-less self-adhered membrane, and (C) 3M 2085VP vapor permeable fluid-applied membrane.

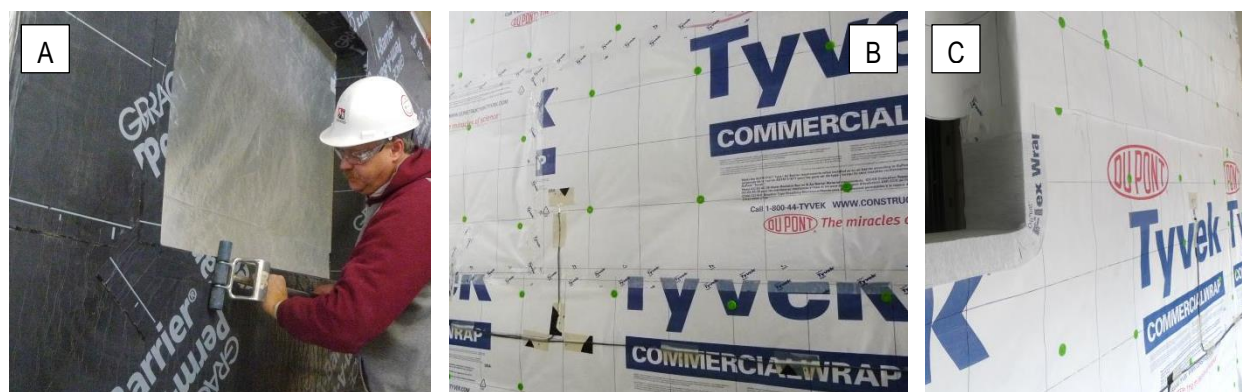
Figure 6. Installation of air- and water- resistive barriers on the test facilities at Cottage Grove, MN. (A) self-adhered membrane with primer, (B) mechanically-fastened membrane, and (C) baseline: mechanically-fastened membrane as a water-resistive barrier (i.e., membrane joints were not taped).

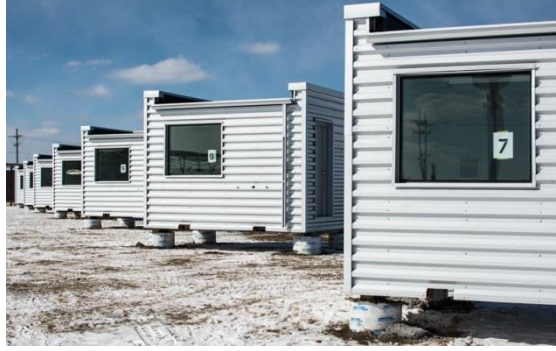
Figure 7. Eight test facilities after construction was completed.

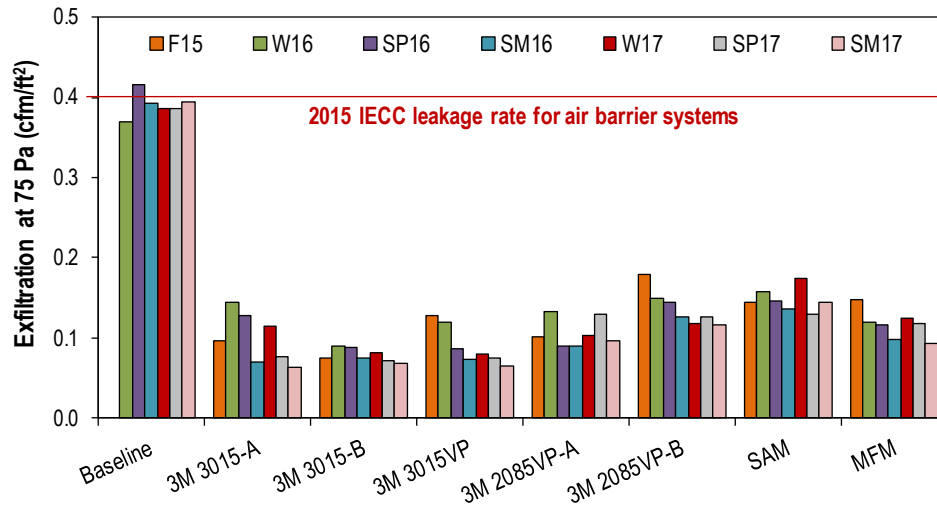
Figure 9. Air leakage rates of test facilities in Cottage Grove, MN, under positive pressure. Results indicate that all buildings with an air barrier meet the International Energy Conservation Code's requirement almost two years after installation. Abbreviations: F, fall; MFM, mechanically-fastened membrane; SAM, self-adhered membrane with primer; SM, summer; SP, spring; W, winter.

ORNL conducted seasonal blower door tests in each of the test facilities according to ASTM E779-10.⁹ Figures 9 and 10 show the exfiltration or pressurization and infiltration or depressurization results, respectively. As expected, exfiltration results are higher than the infiltration values because leakage paths tend to open when buildings are pressurized and close when buildings are depressurized. Nevertheless, all of the test facilities had air leakage rates that were lower than the 0.4 cfm/ft² at 75 Pa that is prescribed in the 2015 IECC. This included the baseline hut, which is the facility with a mechanically-fastened membrane that was not taped at joints. The low leakage rate of the baseline hut is likely due to the presence of a continuous exterior insulation that pressed the membrane against the exterior substrate (Figure 8) and kept the membrane in place during the blower door tests. Figures 9 and 10 also indicate that **the test facilities with the 3M membranes had leakage rates that were slightly lower than the buildings with traditional air barrier materials, that is, self-adhered membrane with primer and mechanically-fastened membrane with taped joints.** Furthermore, blower door measurements suggest that there was not deterioration in the performance of the air barrier systems after two years, but these results may have been influenced by the fact that the buildings were unoccupied and not subjected to the wear and tear from occupant use.

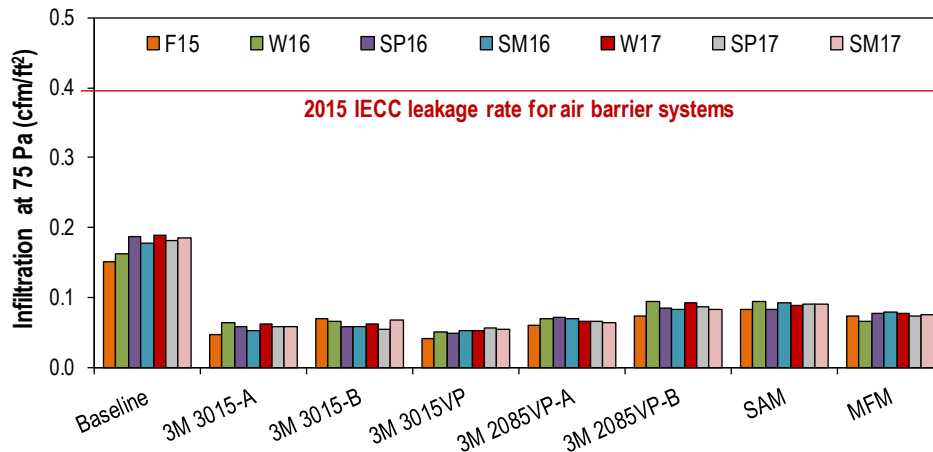
Figure 10. Air leakage rates of test facilities in Cottage Grove, MN, under negative pressure. Results indicate that all buildings with an air barrier meet the International Energy Conservation Code's requirement almost two years after installation. Abbreviations: F, fall; MFM, mechanically-fastened membrane; SAM, self-adhered membrane with primer; SM, summer; SP, spring; W, winter.

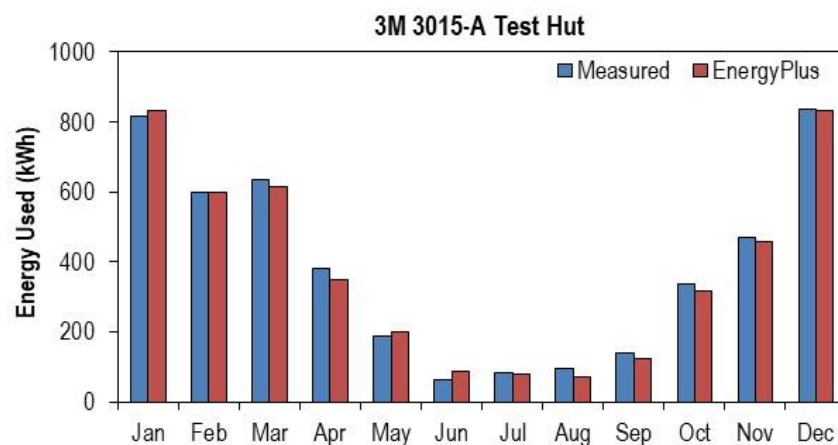
Figure 11. Measured and calculated energy used in the 3M 3015-A test facility. The calculated values were obtained from an EnergyPlus model that complied with ASHRAE Guideline 14 after it was calibrated using collected measurements.

building envelope. The models were calibrated with the following measured data that were collected from May 2016 to April 2017: outdoor and indoor temperature, outdoor relative humidity, wind speed, barometric pressure, direct beam solar radiation, and diffuse solar radiation. The performance of the mini-split air-conditioning system was modeled using the manufacturer's specifications. The calibrated models were used in conjunction with the measured weather data and indoor air temperature from each of the facilities to calculate their energy use. The calculated and measured monthly energy consumption values were compared by determining the normalized mean bias error (NMBE) and the coefficient of variance root mean square error (CV-RMSE). According to ASHRAE Guideline 14 (ASHRAE 2014), the accepted tolerances for these statistical parameters are $\pm 5\%$ and $\pm 15\%$, respectively. Table 3 indicates that the results from the eight facilities met the ASHRAE Guideline 14 compliance criteria. Figure 11 is an example of how the measured energy consumption compared to the results from the calibrated models.

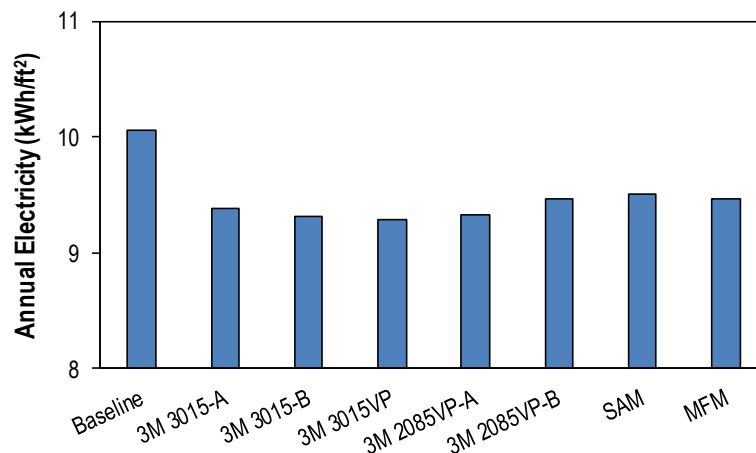
Figure 12. Annual electricity used to cool and heat the test buildings with different air barrier materials. These results were calculated using the calibrated EnergyPlus simulation models. Abbreviations: MFM, mechanically-fastened membrane; SAM, self-adhered membrane with primer.

point, occupancy, lighting, plug load, mechanical ventilation, and internal mass were based on the DOE commercial prototype building model for small offices (DOE 2016b). The HVAC system consisted of a unitary heat pump that was supplemented by a gas furnace; thus, electricity was used for both cooling and heating. Figures 12 and 13 show that all the huts needed comparable amounts of electricity and natural gas. **These results indicate that the new 3M air barrier materials performed in a similar manner as the readily available technologies.** The baseline hut did not utilize much larger amounts of energy than the other buildings because, as it was previously discussed, the air leakage rate of its envelope was relatively low.

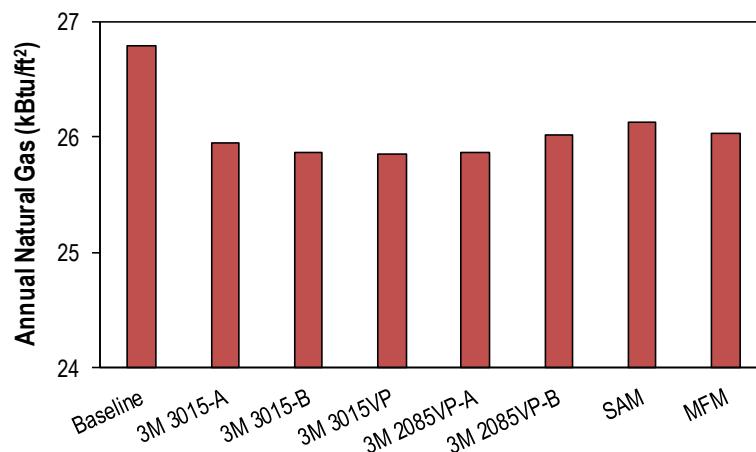
Figure 13. Annual natural gas used to heat the test buildings with different air barrier materials. These results were calculated using the calibrated EnergyPlus simulation models. Abbreviations: MFM, mechanically-fastened membrane; SAM, self-adhered membrane with primer.

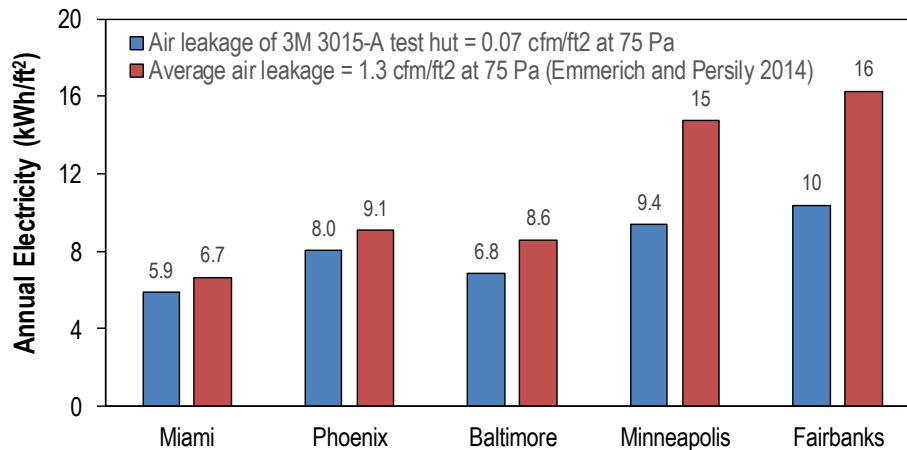
Figure 14. Annual electricity needed to cool and heat the 3M 3015-A test hut (0.07 cfm/ft² at 75 Pa) and a similar structure with the air leakage rate of a building without an air barrier (1.3 cfm/ft² at 75 Pa) using a unitary heat pump. These results were calculated using calibrated EnergyPlus simulation models.

conditions: Miami, FL, Phoenix, AZ, Baltimore, MA, Minneapolis, MN, and Fairbanks, AK. As in the previous simulations, assumptions were based on the DOE commercial prototype building model for small offices (DOE 2016b), and the HVAC system consisted of a unitary heat pump that was supplemented by a gas furnace. Figures 14 and 15 illustrate how the annual electricity and natural gas consumption are affected by higher air leakage rates. **This is especially the case in northern cities such as Minneapolis and Fairbanks, where a properly installed air barrier system can decrease annual electricity and natural gas use by about 36% and 25%, respectively.**

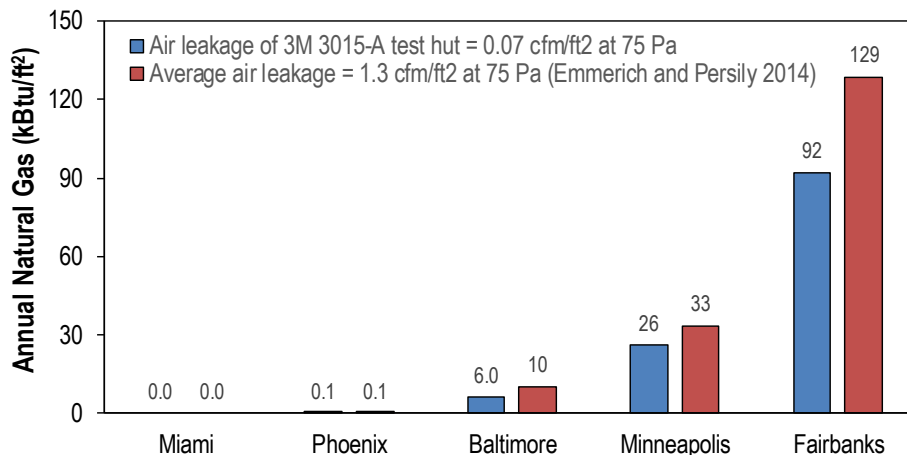
Figure 15. Annual natural gas needed to heat the 3M 3015-A test hut (0.07 cfm/ft² at 75 Pa) and a similar structure with the air leakage rate of a building without an air barrier (1.3 cfm/ft² at 75 Pa) using a supplementary gas furnace. These results were calculated using calibrated EnergyPlus simulation models.

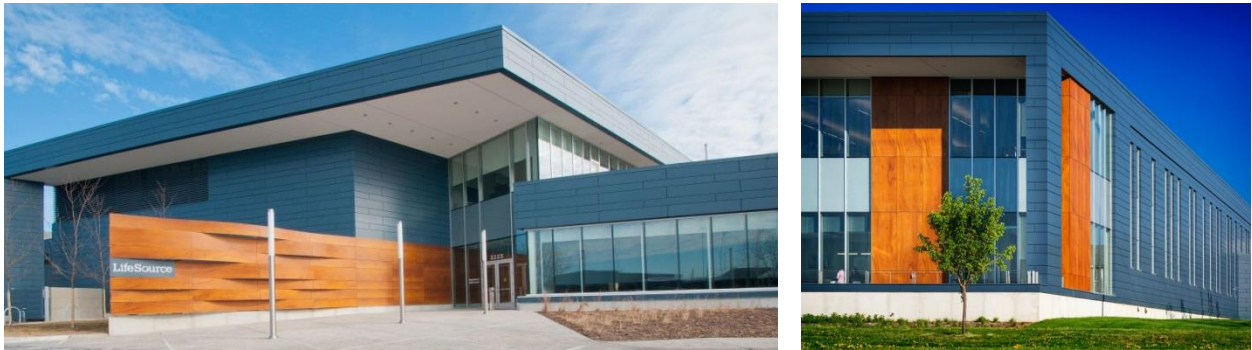
Figure 16. The LifeSource building in Minneapolis, MN, uses the 3M 3015 primer-less self-adhered membrane as its main air- and water-resistive barrier material.

The LifeSource building in Minneapolis, MN, served as a site for third party verification of the 3M 3015 primer-less self-adhered membrane. LifeSource is an organ donation center that works with hospitals and community partners to support donor families, manage the donation process, and educate the community. The building shown in Figures 16 and 17 was completed in 2015 and complies with the 2007 Minnesota State Building Code and the 2006 International Building Code. The structure has two stories with 32,000 ft² on the first floor and 18,000 ft² on the second floor, which are primarily used as offices and laboratories. The 3M 3015 membrane was used as the main air- and water-resistive barrier material on the exterior opaque walls.

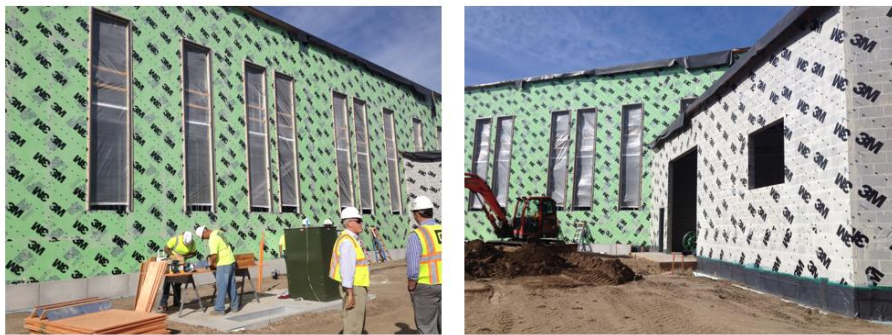
Figure 17. Installation of the 3M 3015 primer-less self-adhered membrane on exterior grade drywall and concrete masonry units.

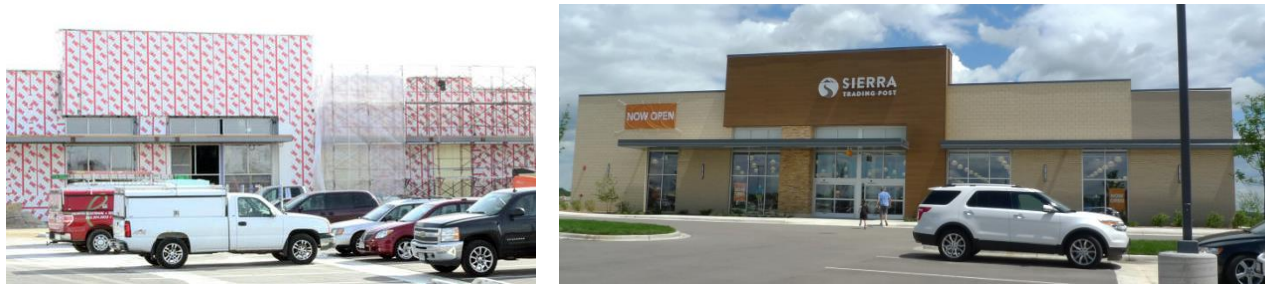
Figure 18. The Sierra Trading Post building in Woodbury, MN, uses the 3M 3015VP vapor permeable primer-less self-adhered membrane as its main air- and water-resistive barrier material.

The Sierra Trading Post building in Woodbury, MN, served as a verification site for the 3M 3015VP vapor permeable primer-less self-adhered membrane. As shown in Figure 18, Sierra is a one-story retail building with a footprint of about 20,000 ft². The building was completed in 2017 and complies with the 2012 Minnesota State Building Code and the 2012 International Building Code. The 3M 3015VP membrane was used as the main air- and water-resistive barrier material on the exterior opaque walls.

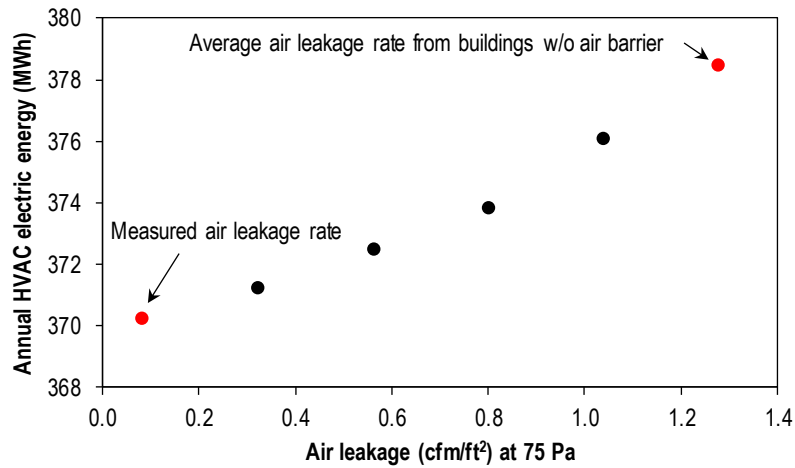
Figure 19. Simulation results of the annual HVAC electric energy consumed by the LifeSource building as a function of air leakage rate through the above grade walls and roof.

Figures 19 and 20 illustrate the simulation results for the annual cooling energy consumption as a function of air leakage rate and suggest that the airtightness level of the LifeSource and the Sierra buildings can lead to an energy usage of about 370 MWh and 46 MWh per year, respectively. These Figures also suggest that the higher leakage rate from buildings without an air barrier could increase the cooling energy use of these buildings by 9 MWh in LifeSource and 38 MWh in Sierra. In both buildings the effect of airtightness on cooling energy use is minor because of the relatively mild summers in the Minneapolis/St Paul area. Conversely, Figures 21 and 22 show that the annual heating energy increased by 35% (i.e., from 1,480 to 1,990 MBtu) in LifeSource and by 79% (i.e., from 4,600 to 8,230 MBtu) in Sierra, given that the winter season is much more severe than the summer. The effect of airtightness was higher in Sierra than in LifeSource partly because of their difference in window-to-wall ratio (WWR). Sierra just has a glass at its storefront (Figure 18); thus, its WWR is ~6%. In contrast, Figures 16 and 17 show quite a few windows that make LifeSource have a WWR of ~25%. A larger WWR means that windows have a greater contribution to the overall heat losses and gains through the building envelope, which in turn diminishes the effect of air leakage. Other contributing factors include that retail and office buildings have different occupancy schedules, plug and lighting loads, and types of HVAC systems.

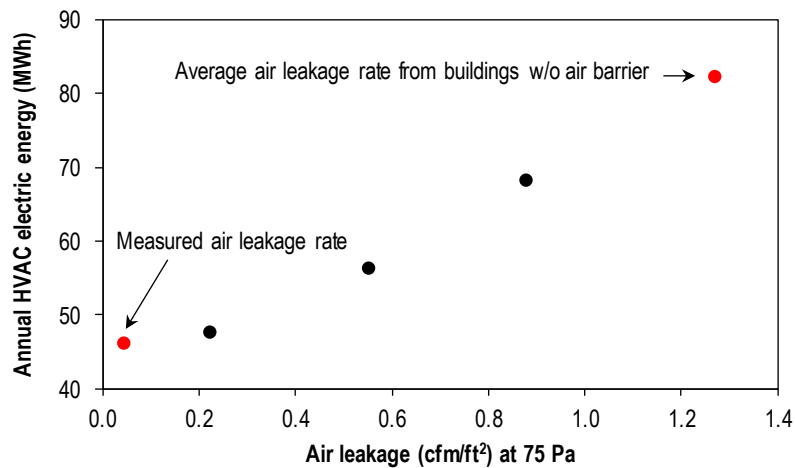
Figure 20. Simulation results of the annual HVAC electric energy consumed by the Sierra Trading Post building as a function of air leakage rate through the above grade walls and roof.

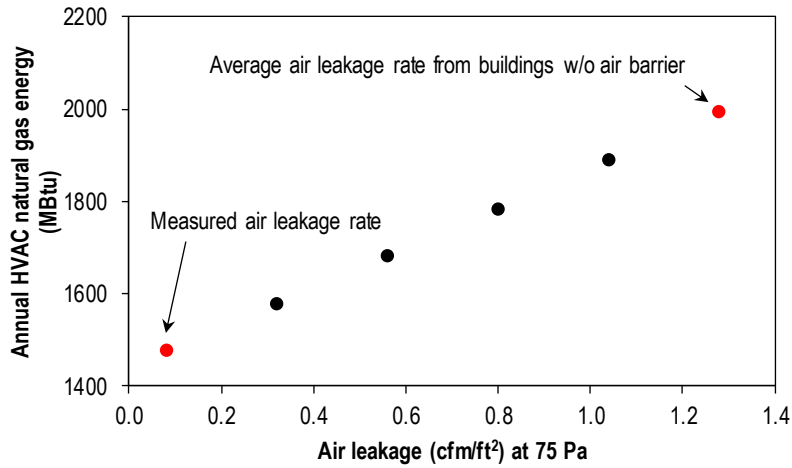
Figure 21. Simulation results of the annual HVAC natural gas energy consumed by the LifeSource building as a function of air leakage rate through the above grade walls and roof.

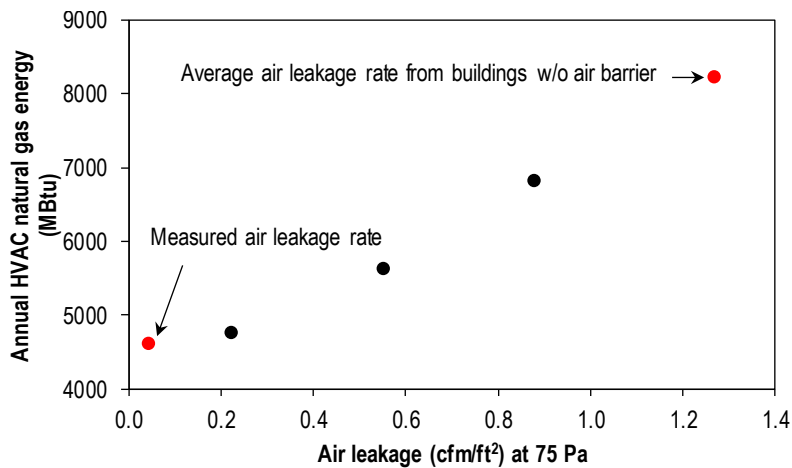
Figure 22. Simulation results of the annual HVAC natural gas energy consumed by the Sierra Trading Post building as a function of air leakage rate through the above grade walls and roof.

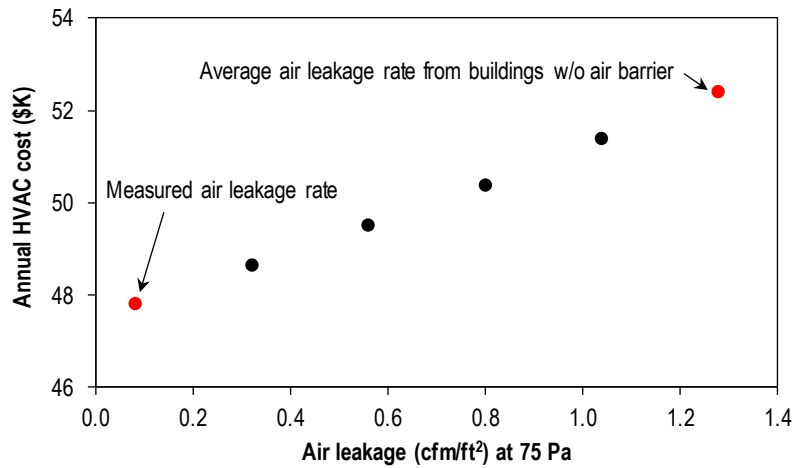
Figure 23. Simulation results of the annual HVAC energy cost for the LifeSource building as a function of air leakage rate through the above grade walls and roof.

Figures 23 and 24 translate energy use to cost by assuming rates of \$0.1 per KWh for electricity and \$7.3 per MBtu for natural gas. Results indicate that by having an airtight envelope LifeSource saves about \$4,600 per year than if it lacked an air barrier system. Similarly, Sierra saves about \$5,900 per year. Note that the energy savings are higher in Sierra than in LifeSource because of differences between the two buildings that were described in the previous paragraph.

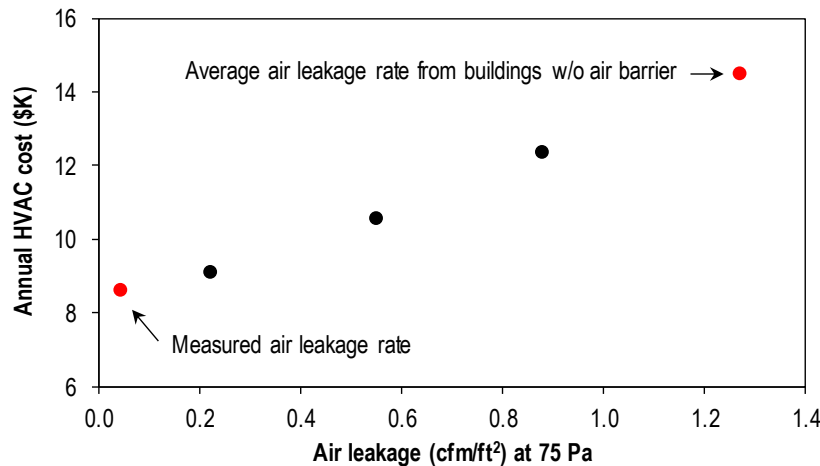
Figure 24. Simulation results of the annual HVAC energy cost for the Sierra Trading Post building as a function of air leakage rate through the above grade walls and roof.
