Mechanical properties and microstructure characterization of unirradiated Eurofer-97 steel variants for the EUROfusion project

Materials Science and Technology Division

Prepared by
OAK RIDGE NATIONAL LABORATORY
Oak Ridge, TN 37831-6283
managed by
UT-BATTELLE, LLC
for the
Karlsruhe Institute of Technology
under contract NFE-16-06240

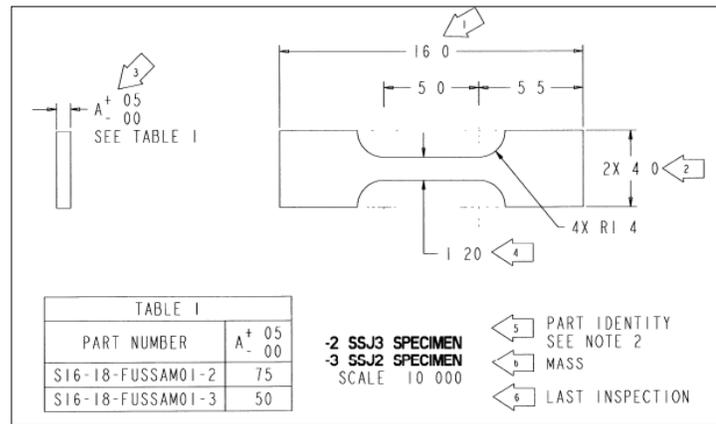
Fig. 1. SS-J3 tensile specimen schematic.

dimensions 16 mm x 4 mm x 0.76 mm, and 5 mm gauge length. Due to unavailability of a contact or non-contact extensometer for such small samples, the elongation was estimated by machine stroke. Using machine stroke obviously introduces uncertainties in the elongation behaviour in the elastic regime due to machine compliance, but it does not affect the plastic regime or the calculated strength values. Because the elongation is provided by machine stroke, the strain rate is the extension rate and not the cross-head speed as is taken in cases with an extensometer. To eliminate any possible misleading elongation values arising due to machine compliance, we have also included the plastic strain information in the report and this should serve as the basis for comparing different steels. High temperature (irradiation temperature) tensile tests on the unirradiated specimens will be conducted once the thermometry data of the irradiated samples is available.

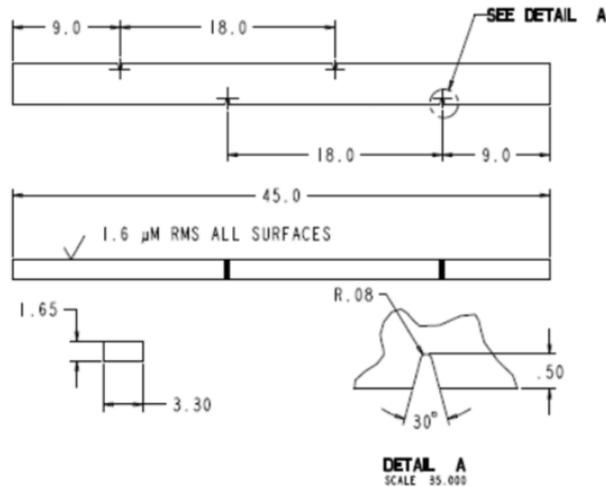
Fig. 2 M4CVN specimen drawing. Units in millimeter.

Fig. 2 shows the miniature multi-notch bend bar M4CVN specimens with a dimension of 45mm (length) x 3.3mm (width) x 1.65mm (thickness) to characterize the transition fracture toughness of the steels based on the ASTM E1921 Master Curve method [1].

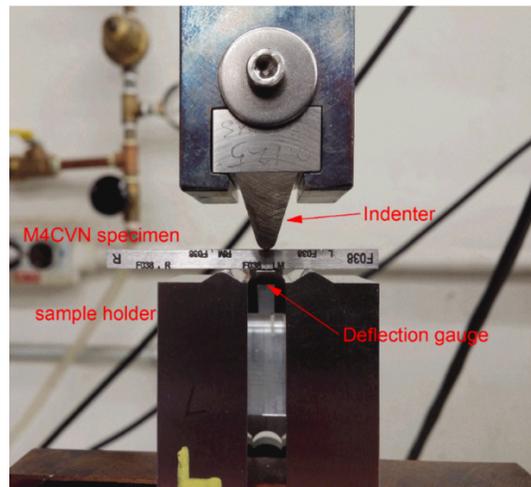
Fig. 3 Fatigue pre-cracking test fixture for a M4CVN specimen

The prerequisite of transition fracture toughness testing is having a sharp starting crack in the specimen which was realized by high frequency fatigue pre-cracking in this study. We performed fatigue pre-cracking on M4CVN specimens using a three-point bend type test fixture mounted on a 44.5 kN capacity servo-hydraulic frame as shown in Fig. 3. The span to width ratio of the specimen was kept constant at four. During the fatigue pre-cracking process, the load-line compliance at the machined notch of the specimen was measured by a deflection gauge which provides the real-time crack length using the following equation from Ref. [2]:

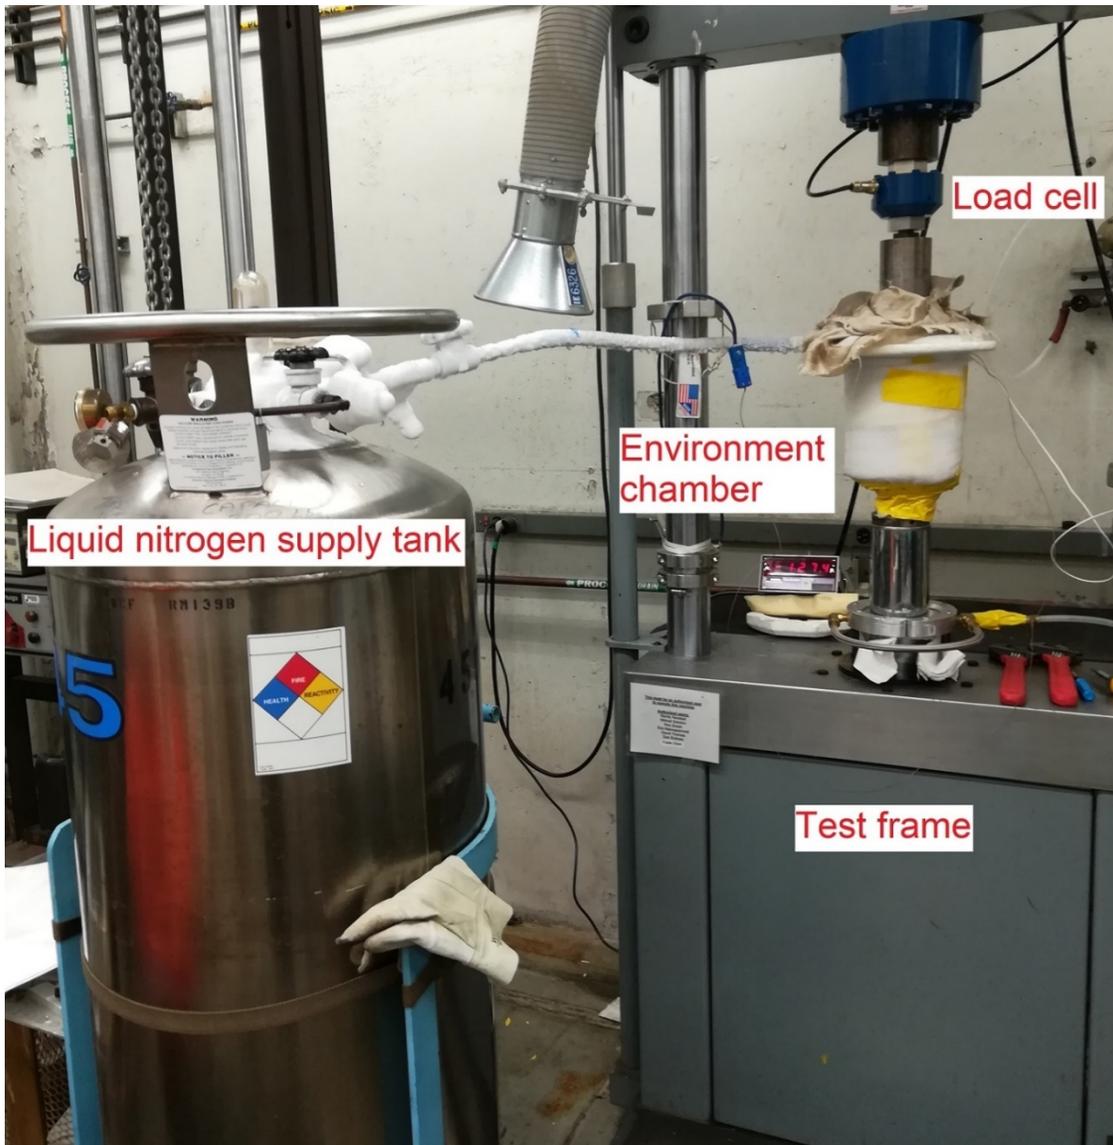
Fig. 4 General layout of the fracture toughness test setup

The test frame used for fracture toughness testing was a 222.4 kN capacity servo-hydraulic frame with a calibrated 4.45 kN capacity load cell. Fig. 4 illustrates the general layout of the experimental setup. We used liquid nitrogen to control testing temperatures which were measured directly from type-T thermocouple wires spot welded to specimens. The environment chamber enclosed specimens and the test setup was used to maintain a relatively stable temperature during testing. As shown in Fig. 5, the M4CVN specimen test setup consists of a specimen indenter and a specimen fixture. The deflection gauge attached to the specimen fixture was used to measure the load-line displacement of the specimen. The push bar can slide left and right and is used to push the specimen against the positioning block such that the specimen notch is aligned with the specimen indenter and the deflection gauge.

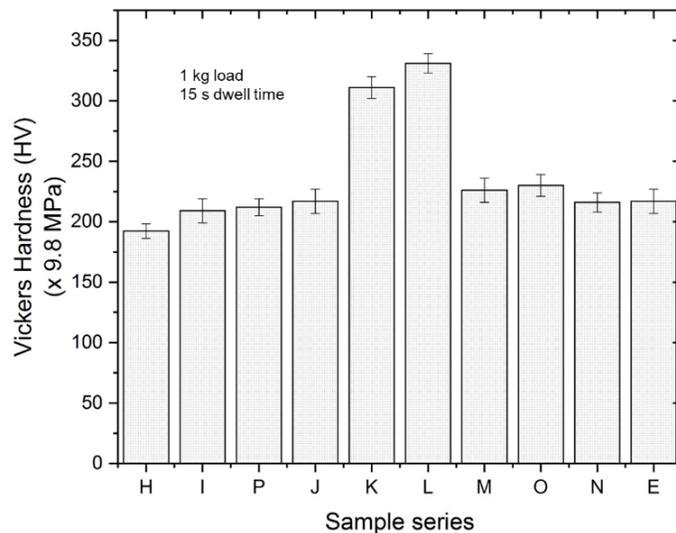
Fig. 6. Vickers hardness tests results performed on SS-J3 head/grip sections.

It is evident from the results that both K and L series steels had the highest hardness, exceeding 300 HV, while all the other steels did not deviate significantly when compared with the reference E series. We attribute this to the much lower tempering temperatures for both these steels, despite having slightly different chemistry and normalizing conditions. L series was tempered at 700 °C, while the K series steel was tempered at a temperature as low as 675 °C. Both these temperatures are lower than 760 °C tempering temperature used for reference Eurofer-97 steels or conventional 9% Cr steels in general. H series steel from KIT batch was the softest, with an average Vickers hardness of only 192 HV.

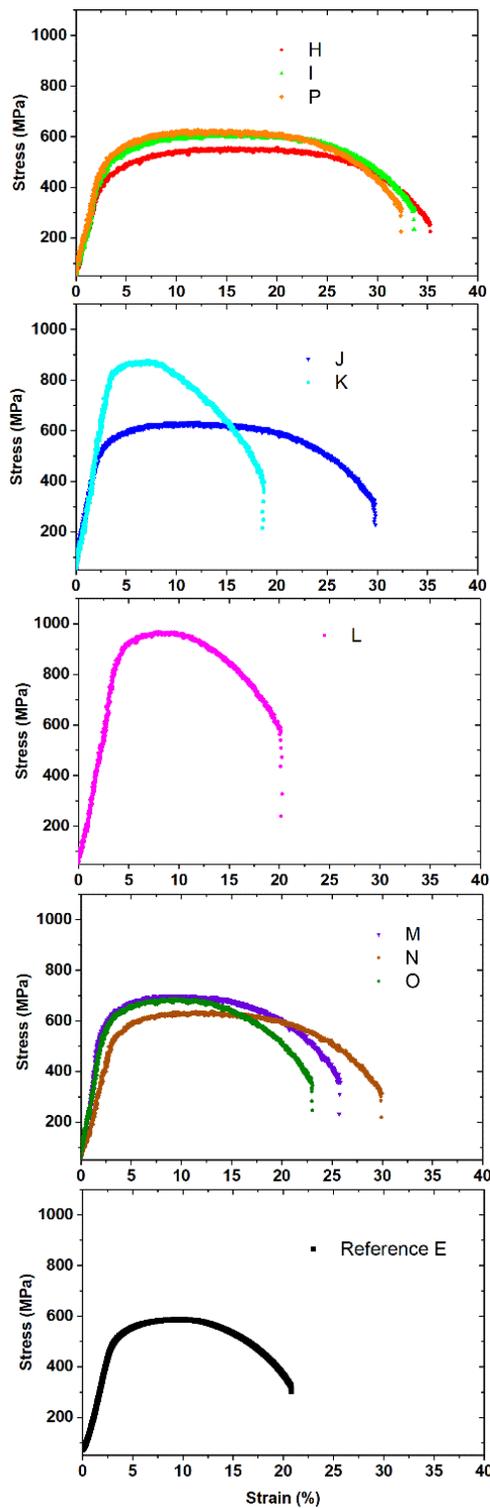
Fig. 7. Engineering stress-strain curves for the Eurofer-97 steel variants. For convenience only one curve per samples is shown.

summary of each test result is tabulated in Table 5. Because of machine compliance, we have separately reported the non-linear plastic strain information that remains is unaffected by the compliance. Reduction in area (RA) after the tensile tests was calculated using SEM imaging on the fracture surface. For convenience, RA values are also reported in Table 5, while fractography of the steels is presented in the next sections. The engineering stress-strain curves for all the steel variants is shown in Fig. 7.

having different austenization temperatures. O series steel, which was hot rolled at 650 °C to 40% reduction had higher yield strength (571-582 MPa) and slightly lower elongation. It is important to highlight that despite the new heat treatment given to the out of spec Eurofer-97 reference bar (old G/F series), tensile tests revealed that the steel was still softer than results known for Eurofer-97.

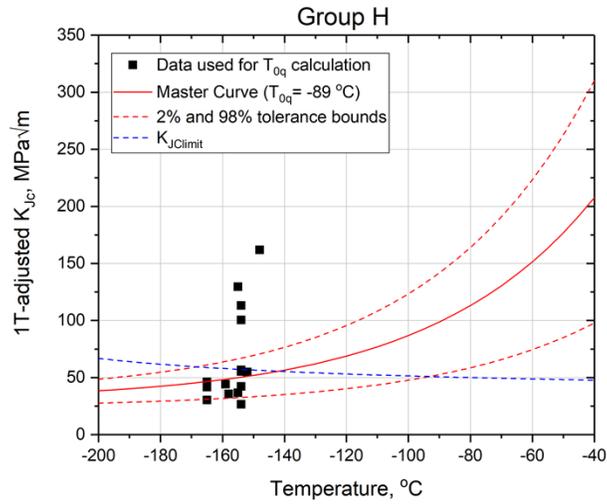
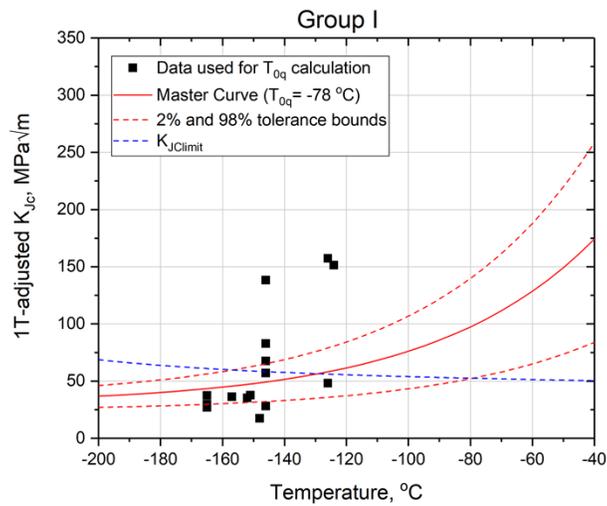
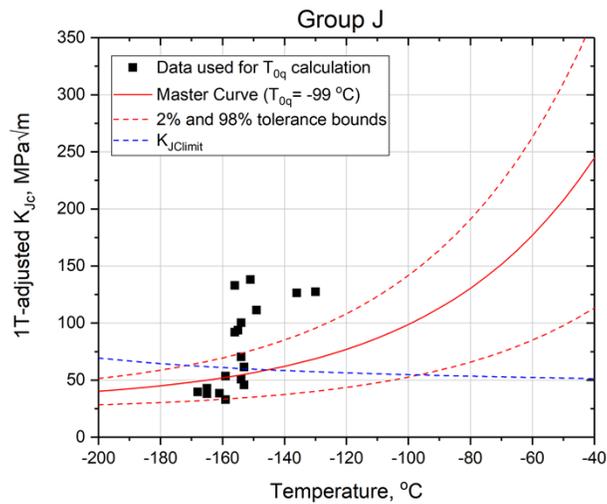
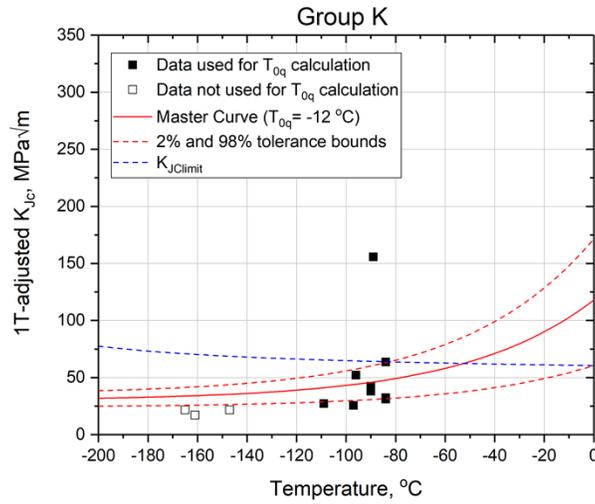
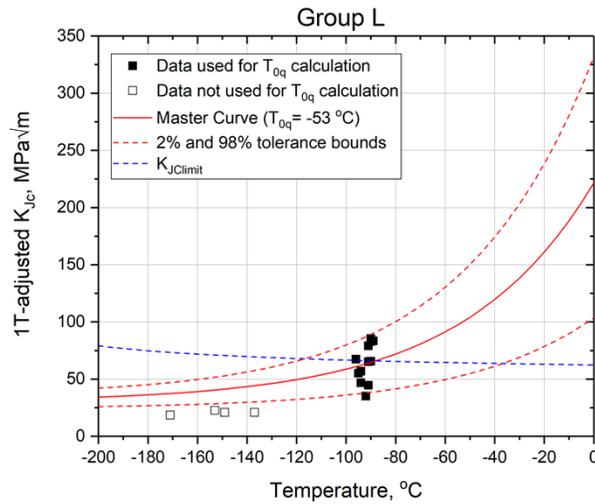
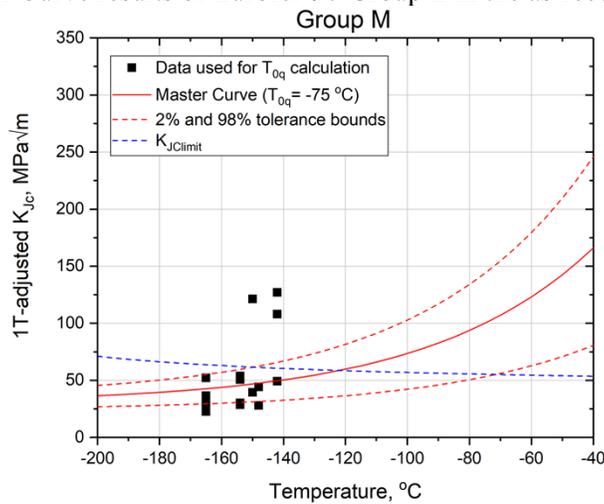
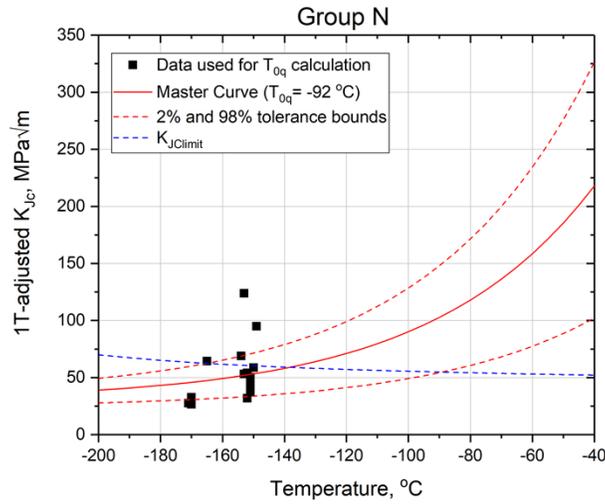
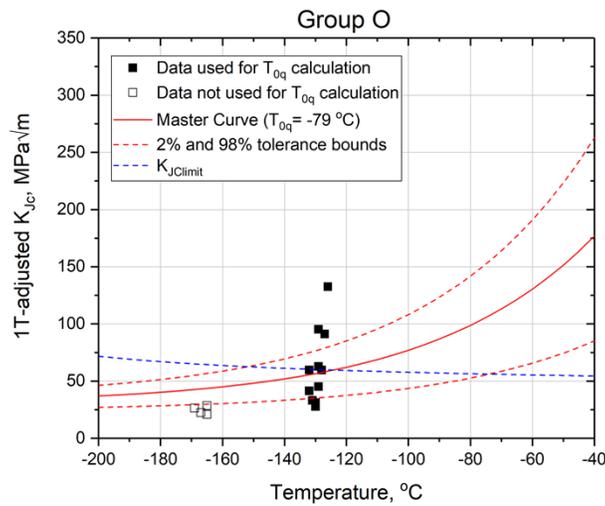
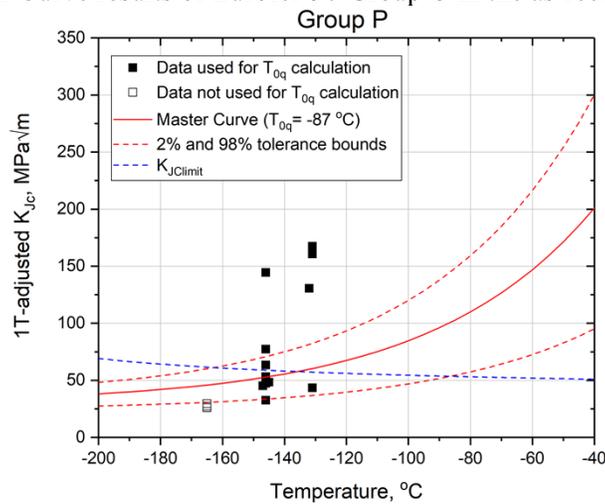
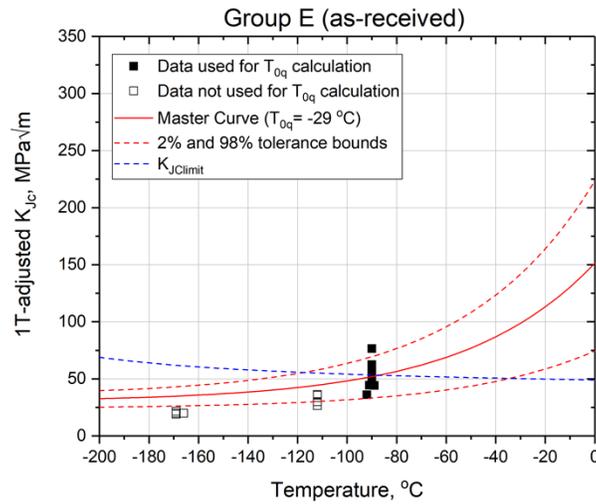
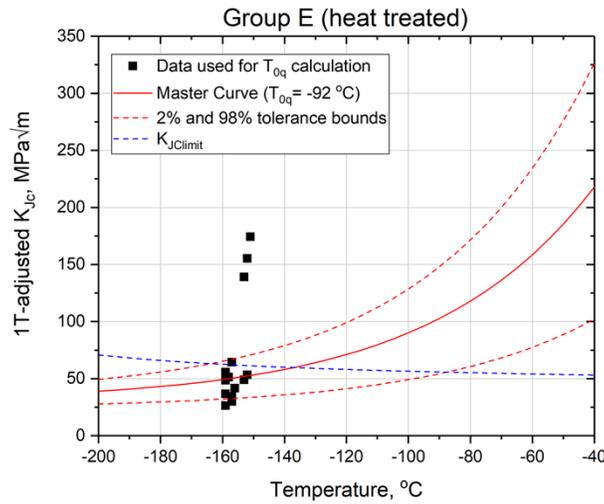
Fig. 8. Master Curve results of Eurofer-97 Group H in the as-received condition

Fig. 9. Master Curve results of Eurofer-97 Group I in the as-received condition

Fig. 10. Master Curve results of Eurofer-97 Group J in the as-received condition

Fig. 11. Master Curve results of Eurofer-97 Group K in the as-received condition

Fig. 12. Master Curve results of Eurofer-97 Group L in the as-received condition

Fig. 13. Master Curve results of Eurofer-97 Group M in the as-received condition

Fig. 14. Master Curve results of Eurofer-97 Group N in the as-received condition

Fig. 15. Master Curve results of Eurofer-97 Group O in the as-received condition

Fig. 16. Master Curve results of Eurofer-97 Group P in the as-received condition

Fig. 17. Master Curve results of Eurofer-97 Group E in the as-received condition

Fig. 18. Master Curve results of Eurofer-97 Group E in the heat-treated condition

The fracture toughness results of ten variants of Eurofer-97steels are summarized in Table 7-17. Figs. 8-18 show the test data along with the derived Maser Curve. The equation for the Master Curve is:

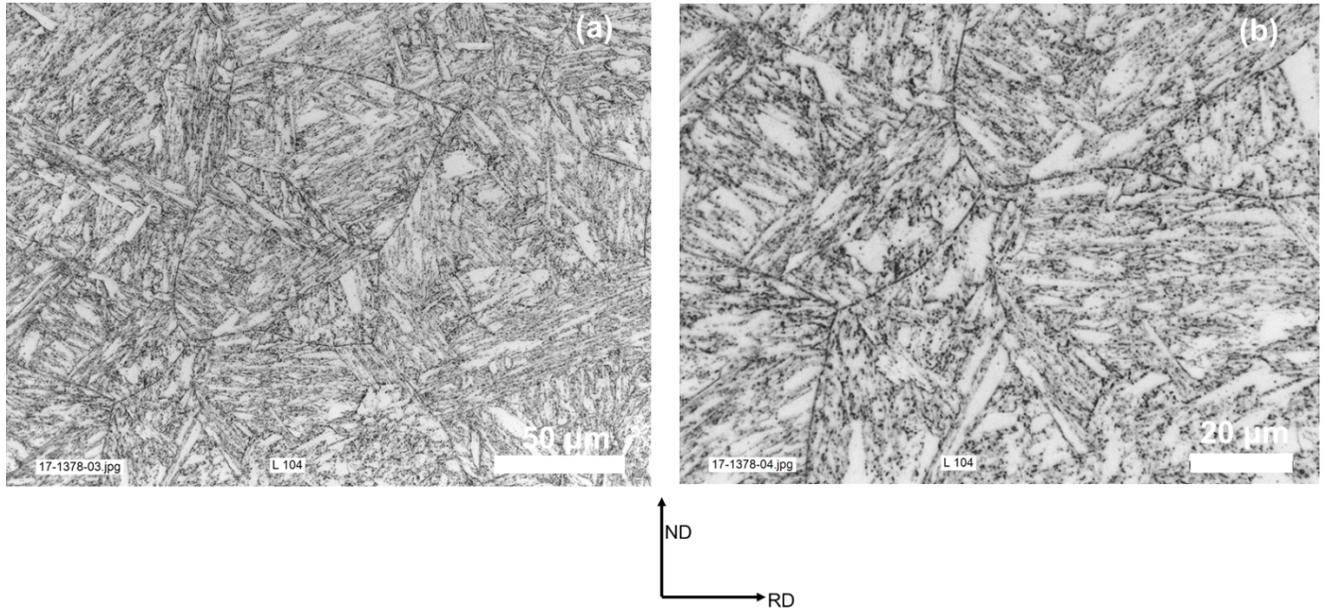
Fig. 19. LOM images at two different magnifications of L series steel after etching using Vilella's reagent. RD = rolling direction, ND= normal direction.

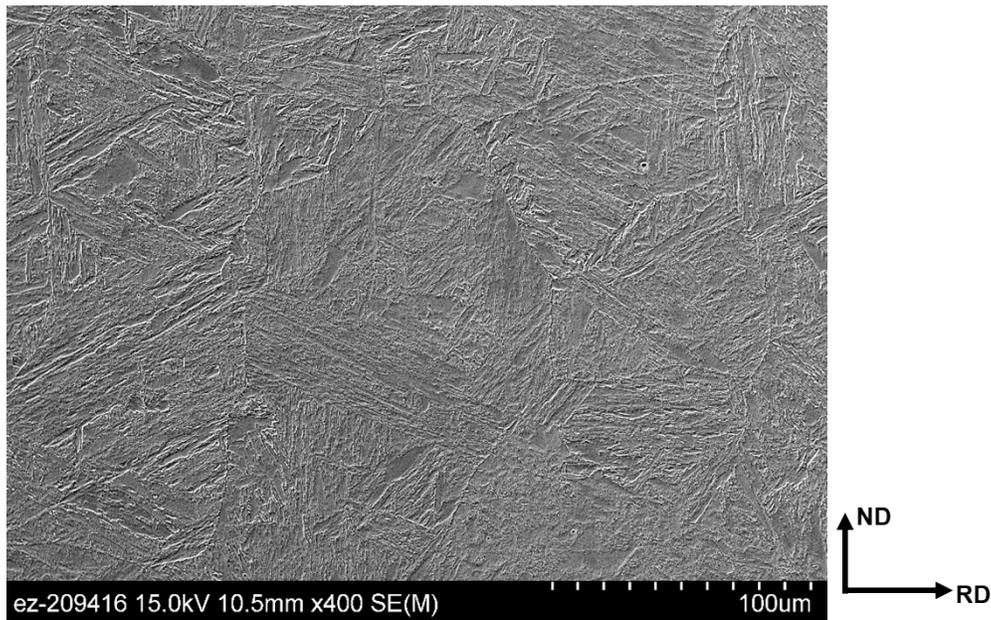
Fig. 20. SEM secondary electron image of L series steel in etched condition.

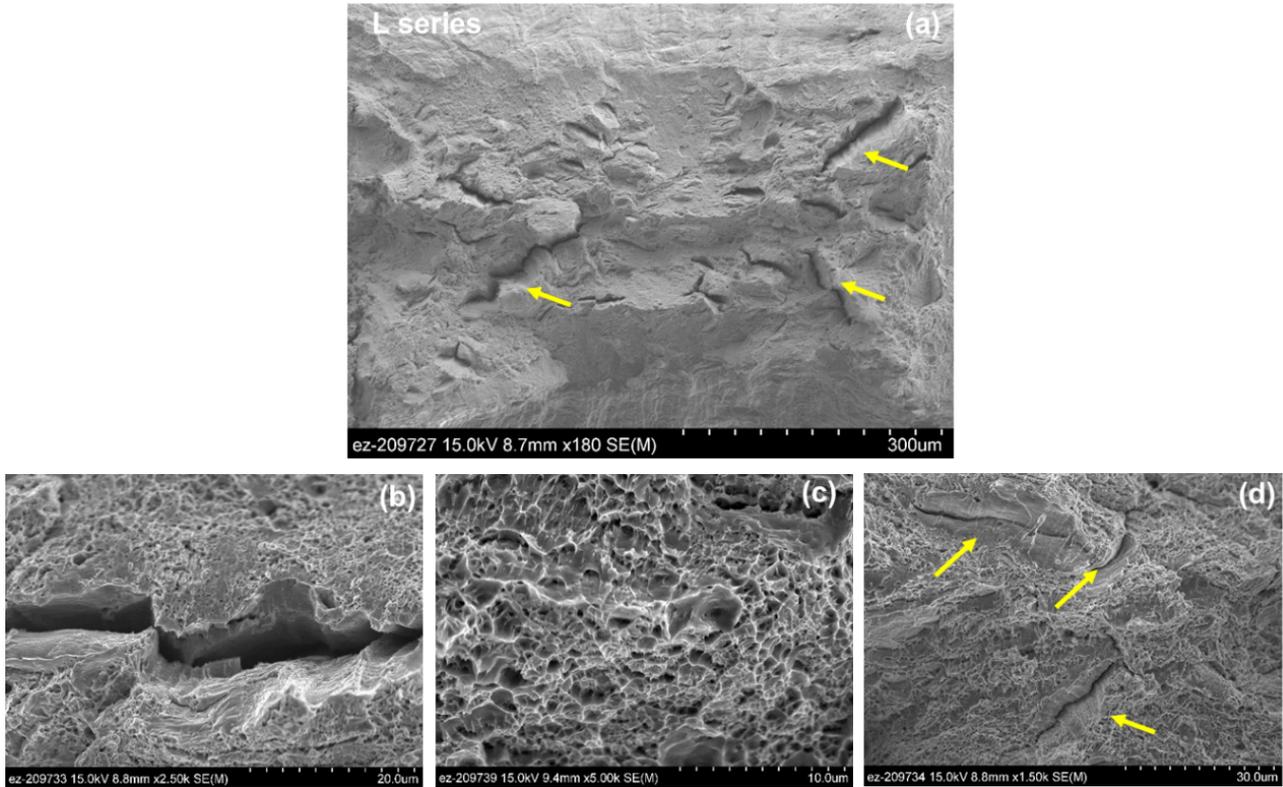
Fig. 21. SEM secondary electron imaging of fracture surface of L series steel. (a) Fracture surface overview. (b, c, d) Relatively high magnification images of different areas of the fracture surface showing brittle cleavages and ductile dimpled areas.

SEM analysis was also performed to study the fracture surface after tensile tests, which revealed a mixed mode of fracture in this steel. Majority of the sample surface failed in a ductile fashion, but numerous areas showed cleavage fracture. Fig. 21a shows the fracture surface overview where some areas showing brittle cleavages are indicated using arrows. Similar brittle areas are depicted in Figs. 21b and 21d at relatively high magnifications. Judging by the way the two cleavage planes are separating in the brittle

areas, it appears that these cracks may be running preferentially along the large PAGs of this steel. As will be shown in the ensuing subsections, similar fracture behaviour was noted in K series steel, which also consisted of very large PAGs. The regions away from the brittle cleavages showed dimpled fracture typical of ductile materials, but showing cup and cone fracture expected due to presence of carbides/nitrides in RAFM steels (Fig. 21c). No excessively large dimples, suggestive of inclusions, were detected on the fracture surface.

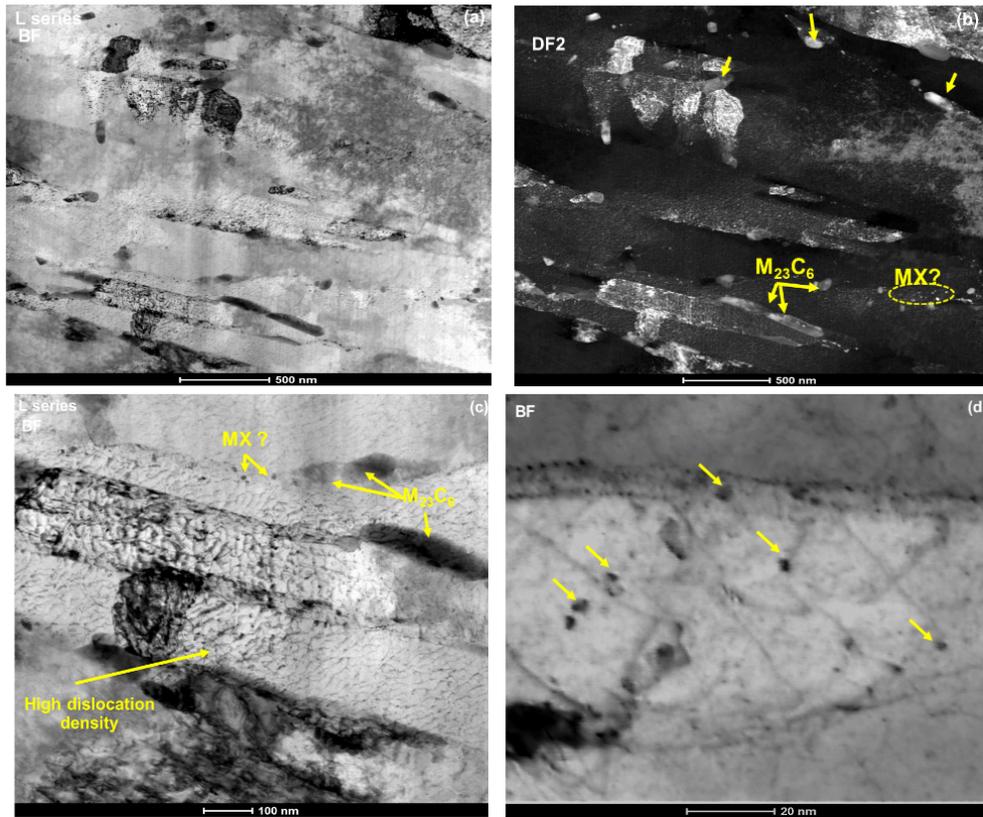
Fig. 22. STEM imaging of L series steel. (a, b) BF and MAADF images showing the sample overview, with some precipitates indicated using arrows. (c) BF image close to two beam conditions showing the high dislocation density. (d) High magnification BF STEM image close to two-beam condition revealing some small precipitates.

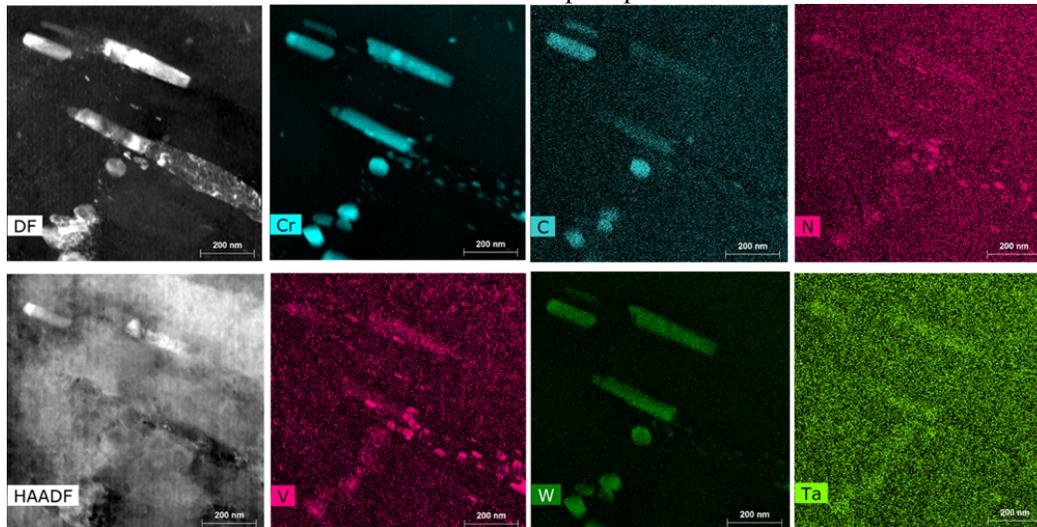
Fig. 23. STEM-EDX mapping of precipitates in L series steel, along with an MAADF (DF) and HAADF. The larger elongated precipitates in Fig. 23 are expected to be $M_{23}C_6$ carbides and were mainly present along the lath boundaries. EDX also revealed small (less than 10 nm) size precipitates which were predominantly Cr and V rich. These precipitates also generated a relatively strong nitrogen signal. We

believe these are the M_2X nitride precipitates as detected in the same steel by Henry et al. Two more examples of these small precipitates, imaged at relatively higher magnifications, is presented in Figs. 24 and 25. Once again, these precipitates were found to be mainly Cr, V rich nitrides. Very few precipitates generating a very strong Ta signal were detected in all the EDX maps, indicating that little to no MX was detected in the samples. Fig. 25 maps were generated from a second FIB foil from the same L series batch.

$M_{23}C_6$ and MX phases because the latter are mostly highly enriched in Ta, V and N while $M_{23}C_6$ typically consists of all the carbide formers. Using this approach, EDX maps revealing the precipitates in the steel are shown in Figs. 23, 24 and 25.

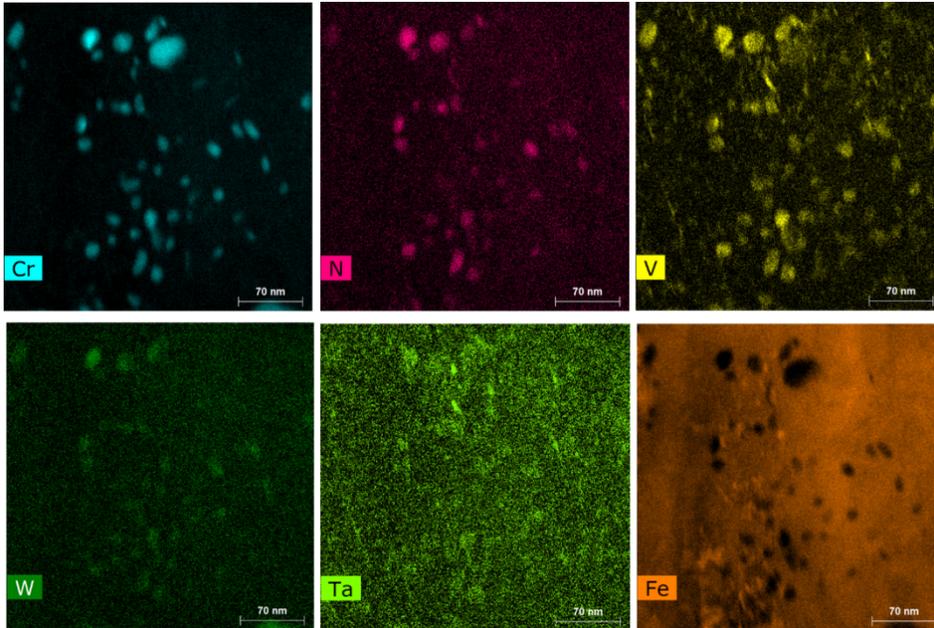
Fig. 24. High magnification STEM-EDX mapping of Cr-V rich precipitates in L series steel.

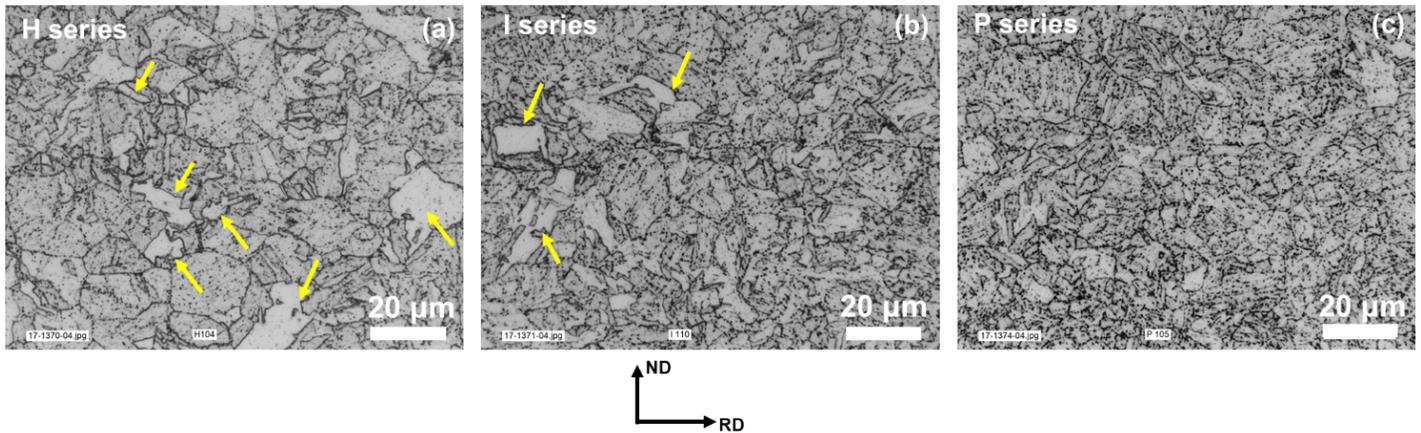
Fig. 26. LOM images of H, I and P series steel after etching using Vilella's reagent. Small arrows indicate the ferrite grains.

Fig. 26 presents the optical images of the etched microstructures of H, I and P series steels. The imaging was performed on the RD-ND plane as indicated in the figure. Judging by these images, the microstructure seems over-tempered. H and I series steels contained ferrite grains. These grains appeared much brighter in the etched steels without much carbides (black dots). Some identified ferrite grains in these two steels are indicated using arrows. SEM BSE images showing the ferrite grains detected in H and I steels are also presented, in Fig. 27. P series steel did not seem to contain the ferrite grains. It is evident from Fig. 26 that H series steel had larger grains as compared to the I and P.

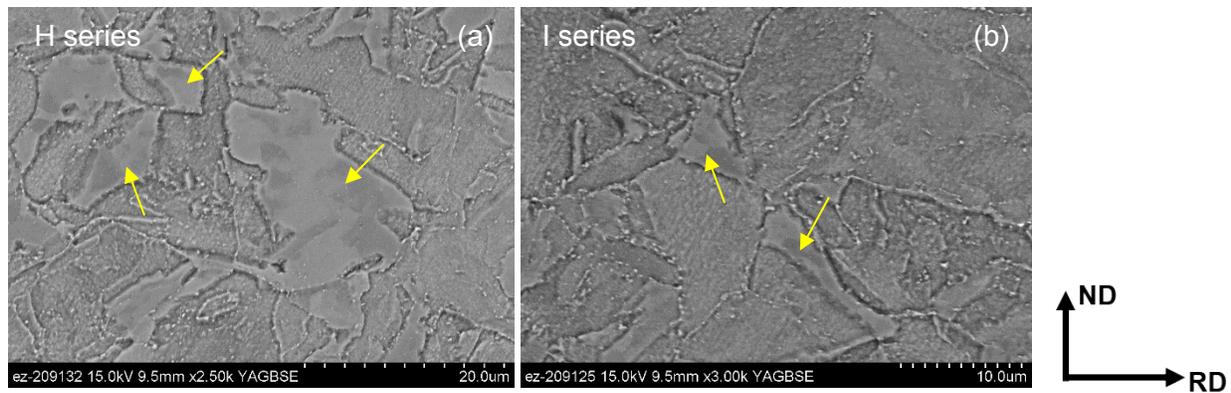
Fig. 27. SEM-BSE images showing the ferrite grains in H and I series steels.

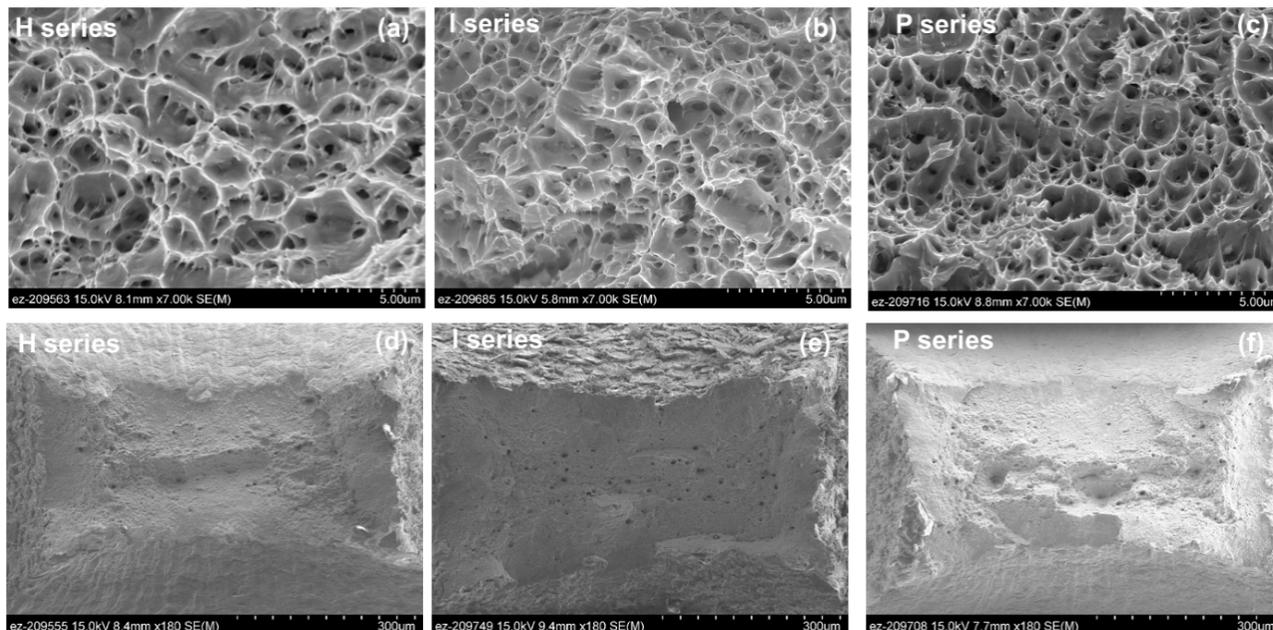
Fig. 28. SEM analysis of the fracture surface. (a, b, c). High magnification secondary electron images. (d, e, f) Overview of the fracture surfaces of the three steels.

SEM analysis was also performed to study the fracture surface after room temperature tensile tests of H, I and P steels. All the three steels showed a highly dimpled fracture surface, typical of ductile metals and containing cup and cone features expected due to the presence of carbides (Fig. 28). A ductile failure of these three steels is fully consistent with the tensile tests results. Additionally, the fracture surface showed many large holes, which suggest the presence of a low density of large ($> 1 \mu\text{m}$) inclusions in the steels. Such holes, or large cup and cone type of features on the fracture surface were particularly prominent for the I series steel (Fig. 28e). Relatively high magnification images of these fracture features are shown in Figs. 29a-29c where inclusion can be identified inside the burrows. Because these inclusions were embedded in the cones of the fracture, it was not possible to check their chemistry using EDX. However, a few large inclusions were detected in SEM analysis of the etched samples surfaces - see backscattered electron images (BSE) images in Figs. 29d-29f. Because these inclusions appeared bright in BSE images,

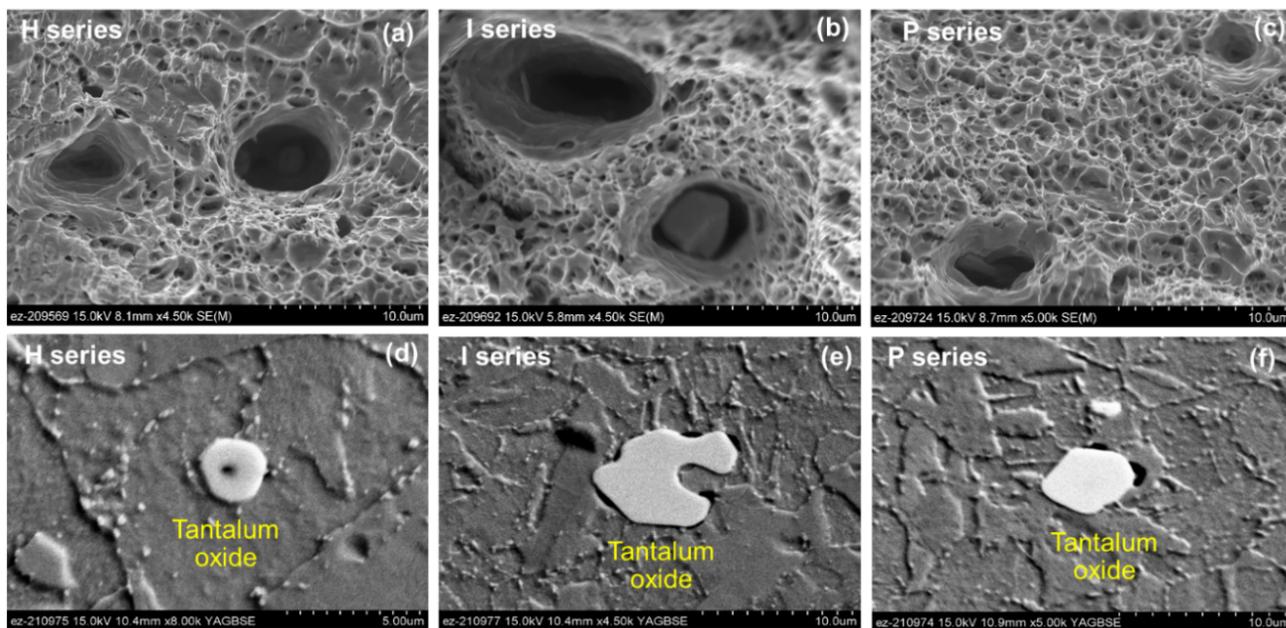
Fig. 29. SEM analysis showing large cup and cone fractures, and steel inclusions. (a, b, c). High magnification secondary electron images. (d, e, f) SEM-BSE images of tantalum rich inclusion in the etched sample surface.

they must contain heavy elements like Ta. We performed an EDX spot spectra in SEM from the inclusion in Fig. 29 e, where the inclusion showed a very high Ta signal (Fig.30). We believe, these are large tantalum oxide inclusion that are not uncommon in RAFM steels and they were responsible for the large cup and cone fracture features detected in the steel and were acting as fracture initiation sites.

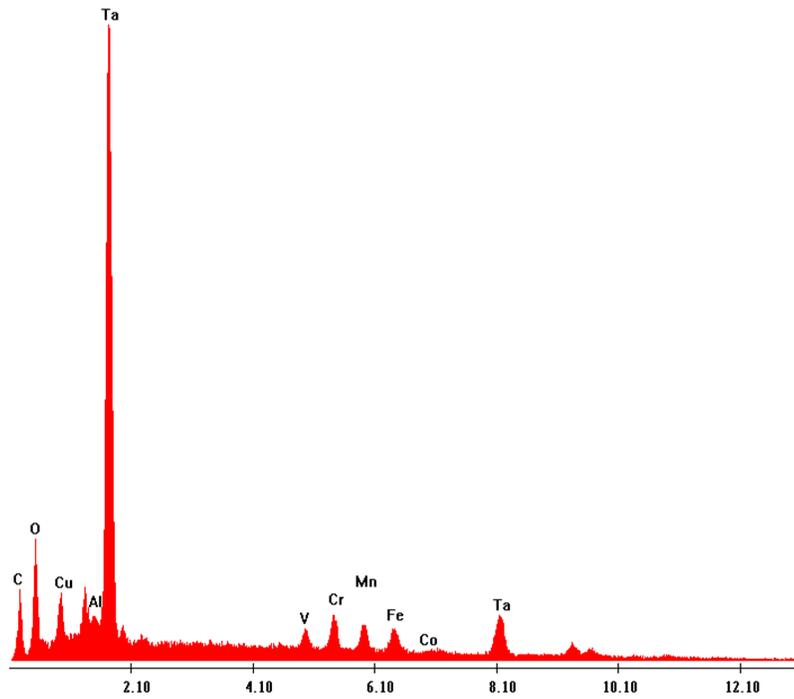
Fig. 30. EDX spot spectra in a SEM from a Ta rich inclusion detected in Fig. 29e: I series steel. X-axis is Energy (keV) and y-axis presents X ray counts. EDAX Genesis EDX system coupled to Hitachi S4800 SEM was used.

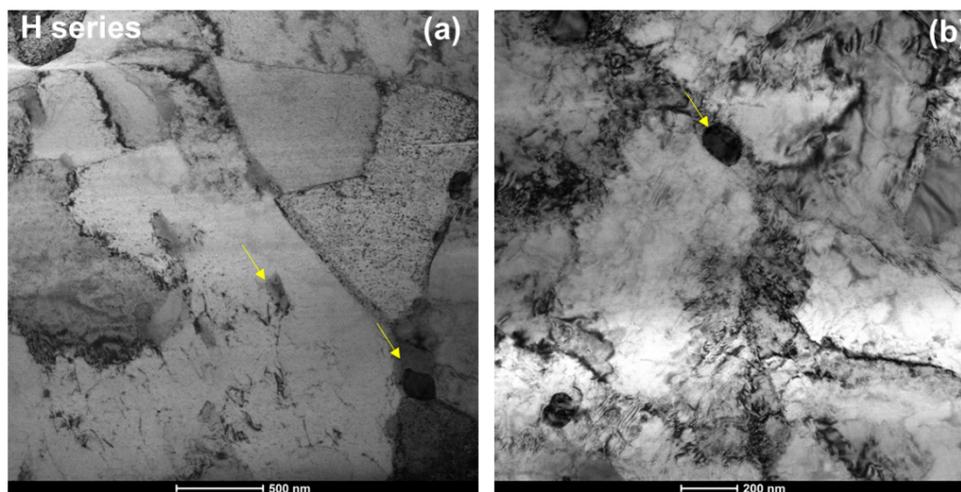
Fig. 31. BF TEM images of H series steel showing areas from two different samples.

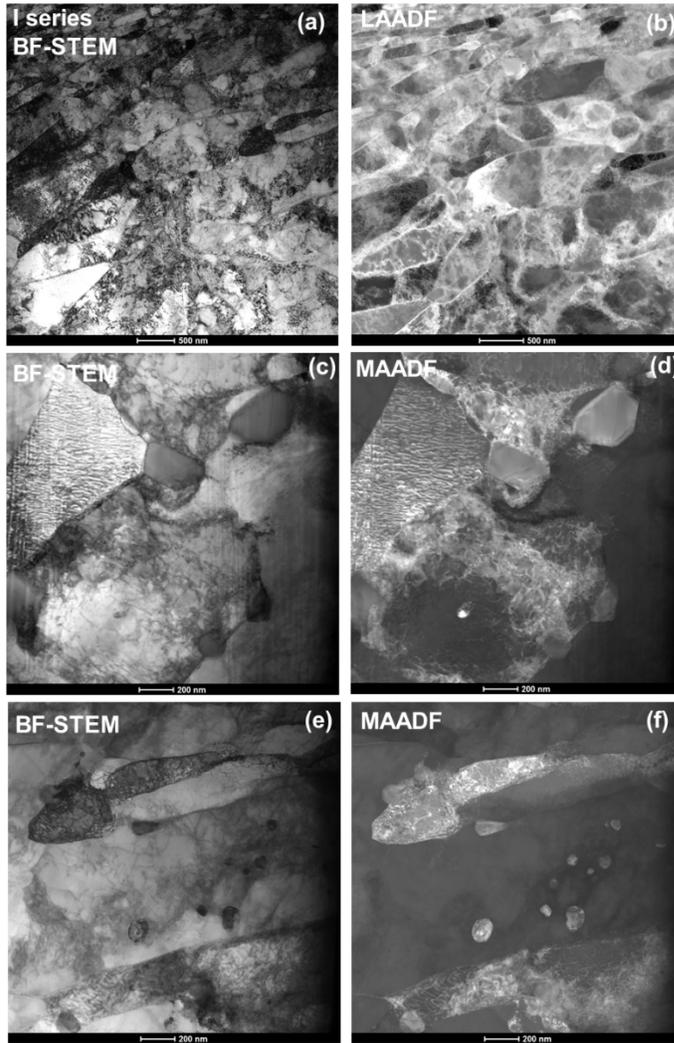
Fig. 34. Overview of I series steel. (a, b) STEM-BF and low-angle annular dark field (LAADF) images showing the lath structure. (c, d) STEM-BF and medium-angle annular (MAADF) image where two large precipitates can be seen in contrast.

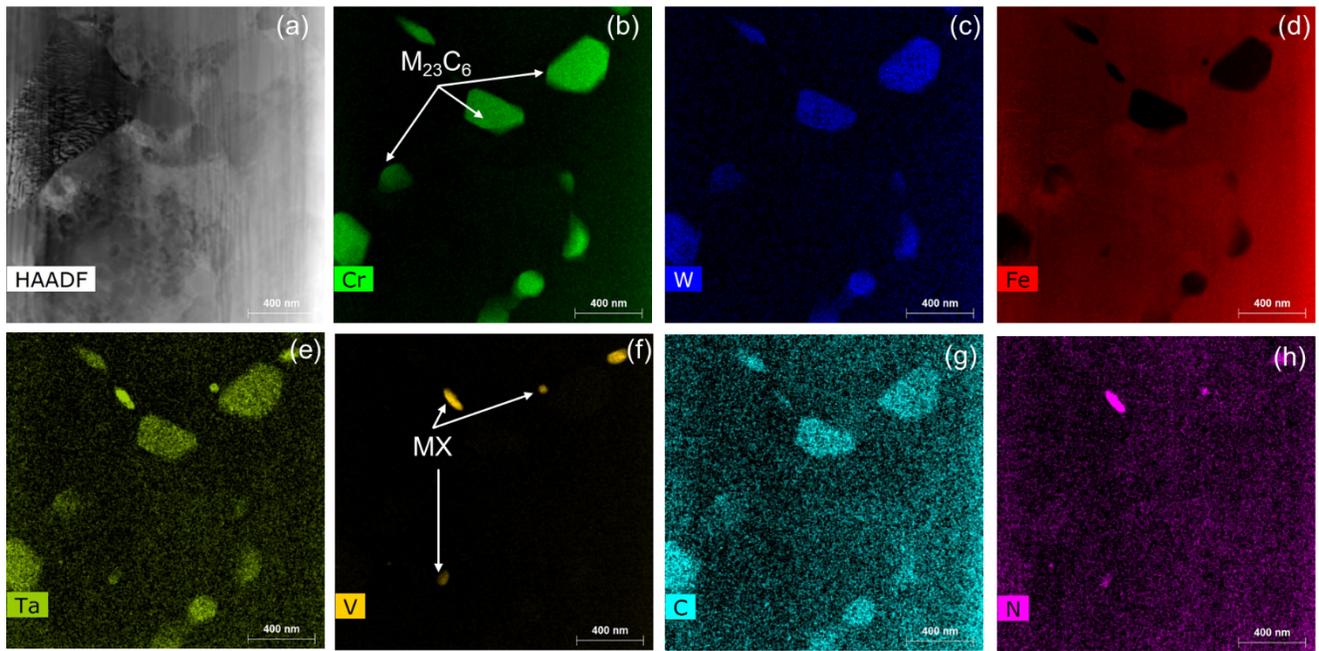
Fig. 35. EDX mapping in STEM mode for I series. (a) HAADF image. (b-h) Elemental maps.

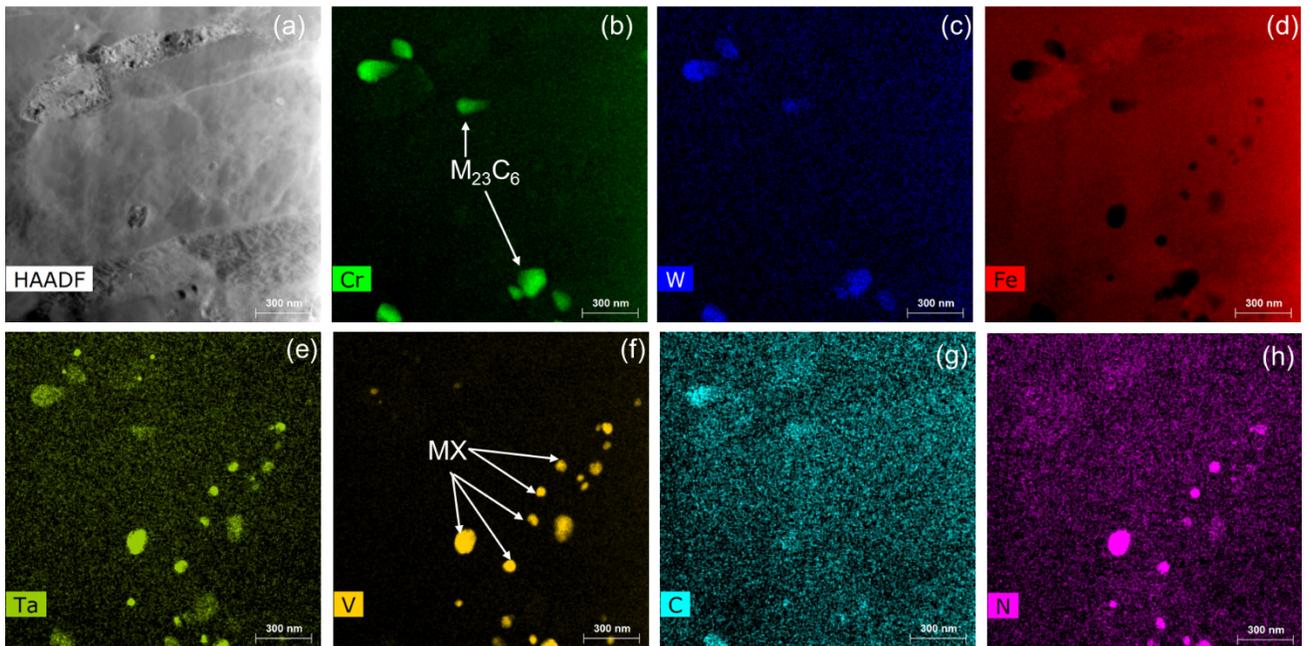
Fig. 36. EDX mapping in STEM mode for I series. (a) HAADF image. (b-h) Elemental maps, second FIB foil.

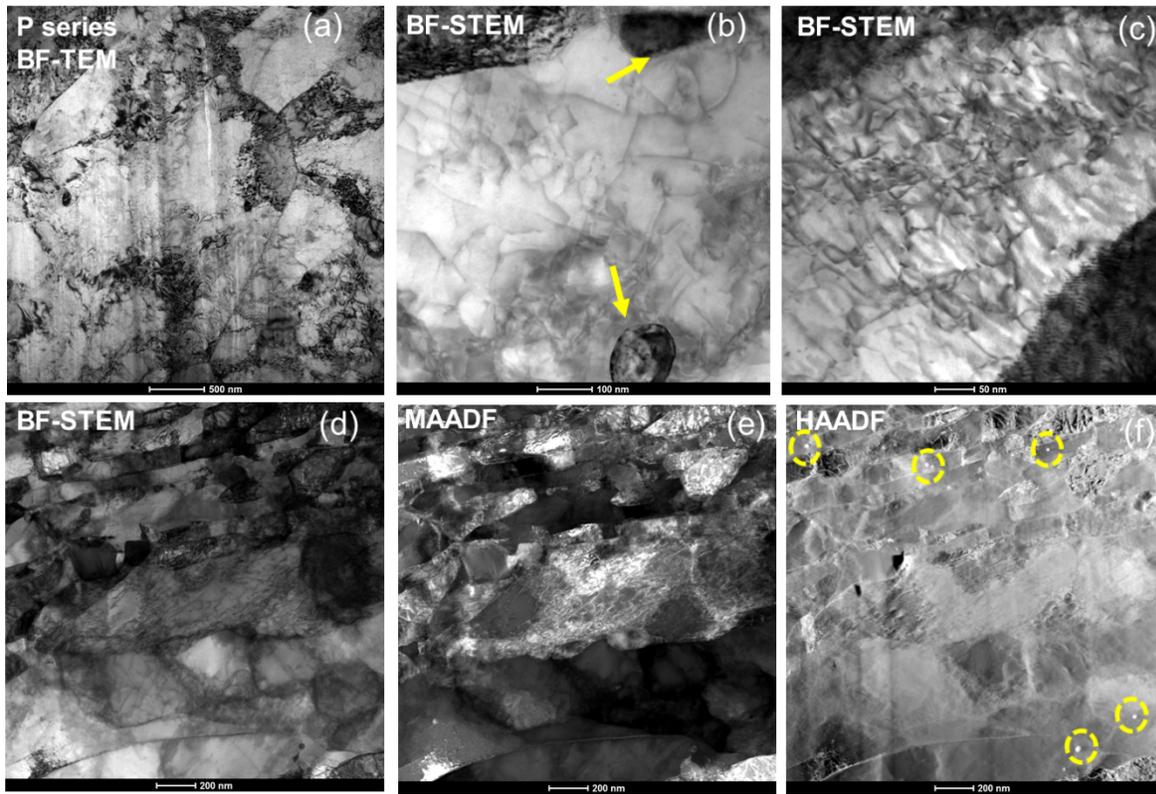
Fig. 37. Overview of P series steel. (a) BF-TEM image. (b,c) BF-STEM images showing the high dislocation density and precipitates. (d, e, f) STEM-BF, MAADF and HAADF images of the same zone. Some bright precipitates in HAADF are encircled.

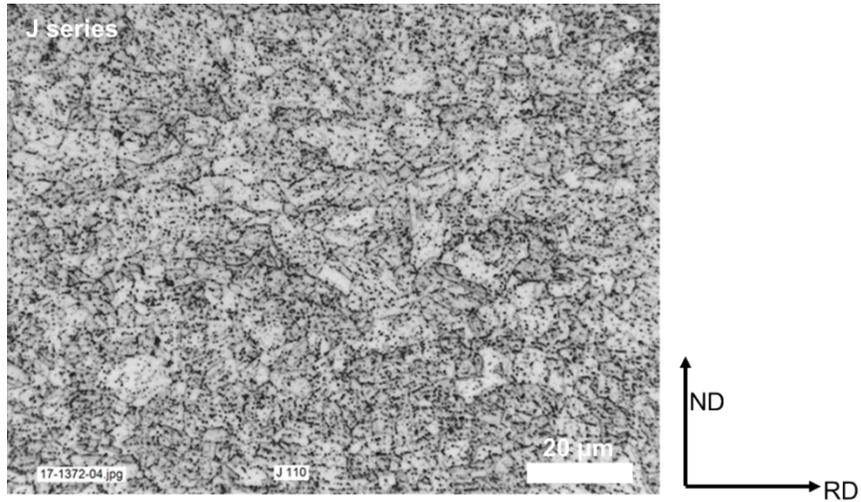
Fig. 39. LOM of J series steel after etching using Vilella's reagent.

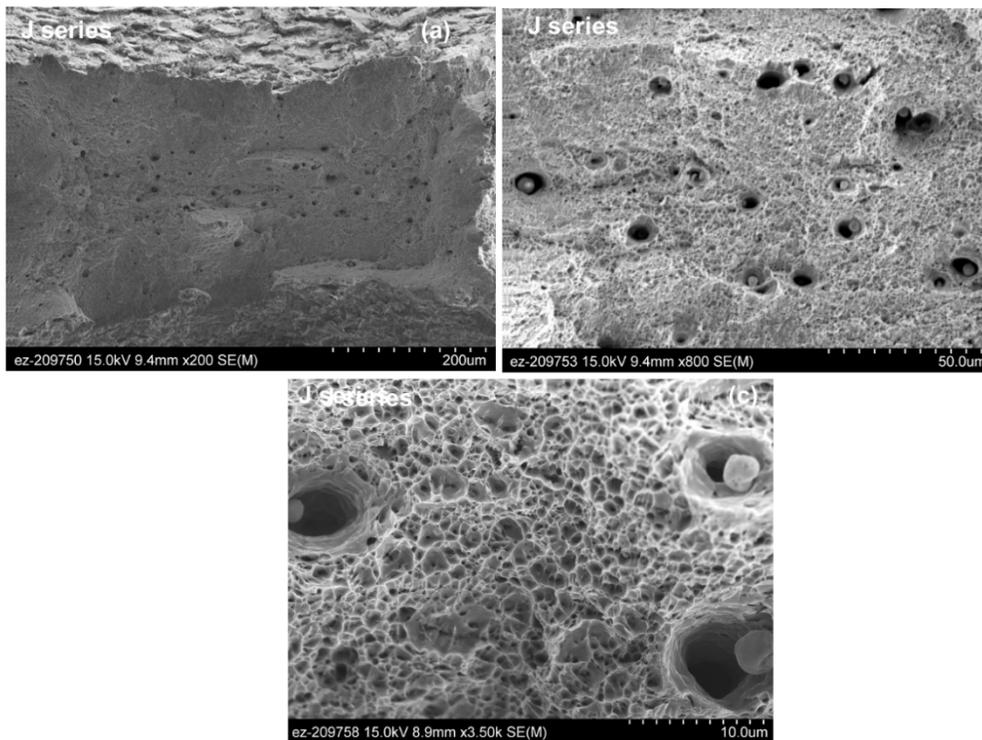
Fig. 40. Fractography of J series steel after tensile tests (secondary electron images). (a) Fracture surface overview. (b) Inclusions on the fracture surface and (c) Ductile fracture surface with cup and cone features.
