Mechanical properties and microstructure characterization of unirradiated Eurofer-97 steel variants for the EUROfusion project

Materials Science and Technology Division

Prepared by
OAK RIDGE NATIONAL LABORATORY
Oak Ridge, TN 37831-6283
managed by
UT-BATTELLE, LLC
for the
Karlsruhe Institute of Technology
under contract NFE-16-06240

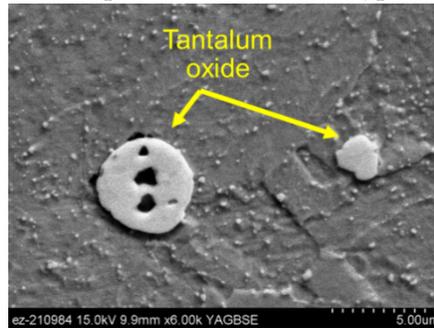
Fig. 41. Inclusions in J series steels. SEM-BSE image on etched surface. Dark areas are holes on the inclusion surface, presumably due to acid attack.

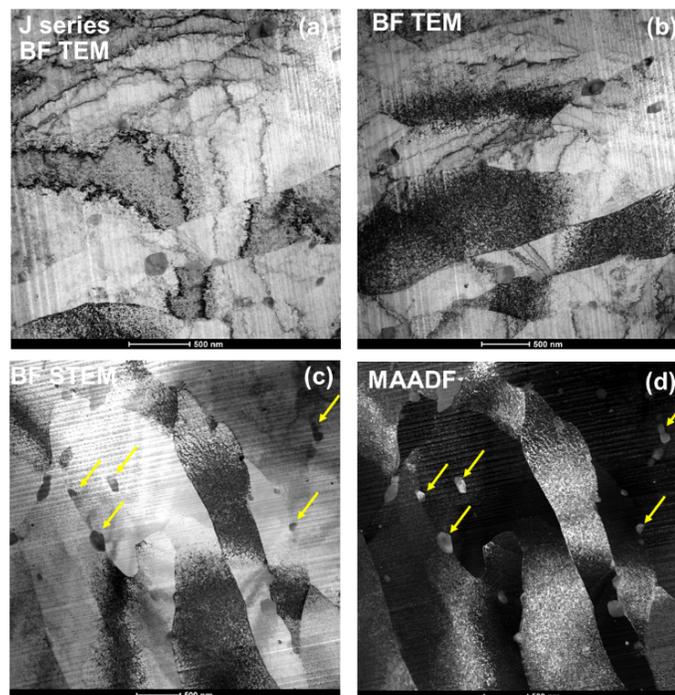
Fig. 42. TEM and STEM imaging of J series (a,b) Conventional BF TEM images, (c, d) BF STEM and MAADF image of the same zone.

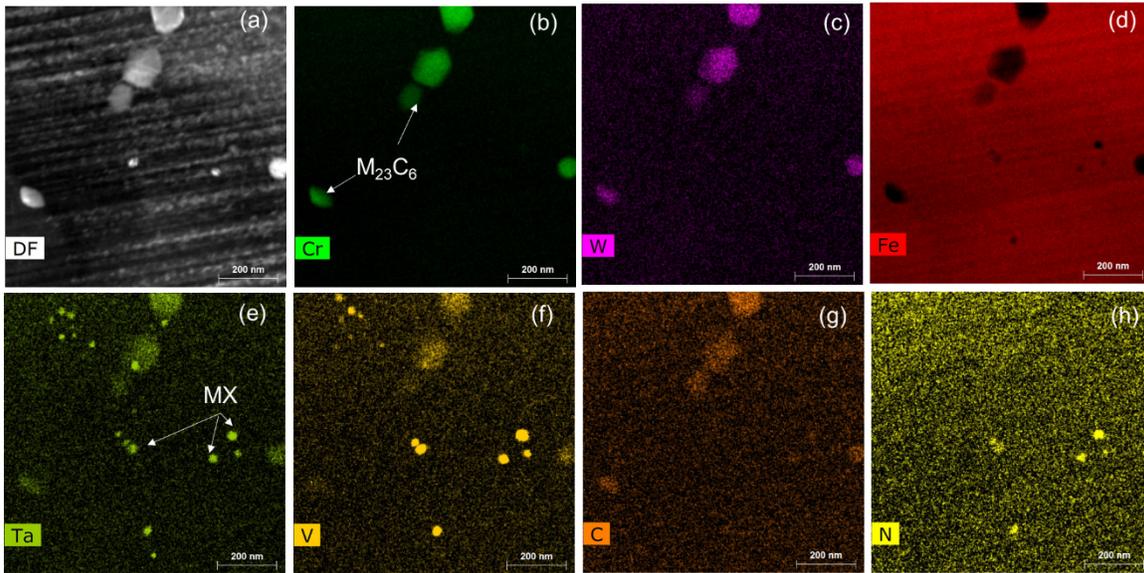
Fig. 44. EDX mapping in STEM mode for J series: different FIB foil. (a) MAADF image. (d-h) Elemental maps.

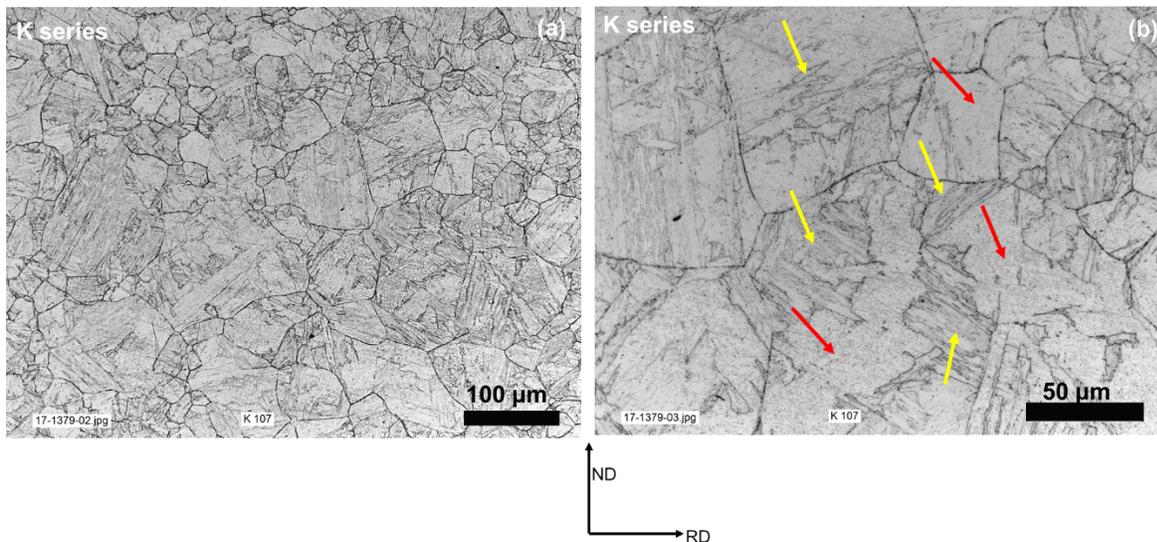
Fig. 45. LOM images of K series steel after etching in Vilella's reagent (a) Low magnification image. (b) Image showing the areas where laths are developed (yellow arrows) and regions where no laths were identified optically, representing under tempered regions (red arrows).

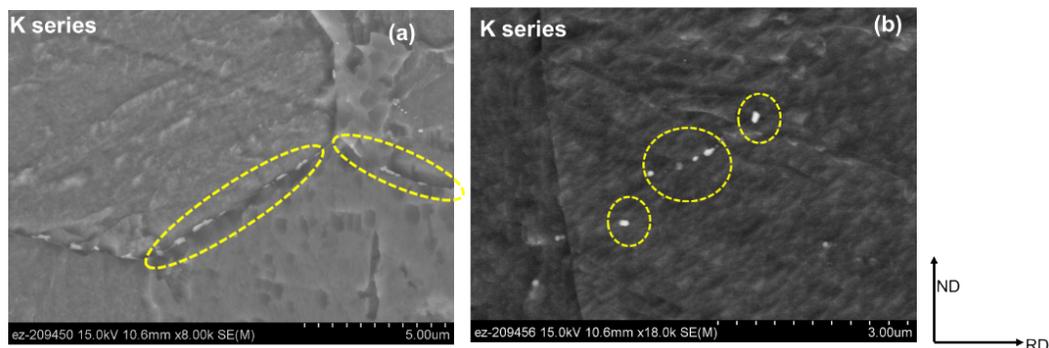
Fig. 46. SEM secondary electron images showing some identified precipitates in K series steel. (a) Precipitate films on grain boundaries and (b) Some precipitates in matrix.

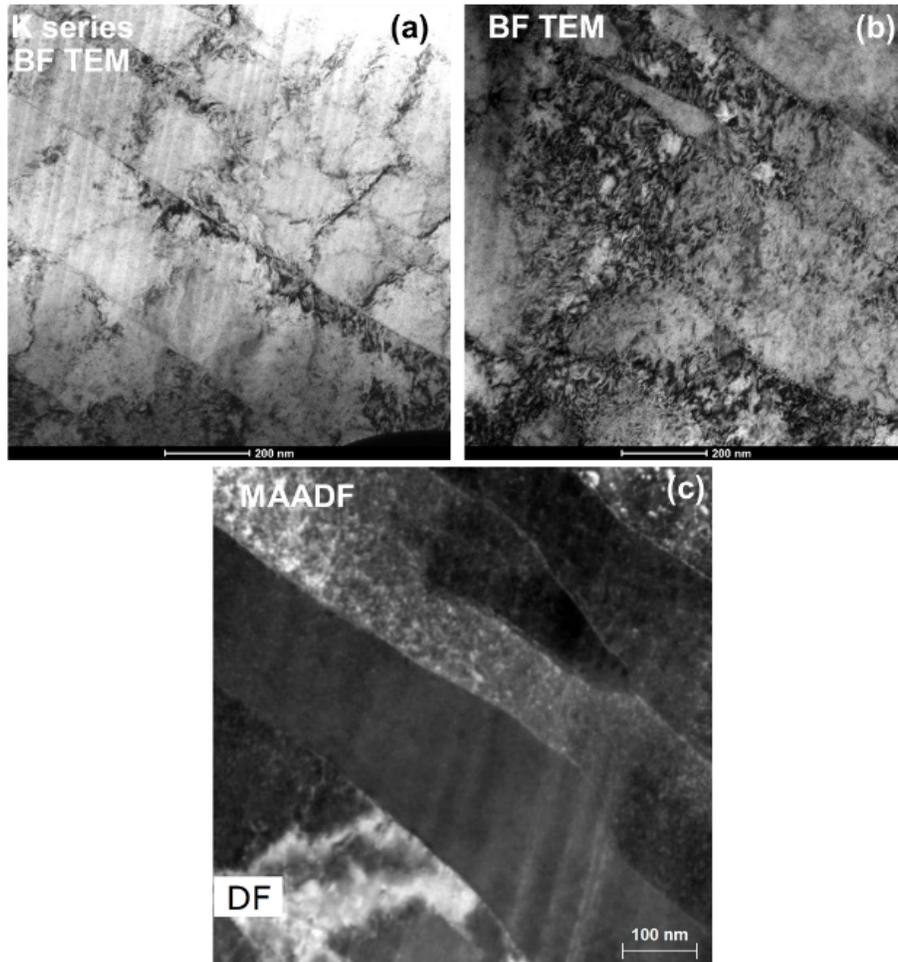
Fig. 47. TEM/STEM imaging of K series steel. (a, b) BF TEM images (c) STEM-MAADF image.

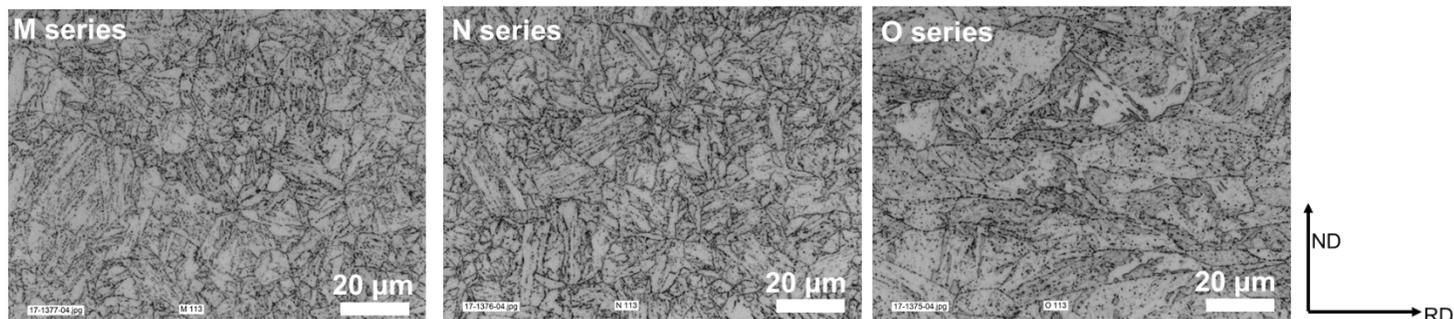
Fig. 50. LOM images of (a) M series (b) N series and (c) O series steels.

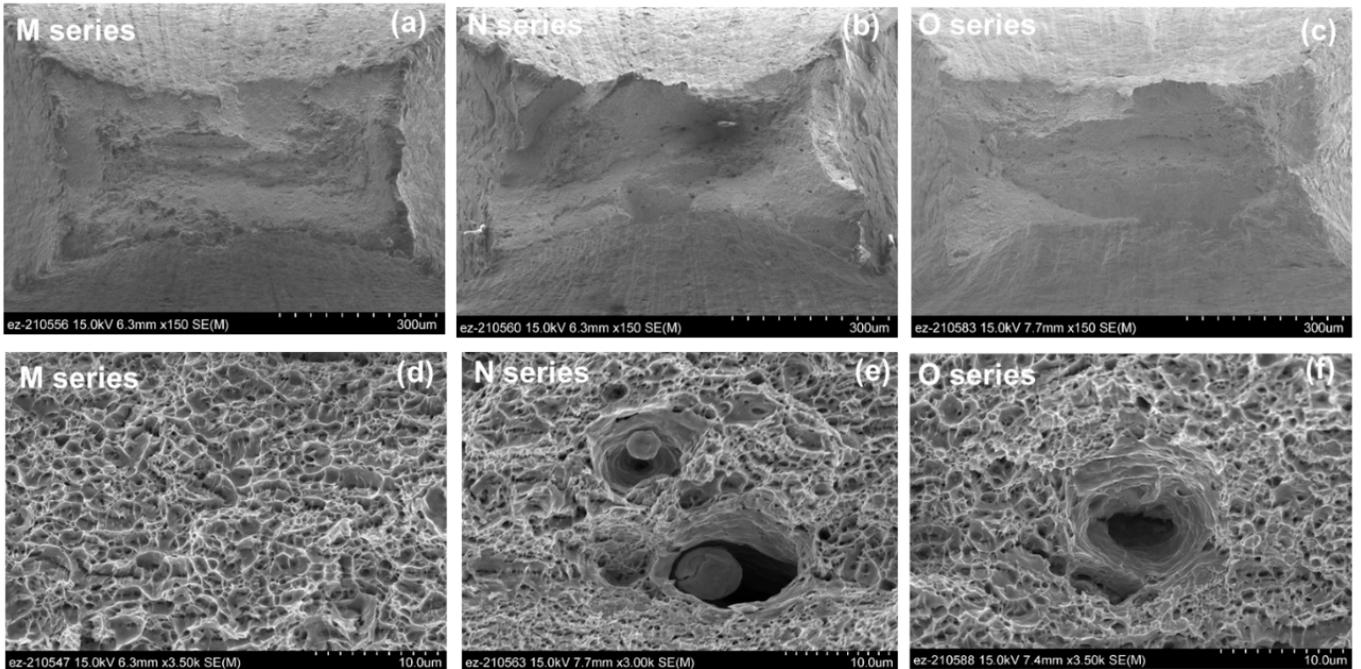
Fig. 51. Fractography on M, N and O series steels using SEM secondary electron imaging. (a-c) Fracture surface overview. (d-f) High magnification images of the fracture surface showing the ductile failure.

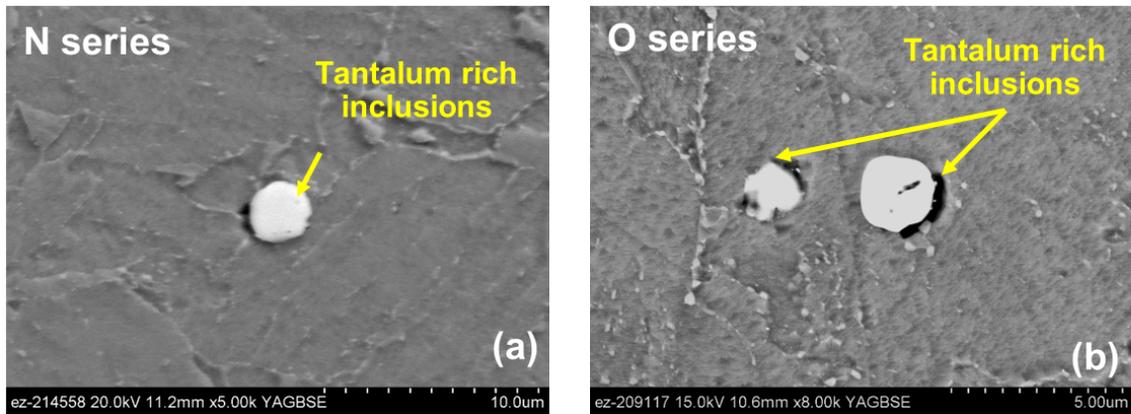
Fig. 52. SEM-BSE images of inclusion in (a) N series and (b) O series steels, expected to be Ta rich oxides.

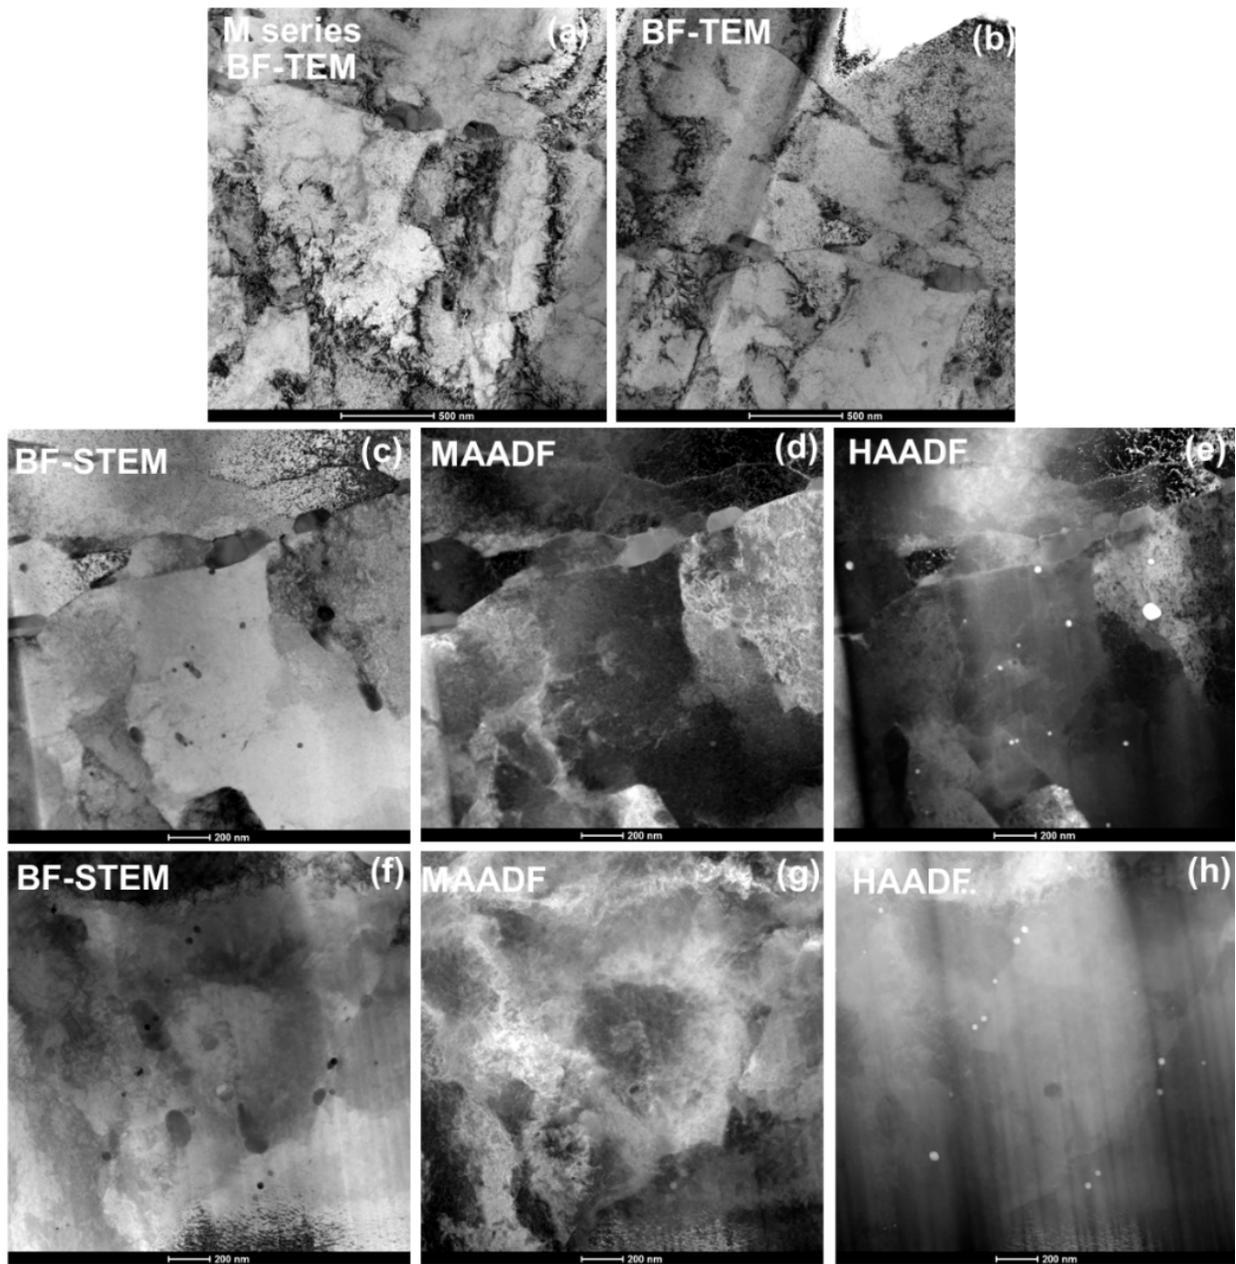
Fig. 53. TEM and STEM imaging of M series steel. (a, b) BF TEM images. (c, d, e) STEM BF, MAADF and HAADF images of the same zone showing precipitates. (f, g, h) STEM BF, MAADF and HAADF images in a different FIB foil of same zone.

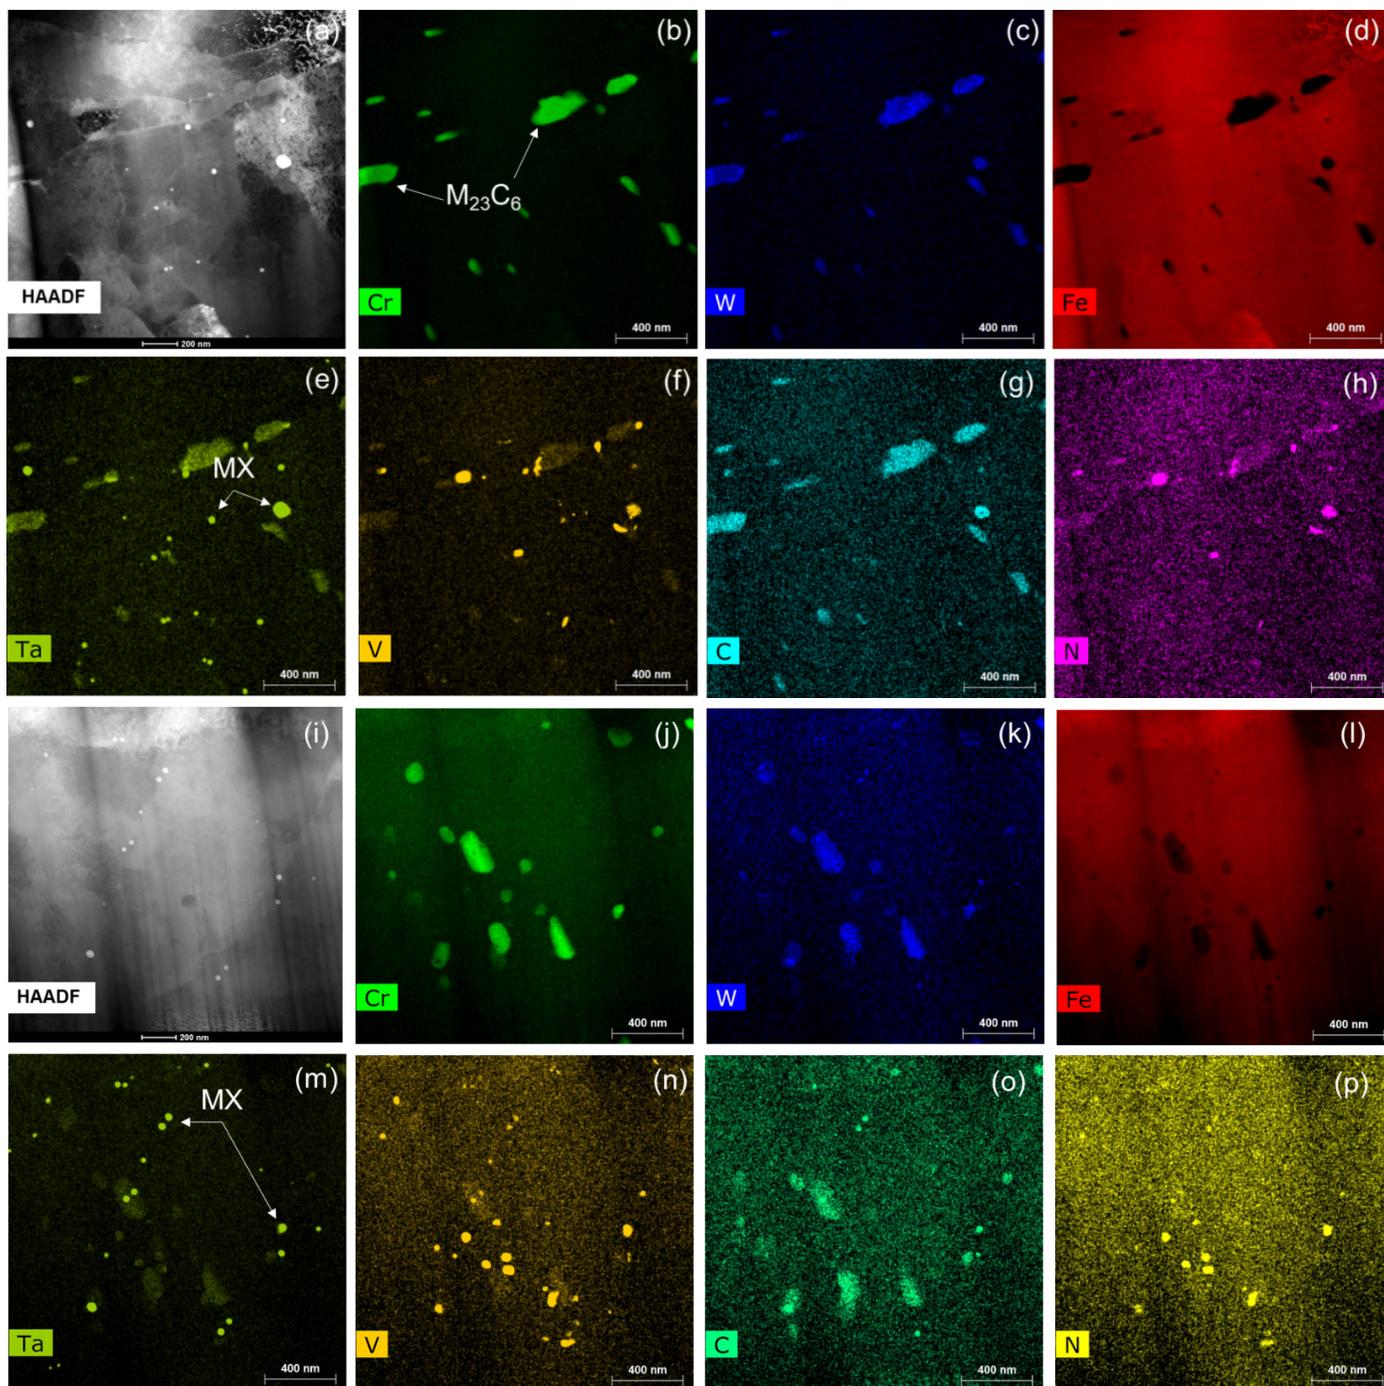
Fig. 54. STEM-EDX mapping of M series steel (a-h) HAADF image and EDX maps of same zone. (i-p) HAADF image and EDX mapping from a different FIB foil.

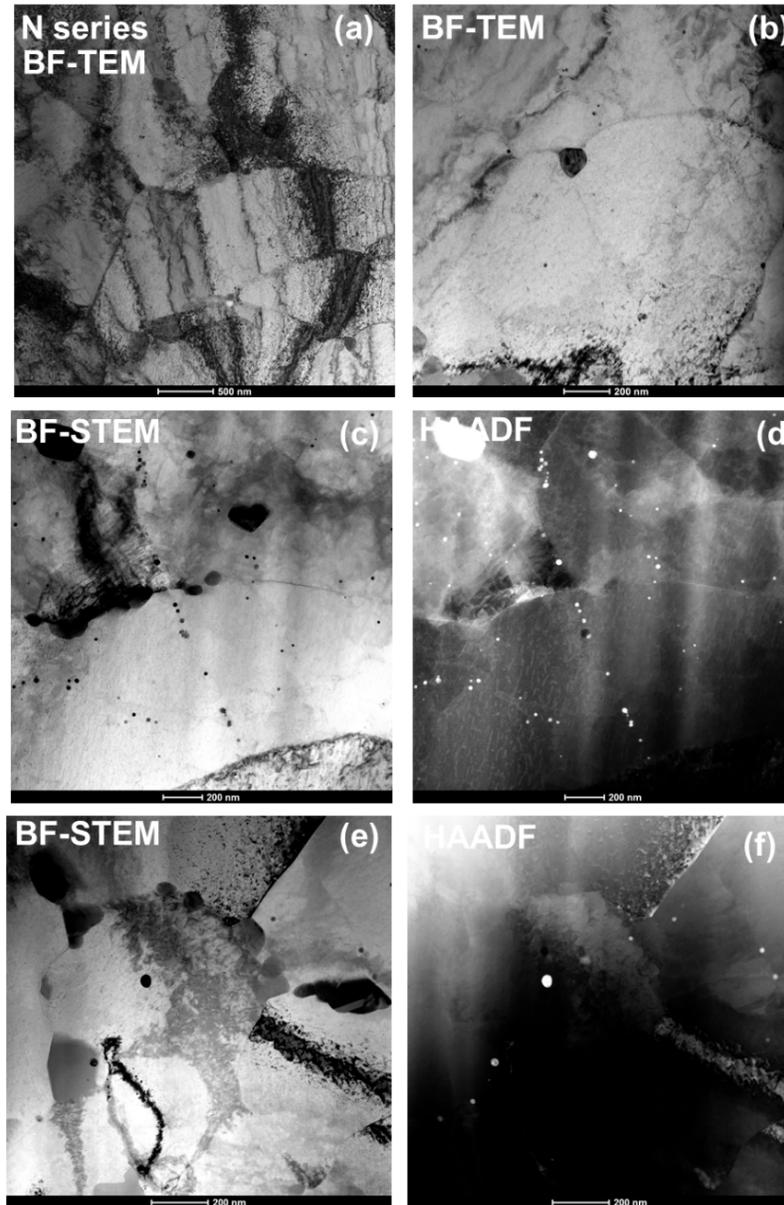
Fig. 55. TEM and STEM analysis of N series steel. (a,b) BF TEM images. (c, d) BF-STEM and HAADF of same zone. (e,f) BF-STEM and HAADF of same zone, different sample.

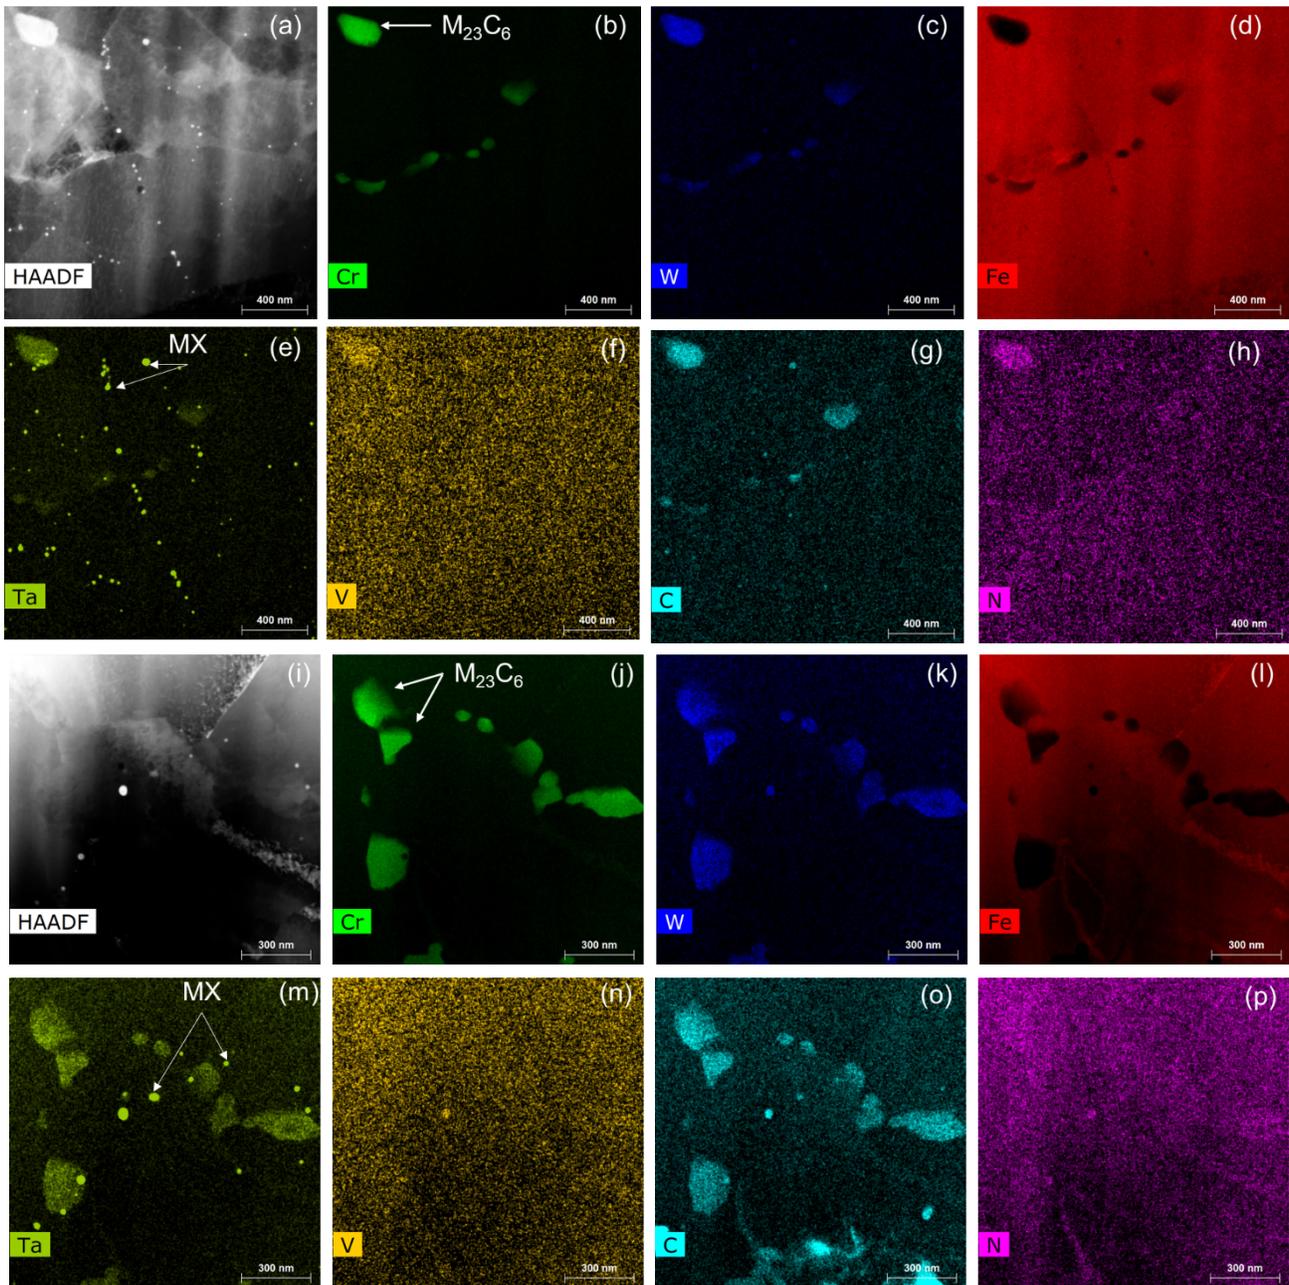
Fig. 56. STEM-EDX mapping of N series steel (a-h) HAADF image and EDX maps of same zone. (i-p) HAADF image and EDX mapping from a different FIB foil.

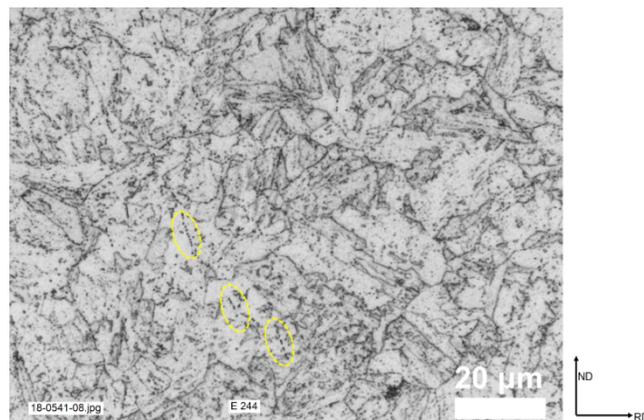
Fig. 60. LOM image of E series steel after etching in Vilella's reagent. Yellow circles show coarse precipitate networks.

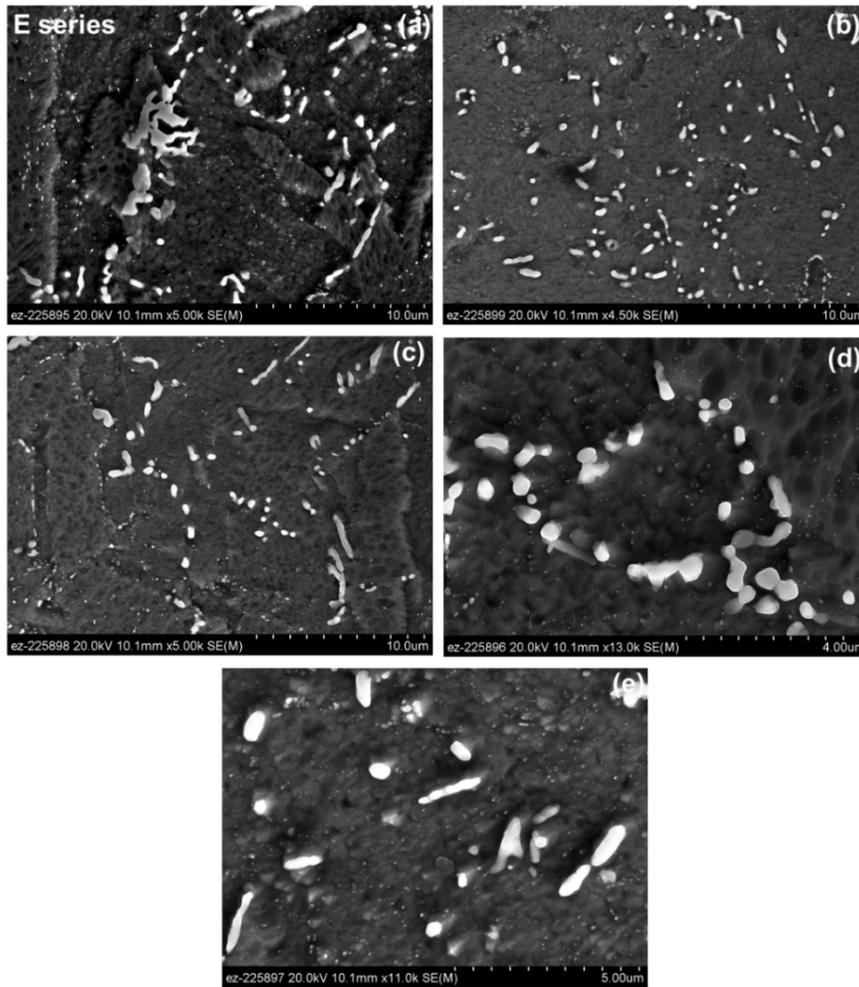
Fig. 62. SEM secondary electron images of very coarse precipitates detected in reference E series Eurofer-97 steel.

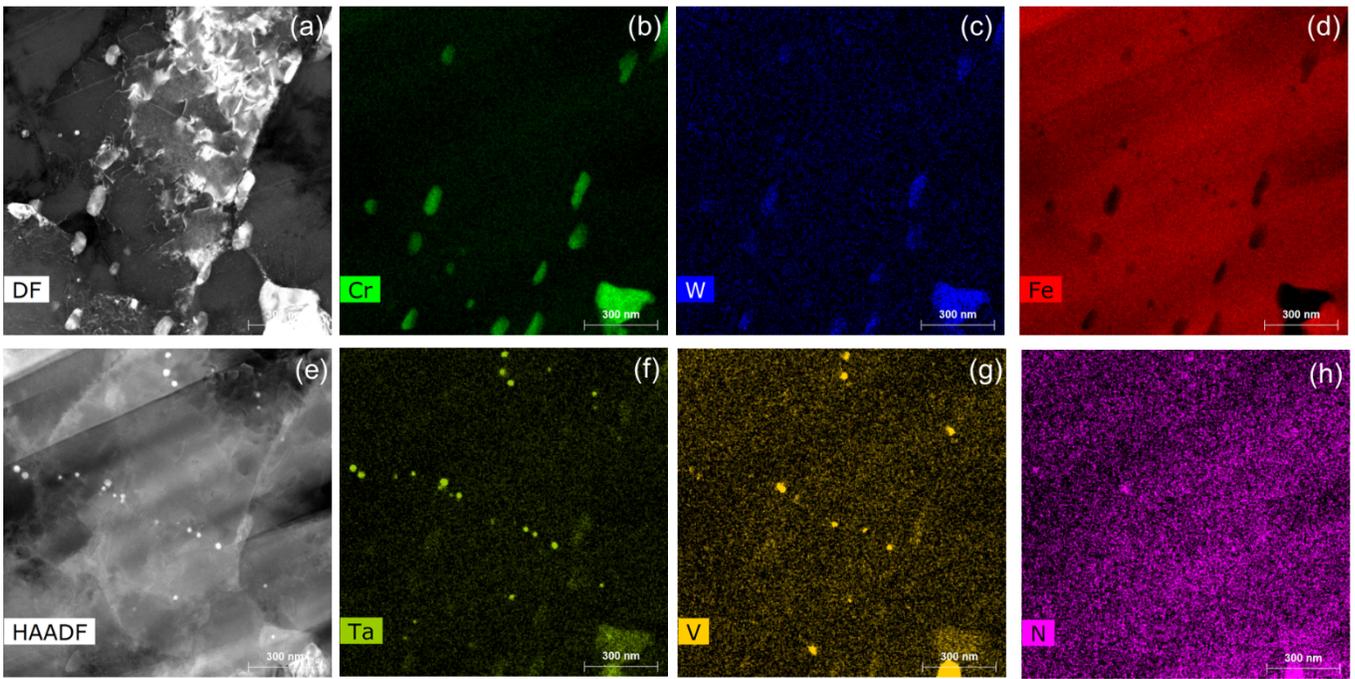
Fig. 66. STEM imaging and EDX mapping of E series steel: same zone of analysis, second FIB foil.

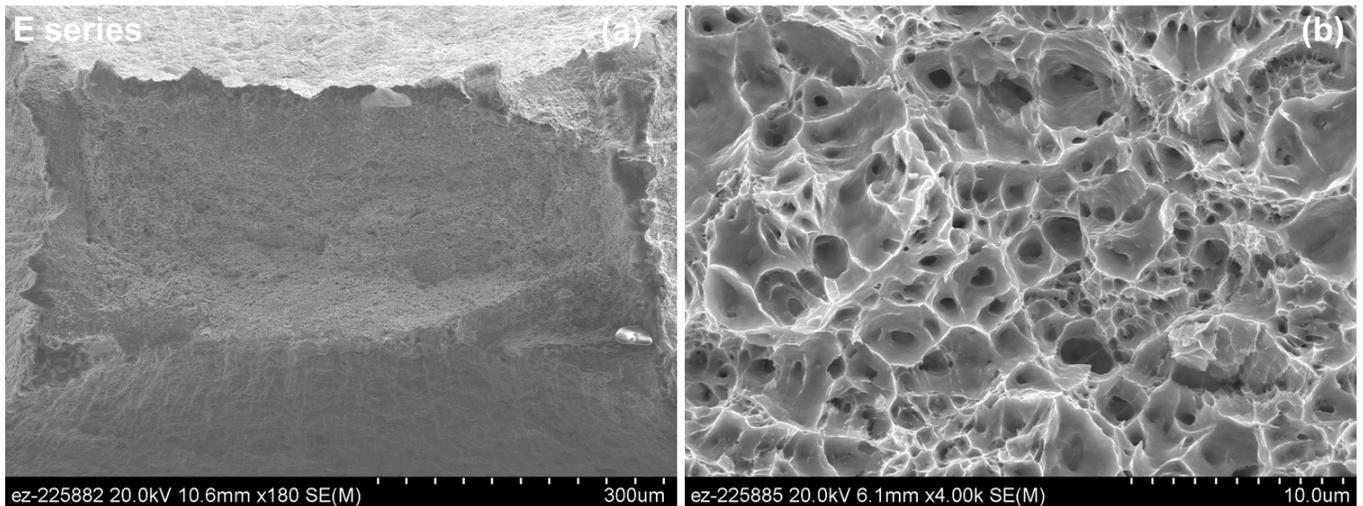
Fig. 67. Fractography of E series steel using SEM secondary electron imaging. (a) Fracture surface overview. (b) Relatively high magnification image showing the ductile cup and cone fracture surface.

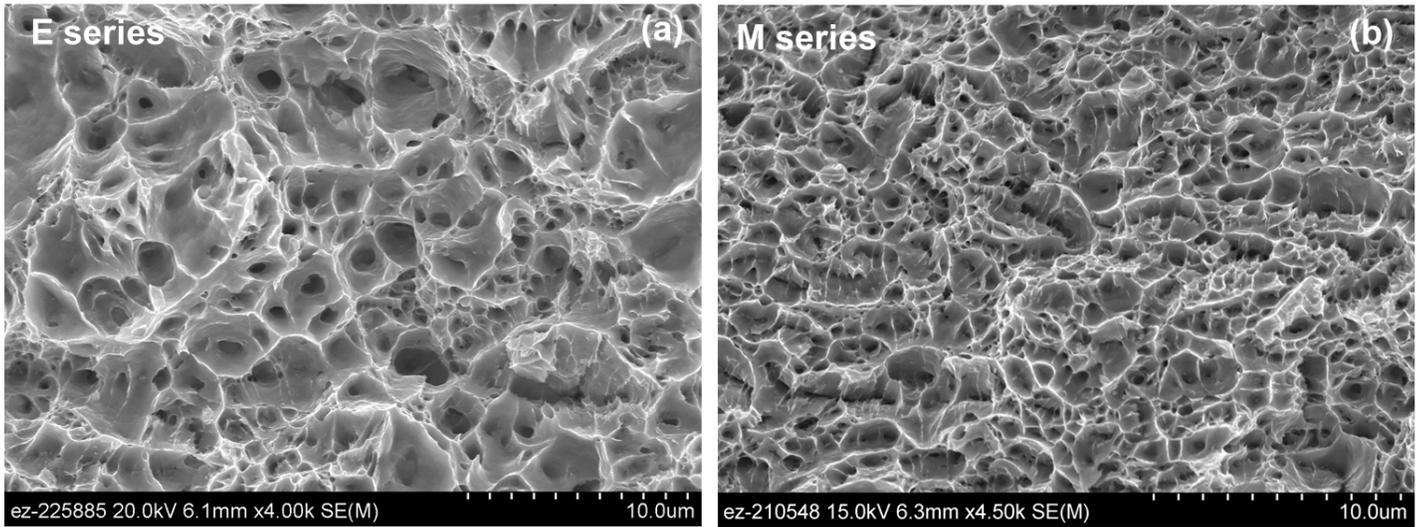
Fig. 68. Comparison of fracture surface of E series with M series steels, further proving the presence of coarse particles in the reference material. (a) E series, x4k magnification. (b) M series, x4.5k magnification.

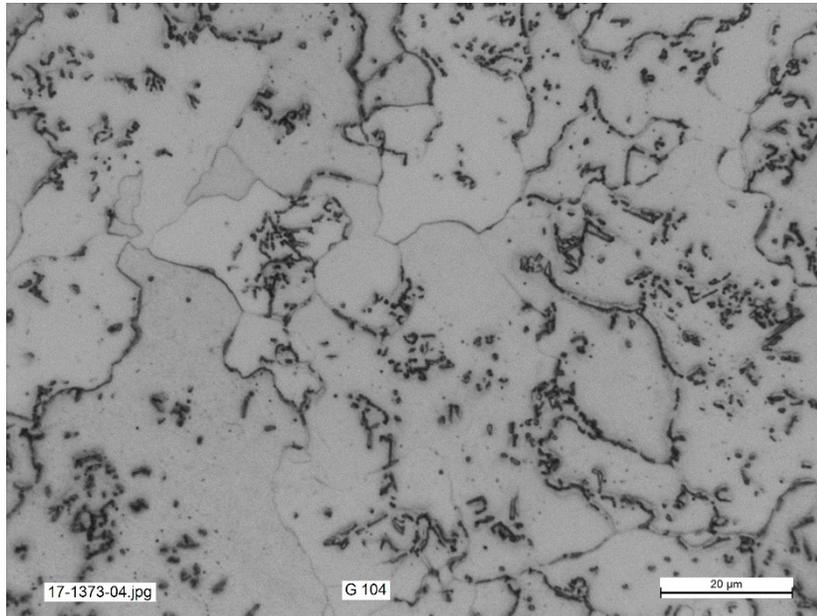
Fig. A1. LOM image of G series steel (old reference) after etching using Vilella's reagent. No martensitic laths were detected, and microstructure consisted of very coarse clustered carbides. Grain boundaries were seen to be decorated with films of precipitates.

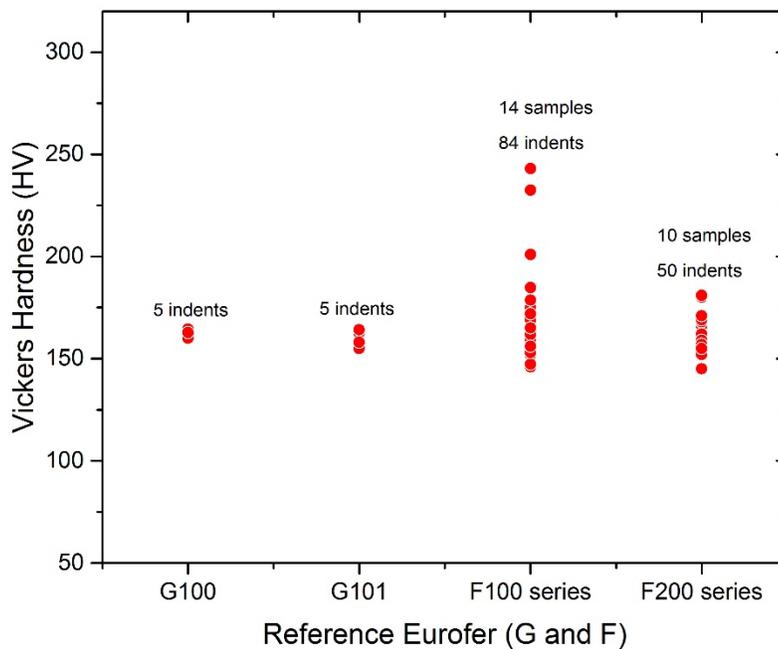
Fig. A2. Vickers hardness indentation results for the reference G and F series steels (G and F were same steels but different names). 1 kg load, 15 s dwell time. These steels were extremely soft.

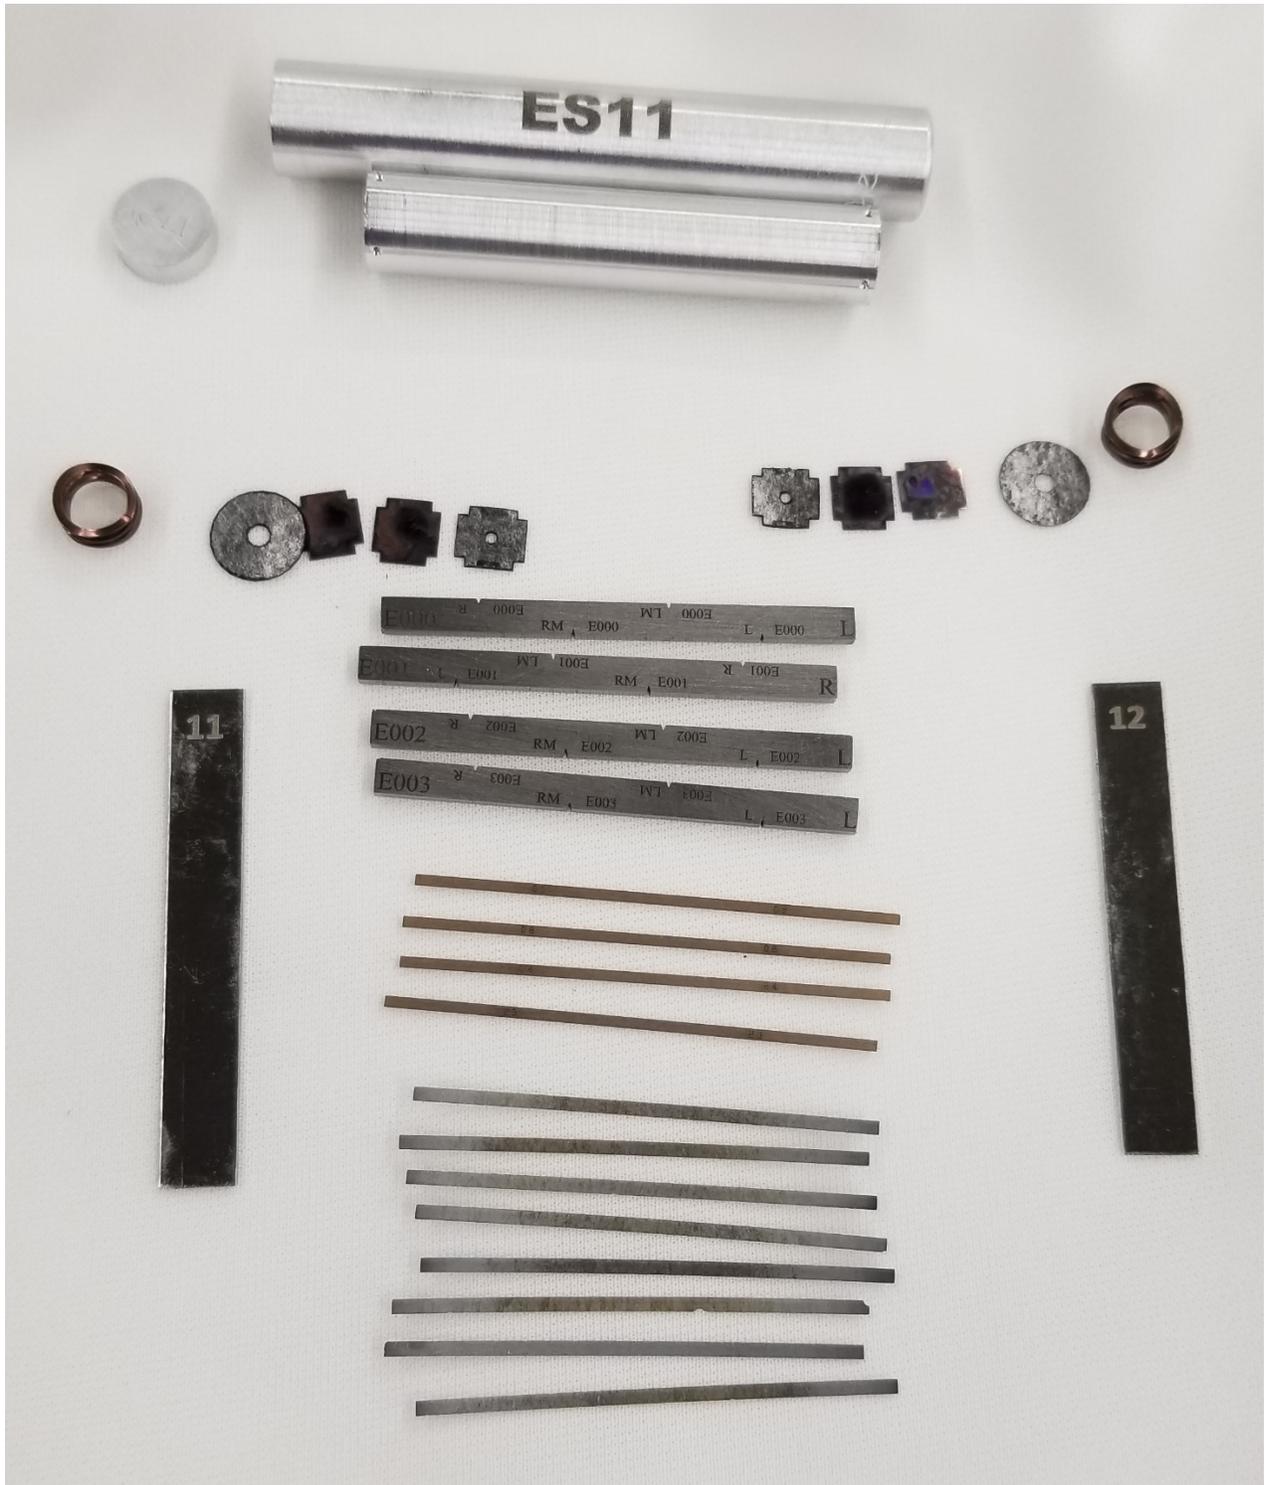
Fig. A18. Parts layout for rabbit ES11.

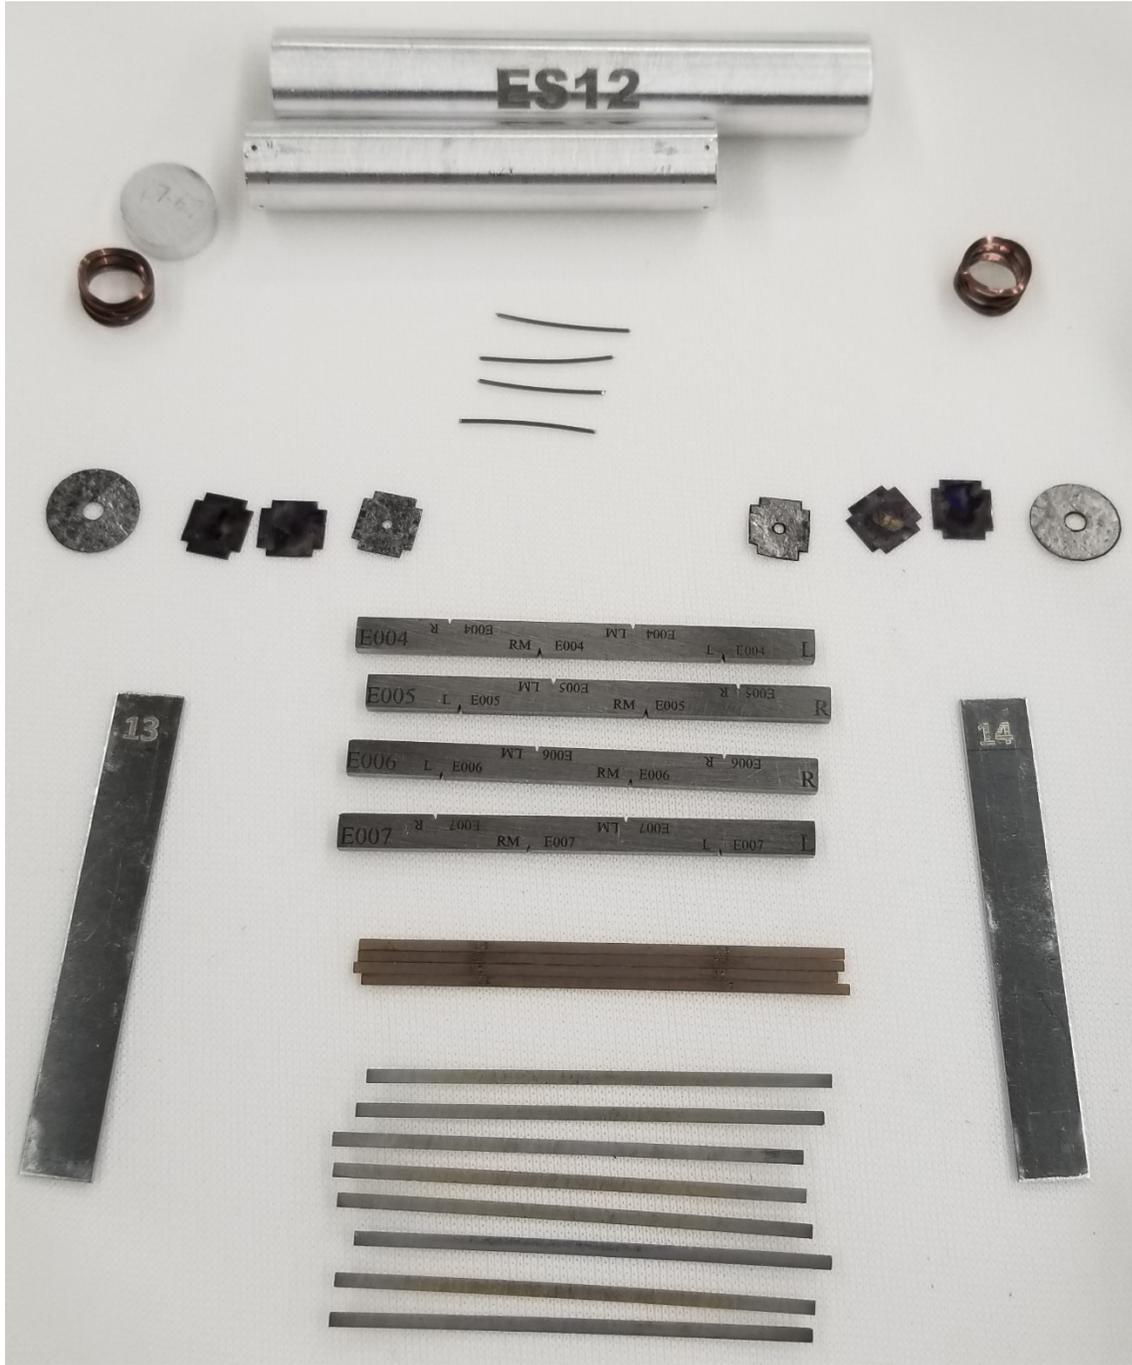
Fig. A19. Parts layout for rabbit ES12.

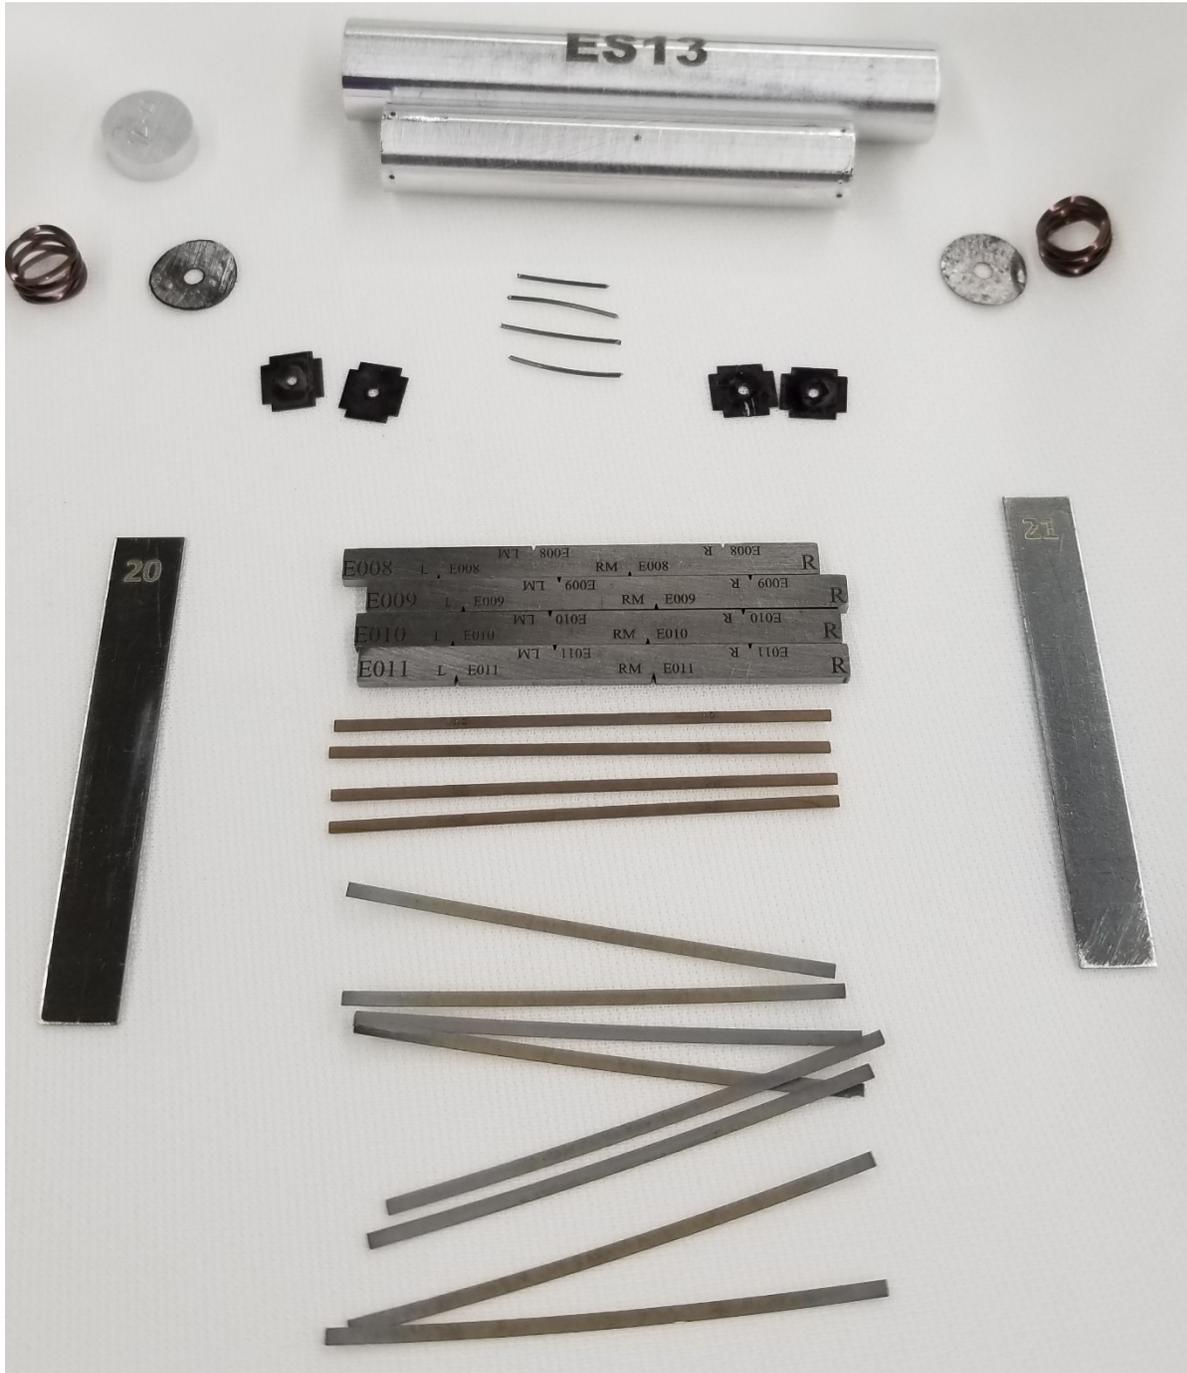
Fig. A20. Parts layout for rabbit ES13.

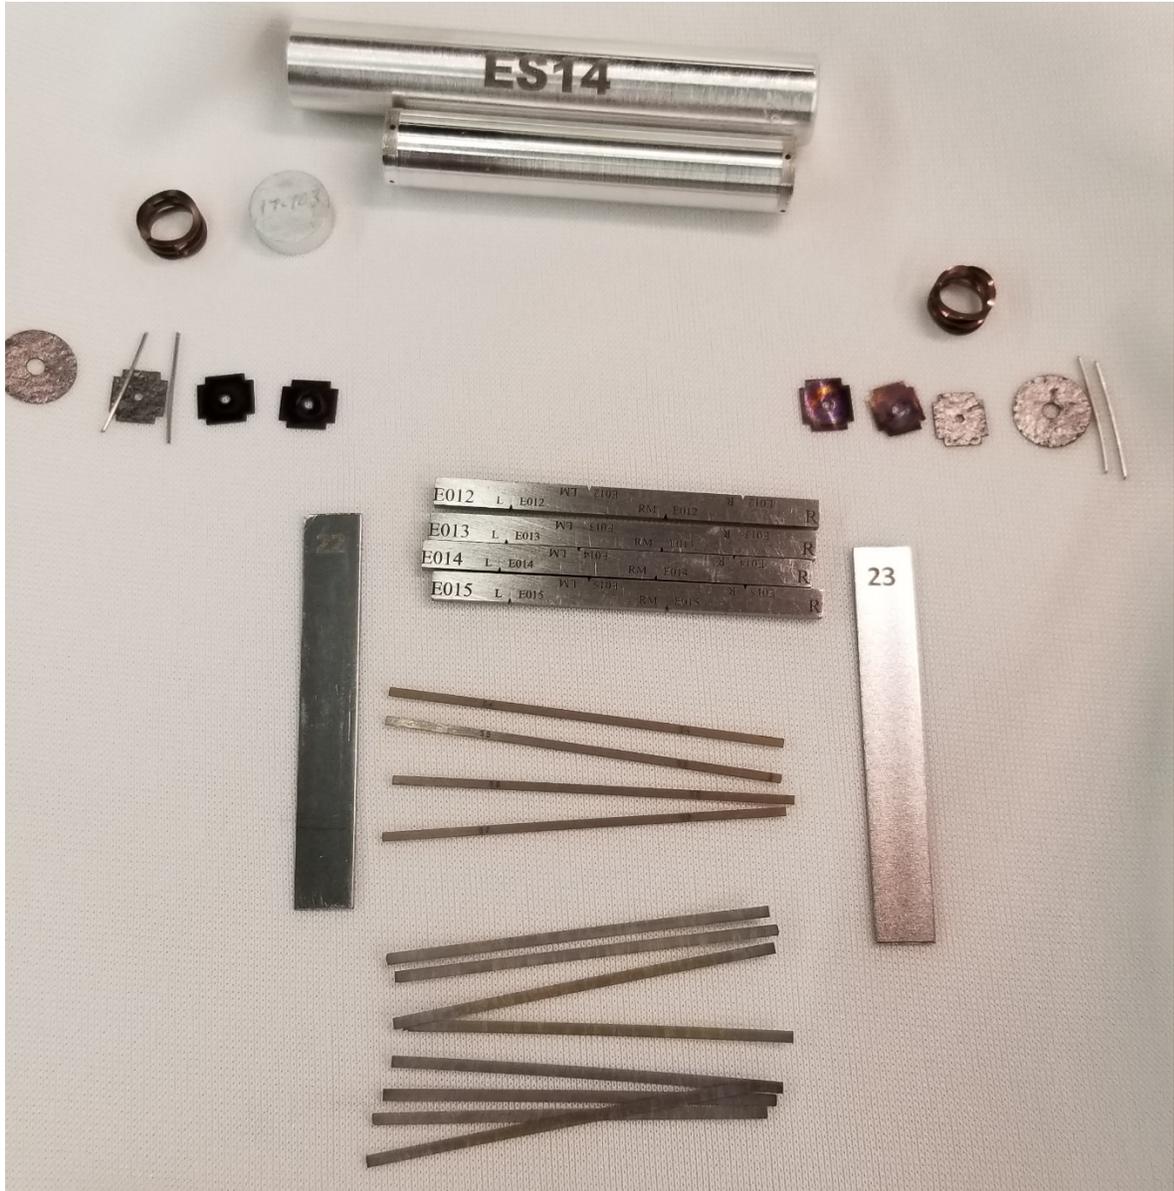
Fig. A21. Parts layout for rabbit ES14.
