Mechanical properties and microstructure characterization of unirradiated Eurofer-97 steel variants for the EUROfusion project

Materials Science and Technology Division

Prepared by
OAK RIDGE NATIONAL LABORATORY
Oak Ridge, TN 37831-6283
managed by
UT-BATTELLE, LLC
for the
Karlsruhe Institute of Technology
under contract NFE-16-06240

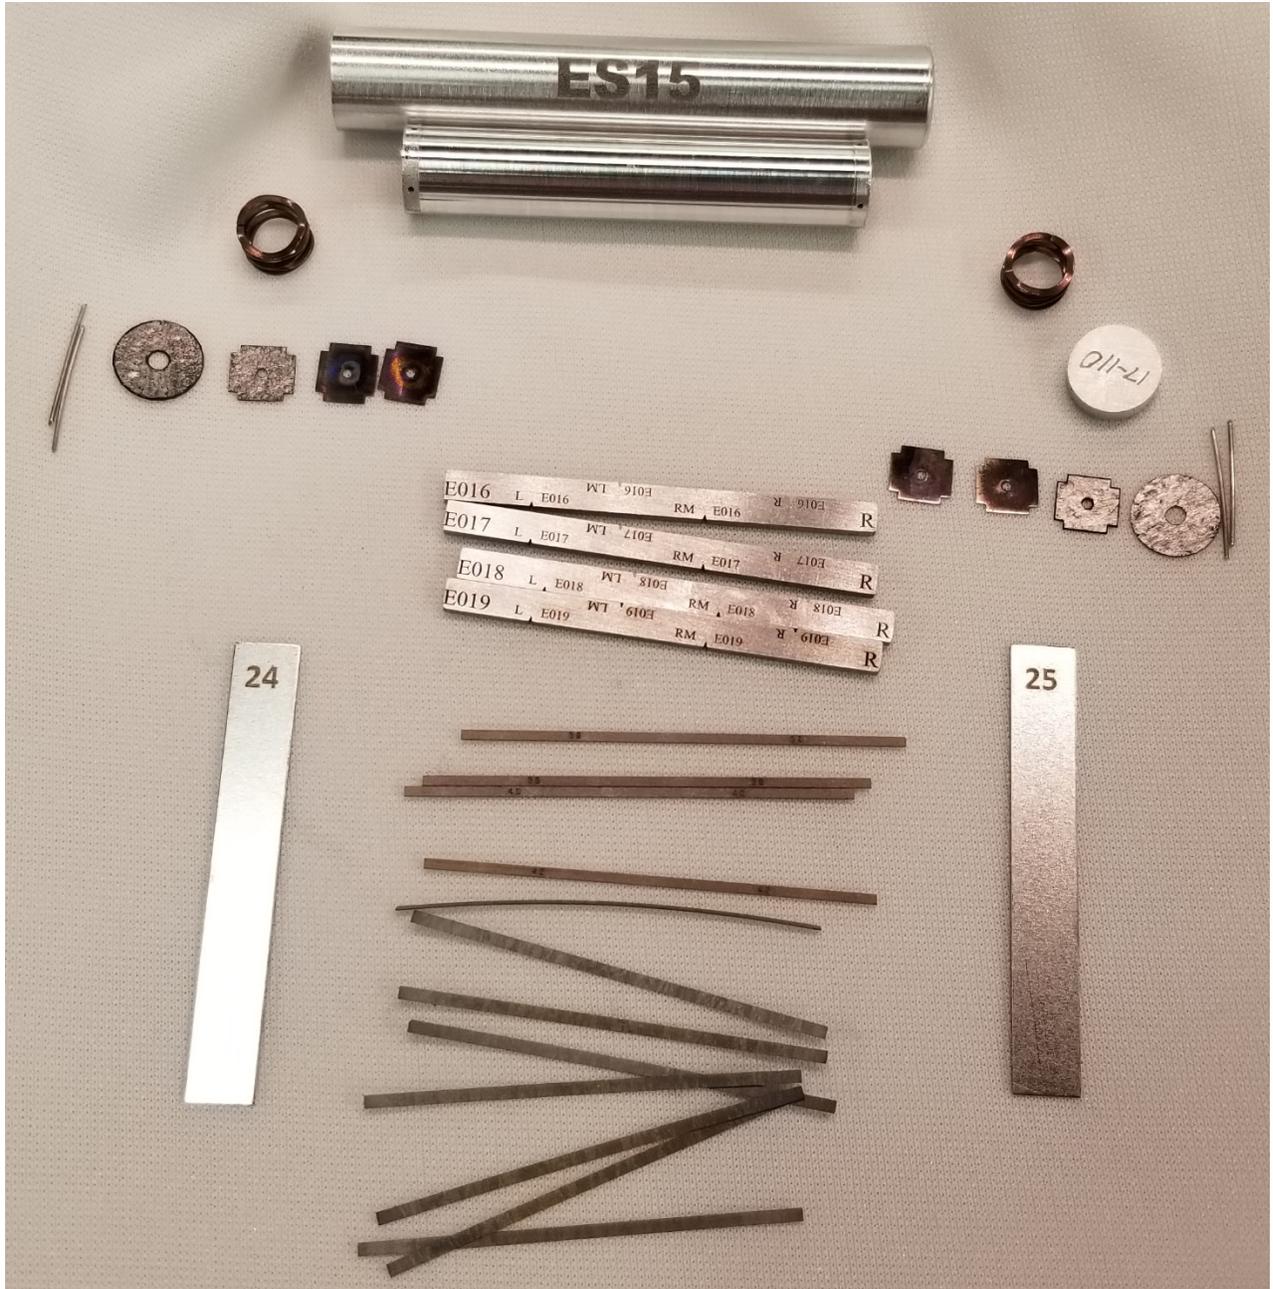
Fig. A22. Parts layout for rabbit ES15.

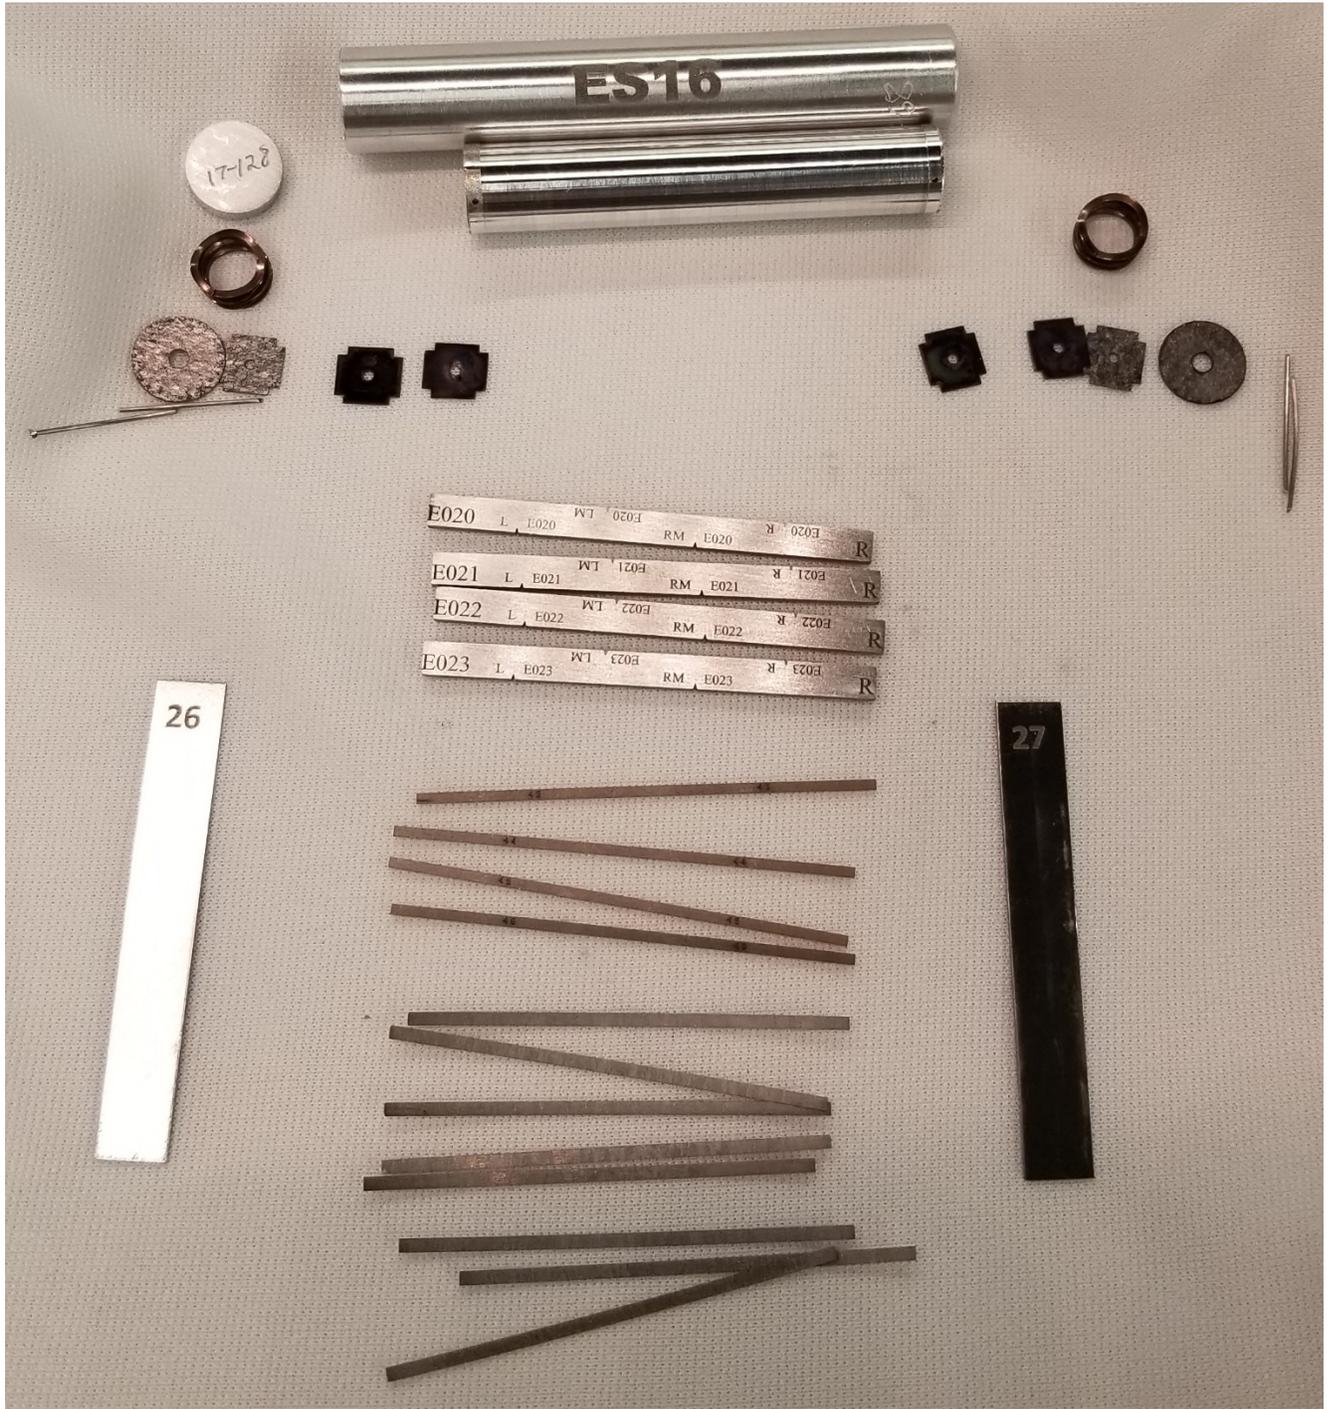
Fig. A23. Parts layout for rabbit ES16.

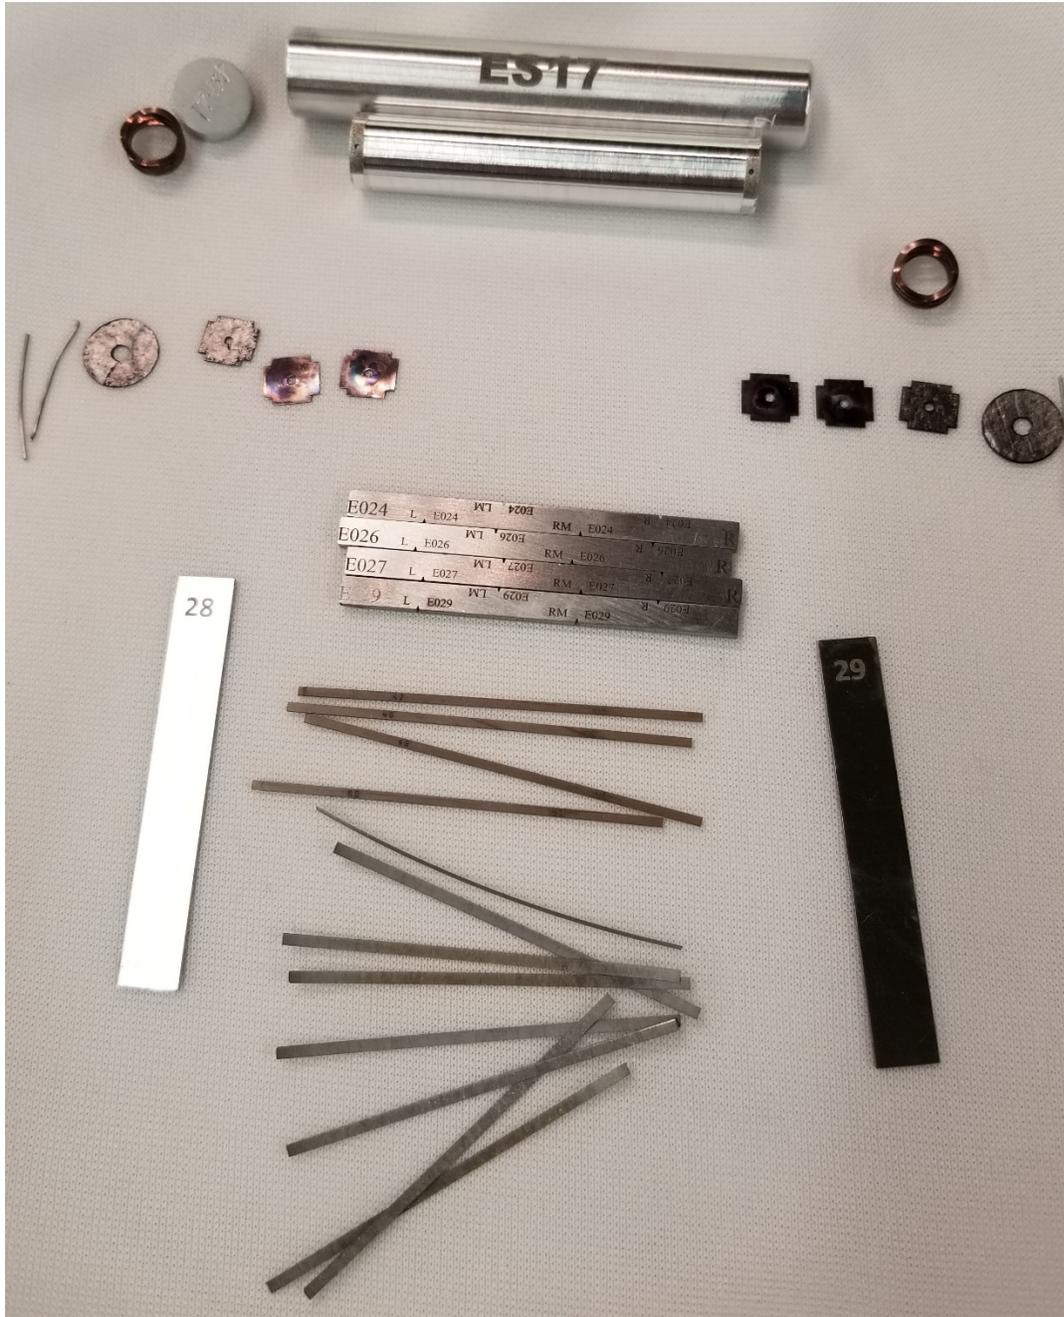
Fig. A24. Parts layout for rabbit ES17.

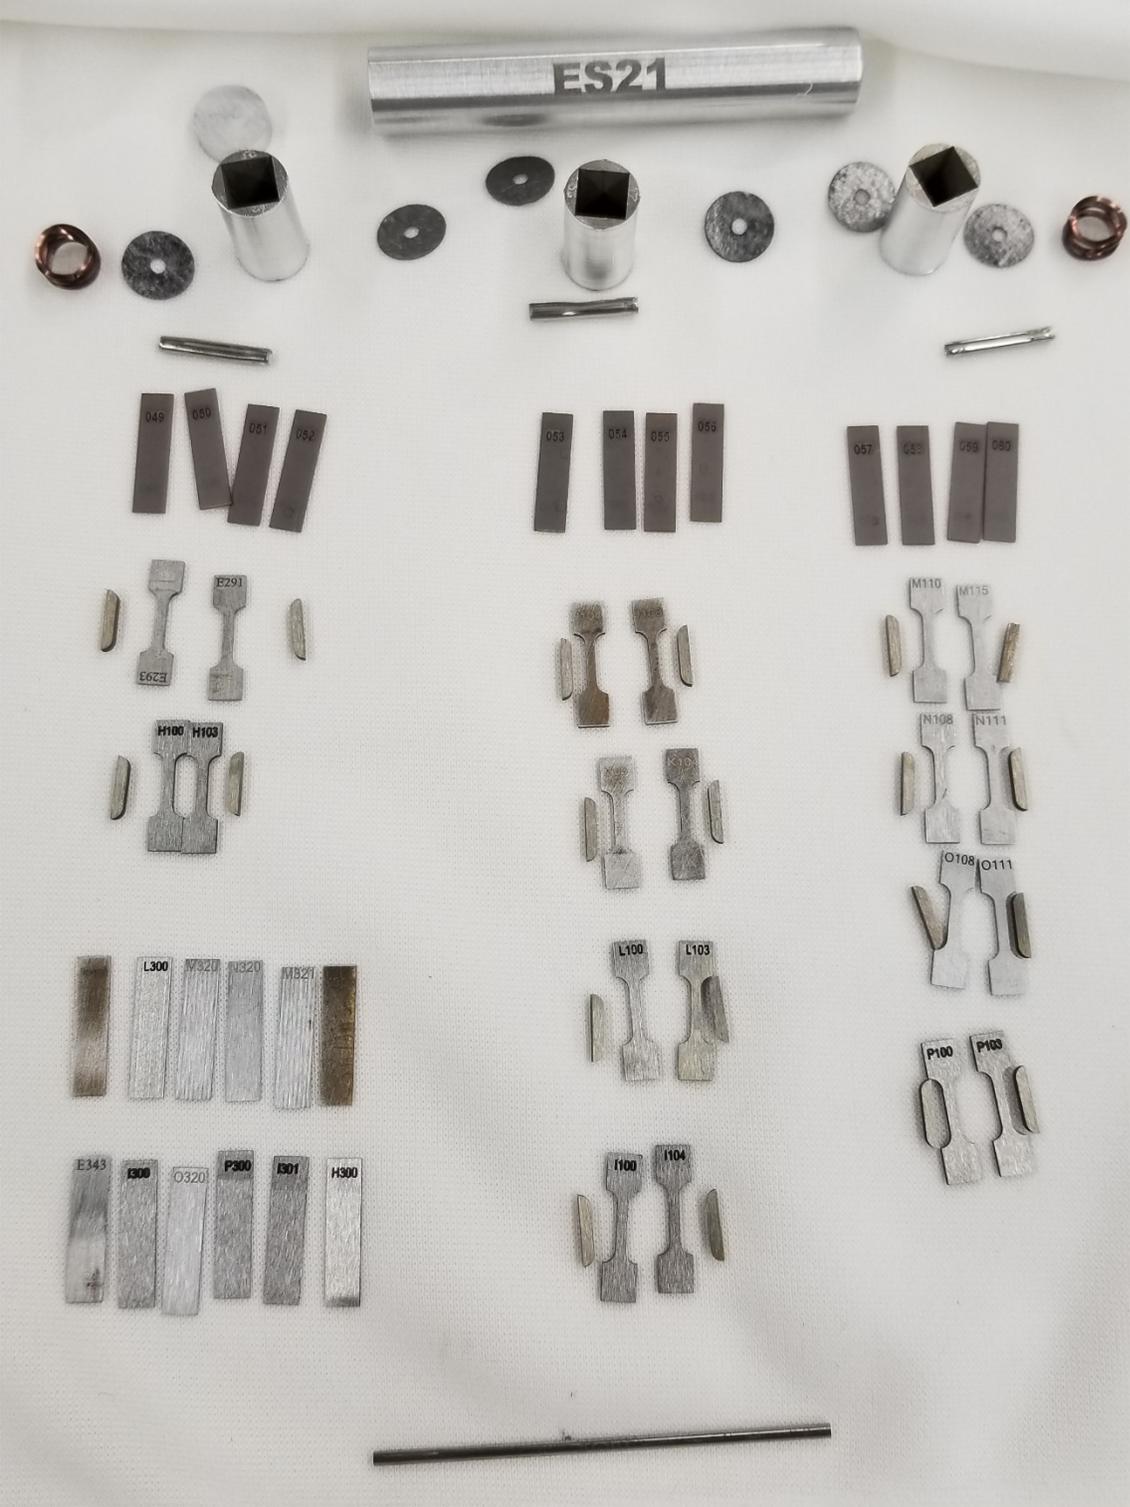
Fig. A25. Parts layout for rabbit ES21.

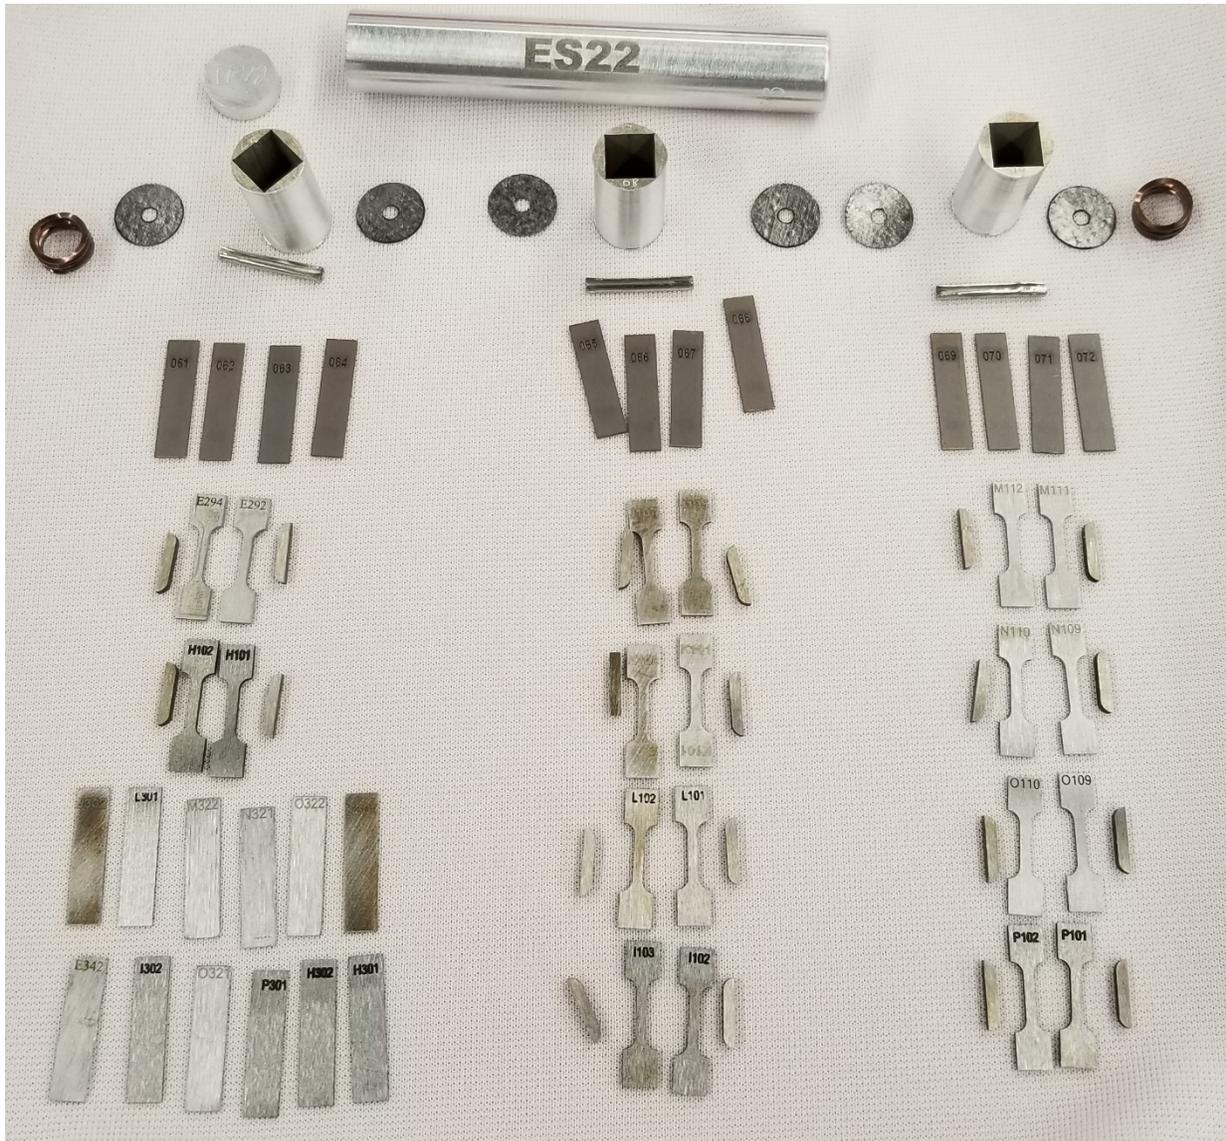
Fig. A26. Parts layout for rabbit ES22.

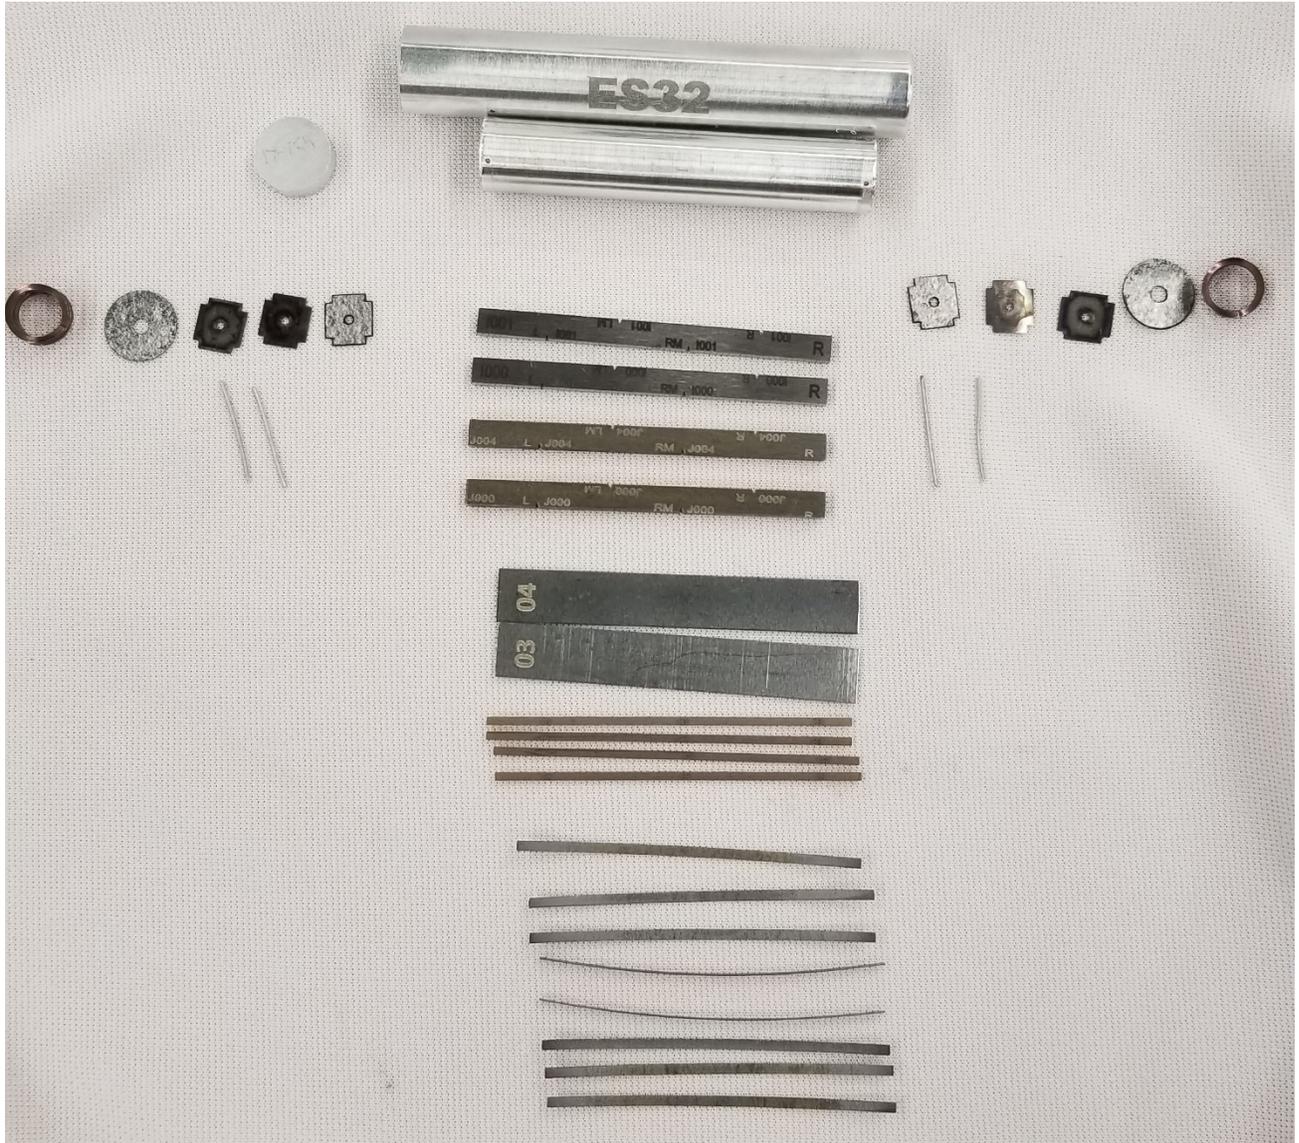
Fig. A28. Parts layout for rabbit ES32.

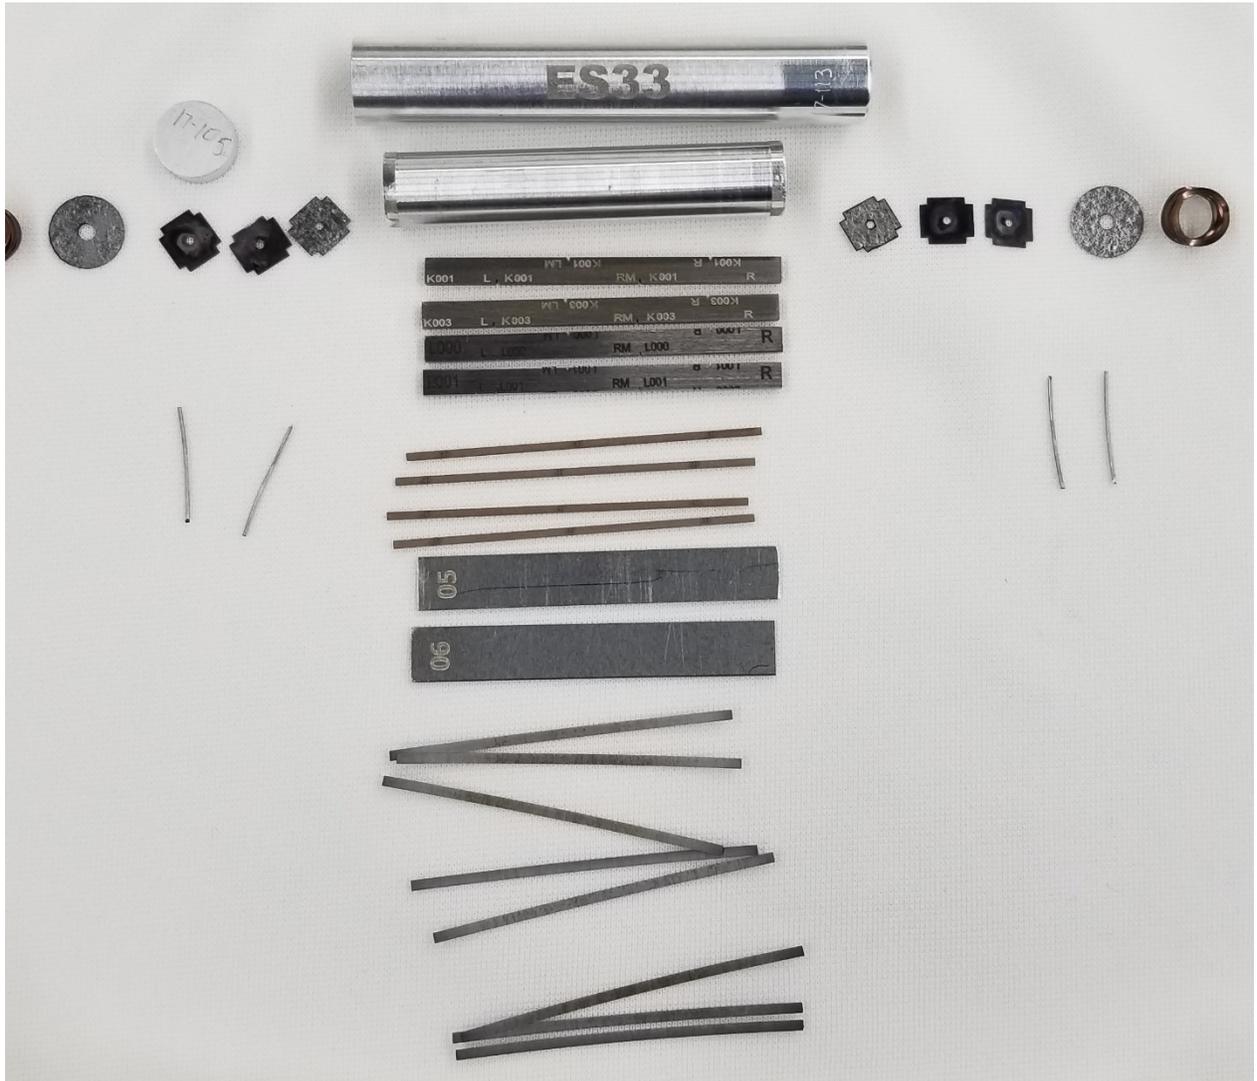
Fig. A29. Parts layout for rabbit ES33.

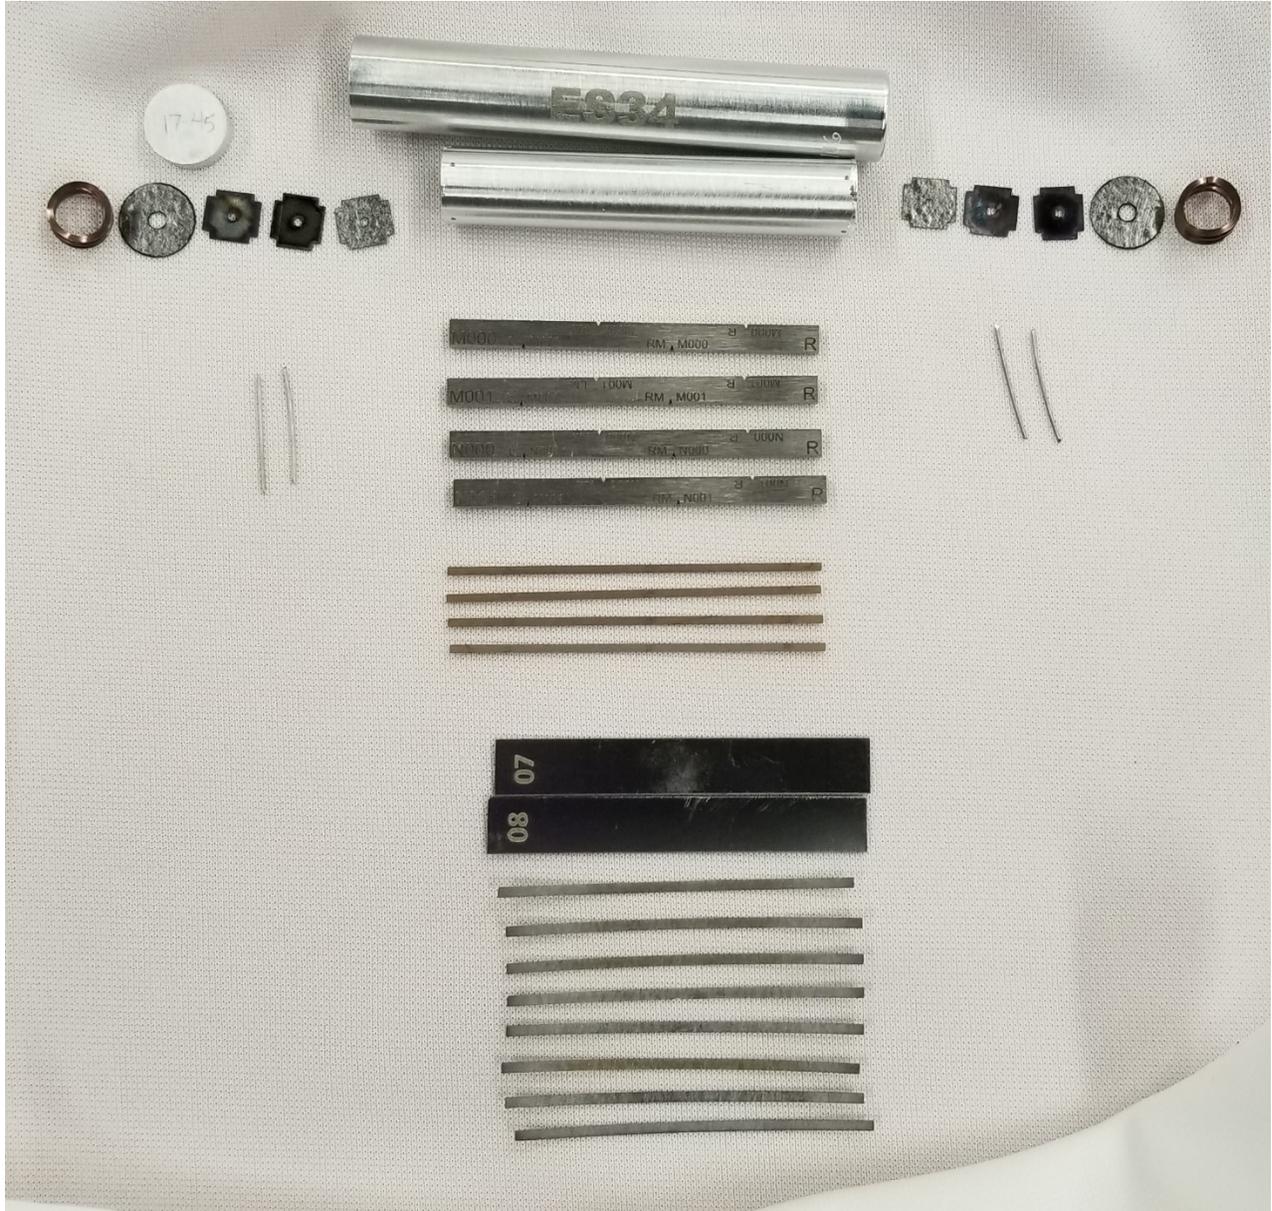
Fig. A30. Parts layout for rabbit ES34.

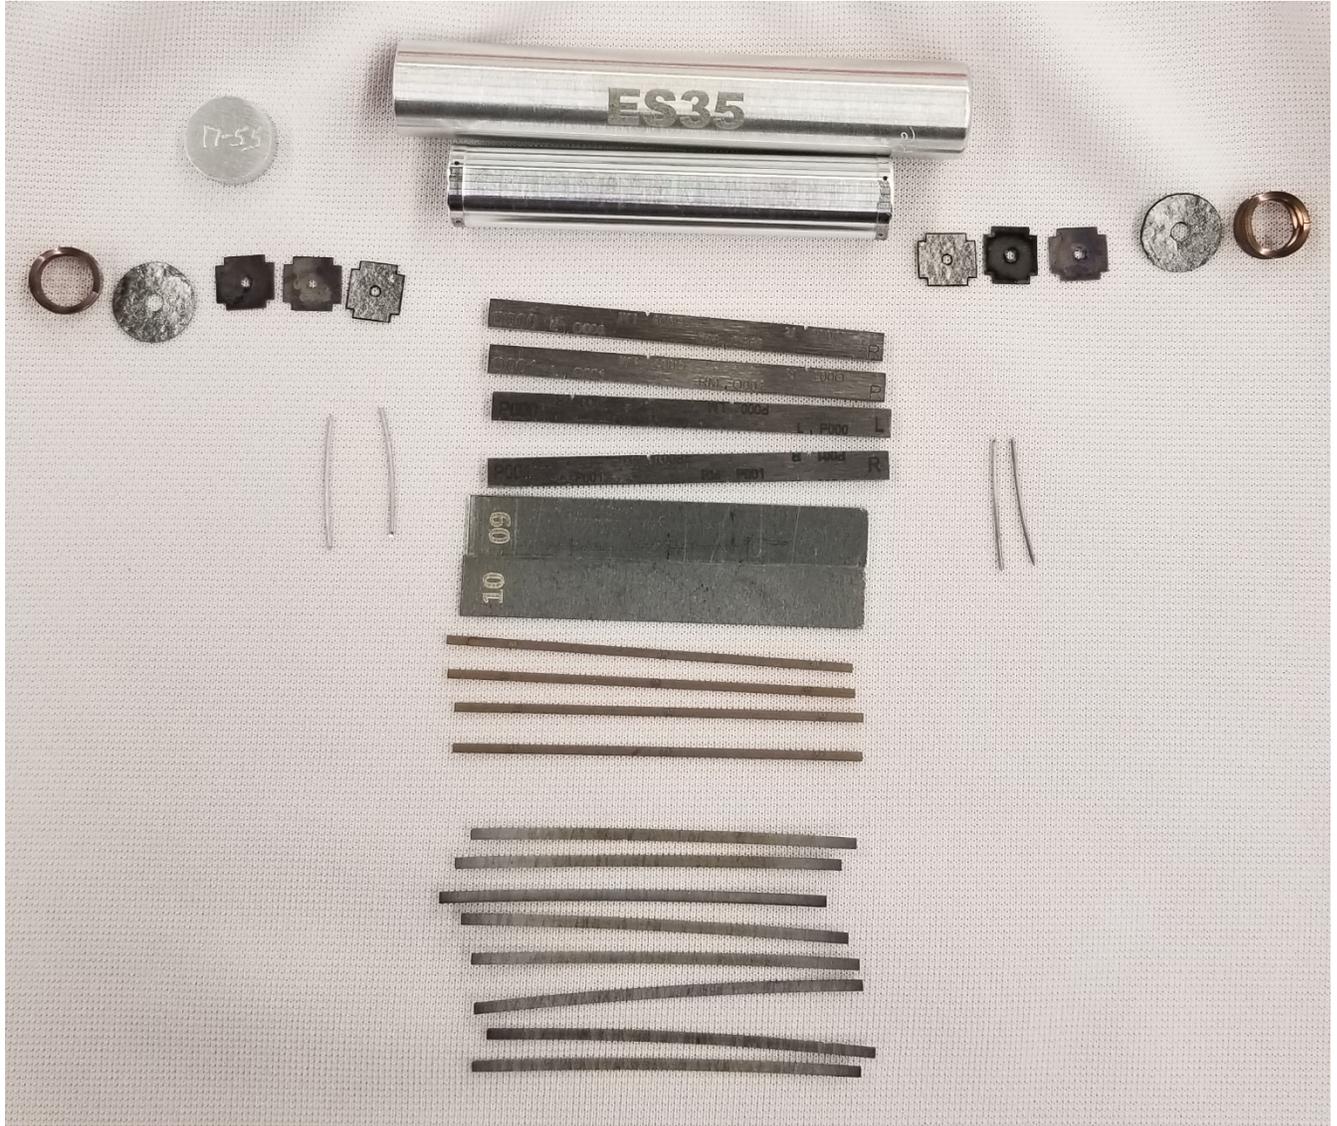
Fig. A31. Parts layout for rabbit ES35.
