The Initiation of Long-Term Creep Rupture Tests on the First Alloy 709 Commercial Heat

Materials Science and Technology Division

THE INITIATION OF LONG-TERM CREEP RUPTURE TESTS ON THE FIRST ALLOY 709
COMMERCIAL HEAT

Date Published: September 7, 2018

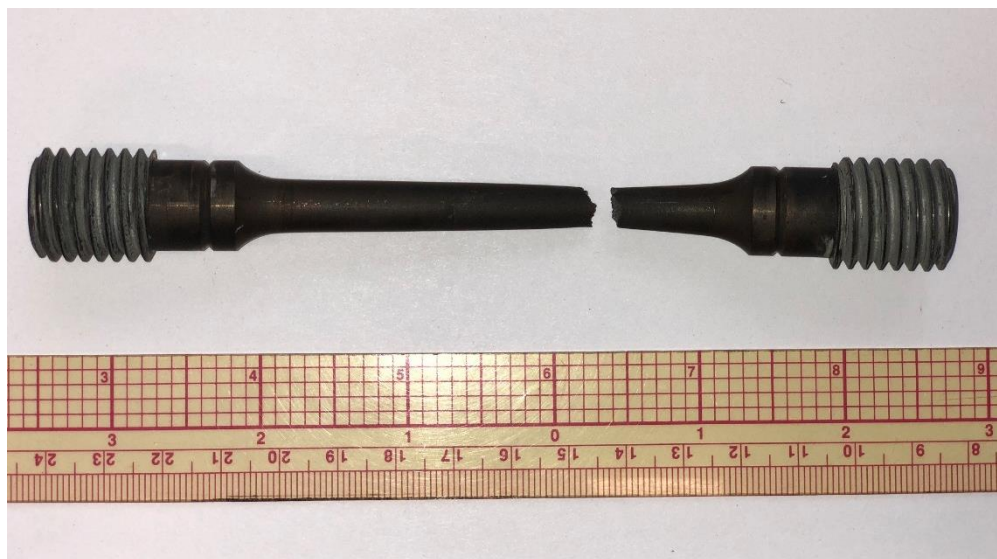
The post-test examination indicated that the failure position was within the gage section and located away from the mounting groove as shown in Fig. 2. Significant elongation and reduction of area were developed with 44% and 53%, respectively. So, the new design was shown to be effective in preventing the creep specimen from the premature brittle failure seen in the specimen with ridges.

Fig. 2 Tested specimen of AOD with S/A 1050°C, under 227 MP, 700°C; rupture time 48 hours.

An accelerated test was performed to verify the design and fabrication of the creep specimens. An AOD specimen with S/A 1050°C was tested under 227MPa, 700°C (TN 33224, specimen #4A1-S21-2). Frame #307 was used due to a low level of expected mechanical loading. The specimen ruptured at 48 hours, which was less than 200 hour expected lifetime. The lower lifetime is understandable considering that an increasing S/A temperature tends to enhance the rupture life. The prediction of 200 hour lifetime was based on the data for the material whose S/A temperature was 1150°C, whilst the tested material had a lower S/A temperature.

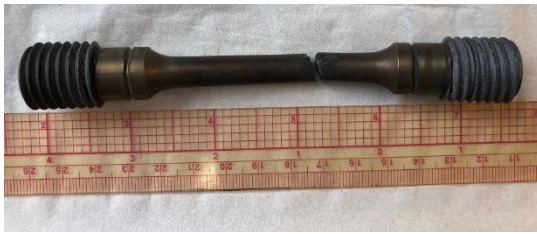
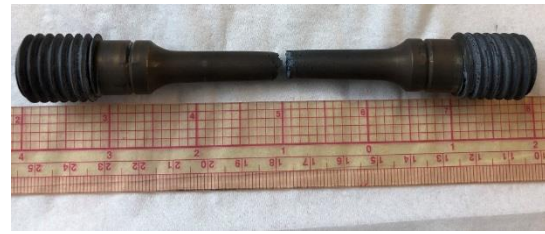
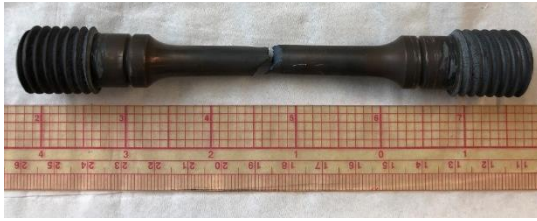
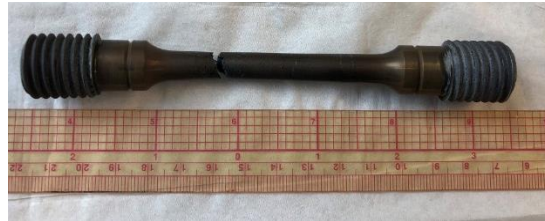
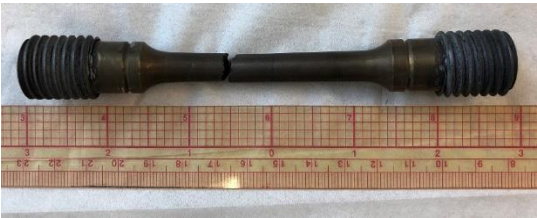
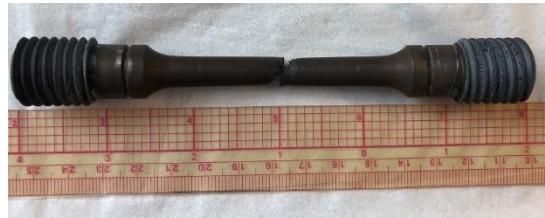
The post-test measurements of the tests completed in terms of elongation (EL) and reduction of area (RA) are given in Table 5. The failures of these specimens were all located within the gage section as shown in Fig. 5.

Fig. 5. Images of tested specimens with various material conditions; test condition was 330 MPa, 600°C.
