# Analysis of Localized Deformation Processes in Highly Irradiated Austenitic Stainless Steel through In Situ Techniques

August 2019

Prepared under the direction of the  
U.S. Department of Energy  
Office of Nuclear Energy  
Light Water Reactor Sustainability Program  
Materials Research Pathway

Prepared by  
OAK RIDGE NATIONAL LABORATORY  
Oak Ridge, TN 37831-6285  
managed by  
UT-BATTELLE, LLC  
for the  
U.S. DEPARTMENT OF ENERGY  
under contract DE-AC05-00OR22725

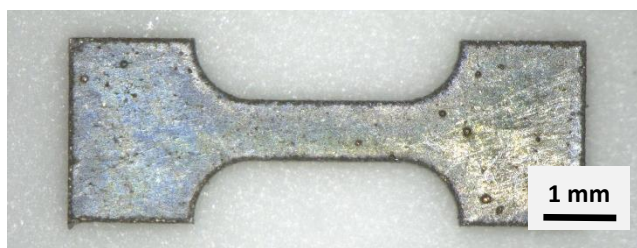
**Figure 3. EDM-manufactured miniature tensile specimen blank. Gauge dimensions: 2 mm (length)×0.8 mm (width) ×0.5 mm (thickness).**

Two identical SS-Tiny specimens (Figure 3) were tested per condition. This number was considered sufficient, as the results of the tests (i.e., nominal mechanical properties and the appearance of the tensile curves) were close for the nominally identical objects (Figure 7). Testing a larger number of specimens would be beneficial but is not feasible due to the limited time at the instrument (i.e., SEM/EBSD) and expenses associated with irradiated specimen manufacturing and preparation.
