Fundamental Science and Technology of Flash Processing Robustness for Advanced High Strength Steels (AHSS)

October 2019

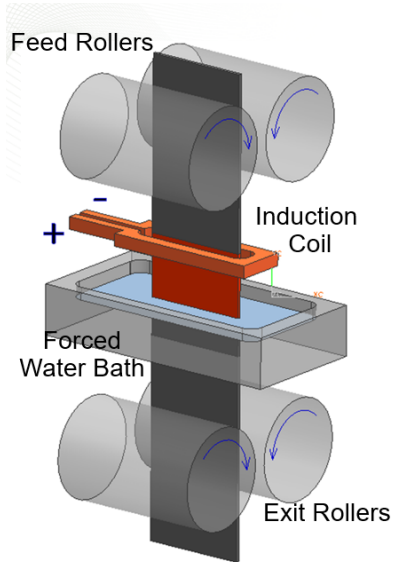
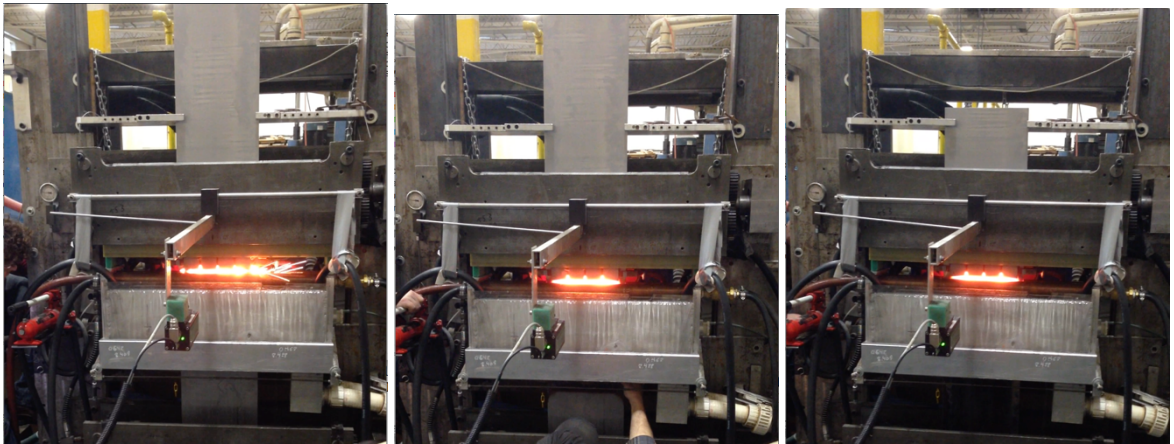
Figure 1- Top: Schematic of the flash process [After Forrest *et. al* 2017]. Bottom: Excerpts from a movie of the flash process. The feed rate can vary from 1.5 – 4 ft/min. An optical pyrometer is shown level with the hot zone but appearing in front of the water quenching.

The flash process is schematically shown in Figure 1. The steel sheet that flows top to bottom through the rollers is induction heated/“flashed”. The peak “flash” processing temperature can be varied from ~1000°C to 1300°C, and the time to reach peak temperature can be varied between 2 to 6 seconds. The steel is then water quenched 1 to 3 seconds after heating. Immediately after quenching the sheet progresses through pinch rollers to maintain positive control of the sheet. An example of flashed sheet is shown in Figure 2. Both an IR camera and Pyrolaser pyrometer measured the surface temperature and surface temperature & emissivity, respectively, of the flashed steel. Table I lists the first set of steel alloys measured for temperature distribution.

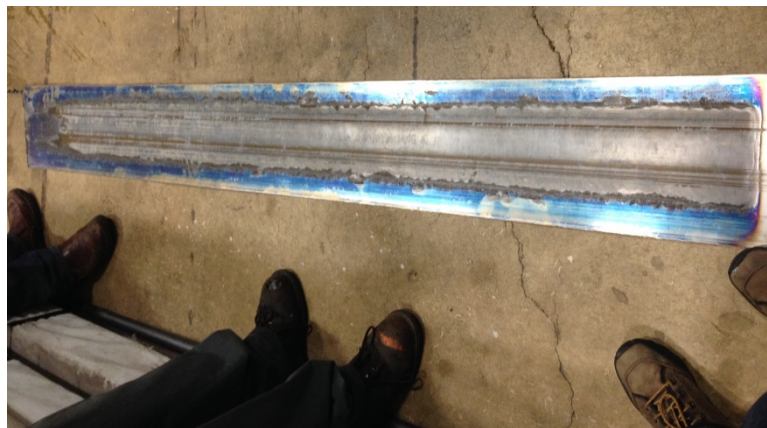
Figure 2 - The product of the flash processing demo of an unknown steel sheet. Note processing of outside edges were not optimized.

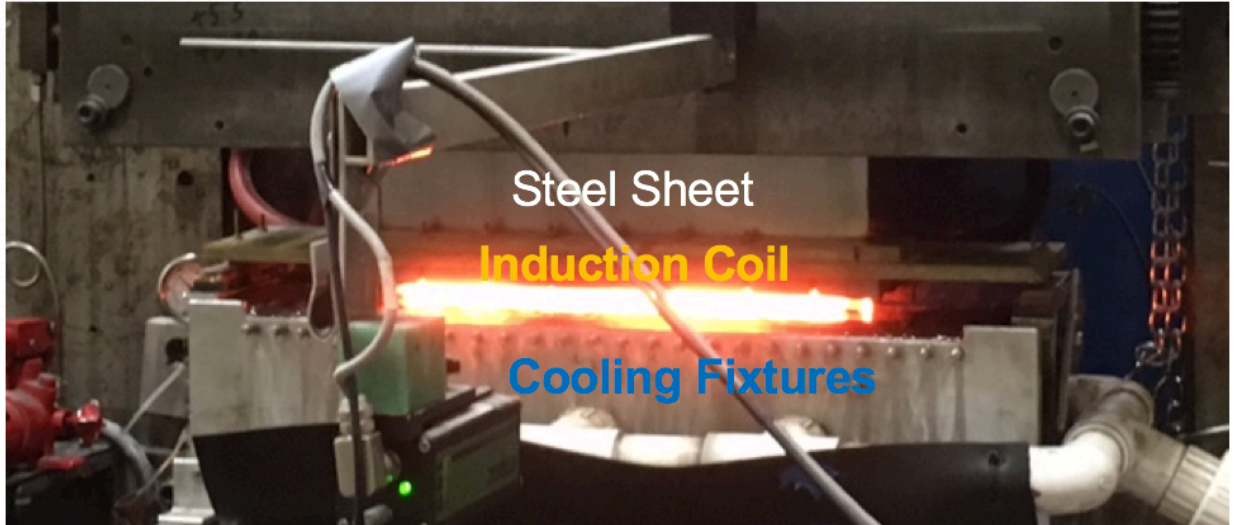
Figure 3 – The steel sheet is being fed from above and passes through the induction coils. The white hot steel is quenched by upwardly squirting water jets. An optical pyrometer with green LED illuminated (not the IR camera) is in the left foreground.

Measurement of the temperature and its distribution were challenging; Figure 3 shows a close up of the flash processing setup. Unfortunately, a “steam effect” mostly interfered with the measurements. This steam originated from the boiling and bubbling of the quenching water near the contact regions between the hot steel sheet and cooling water jets. This steam also rose and condensed on the copper induction coils above. Thus, condensed water dripped down forming an additional “waterfall” effect. The micro bolometer IR camera could not make accurate measurements through the steam nor cooling water because they do not transmit light in the 8-12 μm wavelength range. Thus, they appear opaque.

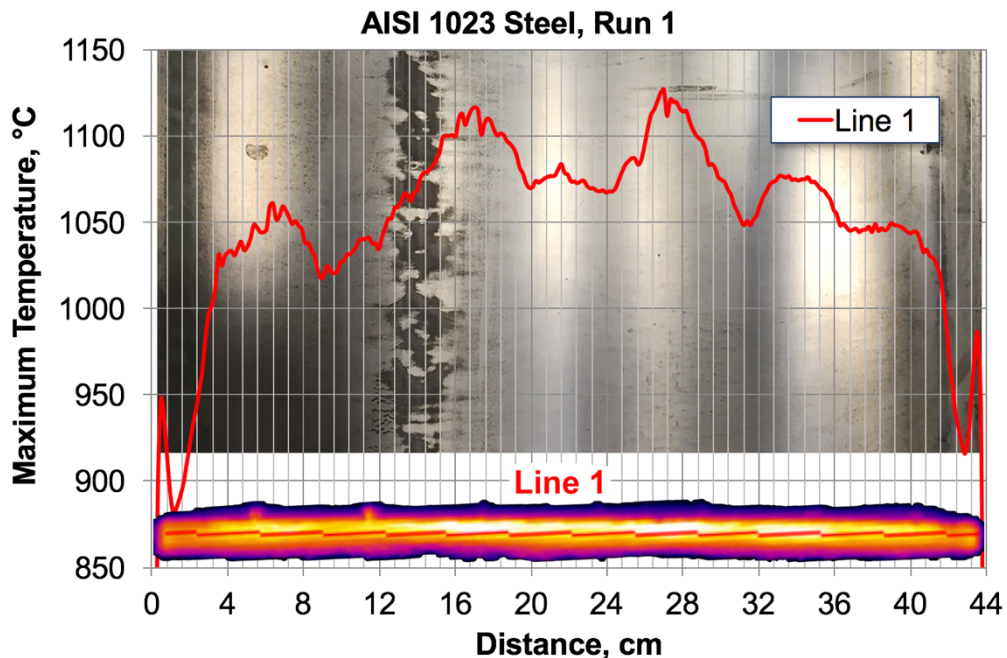
Figure 5 – (Top) The temperature profile as recorded using the “continuous max filter”. (Bottom) A visual image of the maximum temperature reached by each pixel during the entire 3 minute flash/heat treatment of the AISI 1023 steel sheet using the “continuous max filter.” The banding seen on the sheet originates from the flash process; its origin was not investigated.

Although the IR camera was not getting a clear view of the surface due to the water, the temperature variations on the surface were reflected in the visible banding across the sheet (see the top portions of Figures 5 and 6). While the application of the cooper rollers appeared to leave the number of bands unchanged, the bands were widened and narrowed alternatively (see Figure 6). These bands (and corresponding non-uniform temperature distribution) are believed to be related to both the spacing of the single-turn induction coils with magnetic concentrators and the altered applied magnetic field.

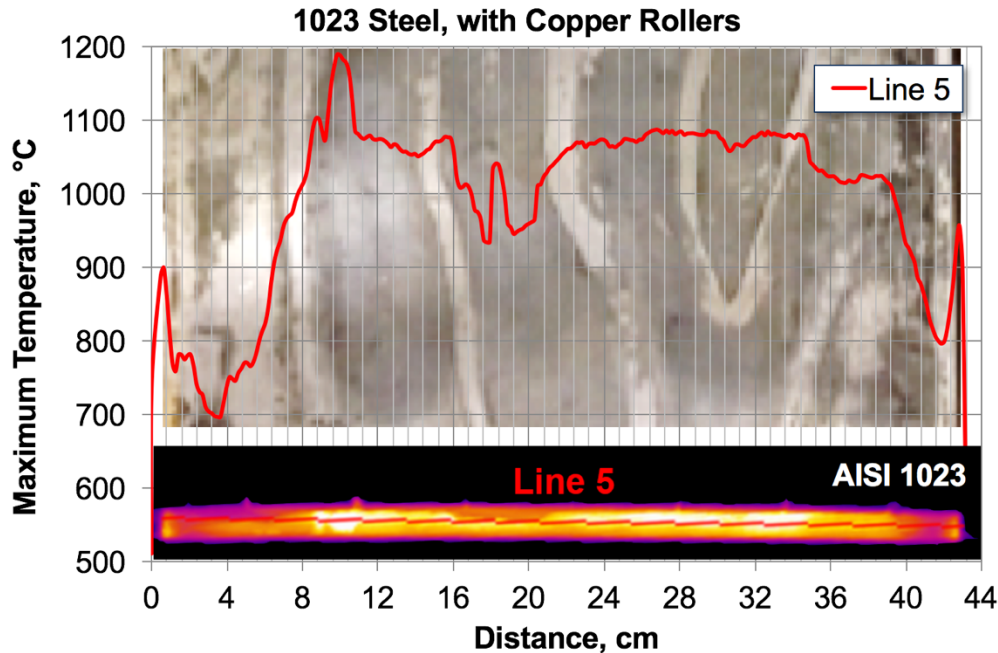
Figure 6 – (Top) The temperature profile as recorded using the “continuous max filter” of the AISI 1023 steel sheet cooled with copper rollers. (Bottom) A corresponding visual image of the maximum temperature reached by each pixel during the entire 3 minute flash/heat treatment using the “continuous max filter.”

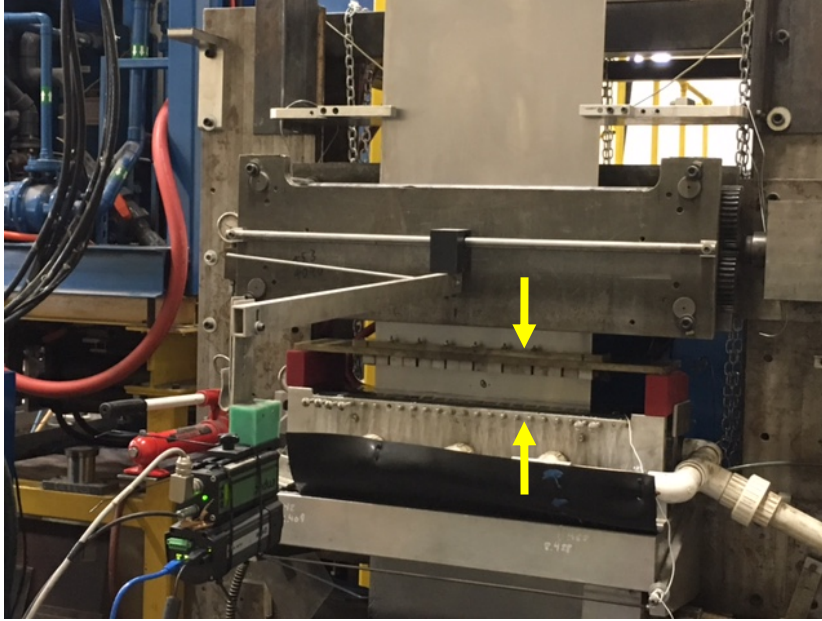
Figure 7. Wider gap (arrows) setup at SFP Works for thermal imaging.

In a second attempt to measure the temperature distribution across the flashed steel sheet, three runs were made when the gap between the induction coil and cooling water pool was doubled (see Figure 7) and the IR camera was strapped under the existing pyrometer for the system. The Pyrolaser was placed behind the IR camera and captured snapshots, measuring both the surface temperature and emissivity. Figure 8 provides two snapshots clearly indicating that the induction heating was not uniform with temperature differences $>100^{\circ}\text{C}$ perpendicular and parallel to the sheet travel direction. After the third run in this configuration, at least one intensifier was damaged (see Figure 9). Here, the large gap needed for better imaging allowed the steel sheet to warp and touch the intensifier block during the flash processing. Since the intensifier is water cooled and the sheet surface temperature was $>1000^{\circ}\text{C}$, thermal shock likely caused the damage to the intensifier block. Consequently, the non-uniform temperature was even more obvious for the 3rd run. Due to the surface non-uniformity and large temperature variations, the Pyrolaser readings were very inconsistent. The raw intensities and temperature distributions were taken a few seconds apart and found to be very different indicating the dynamic nature of the surface temperature (see Figure 10). Since the IR camera was strapped upside down, the images were flipped and compared similarly to Figure 8.

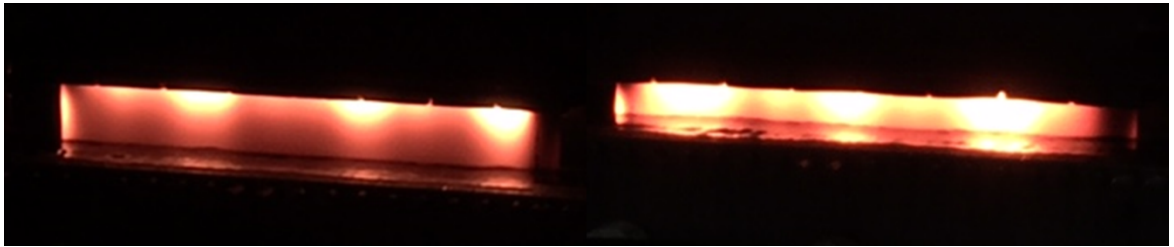
Figure 8. Visible images of the temperature variation/distribution observed during processing.

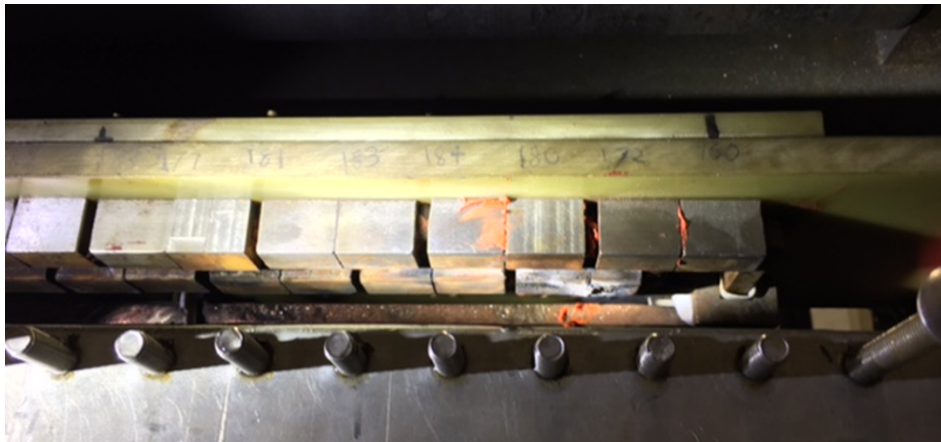
Figure 9. Photo of the induction coil after run #3 showing damage present on an intensifier block in the back row, right most.

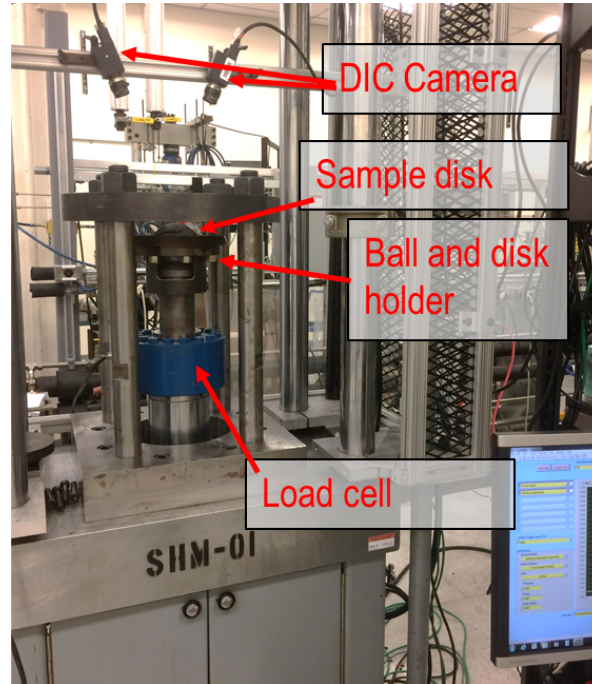
Figure 11. Formability testing apparatus wherein a disk sample is “formed”/bulged to failure. This operation is then similar to deep drawing.

A dome test was adopted as a measure of flashed sheet formability. Figure 11 shows a hydraulic compression/tension frame, set in compression mode, with 100,000 lb. load cell attached. The sample holder clamps down on the circumference of the sample disk, and subsequently, a hemispherical punch (a steel sphere) is pushed up into the disk. Digital Image Correlation (DIC) cameras are angled to image the top of the disk, allowing the measurement of the “3D” strain fields of the dome produced by the punch. Parameters such as dome height and major & minor Lagrangian strain maps were utilized to compare the performance of the as-received and flashed steel sheets. To that end, two sets of six, 5.45 in. (138.4 mm) diameter disks were cut from the as-received steel sheet. One set was ground to one of two uniform thicknesses, 0.028 or 0.056 in. (0.71 or 1.42 mm, respectively), to allow for comparison without thickness variations, while the second set was tested with the as-received thickness.

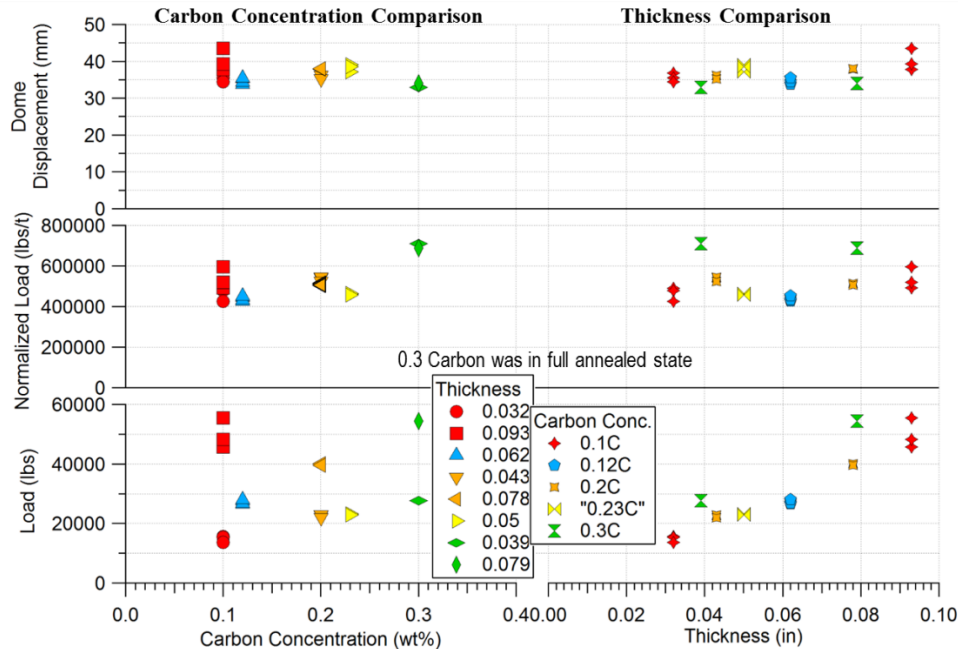
Figure 13. Sheet comparison between bulk carbon concentration (per supplier) and thickness. On the left, the symbol shapes distinguish the different sample thicknesses. On the right, the symbol shapes distinguish the different carbon concentrations. On both sides, the colors indicate the carbon concentration: red=0.1, blue=0.12, orange=0.2, yellow=0.23, and green=0.3 in wt% carbon.

In Figure 13, a comparison of the load, normalized load, and dome displacement are charted against the carbon concentration and sample thickness of the as-received sheets. On the left (labeled “Carbon Concentration Comparison”), this comparison shows that carbon concentration does not affect the performance of the as-received sheets. On the right, the load at failure increases with increasing thickness as expected because there is more material to resist deformation with thicker samples. With normalization for sheet thickness, all the sheets performed similarly. Note, the raw 1030 material is not presented because of the poor properties.

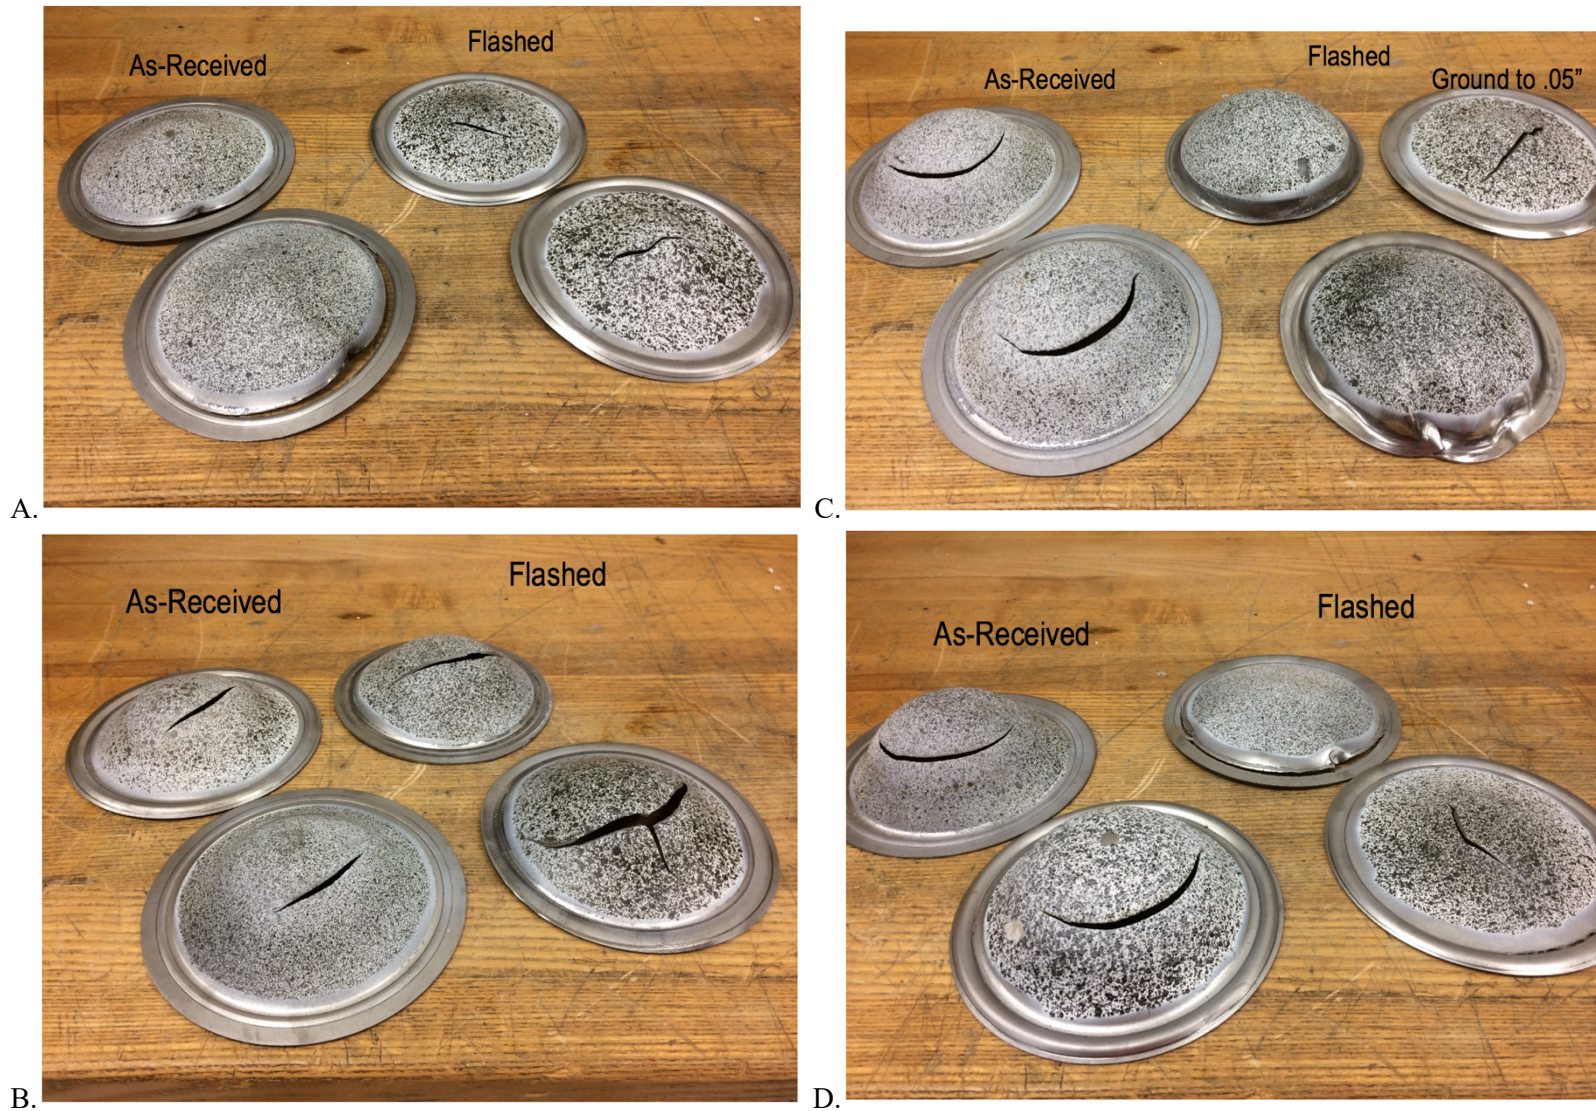
Figure 15 – The domes formed during formability testing. The speckle pattern was sprayed onto the top, which was necessary for the DIC strain measurement technique: A. 10AR04 & 10FP04, B. 12AR06 & 12FP06, C. 20AR08, 20FP08 & 20FP05G and D. 23AR05 & 23FP05.

Because of this challenge, three disks of the 20FP08 sheet were ground to 0.05 in./1.3 mm, the same as M1500. These are represented in Figure 14 with the blue dashed lines (also see Figure 15C). One of samples still slipped giving a large dome displacement. Two disks did not slip and showed poor properties, 19mm to 22mm dome displacement with a load of 100 to 130×10^3 N. However, it should be noted that grinding the disks may have removed some or all of the microstructural parameters which aid in the formability. The 23AR05 (as-received) sample set did form as expected in the un-flashed condition. The flashed condition was brittle and failed very early in the test (see Figure 15D). Similarly, the 30FP04 samples also failed early, although one sample did slip, again showing the effects of slipping.

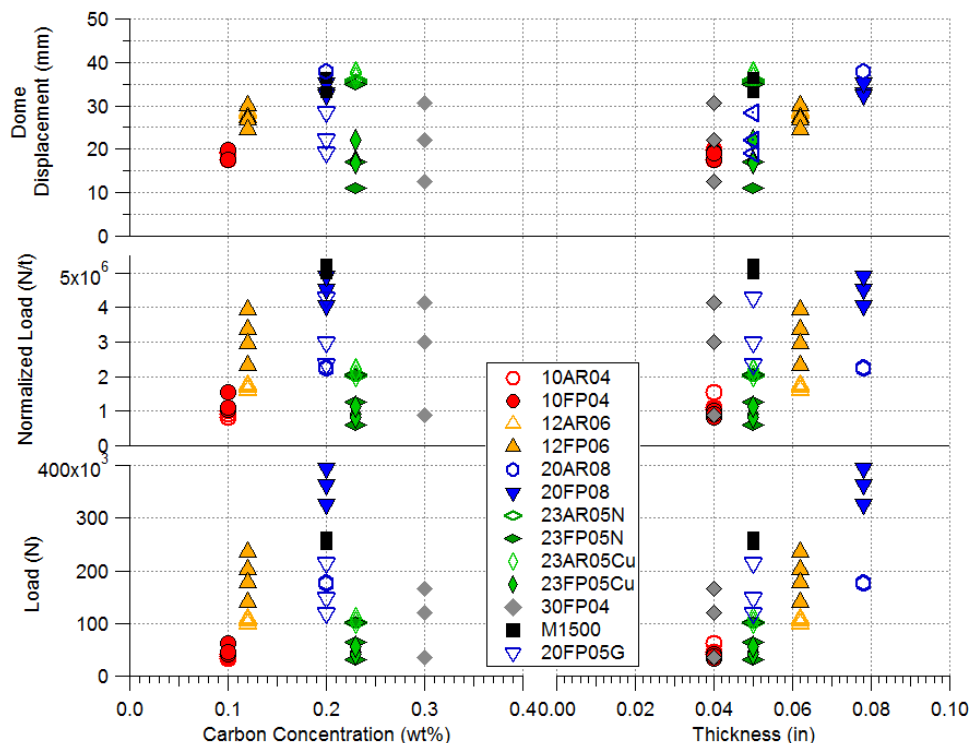
Figure 16 - Sheet comparison between bulk carbon concentration (per supplier) (left) and thickness (right). The symbol shapes and color represent samples from a single sheet, open shapes are as-received/un-flashed and solid shapes are flashed.

In Figure 16, the load, normalized load, and dome displacement are plotted against the carbon concentration and sample thickness of the as-received/un-flashed and flashed sheets. On the left, the deformation as a function of carbon concentration is not linear for the as-received and flashed sheets. On the right, the load at failure increases with increasing thickness, as expected. With normalization, however, the sample performances are not consistent.

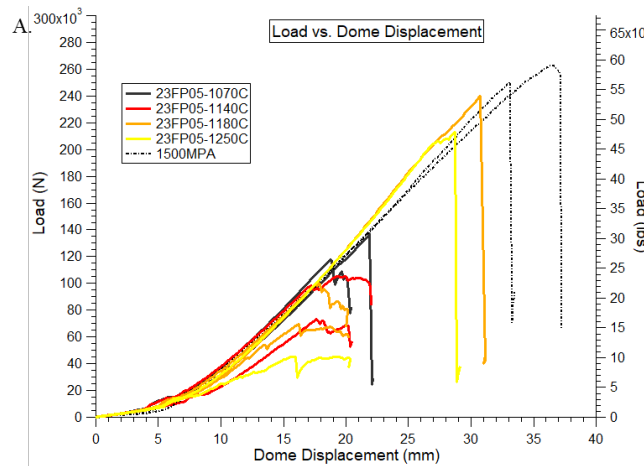
Figure 19 – A. Load versus dome displacement of the 1023 steel sheet with varying flash temperatures. The curves for as-received M1500 have been added for comparison.

Figure 19 shows the load versus dome displacement curves. All the samples flash processed at 1070 °C and 1140 °C cracked along the circumference at the hold down ring when tightening the bolts of the disk clamp. The crack did not traverse the entire circumference (~ 50% - 75%). The cracked samples were still tested with some initial loading still observed. However, the preexisting circumferential cracks led to premature failure (note jagged features in Figure 19). However, one sample from each of the 1170 °C and 1270 °C samples maintained integrity in the disk holder and gave a successful test result (i.e., no slipping on the disk holder and no cracking due to clamping). Both successful disks came from the middle of the sheet with the failure locations for both at the apex of the dome. While the sample disks extracted from the side of the sheet cracked during clamping, the cracking **only** occurred in the regions which were within 2 inches of either edge of the sheet. Note, this was different from the lower temperature samples where all the samples cracked along the entire circumference.

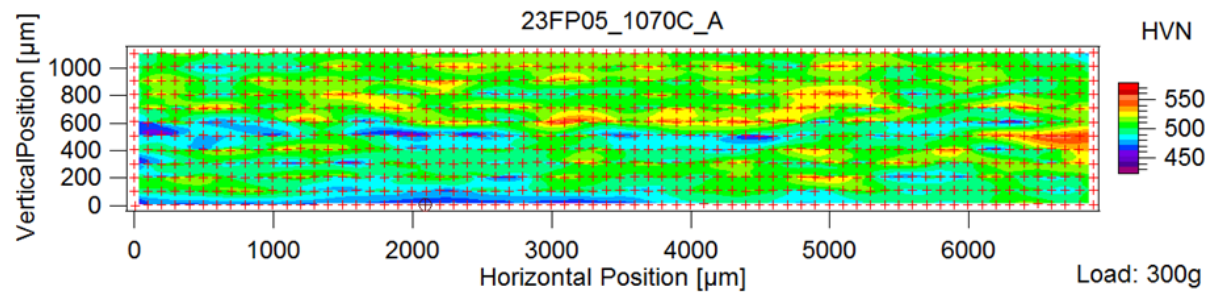
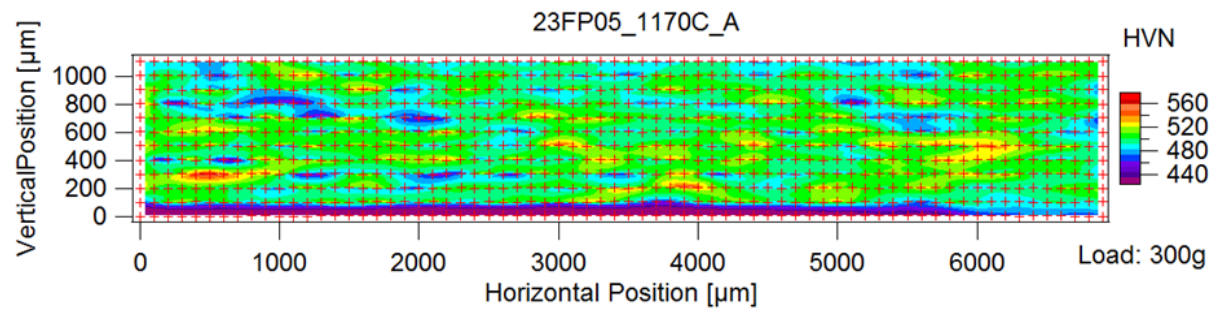
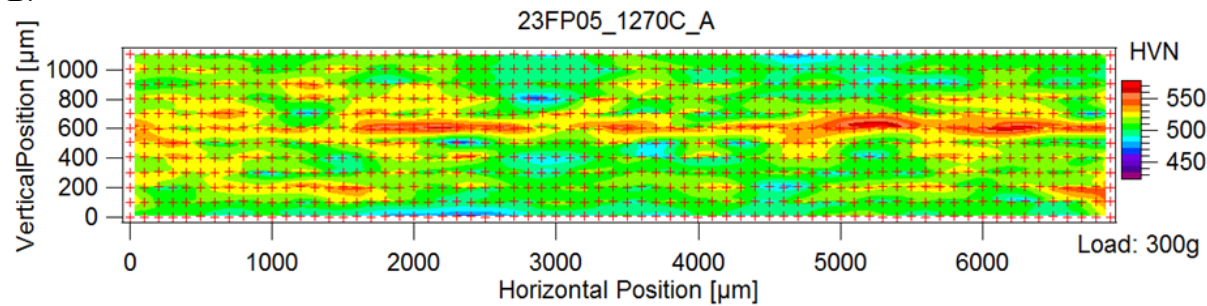
Figure 20 - The hardness profiles for 1023 steel sheet flashed at A. 1070 °C, B. 1170 °C, and C. 1270 °C.

Figure 20 shows the through thickness hardness profiles from samples flashed at three different temperatures. The 1070 °C temperature sample displays the most uniform hardness profile. The lack of the soft exterior with harder center line region, within microstructures after flash processing, *suggests* that the sample will not form [Lolla et al. 2013]. The hardness band is also absent in the hardness profile from the 1170 °C sample, which formed well. However, because of sample limitations, the location of the 1170 °C sample for hardness testing originated 1 to 2 inches away from the area where the disk used in the forming test was extracted. Not surprisingly, spatial differences should be expected to show variations from flash processing due to inhomogeneous temperatures across the width of the sheet. Spatial variations themselves may play an important role in the central hardness band. The 1270 °C hardness sample, however, was taken close to the location where the disk that formed was extracted and does show the typical hardness band. This could be an indication of the correlation between formability and microstructure.

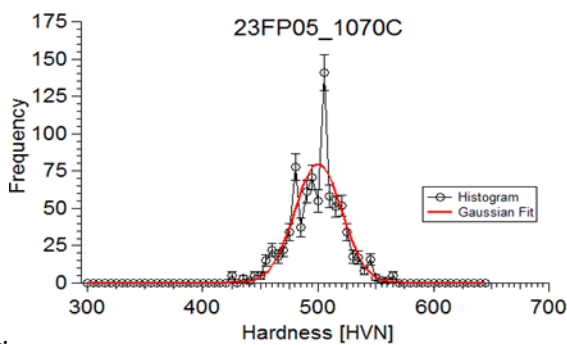
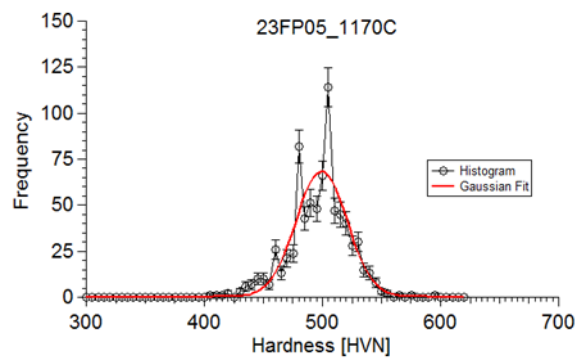
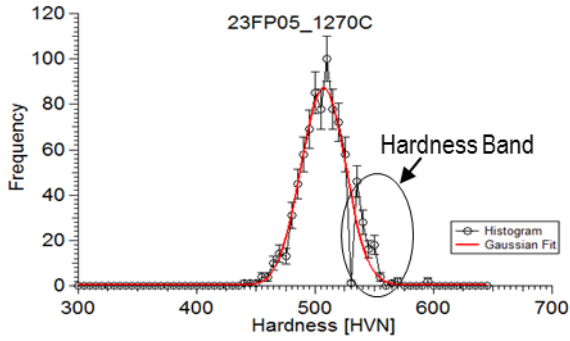
Figure 21 - The histograms of the hardness profiles from Figure 20 for A. 1070 °C, B. 1170 °C, and C. 1270 °C.

Figure 21 shows the histograms of the hardness maps from Figure 20. The averages of all the samples are roughly 500-510 HVN. The spread of hardness values for all the samples is about 100 HVN and is consistent with previous examples of hardness profiles from flash processing. The presence or absence of a hardness band also does not seem to affect the average hardness. However, a small bimodal distribution of higher hardness values may be observed in the 1270 °C sample, representing the hardness band (see Fig 20C) in the center of the cross-section. This supports the hypothesis that the central hardness band correlates to the formability of flashed processed steel. Figure 22 shows the SEM and electron

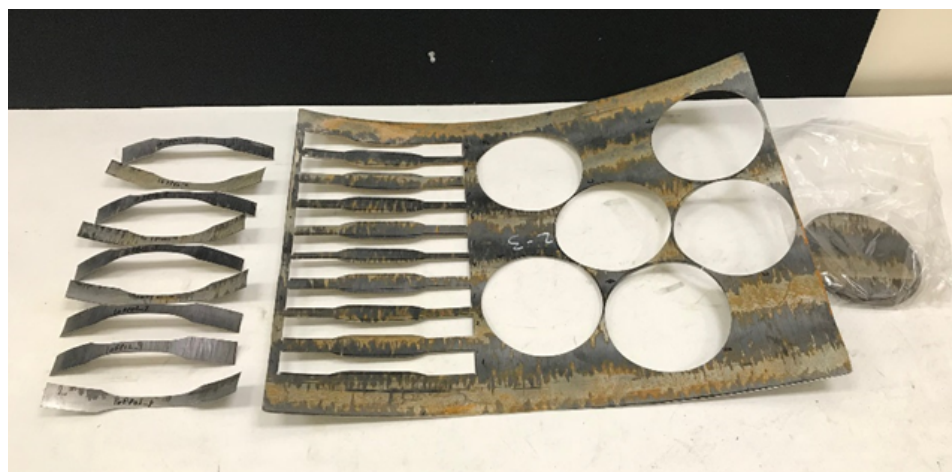
Figure 23 - 1010 sheet after Flash Processing and test specimens cut from the sheet.

A 0.02 in (0.5 mm) thick sheet of 1010 steel was Flash processed at 1150°C . A section of this sheet was then lightly stamped and “formed” at a stamping shop in Michigan. In addition, samples were cut from the same sheet and sent to a commercial testing lab for tensile testing. The remaining section of the flash processed sheet was shipped to ORNL for tensile testing and biaxial dome testing, providing a 1:1 correlation (previously not available) of stamping, tensile testing, and formability. In Figure 23, the residual section of 1010 sheet sent to ORNL is shown wherein tensile bars and dome testing disks were extracted. The tensile specimens shown have a noticeable curve/bow due to residual stresses from the Flash process. The curvature of these specimens is also exaggerated due to the small thickness of the sheet. The disks did not bow appreciably after extraction.

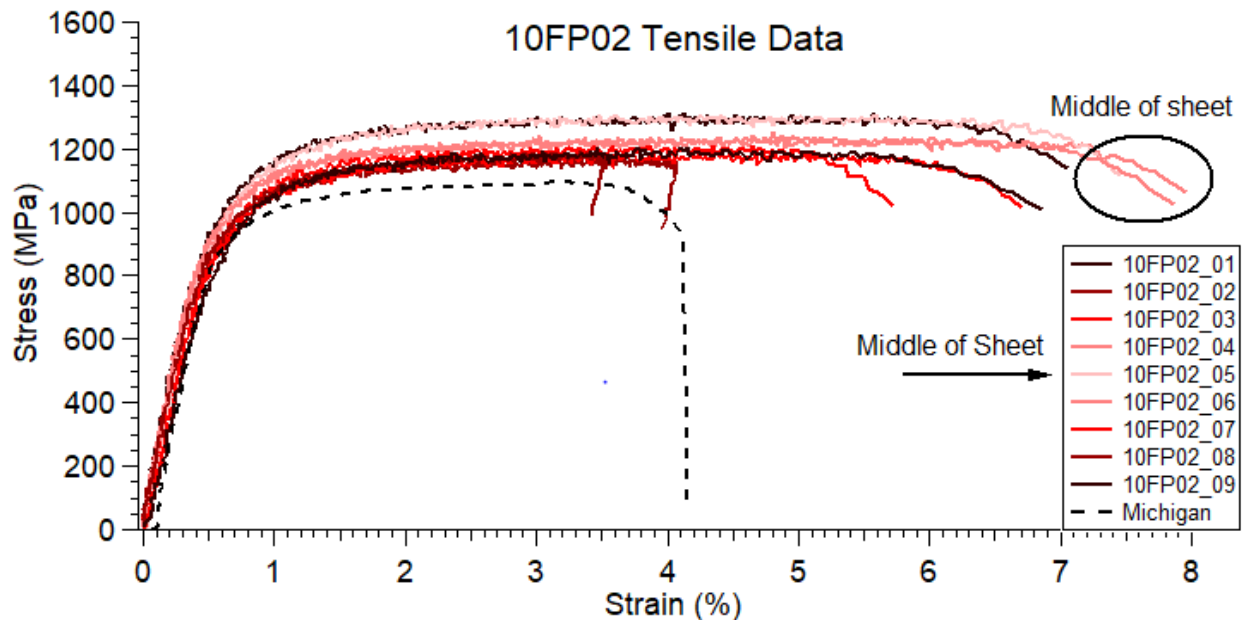
Figure 24 - Tensile data for the 1010 sheet. One curve from external testing is shown for comparison.

Figure 24 shows the tensile stress versus strain curves for the 1010 sheet. The UTS (ultimate tensile strength) of the sheet ranged from 1100 to 1250 MPa. When comparing the data with the specimen tested at a commercial testing lab, all the specimens tested at ORNL had higher UTS's most likely due to loading rate differences between the two labs and/or location in the sheet from where the tensile sample was taken. While the elongation of the sheet ranged from 4% to 8%, an interesting pattern emerged from the test. The two specimens nearest the edges of the sheet, one from each side, had close to 7% elongation (solid dark curves in Figure 24). Moving inward, the elongation of the adjacent samples dropped to 4% (dark red curves) and was similar to the sample tested commercially. Closer to the center, the elongation increases to 8%. It is unclear why the elongation drops and then increases at the center.
