PIE on Five Irradiated AGR-1 Compacts

September 2012

Advanced Gas Reactor (AGR) program

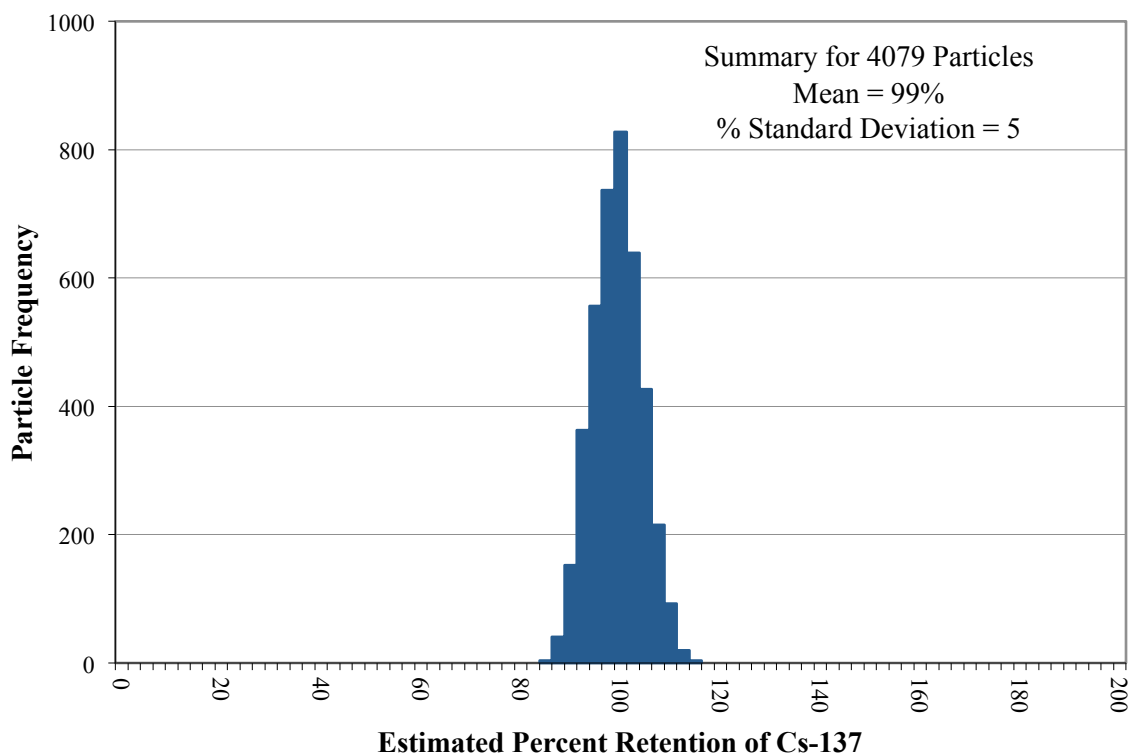
Figure 2. Estimated fraction of ^{137}Cs retained in particles from Compact 6-1-1 based on calculated inventory and adjusted for variation in fissionable material and burn-up using the measured ^{144}Ce activity. Results suggest low Cs release and good accuracy in the calculated inventory.

In between DL and BL, all the particles recovered from each compact were surveyed using the IMGA to sort out any with unusual inventories of ^{144}Ce , ^{137}Cs , or $^{110\text{m}}\text{Ag}$. These 80–100 second gamma scans also provided a determination of the cesium retention by the particles. Figure 2 shows the ^{137}Cs distribution measured for Compact 6-1-1, and this result is representative of the results for the other compacts. The narrow spread in the ^{137}Cs content is at least partially due to analysis uncertainty, and the average retention value of 99% supports the conclusions that cesium was well retained and that the calculated inventory was accurately predicted.

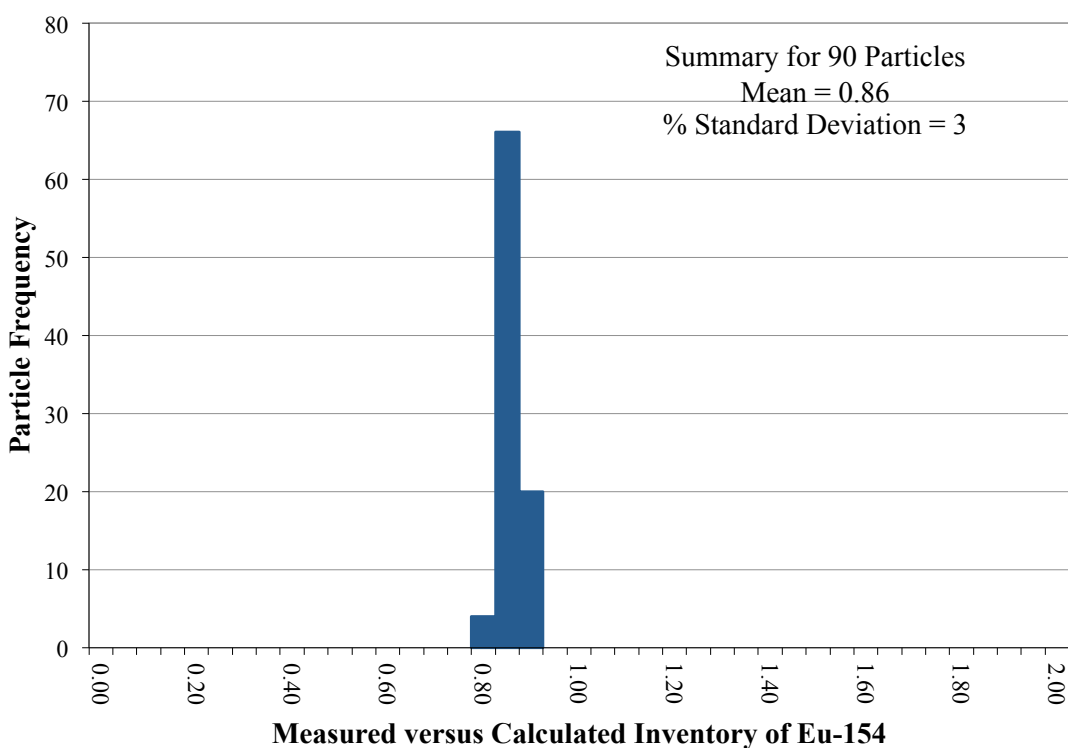
Figure 3. Ratio of ^{154}Eu retained in 90 particles from Compact 4-4-2 versus calculated inventory, adjusted for variation in fissionable material and burn-up using the measured ^{137}Cs activity.

Europium behavior was similar for all compacts. Figure 3 shows a representative ^{154}Eu distribution obtained for Compact 4-4-2. Similar to Figure 2, the europium retention has been plotted as a ratio of the measured value versus the calculated inventory at the end of irradiation. Like cesium, the europium distribution was narrow; this is indicative of uniform europium retention behavior for all the particles. However, the calculated average retention does not agree with the europium release determined from DLBL and analysis of the irradiation capsule components. These analyses indicated europium release of less than a few percent. For most of the compacts, the measured versus calculated europium inventory determined by IMGA has averaged between 0.84–0.86. This indicates that the calculated inventory for europium is higher than the actual amount of europium generated in the fuel by the three-year irradiation.

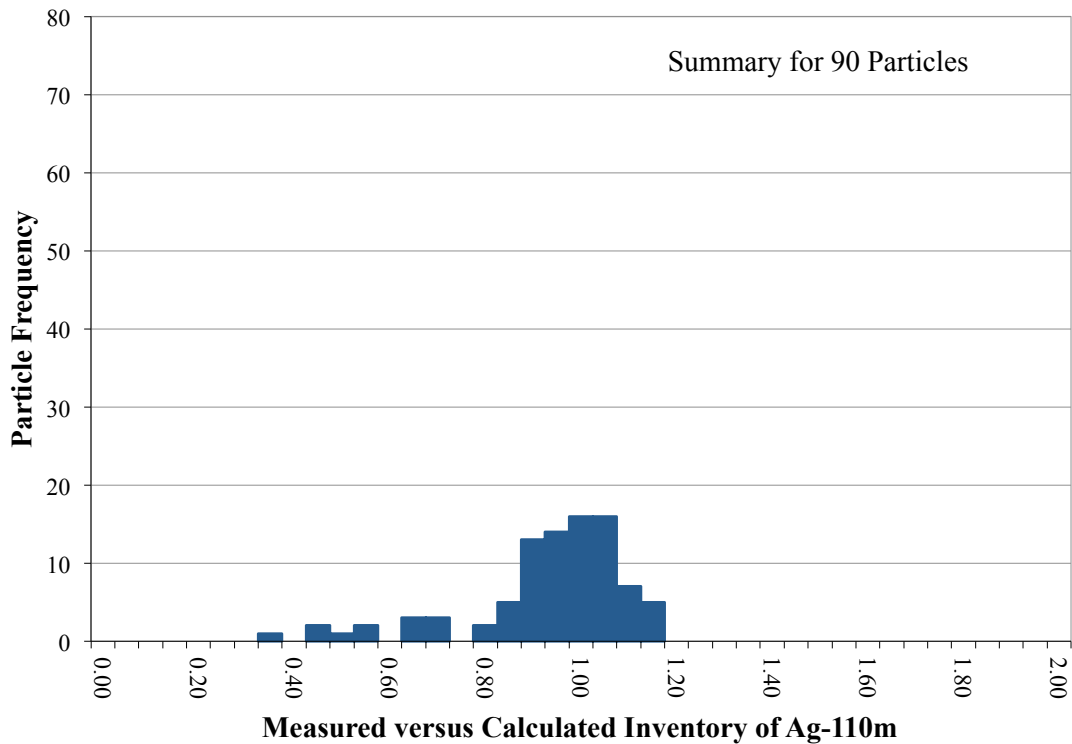
Figure 4. Ratio of ^{110m}Ag retained in 90 particles from Compact 4-4-2 versus calculated inventory, adjusted for variation in fissionable material and burn-up using the measured ^{137}Cs activity.

The IMGA data from the 4-6 hour scans showed that the silver retention within each compact varied considerably from particle-to-particle. Figure 4 shows the broad distribution in $^{110\text{m}}\text{Ag}$ measured for the random particle sample from Compact 4-4-2. There is a broad peak centered around an average retention close to the full calculated inventory of $^{110\text{m}}\text{Ag}$, with a low-end tail indicating a sub-population of particles with lower silver retention. This general trend was also seen for Compacts 6-1-1 and 5-2-3, but the sub-populations with lower retention were larger and shifted down, with some particles having an undetectable activity from $^{110\text{m}}\text{Ag}$ (Figure 5 and Figure 6). Particles with low silver retention were analyzed by x-ray tomography and materialography for comparison to particles with average silver retention.

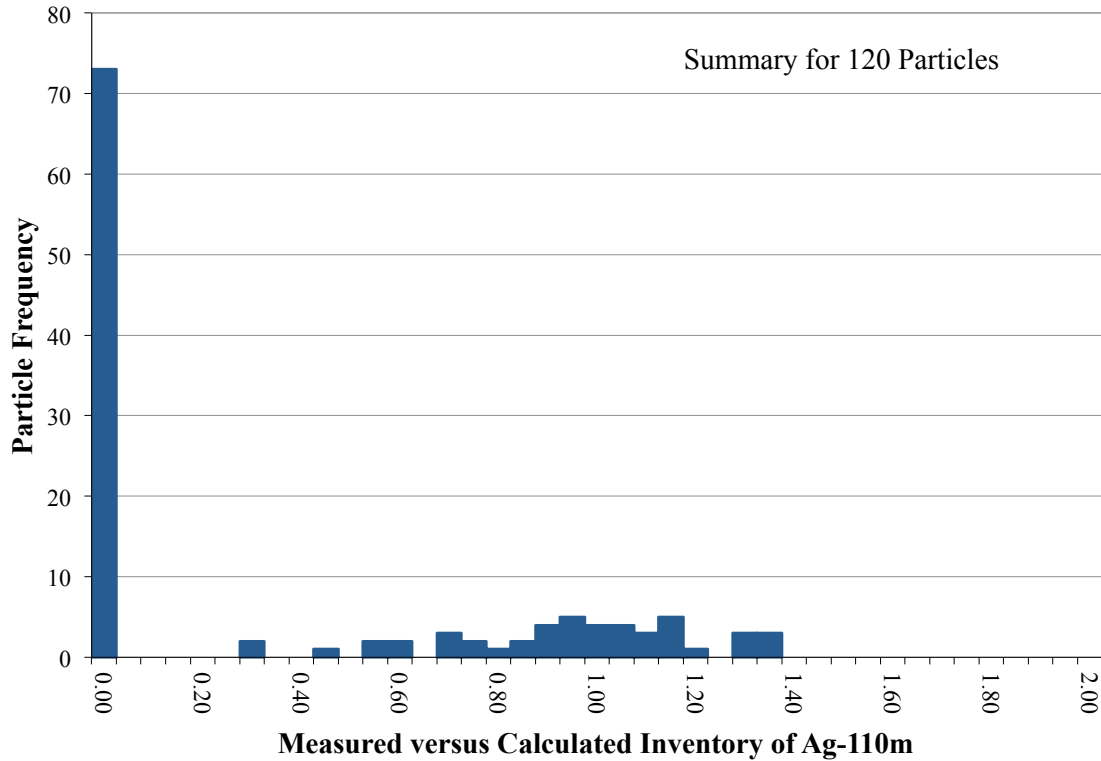
Figure 5. Ratio of ^{110m}Ag retained in 120 particles from Compact 6-1-1 versus calculated inventory, adjusted for variation in fissionable material and burn-up using the measured ^{137}Cs activity.

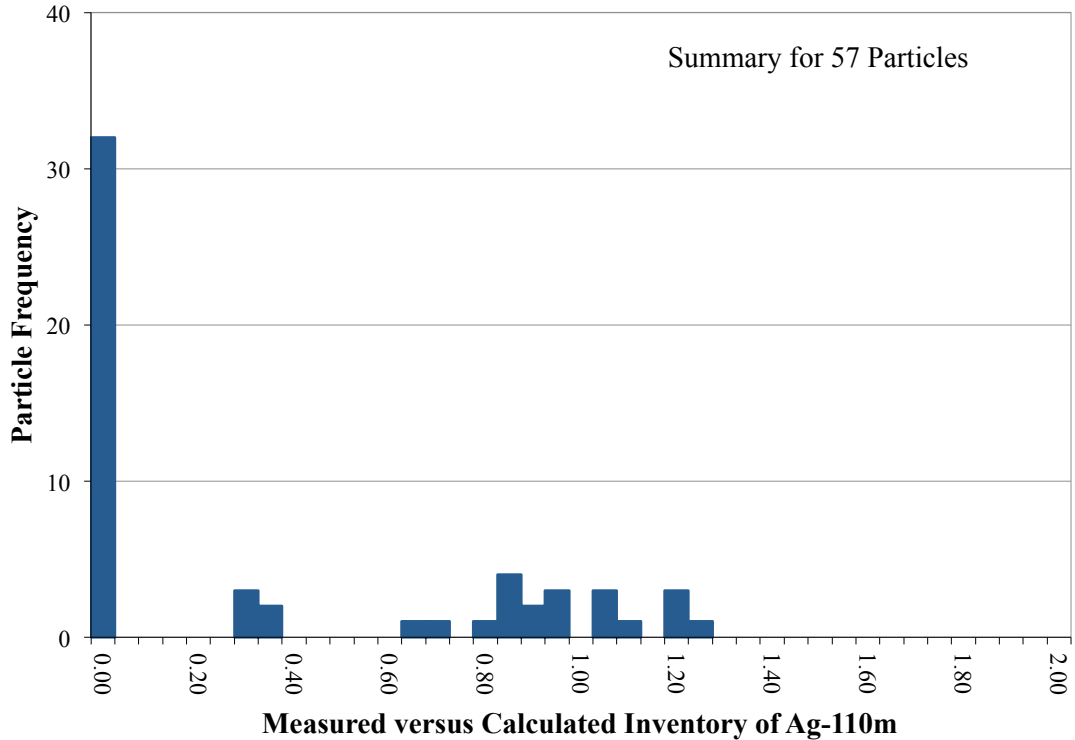
Figure 6. Ratio of ^{110m}Ag retained in 57 particles from Compact 5-2-3 versus calculated inventory, adjusted for variation in fissionable material and burn-up using the measured ^{137}Cs activity.

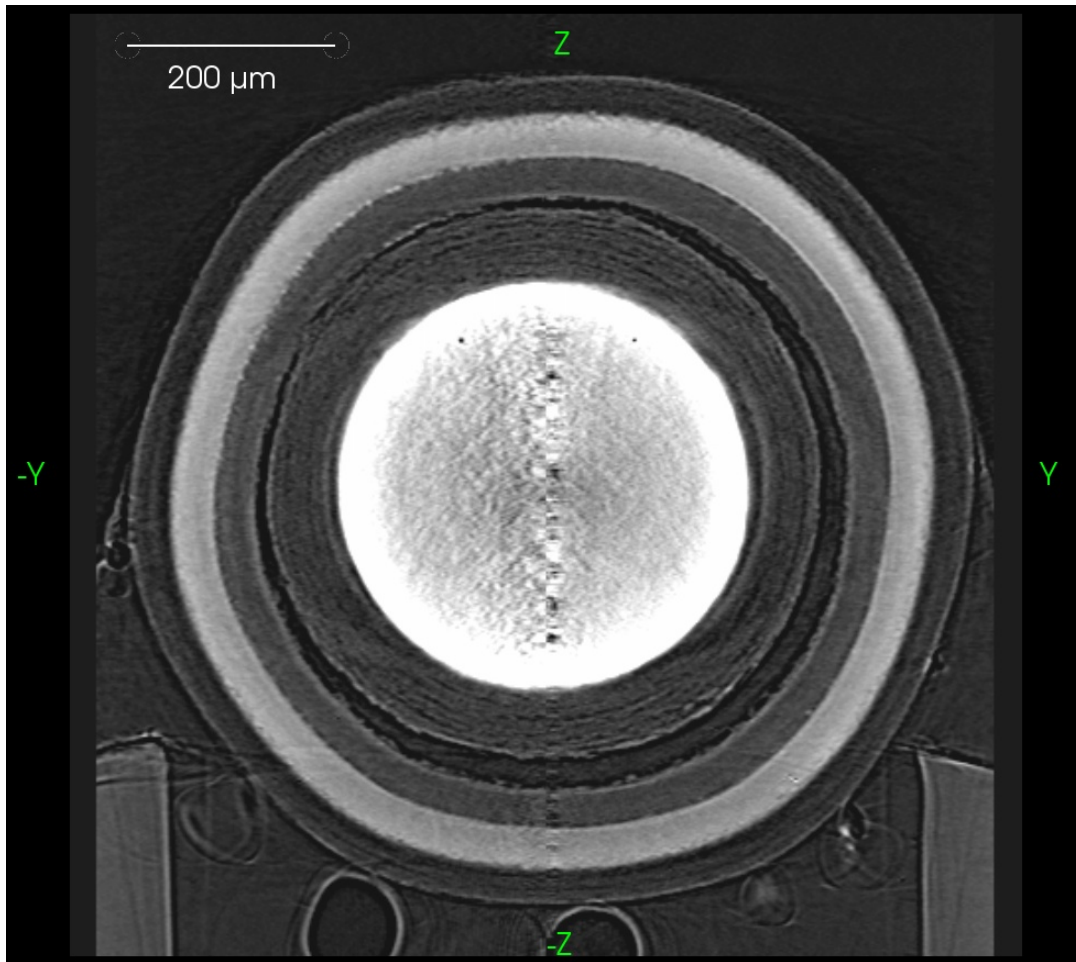
Figure 7. X-ray tomograph of a typical irradiated particle microstructure showing a densified buffer and no apparent coating damage (particle from Compact 4-4-2).

X-ray tomography was performed on particles selected from each of the three as-irradiated compacts. Figure 7 shows one typical irradiated particle microstructure with no apparent coating damage beyond the separation of the buffer from the IPyC due to the irradiation-induced densification of the buffer. In some cases, the buffer densification causes the layer to fracture, and the kernel will often expand into the opening between the buffer fragments. This behavior was reported in detail in INL/EXT-12-25301, *Ceramographic Examinations of Irradiated AGR-1 Fuel Compacts*, and Figure 8 shows a typical example. Also visible in Figure 8 is a fission product cluster at the IPyC/SiC interface. Particles were selected for x-ray tomography based on their ^{110m}Ag retention. Particles in the sub-populations with undetectable silver (Figure 5 and Figure 6) were compared to those with average and above average silver content. No correlation between silver retention and coating microstructure has yet been discovered.

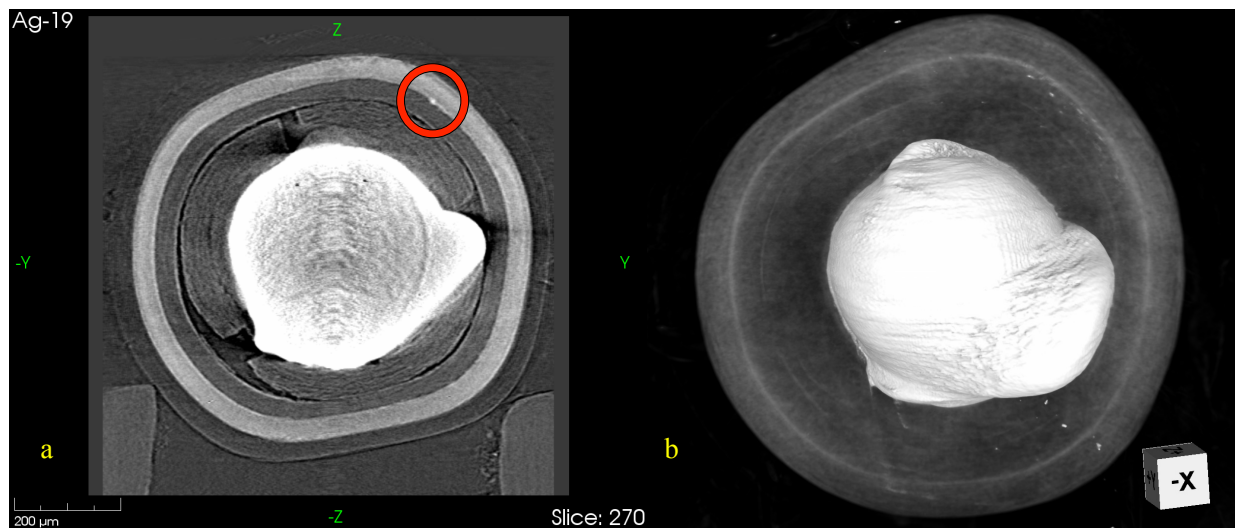
Figure 8. X-ray tomograph (a) and 3-D rendering (b) of a particle with fractured buffer and protruding kernel (particle from Compact 6-1-1). Also visible (circled) is a fission product cluster at the IPyC/SiC interface.

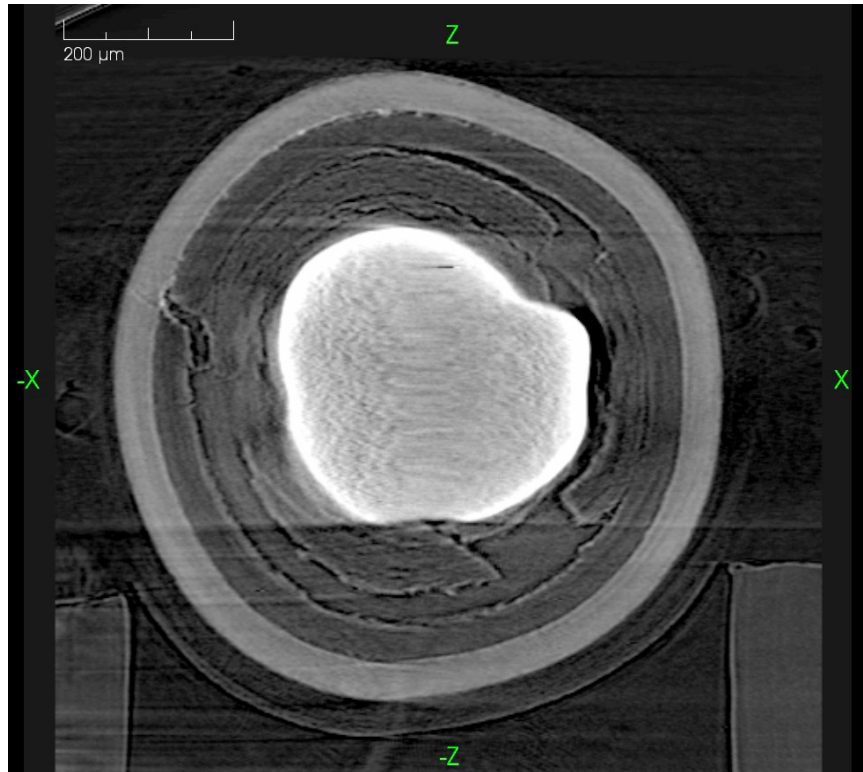
Figure 9. X-ray tomograph of first particle with reduced cesium retention from Compact 5-2-3. Buffer fracture and delamination has apparently led to failure of the IPyC and SiC layers.

Figure 9 and Figure 10 show one of the two particles from Compact 5-2-3 with lower than average cesium retention. It can be seen that the buffer layer fractured during irradiation. The buffer fracture and delamination appears to have led to fracture of the IPyC and ultimate cracking of the SiC layer. Figure 11 and Figure 12 show the second particle from Compact 5-2-3 with lower than average cesium retention. This particle shows similar cracking of the buffer, IPyC, and SiC. Note that in both particles, the IPyC crack occurred where the buffer was still attached to the IPyC. It is expected that the outer pyrocarbon (OPyC) layer of these particles remained intact, based on the lack of ^{85}Kr release during irradiation or kernel leaching during electrolytic deconsolidation. The entire OPyC layer was not visible in the x-ray images of the first particle, because of imaging conditions. The second particle was imaged with lower energy x-rays and thicker epoxy overcoat; no OPyC cracks could be resolved. Both particles also show bright spots in the x-ray images that indicate fission products clustered at the site of the defect. These are more prevalent in the second particle, and there may be some corrosion in the SiC at the defect site.

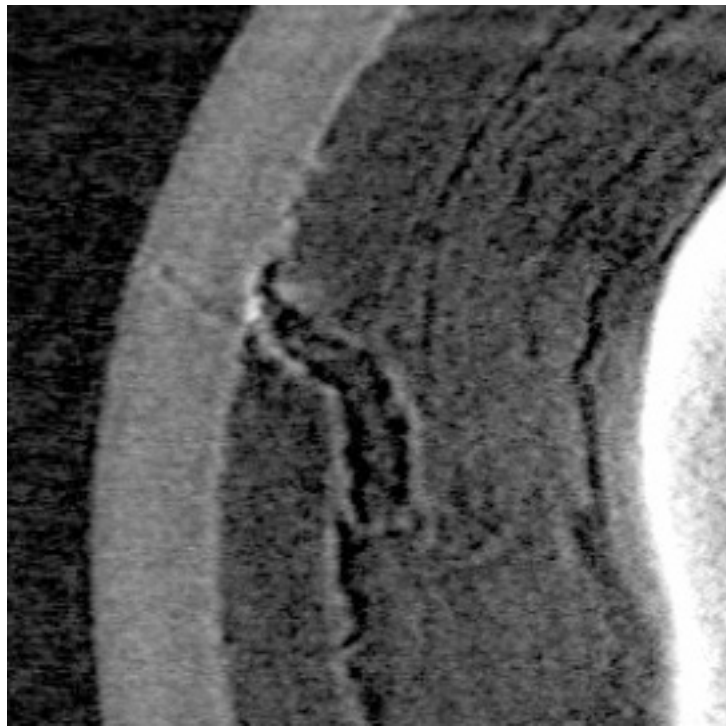
Figure 10. Close-up of particle in Figure 9 using higher resolution tomographic reconstruction. A fine crack through the SiC is evident.

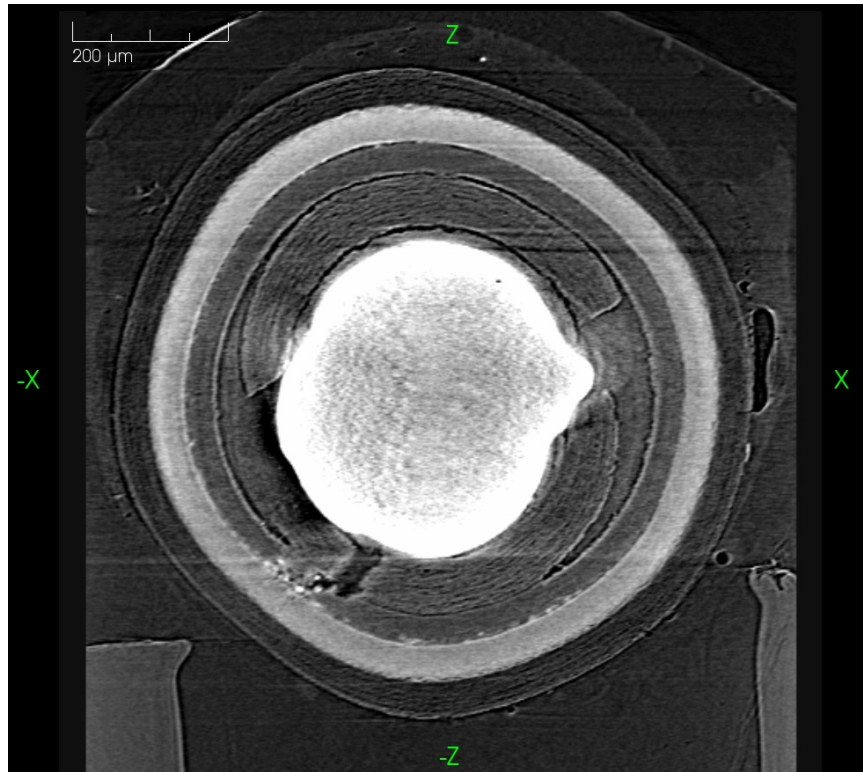
Figure 11. X-ray tomograph of second particle with reduced cesium retention from Compact 5-2-3. Buffer fracture and delamination has apparently led to failure of the IPyC and SiC layers. Bright spots at location of IPyC/SiC failure are fission product clusters.

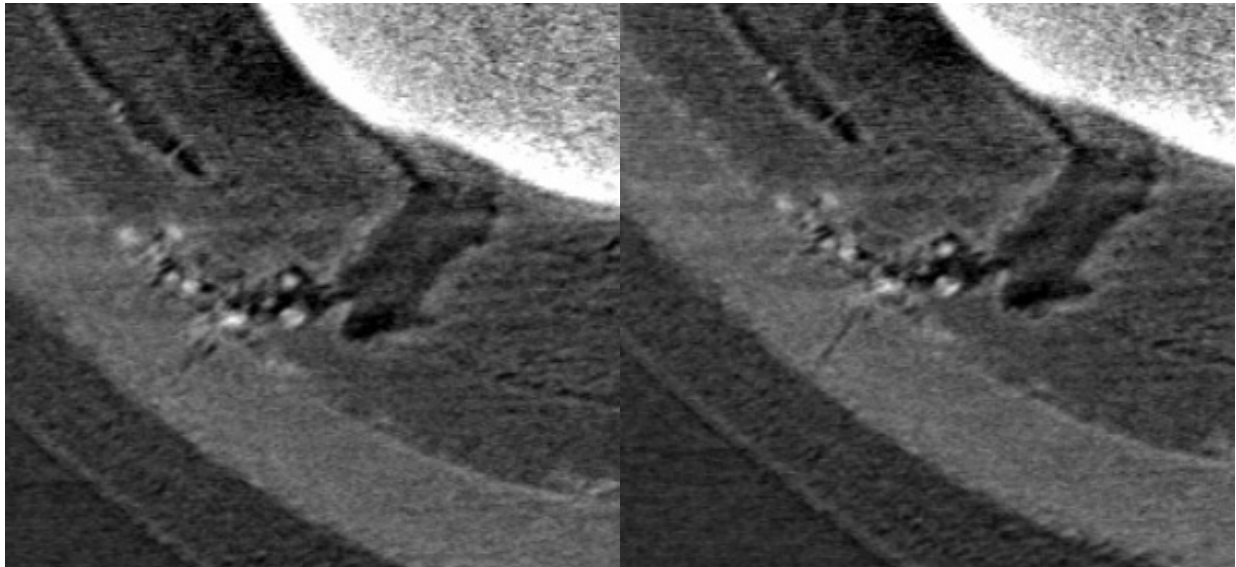
Figure 12. Two close-up images of particle in Figure 11 using higher resolution tomographic reconstruction. A fine crack through the SiC is evident and there may be some fission product corrosion near the IPyC/SiC interface.

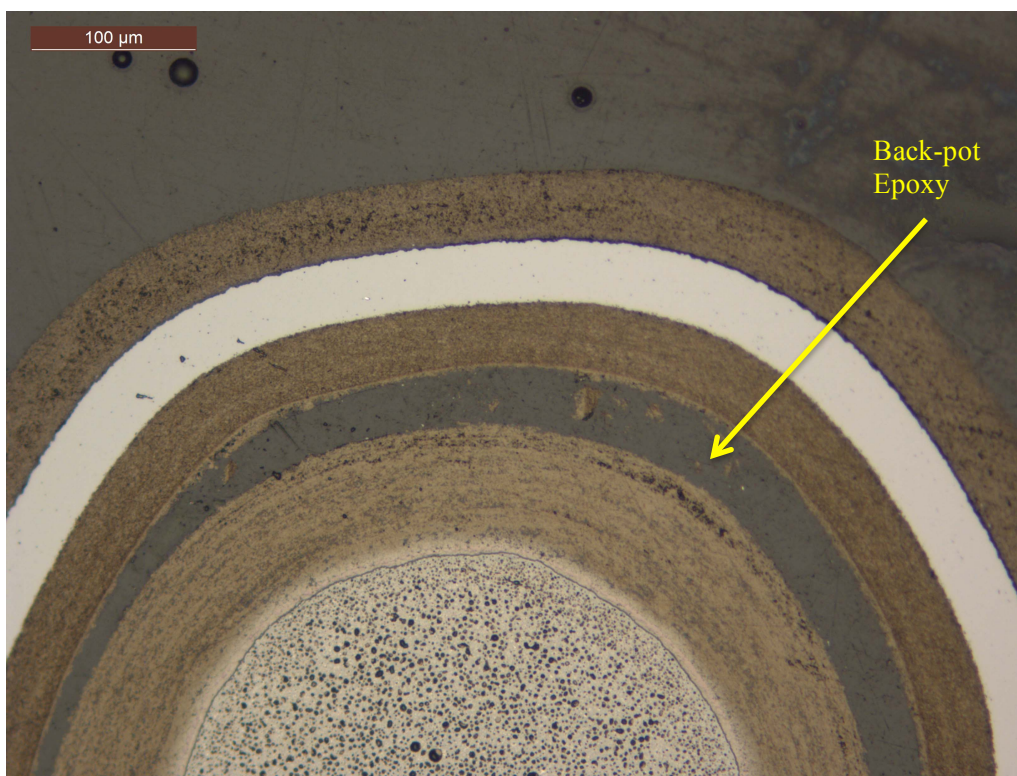
Figure 13. Optical micrograph of polished cross section of particle from Compact 6-1-1.

Although x-ray tomography provides definite advantages in terms of non-destructive three-dimensional analysis, mechanical cross sectioning allows for higher resolution imaging, elemental analysis, and investigation of kernel microstructure. Figure 13 and Figure 14 show images obtained using an optical microscope of a polished cross section of a particle from Compact 6-1-1. The porous nature of the irradiated kernel, not visible using low energy x-rays, can be clearly seen in the polished cross section. Some residual buffer is evident on the inside surface of the IPyC layer providing insight on how this interface delaminated. The interface between the IPyC and the SiC remained intimately stitched, but there is a slight gap between the SiC and the OPyC that needs further investigation. Figure 15 shows a particle from Compact 5-2-3 with a fractured buffer and protruding kernel. The absence of an intact buffer to restrain kernel swelling resulted in much larger gas pockets in the kernel interior.

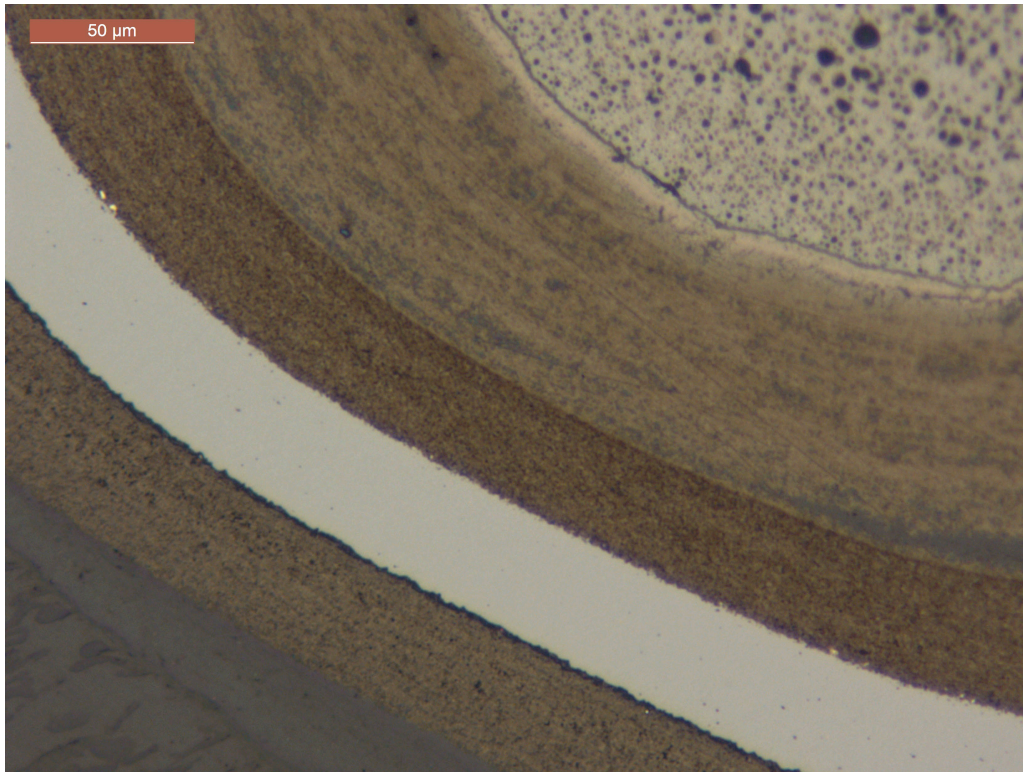
Figure 14. Optical micrograph of polished cross section of particle from Compact 6-1-1.

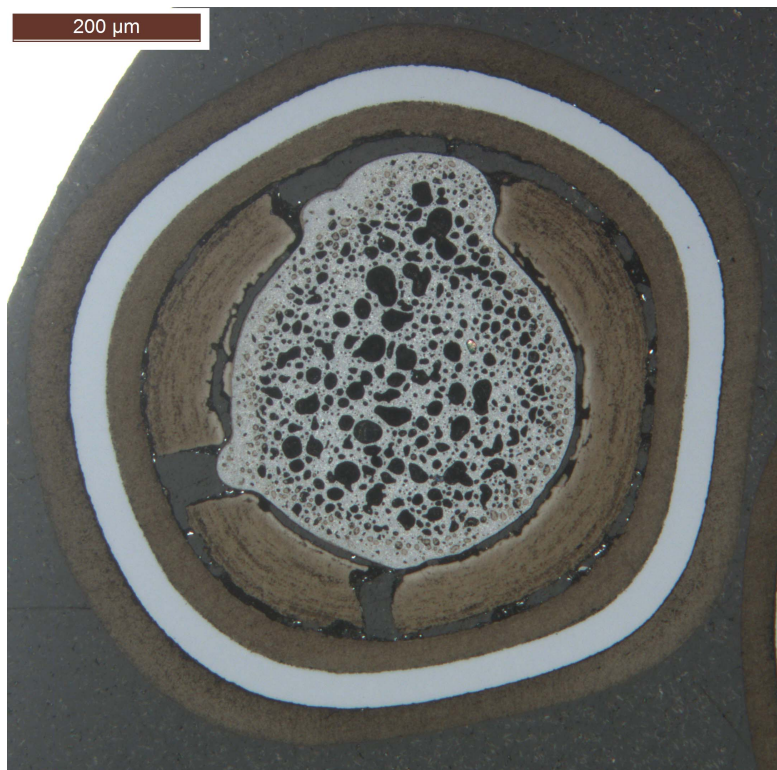
Figure 15. Optical micrograph of particle from Compact 5-2-3 with fractured buffer and protruding kernel.

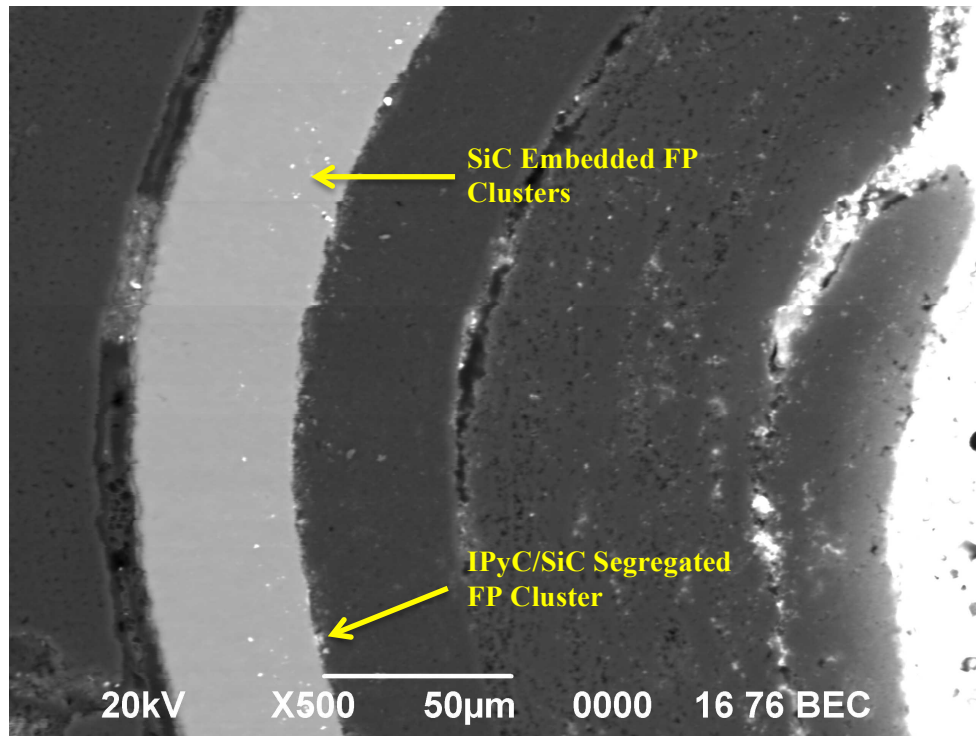
Figure 16. Back-scattered electron image of particle from Compact 6-1-1 showing fission product (FP) cluster at the inside surface and within the SiC.

SEM was performed on some polished particle cross sections to investigate fission product clustering outside of the kernel. Figure 16 shows a back-scattered electron image, where fission product clusters in the TRISO layers appear as bright spots. WDS analysis (Figure 17) identified many of these fission product clusters to contain palladium and uranium. Further studies are needed to consider the possible connection between these fission product clusters and silver transport through intact SiC. Additional observations on Compact 6-4-3, discussed in the next section, support this possibility.

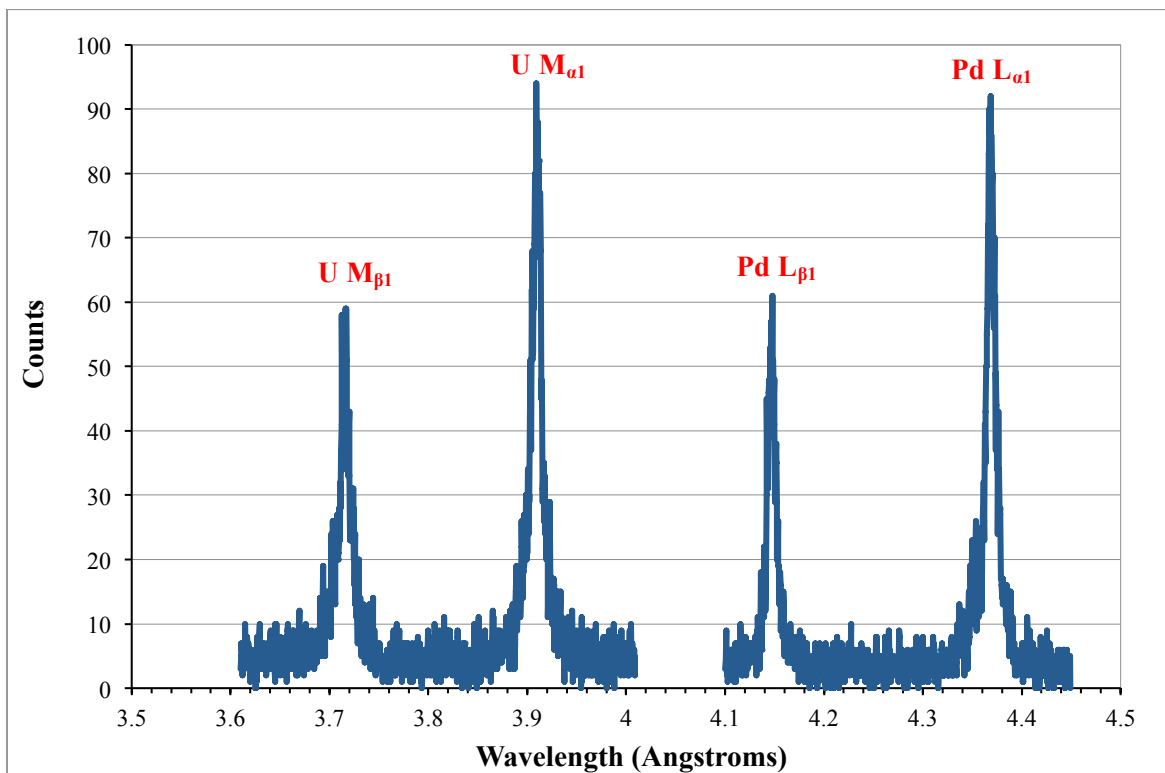
Figure 17. WDS wavescans indicating Pd and U in a fission product cluster embedded in the SiC.

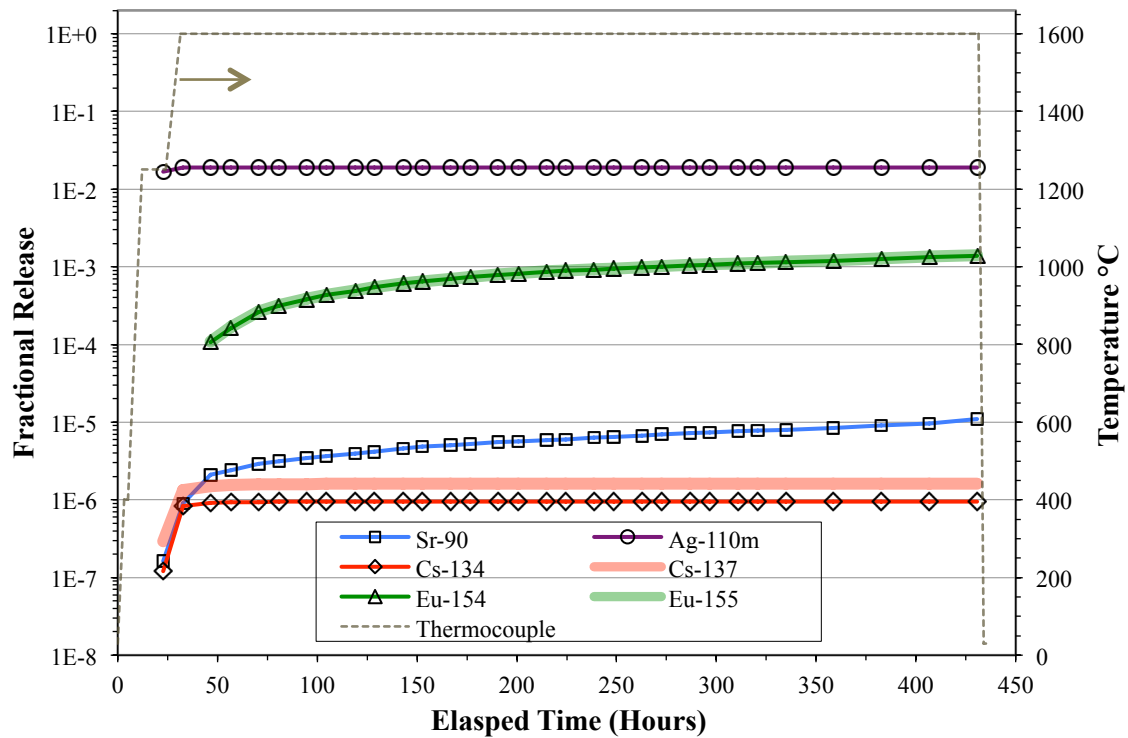
Figure 18. Release of fission products from Compact 6-4-3 during safety testing to 1600°C.

Figure 18 shows the temperature profile and estimated time-dependent fission product releases from Compact 6-4-3. The plotted fractional release values are the cumulative amount of each fission product collected on the deposition cups, adjusted for radioactive decay and average collection efficiency, and divided by the predicted compact inventory for each fission product at the end of the irradiation. Silver was released from the compact as it was initially heated up, and no additional significant silver release was detected while the compact was held at 1600°C for 400 hours. The observed $^{110\text{m}}\text{Ag}$ release was of the same order of magnitude as that observed in the DLBL analysis of the as-irradiated compacts (Table 1), and post-safety test DLBL (Table 2) measured a significantly smaller quantity. This suggests that the silver release observed at the beginning of the safety test came from silver outside the SiC, presumably released through intact SiC during irradiation. Also note that palladium, which was observed in the as-irradiated compacts at relatively high levels, was not detected by DLBL after the safety test, indicating it may also have left the compact when it was heated to 1600°C. Palladium is not detected by gamma spectrometry, and additional mass spectrometry will be required to detect it after the CCCTF test.

Migration of europium and strontium to the cold finger was slow, and it is likely that their time-dependent release shown in Figure 18 was a function of the migration kinetics, as opposed to time dependent release from the compact. Table 3 shows that these fission products were held up in the CCCTF graphite holder and tantalum furnace liner, whereas silver readily condensed on the water-cooled deposition cups.

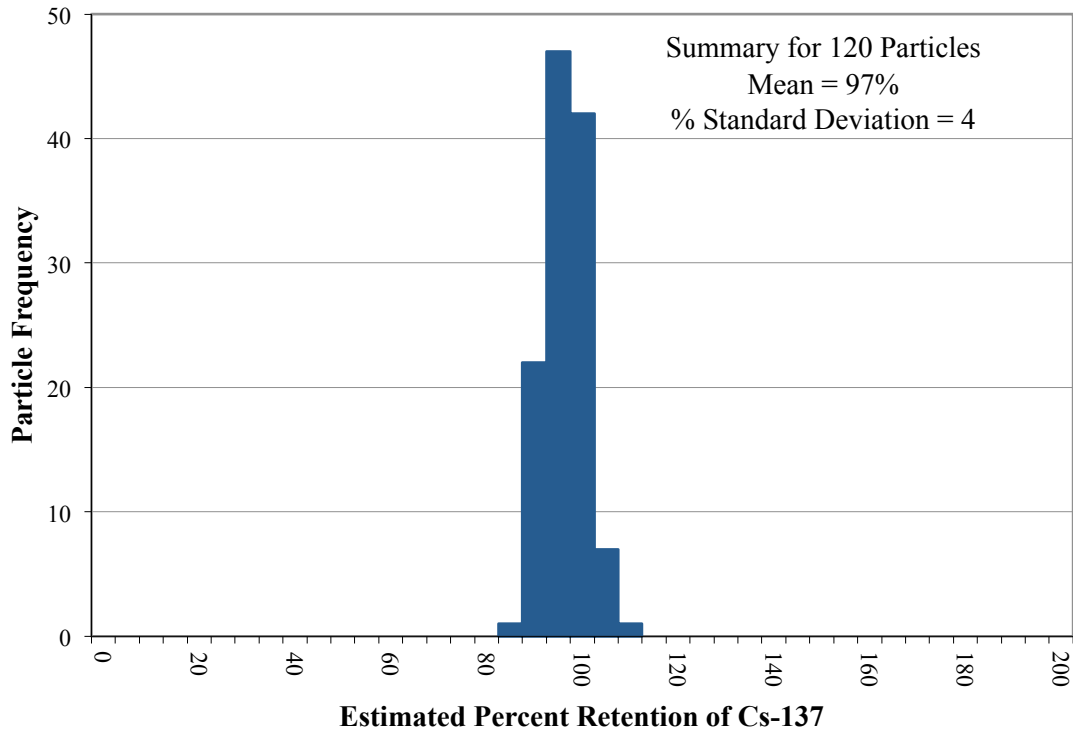
Figure 19. Estimated fraction of ^{137}Cs retained in particles from Compact 6-4-3 based on calculated inventory and adjusted for variation in fissionable material and burn-up using the measured ^{144}Ce activity.

Cesium release at 1600°C was low. Four hour IMGA analysis of 120 particles from Compact 6-4-3 (Figure 19) showed that the ^{137}Cs distribution was little changed from that observed for as-irradiated compacts (Figure 2). Silver retention in the particles was broadly distributed with a small population that had lost almost all their silver (Figure 20), but these results were similar to as-irradiated compacts and it cannot be concluded that the distribution is a result of the safety test. The main peak in the silver distribution was centered around a ratio of 0.8 measured versus calculated inventory, which is lower than observed for most compacts; the reason for this is not understood, but the shift is too large to explain by the amount of silver released in the safety test.

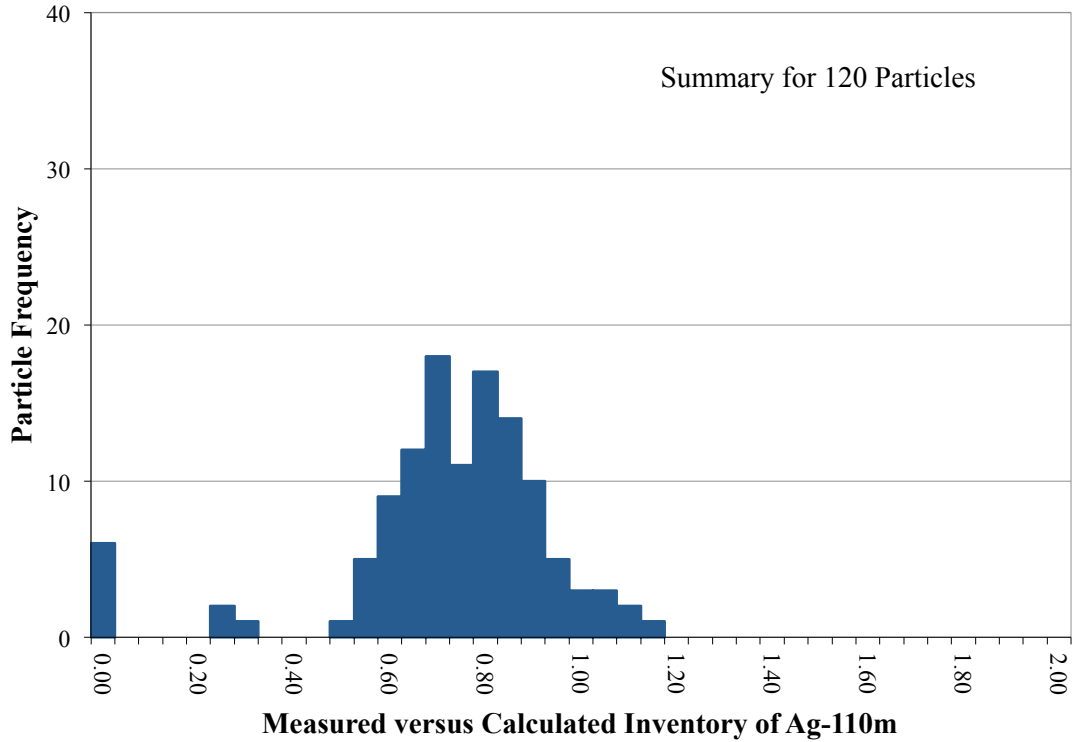
Figure 20. Ratio of ^{110m}Ag retained in 120 particles from Compact 6-4-3 versus calculated inventory, adjusted for variation in fissile material and burnup using the ^{137}Cs activity.

The six particles with ^{110m}Ag content below the detection limit of the 4-hour IMGA scan, were analyzed by x-ray tomography or materialography (three particles each) and compared to six other particles with higher silver retention. There was no apparent correlation between the particle microstructure and the silver retention, and the observed microstructure was similar to that observed on as-irradiated particles. Figure 21 shows two x-ray tomography examples, one with typical buffer/IPyC separation, and one with cracks in the buffer and IPyC layers. The cracked inner layers have been observed in particles from other compacts and appear to occur more often when the buffer and IPyC layers do not separate.

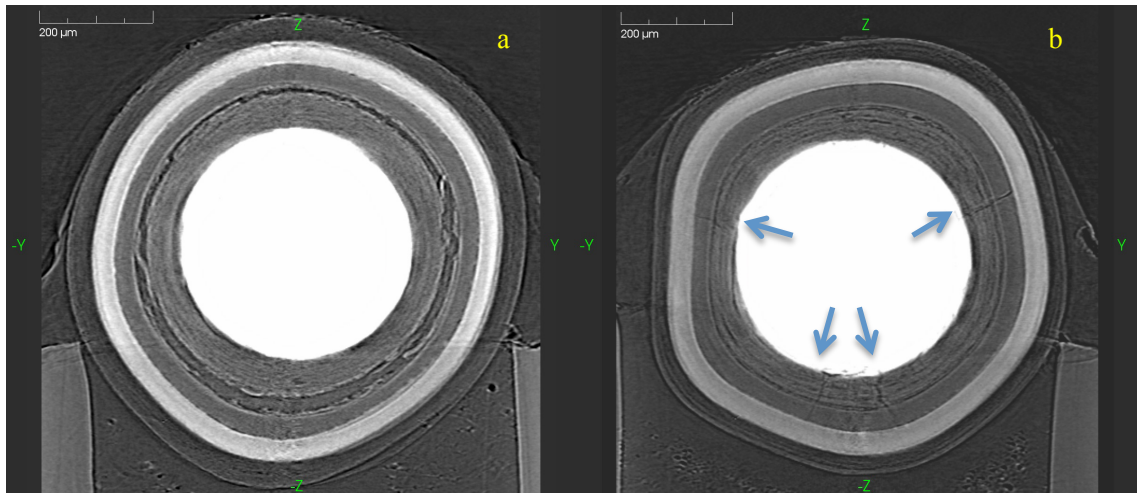
Figure 21. X-ray tomographs of a typical particle (a), and a particle with unusual cracks in the buffer and IPyC layers (b). Both of these particles exhibited normal silver retention.

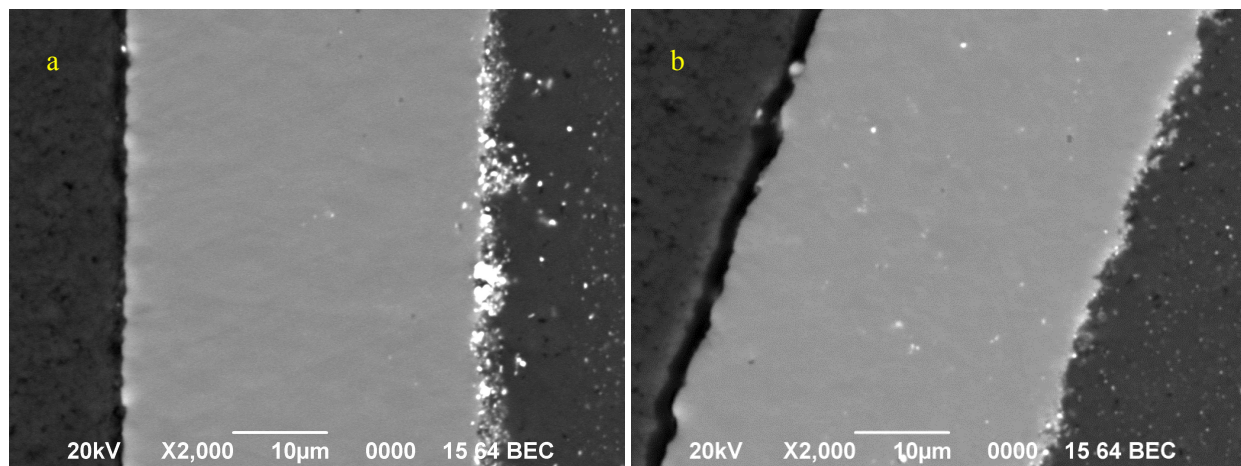
Figure 22. Back-scattered electron images of particle from Compact 6-4-3 with average ^{110m}Ag retention (a) and ^{110m}Ag retention below the detection limit (b). Bright spots indicate fission product clusters.

SEM/WDS analysis of mechanically polished cross sections was used to observe fission product clustering outside of the kernel. Results were similar to those obtained from the SEM analysis of Compact 6-1-1, but it was also noticed in these finer polished specimens that the Pd-U fission product clusters inside the SiC layer, evident as bright spots in Figure 22, could be observed further from the IPyC interface for those particles that released more silver. Further study of the fission product distribution within the SiC is needed to verify this result.

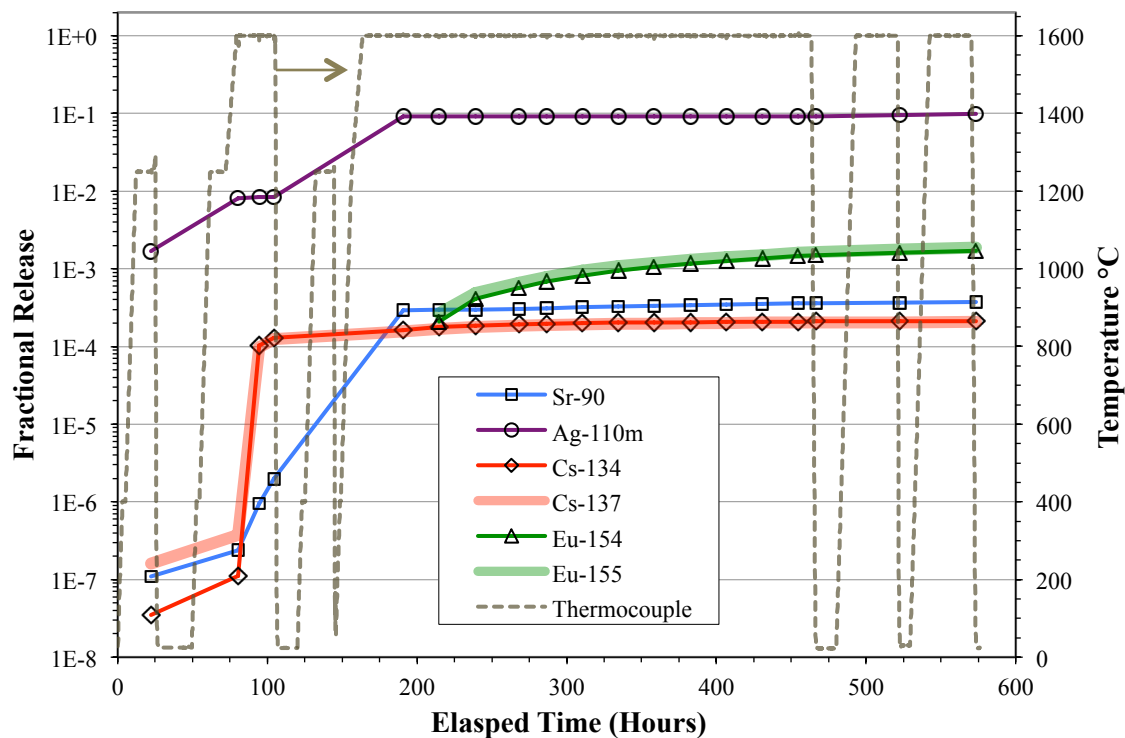
Figure 23. Release of fission products from Compact 3-3-2 during safety testing to 1600°C.

Figure 23 shows the temperature profile and estimated time-dependent fission product releases from Compact 3-3-2; this safety test was unusual because of the thermal cycling evident in the plotted temperature profile. At the beginning of the test, a power supply problem caused the circuit breaker to shut off power in response to an overcurrent condition. The test was restarted and the compact was heated to 1600°C. After removal of the fourth deposition cup, the cold finger jammed and the furnace had to be shutdown until the problem could be corrected. As the compact was being reheated after the cold finger jam, the intermittent power supply failure reoccurred. One interesting result of the inadvertent thermal cycling was that additional silver appeared to be released as a result. In order to better investigate this effect, two additional temperature cycles were intentionally added to the end of the run.

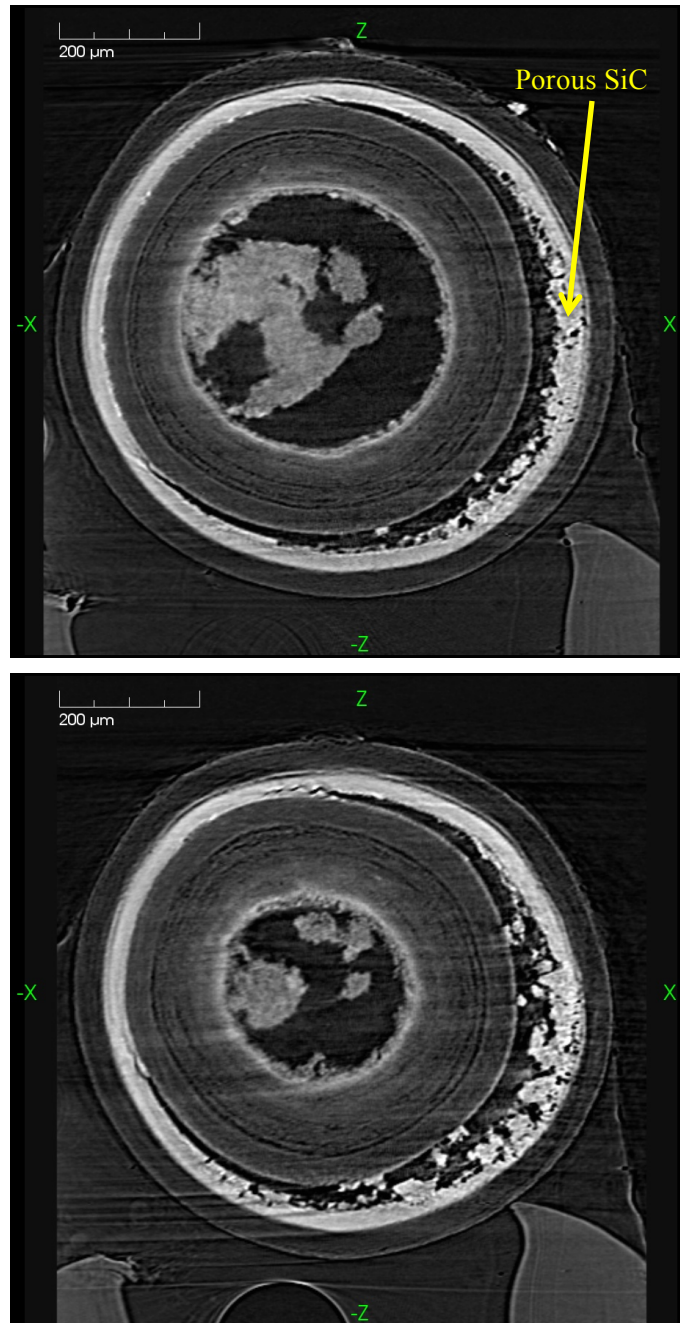
Figure 24. Two x-ray tomographs of two parallel planes through the abnormal particle from Compact 3-3-2.

After completion of x-ray imaging, the particle shown in Figure 24 was placed in a materialography mount and ground down to reveal the defective region. Figure 25 and Figure 26 show a polished cross section through the particle. A crack can be seen in the SiC layer that probably occurred when the particle was heated to 1600°C during the post-irradiation safety test, resulting in cesium release. The fact that negligible cesium was detected on the Capsule 3 components indicates that the defective SiC remained intact until after the irradiation test, in contrast to the behavior of the defective particles in Compact 5-2-3.

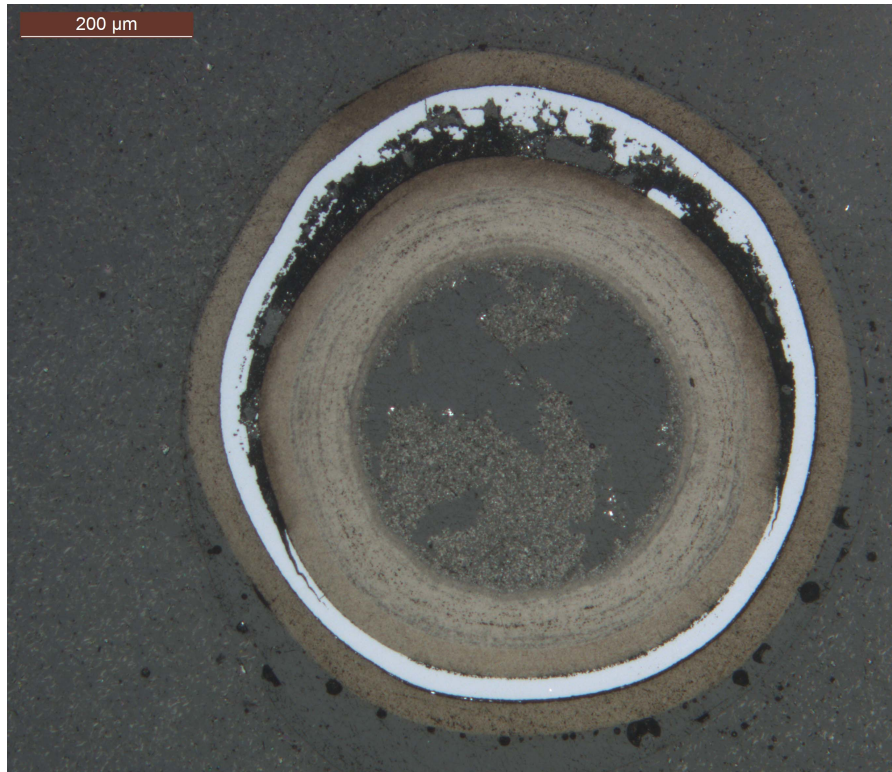
Figure 25. Optical micrograph of a polished cross section of the abnormal particle from AGR-1 Compact 3-3-2, prepared from specimen mounted for x-ray tomography (Figure 24).
