PIE on Five Irradiated AGR-1 Compacts

September 2012

Advanced Gas Reactor (AGR) program

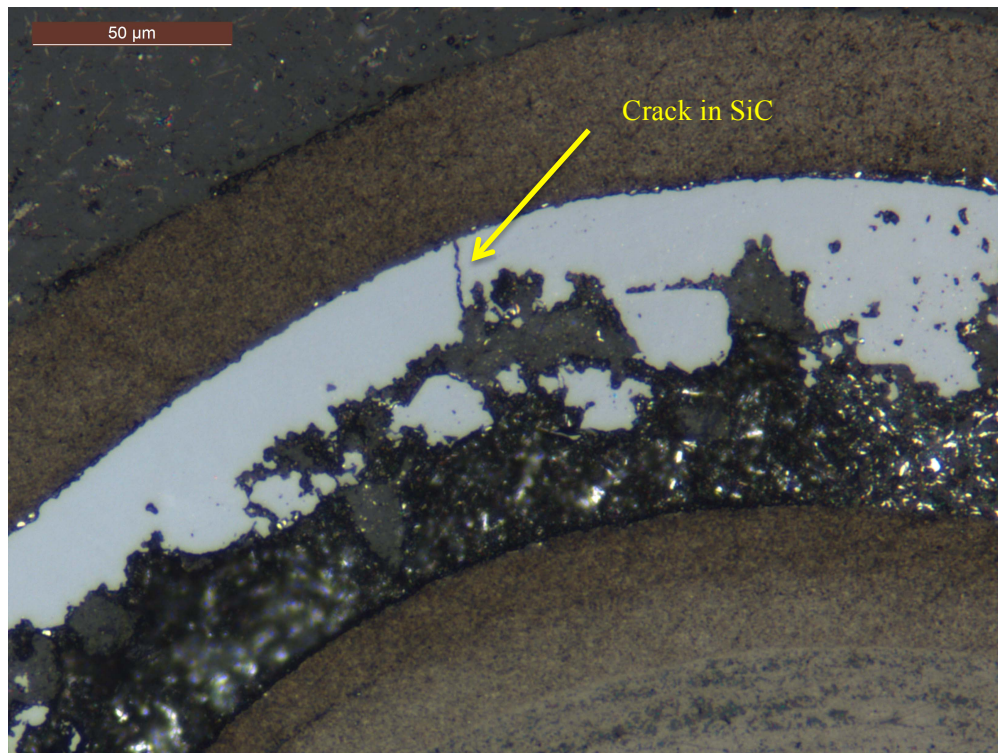
Figure 26. Higher resolution optical image of crack through SiC layer in abnormal particle from AGR-1 Compact 3-3-2.

After completion of x-ray imaging, the particle shown in Figure 24 was placed in a materialography mount and ground down to reveal the defective region. Figure 25 and Figure 26 show a polished cross section through the particle. A crack can be seen in the SiC layer that probably occurred when the particle was heated to 1600°C during the post-irradiation safety test, resulting in cesium release. The fact that negligible cesium was detected on the Capsule 3 components indicates that the defective SiC remained intact until after the irradiation test, in contrast to the behavior of the defective particles in Compact 5-2-3.

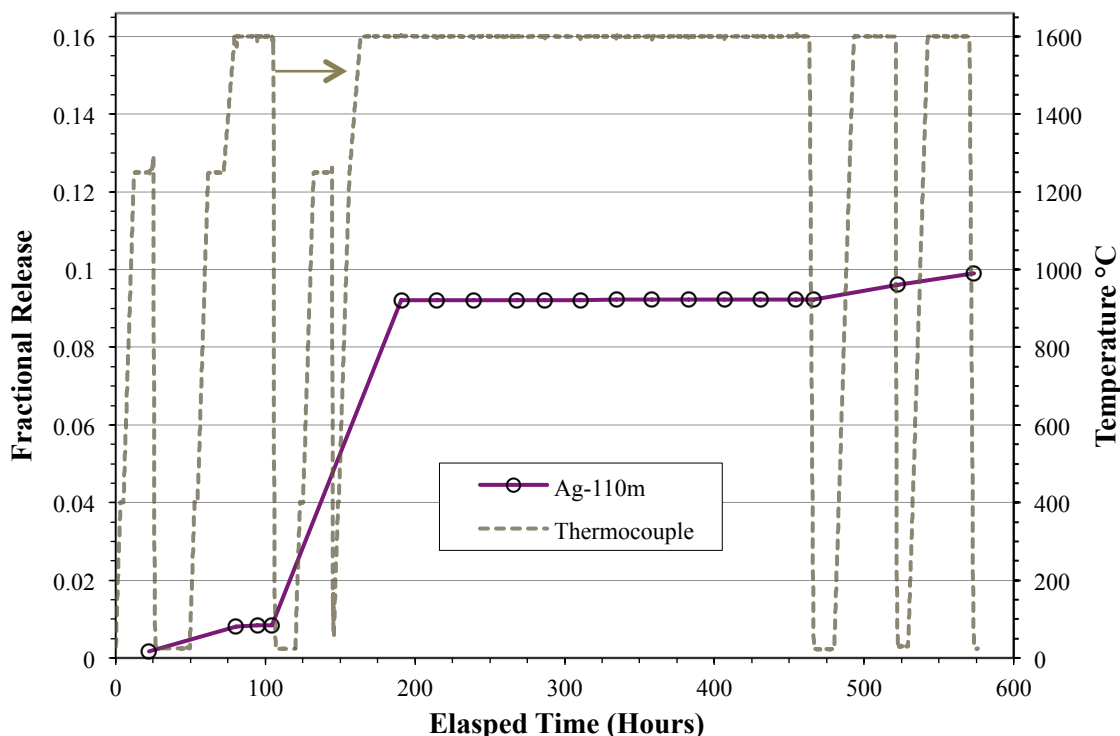
Figure 27. Silver release during AGR-1 Compact 3-3-2 heating test.

Of particular note was that silver release was detected each time Compact 3-3-2 was heated, but no significant silver release was detected while the compact was held at elevated temperature in between the thermal cycles. As mentioned above, two additional thermal cycles were added to the end of the run to further investigate this effect. The silver data is presented using a linear scale in Figure 27 to make the multiple silver release events more evident. Silver release dropped off after the initial rise to 1600°C. After the run was interrupted by the cold finger jam at around 100 hours into the test, the compact was heated to 1300°C, cooled, and then heated to 1600°C. This resulted in a large spike in silver detected at the next deposition cup change. Constant exposure at 1600°C for almost 300 hours did not result in any additional significant silver collection. However, when the furnace was intentionally cooled and ramped back up to 1600°C two more times, more silver was released each time. At this point, it is not clear whether this unusual behavior is due to the temperature cycling or due to the local temperature gradients in the fuel and fuel holder driven by the changing temperature.

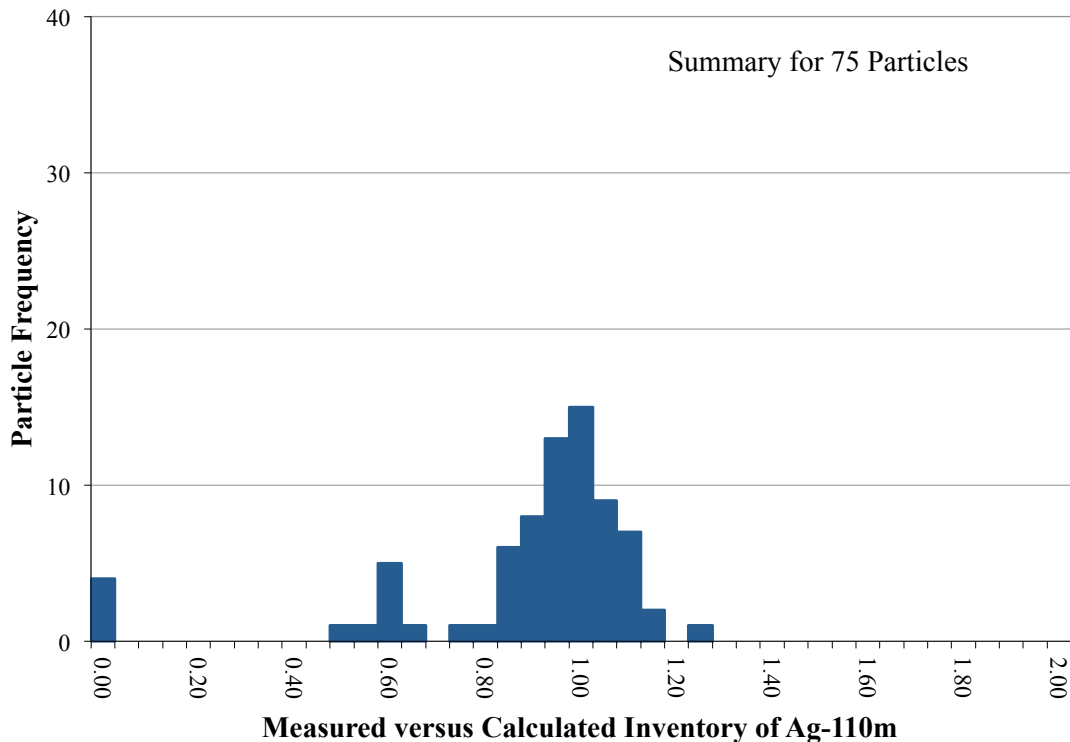
Figure 28. Ratio of ^{110m}Ag retained in 75 particles from Compact 3-3-2 versus calculated inventory, adjusted for variation in fissile material and burnup using the ^{137}Cs activity.

In addition to the 100 second scan of each particle recovered from Compact 3-3-2 used to find the defective particle, 75 particles were riffled out for 5 hour scanning. Results were similar to the other compacts. Narrow distributions were observed for cerium, cesium, and europium. The distribution for ^{110m}Ag was typically broad, with a peak centered around the calculated inventory and a small population of particles that retained less silver (Figure 28). As was done for other compacts, x-ray tomography and materialography were performed on particles selected from this set of 75 particles based on their silver inventory. Microstructure varied as has been seen for particles taken from other compacts, but no obvious correlation to silver retention was observed. Polished cross sections were prepared using conductive epoxy to support future planned SEM analysis to further study the possible role of palladium in silver migration through SiC.
