# REAL-TIME CANISTER WELDING HEALTH MONITORING AND PREDICTION SYSTEM FOR SPENT FUEL DRY STORAGE

**REAL-TIME CANISTER WELDING HEALTH MONITORING AND PREDICTION  
SYSTEM FOR SPENT FUEL DRY STORAGE**

Prepared by  
OAK RIDGE NATIONAL LABORATORY  
Oak Ridge, TN 37831-6283  
managed by  
UT-BATTELLE, LLC  
for the  
US DEPARTMENT OF ENERGY  
under contract DE-AC05-00OR22725

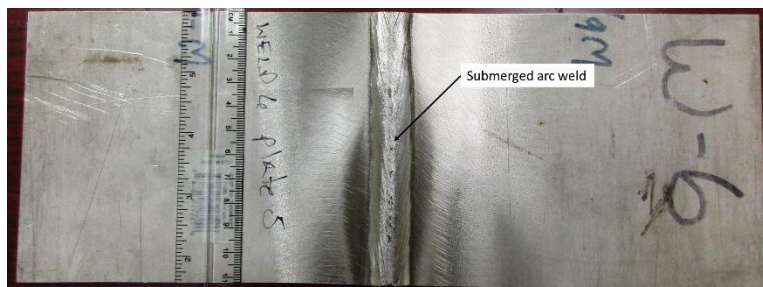
After SAW, the weld was cut into 4.5" X 12" size coupons for the accelerated corrosion test, as shown in Figure 1.

Figure 1. Submerged arc weld coupon for corrosion test

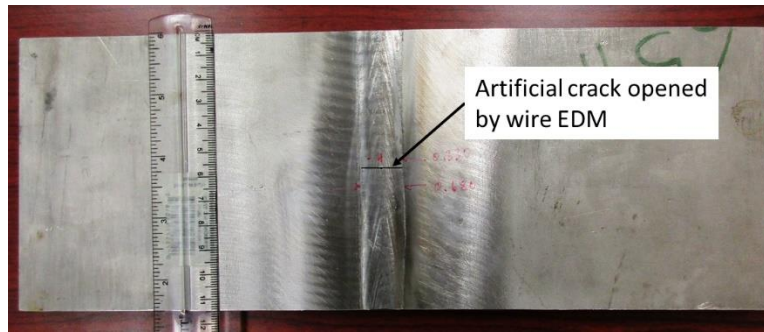
Two weld coupons were prepared for the corrosion test, one coupon was prepared for as welded condition, the second coupon was modified to include an artificial crack in the weld. The opened crack simulated the CISCC in actual SNF canisters. As we have discovered in our previous study, the principal welding tensile residual stress direction in the heat affected zone (HAZ) is along the welding direction [Tang, November 2019], therefore, the potential CISCC would most likely be perpendicular to the principal tensile residual stress or the welding direction. The artificial crack was opened in the weld using a wire electrical discharge machine (wire EDM). It was perpendicular to the welding direction and crack tips were located at the weld toes. In the welded joint, the HAZ is the most sensitive metallurgical zone for CISCC. Our previous study showed that in the HAZ, welding tensile residual stress values increase as the measuring spot moves closer to the weld metal zone (WMZ) [Tang, November 2019]. Therefore, the weld toe, which is the interface of the WMZ and HAZ, is the least corrosion resistant location in this weld. A 0.001" diameter EDM wire was used to open the crack, resulting in a width of 0.0125". The artificial crack opened coupon is shown in Figure 2.

Figure 2. Submerged arc weld coupon with artificial crack

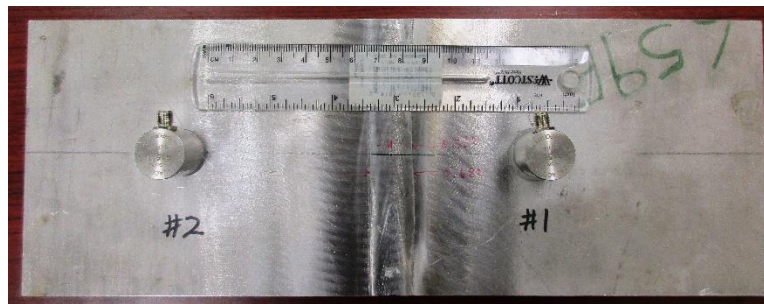
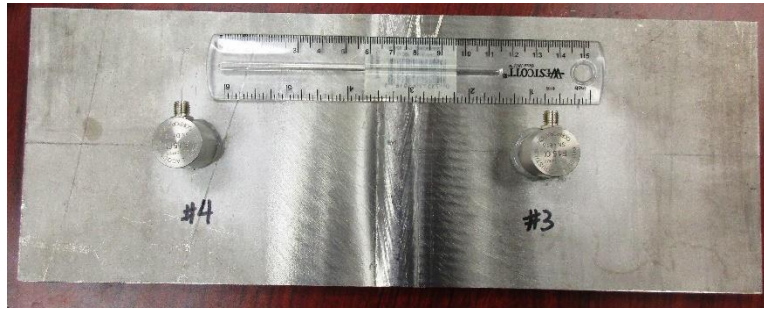
All monitoring devices, including crack propagation signal collecting sensors, signal collecting devices, and control software, were received from IAI. Two sensors were attached to each weld coupon on both sides of the weld using hot melt glue. One was 2" away from the weld toe/crack tip, and the other one was 3" away from the weld toe/crack tip. Sensor IDs corresponding to corrosion test coupons and locations are listed in Table 3. Corrosion test weld coupons with monitoring sensors attached are shown in Figure 3.

Figure 3. Submerged arc weld coupon with sensors attached for corrosion test.  
Top, weld coupon with artificial crack; bottom, weld coupon without artificial crack.

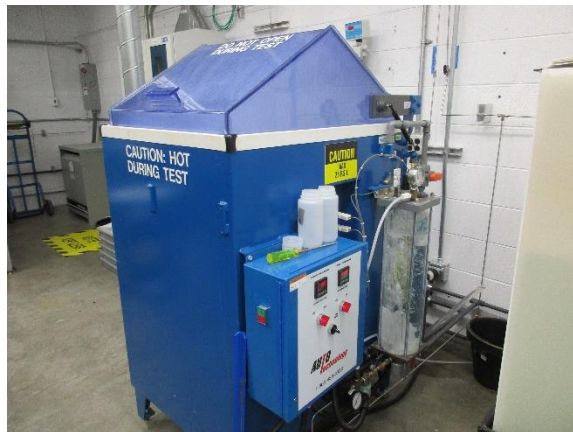
The corrosion test was carried out in a salt fog cabinet called Unifog Dispersion Tower manufactured by Auto Technology. The Unifog Dispersion Tower contains adjustable cone for uniform collection rates, salt spray atomizer nozzle, internal reservoir with cover, pick-up tube and filter assembly. It supplies condensing humidity and liquid mist during the corrosion test. The Unifog Dispersion Tower used for the corrosion test is shown in Figure 4. The picture of test coupons inside the test chamber is shown in Figure 5 and the whole monitoring system setup is shown in Figure 6. The accelerated corrosion test used 5% NaCl solution as the media, and the testing temperature was maintained to 35 °C.

Figure 4. Unifog Dispersion Tower

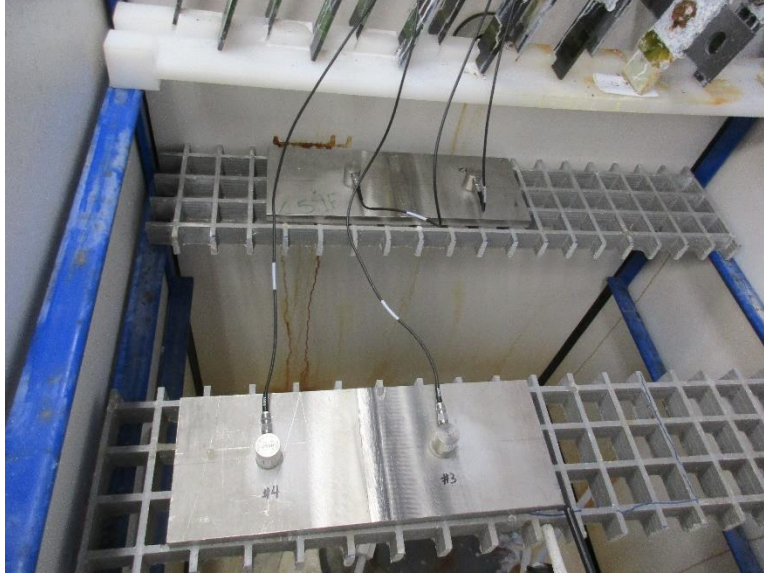
Figure 5. Submerge arc weld coupon in the corrosion testing chamber

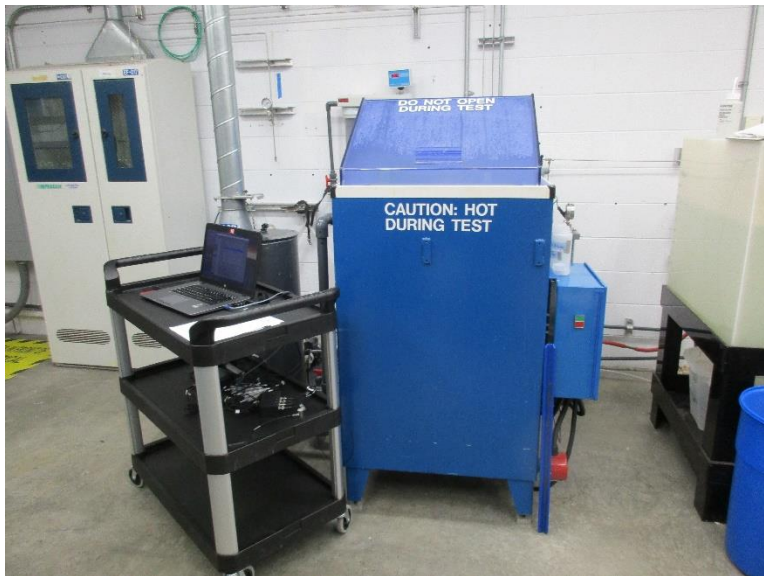
Figure 6. Corrosion testing and monitoring system setup

After the monitoring system has been setup, the accelerated corrosion test was running continuously except weekends and holidays with continuous data collection throughout the test period. The corrosion test and data captured were checked at least once a day. The Unifog Dispersion Tower was maintained daily and the test chamber was cleaned after the machine was shut down for weekends and holidays. The data captured was copied and sent to IAI every week while the test was running.

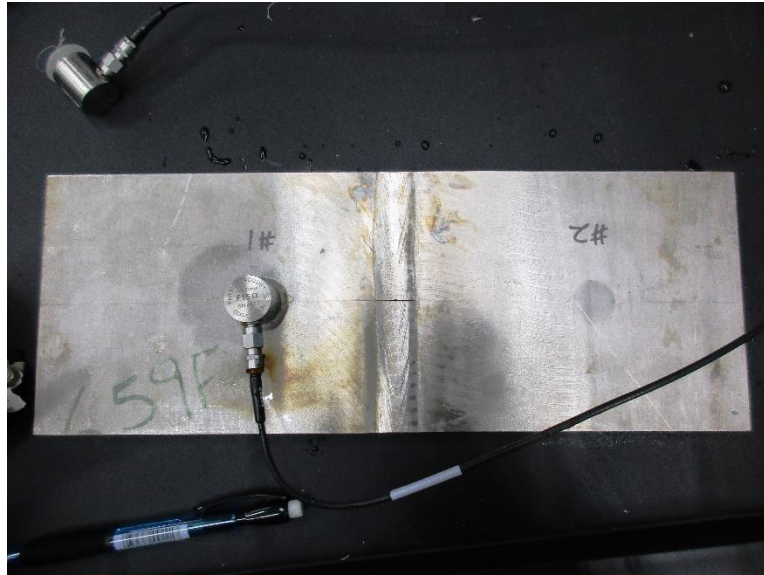
detached sensors were noticed after about a week of corrosion testing in the test chamber. The sensor detaching was probably caused by a number of factors including, attachment technique, the low power glue gun (25 W), the corrosive environment, and others. Figure 7 shows that the #2 sensor detached from the testing coupon after testing in the corrosion environment for about a week. This detaching of sensors also affected the recorded signal amplitude. In the future, a more reliable sensor attaching method/technique should be applied to ensure the recorded signal quality.

Figure 7. The #2 sensor detached from the coupon after a week of corrosion testing.

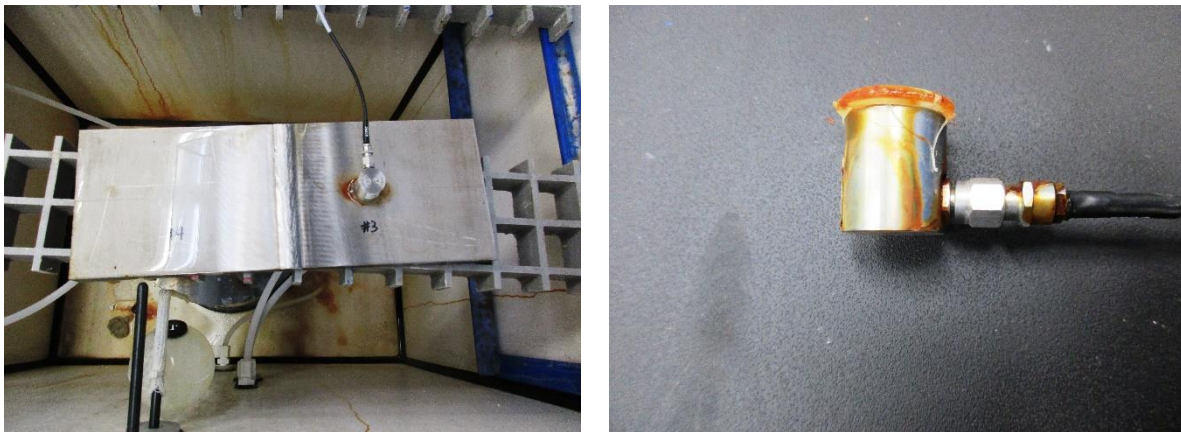
Figure 8. Traces of rusting on the weld coupon (Left) and the monitoring sensor (Right) after a few weeks of corrosion testing.

Traces of rusting were observed on the weld coupon surface and monitoring sensors after a few weeks of corrosion testing in the Unifog Dispersion Tower, shown in Figure 8. Thorough observation identified that the rust was not initiated at the coupon or the sensor surfaces, but at connectors between the sensor

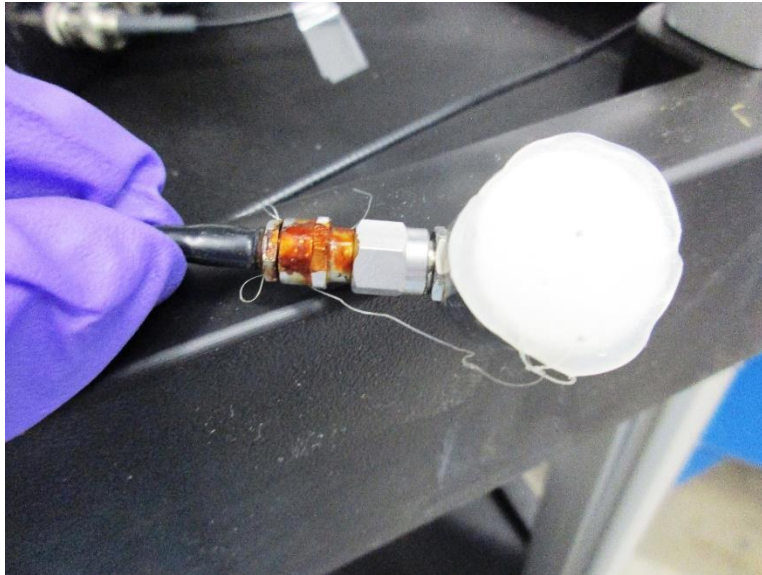
and the cable, see Figure 9 for details. Further observation/examination is needed to identify the rusting initiation spot after the corrosion testing.

Figure 9. Rusting at the connector of the sensor and the cable.
