MICROSTRUCTURE AND STRENGTH OF A THICK-SECTION GAS-TUNGSTEN ARC WELD IN CAST HAYNES® 282® ALLOY

September 2020

Prepared by
OAK RIDGE NATIONAL LABORATORY
Oak Ridge, TN 37831-6283
managed by
UT-BATTELLE, LLC
for the
US DEPARTMENT OF ENERGY
under contract DE-AC05-00OR22725

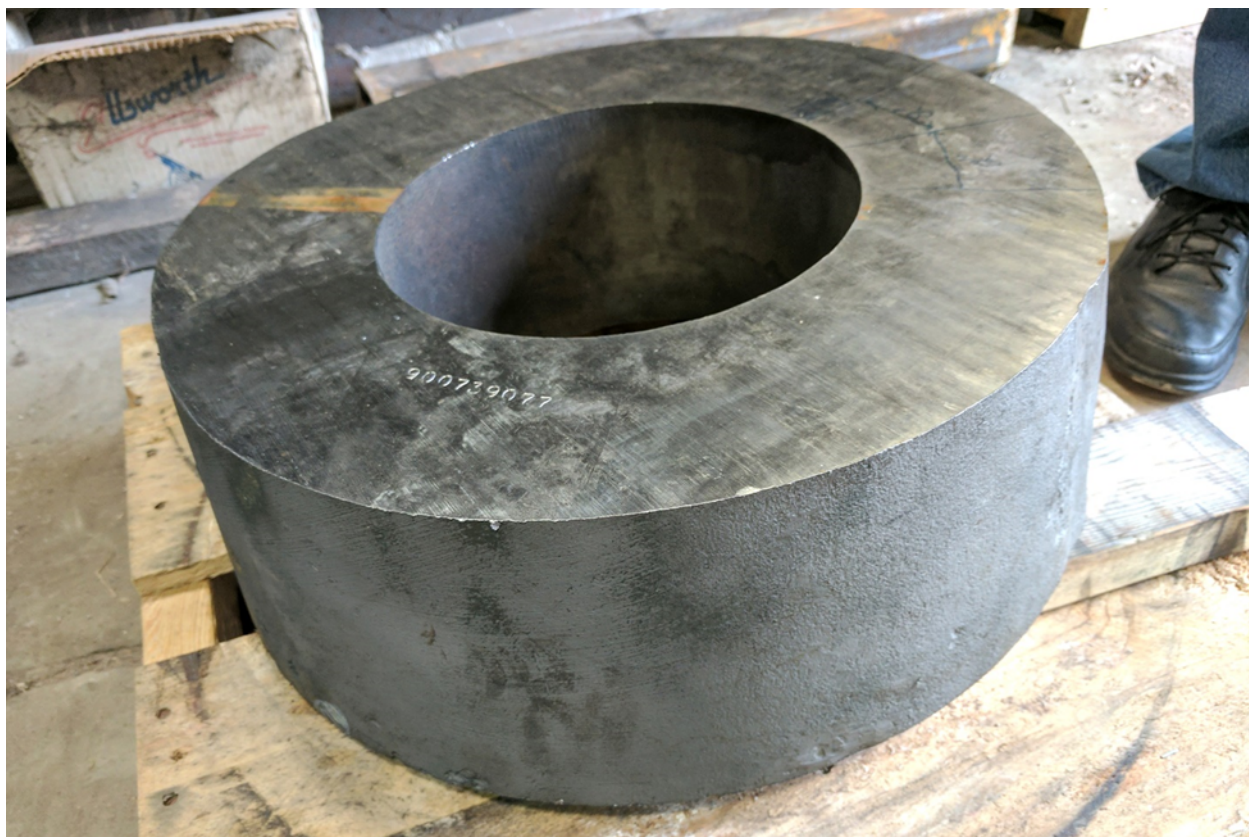
Figure 1: Ring section of Haynes 282 alloy after homogenization and strengthening heat treatment

The Haynes 282 material for this weld was a hollow cylindrical ring section cut from a large, prototype valve body casting weighing approximately 7,700 kg [8]. The ring section was homogenized, spending 68 h between 1190-1225°C, and given the recommended two-step strengthening heat treatment of 2 h at 1010°C followed by 8 h at 788°C [11]. Figure 1 is a photograph of the ring section, as it was supplied for welding. The size of the ring was approximately 355-mm-OD x 100-mm-wall x 152-mm-ring height. The ring was finally cut into two 180° arc sections, one of which was used for welding. This was done to provide enough material for various test specimens while limiting the weld length, and, therefore, the total weight of welding wire needed to complete the desired weld.

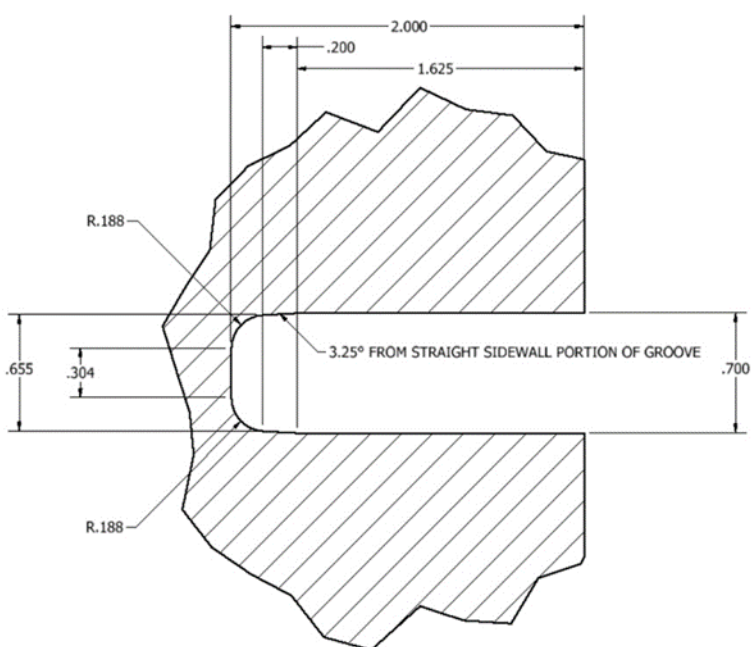
Figure 2: Weld joint machining details (units in inches)

Because extensive machining was required to prepare a joint for welding, the 180° arc section was given another heat treatment of 1 hour at 1150°C to reduce its hardness. The top and bottom surfaces were then machined parallel. The EDM wire cutting process was used to remove excess from the OD and ID and to accurately cut the arc of the OD and ID so they were concentric to each other. After this, EDM was then used to bisect the 180° arc section along its circumference to produce two identical half-ring pieces. The two half-rings were then tack-welded together to form a complete 360° ring that was mounted onto a vertical lathe for machining onto the ring face of the narrow gap joint detail shown as Figure 2. Finally, this assembly was reconfigured as two half-rings and set-up for welding.

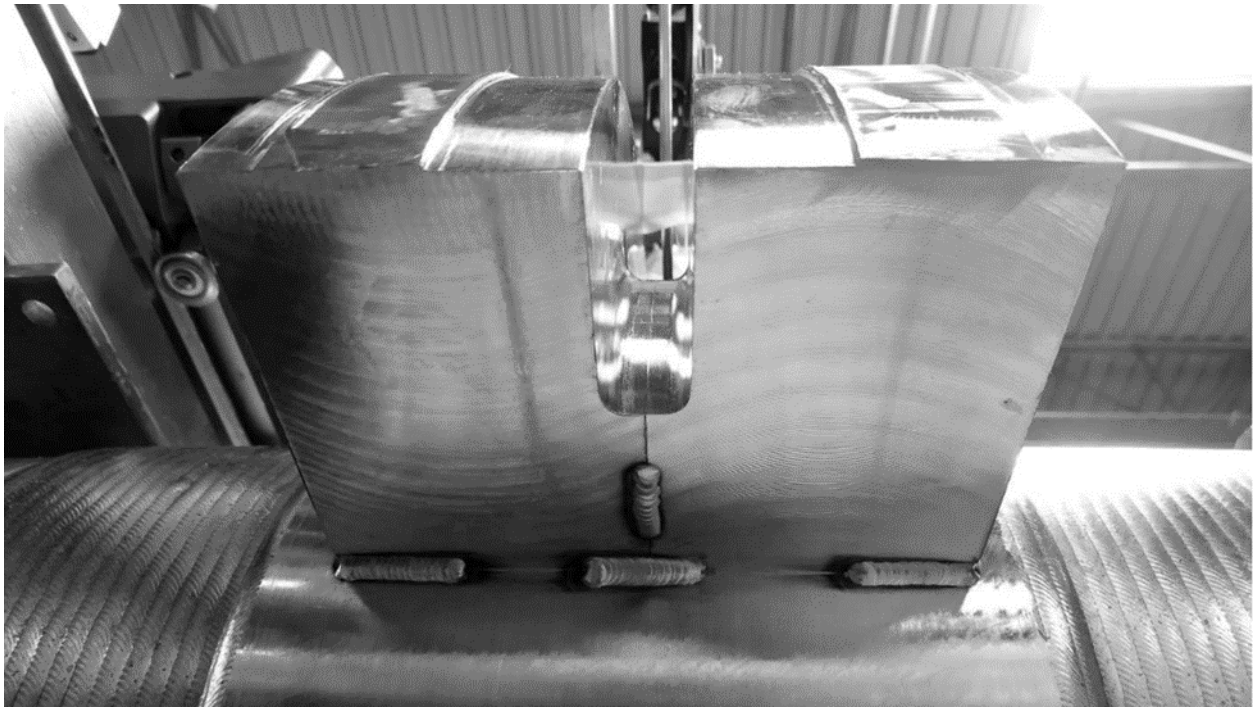
Figure 3: Photograph showing the cast 282 half-ring sections set-up for welding after mating to the weld-overlaid carbon steel pipe but before gusset attachment

Positioning the half-ring assembly for welding involved rigidly attaching it to a length of thick-walled carbon steel pipe with gussets of Inconel 625 plate, Figure 3. The carbon steel pipe had been weld-overlaid with Inconel 617 and machined to mate its OD to the ID of the half-ring assembly.

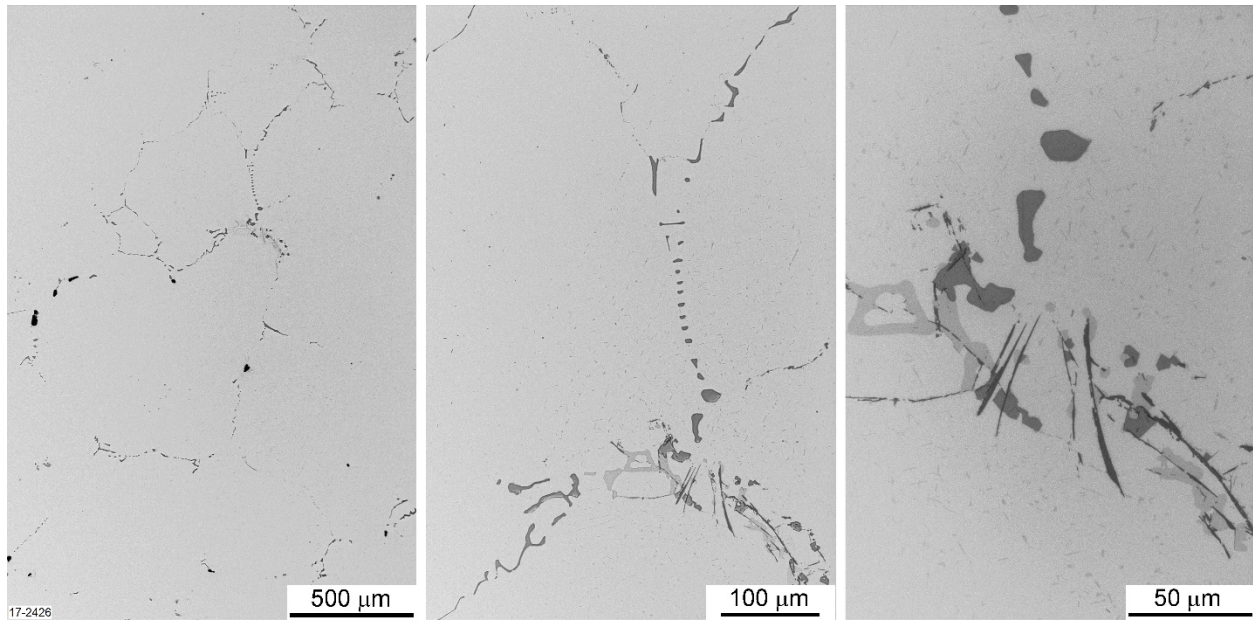
Figure 4: Optical micrographs showing general features of cast microstructure after solution treatment

The cast base metal microstructure was characterized by a large average grain size. No attempt was made to measure grain size, but grains exceeding several millimeters in major dimension could be seen on smooth, cut, or machined surfaces without the aid of magnification. Optical micrographs showing second phases precipitated on grain boundaries are shown in Figure 4 and Figure 5. Grain boundaries were outlined by second-phase particles. Judging from their shape and contrast, the particles represent multiple phases. The relative fractions of the various particles were variable throughout the microstructure. Comparison of Figure 4 and Figure 5. shows the microstructure after the strengthening heat treatment was visually identical to that of the solution treated metal.

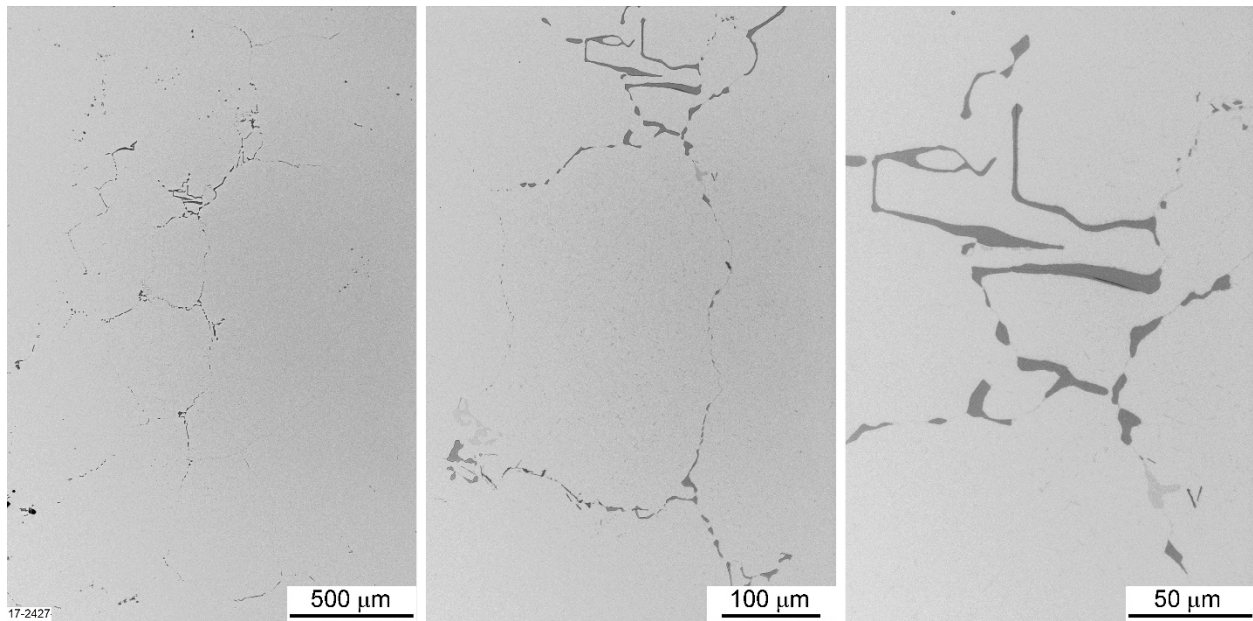
Figure 5: Optical micrographs showing general features of cast microstructure after post-weld strengthening heat treatment

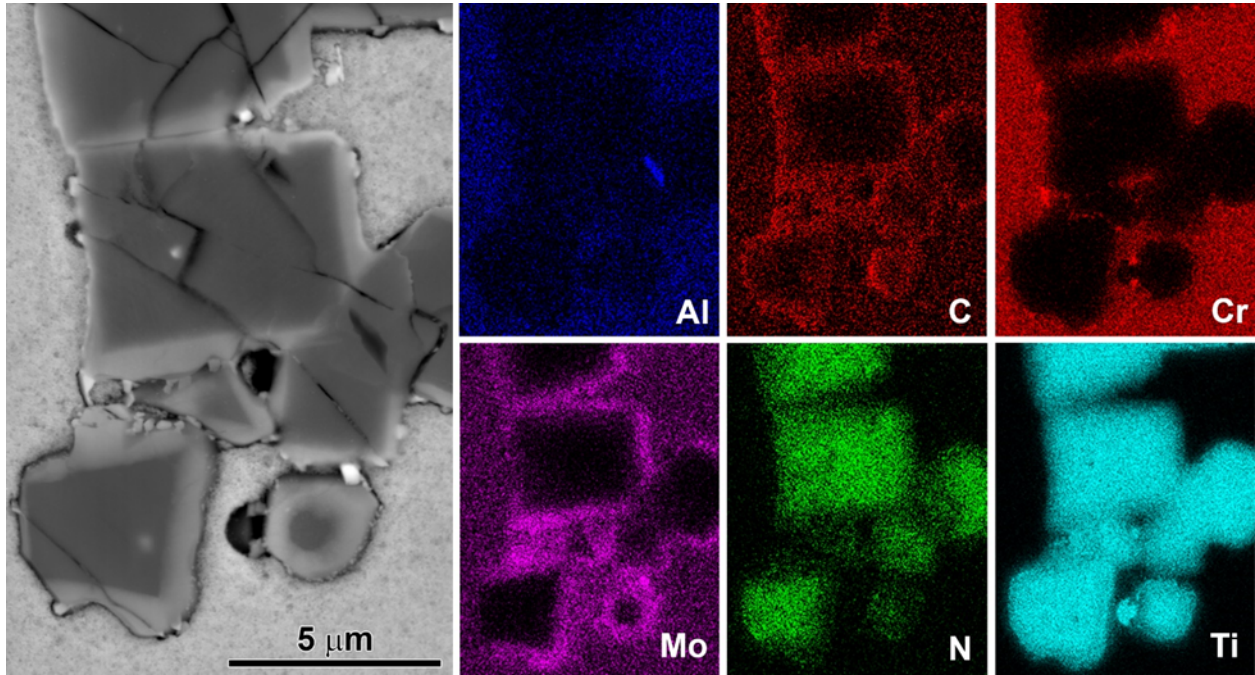
Figure 6: SEM micrograph showing details of isolated second phase particles after strengthening heat treatment

The particles illustrated by Figure 6 were found randomly distributed throughout the base metal microstructure regardless of heat treatment. They had roughly geometrical shapes, and many of them were found in the matrix rather than on grain boundaries. The EDS mapping showed that their cores consisted primarily of Ti and N surrounded by rims also enriched in C and Mo. The size of these particles was often in the range of many microns in major dimension. Many of the larger particles contained cracks as Figure 6 also shows. Other small, submicron particles shown in Figure 6 were enriched in either Al, Cr, or Mo.

Most of the large second-phase particles like those shown in Figure 6, Figure 7, and Figure 8 are MC phase. These have variable chemical composition of (Mo,Ti)(C,N) and formed both on grain boundaries and interdendritically. Both Matysiak et al [15] and Yang et al [16] confirmed by diffraction that these types of particles with variable chemical composition have the fcc structure expected of an MC-type phase. The large particle in Figure 7 is surrounded by many smaller particles in the matrix. Many of those at its interface with the matrix are likely to be M_6C [16]. Presumably, the small Al-rich particles highlighted in Figure 7 are either Al-oxides or Al-nitrides. The group of small Cr-rich particles in Figure 7 must be $M_{23}C_6$ that formed during the final strengthening heat treatment at 788°C.

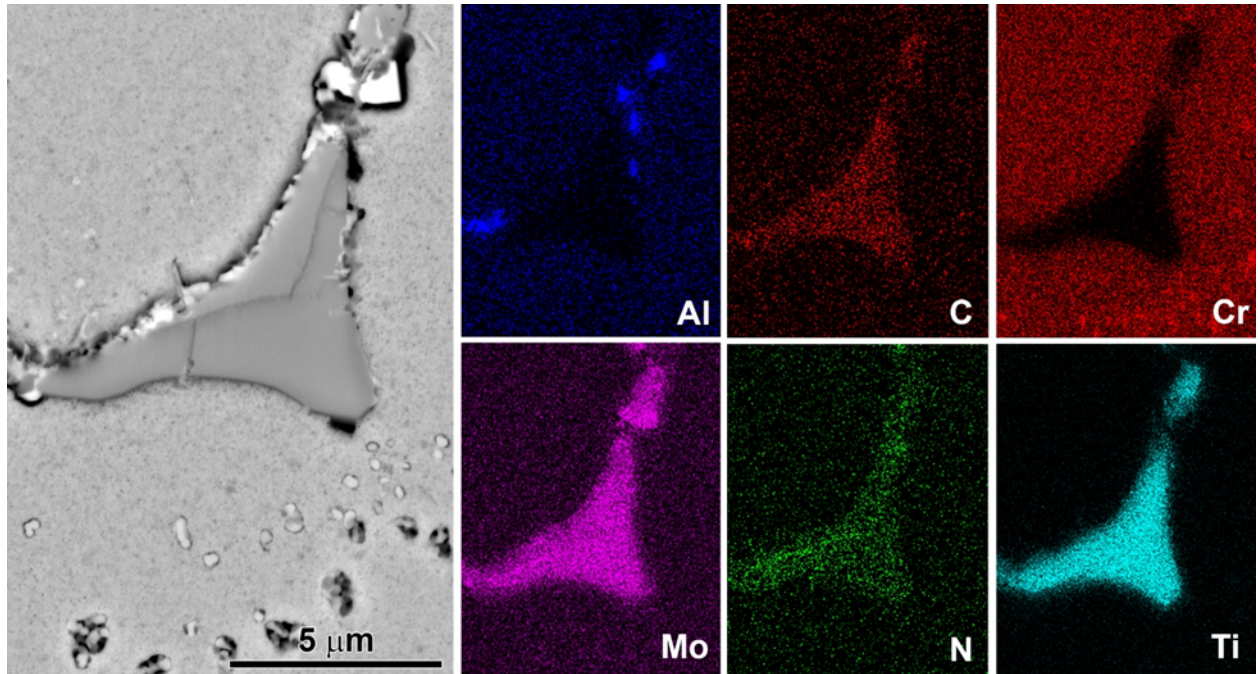
Figure 7: SEM micrograph showing second phase particles on grain boundary after strengthening heat treatment

The particles found on grain boundaries and in interdendritic regions are highlighted by Figure 7 and Figure 8. The large, irregularly shaped particle in Figure 7, found on a grain boundary, is composed primarily of C, N, Mo and Ti. The uniform contrast of the particle suggests its chemical composition also is uniform. Cracks in the particle are also visible. The large particle is surrounded by numerous smaller, submicron-size particles. The EDS mapping indicates some of these are enriched with Al. The mapping results coupled with the bright contrast in the SEM image confirms that many of the small particles are enriched with Mo. A group of submicron particles in the matrix below the large particle is enriched in Cr.

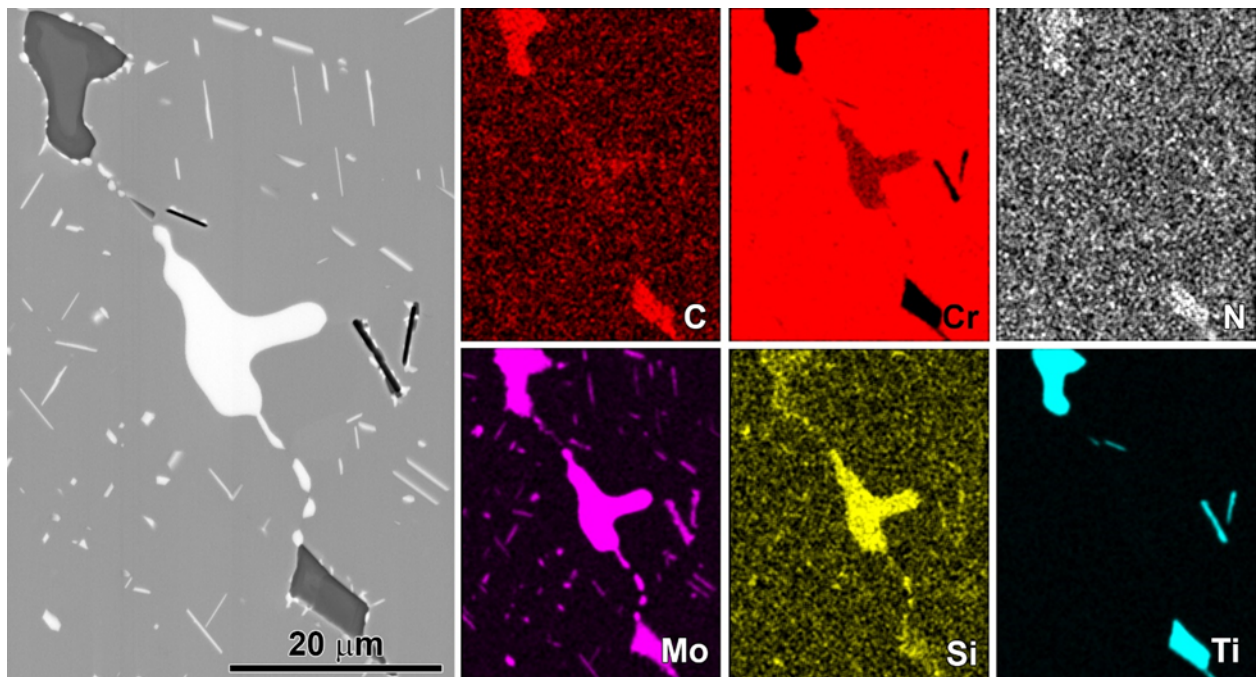
Figure 8: SEM micrograph showing second phase particles on grain boundary after strengthening heat treatment

A length of grain boundary from a different region in the heat-treated casting is shown in Figure 8. A distinctive feature at this location is the large particle of white contrast. The EDS mapping indicates it is composed mainly of Mo and Si with smaller concentrations of C and Cr. Other smaller particles both along the grain boundary and in the matrix appear to have the same composition because of their bright contrast. The two other large particles on the grain boundary are enriched in C, N, Mo, and Ti, and, judging from contrast, they have cores and rims of differing chemical composition. This is similar to those shown in Figure 6, except that their contrast characteristics are reversed with cores that are brighter than their rims. Rod-shaped particles enriched in Mo and Ti also occur in the matrix at this location. The dark contrast associated with these is like that of the dark rims around the larger particles on the grain boundary.

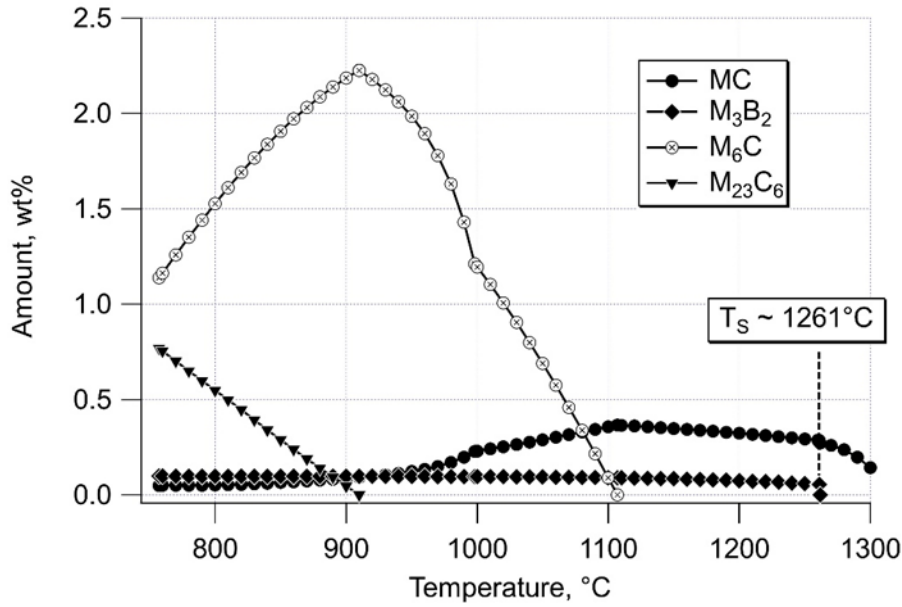
Figure 9: Calculated variation of equilibrium phases with temperature

By supplementing the metallographic observations with thermodynamic calculations most of the second phase particles in the base metal were identified with reasonable confidence. The results of calculating the variation of equilibrium second phases with temperature are shown as Figure 9 [12] where the fcc matrix

is omitted to highlight the minor phases. Also omitted is γ' , which has a calculated solvus of 998°C, and μ , with a calculated solvus of 757°C. The γ' is omitted because it was not directly observed, and there is no reason to expect its presence deviates from expected behavior [10,13]. The μ was omitted because its formation is not expected without long time aging [14]. Furthermore, there are no published accounts of significant μ formation in Haynes 282. Also highlighted in Figure 9 is the calculated solidus of 1261°C. Considering the extensive heat treatments the casting received before welding, consisting of homogenization, the strengthening heat treatment, and solution treatment, it was expected that the casting microstructure was better represented by equilibrium conditions rather than those of a Scheil non-equilibrium solidification analysis. Scheil analyses with and without back diffusion, however, were also done.

Figure 9 indicates that an MC phase is stable above the solidus. If it formed in the liquid phase its shape would be relatively unconstrained by surface energy considerations, and it would tend to appear in areas that were last to solidify as well as being more generally distributed throughout the base metal. These features along with the EDS results are consistent with identifying the large particles shown in Figure 6 as cubic TiN. Other works on cast 282 [15,16] also show that both TiN and cored, irregularly-shaped MC particles are commonly observed. The calculated equilibrium composition of MC phase is presented in Figure 10. This result indicates that above the 1261°C solidus nearly pure TiN is the most likely form of MC phase. Below the solidus, the MC phase tends to become increasingly enriched in C until higher N concentrations are more stable once again at temperatures below about 750°C. Figure 9 also predicts that the amount of MC phase slightly increases with decreasing temperature between the solidus and the solvus of M₆C. The formation of thin C-enriched rims on the primary TiN particles is consistent with this predicted behavior. Although it is not captured by the thermodynamic analysis, enrichment of the MC phase with C appears also associated with enrichment of Mo. Some of the submicron-sized particles in Figure 7 are likely Mo₆C and Cr₂₃C₆ as discussed in detail by Yang et al. [16]. Small Al-rich particles inside TiN, like Figure 7 shows, were also found by Matysiak et al [15]. Those were assumed to be oxides on which the nitride nucleated.

Although the occurrence of borides is predicted, Figure 9, none could be specifically identified during any of the characterization. No borides were reported in the works of either Matysiak et al [15] or Yang et al [16] on cast Haynes 282. On the other hand, M_5B_3 has been identified in Haynes 282 and linked to the heat-affected zone cracking of welds [17].

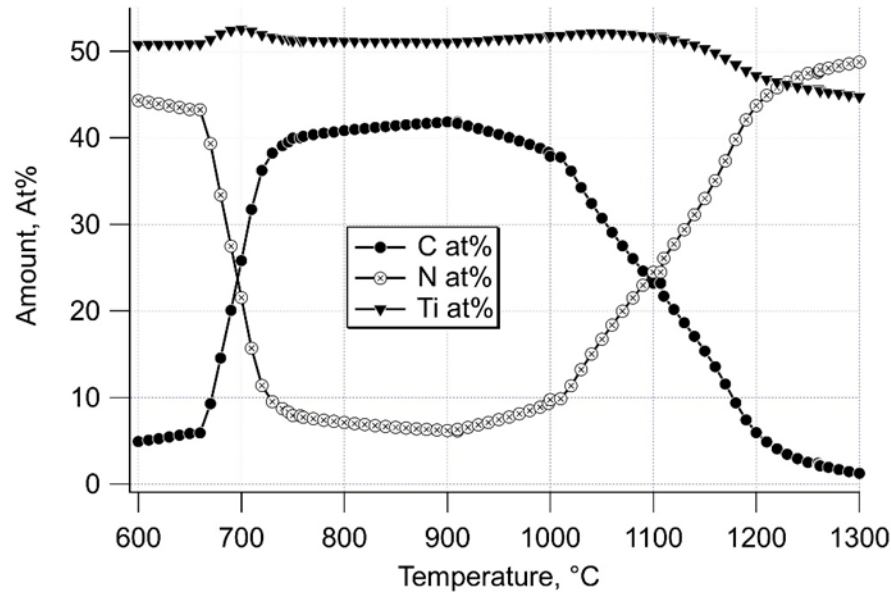
Figure 10: Calculated equilibrium composition of MC phase

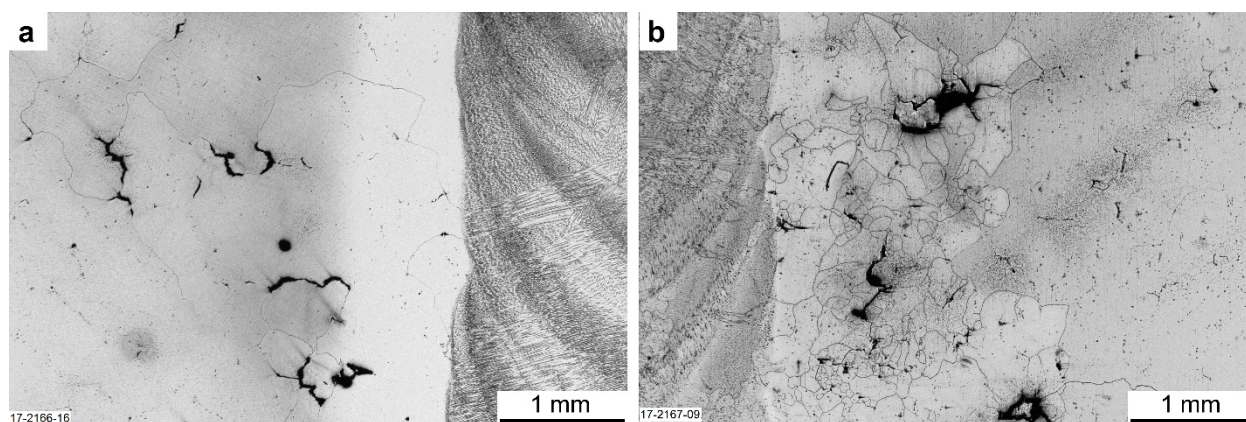
Figure 11: Optical micrographs showing weld heat-affected zone microstructure of solution treated base metal (a) and after post-weld strengthening heat treatment (b)

The heat-affected zone microstructure of solution treated base metal, Figure 11(a), was characterized by a distinct region of light etching adjacent to the weld fusion line. Because the fusion line establishes a temperature at the solidus, the near heat-affected zone, i.e., that region of the heat-affected zone

Figure 11(b) shows the microstructure of a similar heat-affected zone region after the post-weld strengthening heat treatment. To varying degrees, regions of recrystallization in the near heat-affected zone, like that shown in Figure 11(b), were distributed along the periphery of the weld. These were typically adjacent to the fusion line. Although cracks were also found at this location, they generally did not intersect the fusion line, but tended to occur a short distance from it.

associated with the machining. It is clear that the welding operation did not induce recrystallization, Figure 11(a). The recrystallization must have initiated during heating to and holding at 1010°C, the first step of the second strengthening heat treatment. Whether this can be a source of concern for mechanical behavior will need further evaluation. In any event, it is likely that machining operations can be modified to minimize or eliminate conditions favorable to promoting recrystallization.

Considering this rationale, the optical micrograph after welding the solution-treated casting, Figure 11(a) illustrates a situation that could be identified as strain-age cracking. The heat-affected zone adjacent to the fusion line at this location is free of visible defects. The peak temperatures in this region would have been high, approaching the solidus, but cooling rates would also be relatively high. These conditions are not conducive to precipitation of strengthening phases. With increasing distance from the weld fusion line, both the peak temperatures and cooling rates will progressively decrease. In a zone of moderate distance from the fusion line, peak temperatures would be below the γ' solvus and residence time there could be long enough for significant precipitation. These regions would be susceptible to strain-age cracking, so the microstructure highlighted by Figure 11(a) is consistent with this behavior.

Often the probable source of heat-affected zone cracking can be established by metallographic examinations. Many of the heat-affected zone cracks like shown in Figure 11(b) either intersected the fusion boundary between base metal and weld metal or were close to it. It was not possible, however, to determine unequivocally that any phases indicative of liquation occurred at these crack surfaces. On the other hand, cracks like that shown as Figure 12 were found at various locations in the heat-affected zone. The evidence from Figure 12 and Figure 13 suggests that this crack could have resulted from liquation of a large MC particle and that reactions with nearby particles contributed to the event. Based on the foregoing discussion, it seems prudent to be concerned about heat-affected zone cracking in cast Haynes 282, but firmly establishing tendencies for it will require a more focused, detailed study.

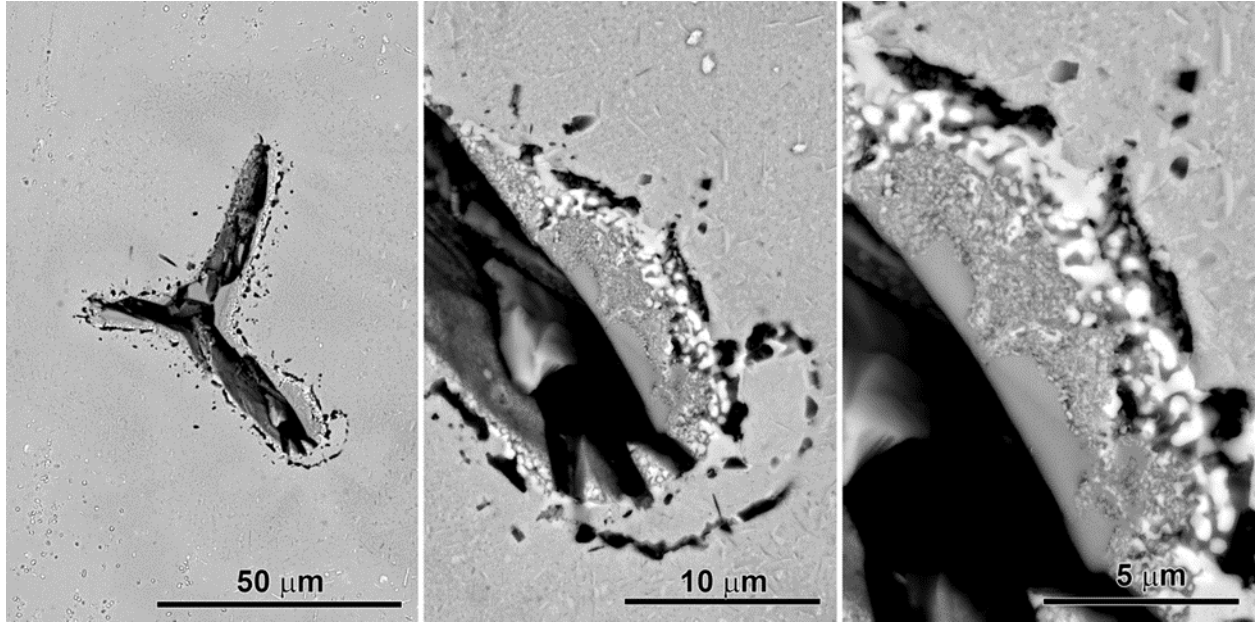
Figure 12: SEM micrograph of a second-phase particle in the weld heat-affected zone after post-weld strengthening heat treatment

An example of a feature found in the heat-affected zone is illustrated with Figure 12 and Figure 13. The overall shape of the feature is similar to the large MC particle shown in Figure 7, but instead of being an intact particle it is a crack surrounded by phases of more complex morphologies. The EDS mapping was inconclusive about the C distribution, but spot analyses confirmed that locations such as the location labeled 3 on the image are the (Mo,Ti)(C,N) found throughout the cast microstructure. The bright contrast features labeled 1 appear to be individual particles that are primarily elevated in Mo and Cr. This also was confirmed by spot analysis. The region labeled 2 in the image appears composed of more than one phase. It is elevated in Mo, Ti, and N. Other particles that may be Al-nitride or Al-oxide are also visible. The overall appearance is suggestive of the transformation or reaction of a large MC particle into various product phases.

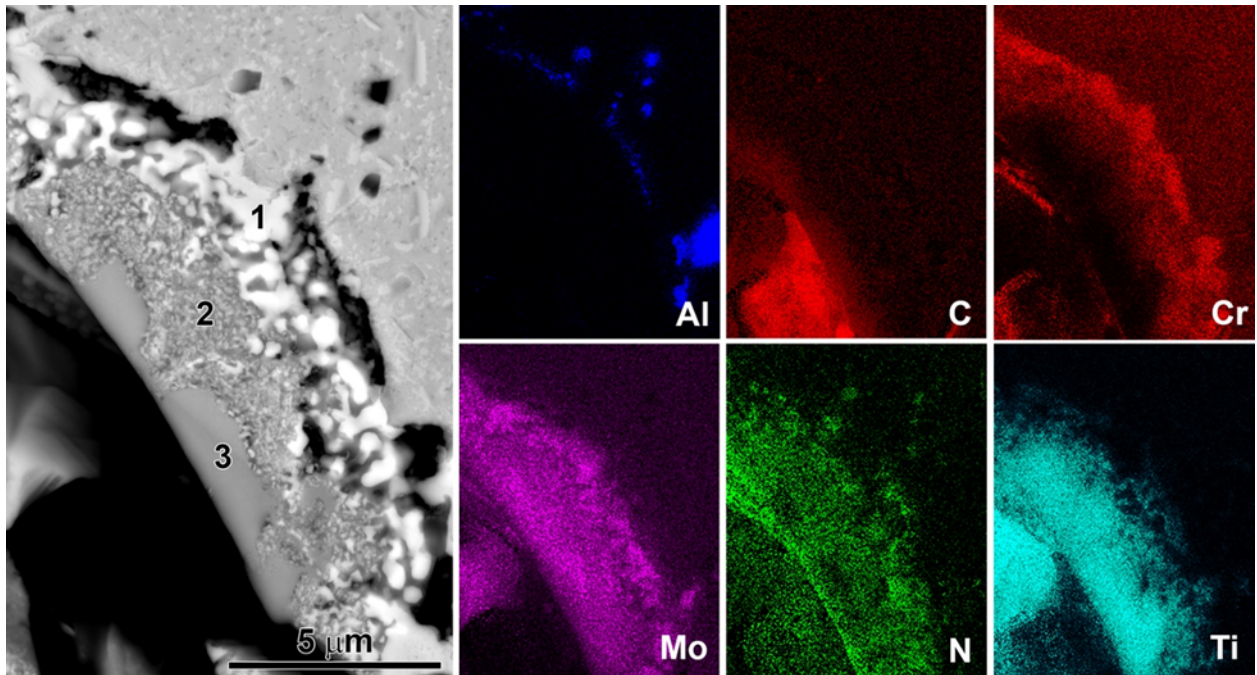
Figure 13: SEM micrograph of second-phase particle including EDS chemical composition maps

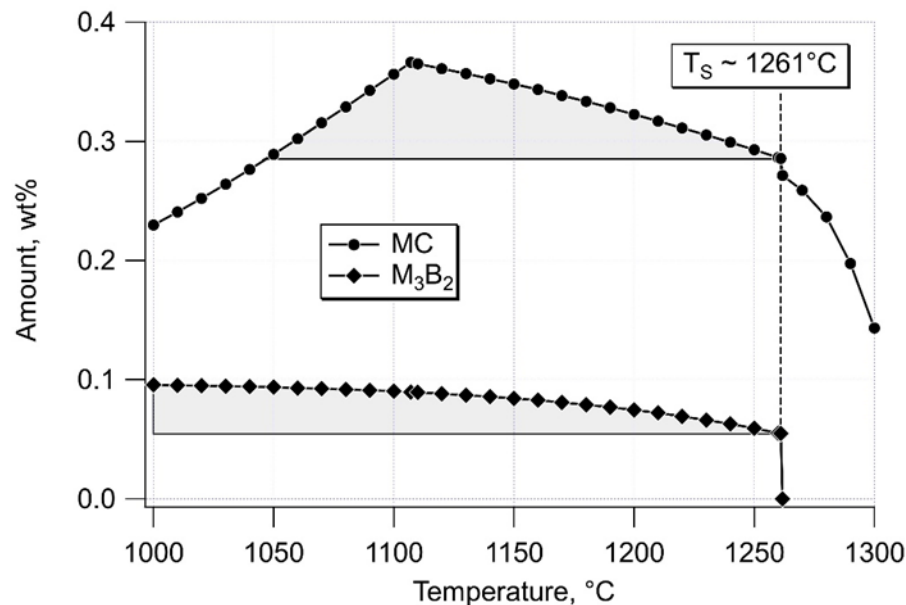
Figure 14: Calculated variations of the amounts of MC and M_3B_2 phases

Rapid dissolution of borides and carbides on grain boundaries is a plausible source of liquation in Haynes 282. This can be visualized with Figure 14 where the thermodynamic predictions from Figure 9 are replotted to highlight the M_3B_2 and MC phases. Below the 1261°C solidus, the amount of M_3B_2 continuously increases. Consequently, metal that experienced heat treatments below the solidus would likely contain an amount of M_3B_2 higher than the amount stable at the solidus. When metal with the higher amount of M_3B_2 was heated to the solidus during welding, for instance, an amount of M_3B_2 higher than what existed at the solidus would begin rapidly dissolving. The shaded region in Figure 14 represents this amount. The dissolution of any excess amounts of M_3B_2 that exist on grain boundaries will increase the local concentrations of B which is a powerful melting point depressant in Ni. A plausible result of this

is the occurrence of liquid films at low temperatures relative to the solidus and an increased tendency for heat-affected zone cracking. A similar situation exists for MC phase although its behavior is somewhat more complicated because of the formation of M_6C below about 1110°C. Rapid dissolution of MC could cause locally elevated concentrations of Ti, another powerful melting-point depressant in Ni.

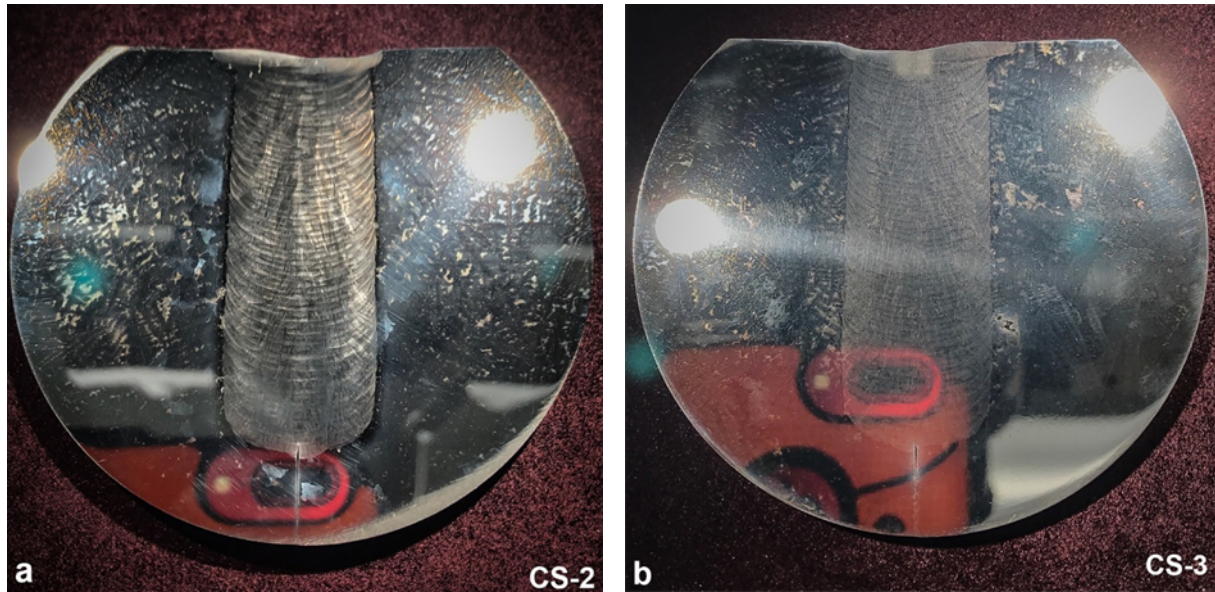
Figure 15: Photographs of full-section weld deposit (a) as-welded, and (b) after post-weld strengthening heat treatment

The photographs in Figure 15 show the full depth of the cross-sectioned weld before and after final heat treatment. The weld deposit is characterized by the variations of microstructure normally associated with deposition of successive weld beads. Otherwise, it appears to be of high quality with no visible indications of physical defects like porosity, lack-of-fusion defects, cracking, or entrapment of extraneous materials. Defects in the cast base metal are also visible.

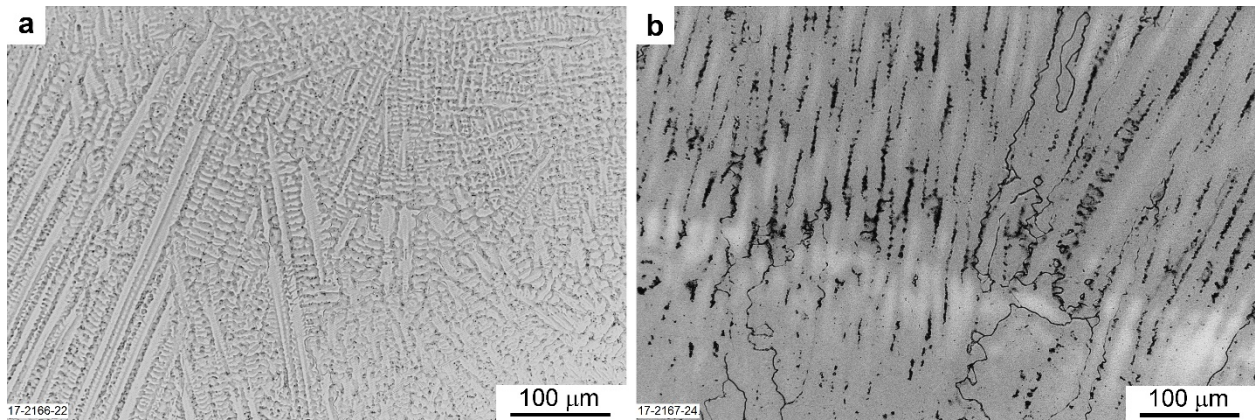
Figure 16: Optical micrographs of the weld deposit before (a) and after (b) post-weld strengthening heat treatment

Optical micrographs taken in the weld deposit show its microstructure before, Figure 16(a), and after, Figure 16(b), the final heat treatment. The dendritic structure with secondary dendrite arm spacing in the 5-8 μm range is clearly visible before heat treatment. Interdendritic regions etched much darker after heat treatment, presumably related to precipitation in those locations. Well defined grain boundaries are also visible after heat treatment. The light etching band in the lower half of Figure 16 is associated with the boundary between successive weld beads. Heating from deposition of the upper bead could promote a local variation of precipitation and encourage a limited amount of elemental distribution. Epitaxial growth of grains from the lower bead into the upper one is also apparent.

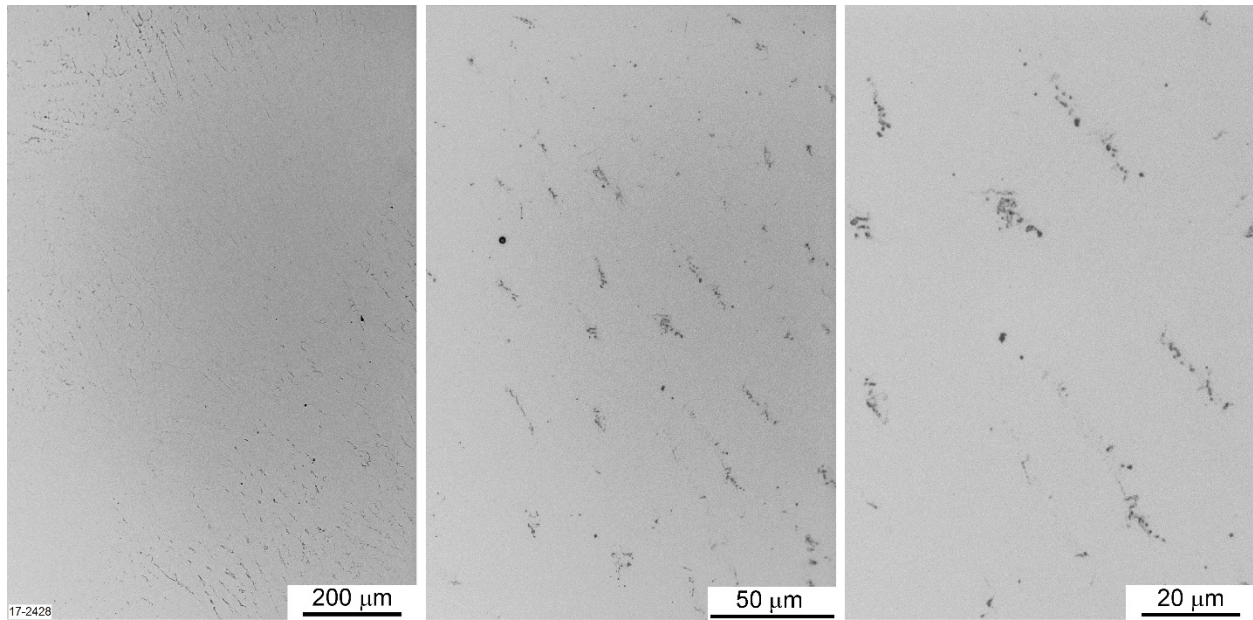
Figure 17: Optical micrographs of weld deposit after post-weld strengthening heat treatment

The series of optical micrographs presented as Figure 17 provide a more detailed view of the weld deposit after post-weld heat treatment. This specimen was prepared for examination in the SEM. The dark features in the micrographs are the interdendritic regions.

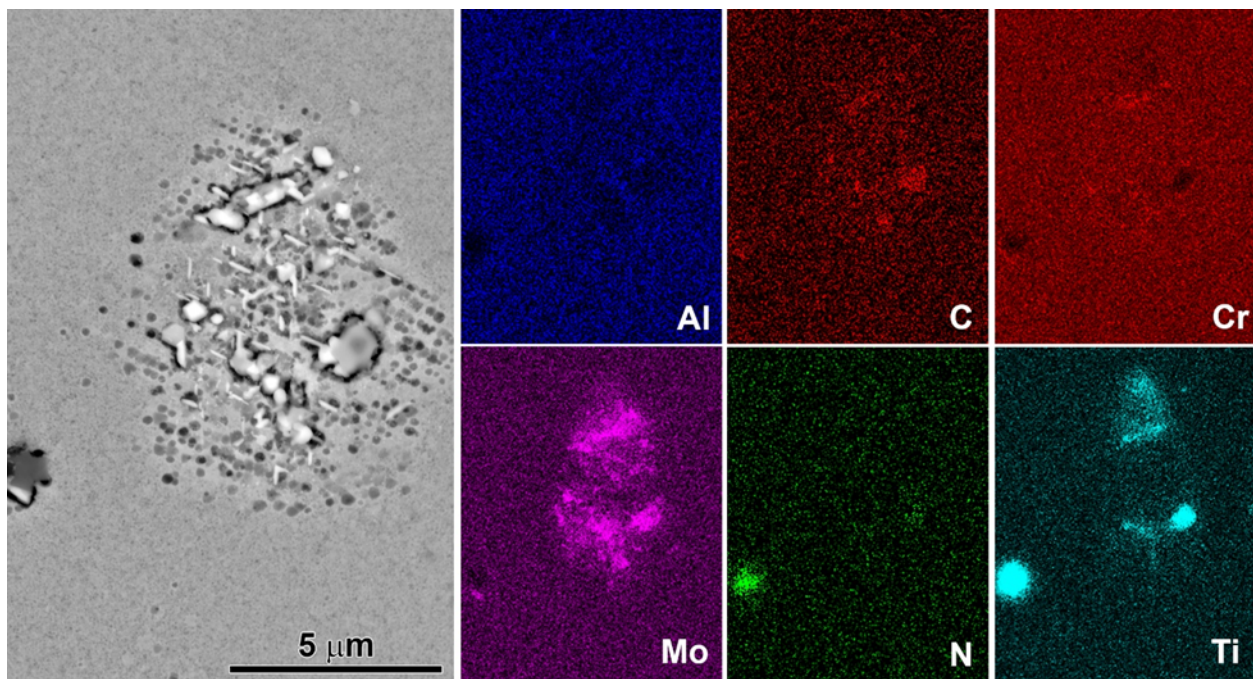
Figure 18: SEM micrograph and analysis results from interdendritic region of weld deposit after post-weld strengthening heat treatment

The results from SEM examination of an interdendritic region in the weld deposit are shown in Figure 18, where particles ranging in size from submicron to several microns in major dimension were found. The chemical analysis results show that Mo is distributed throughout the group of particles. Judging from their contrast, many particles have relatively high Mo concentrations, including small particles that present as rod-shapes on this planar surface. These could be the type of particles imaged in Figure 8. A few of the

larger particles appear to have the contrast, contrast gradation, and chemical composition characteristics of the MC carbide and nitride phases found throughout the base metal. There is also an indication of the presence of small particles enriched in Cr, similar to those shown in Figure 7. The small spherical particles distributed mainly around this grouping are likely the γ' phase.

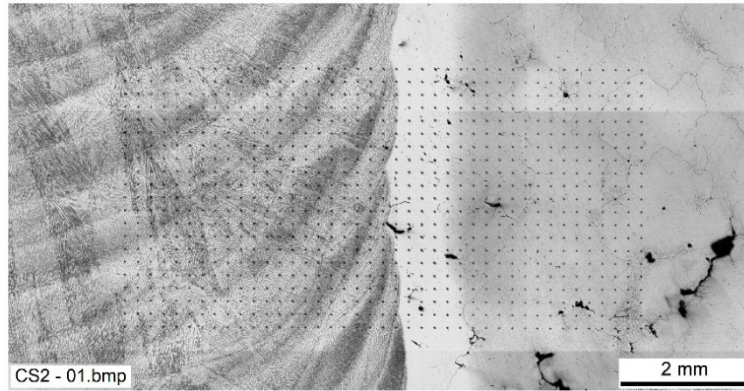
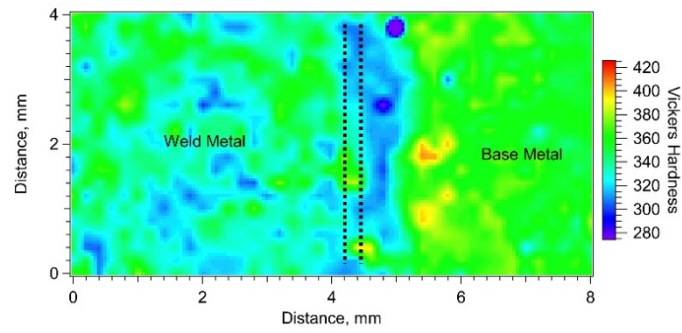
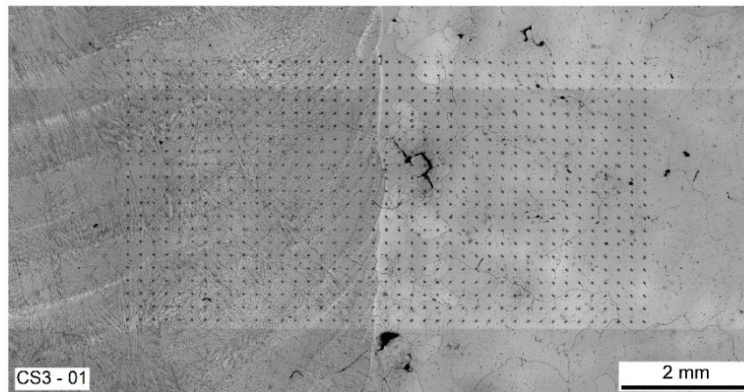
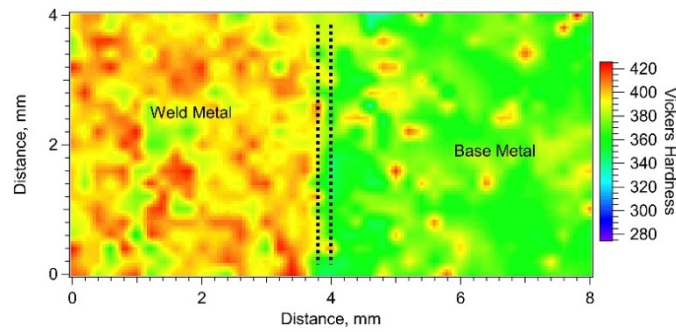
Figure 19: Hardness distributions: (a) as welded condition with solution-treated base metal; (b) and after post-weld strengthening heat treatment

The results from hardness testing are presented in Figure 19. The upper portion of each figure is an optical micrograph showing the arrays after the indentation procedure, and the lower portion is an image plot of the data showing its distribution around the weld deposit/base metal fusion boundary. The approximate location of the fusion boundary is also shown on the hardness image plots. Average hardness values were determined using the leftmost 5 x 21 indent arrays for the weld deposit and the rightmost ones for base metal. In the as-welded condition, Figure 19(a), the weld deposit hardness is 341 ± 16 , and the base metal hardness is 355 ± 10 . Using a 3 x 21 array, the hardness was estimated as 321 ± 26 in the narrow, light-etching region in the base metal adjacent to the fusion boundary.

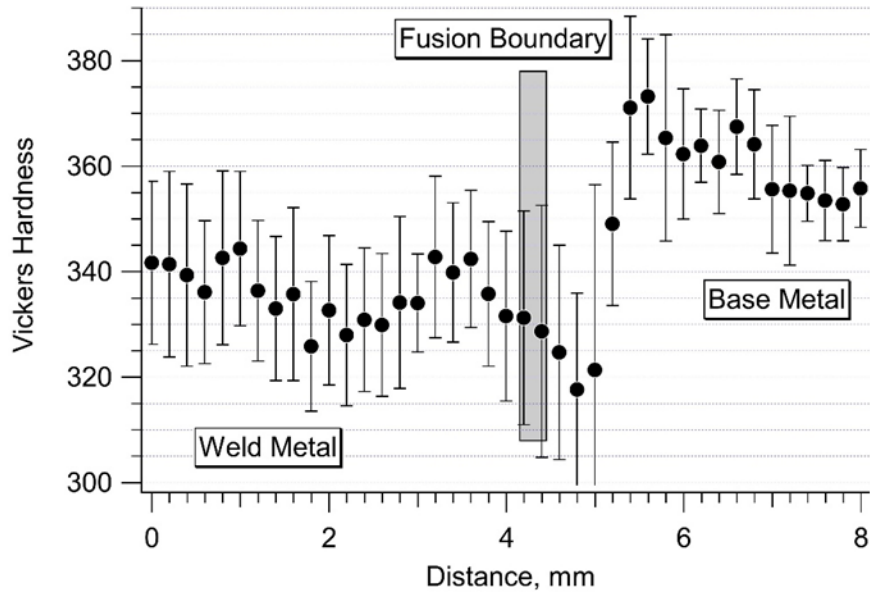
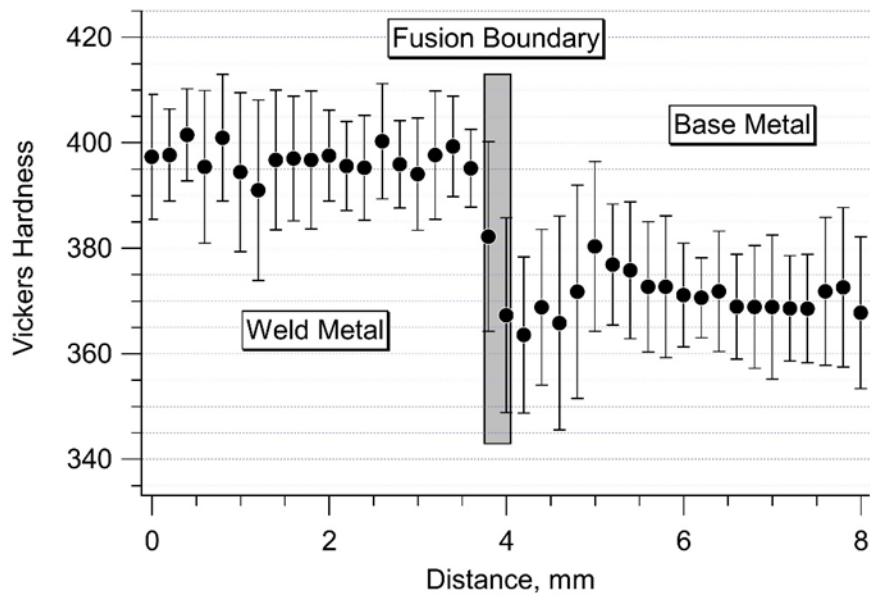
Figure 20: Hardness traverse plots: (a) as-weld condition with solution-treated base metal; and, (b) after post-weld strengthening heat treatment

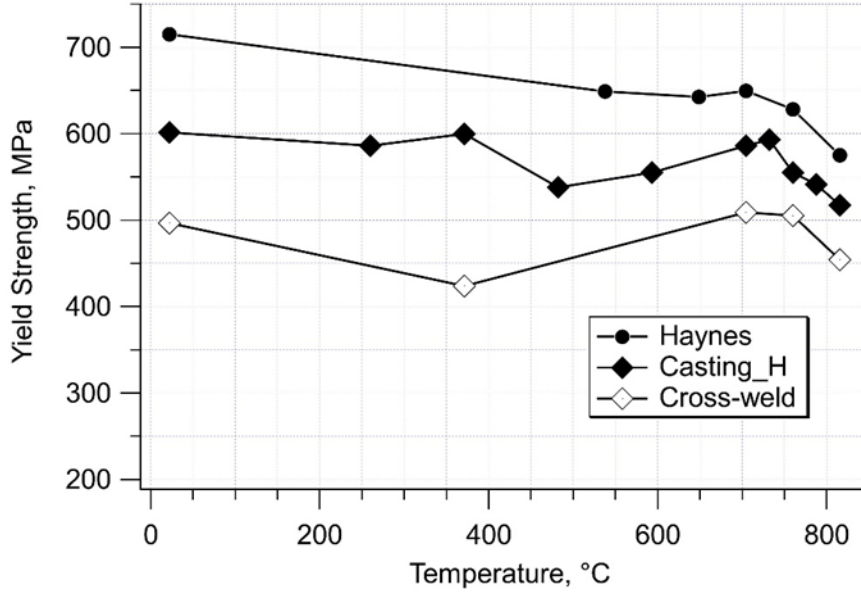
Figure 21: Comparison of yield strength for base metal and cross-weld test specimens

No detailed fractography was done on the broken cross-weld specimens but most failure locations were clearly in the cast base metal. Even those specimens designated in Table 2 as failing in the heat-affected zone will need closer examination to determine whether microstructure there was specifically responsible for failure. One factor that would contribute to lower strength in the cross-weld specimens is the presence of casting defects. No effort was made to specifically characterize the overall defect condition of the original large casting, but there is no reason to assume defects were uniformly distributed. The location where stock sourced for making the weld was taken, near a riser, appeared to contain a relatively high concentration of casting defects compared to the H location [8] used for the cast base metal values plotted in Figure 21.

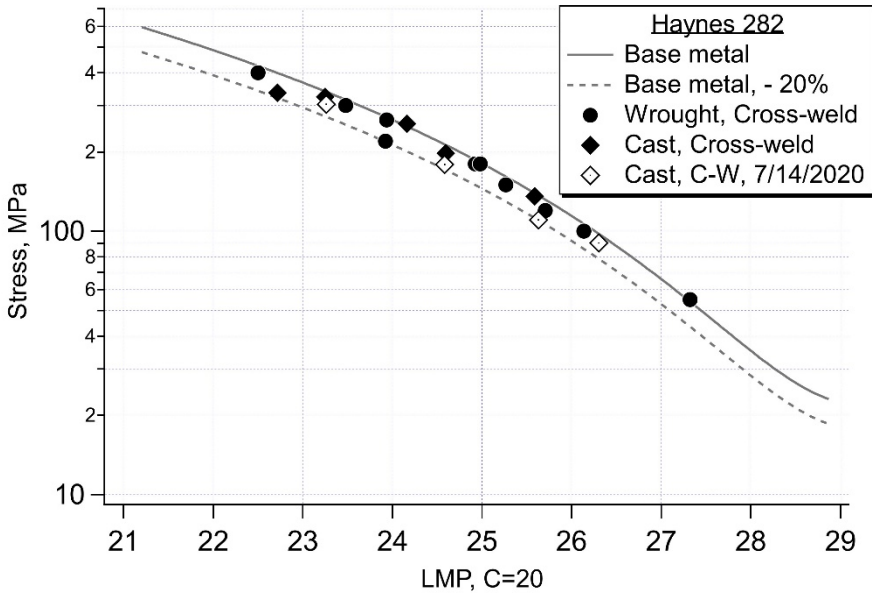
Figure 22: Larson-Miller plot of cross-weld stress-rupture results. Open symbols represent on-going tests.

The results from stress-rupture testing of cross-weld specimens are tabulated in Table 3. The variation of Larson-Miller parameter with applied stress is shown in Figure 22, where the solid line represents the reference results from testing wrought base metal [7,8,25]. Also included on the plot are results from tests of cast base metal [27], and cross-weld specimens of wrought base metal [7]. The dotted line in Figure 22 represents the base metal reference data with stress values reduced by 20%. The bracketed values for life in Table 3 indicate specimens still in-test as of 07/14/2020. Just as for the tension tests, the failure locations of the cross-weld specimens were in the cast base metal. This indicates that the rupture strength of the weld deposit exceeds that of the cast base metal and that the intrinsic strength of the cast base metal controlled failure. It further suggests that heat-affected zone microcracking and localized recrystallization had no significant effect on cross-weld rupture strength.

Figure 22 shows that the cross-weld rupture strength is essentially identical for cast and wrought base metal. Furthermore, the rupture strengths of cross-weld specimens as well as cast base metal specimens were well within 80% of the rupture strength of wrought base metal reference results.
