Progress Report on Plane-Strain Tension Testing of ATF FeCrAl Cladding

**Nuclear Technology
Research and Development**

***Prepared for US Department of Energy
Advanced Fuel Campaign***

ORNL/SPR-2020/1631

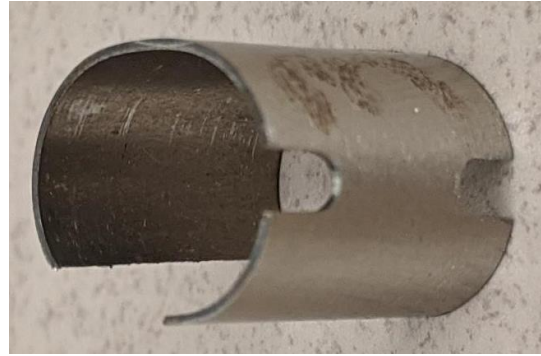
Figure 11. Twelve mm long C26M specimen tested at 275°C at the 12 o'clock orientation that did not fail at the specimen gage, suggesting a manufacturing defect or a nonmetallic inclusion.

One 275°C test was performed with the C26M 12 mm length specimen at the 12 o'clock location, but its results were not included in the previous data because the specimen did not fail in the gage section. This result is shown below in Figure 11. This result may have been caused by tube quality or loosened connections in the fixture during heating. More tests are required to completely understand this failure mode.

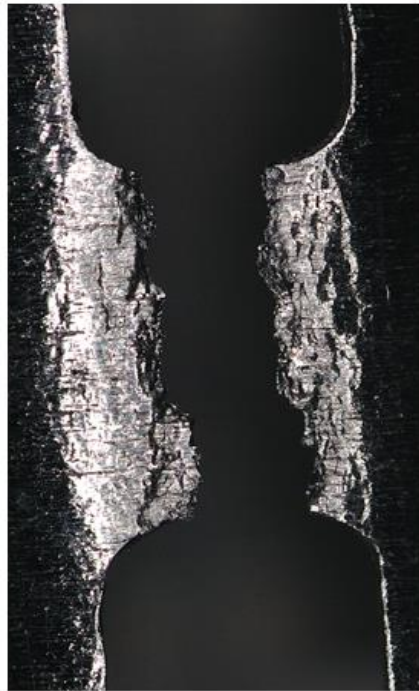
Figure A-7. Gage shape and mechanical test data for 6 mm B136Y specimens tested at the 12 o'clock (left) and 3 o'clock (right) orientations.

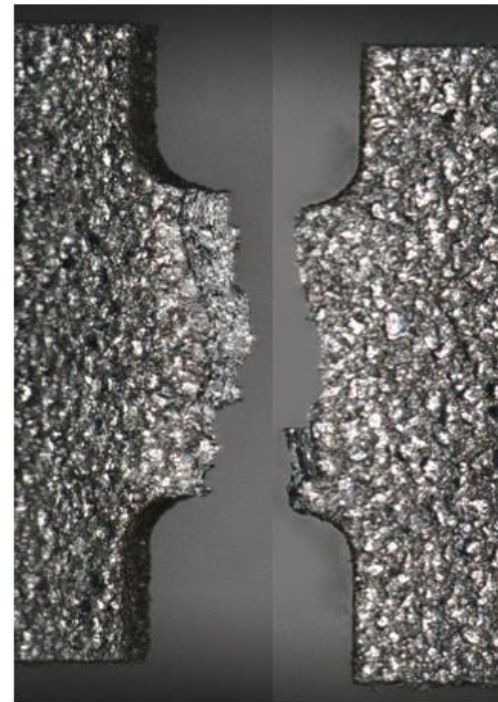
Figure A-9. Gage shape and mechanical test data for 3 mm Al 6061 specimens tested at the 12 o'clock (left) and 3 o'clock (right) orientations.

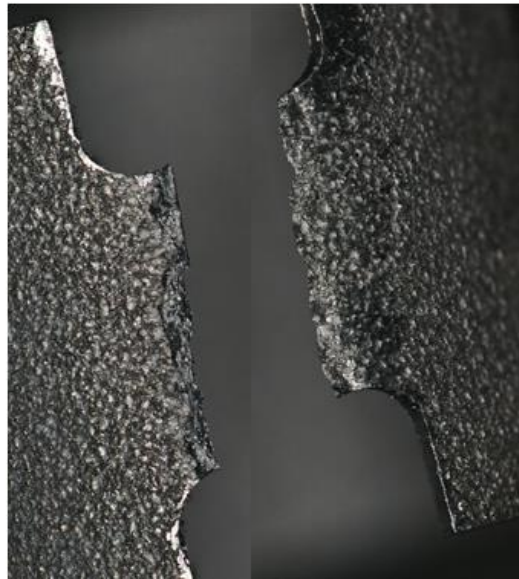
Figure A-10. Gage shape and mechanical test data for 6 mm Al 6061 specimens tested at the 12 o'clock orientation.

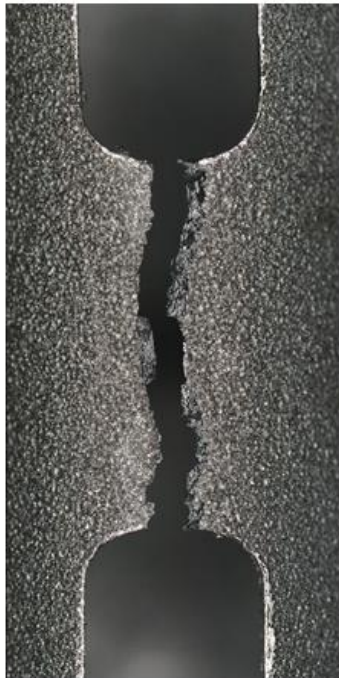
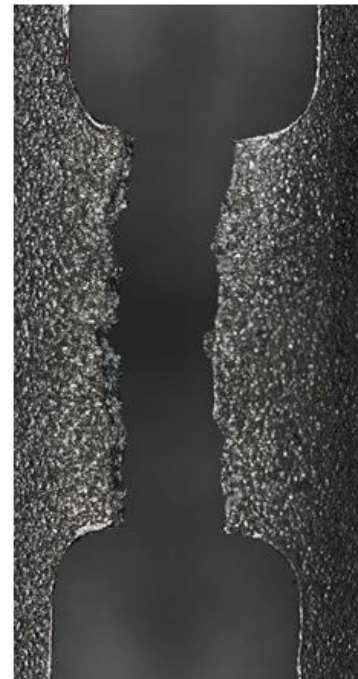
Figure A-11. Gage shape and mechanical test data for 12 mm Al 6061 specimens tested at the 12 o'clock orientation (left) and the 3 o'clock orientation (right).
