*Sister Rod Destructive Examinations (FY20)*

***Appendix B:  
Segmentation,  
Defueling,  
Metallographic Data and  
Total Cladding Hydrogen***

**Spent Fuel and Waste Disposition**

**ORNL/SPR-2020/1744**

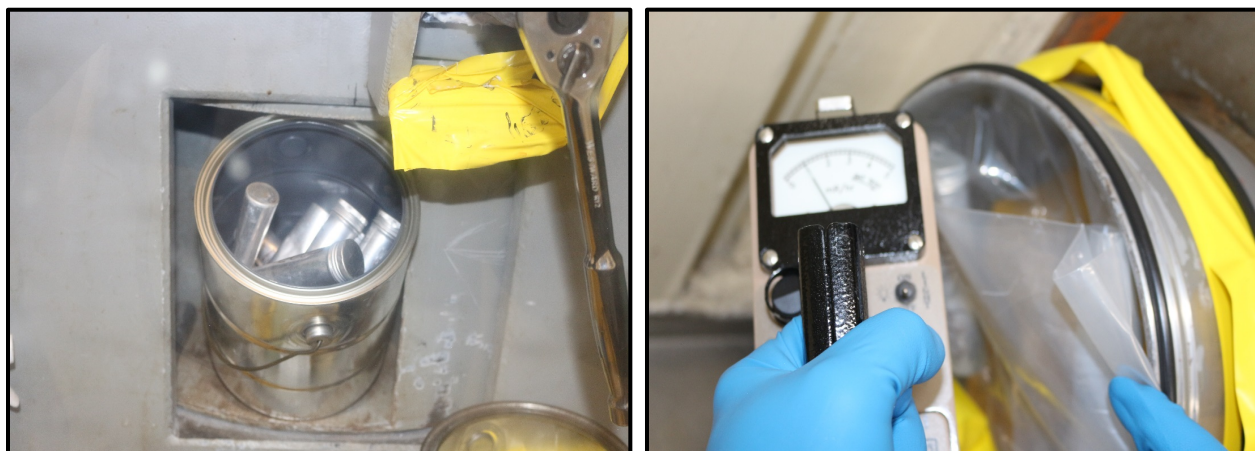
**Figure B-1. Defueled cladding segments in aluminum containers awaiting shipment to ANL (left) and contact dose rate measurement on a single container (right).**

Twelve rod cladding segments were selected from the Phase 1 sister rods for ring compression testing as listed in Table B-1. The segments were defueled by boiling them individually in an acid bath, and each piece of defueled cladding was weighed and packaged individually in aluminum containers. The dose rate was measured at contact and at 1 ft. The dose rates represent the hottest spots on the container. The exterior surfaces of the aluminum containers were decontaminated before they were loaded into the shipping container. The dose rate of a decontaminated empty aluminum container is expected to be <20mR/hr. Figure B-1 shows the cladding segments in their aluminum containers awaiting shipment to Argonne National Laboratory and a dose rate measurement being taken on one sample in its aluminum container using a Ludlum 9-4 ion chamber.

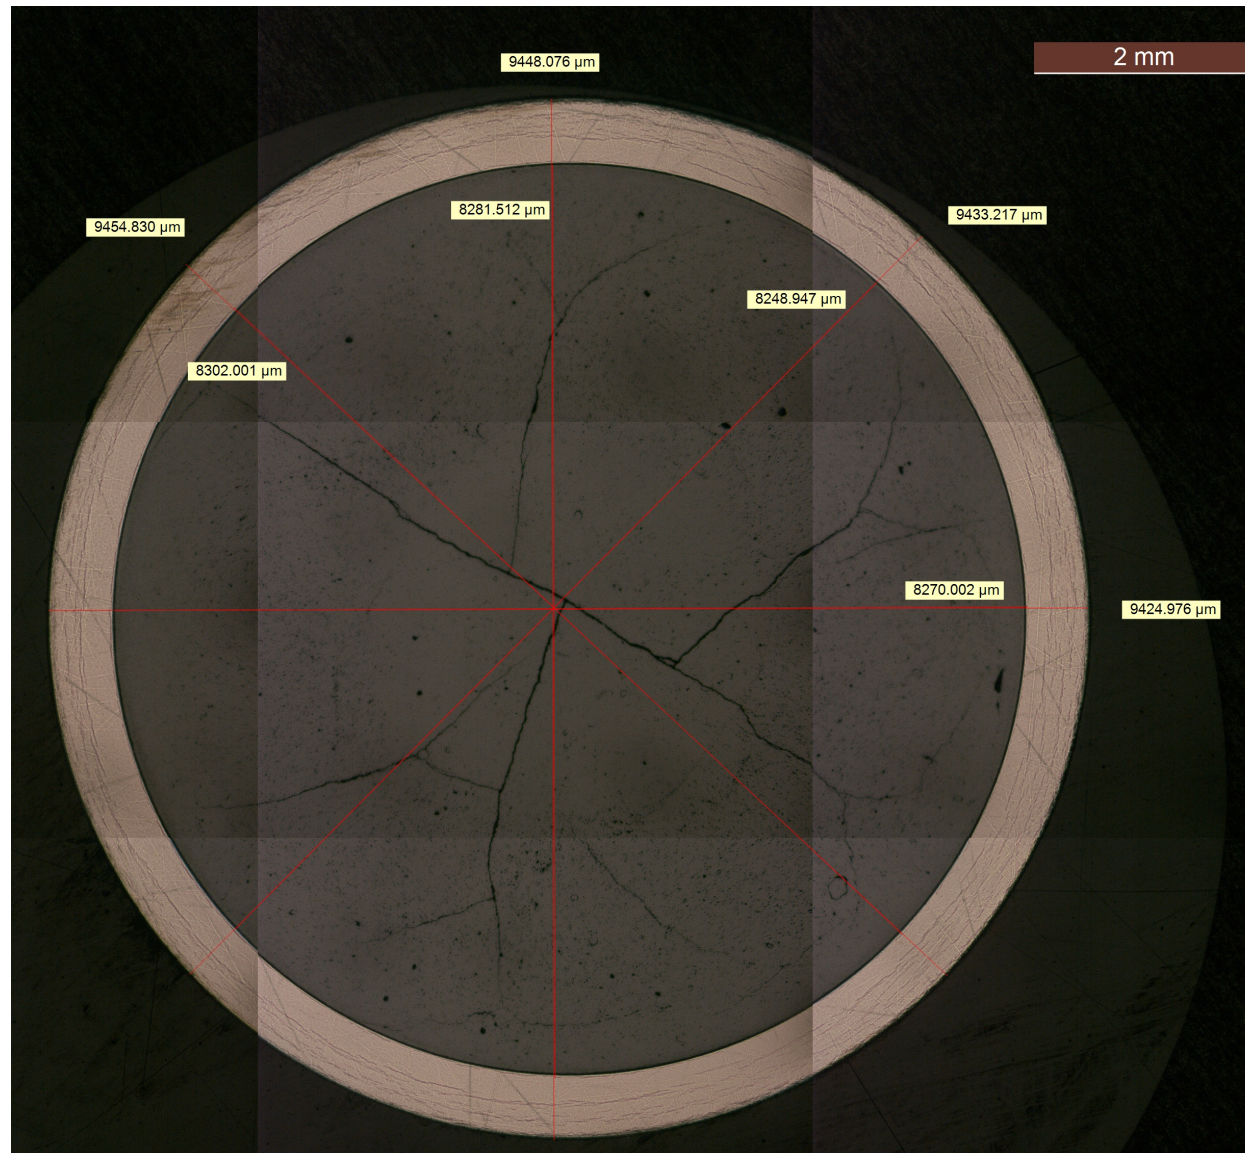
Figure B-13. Fueled overall view, 6U3K09-2616-2635 (baseline rod).

The precipitated hydrides in the baseline ZIRLO-clad rods (3D8E14 and 6U3K09) are primarily located at the OD and ID of the cladding and are oriented circumferentially. For 3D8E14, there are many short hydrides in the central region of the wall that form a cross pattern and there are several relatively long radial hydrides located at the cladding ID, as shown in Figures B-11 and B-12. 6U3K09 was not polished well enough to fully visualize the cladding hydrides, although there is a deeper OD field of circumferential hydrides (Figure B-14). The 6U3K09 pellet is cracked in the expected pattern with no missing pellet surface visible. The depth of the pellet HBU rim is 59  $\mu\text{m}$  on average for the baseline rod (2,616 – 2,635 mm in elevation).
