Post Irradiation Examination of Candidate NpO_2 Targets for ^{238}Pu Production

POST EXAMINATION OF CANDIDATE NpO₂ TARGETS FOR ²³⁸Pu PRODUCTION

Prepared by
OAK RIDGE NATIONAL LABORATORY
Oak Ridge, TN 37831-6283
managed by
UT-BATTELLE, LLC
for the
US DEPARTMENT OF ENERGY
under contract DE-AC05-00OR22725

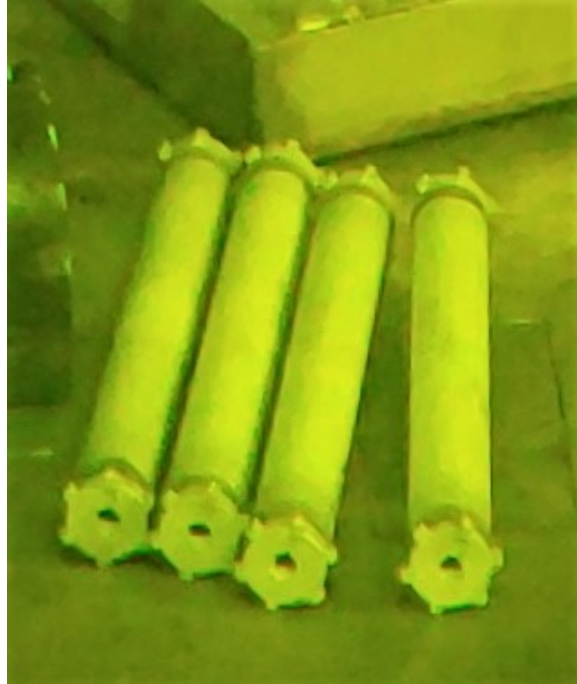
Figure 3. The four targets as received at Building 3525. Note the whitish oxide layer on the aluminum secondary capsules. Not shown in the picture is the NP01, NP02, NP03, and NP04 labeling etched on the aluminum.

The targets were loaded into the Building 3525 north hot cell bank and were briefly inspected for any damage; none was noted, and the targets appeared to be in good shape. An oxide layer (normal) was observed on the exterior of the aluminum capsules. A photo of the capsules is shown in Figure 3.

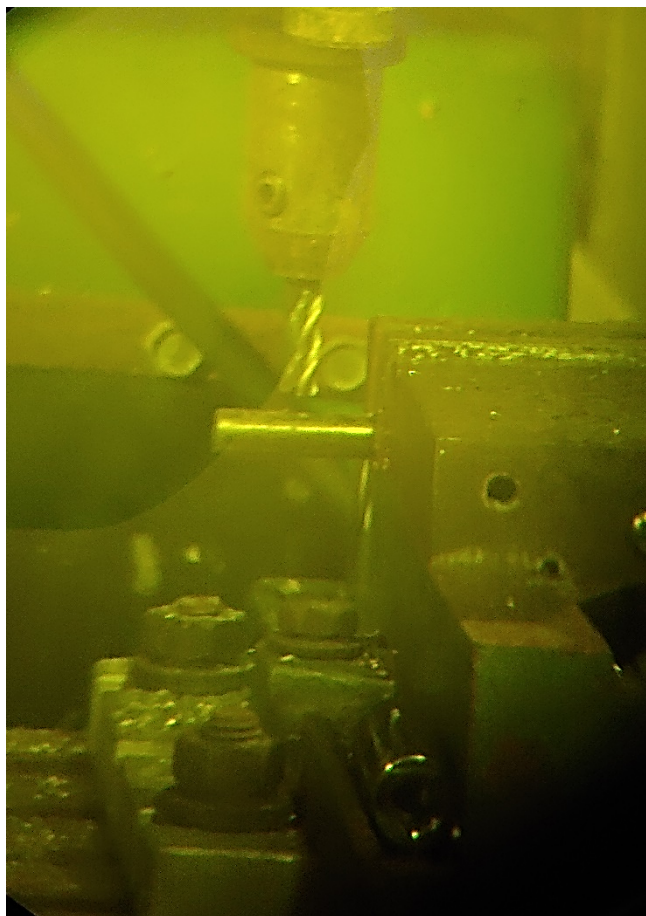
Figure 7. Milling the puncture flat on a target.

After the visual observation, a flat spot was milled on the targets to thin the cladding for the gas puncture task. Target NP01 was milled first and was punctured before the others were milled. Based on the results of this first puncture (see below), the flat spots on the other targets were made somewhat larger to accommodate any slight misalignment in the apparatus and to center the punch better in the milled flat region. A typical milling operation is shown in Figure 7.

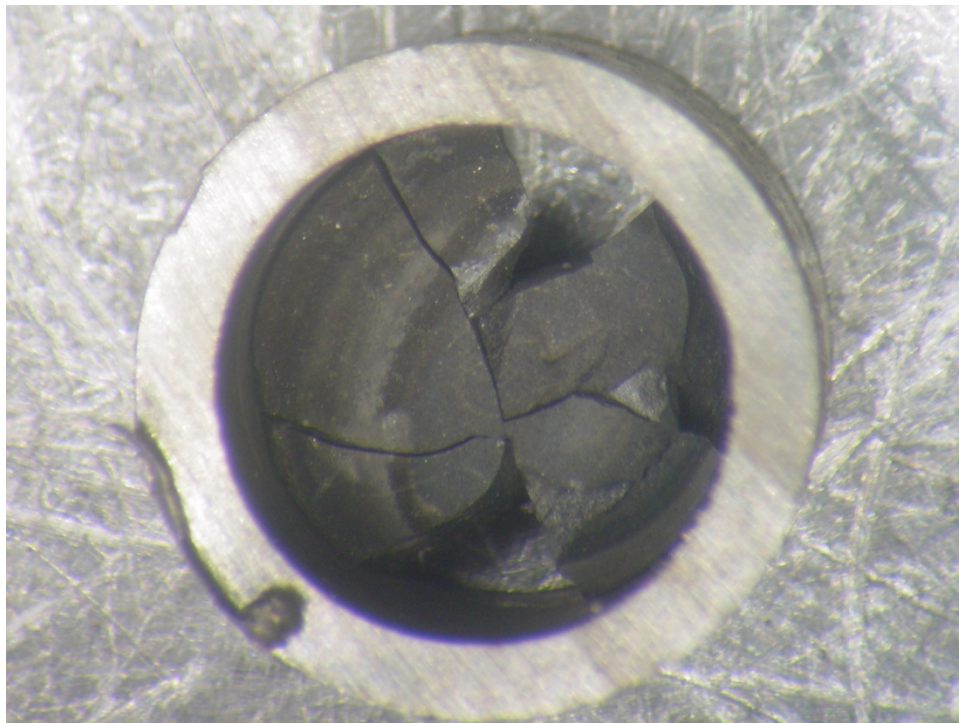
A few hours after cutting, and prior to MET mount preparation, the axial sample for target NP01 crumbled into pieces and could not be mounted. To recover as much data as possible, the material was examined using an in-cell stereomicroscope to see if the melt wire could be located, but it was not found. However, examination revealed that the pellet had broken into small pieces and had not disintegrated into powder. There was no evidence of melting—the appearance was that of broken, consistent material. The

Figure 14. Top view of NP01 axial specimen.

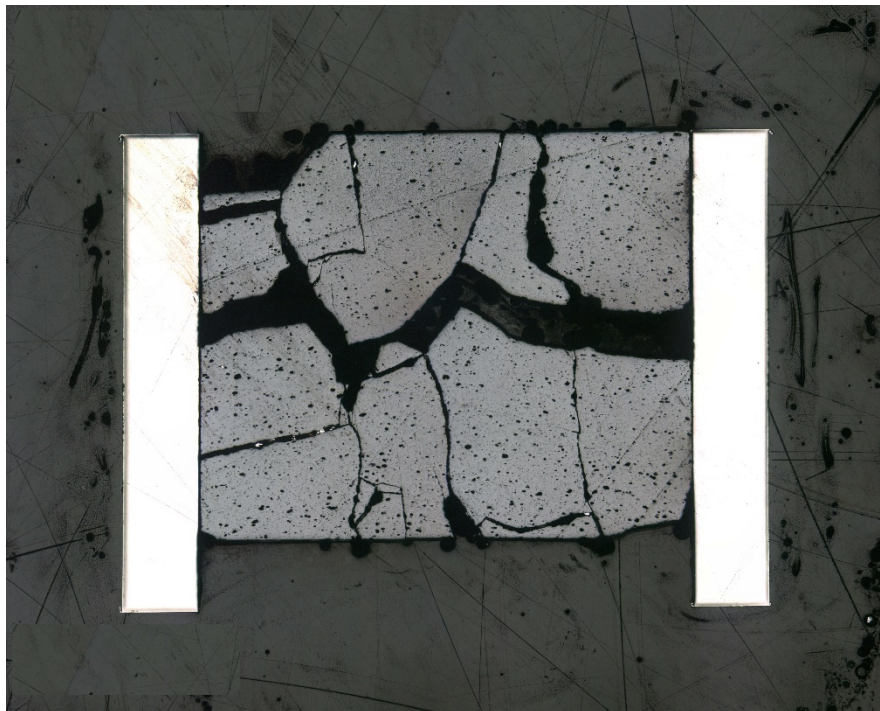
Figure 20. Longitudinal mount NP02L. This mount suffered extensive cracking, but there appears to be no deleterious behavior of the pellet or clad. This mount was ground down to near, but not exactly center.

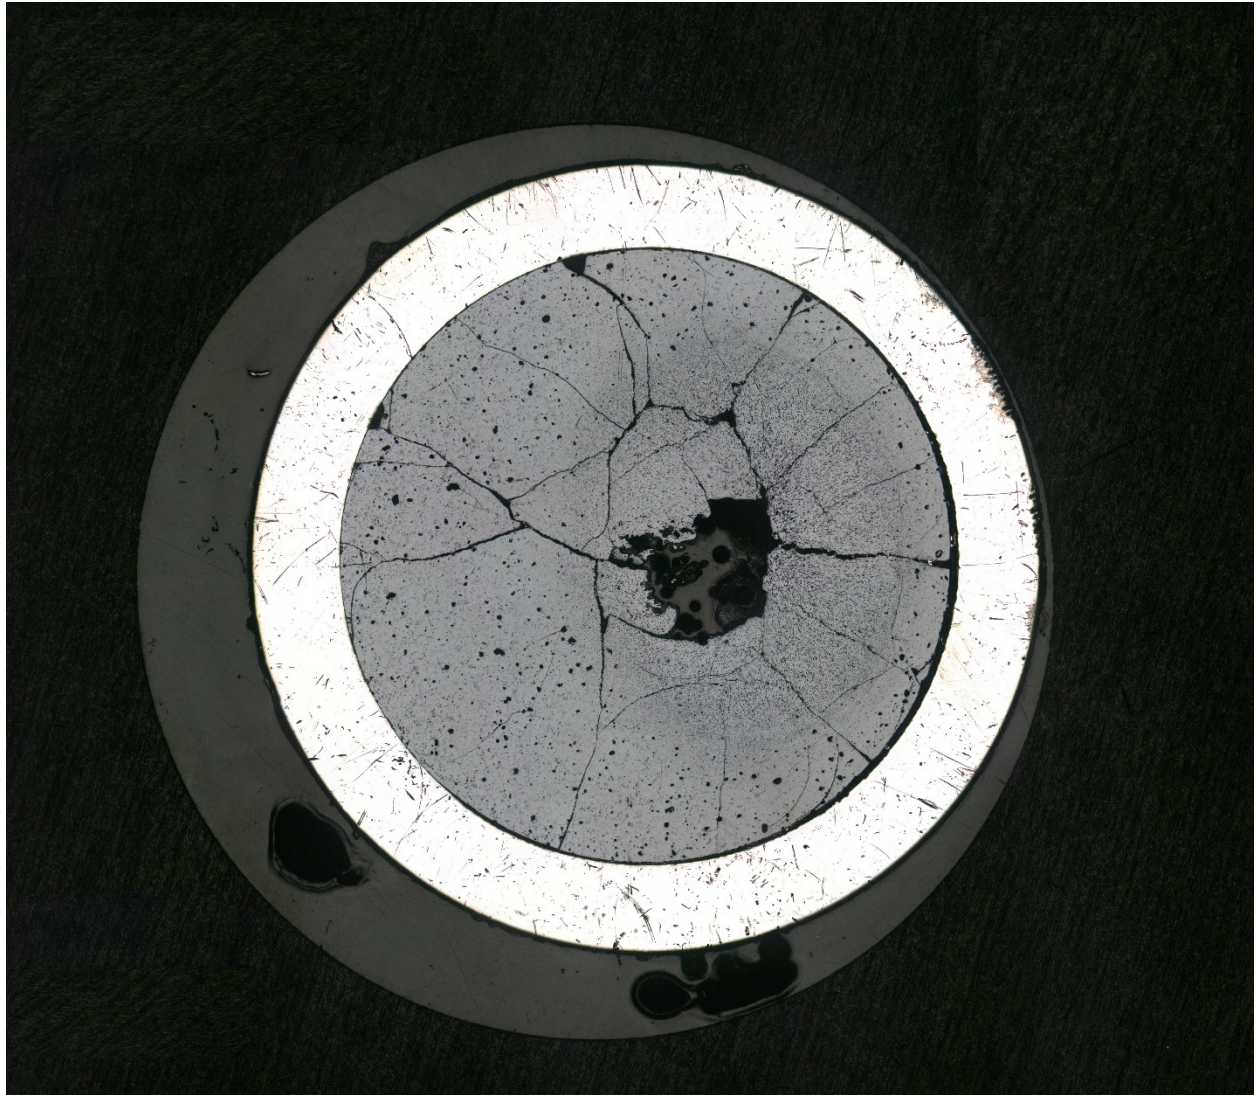
The axial cross section mount NP03A is shown in Figure 21; the heat-affected region and cracking are similar to that of NP02A, but the region appears to be somewhat larger, and like NP02A, the central region is affected by pull-out and the likely loss of the melt wire during handling. The NP03A pellet-gap can be seen in Figure 21; the average value is close to that of NP02A and is smaller than that of NP04A. The outer diameter is 1.0% larger than the nominal fabrication value. Less cracking and relocation is apparent in the longitudinal mount NP03L, possibly due to a better cut location. As seen in Figure 22, there is a gap between the pellet and the clad and the rather flat pellet bottom at the junction between the two pellets. All the mounts show no significant pellet swelling, with the existence of a small gap between the pellet and clad, probably due to minor pellet densification.

Figure 21. Mount NP03A. The heat-affected zone is in the right half of the image. It is similar to that of NP02A, but larger in area. Unfortunately, a large pull-out area obscures a portion of the heat-affected zone, which is also where the melt wire was expected to be.
