High-Temperature Steam Oxidation of Irradiated FeCrAl in the Severe Accident Test Station

**Nuclear Technology
Research and Development**

***Prepared for
U.S. Department of Energy
Nuclear Technology R&D
Advanced Fuels Campaign***

***May 2021
M3FT-21OR020204074***

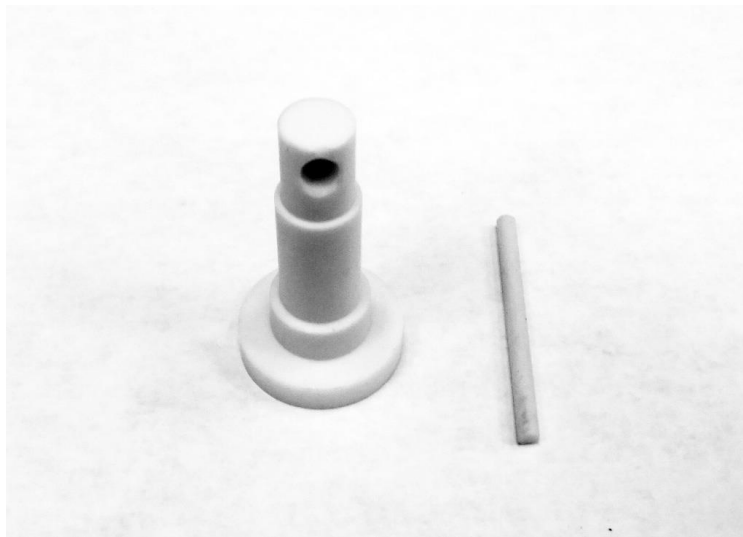
Figure 2. Specimen holder used for the SATS high-temperature steam oxidation tests.

furnace for testing fuel segments [5][5], [6][6]. The LOCA furnace has been successfully used in LOCA fragmentation tests on high-burnup fuels [7][7][8][8][9][9]. The tests of irradiated FeCrAl C35MN specimens in this report were conducted with the high-temperature furnace. Figure 2 shows the specimen holder used in this work.

All in-cell tests of irradiated ATF-18 specimens were conducted with the standard sample holder (see Figure 2) under the same test conditions for out-cell tests for unirradiated surrogate specimens. The specimen was first ramped from room temperature to 600°C under an argon atmosphere at a rate of 20°C/min. Following this test segment, the argon supply was shut off, steam was supplied to the test section, and the temperature was ramped to 1200°C at 7.5°C/min. The sample was either held at 1200°C or slowly ramped to 1300°C at 1.82°C/min. The tests and temperatures at which the in-cell tests were stopped are illustrated in Figure 10. Figure 11 is the temperature history of the in-cell test ATF-18G2.

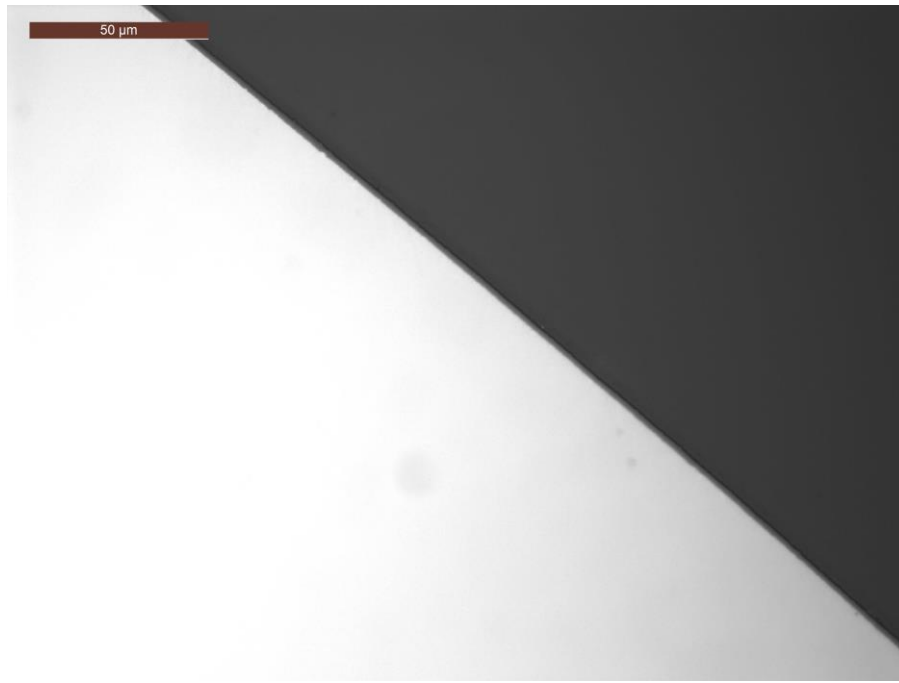
Figure 6. Micrographs of the OD (a) and ID (b) surfaces of the unirradiated C35MN oxidized in steam at 1300°C for 1 min.

Figures 6–8 show the OD and inner diameter (ID) images for the ATF18 surrogate specimens subjected to steam oxidation at 1300°C. The thickness of the OD and ID oxide layers is quite uniform and well defined, so the oxide layer thickness was measured at four azimuthal locations (every 90°) of the cross-section of the MET mounts. The measured oxide layer thicknesses are given in Table 1.

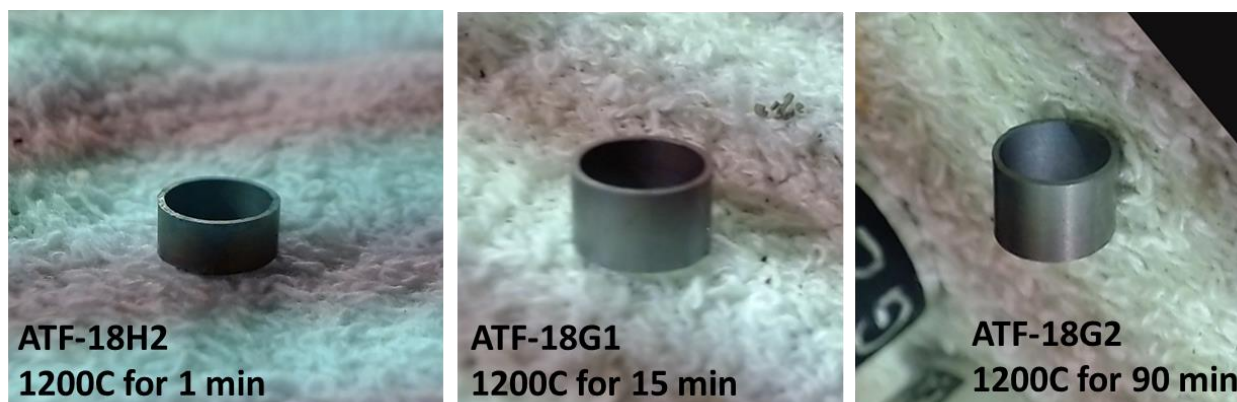
Figure 12. Post-test images of irradiated ATF-18 specimens oxidized at 1200°C.

Although unirradiated specimens performed very well at 1300°C, the irradiated specimens started melting as soon as the temperature reached 1300°C. However, the ATF-18 specimen was very stable at 1200°C. In addition, the oxygen pickup at 1200°C was extremely low, under the limit of the scale for weight gain measurements. Therefore, no weight gain data were reported for the ATF-18 specimens oxidized in the in-

cell SATS. Post-test images of these tests at 1200° and 1300°C are provided in Figures 12 and 13. Table 2 lists the test conditions and results of the steam oxidation tests of irradiated ATF-18 tubing specimens.
