*Sister Rod Destructive Examinations (FY21)*

# ***Appendix F: Cyclic Integrated Reversible- Bending Fatigue Tests***

## **Spent Fuel and Waste Disposition**

*Oak Ridge National Laboratory*

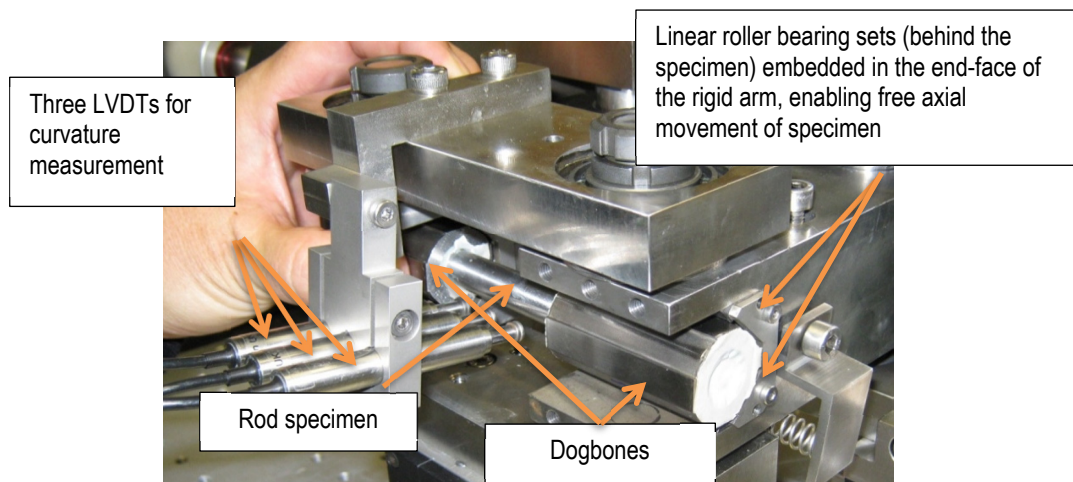
**Figure F-3. Image showing the grip design of CIRFT with one end-block removed.**

The distances built into the CIRFT machine and the length of the segment dogbone are important because they are used to calculate all load, moment, and curvature values. Important fixed physical distances include the length of the U-frame arms (101.60 mm) and the location and contact geometry of the LVDTs. Also, the motor's recorded stroke length during the test is directly applied in the data reduction, and the SNF rod outer diameter (OD) is used to calculate strain and stress.

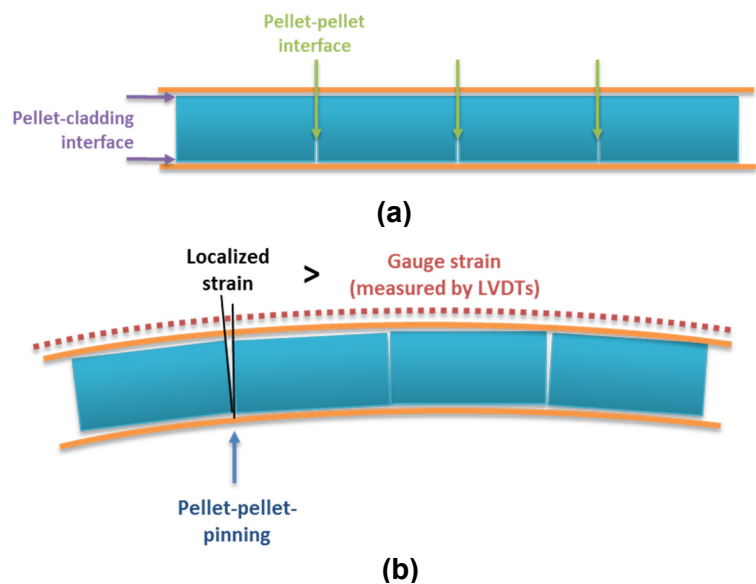
Figure F-6. Cladding and pellet stack (a) in the neutral position and (b) in bending. [F-5].

Although the LVDTs used on the CIRFT device only measure the gross rod deflection within the gauge section, several pellet lengths with several pellet-pellet interfaces are included in the gauge section, and any effects related to the pellet-pellet interfaces are embedded in the CIRFT data. As observed in previous test results, fractures are typically located at the pellet-pellet interfaces, which is consistent with the reduced mechanical cross section and potential interaction between the pellet end and cladding at those locations during bending. This is described by Wang and Wang as a fuel pellet “pinning” effect, as illustrated in Figure F-6.

Although it is unlikely that the localized effect can be observed in the CIRFT data, Wang and Wang investigated the effects on the cladding using finite element analysis (FEA) and found that the localized strain in the cladding at the pellet-pellet-cladding interface region is three to four times higher than that in regions supported by the body of the fuel pellet. This is caused by (1) the interaction of the pellet end with the cladding, and (2) the localized axial tension that is applied as the gap is opened.

Wang and Wang further explored the shift in the neutral axis that occurs during pinning. The neutral axis shifts constantly with each cycle, but the maximum strain still occurs at the outer radius of the cladding.

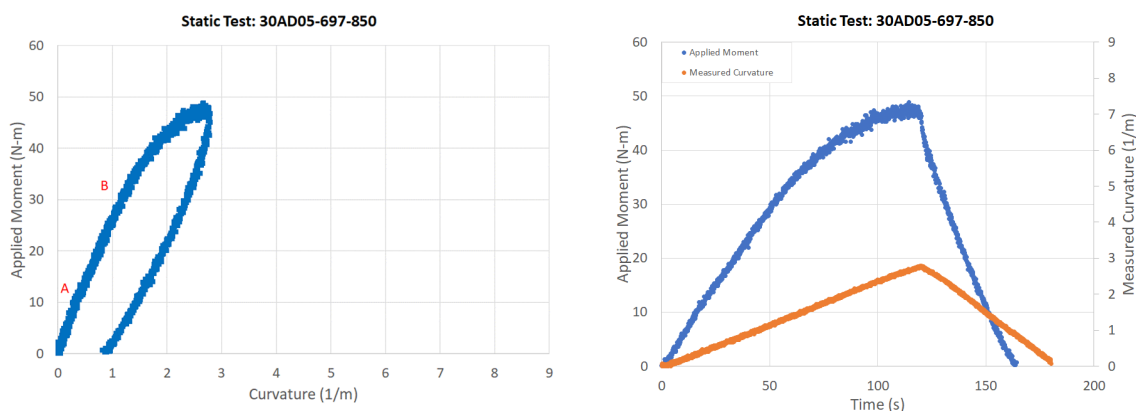
(a) Applied moment as a function of the measured curvature

The static test is performed to measure the range of flexure of representative specimens for each sister rod cladding type: M5, ZIRLO, and Zirc-4 or LT Zirc-4. Six specimens—one of each cladding type and heat treatment—were tested in static mode to measure the flexural rigidity before testing the fatigue response in dynamic mode. An example of the data typically acquired is shown in Figure F-7; all were flexed beyond the knee in the curve, which is labeled as point B in Figure F-7(a). The static flexural rigidity is calculated on the linear portion of the curve from approximately points A to B; this is consistent with the definition of EI2 in Reference [F-20].

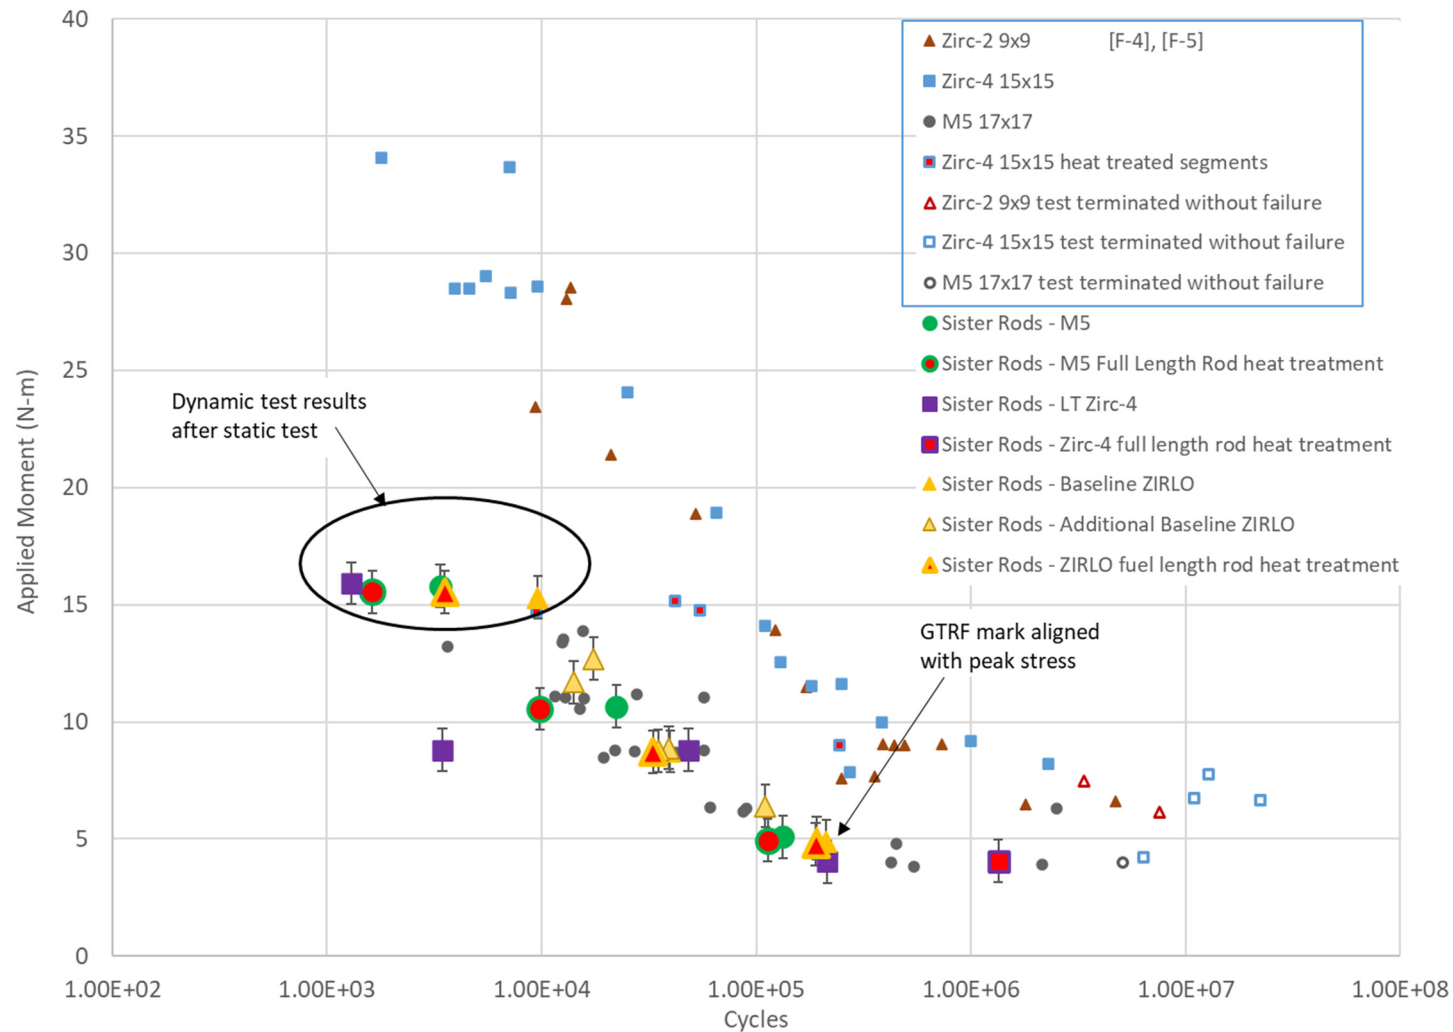
**Figure F-8. Results of CIRFT tests plotted with reference data, applied moment vs. cycles to failure. The error bars on the sister rod data represent the calculated uncertainty (0.8 N-m) in Section G-3.3, Appendix G (non-sister rod data from [F-4], [F-5]).**

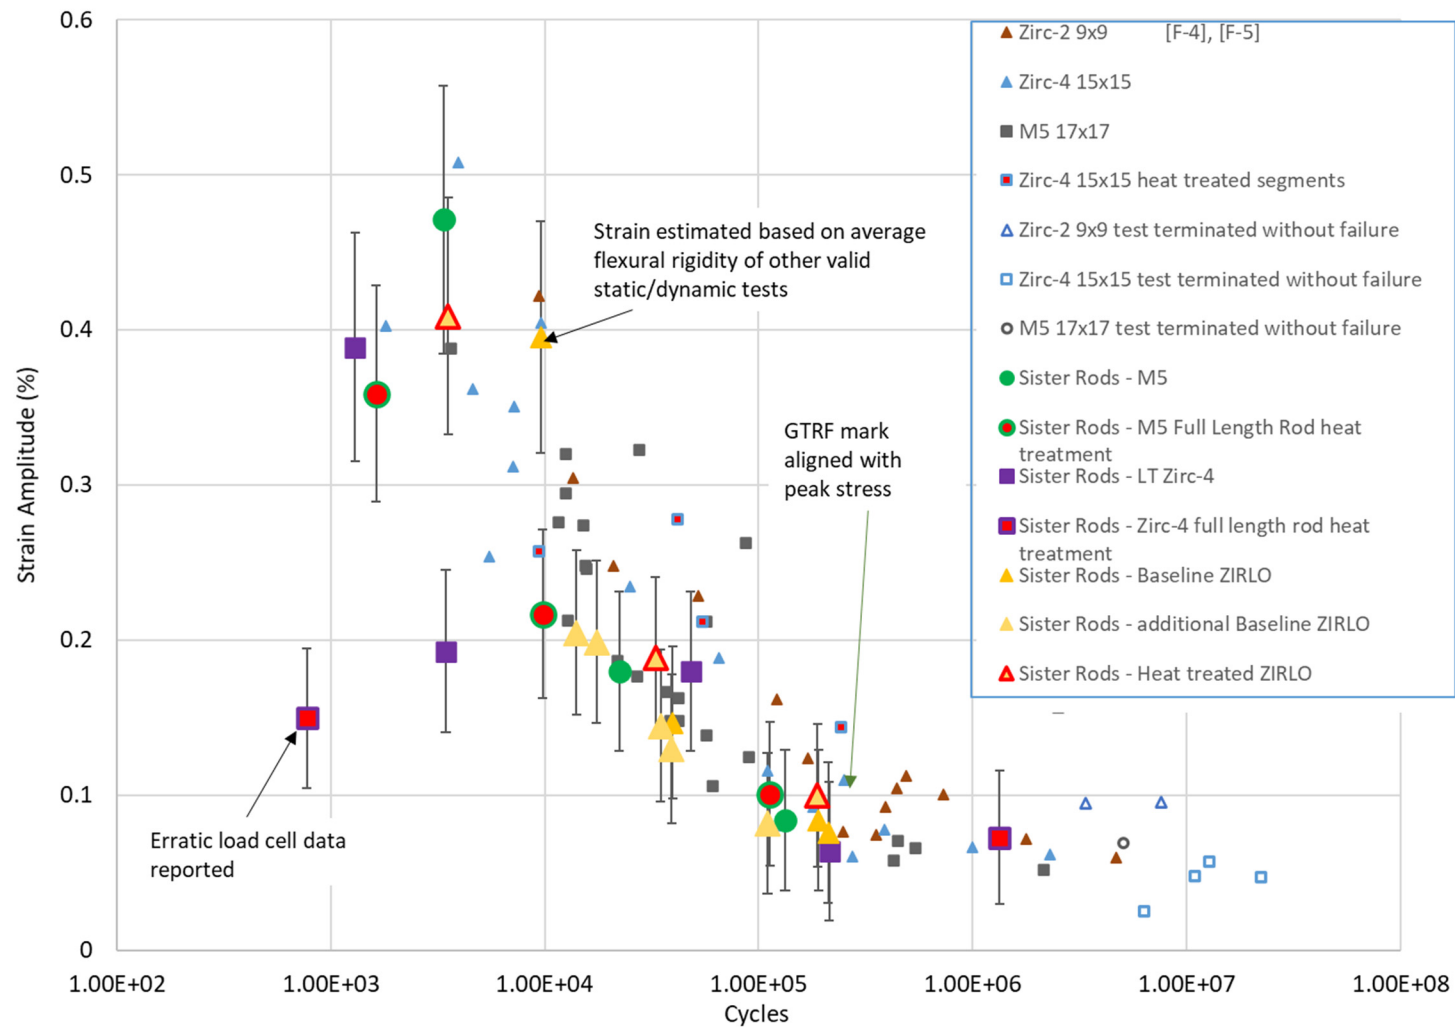
Figure F-9. Results of CIRFT tests completed to date, strain amplitude vs. cycles to failure. The error bars on the sister rod data represent the calculated uncertainty in Section G-3.4, Appendix G (non-sister rod data from [F-4], [F-5]).

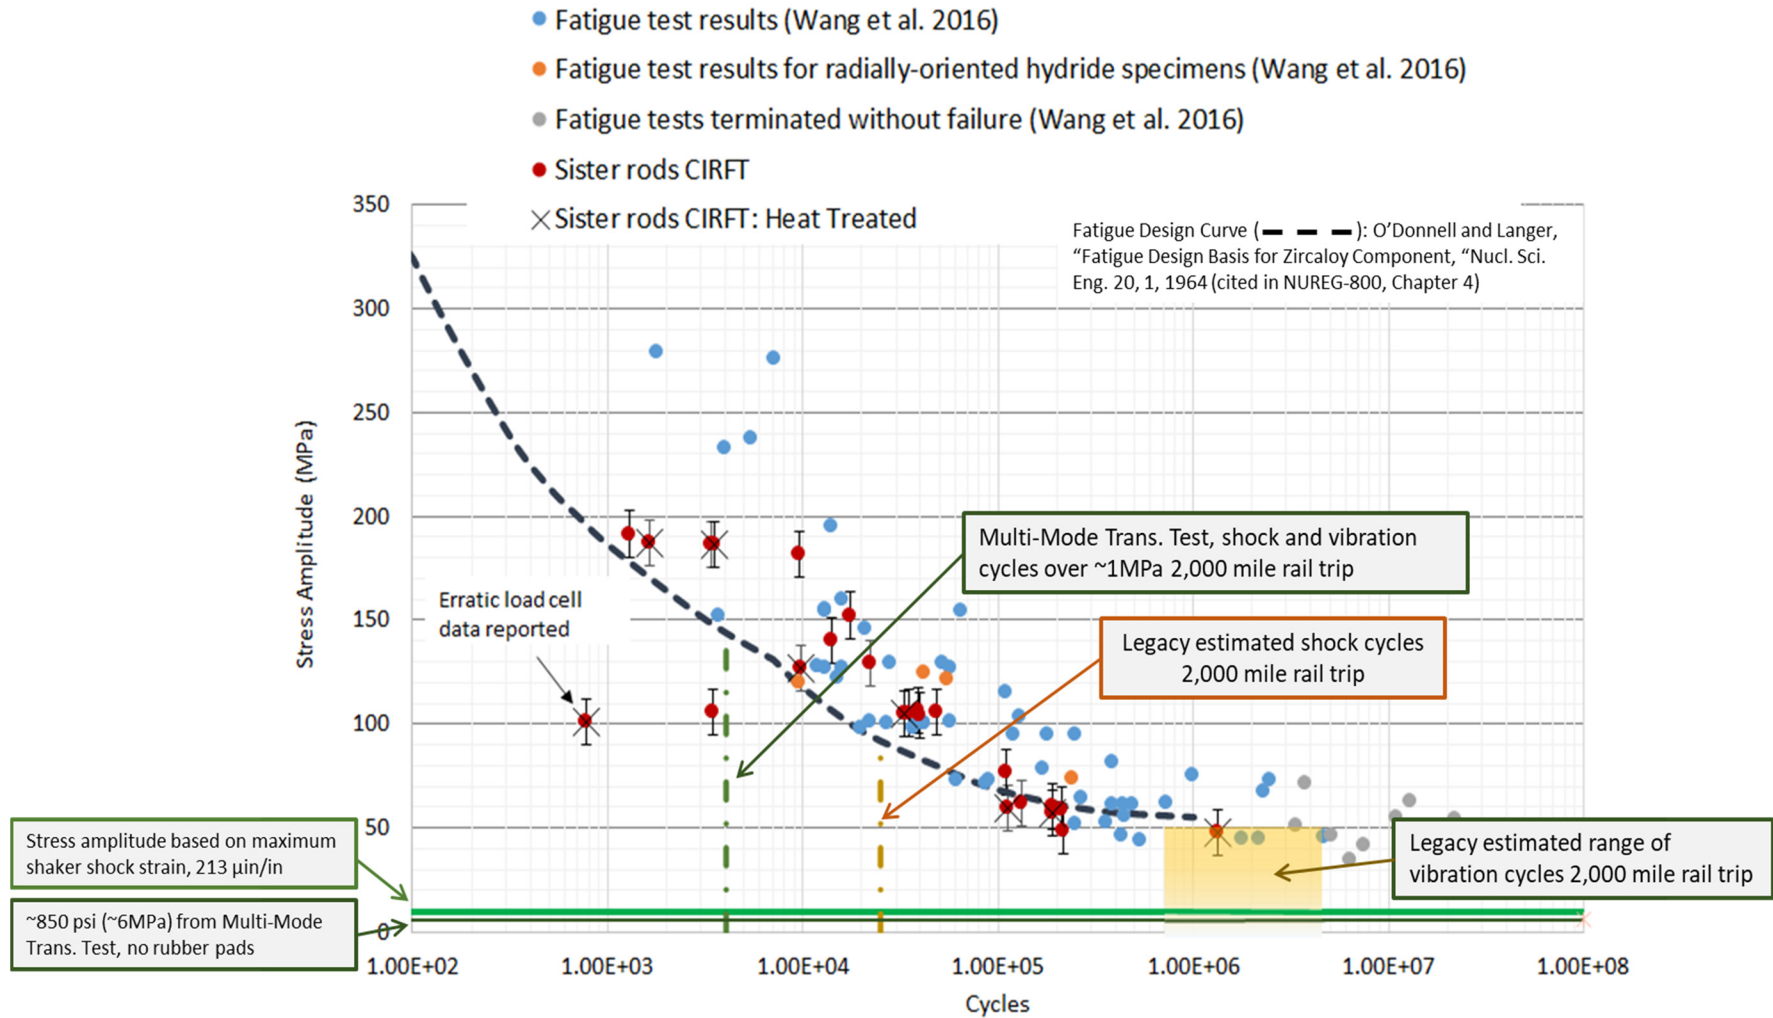
**Figure F-10. Average stress amplitude of the composite rod based on Eq. (F-7), as a function of cycles to failure for the sister rods. The error bars on the sister rod data represent the calculated uncertainty in Section G-3.5, Appendix G.**

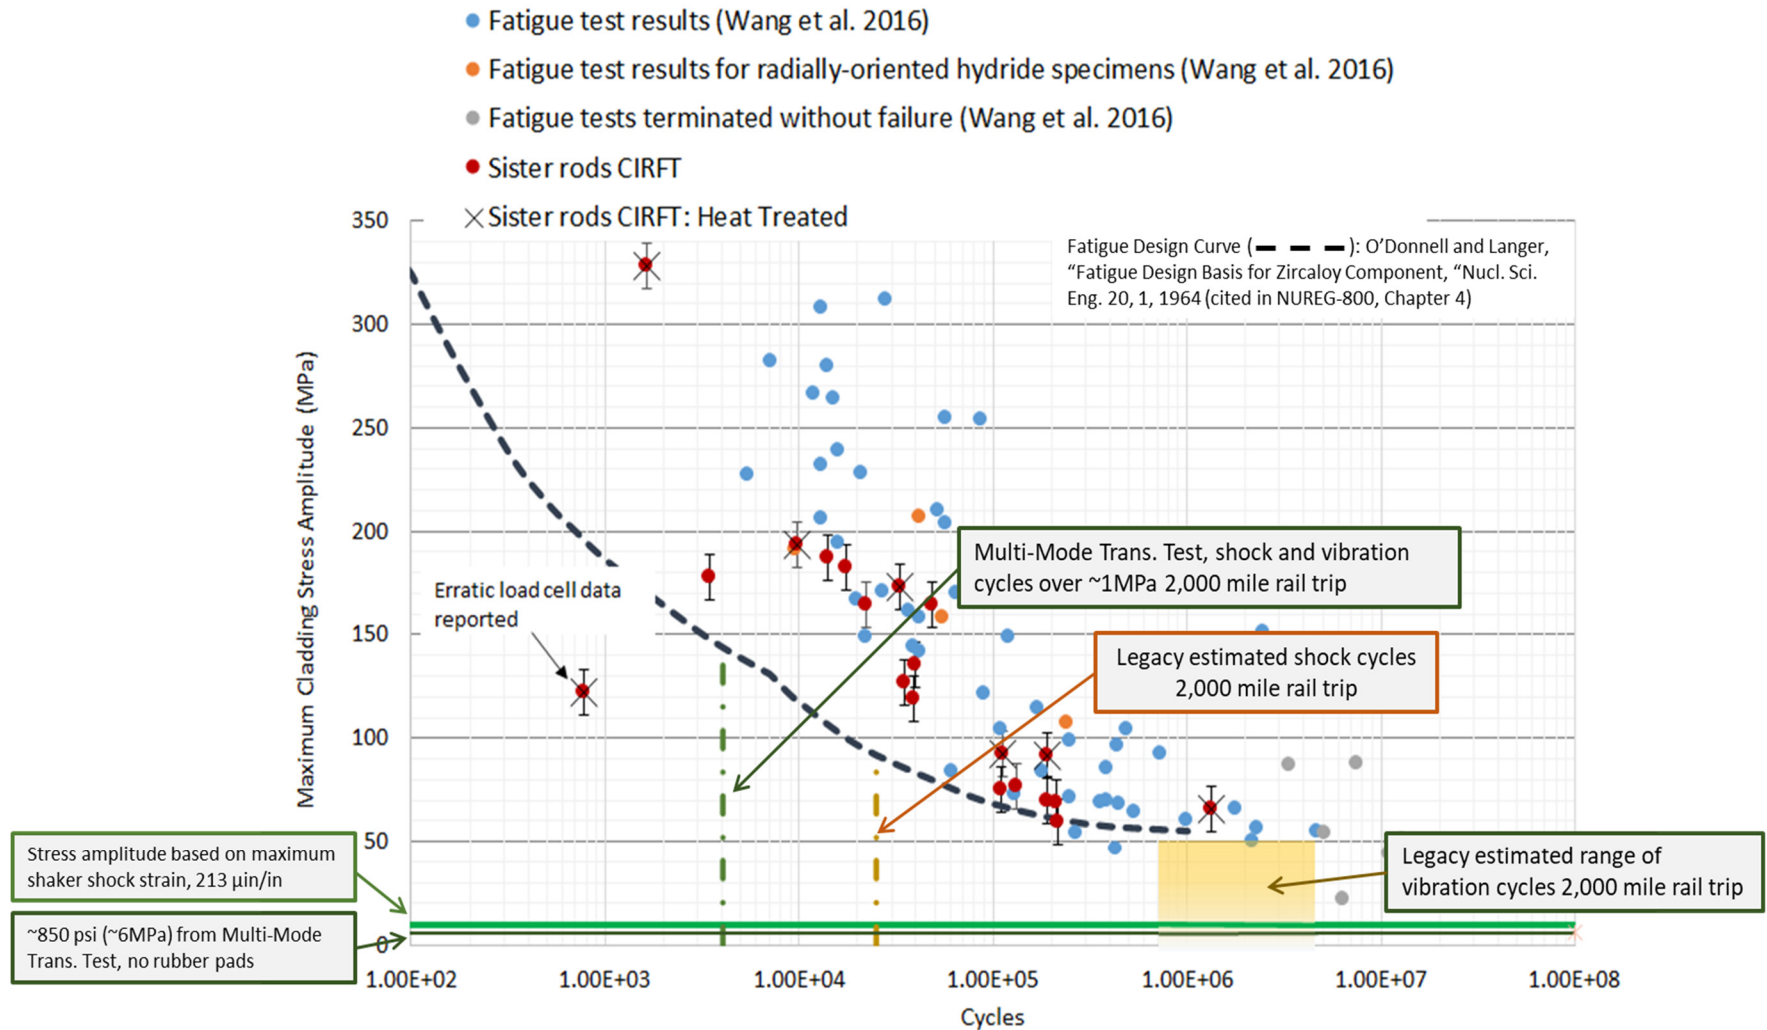
Figure F-11. Cladding stress amplitude as a function of cycles to failure for the sister rods. The error bars on the sister rod data represent the calculated uncertainty in Section G-3.5, Appendix G.

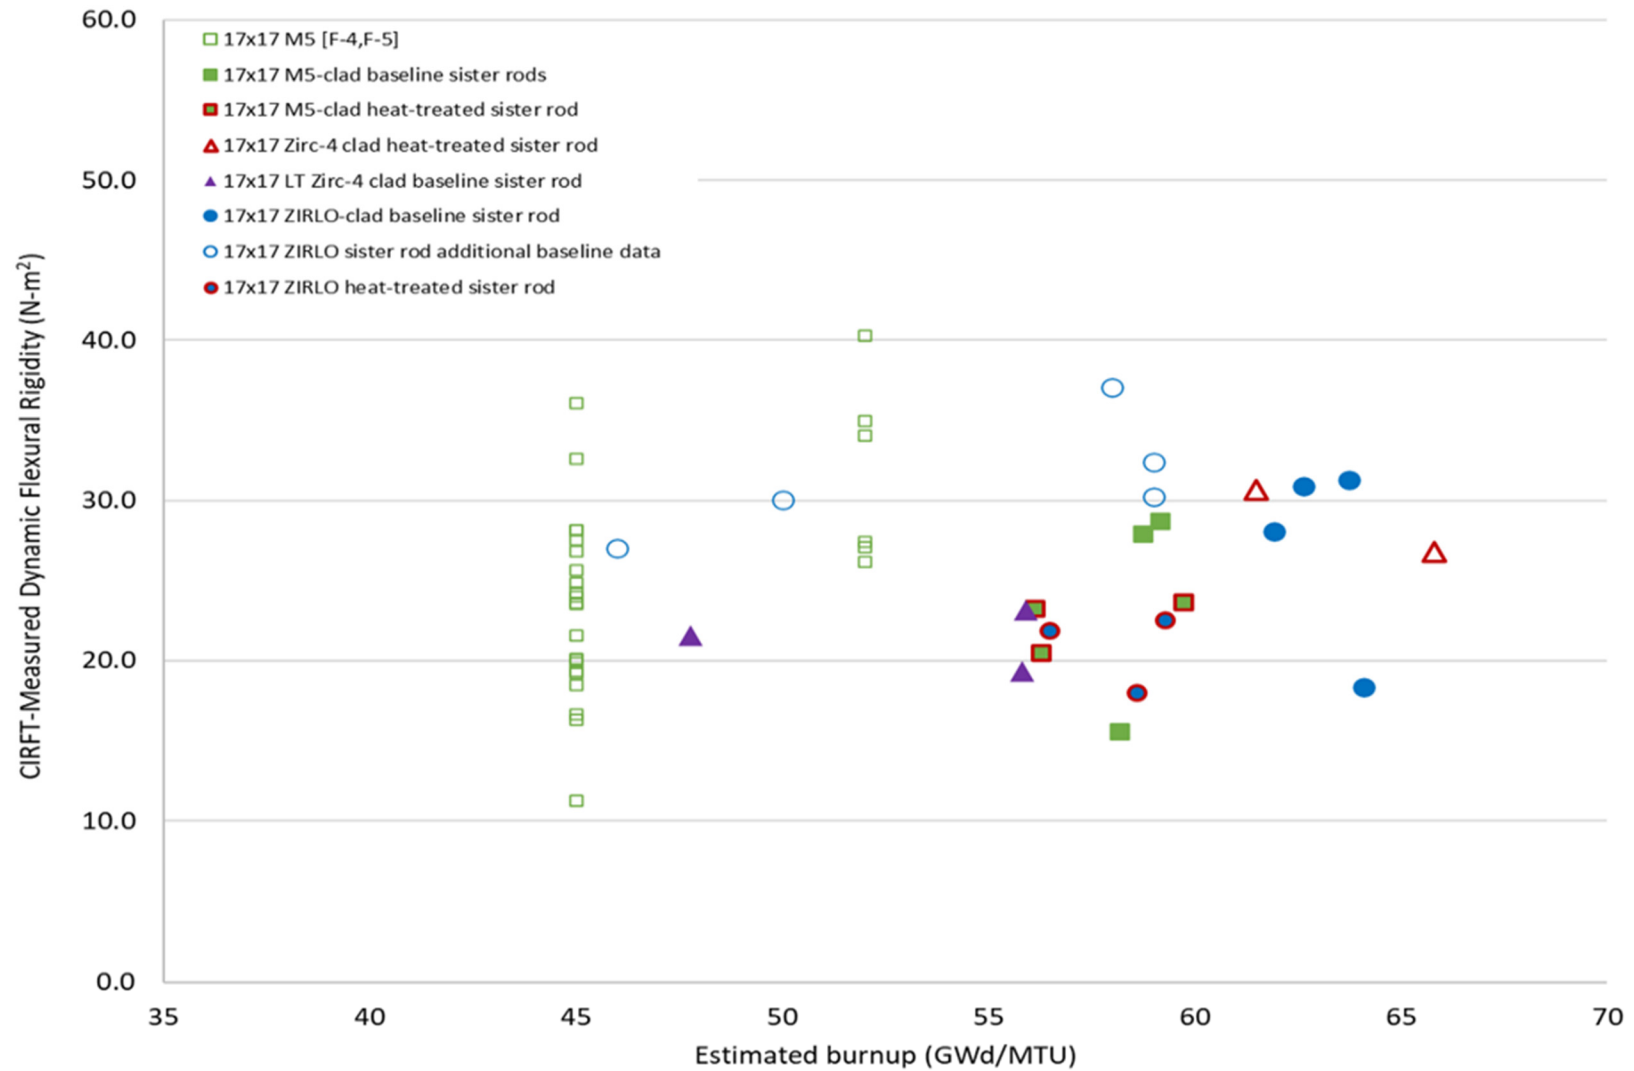
Figure F-12. CIRFT-measured flexural rigidity of the sister rod segments tested as a function of estimated segment burnup plotted with previous CIRFT data.

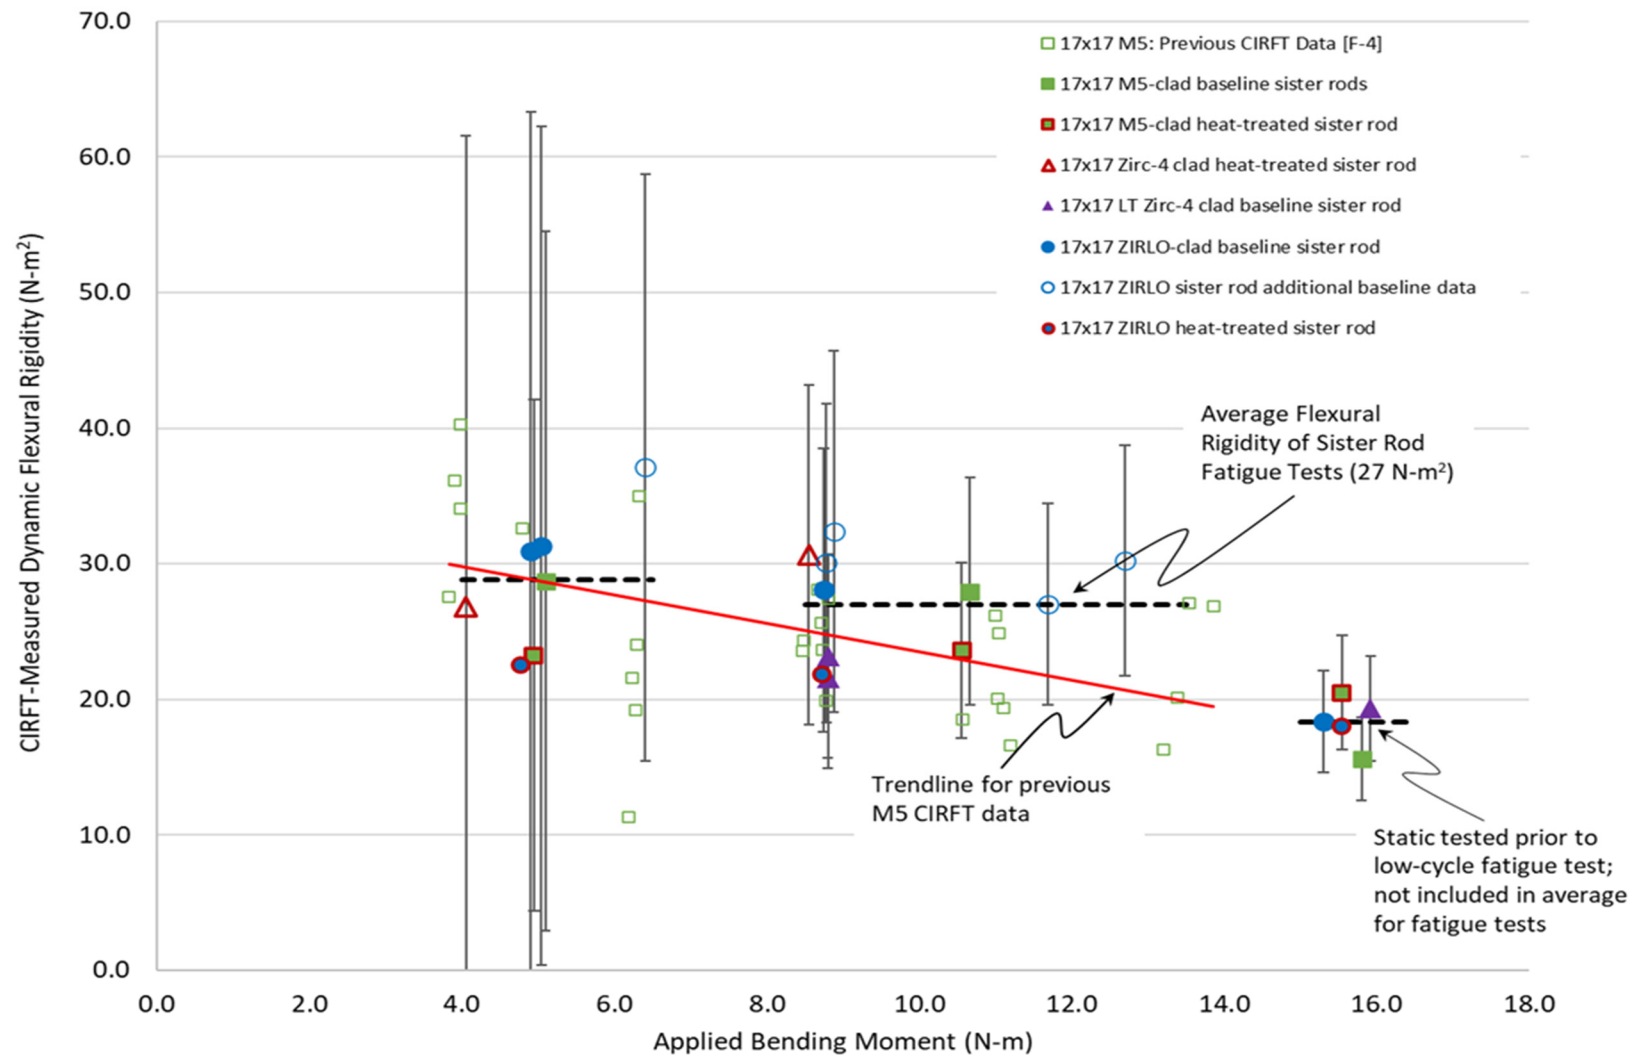
Figure F-13. Trend of CIRFT-measured dynamic flexural rigidity with applied bending moment. The error bars on the sister rod data represent the calculated uncertainty in Section G-3.6, Appendix G.

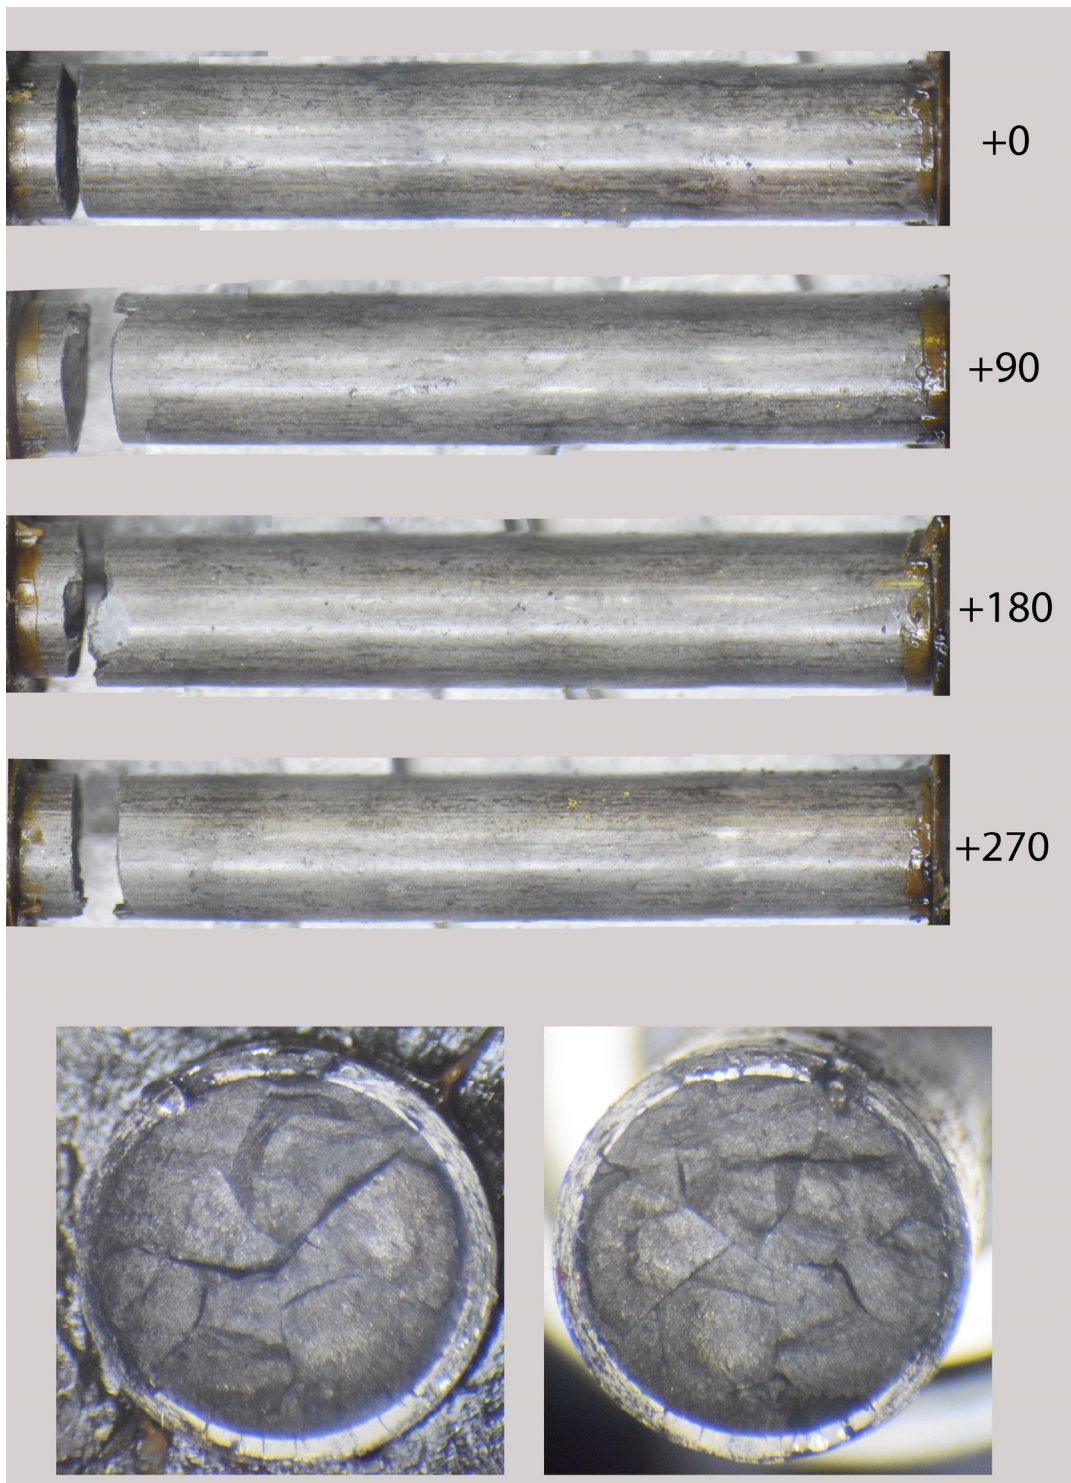
Figure F-14. 6U3K09-3353-3506 post-fatigue test condition.

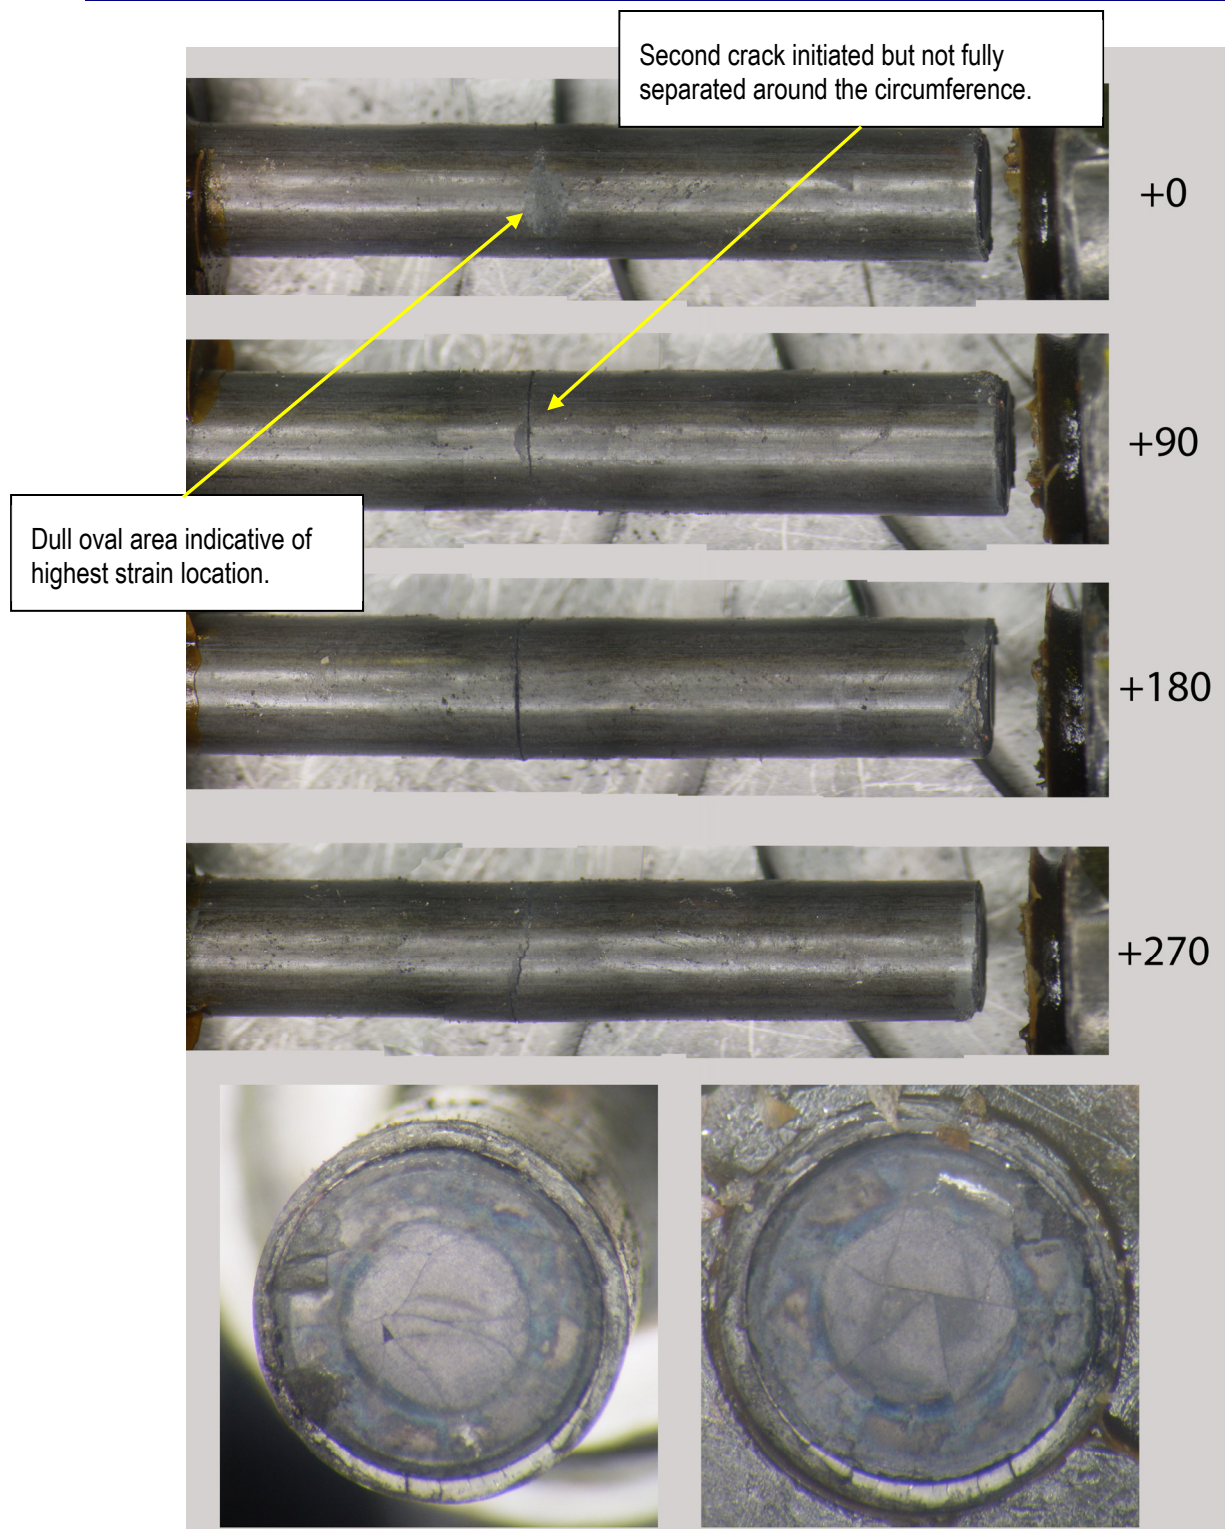
Figure F-15. 6U3K09-2310-2463 post-fatigue test condition.

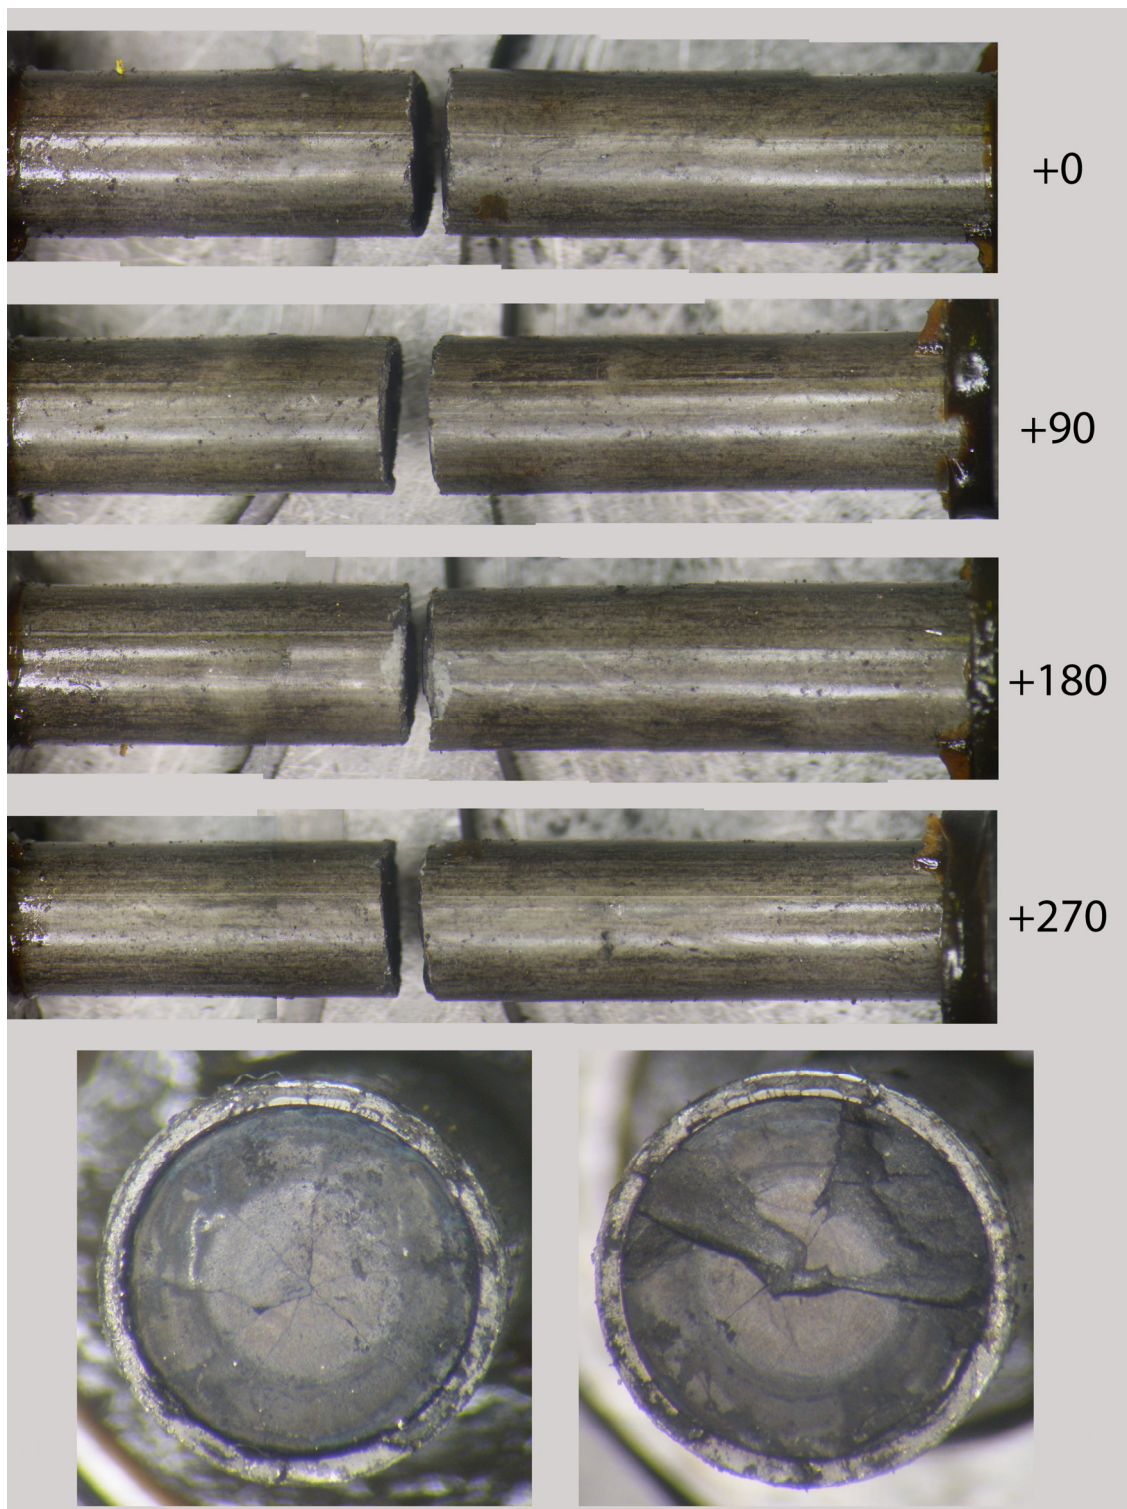
Figure F-22. 3D8E14-2963-3116 post-fatigue test condition.

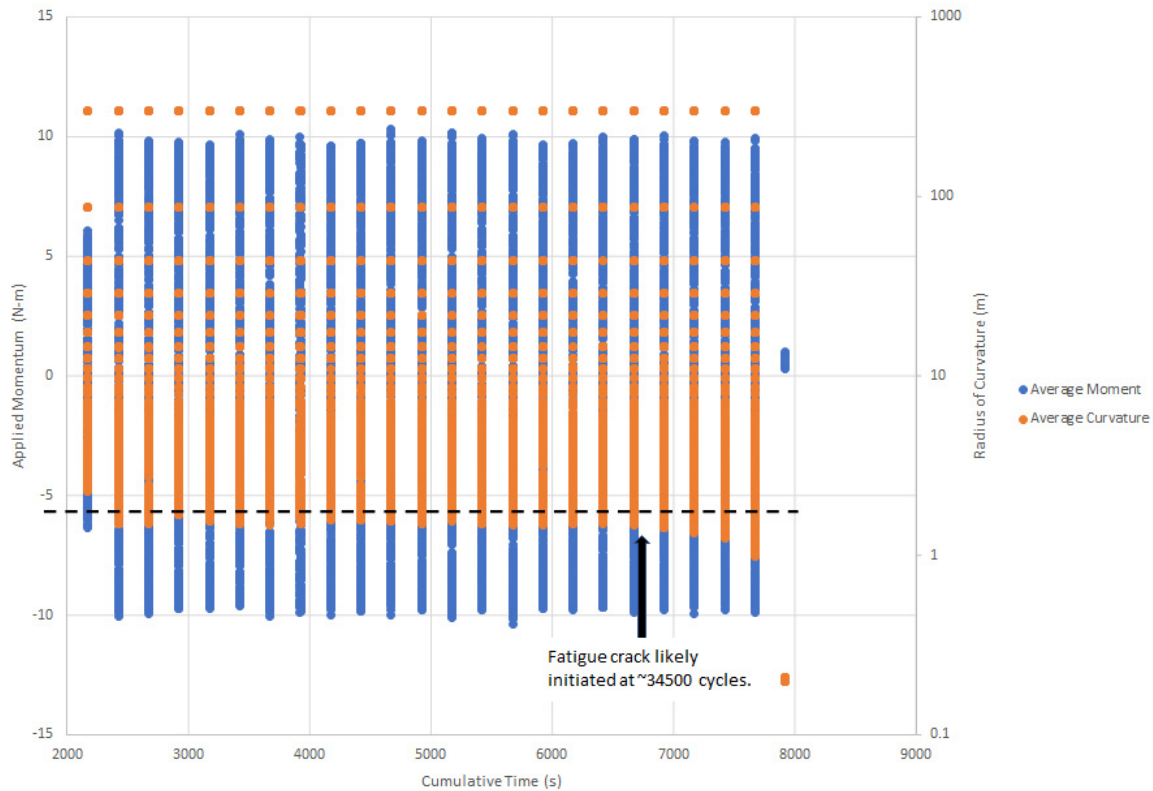
**Figure F-38. Applied moment and measured radius of curvature as a function of cumulative time for the final test session of 3D8E14-2963-3116. The decrease in radius of curvature is likely caused by the initiation and growth of a fatigue crack.**

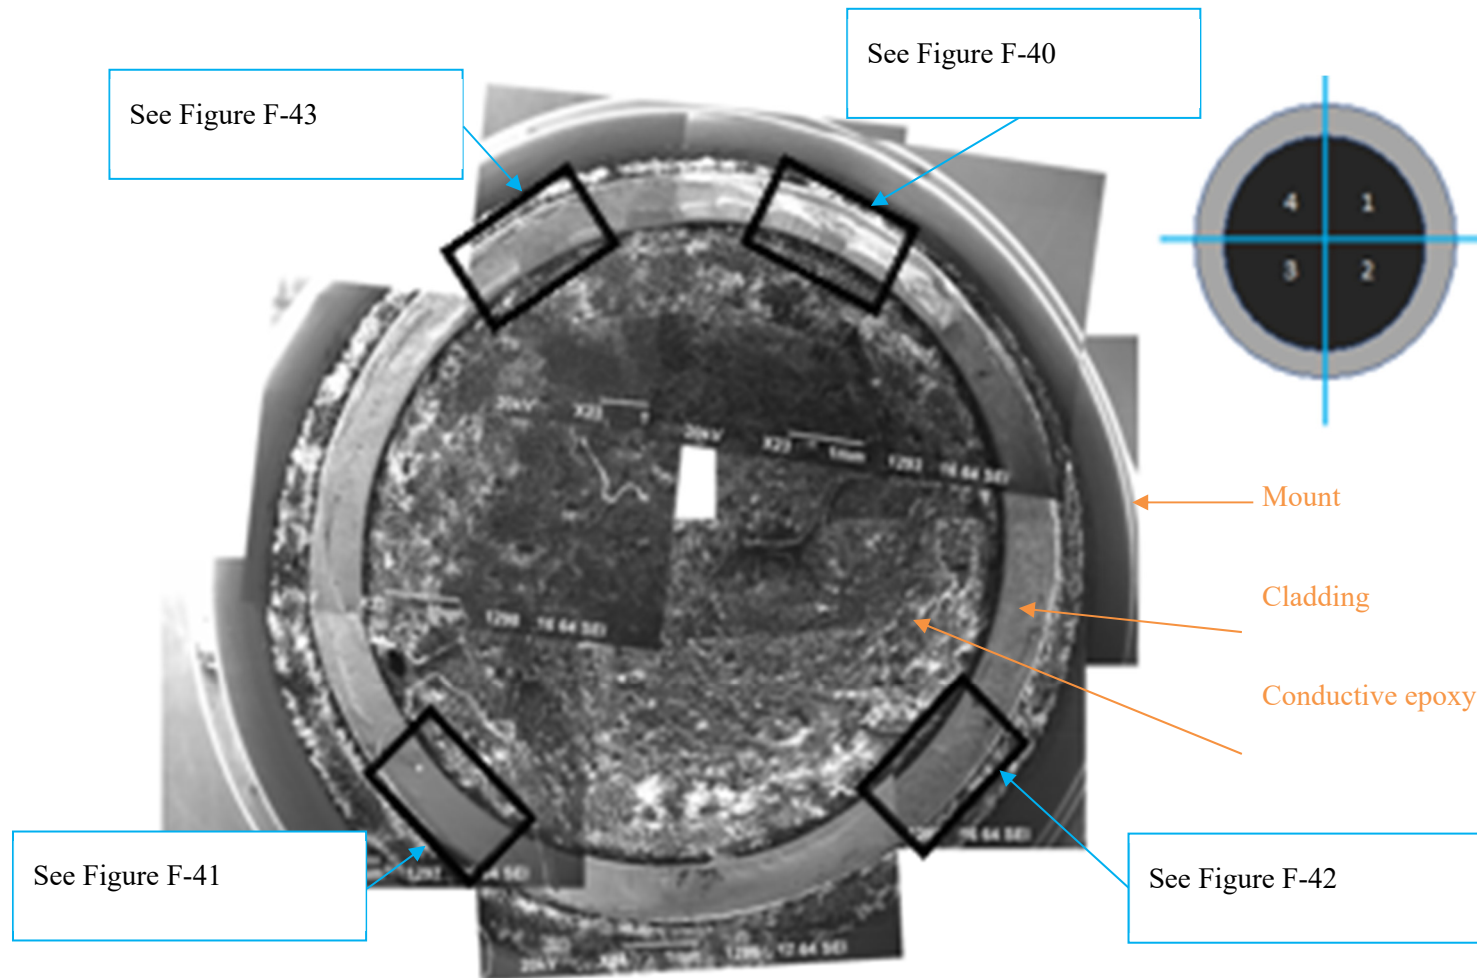
**Figure F-39. 23X montage of the surface of the fatigue failure in sample 3D8E14-2963-3116. The areas identified in the various quadrants were investigated at higher magnification (see Figures F-40 to F-43).**

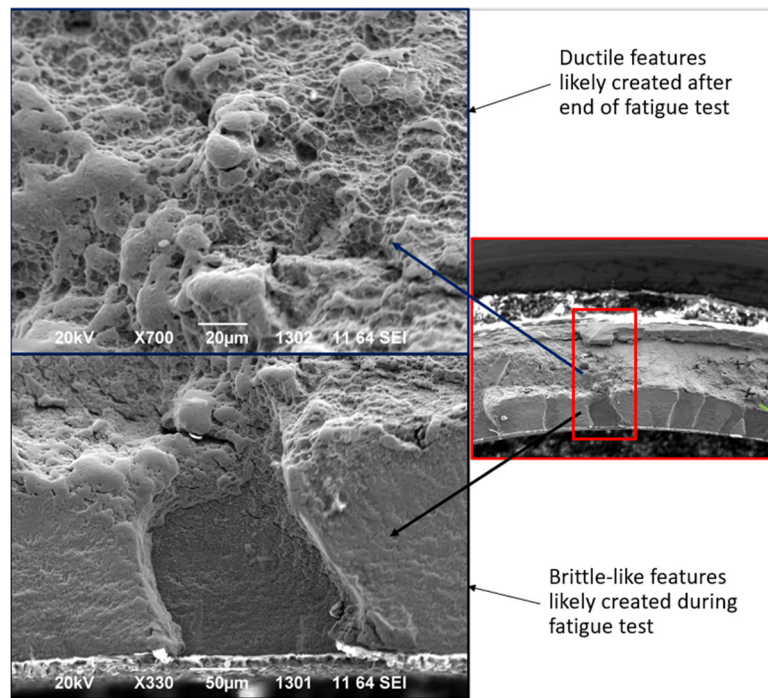
Figure F-40. 330× and 1,000× images of quadrant 1 in sample 3D8E14-2963-3116.

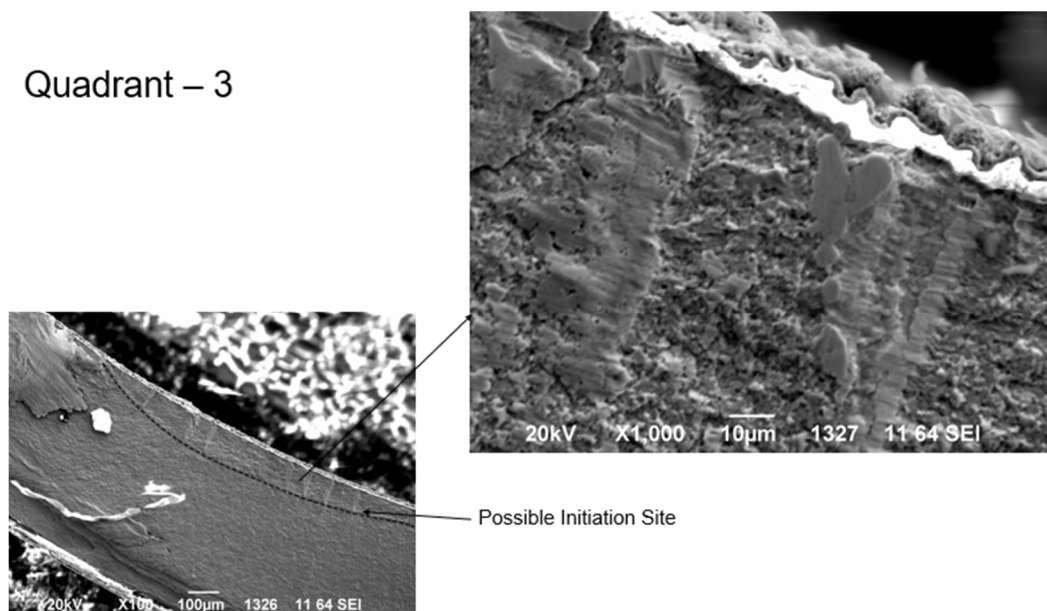
Figure F-41. 100× and 1,000× images of quadrant 3 in sample 3D8E14-2963-3116, approximately 180° from region in quadrant 1, that is suspected to have failed after fatigue test ended.

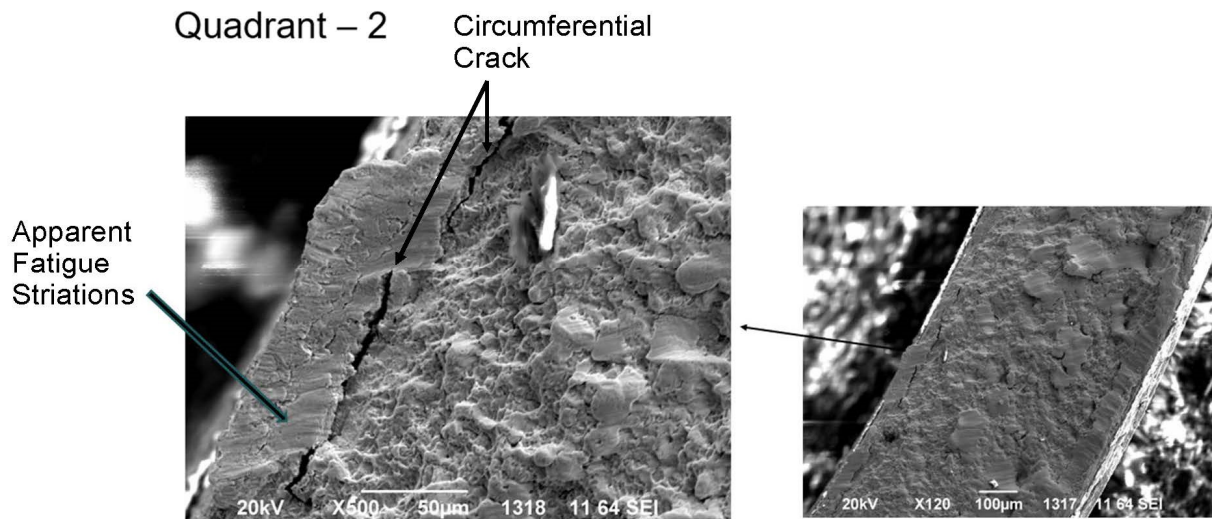
**Figure F-42. 120× and 500× images of quadrant 2 in sample 3D8E14-2963-3116, showing signs of fatigue striations typical of fatigue crack propagation, indicating propagation in the circumferential direction.**

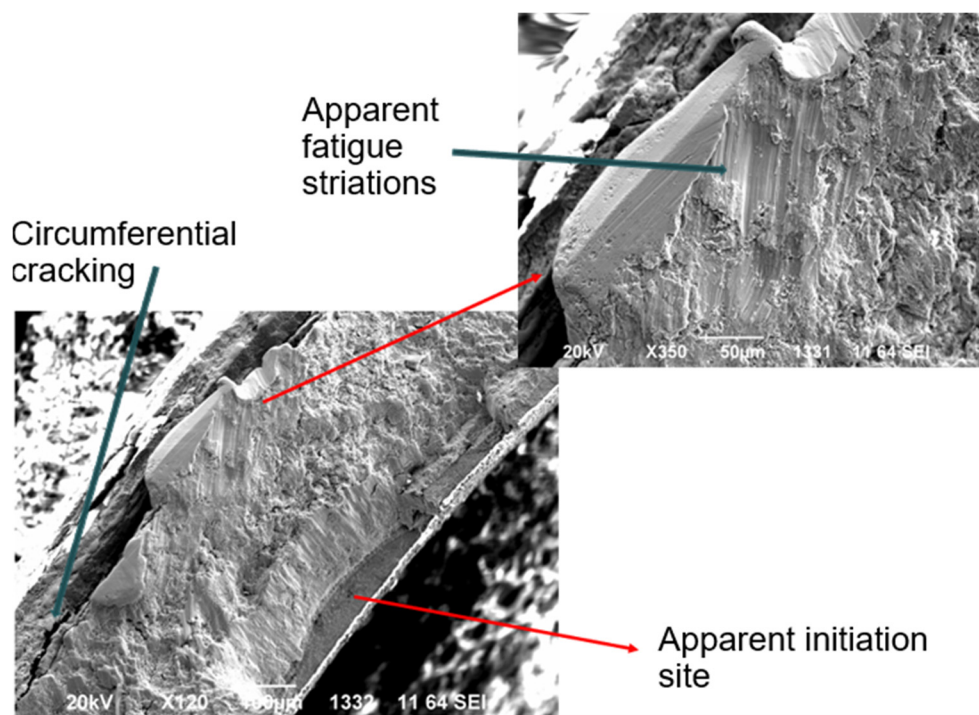
**Figure F-43. 120× and 350× images of quadrant 4 in sample 3D8E14-2963-3116 showing signs of fatigue striations typical of fatigue crack propagation. The flatness of the feature on the cladding ID may be associated with fatigue initiation. There are also circumferential cracks near the cladding OD that may be associated with hydrides.**
