*Sister Rod Destructive Examinations (FY21)*

# ***Appendix F: Cyclic Integrated Reversible- Bending Fatigue Tests***

## **Spent Fuel and Waste Disposition**

*Oak Ridge National Laboratory*

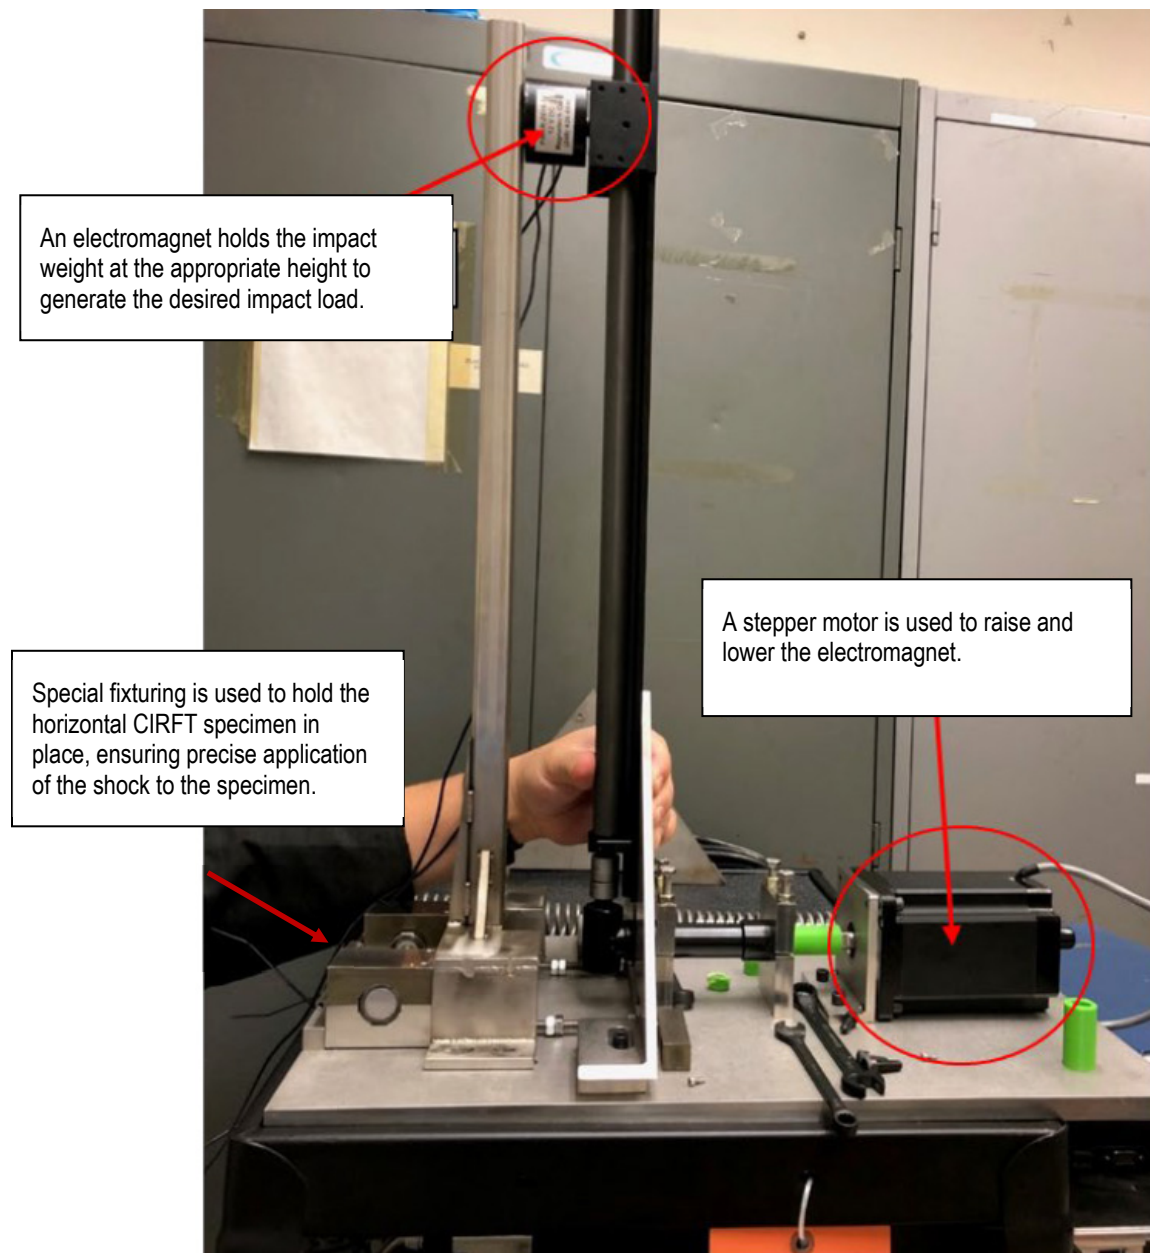
**Figure F-44. Cumulative shock fixture developed to apply a normal transport condition shock before fatigue testing.**

Equipment for performing the cumulative shock tests, as shown in Figure F-44, was developed and is currently being tested out-of-cell. The design incorporates an electromagnet and weight and uses gravity to deliver one or more impacts to the CIRFT specimen before fatigue testing. The parameters for the impact (e.g., impact load, number of impacts) have not yet been established. To help determine the necessary drop height, impactor weight, and impactor weight geometry for postulated normal condition impacts, a finite element model was developed for the impact system. The model and results are discussed in the following sections.

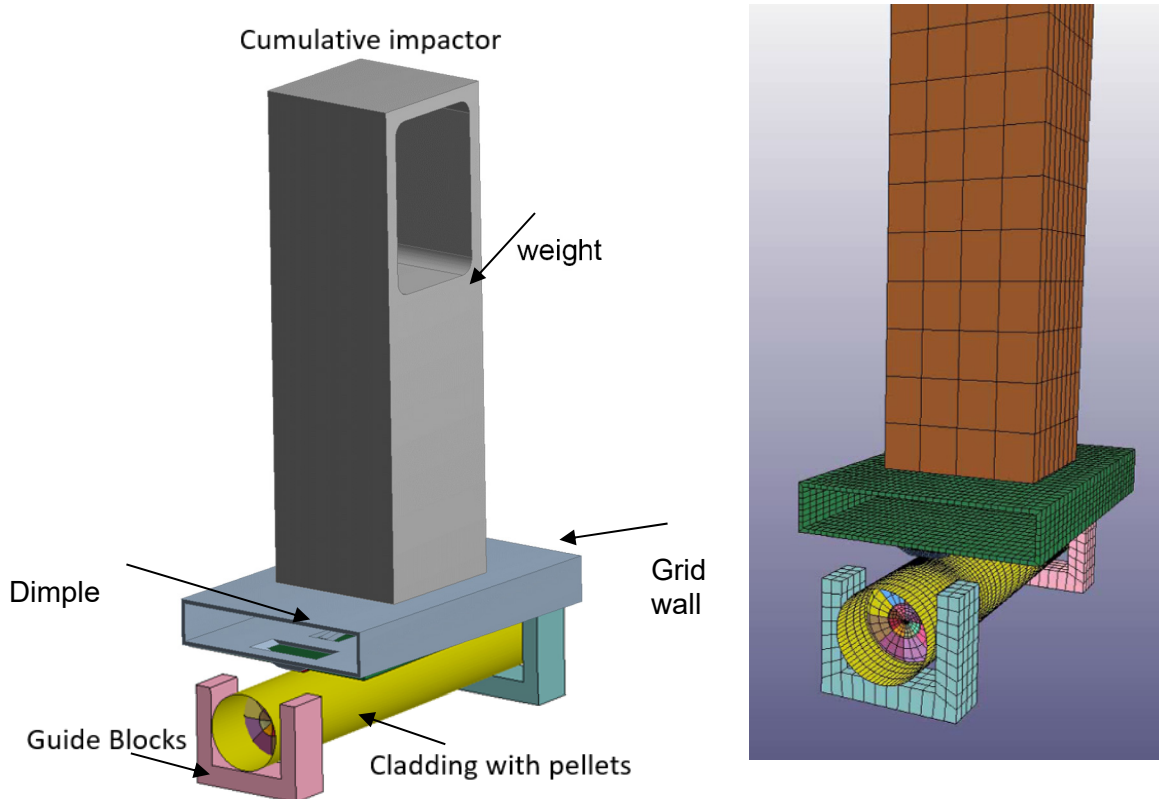
**Figure F-45. The cumulative impactor CAD model (left) and finite element model (right) include a rod segment with discrete pellets, guide blocks, and a weight with impact geometry.**

Structurally insignificant features such as small curves and lines such as fillets and chamfers were omitted from the finite element model. The omitted features are small and are not expected to significantly influence the structural response. The mesh element size near the impact zone was 0.5 mm; all other element sizes ranged from 0.5 to 2 mm. The cladding was modeled using linear shell elements.

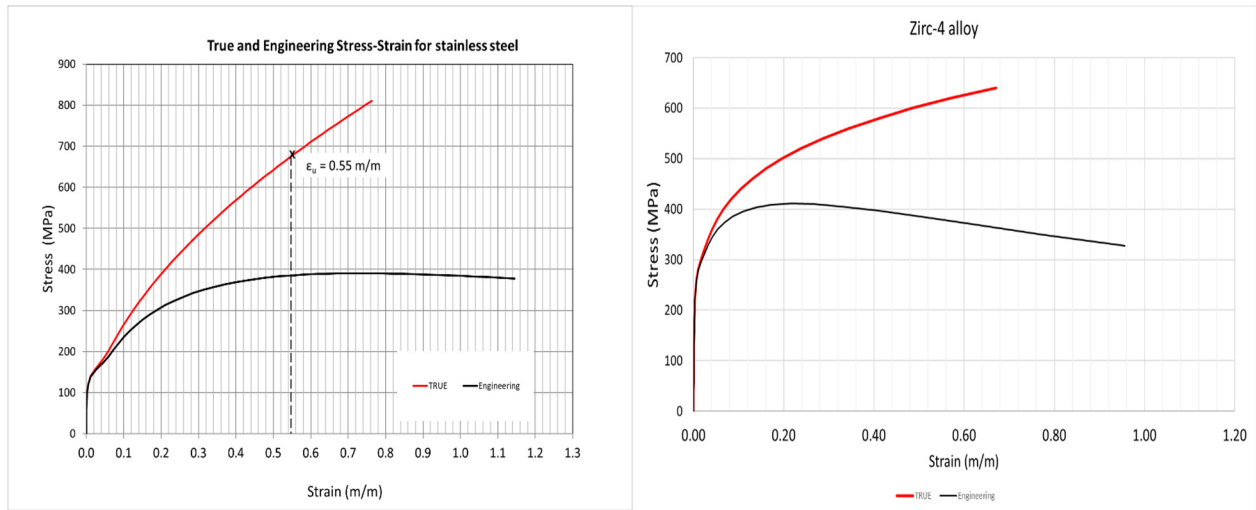
**Figure F-46. 304 stainless steel (left) and Zirc-4 (right) true stress–strain curves used compared with corresponding engineering stress–strain curves.**

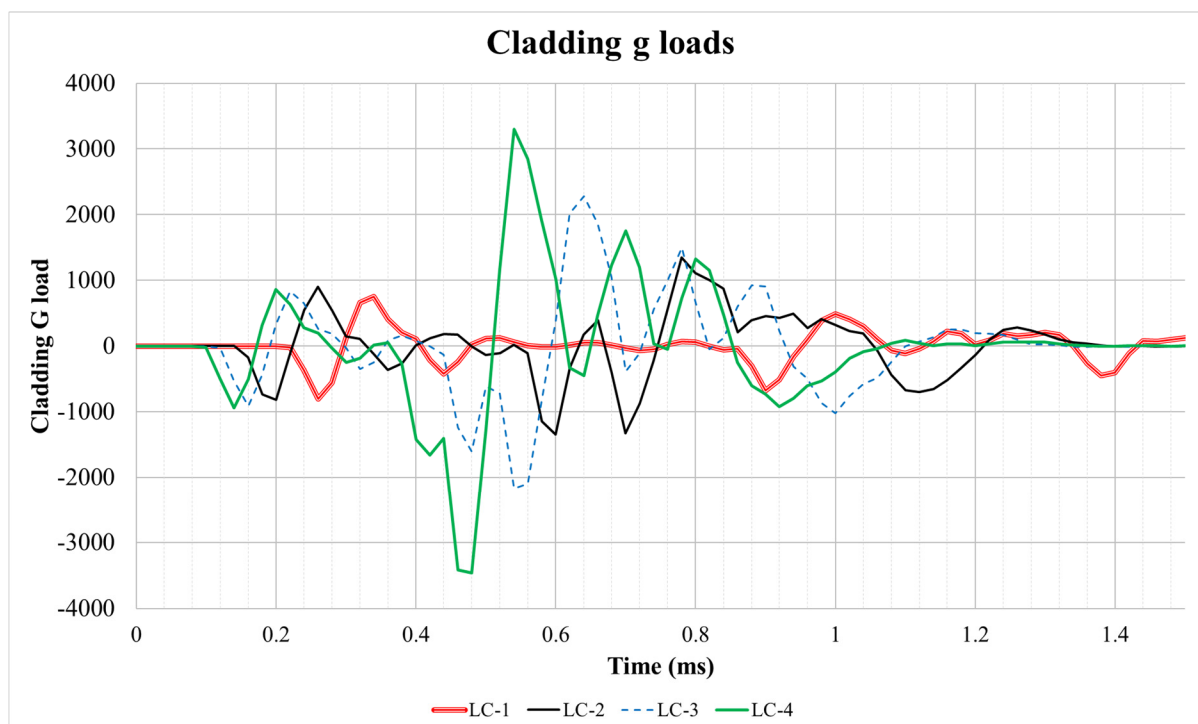
Figure F-47. Impactor end configuration (a) results for load cases 1–4.

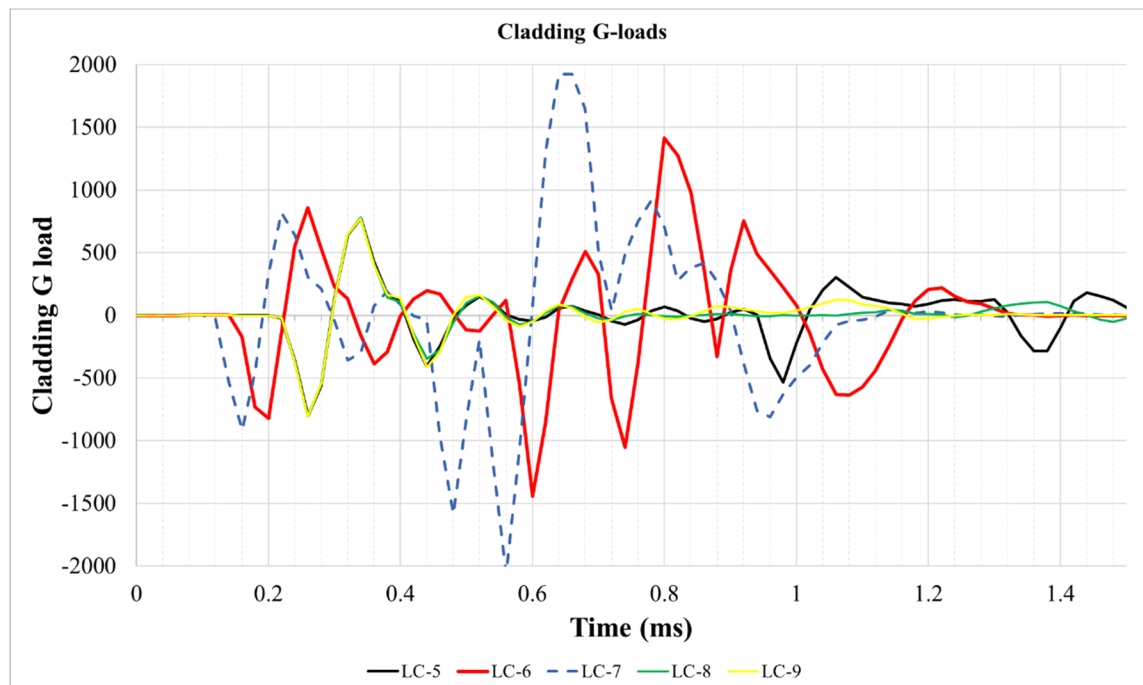
**Figure F-48. Impactor end configuration (a) results for load cases 5–9.**

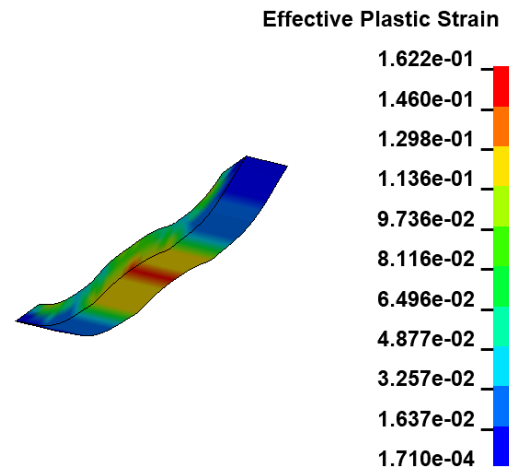
**Figure F-49. Plastic strain occurred on the dimples for impactor end configuration (a).**

None of the combinations resulted in a g-load below 20 g. For example, the results from impactor end configuration (d), the plate with dimples, are provided. The impactor-applied g-load as a function of time is provided in Figure F-47 for load cases 1–4 and in Figure F-48 for load cases 5–9. For this impactor geometry, the initial impact takes less than 0.3 ms, after which the weight is rebounded. The g-load on the rod during the impact ranges from 781 to 3,298 g, as listed in Table F-11. Load case 4 has the highest drop height and heaviest weight, and it resulted in the maximum g-load because it had the largest potential energy when compared with the other load cases. Load cases 1, 8, and 9 resulted in a cladding g-load less than 800. All load cases resulted in g-loads greater than 500, with multiple shock waves on the cladding and localized plastic strain on the impactor weight dimples, as shown in Figure F-49.

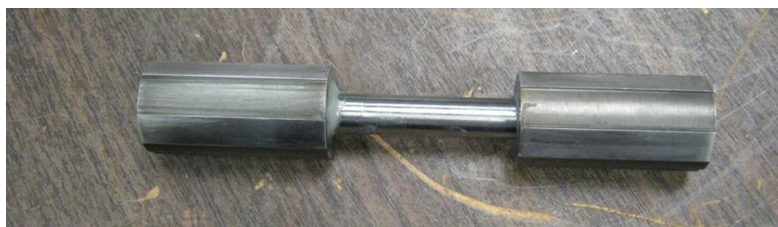
**Figure F-50. CIRFT dogbone.**

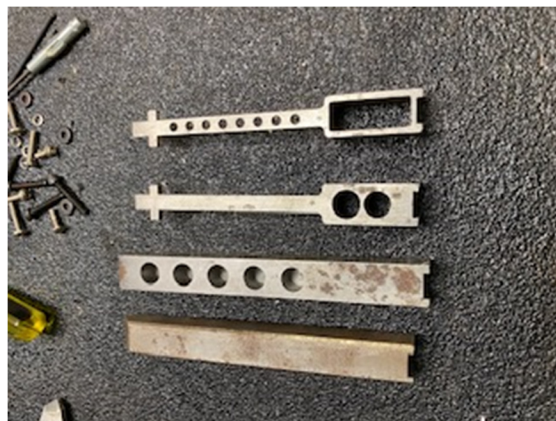
Figure F-52. Impactors used in the physical tests.
