Sister Rod Destructive Examinations (FY21)

Appendix E: Mechanical Testing

Spent Fuel and Waste Disposition

M2SF-22OR010201042

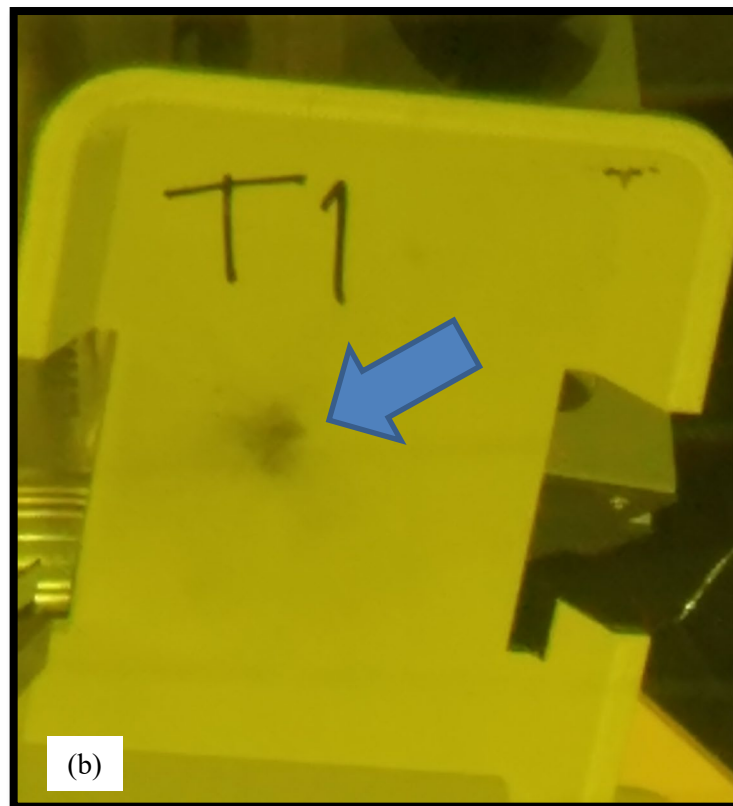
Figure E-19. (a) Post-test debris was captured by a catch tray located below the specimen with (b) the typical RT debris field composed of small particles.

The catch tray placed below each specimen during testing collected most of the debris. As shown in Figure E-19(a) and (b), when fracture occurred at pellet-pellet ends, the debris consisted of small particles. A more rigorous method of capturing and quantifying dust-type debris has been implemented and is described in Appendix I.

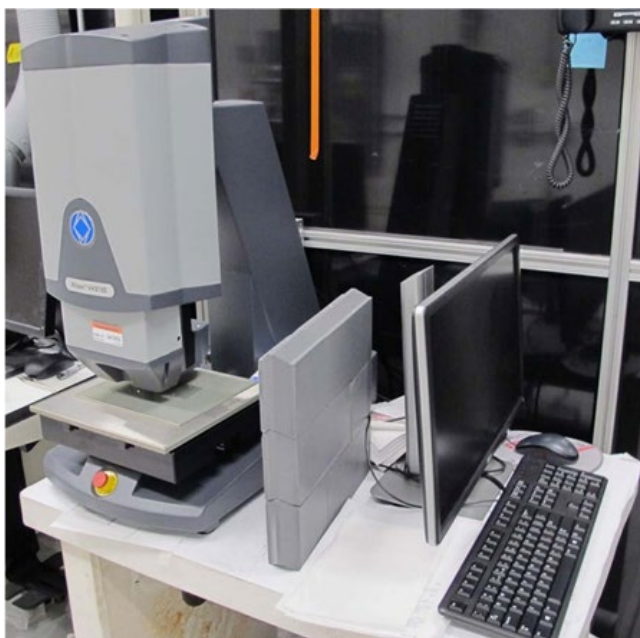
Figure E-20. LAMDA laboratory's Buehler Wilson VH3100 Microhardness Tester.

Tests at LAMDA were performed at RT using the Buehler Wilson VH3100 Microhardness (Figure E-20) tester. The tester has both Vickers and Knoop indentation capability with a maximum load capacity of 10 kg. All tests in this report were completed using a Vickers indenter.
