**Post-Invasion Damage Assessment:
Ukraine's Crop Storage Infrastructure**
8 September 2022

Yale SCHOOL OF PUBLIC HEALTH
Humanitarian Research Lab

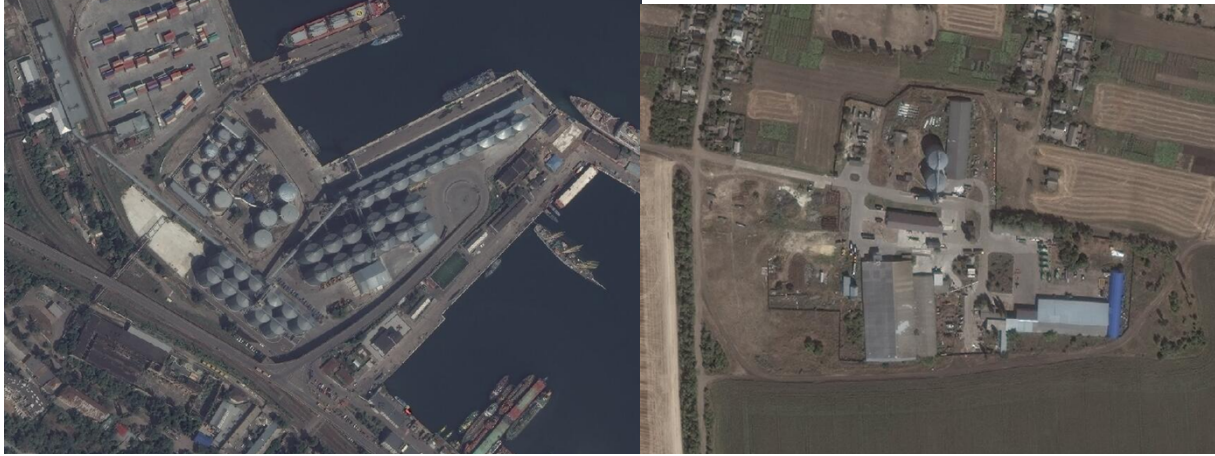
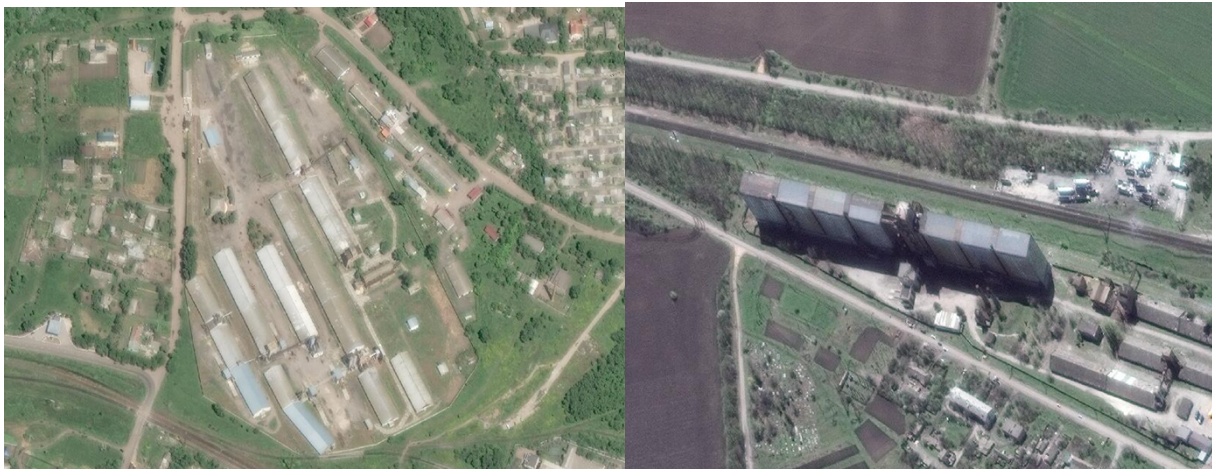
1.A. 241k tonne capacity shipping facility ©2022 Maxar Technologies 1.B. 9.5k tonne capacity rural grain facility ©2020 Maxar Technologies

1.C. 50k tonne capacity shipping facility ©2021 Maxar Technologies 1.D. 150k tonne capacity rural grain facility ©2022 Maxar Technologies

Figure 1. Example of grain facility morphology. Fig.1. A 241 tonne capacity shipping facility Brooklyn-Kyiv-ZPK¹² in Odessa. Fig.1.B 9.5 tonne capacity rural operation Safety SFH near Verkhoyansk. Fig.1.C Prometheus Artsyz Elevators, a 50k tonne capacity facility in Artsyz. Fig.1.D. Zhelev SS and the Kamysh-Zaryansky Elevator Company, a 150k tonne facility in Komysh-Zoria.

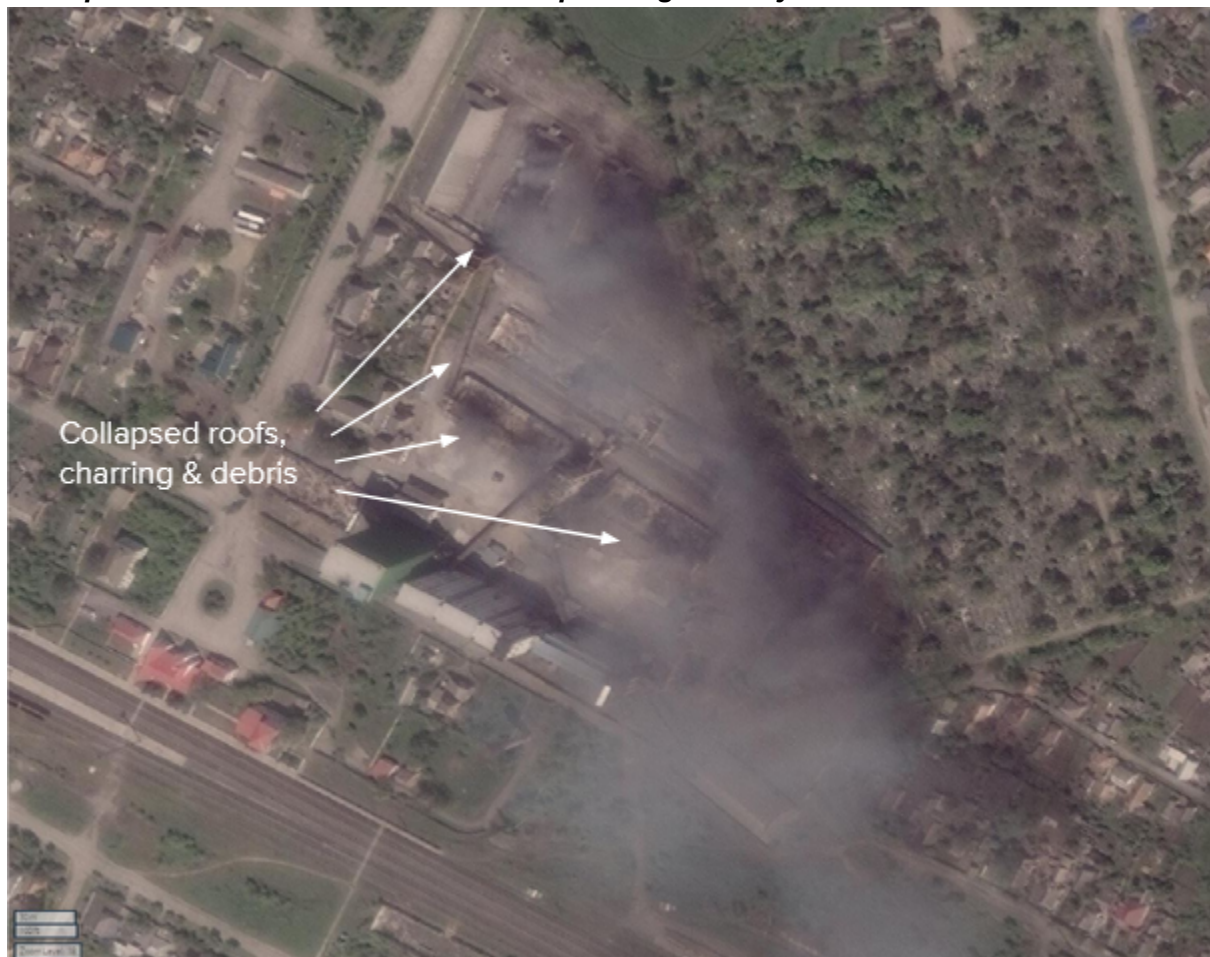
Example 1: Recent bombardment at crop storage facility

Figure 8. *Orikhiv VSP Optimus Agro Trade Zaporizhzhia Oblast on 2022-05-11. There appears to be substantial smoke emanating from large areas of damage that is consistent with the apparent effects of heavy artillery and/or missile fire: collapsed roofs, severe charring, and substantial debris.*

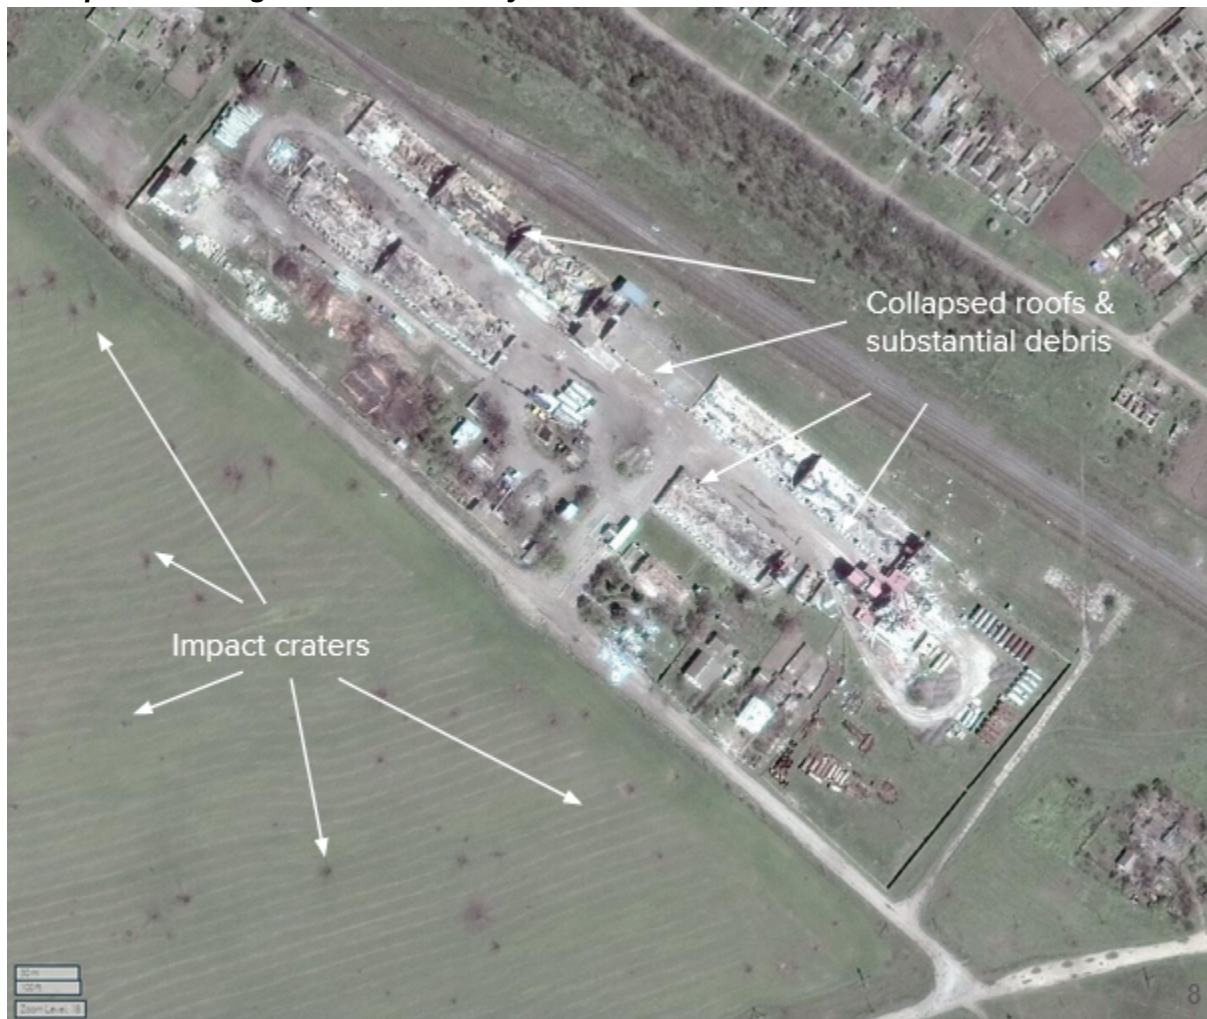
Example 2: Damaged elevator facility

Figure 9. Global Grain (Kopan HPP) in Kherson Oblast. Destroyed grain elevators surrounded by debris and discoloration on 2022-08-23. Impact of craters are visible south west of the compound.

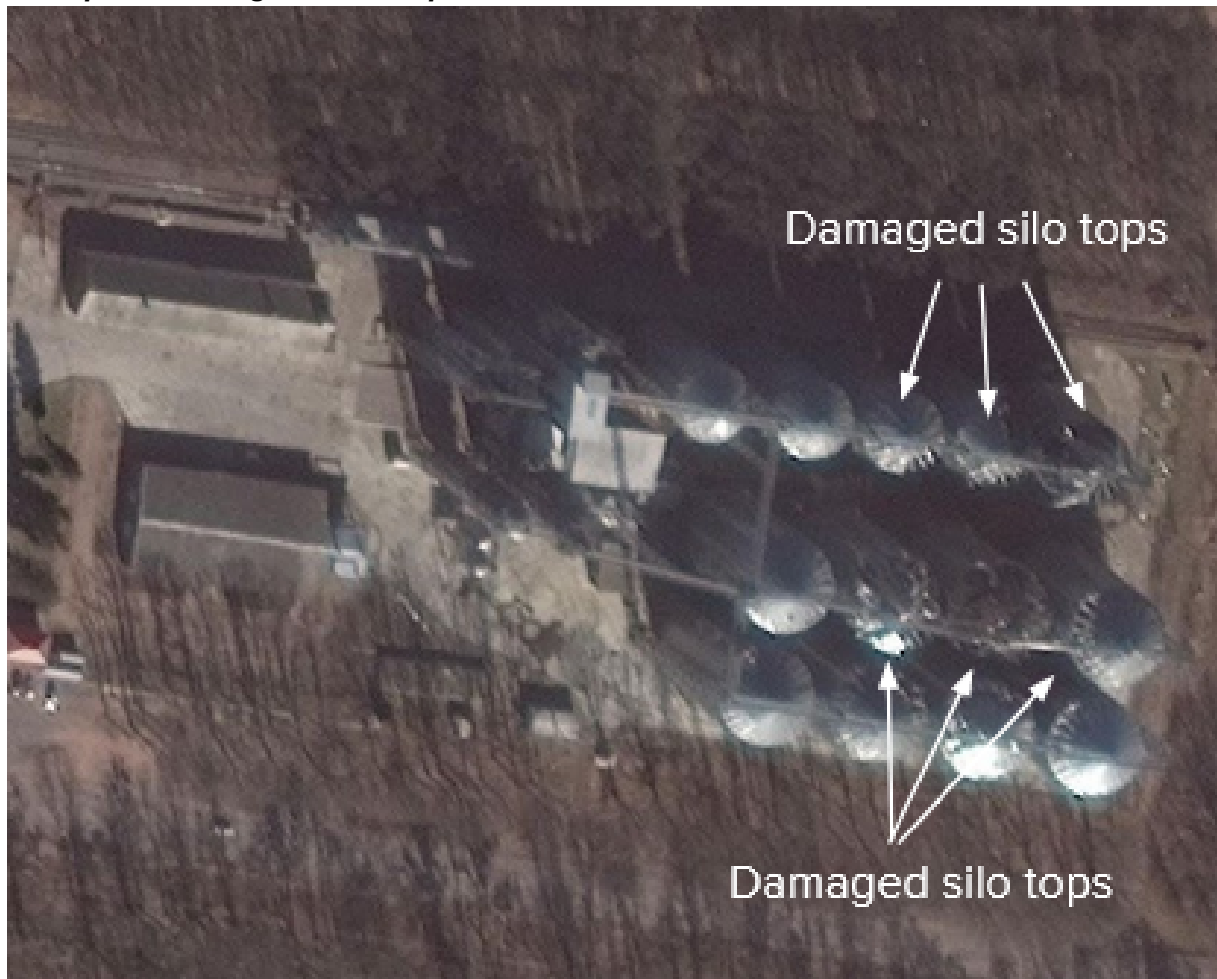
Example 3: Damaged silo complex

Figure 10. Porttransbud (Ovruch Branch Rise) in Zhytomyr Oblast. There are dark markings on the tops of at least six of the facility's silos, with the greatest apparent damage to the silo in the second row, second from the right/east. Visible damage sustained by silos as of 2022-02-27.

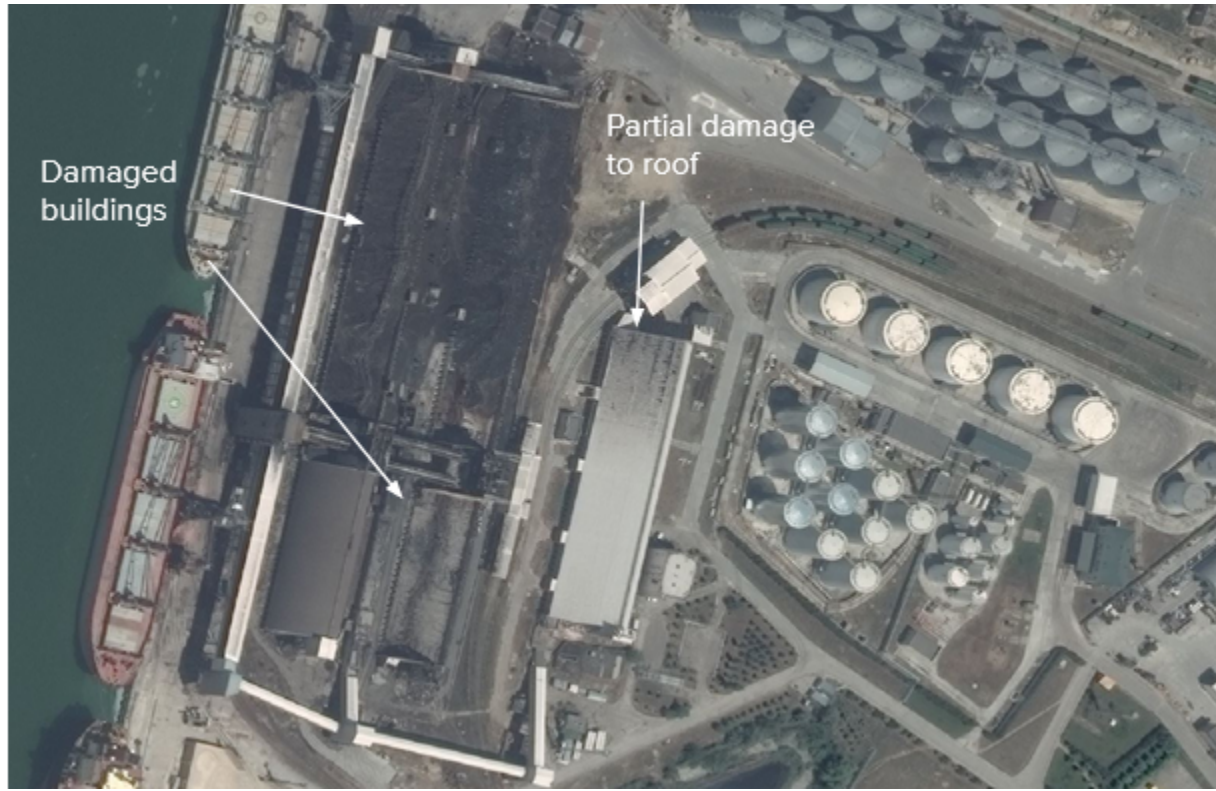
Example 4: Damaged crop storage facility at shipping complex

Figure 11. SME Niko-Terra facility in Mykolaiv Oblast. Multiple structures within a grain facility compound have been visibly damaged. The structures in the western part of the complex are destroyed: roofing is either partially or entirely collapsed and extensive charring is visible as of 2022-07-05.

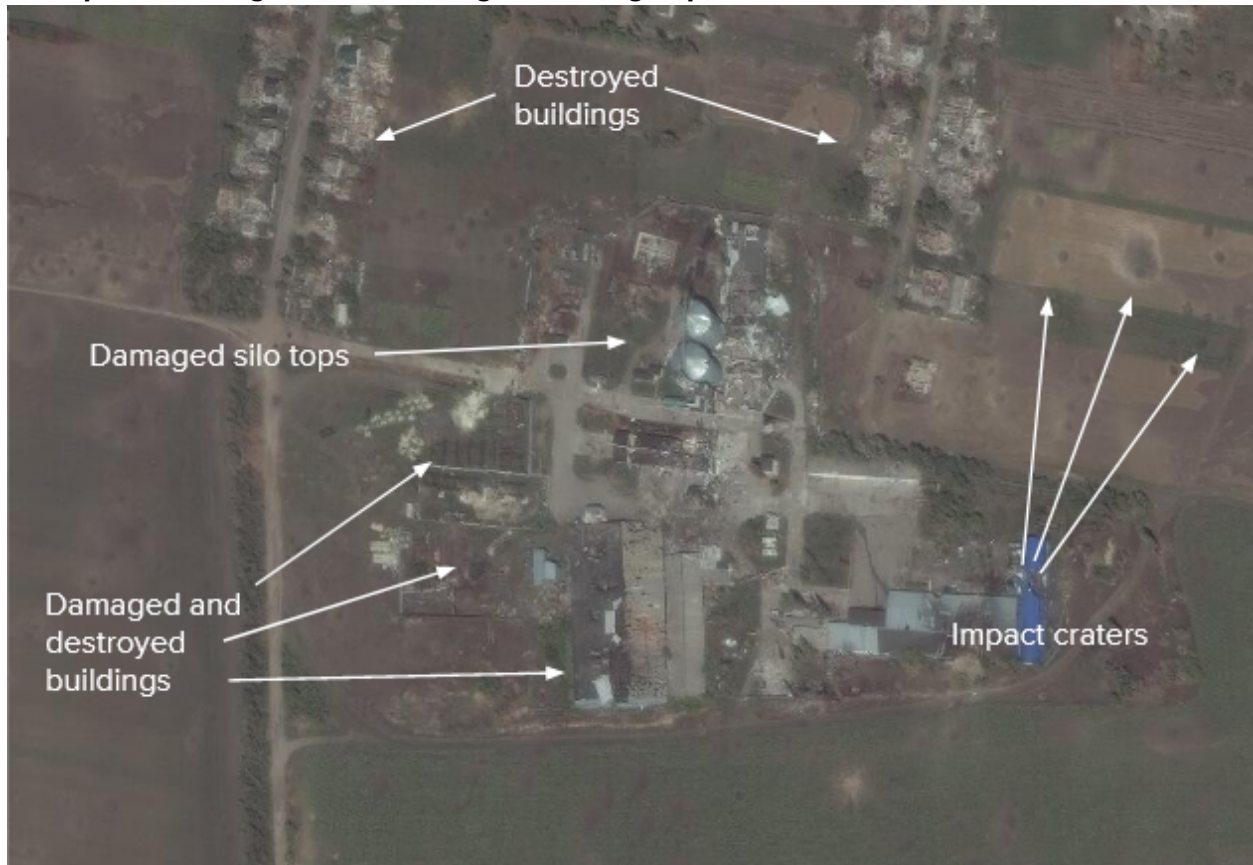
Example 5: Damaged small-scale grain storage operation

Figure 12. Safety SFH in Donetsk Oblast on 2022-09-06. Extensive damage is observable throughout the facility and nearby houses. Impact cratering can be seen in and around the facility.
